Release Notification and Corrective Action

Name of Company Apache Corporation	Contact Trammell, De Valle
Address PO Box 1849, Eunice, NM 88231	Telephone No. (575) 393-7106
Facility Name H Corrigan Battery	Facility Type Tank Battery

Describe Cause of Problem and Remedial Action Taken.*
The produced water tank at the H Corrigan Tank Battery was hit by lightning on May 10, 2013 which caused the release of 120 barrels of produced water. Vacuum trucks were called to the site and recovered a total of 110 barrels. The site was field sampled at the surface and representative samples were taken to a commercial laboratory for analysis.

**APACHE H
CORRIGAN
BATTERY AD**
LEGALS: UL/G sec. 4
T-22-S R-37-E
LEA COUNTY, NM

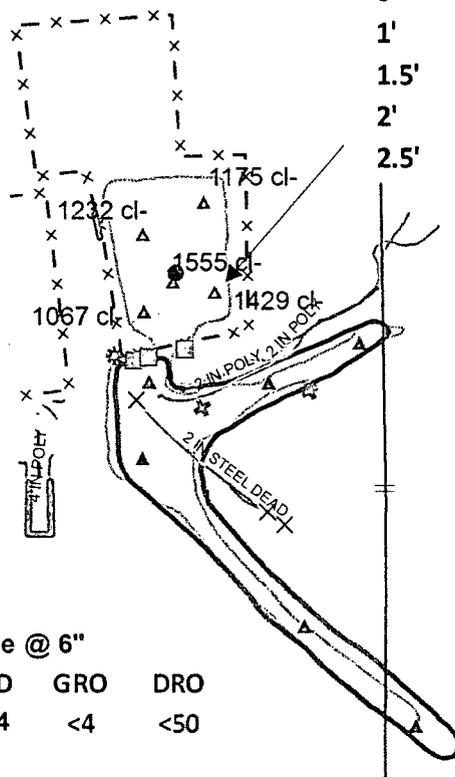
Excavation Sampling Data

9,504 total square feet affected
with 1,274 square feet in the pasture.

Depth	Cl-	GRO	DRO
surface	624	<4	203
6"	667		
1'	373		
1.5'	266		
2'	172	<20	1350
2.5'	98	<8	377

Cl-
73.5

Facility @ surface
5 pt comp Cl- PID
 1178 0

Cl-	PID	GRO	DRO
6 pt comp	63.7	5.4	<4	<50

Cl-	PID	GRO	DRO
surface	726	46.2	<80	1470
6"	564	88.5		
1'	462	64.2		
1.5'	451	31.2		
2'	535	33.7		
2.5'	384	16.6		
3'	255	4.4		
3.5'	126	9.3	<4	<50
4'	97	4.4	<4	<50

DGW = 81 ft

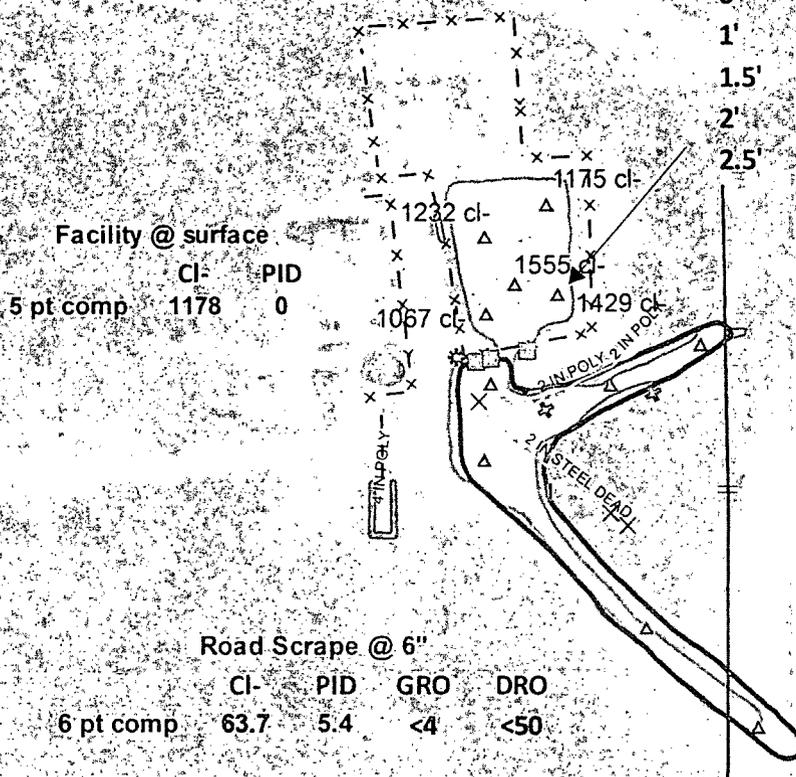
Excavation Sampling Data

9,504 total square feet affected
with 1,274 square feet in the pasture.

Depth	Cl-	GRO	DRO
surface	624	<4	203
6"	667		
1'	373		
1.5'	266		
2'	172	<20	1350
2.5'	98	<8	377

Imported caliche
Cl-
73.5

DGW = 81 ft

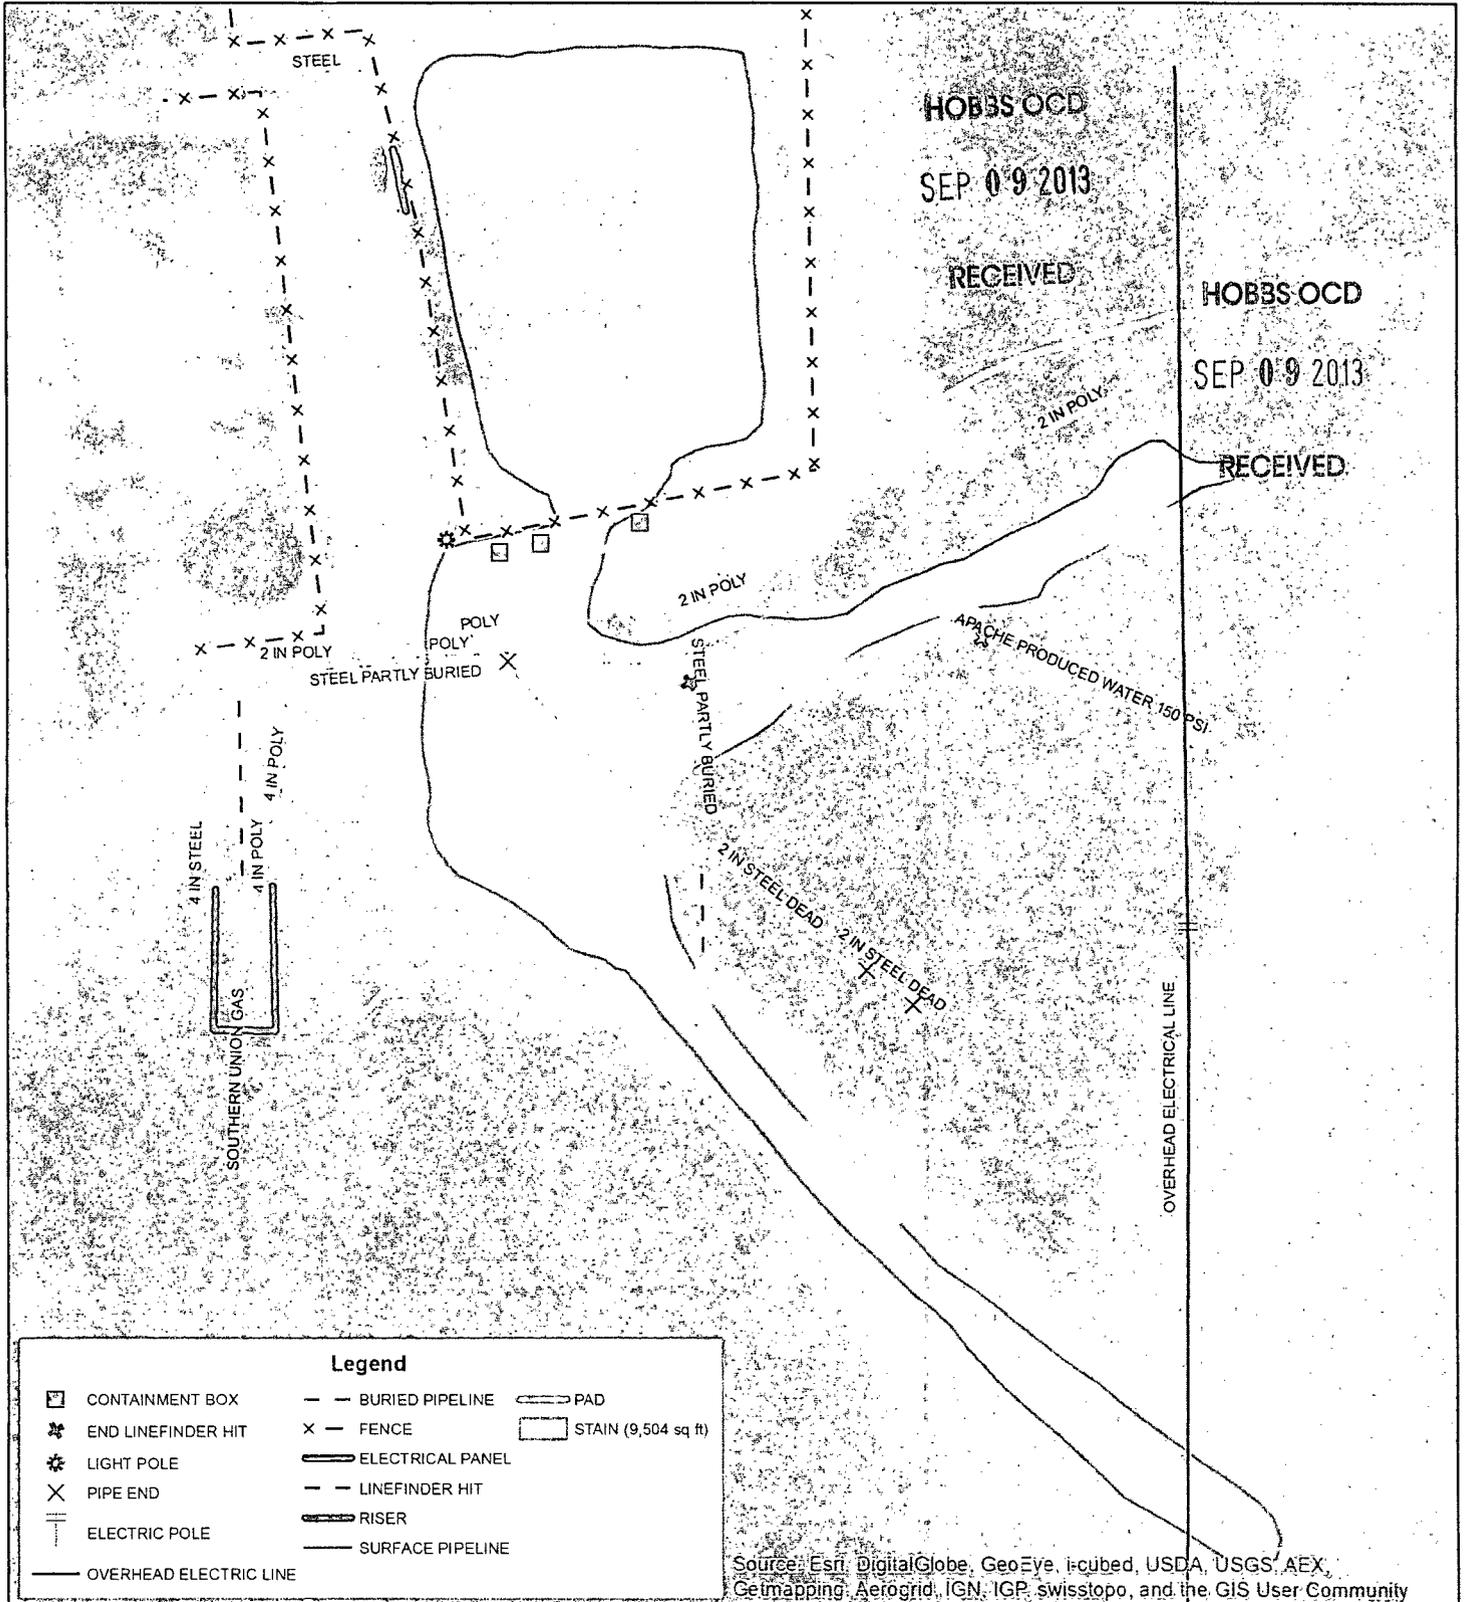
**APACHE H
CORRIGAN
BATTERY AD**
 LEGALS: UL/G sec. 4
 T-22-S R-37-E
 LEA COUNTY, NM

Legend		
	CONTAINMENT BOX	
	END LINEFINDER HIT	
	LIGHT POLE	
	PIPE END	
	ELECTRIC POLE	
	OVERHEAD ELECTRIC LINE

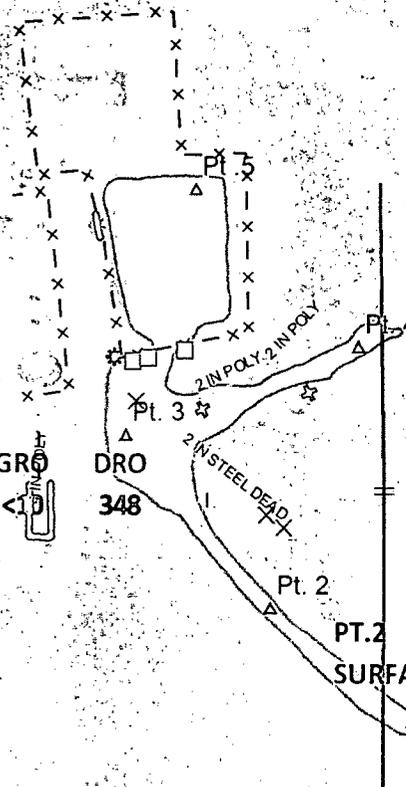
Initial Sampling Data

9,504 total square feet affected
with 1,274 square feet in the pasture.

PT.5 LAB CI- GRO DRO
SURFACE SAMPLE 1220 <10 100

PT.4 LAB CI- GRO DRO
SURFACE SAMPLE 1730 1070 5710

PT.3 LAB CI- GRO DRO
SURFACE SAMPLE 608 <10 348

PT.2 LAB CI- GRO DRO
SURFACE SAMPLE 816 <10 279

PT.1 LAB CI- GRO DRO
SURFACE SAMPLE 656 <10 337

DGW = 81 ft
