Release Notification and Corrective Action

NEDU #718

Closure Report

**RE: TERMINATION REQUEST
Apache – NEDU #718 AD
UL/P sec. 15 T21S R37E
API No. 30-025-34742**

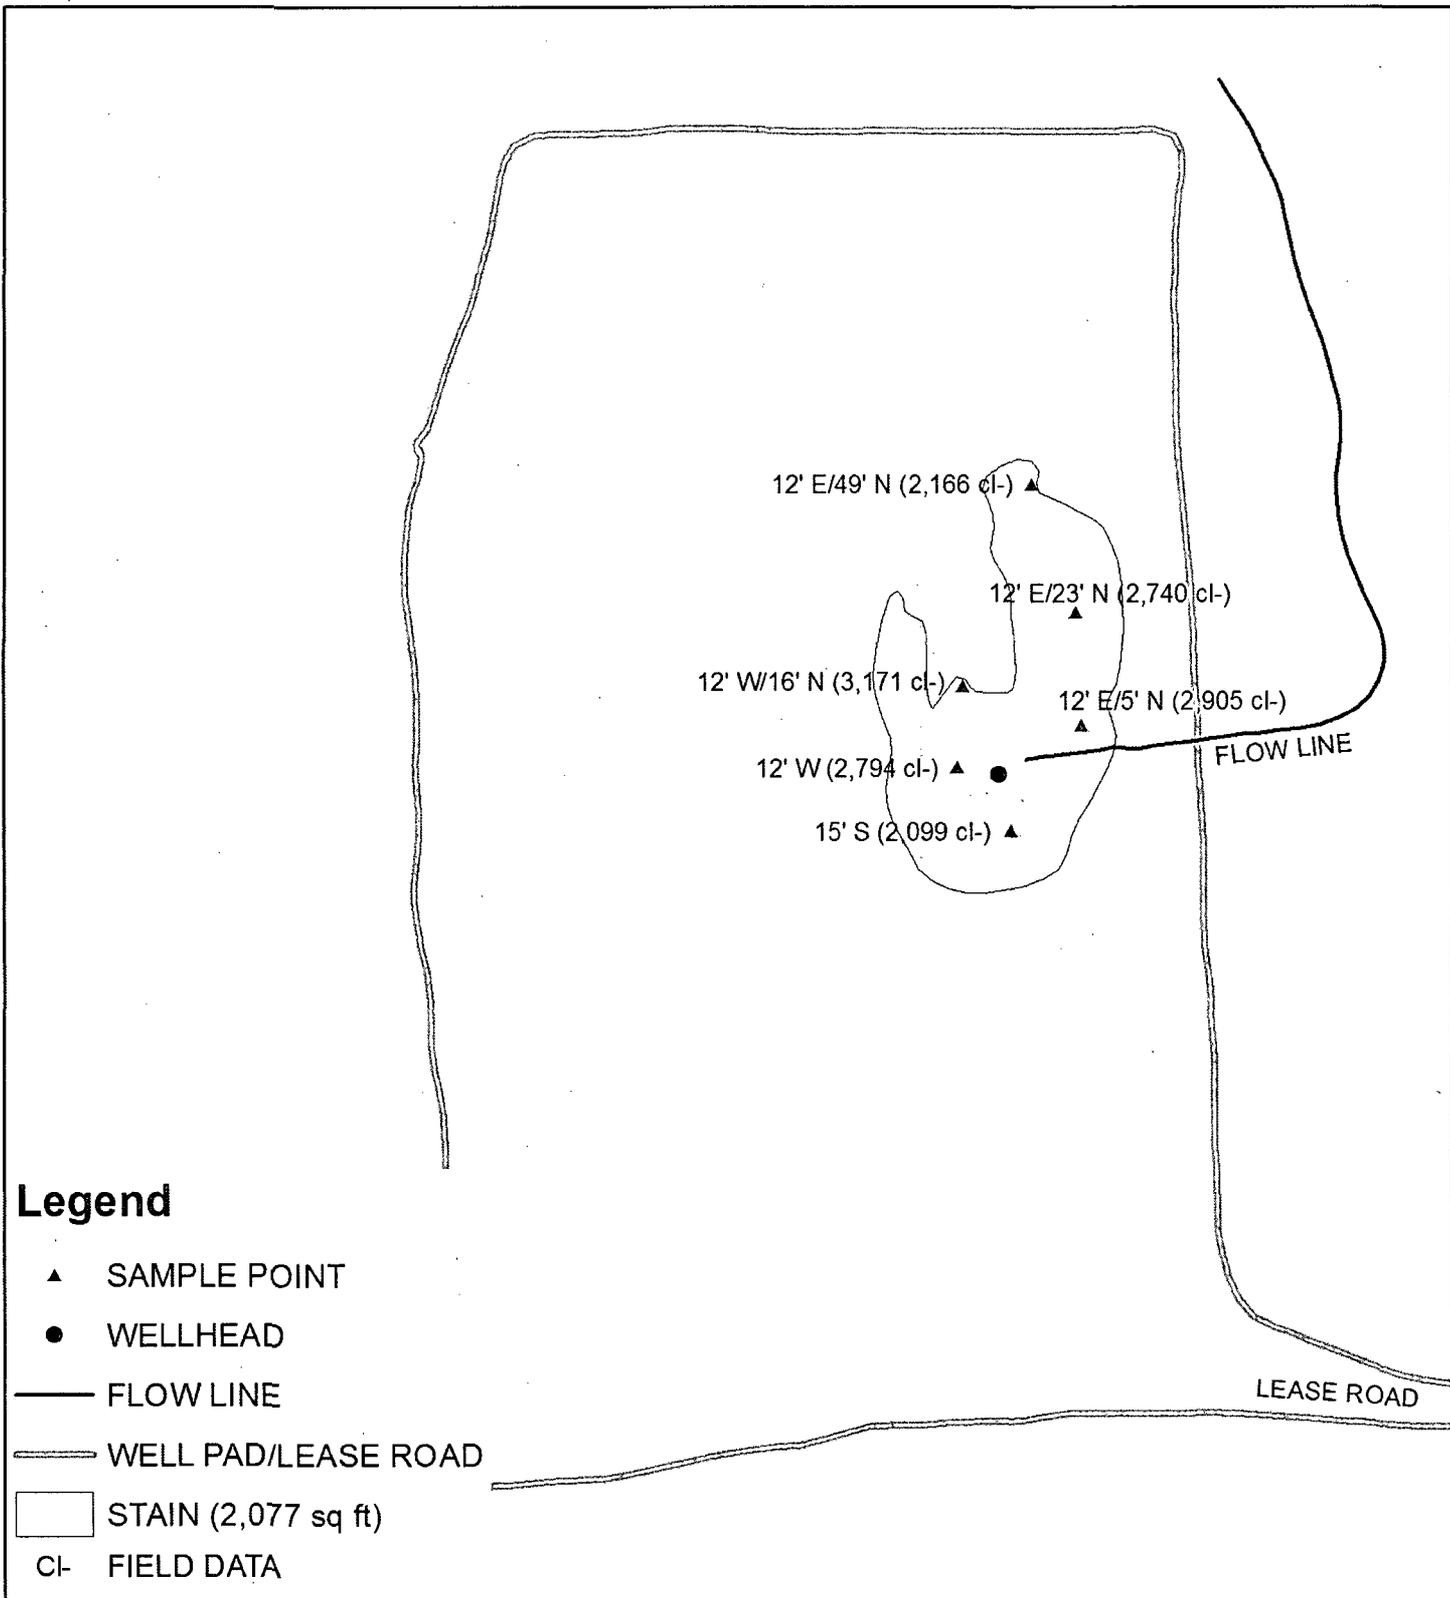
On August 19, 2011, RECS personnel initiated work on the NEDU #718. Soil samples were collected from the site as excavation of the leak proceeded and field tested for chloride (Figure 1). Headspace measurements were also taken in the field using a Photo Ionization Detector (PID). Excavation of the impacted area began, covering a lateral area of 2,077 ft².

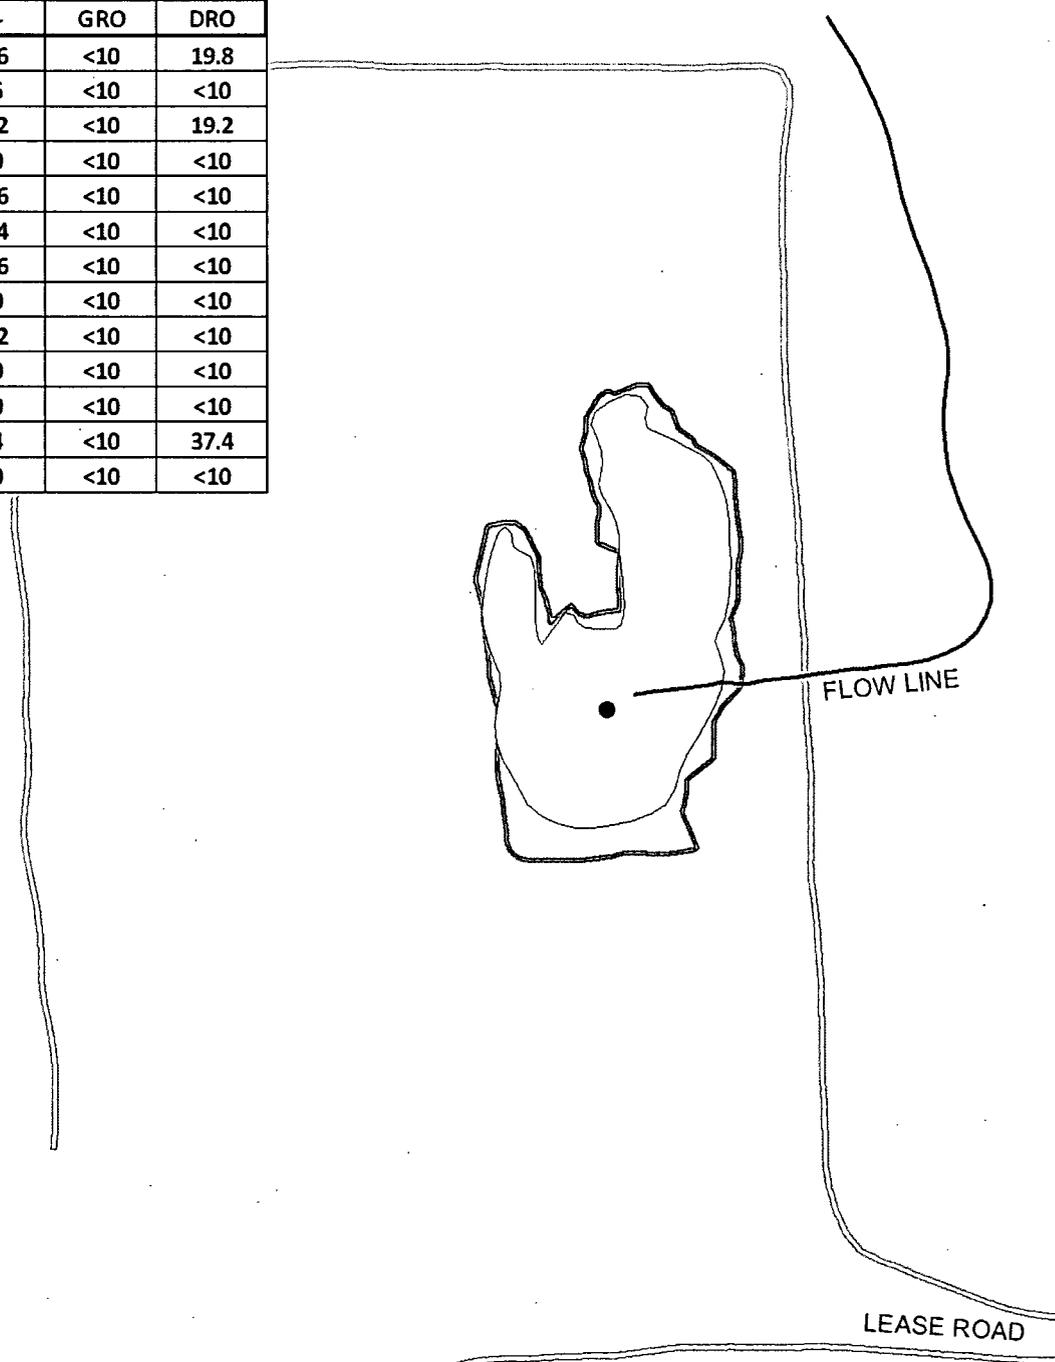
Figure 2

FINAL EXCAVATION LAB DATA

Sample Description	Cl-	GRO	DRO
W. WALL NORTH END	<16	<10	19.8
N. WALL EAST END	96	<10	<10
N. WALL WEST END	112	<10	19.2
S. WALL WEST END	80	<10	<10
S. WALL EAST END	<16	<10	<10
E. WALL NORTH END	224	<10	<10
E. WALL SOUTH END	<16	<10	<10
W. WALL SOUTH END	80	<10	<10
BOTTOM CENTER @ 2'	112	<10	<10
NW BOTTOM CORNER @ 2'	80	<10	<10
NE BOTTOM CORNER @ 2'	80	<10	<10
SE BOTTOM CORNER @ 2'	64	<10	37.4
SW BOTTOM CORNER @ 2'	80	<10	<10

- WELLHEAD
- FLOW LINE
- - - WELL PAD/LEASE ROAD
- STAIN (2,077 sq ft)
- EXCAVATION

On August 23, 2011, RECS personnel returned to the site and collected soil samples from the 2 ft. deep excavation (Figure 2). Representative grab samples were collected from the excavation walls and the excavation floor, and submitted to a commercial laboratory for chloride and TPH (GRO/DRO) analyses. Chloride did not exceed 224 ppm (parts per million or mg/kg) in the wall samples, or 112 ppm in the excavation floor samples. TPH did not exceed 37.4 ppm in all samples (Appendix C).

Impacted soils were removed from the excavation and transported to a NMOCD approved disposal facility. The excavation was backfilled with clean caliche and contoured to the surrounding area. See Appendix B for photographs of field activities.

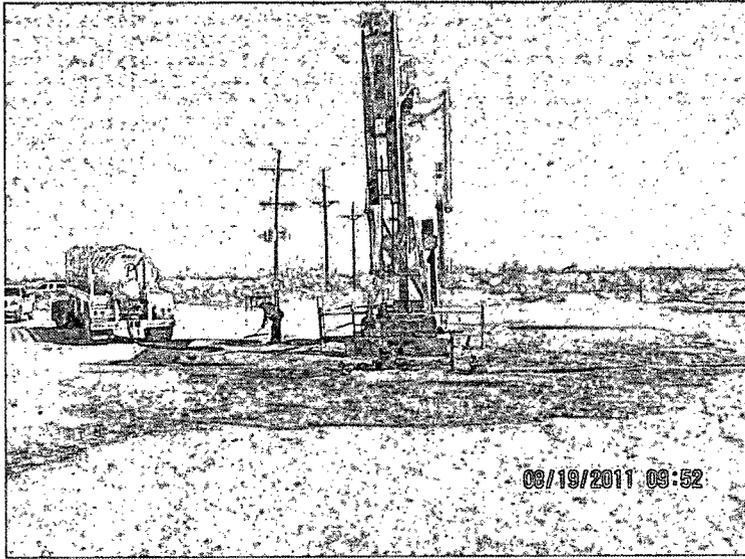
08/19/2011 09:52

Initial release, facing north

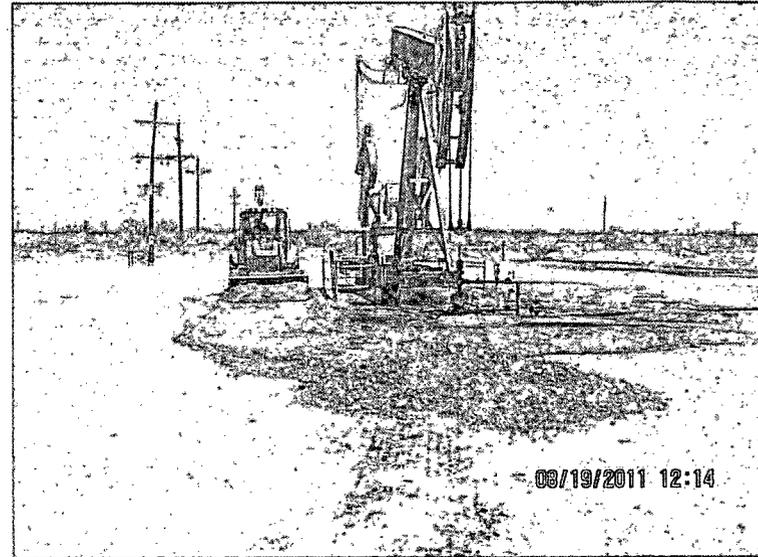
08/19/2011 12:14

Excavating release area, facing north

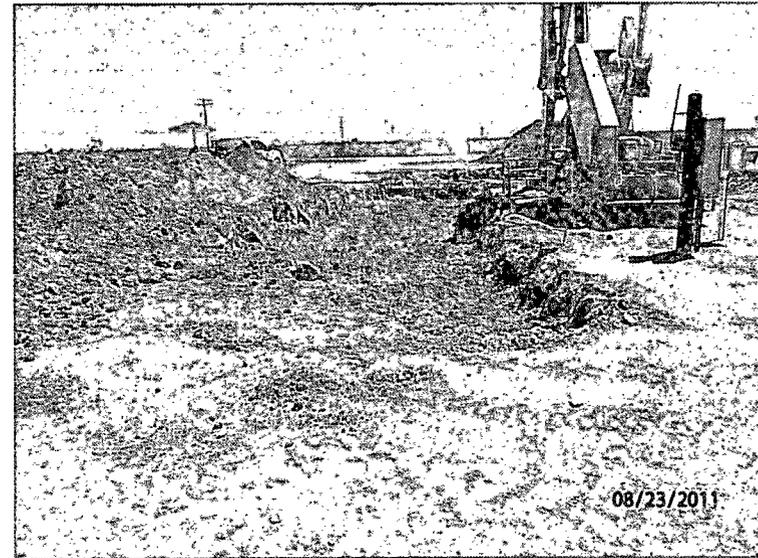
08/23/2011

Final excavation, facing south

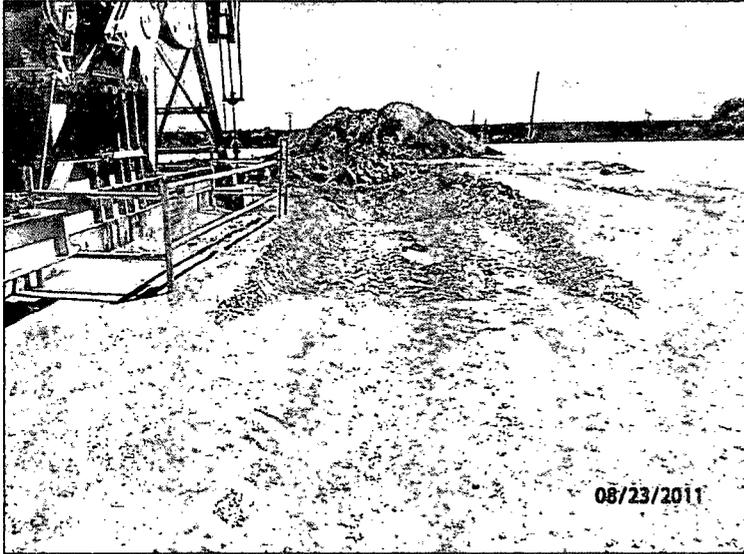
08/23/2011

Final excavation, facing south

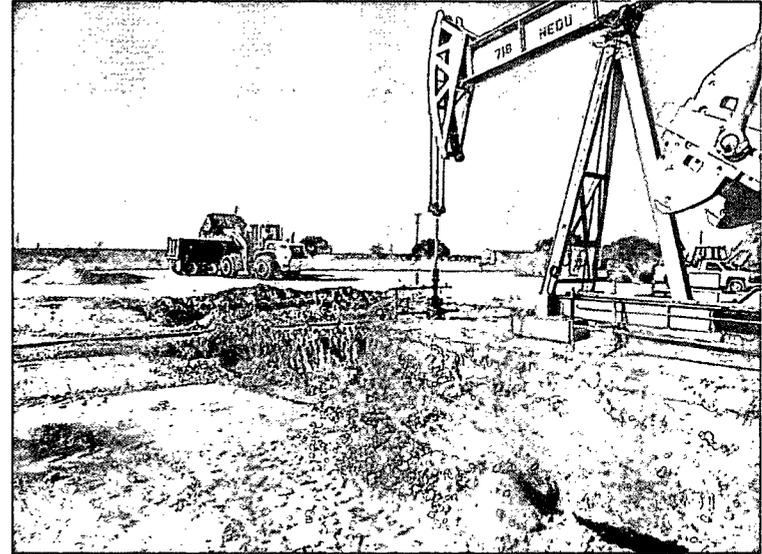
8/25/2011

Exporting soil, facing southwest

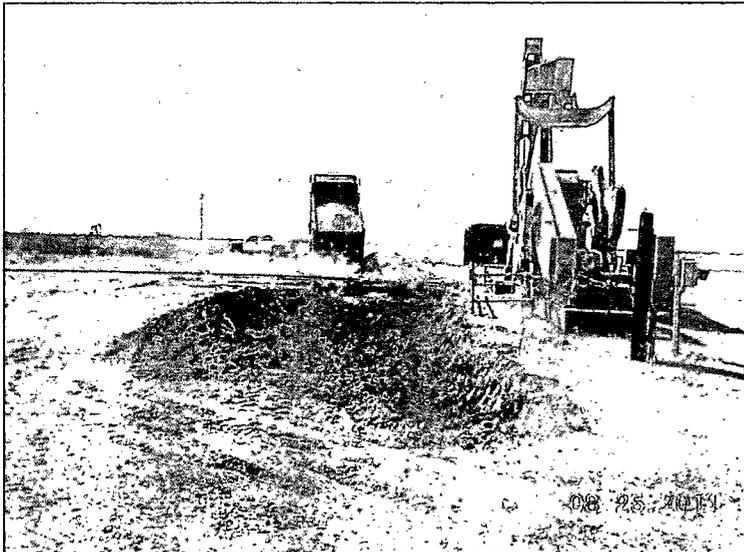
08.25.2011

Importing caliche, facing south

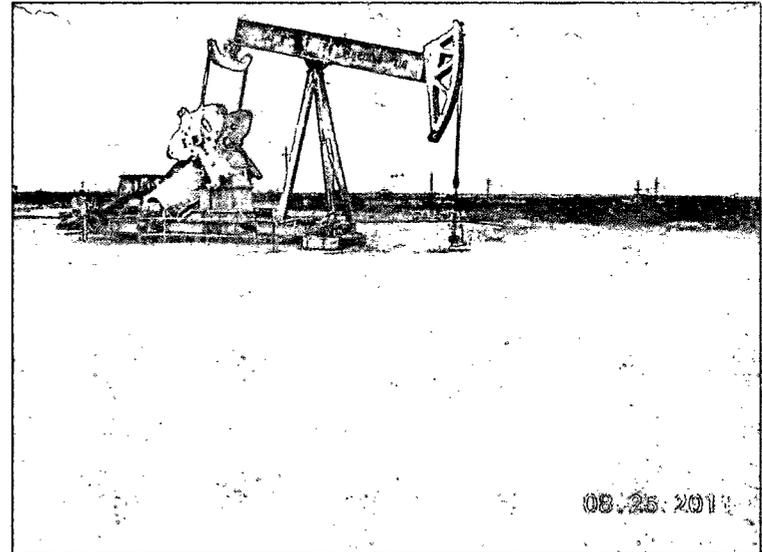
08.25.2011

Site complete, facing east
