**Release Notification and Corrective Action**

Hawk B-1 #55

The purpose of this report is to document the remediation activities and present supporting analytical data to the NMOCD, requesting closure of the referenced produced water and hydrocarbon release incident in accordance with the Guidelines for Remediation of Leaks, Spills and Releases.

# Apache Hawk B-1 #55 Leak

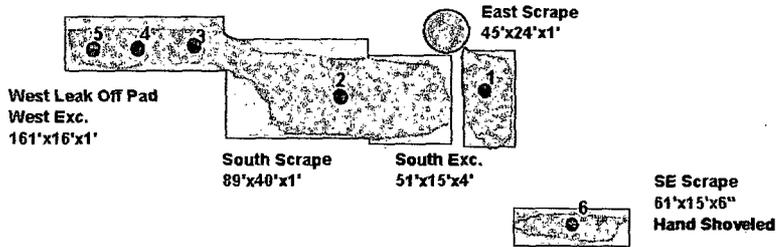
Key	
	Leak Source
	Initial Leak Area
	Excavated Areas
	Sample Point

Surface Field Sample Data	
Sample Description	Cl-
1. East Stain Center	1616
2. Southwest Stain Center	599
3. Leak Off Pad East Center	411
4. Leak Off Pad Center	290
5. End of Leak Off Pad West Center	247
6. South Leak Off Pad Center	137

West Excavation Lab Data	
Sample Description	Cl-
West Leak Off Pad Comp	32

East Scrape Lab Data	
Sample Description	Cl-
East Scrape Btm @ 1'	128

South Scrape Lab Data	
Sample Description	Cl-
South Scrape Btm @ 1'	96

South Excavation Lab Data	
Sample Description	Cl-
South Exc Btm @ 4'	96
South Exc West Wall	112
South Exc North Wall	128
South Exc South Wall	144

The contaminated soil was excavated, 548 cubic yards of contaminated soil was hauled to Sundance Services for disposal and 624 cubic yards of clean caliche was purchased from a local landowner for backfill.

Based on the analytical results of the confirmation soil samples collected from the excavation and which confirmed that the soil was less than the Standard of 250-ppm chlorides. Consequently, no further action is recommended or planned for this site at this time and on behalf of Apache Corporation we respectfully request that the NMOCD grant closure for the Hawk B-1 #55.

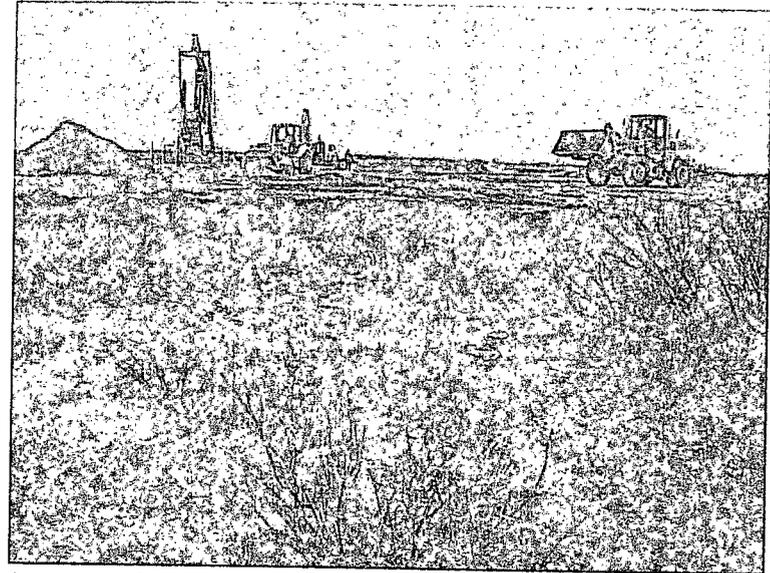
Scraping leak on pad, facing east

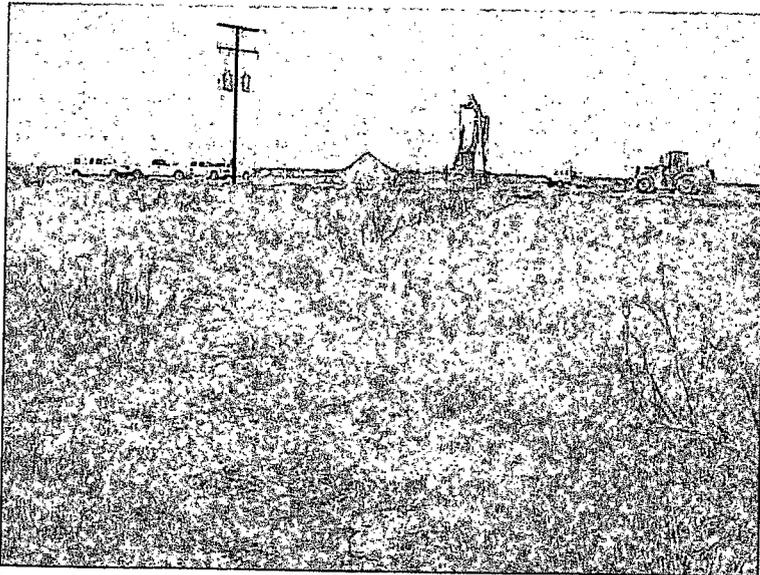
Initial release west of pad, facing east

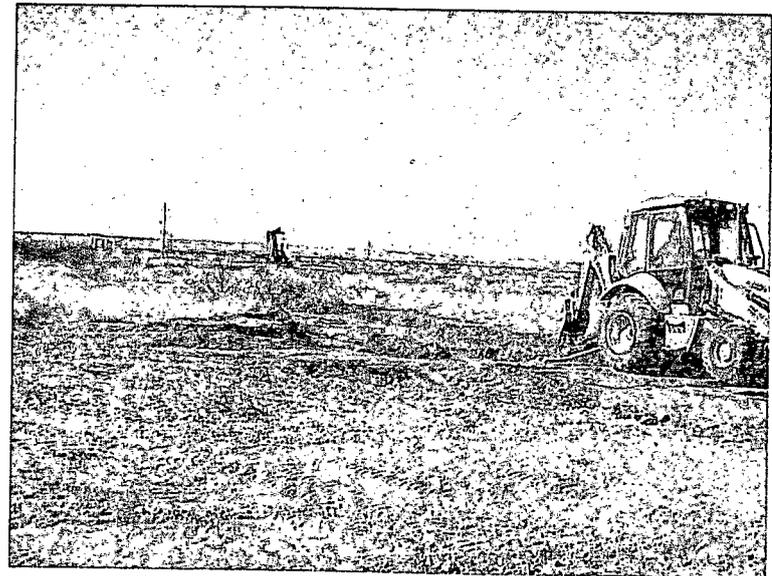
Excavating west leak off pad, facing west 1/14/2011
