Release Notification and Corrective Action

Southeast Lusk 34 Federal #006

Closure Report

**RE: TERMINATION REQUEST
Apache – Southeast Lusk 34 Federal #6 AD
UL/A sec. 34 T19S R32E**

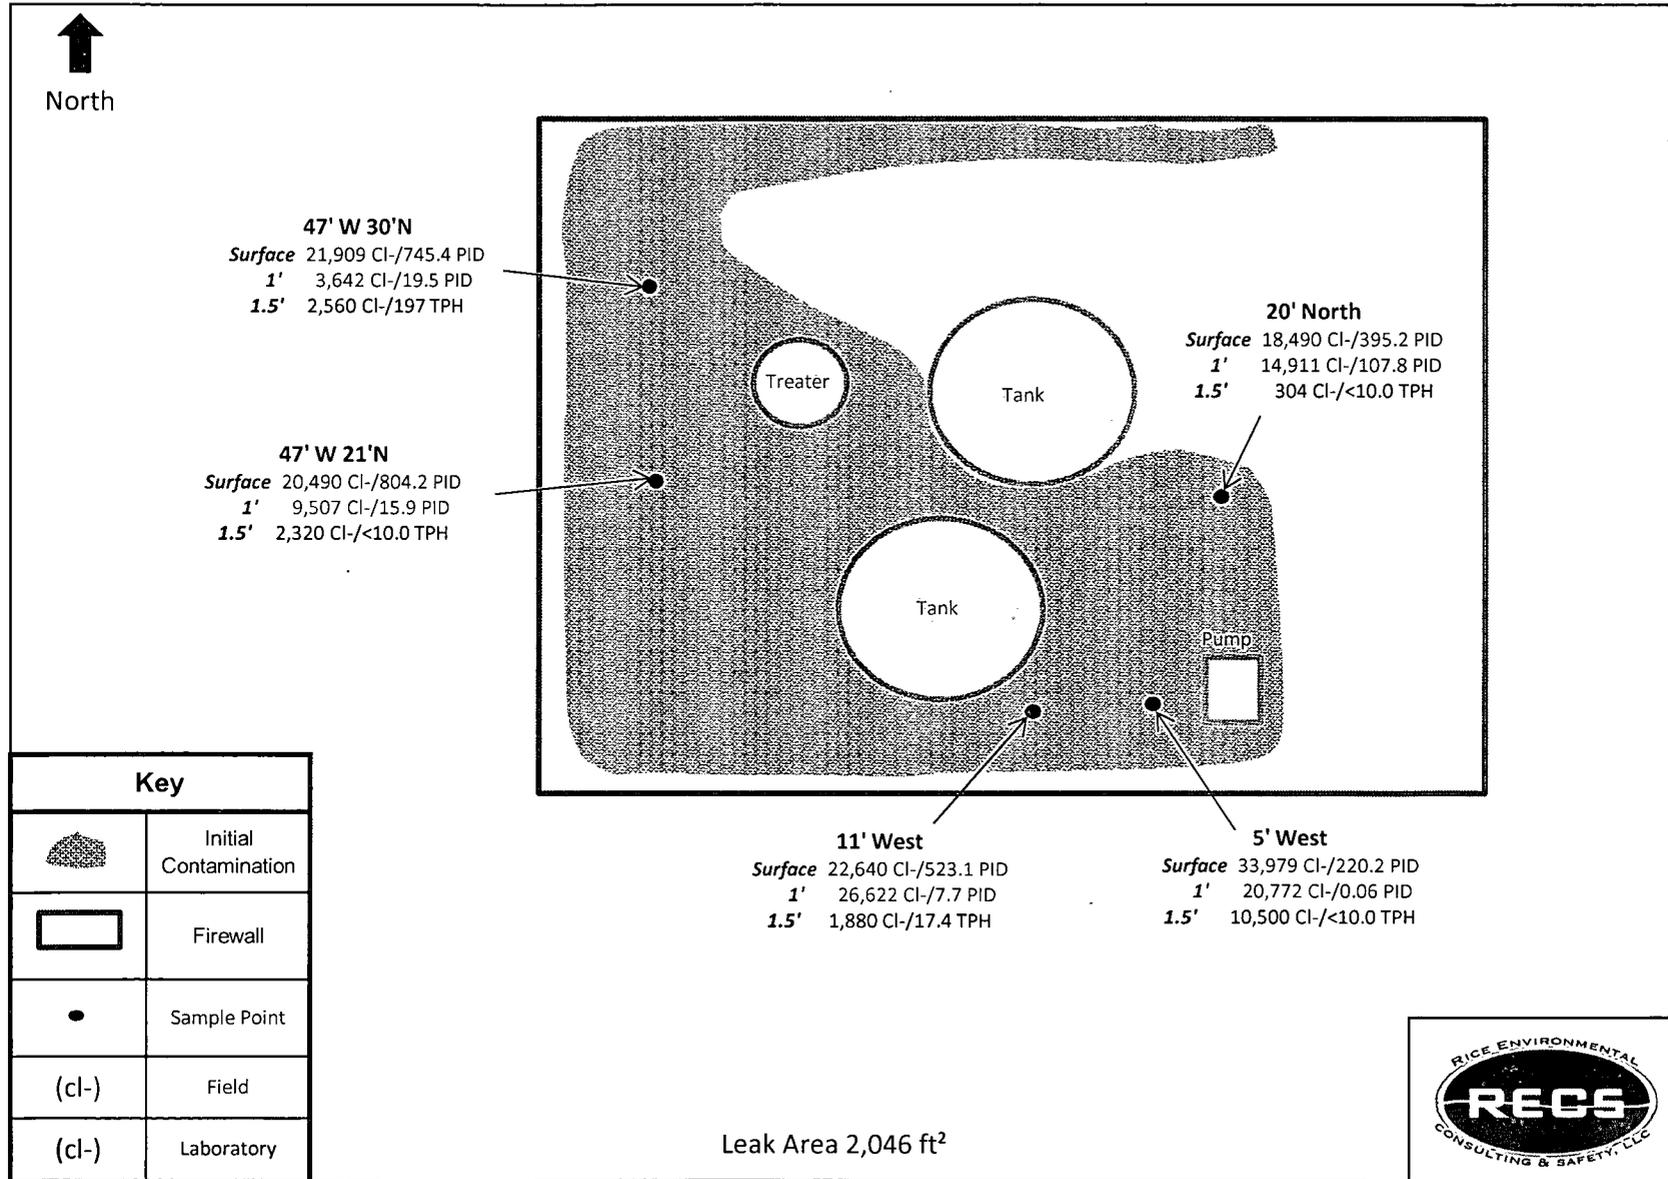
Figure 1 : Site Diagram with Sample Summary
Apache SE Lusk 34 Federal #6 AD

On July 15, 2011, RECS personnel initiated work on the Southeast Lusk 34 Federal #6. Soil samples were collected at surface and at 1 ft. below ground surface (bgs) and tested for chloride. Headspace measurements were also taken in the field using a Photo Ionization Detector (PID) (Figure 1). The impacted area within the firewall was excavated using a shovel crew to approximately 1.5 ft. bgs. A total of 20 cubic yards of impacted soil was removed from the excavation and transported to a NMOCD approved facility for disposal. The excavation was backfilled with 20 cubic yards of clean imported caliche and contoured to the battery floor.

On April 18, 2012, RECS personnel returned to the site and collected soil samples at 1.5 ft. bgs. The samples were field tested for chloride, and headspace measurements were taken in the field using a PID. The samples were sent to a commercial laboratory for chloride and TPH (GRO/DRO) analyses (Figure 1 and Appendix D). All samples showed a significant decline in levels of constituents from surface to 1.5 ft. bgs. Most of the samples contained 2,560 ppm chloride or less. The 5' West sample contained 10,500 ppm, reduced from 33,979 ppm at surface. TPH was present at 197 ppm or less in all samples.

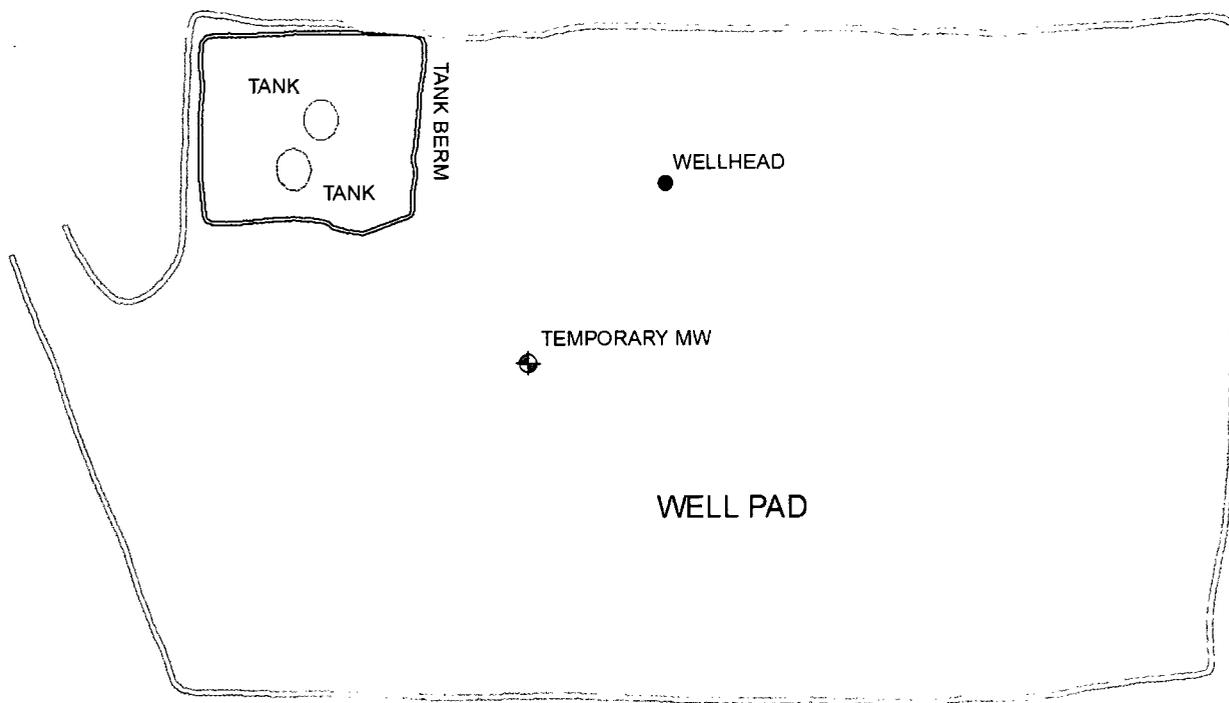
Figure 2

On July 25, 2011, a temporary monitor well was drilled on the well location (Figure 2) to determine depth of groundwater at the site. A red bed clay formation was encountered at 75 ft. bgs, and drilling ceased at 100 ft. bgs. The temporary well was set with 2 inch PVC casing with screen from 80 ft. to 100 ft. bgs to allow potential groundwater to accumulate. On July 28, 2011, RECS personnel used a Heron Water Level Meter to verify any accumulation of groundwater. No water was detected within the borehole at the total depth of 100 ft. bgs. On July 28, 2011, RECS personnel removed the monitoring well casing and plugged the borehole to ground surface with bentonite (Appendix B).

Apache
SE LUSK 34 FEDERAL #6

UL/A SECTION 34
T-19-S R-32-E
LEA COUNTY, NM

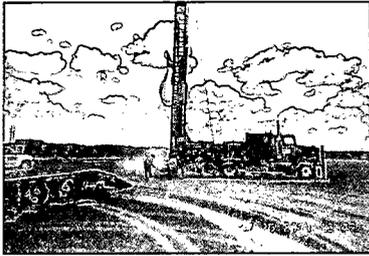
Driller:	Harrison & Cooper, Inc.		
Drilling Method:	Air rotary		
Start Date:	7/25/2011		
End Date:	7/25/2011	Company: Apache Corporation Project Name: SE Lusk 34 Federal #6 AD Well ID: Temp MW-1 Project Consultant: RECS	
Comments:		Location: UL/A sec. 34 T19S R32E Lat: 32°37'16.505"N County: Lea Long: 103°44'55.733"W State: NM	
Field testing did not occur on well. Samples were only taken to location of the red bed clay. All samples were from cuttings. DRAFTED BY: L. Weinheimer TD = 100 ft GW = none

Depth (feet)	Chloride field tests	LAB	PID	Description	Lithology	Well Construction
45 ft						annular space left open
50 ft						PLUGGED 7/28/2011
55 ft						
60 ft						
65 ft						
70 ft						
75 ft						
80 ft				RED BED CLAY

On July 25th, 2011, RECS personnel drilled a temporary monitoring well at the Apache SE Lusk 34 Federal #6. On July 28th, 2011, I supervised RECS personnel checking for water accumulation within the borehole using a Heron depth to water meter. The meter indicated no water had accumulated within the borehole at the total depth of 100 ft.

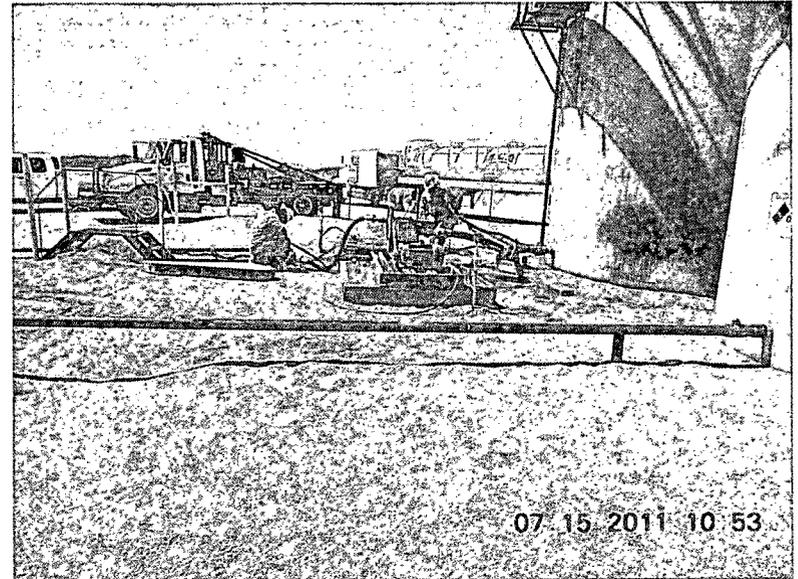
Leak Source Area, Facing South

The site is an accidental discharge of fluids within the battery firewall at the Apache Southeast Lusk 34 Federal #6 when a plunger ruptured and released 10 bbls of produced water. The plunger was repaired, and standing fluids totaling 5 bbls were recovered with a vacuum truck. An initial form C-141 was submitted by Apache Corporation on July 7, 2011 (Appendix A). The site is located north of U.S. Highway 62/180 west of Hobbs, near the Laguna Plata area in unit letter 'A', section 34, T19S, R32E in Lea County, New Mexico.

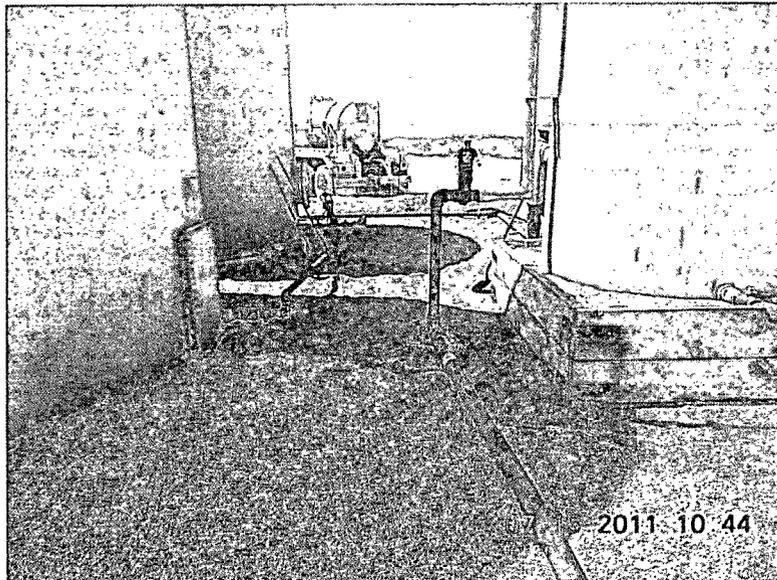
Between Tanks and Treater, Facing South

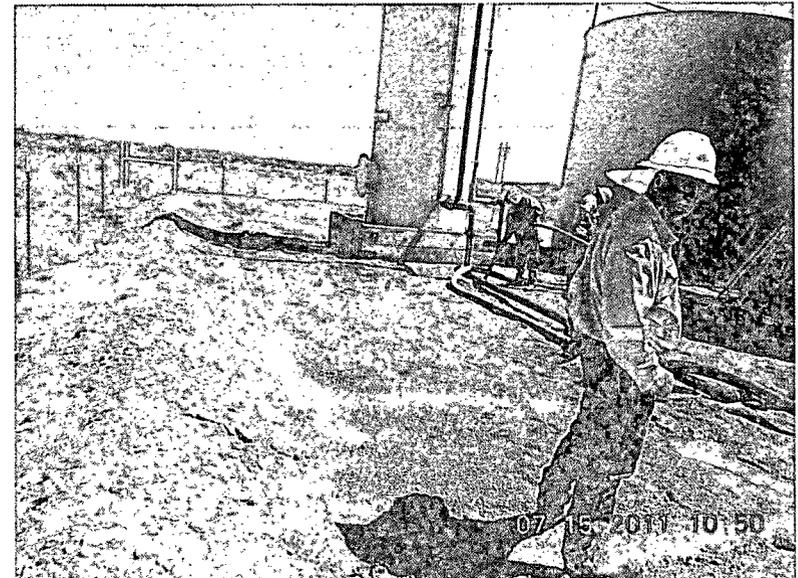
Facing North on West Side

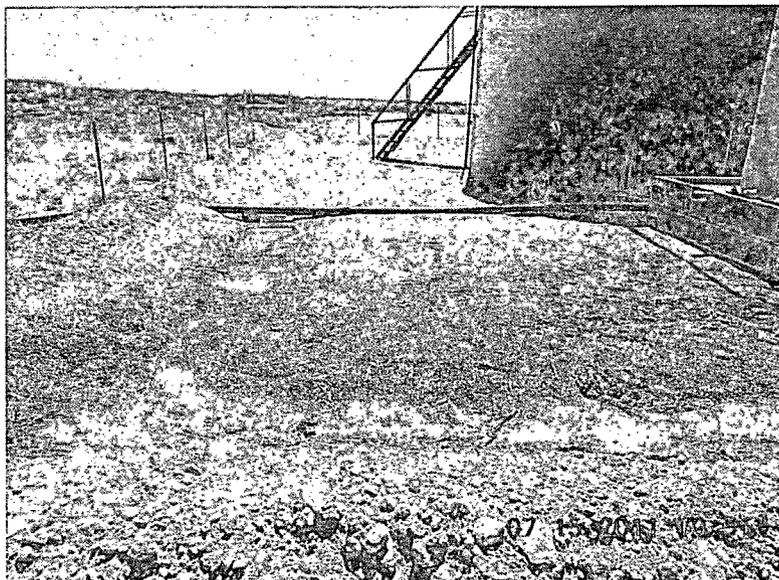
Facing East at Northwest Corner 7/15/2011

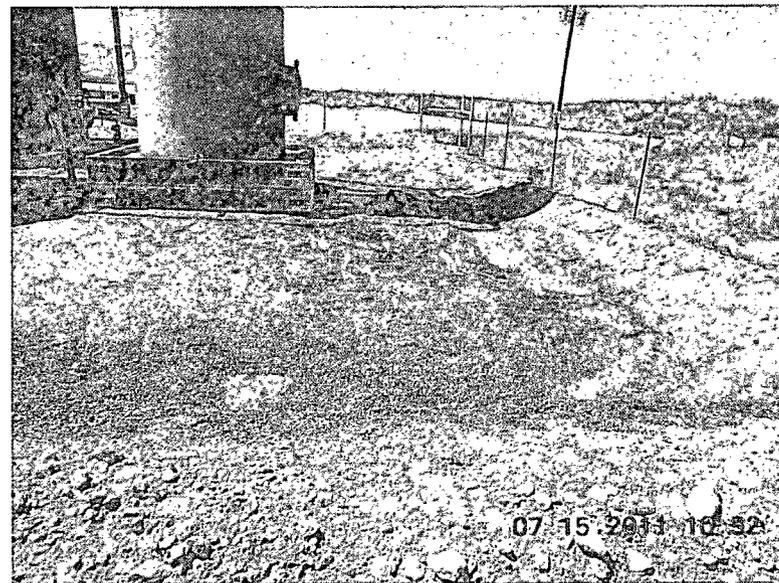
Facing South at Northwest Corner 7/15/2011

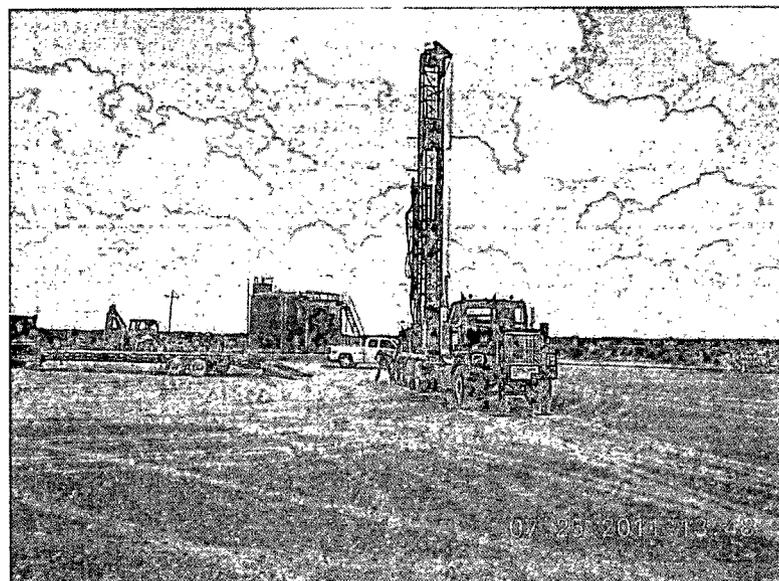
Drilling Temporary Monitor Well 7/25/2011

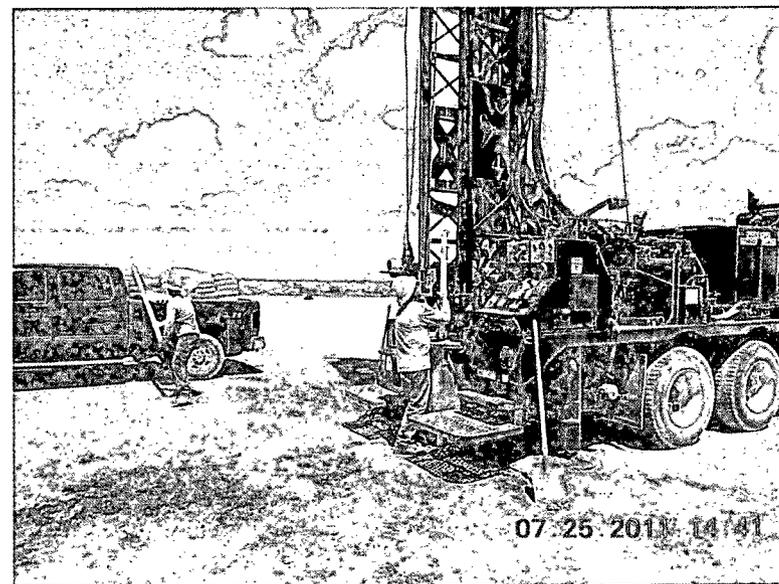
Installing Casing 7/25/2011

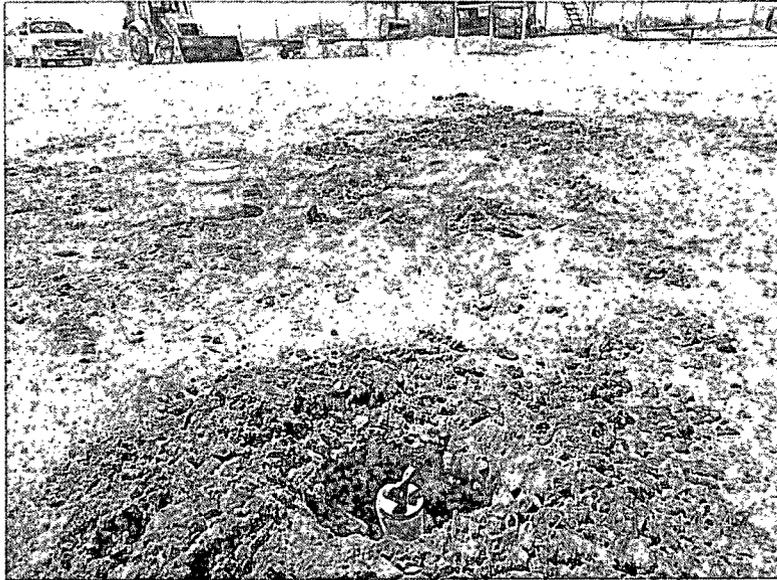
Temporary Monitor Well Set

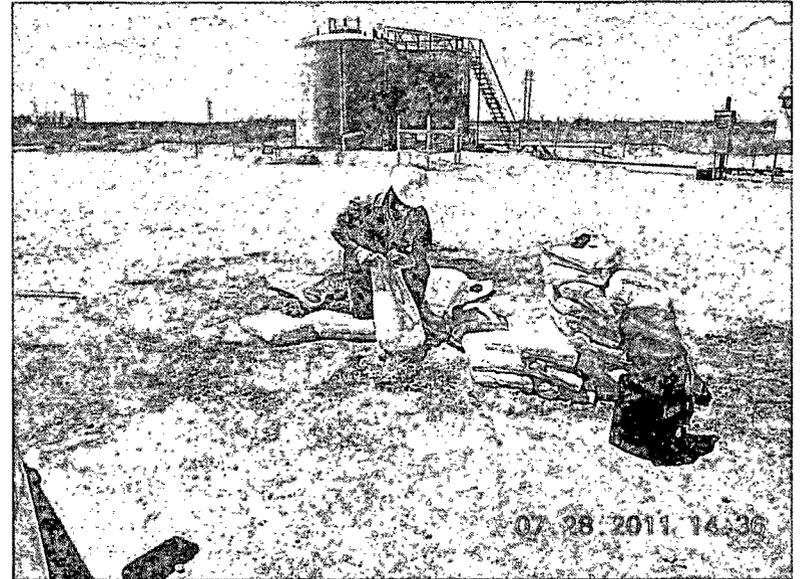
Plugging Temporary Monitor Well

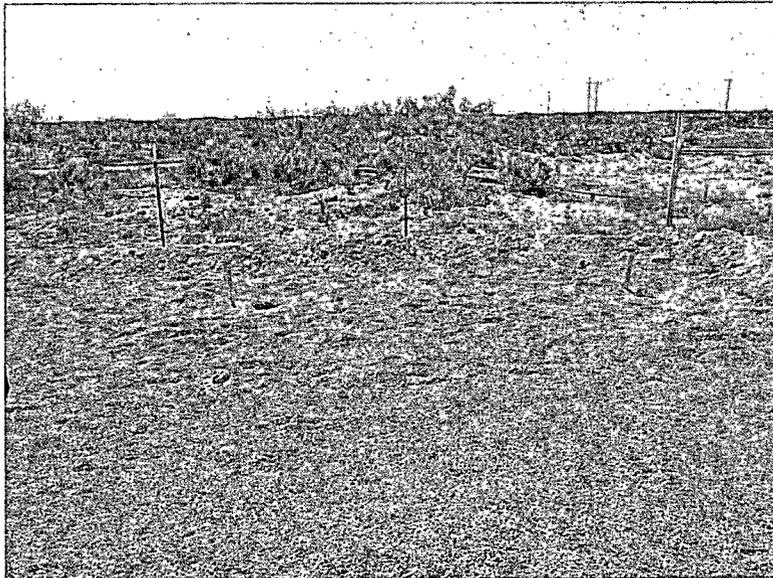
Staked Sample Points in Northwest Corner 4/18/2012

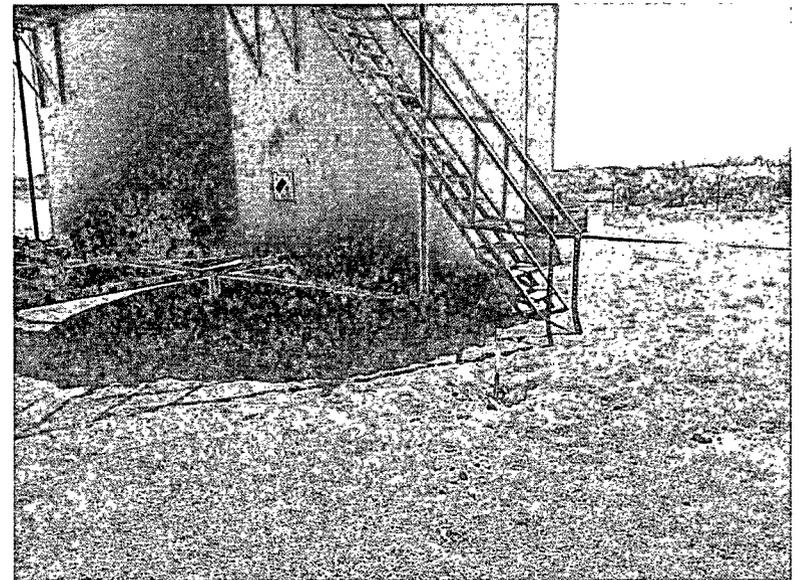
Staked Sample Points on East Side
