**Release Notification and Corrective Action**

Name of Company Apache Corporation	Contact Natalie Gladden
Address PO Box 1849, Eunice NM 88231	Telephone No. 575-390-4186
Facility Name Lockhart B13 A SWD (nearest well #1)	Facility Type SWD
Surface Owner BLM	Mineral Owner BLM/State
API No. 30-025-06555

**Internal Incident Report – Spill/Release**

**Location:** Lockhart B13 A SWD

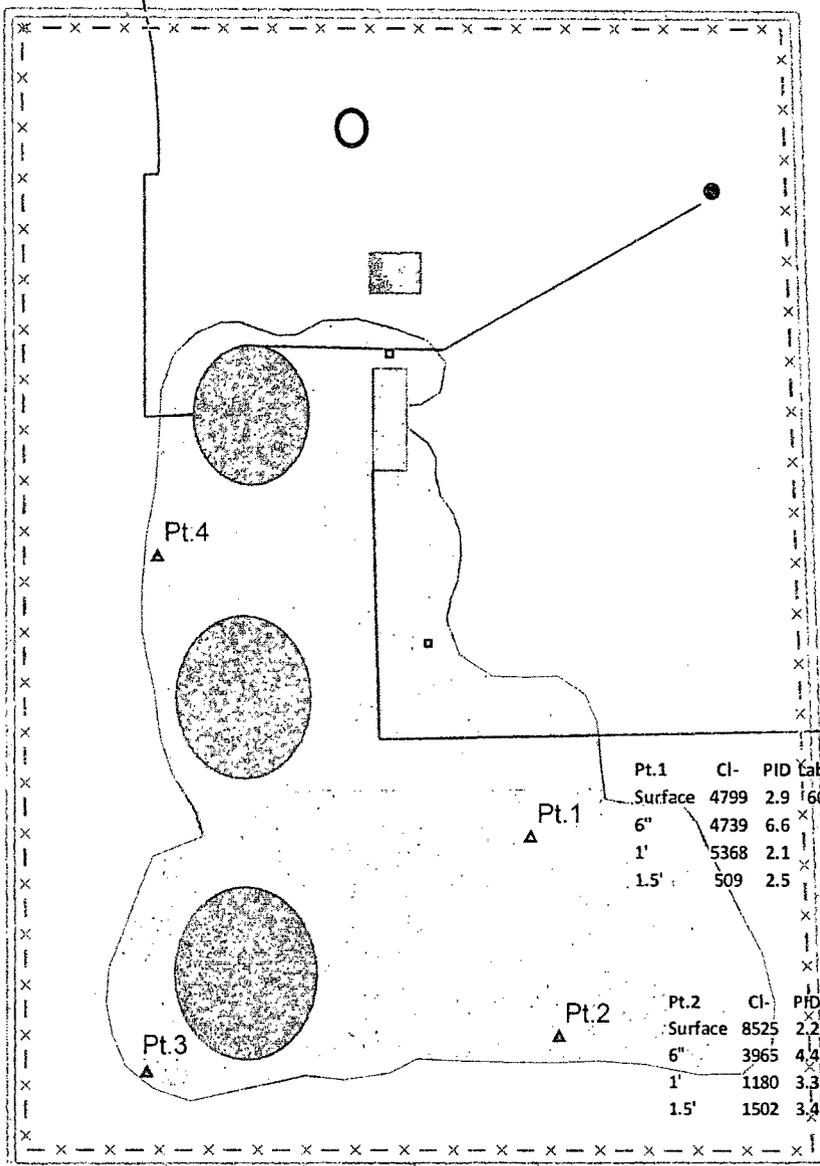
# Initial Sampling Data

Pt.4	Cl-	PID	Lab	Cl-	GRO	DRO
Surface	11390	7	14500	<10	<10	
6"	13487	6.3				
1'	2478	40				
1.5'	866	40				
2'	963	8.6

Pt.1	Cl-	PID	Lab	Cl-	GRO	DRO
Surface	4799	2.9	16000	<10	16.7	
6"	4739	6.6				
1'	5368	2.1				
1.5'	509	2.5

Pt.3	Cl-	PID	Lab	Cl-	GRO	DRO
Surface	1095	2.2	1300	<10	<10	
6"	4232	9.1				
1'	5335	3.2				
1.5'	458	2.5

Pt.2	Cl-	PID	Lab	Cl-	GRO	DRO
Surface	8525	2.2	11600	<10	<10	
6"	3965	4.4				
1'	1180	3.3				
1.5'	1502	3.4

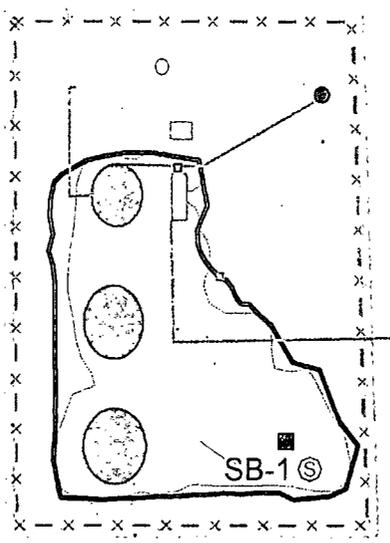
# Vertical and Soil Bore Sampling Data

Vertical		
Depth	Cl-	PID
6"	2613	1
1'	1360	1.8
1.5'	1268	0.2
2'	581	0
2.5'	528	0
3'	651	0
3.5'	515	0
4'	738	0
4.5'	762	0
5'	795	0
5.5'	1016	0
6'	741	0.2
7'	1121	0
8'	918	0
9'	677	0.1
10'	1419	2.6
11'	1505	18.6
12'	1261	20.3
13'	1691	25.6

SB-1				
Depth	Cl-	PID	GRO	DRO
SS	6160	7.1	<10	256
3'	831	12.3		
6'	301	6.1		
9'	433	5.8		
12'	699	5		
15'	375	5.6		
18'	1200	6.4	<10	<10
21'	1073	6.1		
24'	810	6.1		
27'	545	7.2		
30'	888	5.6		
33'	980	4.5		
36'	704	5.3		
39'	420	9.2		
42'	476	9.1		
45'	421	15.9		
48'	240	12.1	<10	<10
51'	128	17.5	<10	<10
54'	240	7.1	<10	<10

SB-2 59.5'  
 TDD IN RED BED  
 NO WATER  
 COLLECTED

On Saturday August 31, 2013 soil bore #2 at the Apache Lockhart B #13A SWD, Lea County T21S, R37E, Sec 13 Unit Letter K was checked with a Solinst Water Level Meter for water accumulation within the borehole. The meter indicated no water accumulation within the borehole at the total depth of 59.4 feet.
