NEDU #926

Closure Report

RE: TERMINATION REQUEST

NEDU #926 ILLEGAL DUMP

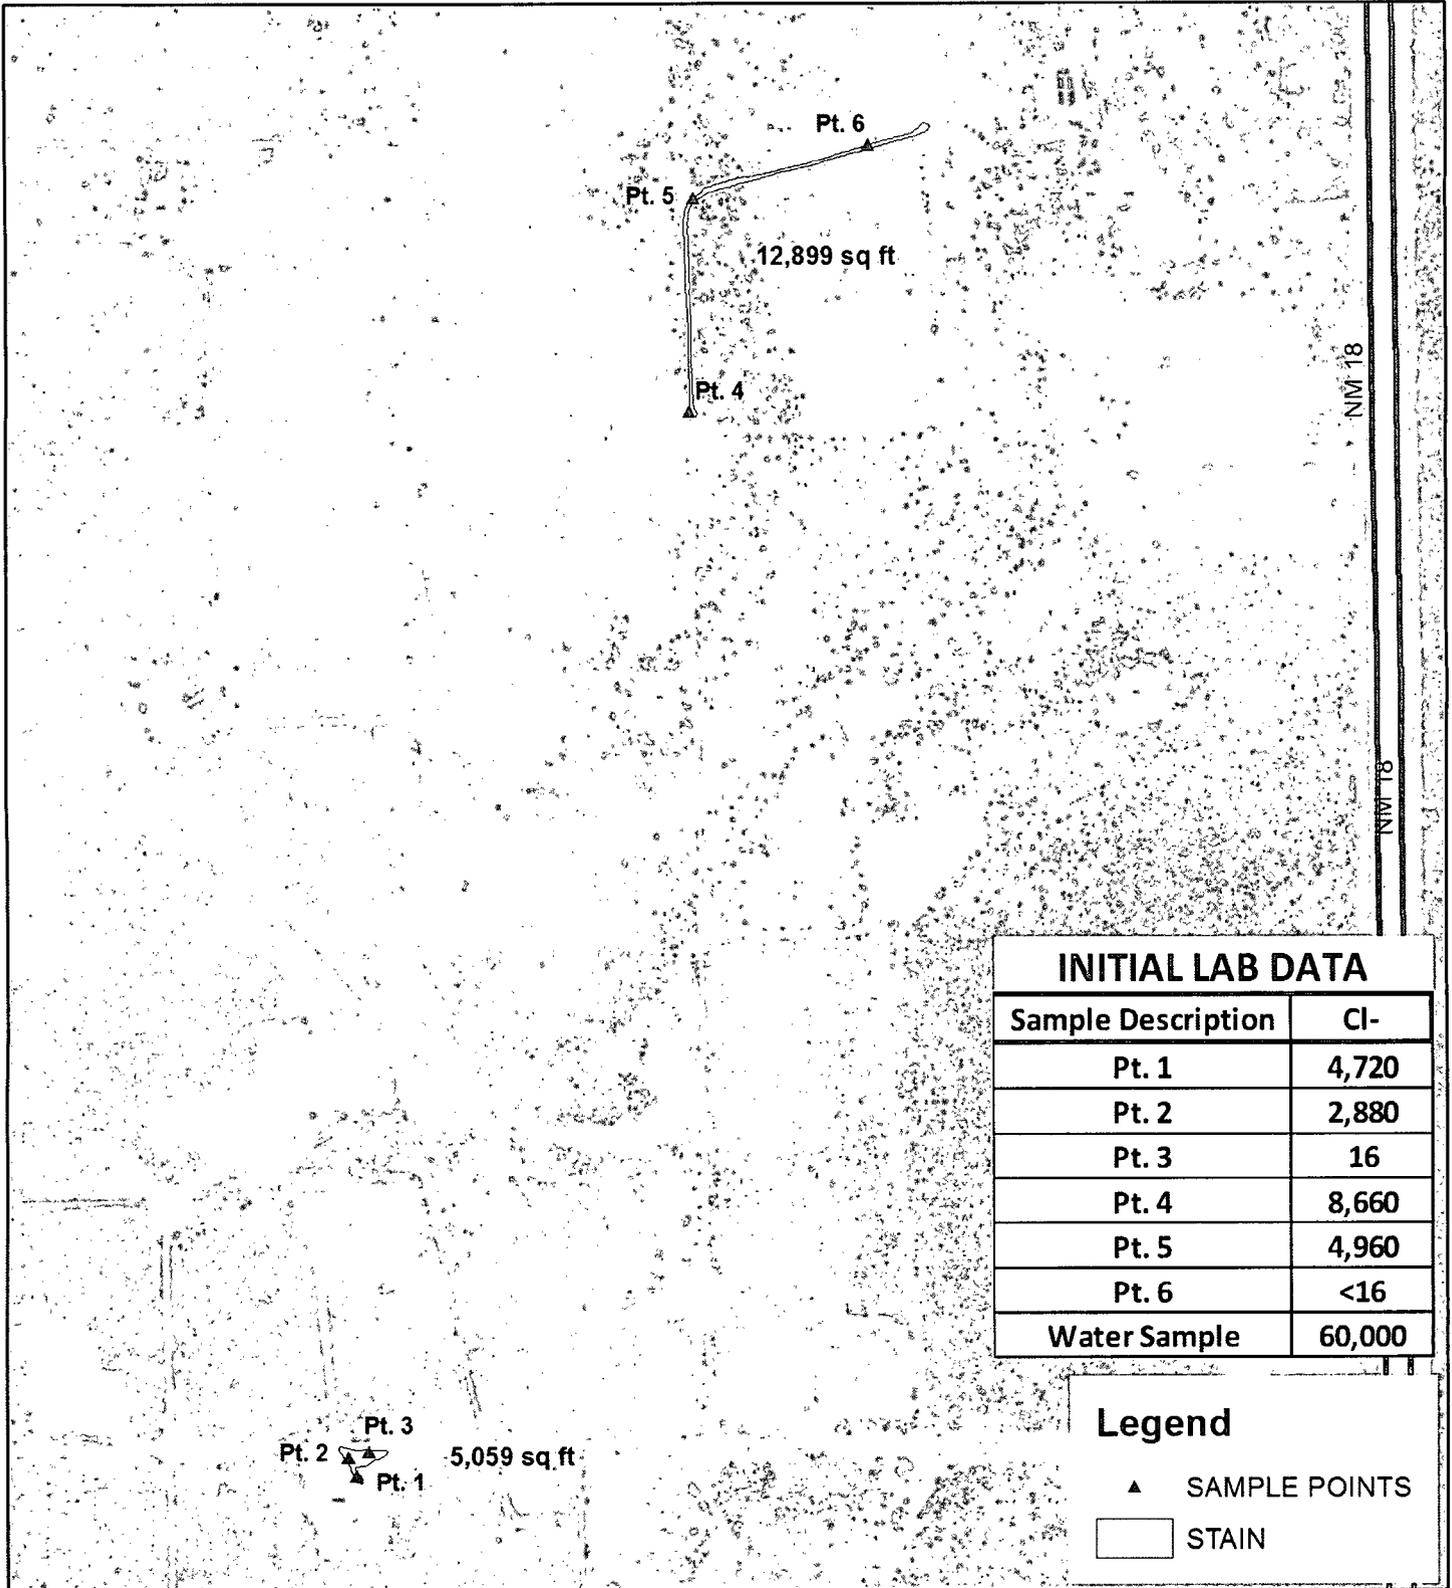
DGW = 50 ft
Figure 1

On January 25, 2012, RECS personnel initiated work on the NEDU #926 (Figure 1). Surface soil samples were collected from the well pad area and the road area and were field tested for chloride. Headspace measurements were also taken in the field using a Photo Ionization Detector (PID). The samples were submitted to a commercial laboratory for chloride analysis, and ranged from <16.0 ppm (parts per million or mg/kg) to 8,660 ppm (Appendix B).

INITIAL LAB DATA	
Sample Description	Cl-
Pt. 1	4,720
Pt. 2	2,880
Pt. 3	16
Pt. 4	8,660
Pt. 5	4,960
Pt. 6	<16
Water Sample	60,000

NEDU #926 ILLEGAL DUMP

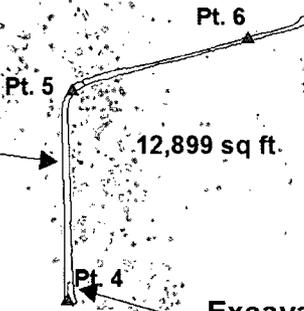
Figure 2

The impacted areas were excavated from 6 inches below ground surface (bgs) to 2 ft. bgs. On February 1-2, 2012, RECS personnel collected and field tested samples from the excavations (Figure 2). Representative grab samples from the walls and bottoms of the excavations were submitted to a laboratory for chloride analysis. All samples yielded 80 ppm or less with the exception of the west wall of the 2' deep well pad excavation which contained 432 ppm.

Road Scrape
320' x 23' x 6" - 2'

Excavation
57' x 23' x 2'

Sample Description	CI-
N. Wall Road Scrape	<16
E. Wall Pt. 2 Road Scrape	48
W. Wall Pt. 2 Road Scrape	48
3 pt. Comp Btm Road Scrape	32
N. Wall RD Scrape 2' Excav.	48
E. Wall RD Scrape 2' Excav.	<16
S. Wall RD Scrape 2' Excav.	32
W. Wall RD Scrape 2' Excav.	<16
5 pt. Btm Comp 2' RD Scr. Excav.	48
N. Wall Pad Scrape	80
E. Wall Pad Scrape	32
S. Wall Pad Scrape	64
W. Wall Pad Scrape	432
5 pt. Btm Comp Pad Scrape	32

Pad scrape
93' x 115' x 6"

Impacted soils were removed from the excavations and transported to a NMOCD approved disposal facility. The excavations were backfilled with clean soil (Appendix B) and leveled. See Appendix C for photographs of field activities.

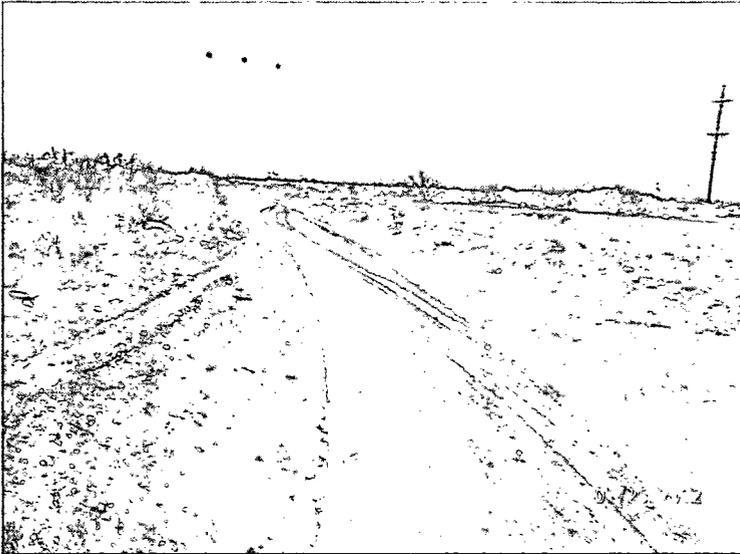
Initial release on road, facing southwest 1/25/2012

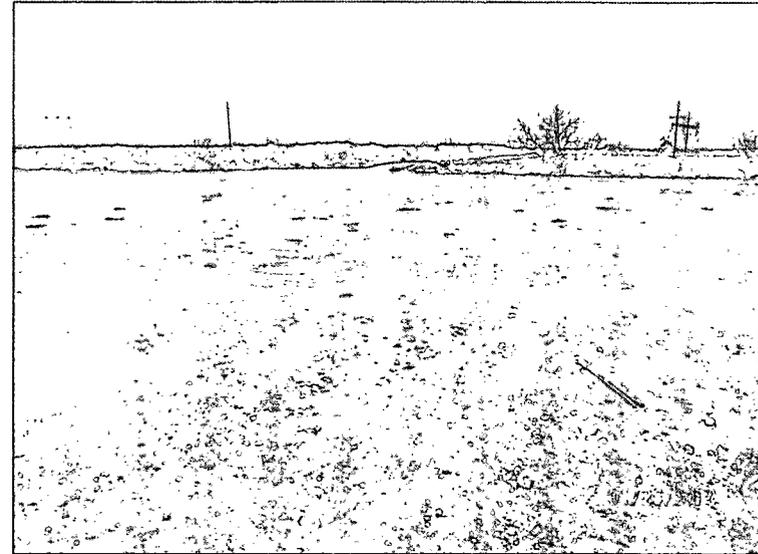
Initial release on pad, facing northwest 1/25/2012

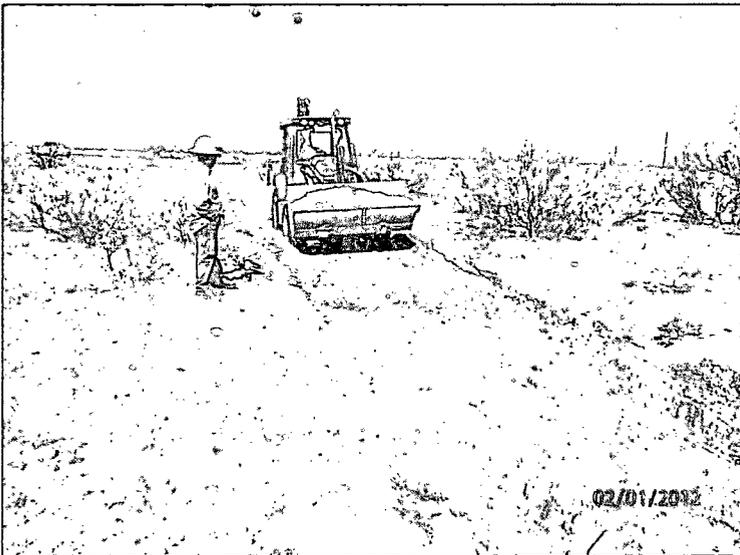
Scraping road, facing northeast 2/1/2012

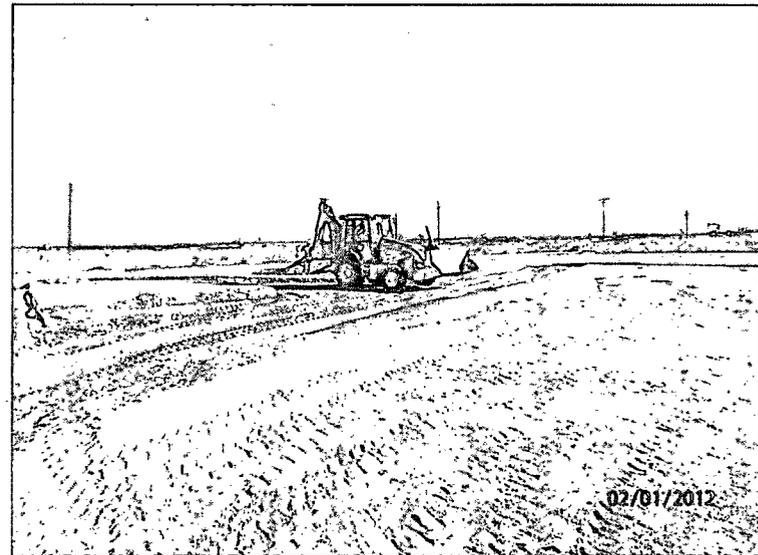
Scrape on pad, facing southeast 2/1/2012

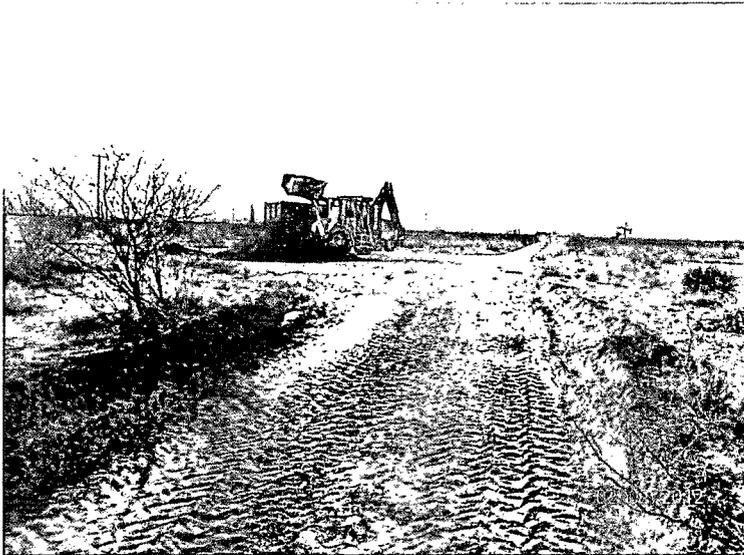
Exporting soil, facing southeast

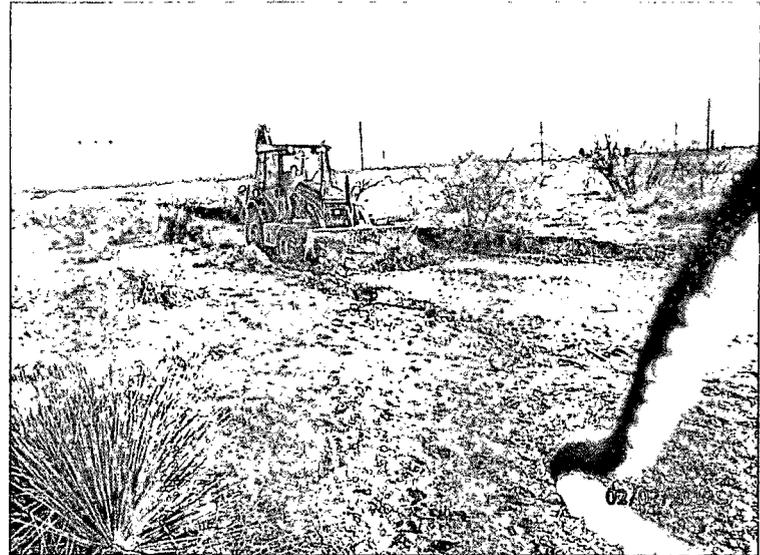
Scraping road, facing northeast

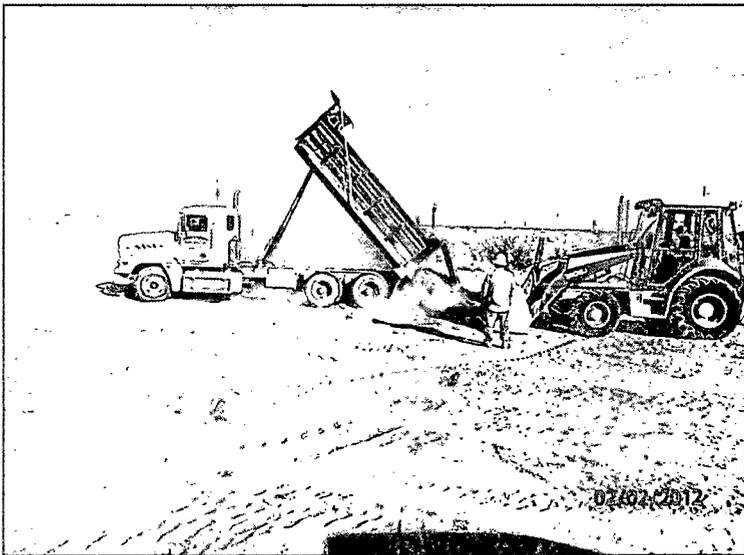
Importing backfill, facing west

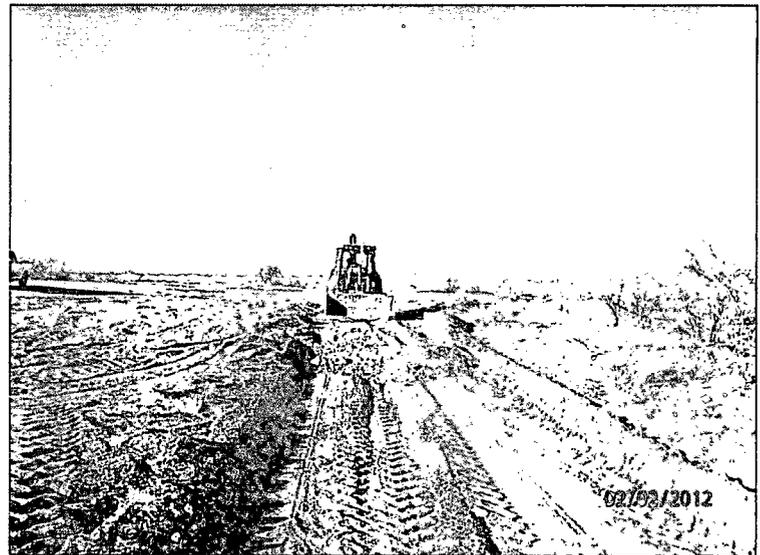
Backfilling excavation, facing northwest

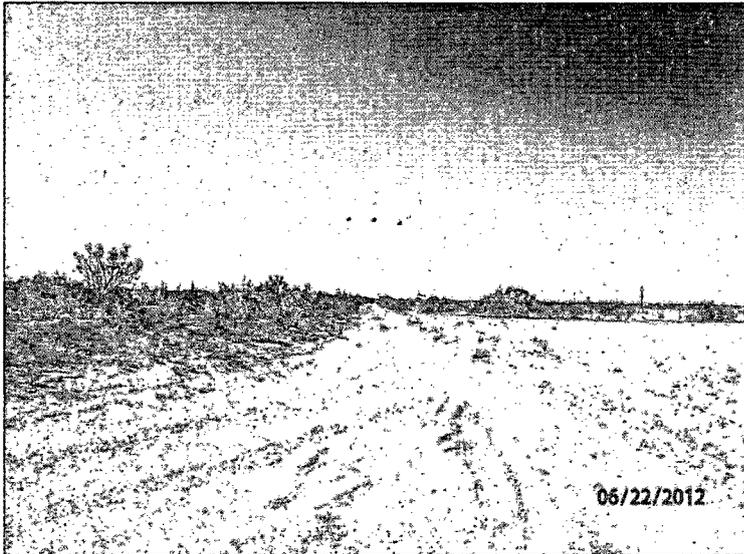
Site complete, facing south

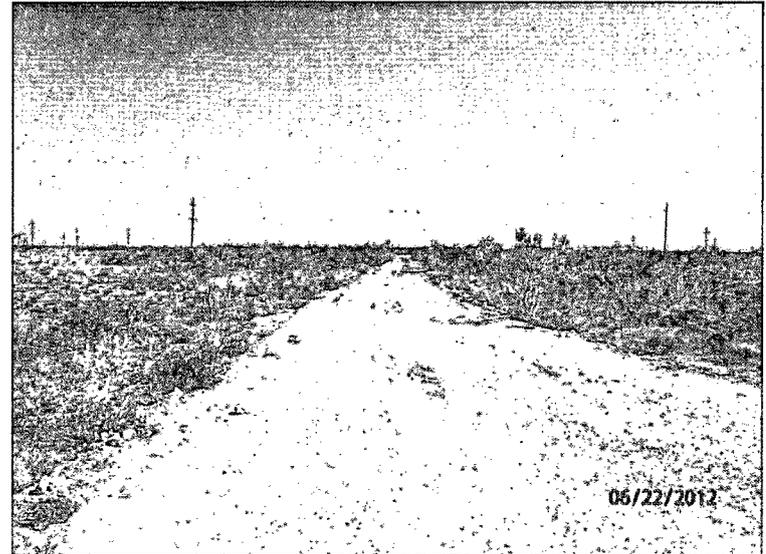
Site complete, facing north

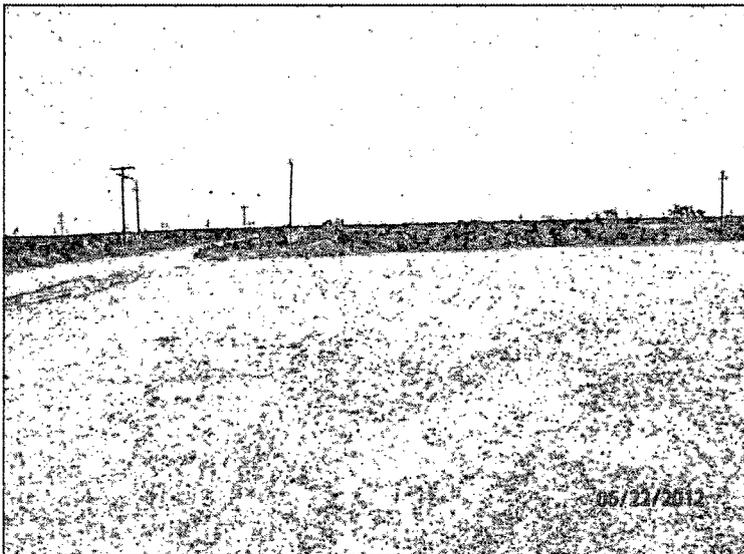
Site complete, facing east

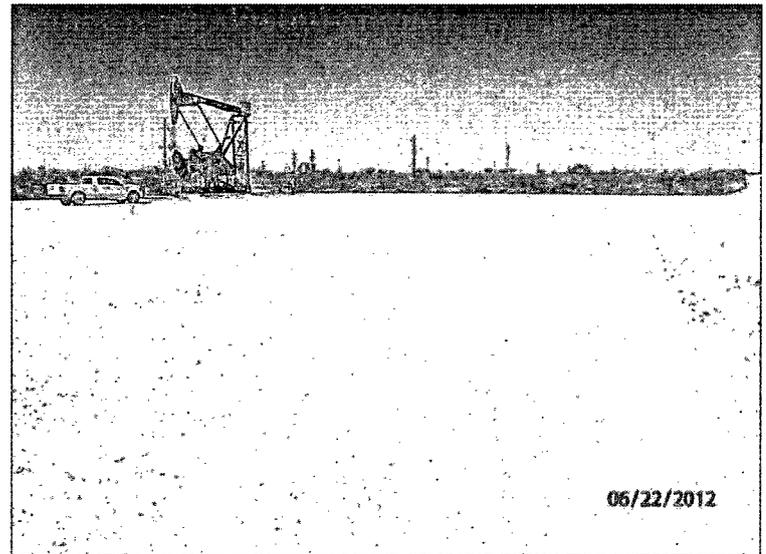
Site complete, facing southwest
