REMEDICATION SUMMARY AND RISK-BASED SITE CLOSURE REQUEST

BOPCO, LP
Remuda Basin Unit #1 Battery
Eddy County, New Mexico
Unit Letter "P" (NE/SE), Section 24, Township 23 South, Range 29 East
Latitude 32.288041° North, Longitude 103.936333° West
NMOCD Reference # 2RP-1458

June 2014

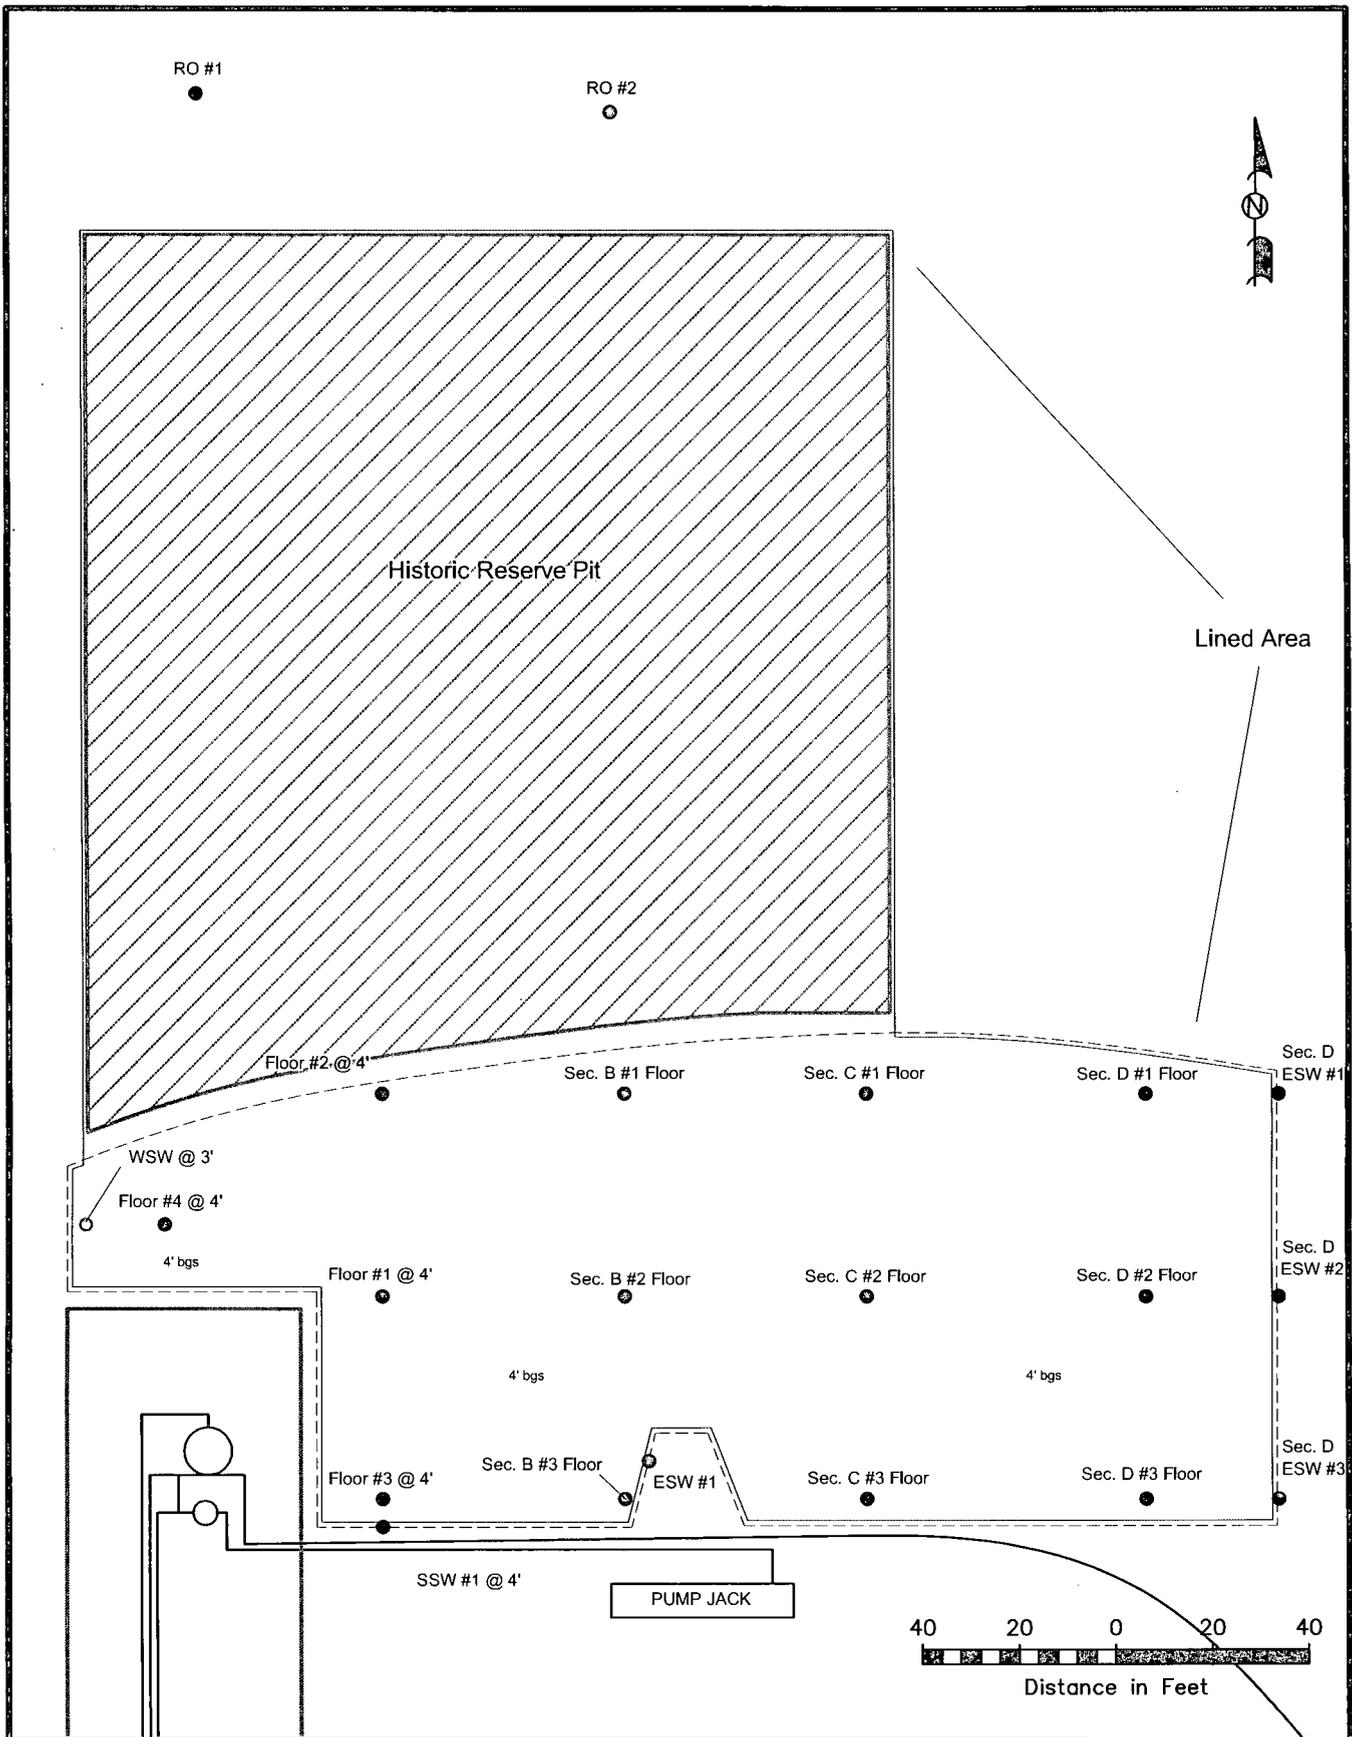
Figure 2a – Site & Sample Location Map – Northern Portion of Release Site

Excavation Extent		Liner Margins Reserve Pit
	Fire Wall		
	Pipeline		
	Sample Location

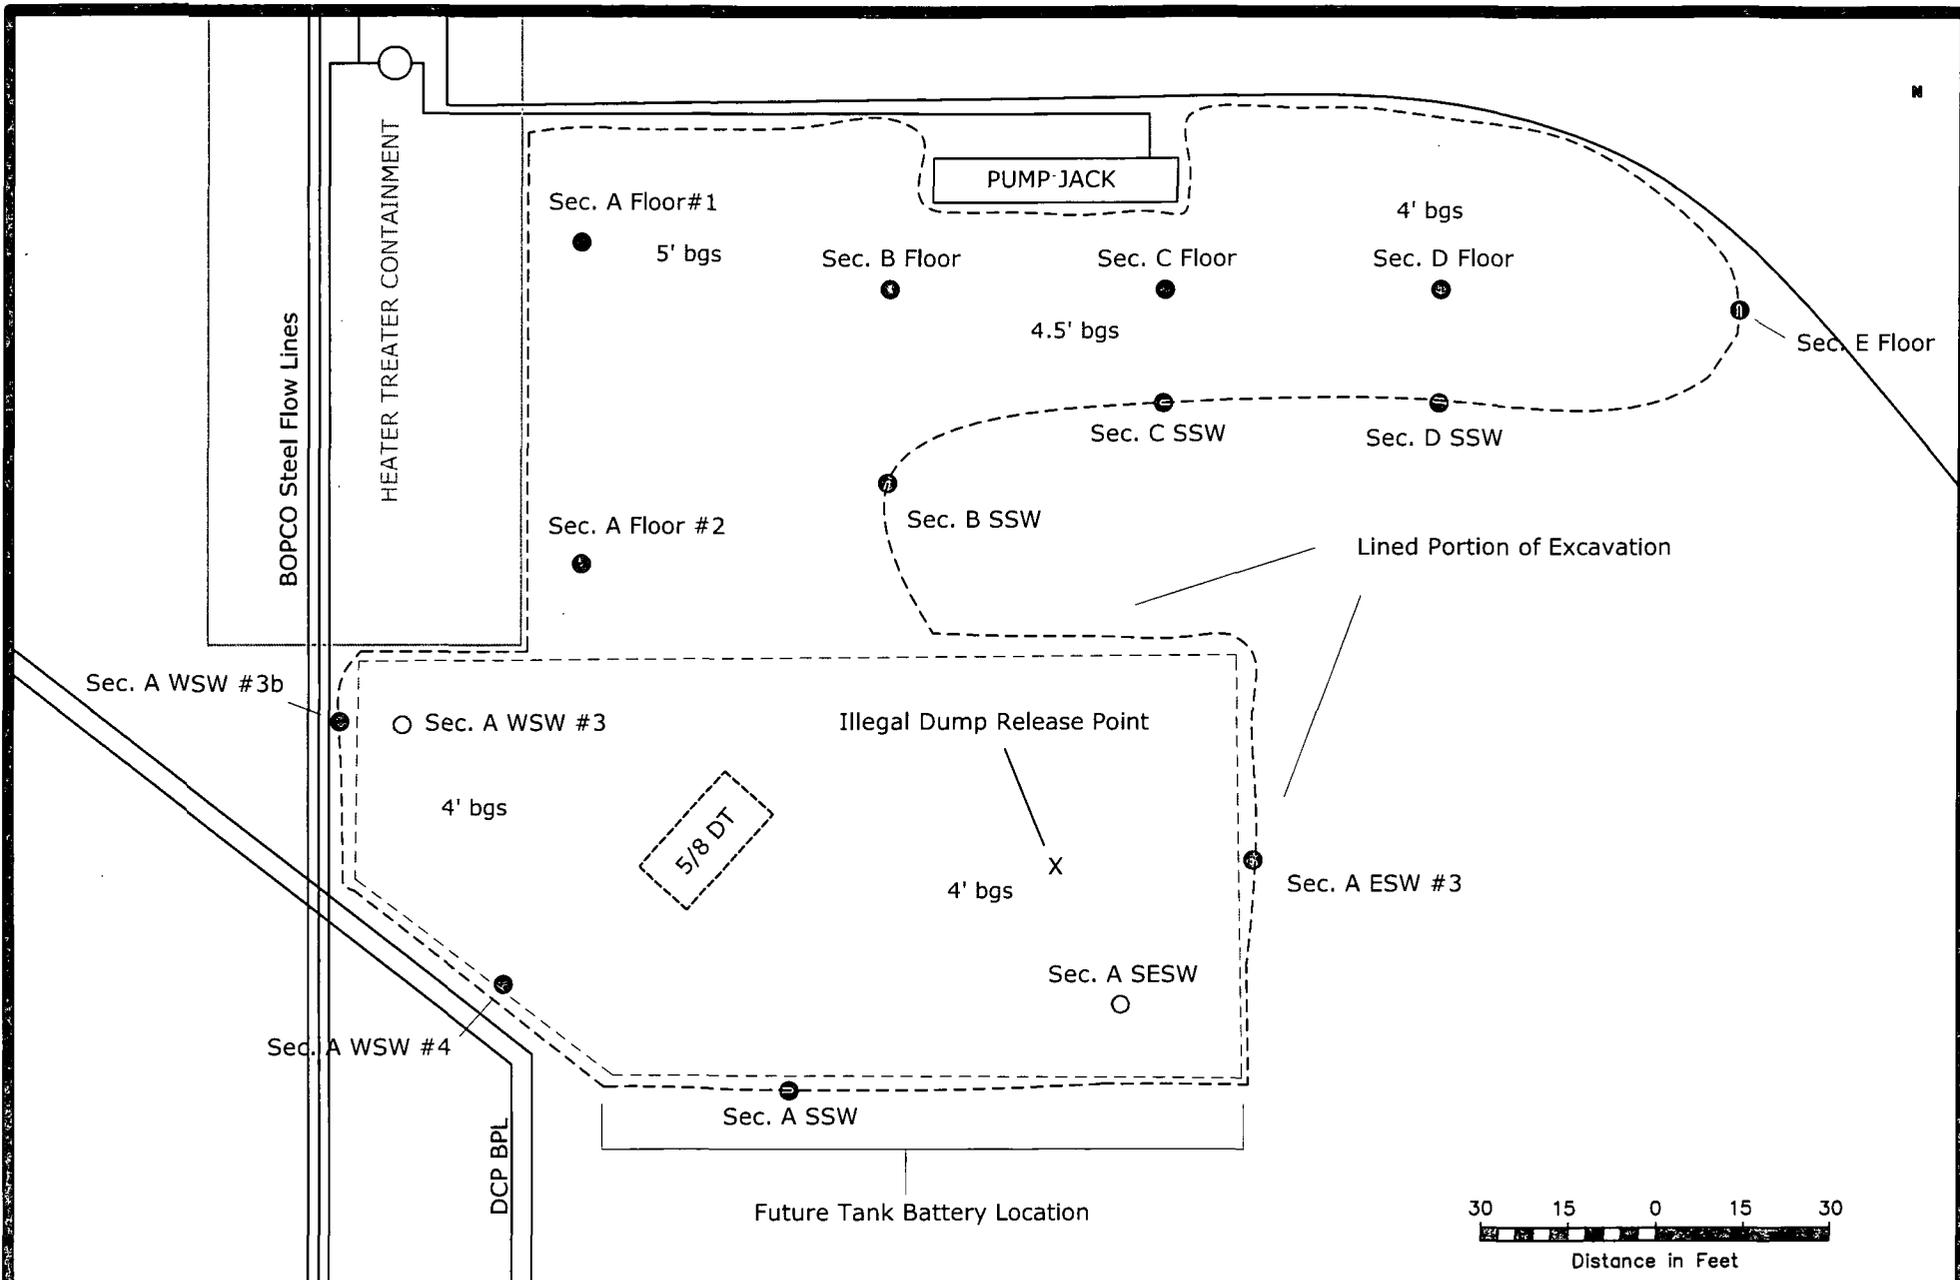
Figure 2b – Site & Sample Location Map – Southern Portion of Release Site

-----	Excavation Extent	-----	Liner Margins
=====	Fire Wall		
=====	Pipeline		
●	Sample Location

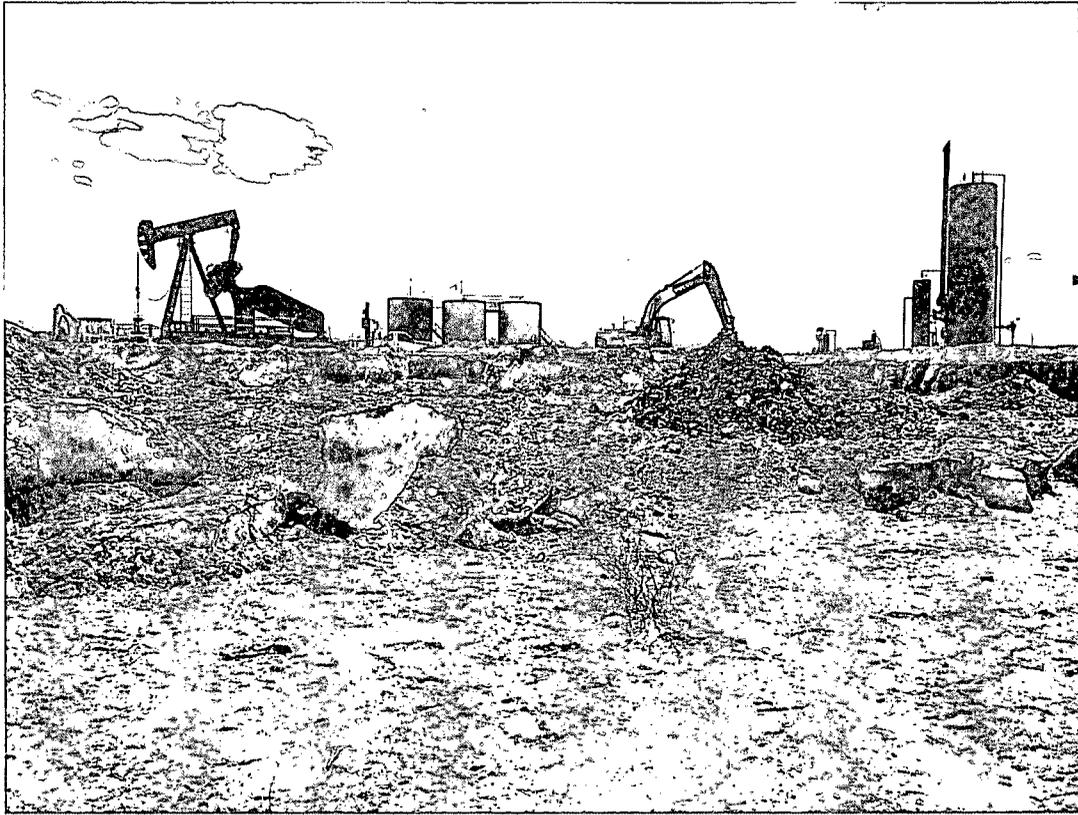
Photograph of the excavated area on the northern portion of the well pad taken from the edge of the drilling reserve pit. (Looking South)

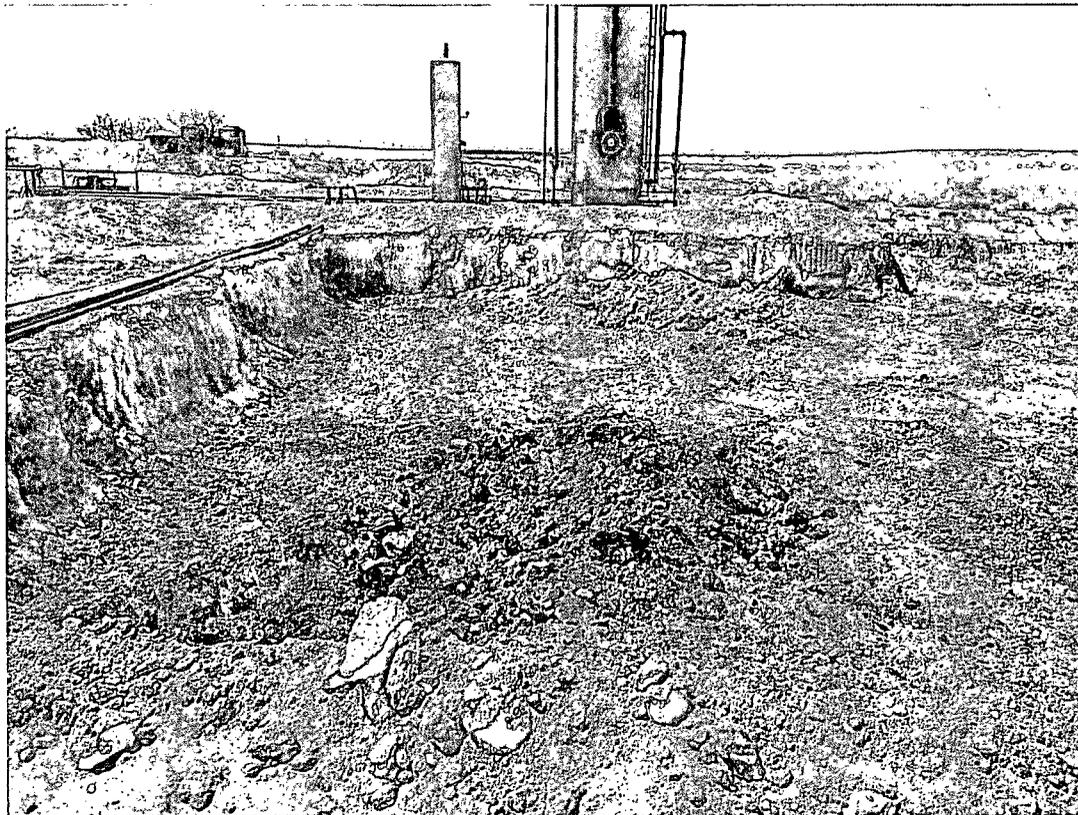
Photograph of the excavated area on the northern portion of the well pad. (Looking West)

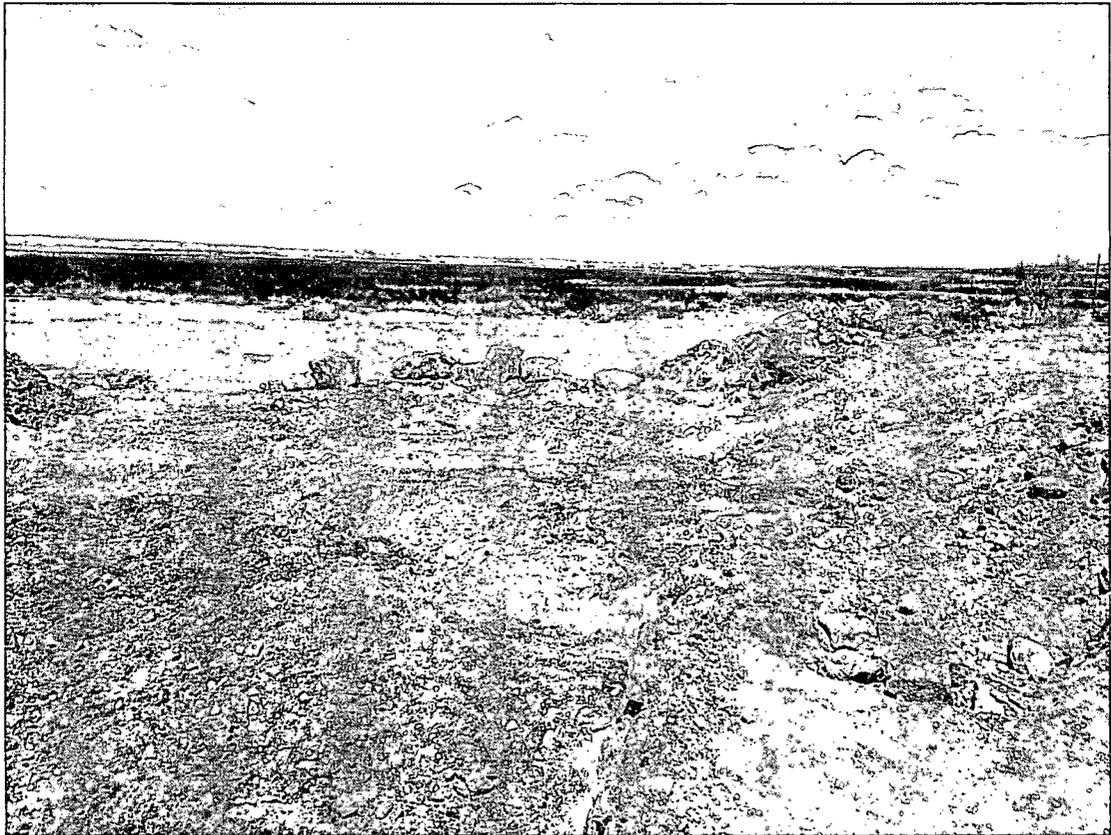
Photograph of the excavated area on the northern portion of the well pad looking over the drilling reserve pit. (Looking North)

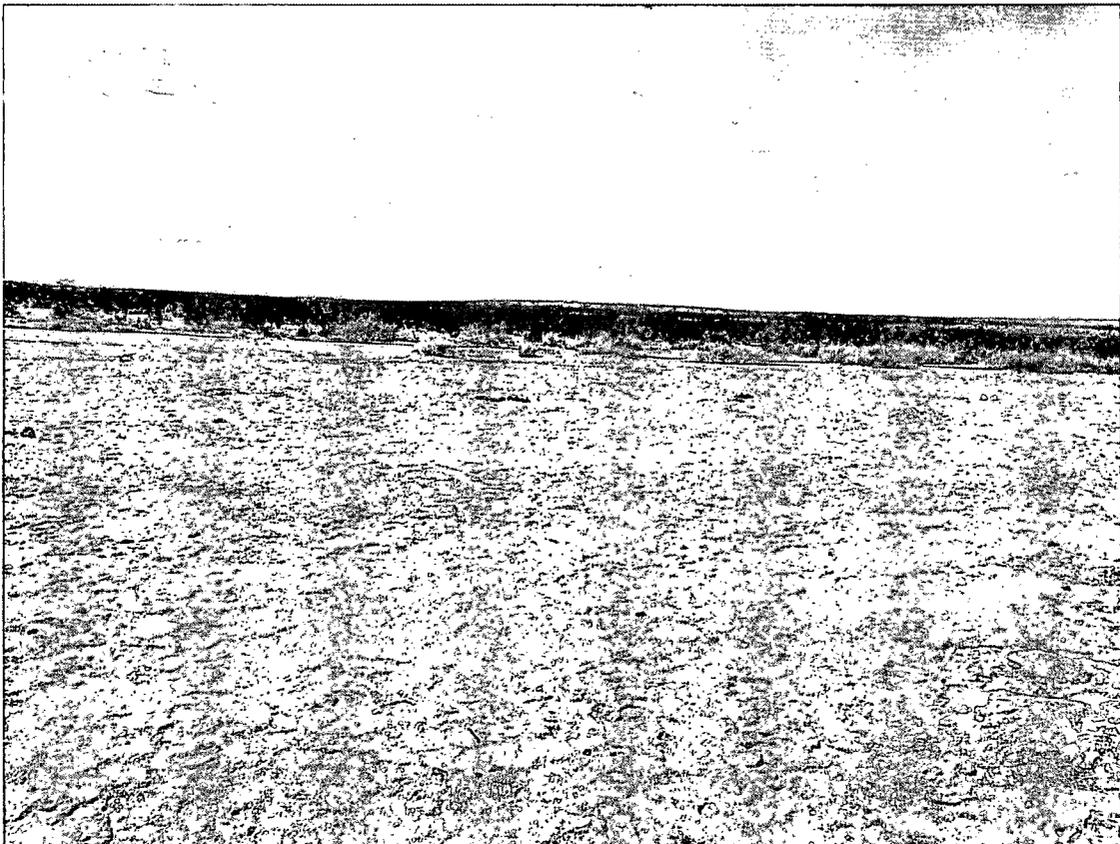
Photograph of the drilling reserve pit and exposed liner. (Looking West)

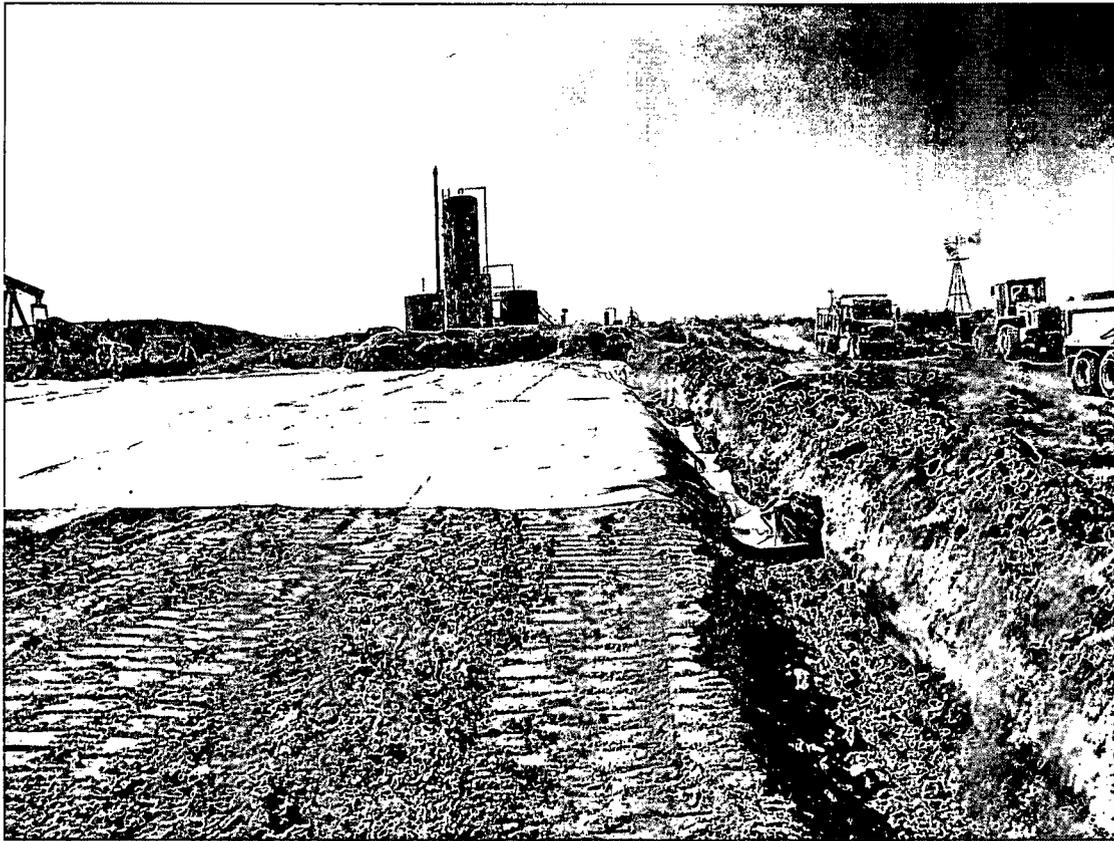
Photograph of the installation of 20-mil polyurethane liner cap atop historic drilling reserve pit. (Looking North)

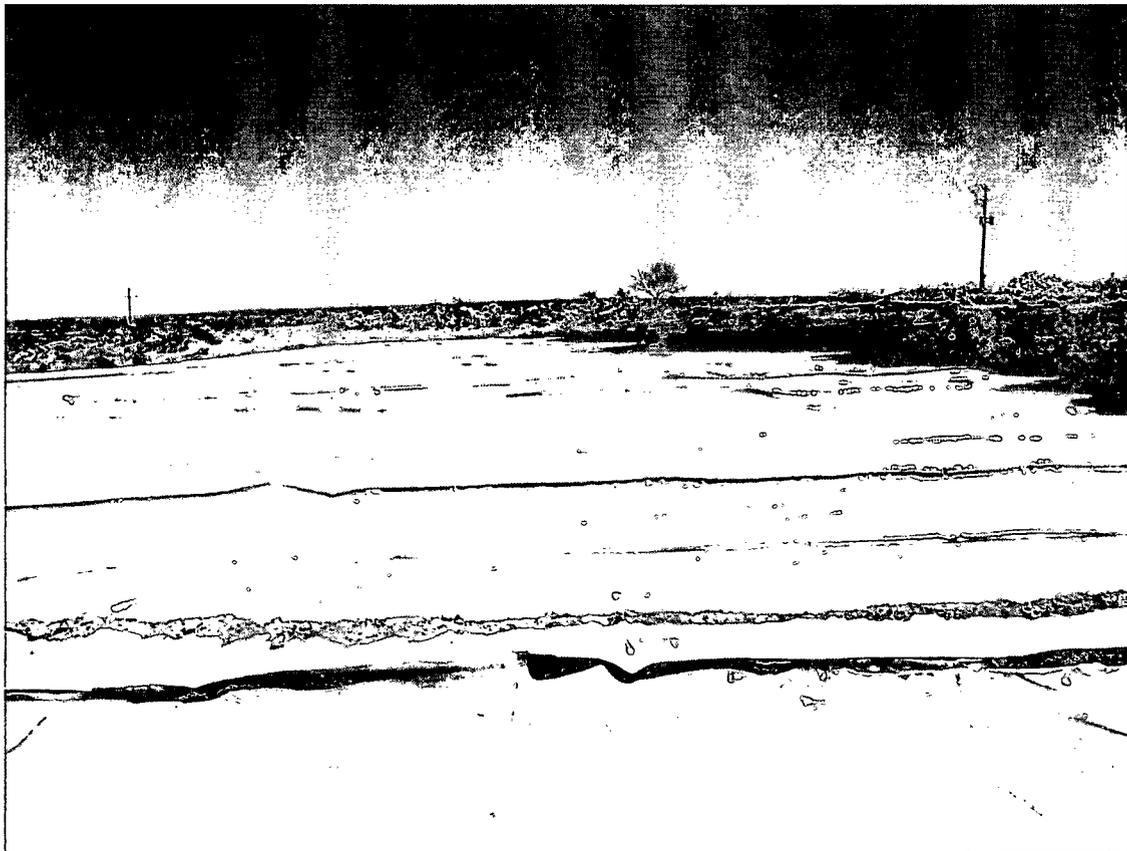
Photograph of 20-mil polyurethane liner cap installed on top of historic drilling reserve pit. (Looking East)

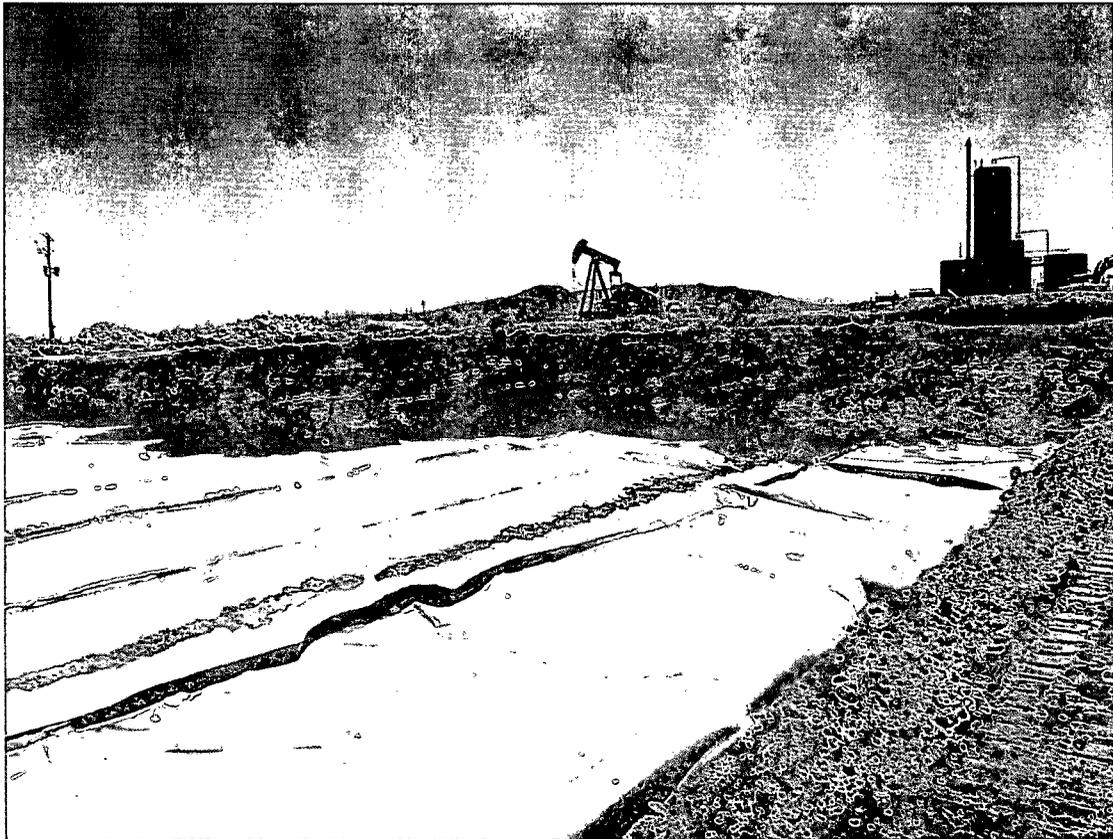
Photograph of 20-mil polyurethane liner cap and layer of top soil installed on top of historic drilling reserve pit. (Looking Southeast)

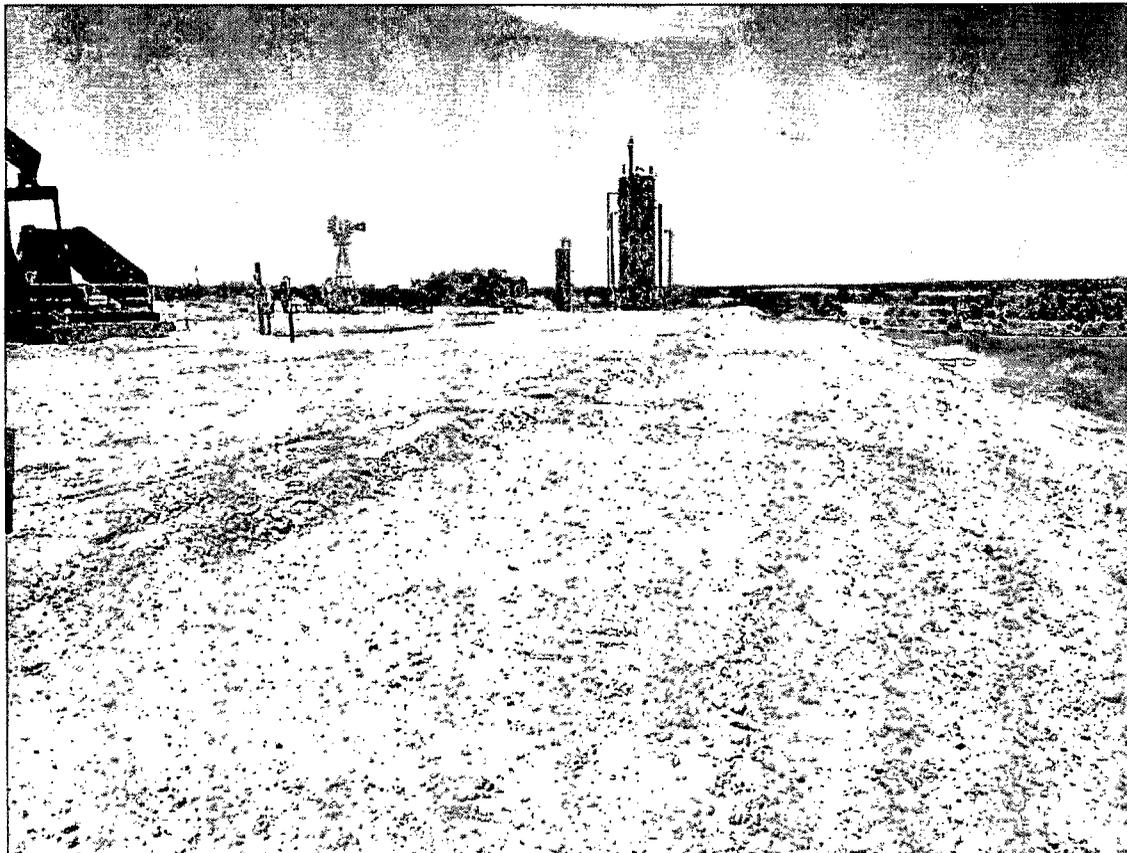
Photograph of the northern edge of the well pad meeting the recapped drilling reserve pit. (Looking West)

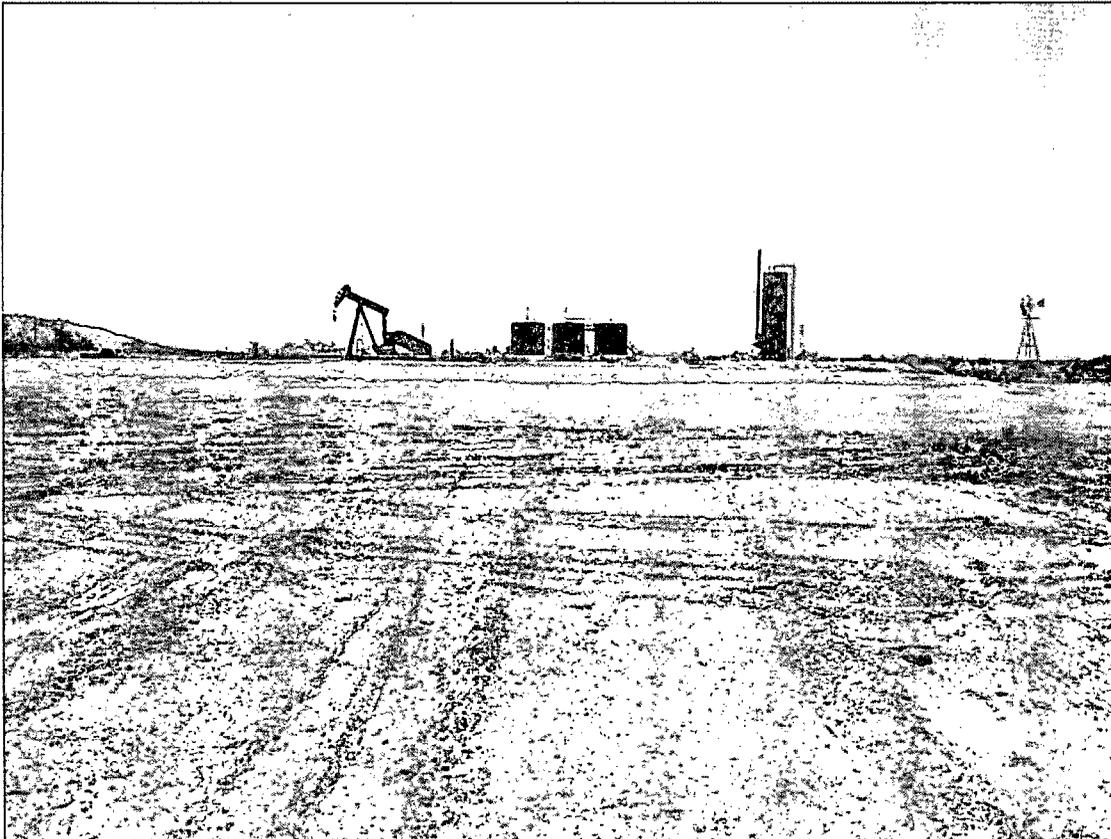
Photograph taken from the northern edge of the recapped reserve pit looking toward the well pad. (Looking North)

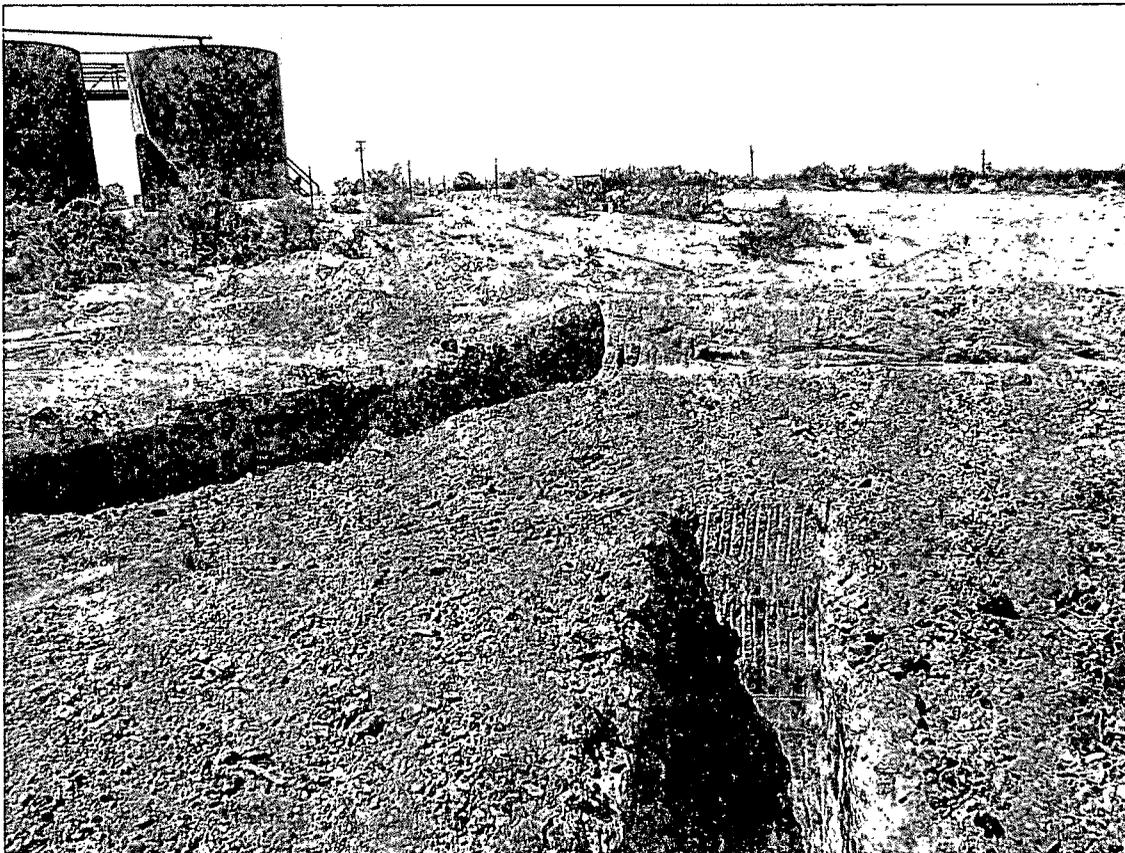
Photograph of the excavated area and delineation trench in the southern portion of the well pad. (Looking Southwest)

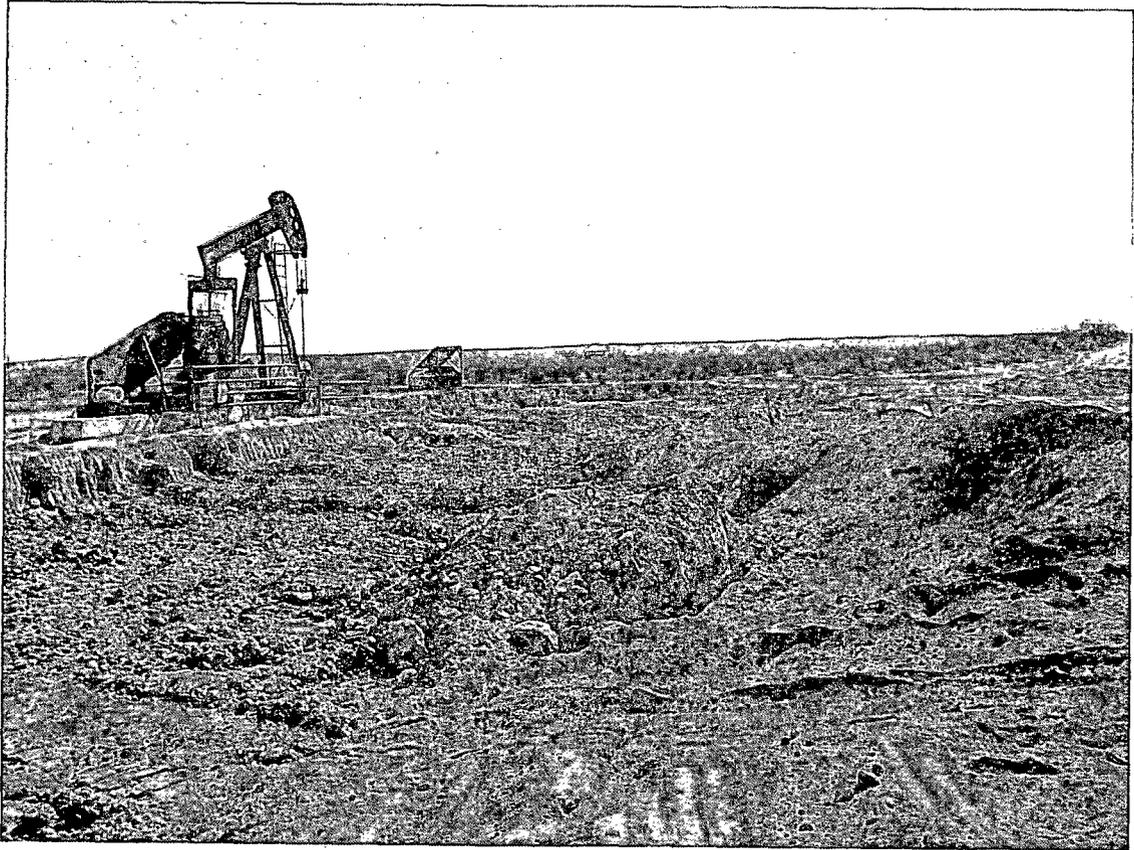
Photograph of the excavated area in the southern portion of the well pad. (Looking Northeast)

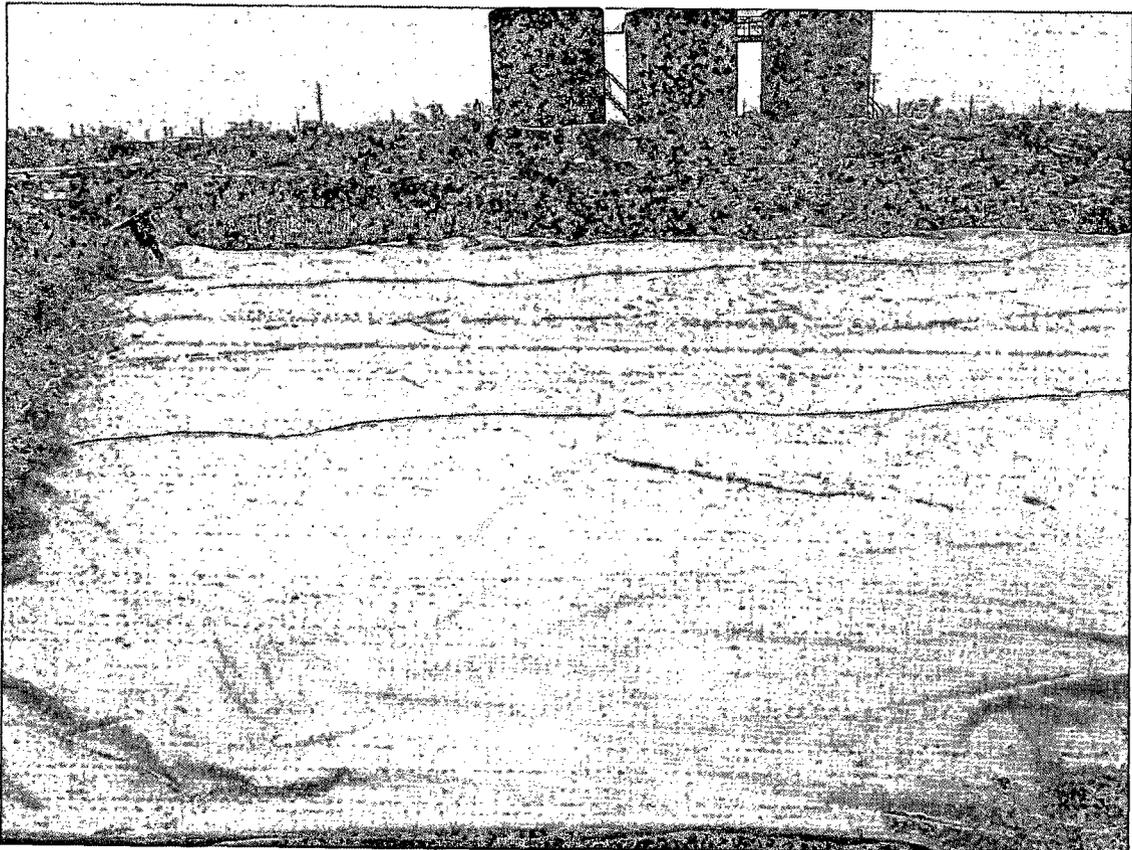
Photograph of the installation of a 20-mil polyurethane liner in the floor of the excavation in the southern portion of the well pad (Looking South)

extent practicable and a twenty-millimeter polyurethane liner be installed in the floor of the environmental excavation atop soil exhibiting chloride impact above NMOCD regulatory standards. Upon completion of remediation activities and repairing the well pad, above ground tanks associated with the Remuda Basin Unit #1 Battery will be relocated atop the risked-out portion of the well pad. A new, impervious containment will be constructed around the Remuda Basin Unit #1 Tank Battery. The containment will consist of steel walls extending approximately two feet (2') above ground surface, lined with felt, and coated with an impermeable spray-on polyurethane liner.

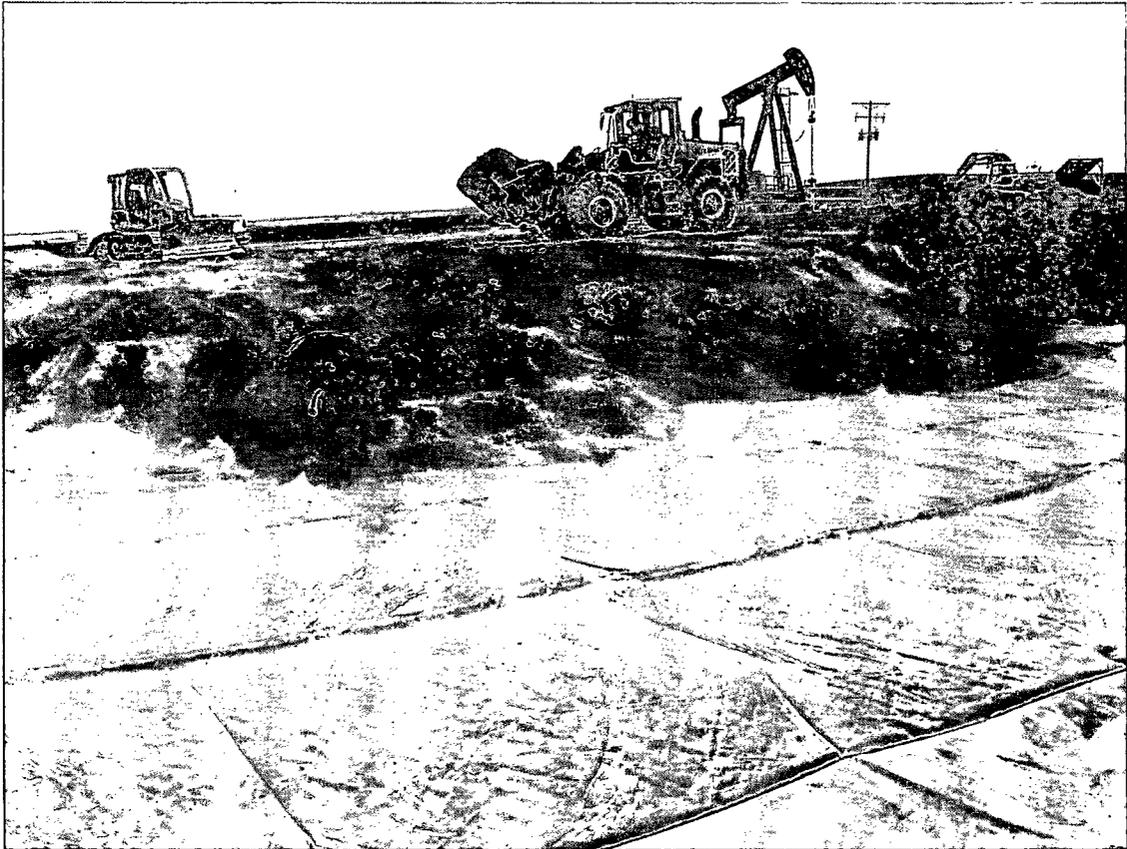
Photograph of the installation of pad sand atop the polyurethane liner in the southern portion of the well pad (Looking Northeast)

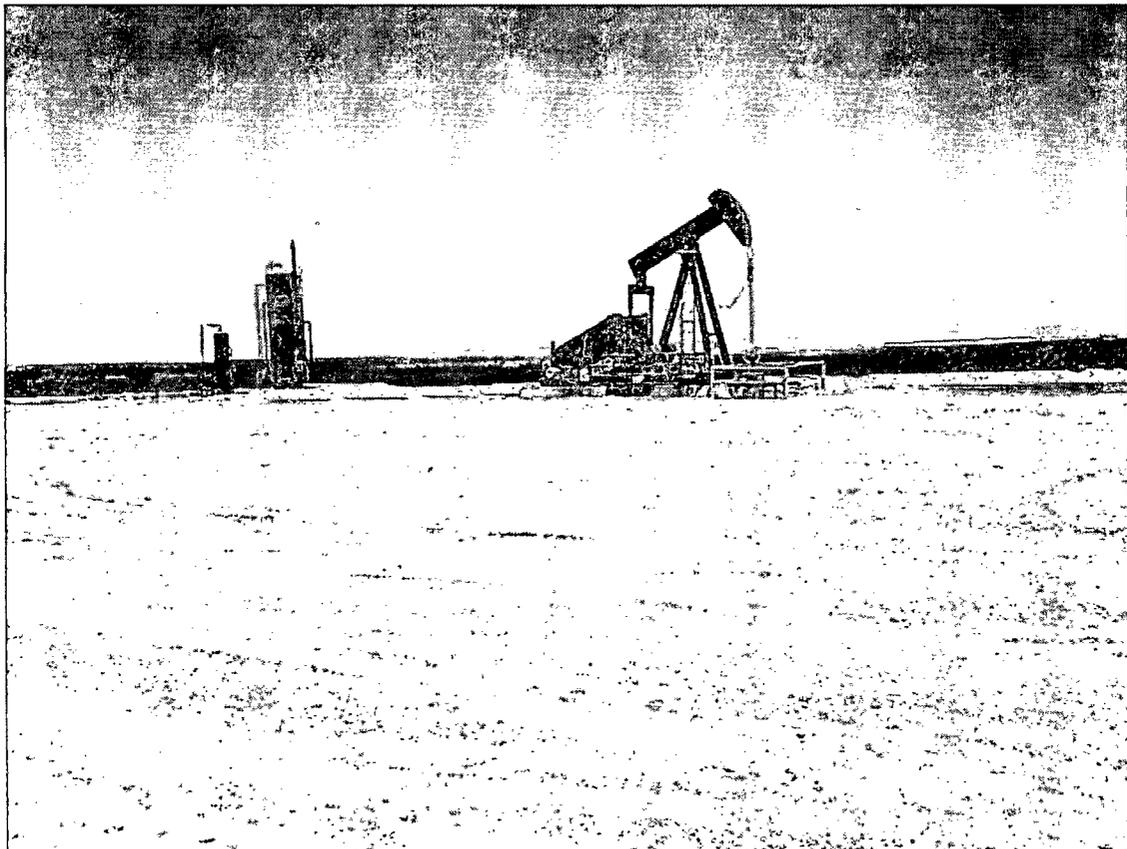
Photograph of the Remuda Basin Unit #1 Tank Battery after remediation activities. (Looking Northwest)

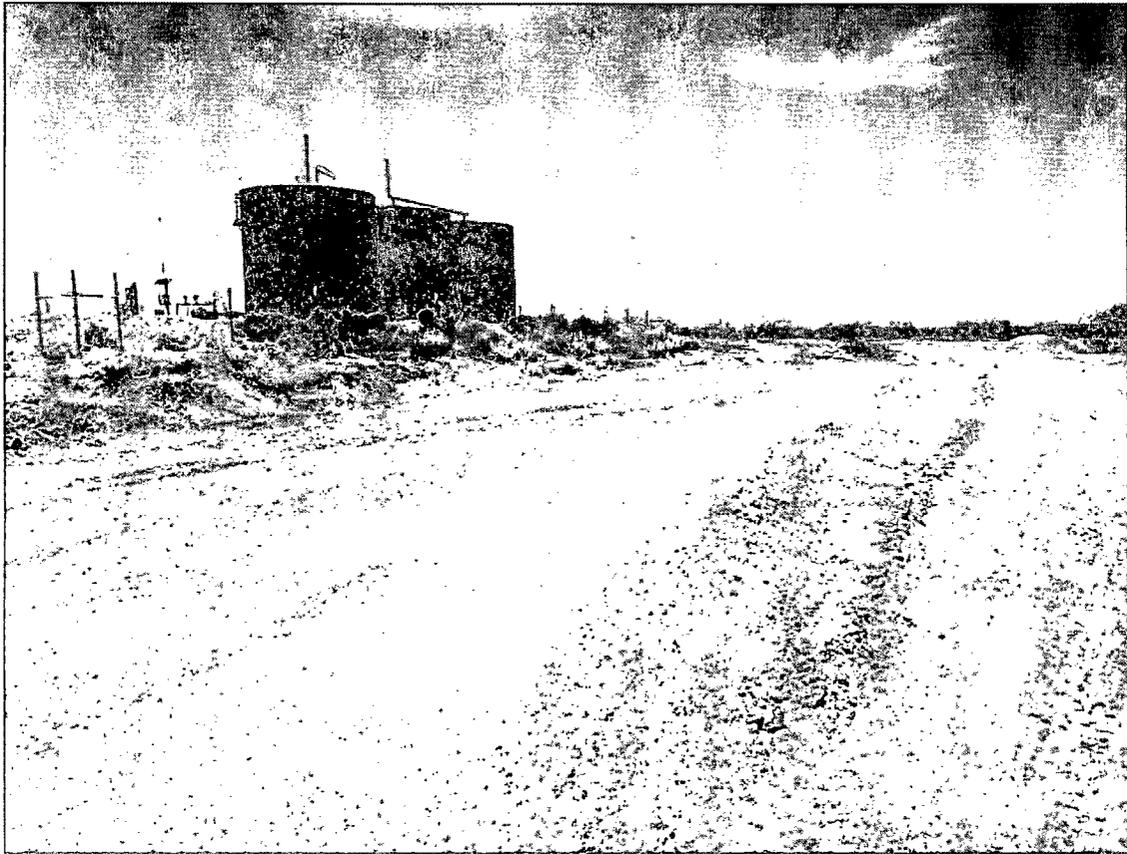
Photograph of the remediated well pad and future tank battery location at the Remuda Basin Unit #1 Tank Battery. (Looking West)

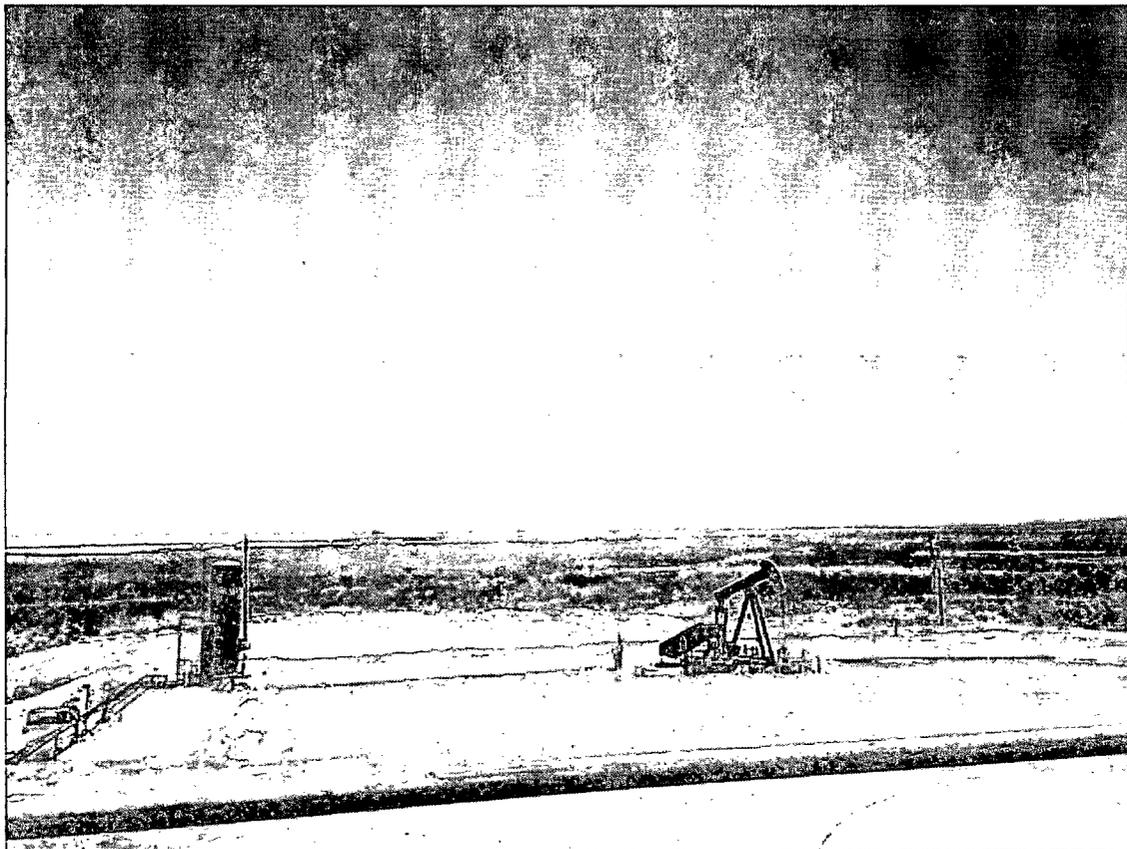
Photograph of the remediated well pad looking out over the recapped drilling reserve pit. (Looking North)

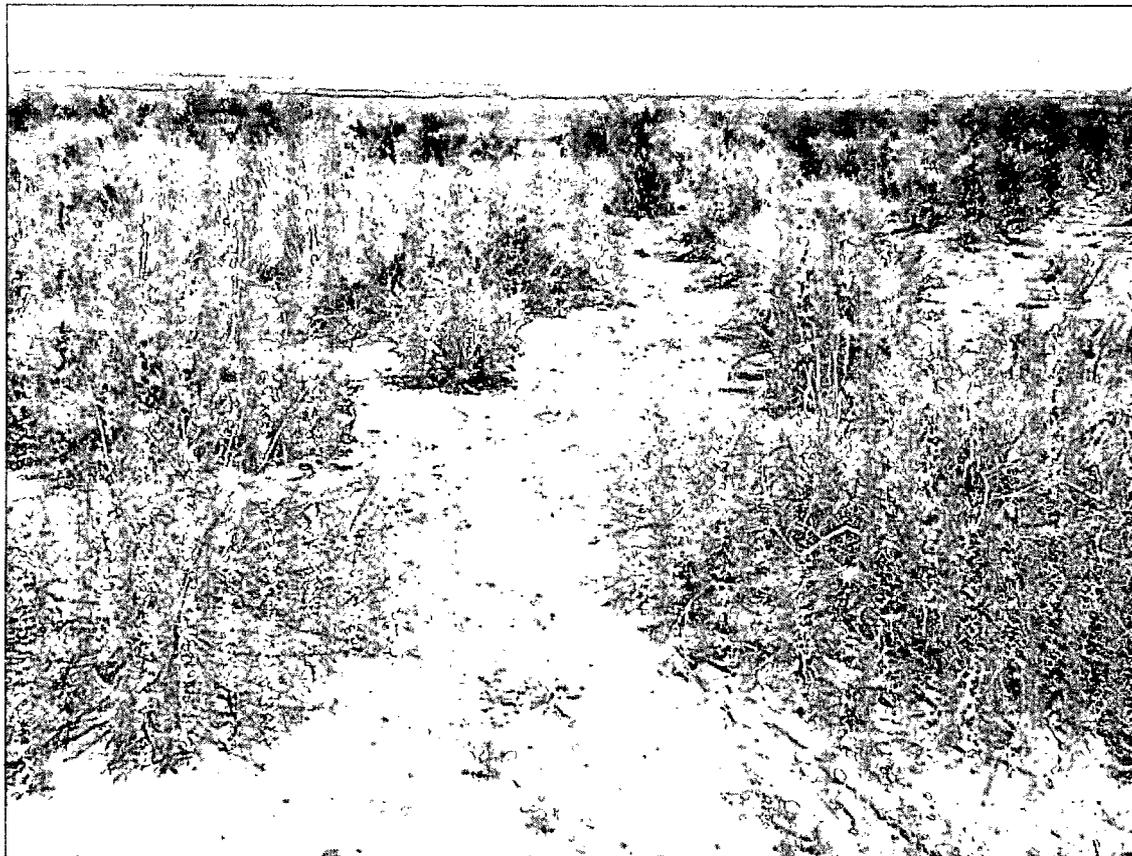
Photograph of the inferred affected run-off area exiting the historic drilling reserve pit at Remuda Basin Unit #1 Tank Battery. (Looking North)

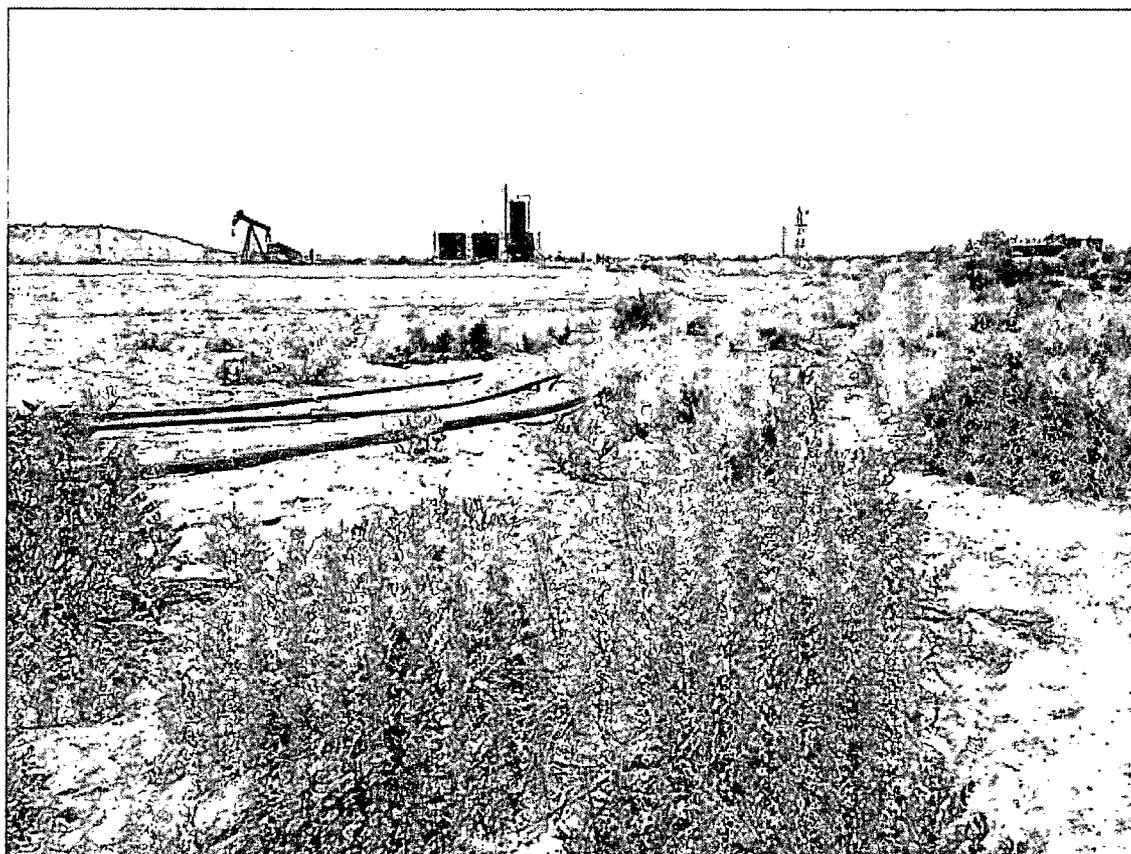
Photograph of the inferred affected run-off area exiting the historic drilling reserve pit at Remuda Basin Unit #1 Tank Battery. (Looking South)
