REMEDIATION SUMMARY & RISK-BASED SITE CLOSURE REQUEST

**BOPCO, LP
POKER LAKE UNIT #158 FLOWLINE
Eddy County, New Mexico
UNIT LTR "A" (NE/NE), Section 7, Township 24 South, Range 30 East
Latitude 32.237274° North, Longitude 103.914835° West**

June 2011

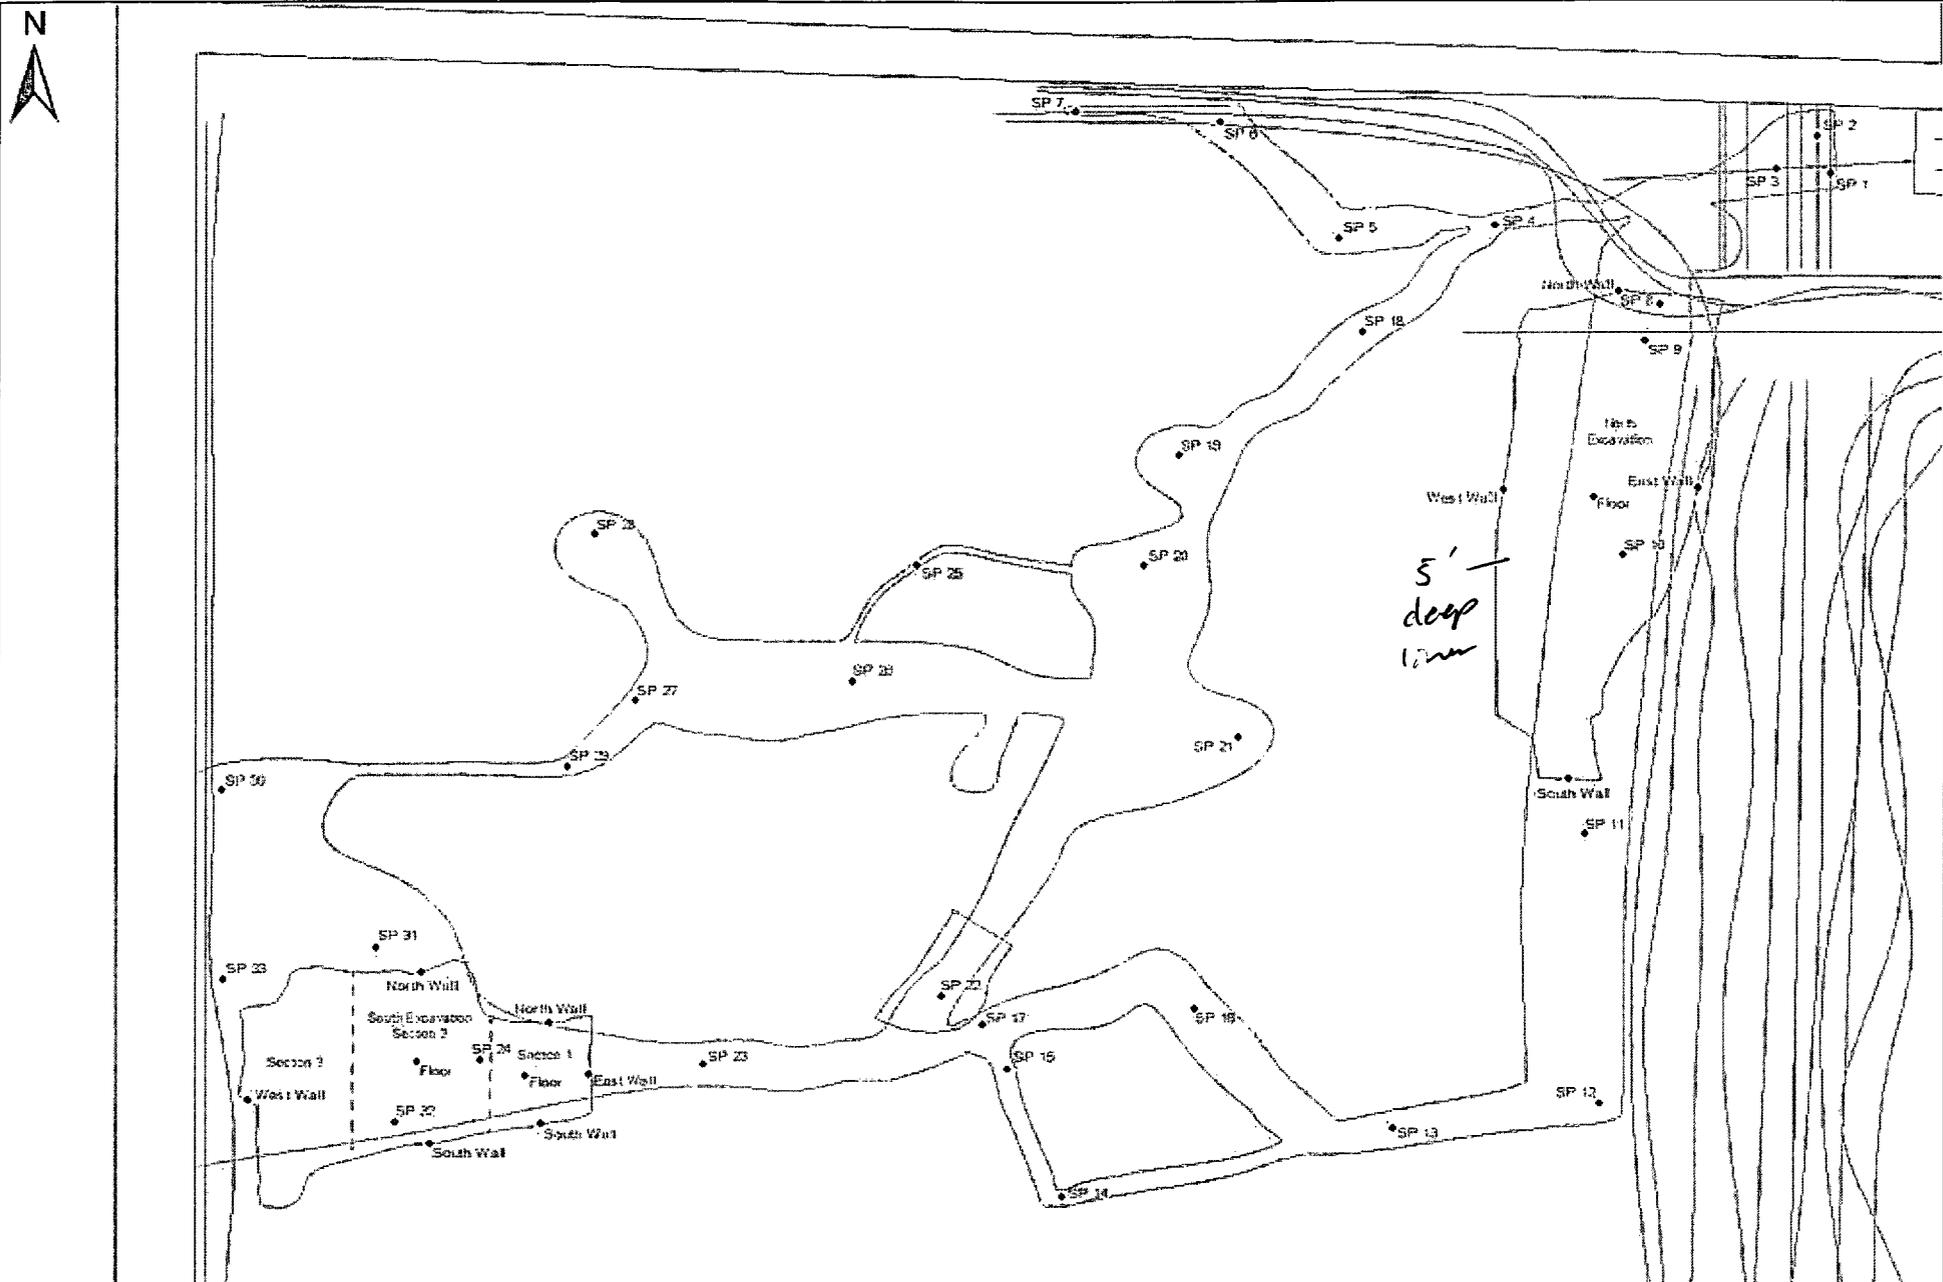
Figure 2 – Site & Sample Location Map

Based on results of field-tests, the release site was divided into two sections: North Excavation and South Excavation. The North Excavation (N Exc) was advanced in the area defined by soil samples Sample 8, Sample 9, and Sample 10. The South Excavation (S Exc) was advanced in the area defined by soil samples Sample 24 and Sample 32. In an effort to mitigate damage to surface topography and vegetation, the South Excavation was further divided into three subsections: Section 1, Section 2, and Section 3. Field tests indicated no further remediation would be required in the area defined by soil sample Sample 22.

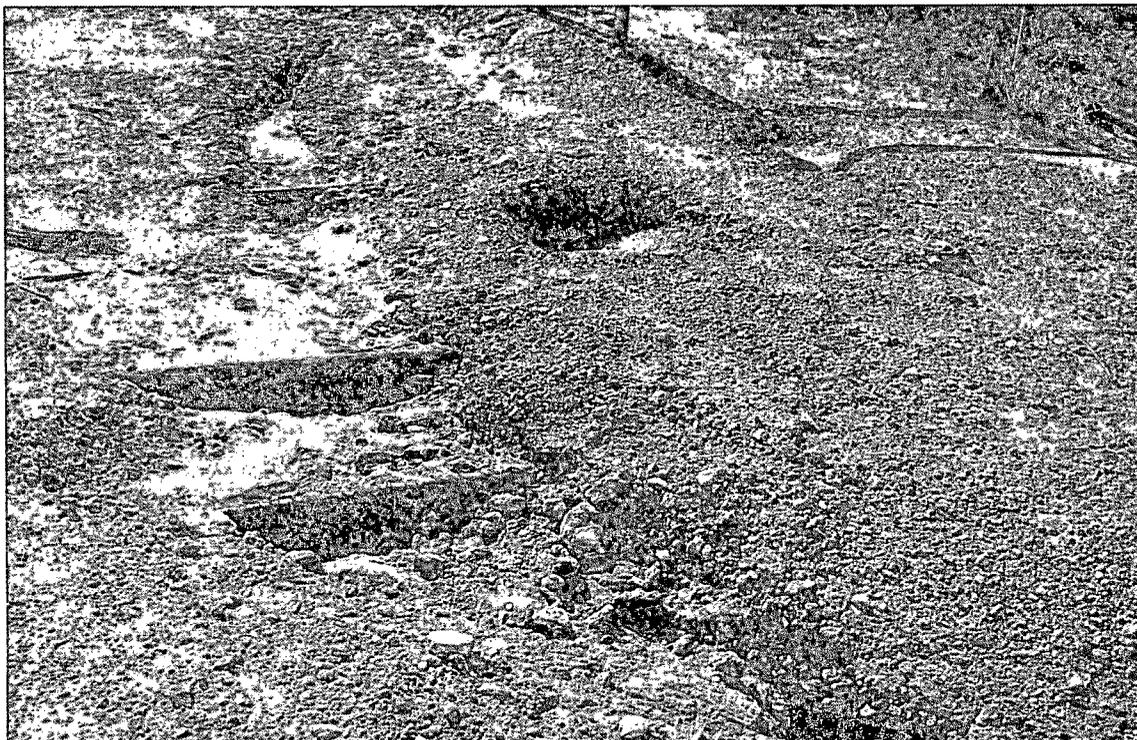
Poker Lake Unit #158 Flowline - Release Point

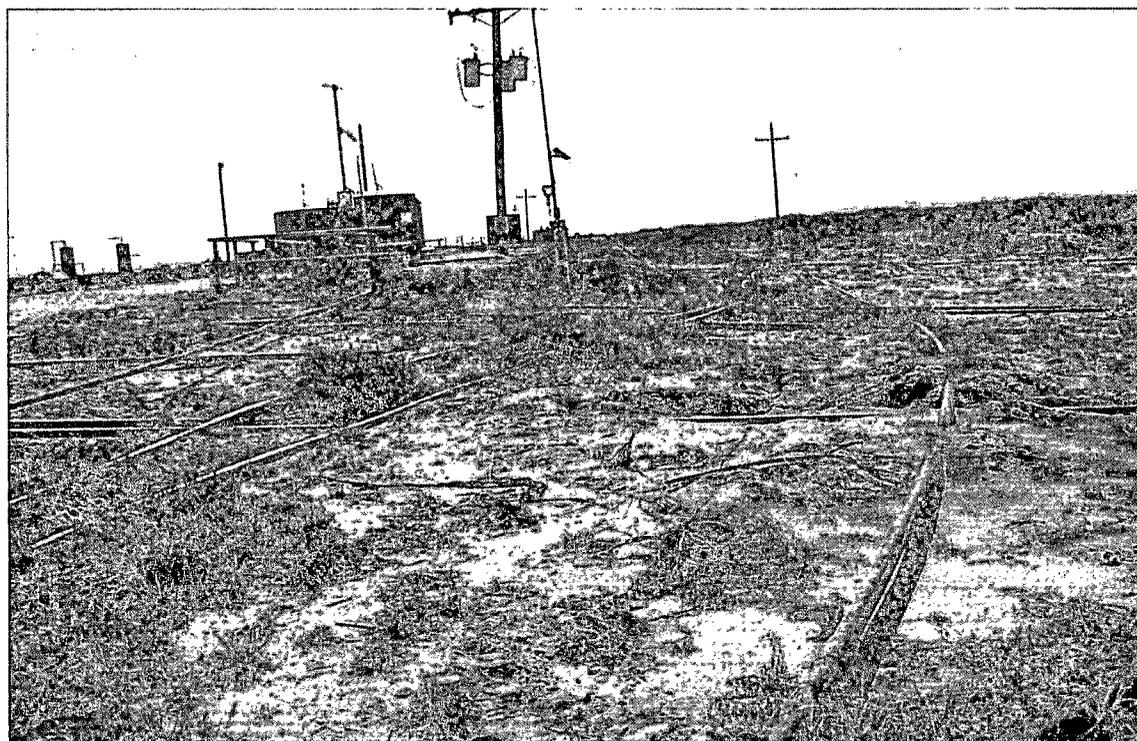
Poker Lake Unit #158 Flowline - Release Site (Facing East)

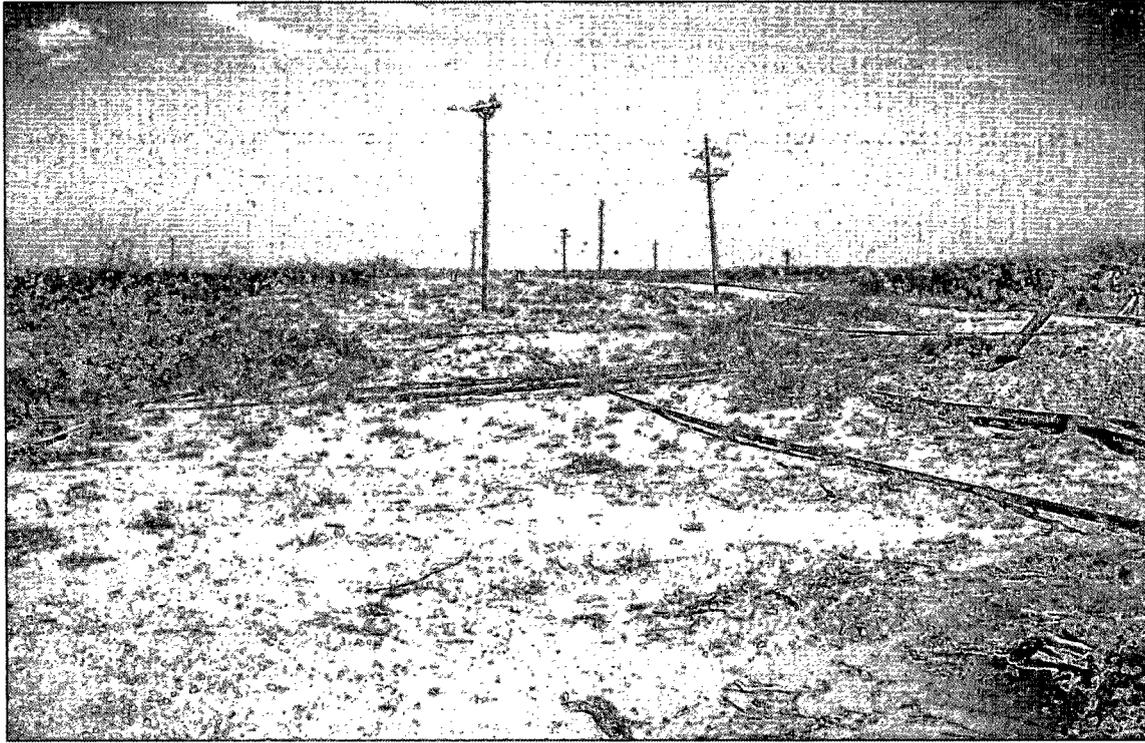
Poker Lake Unit #158 Flowline - Release Site (Facing West)

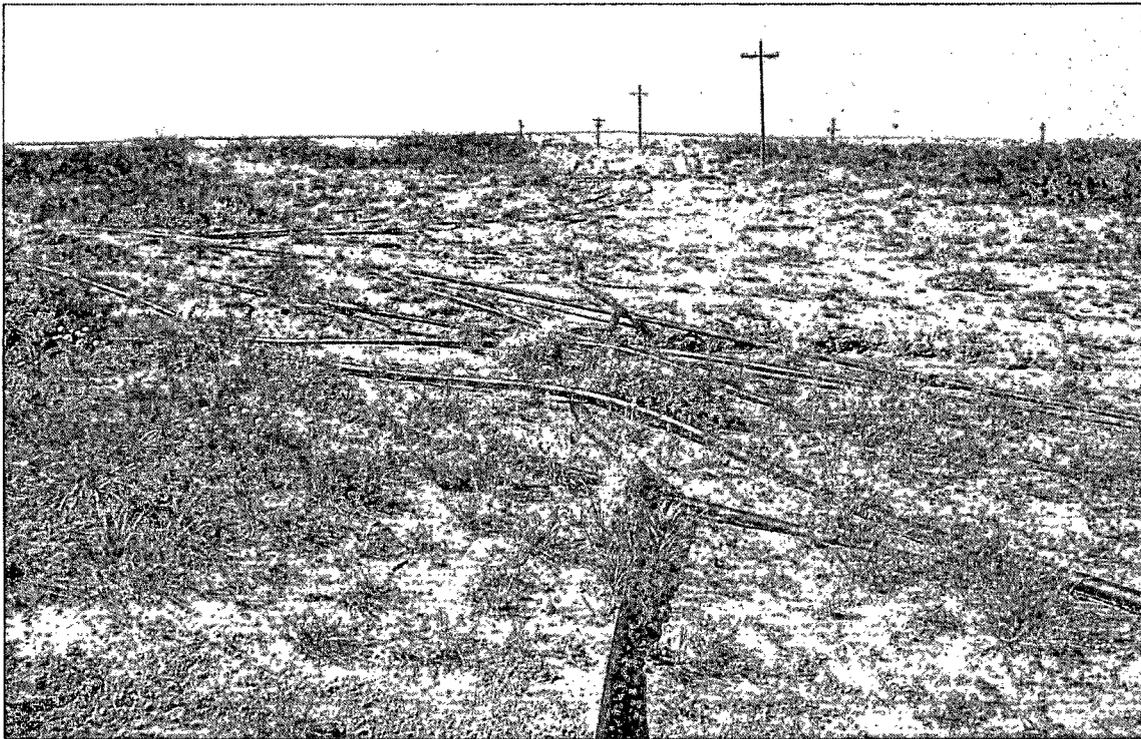
Poker Lake Unit #158 Flowline - Release Site (Facing South)

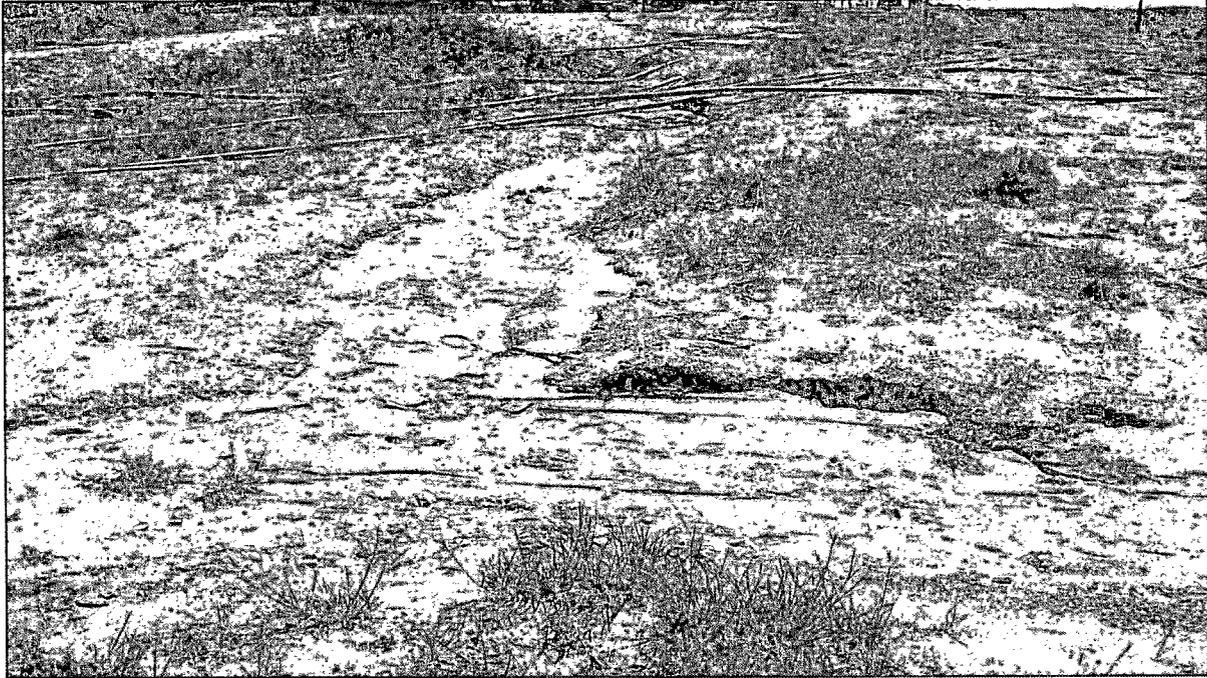
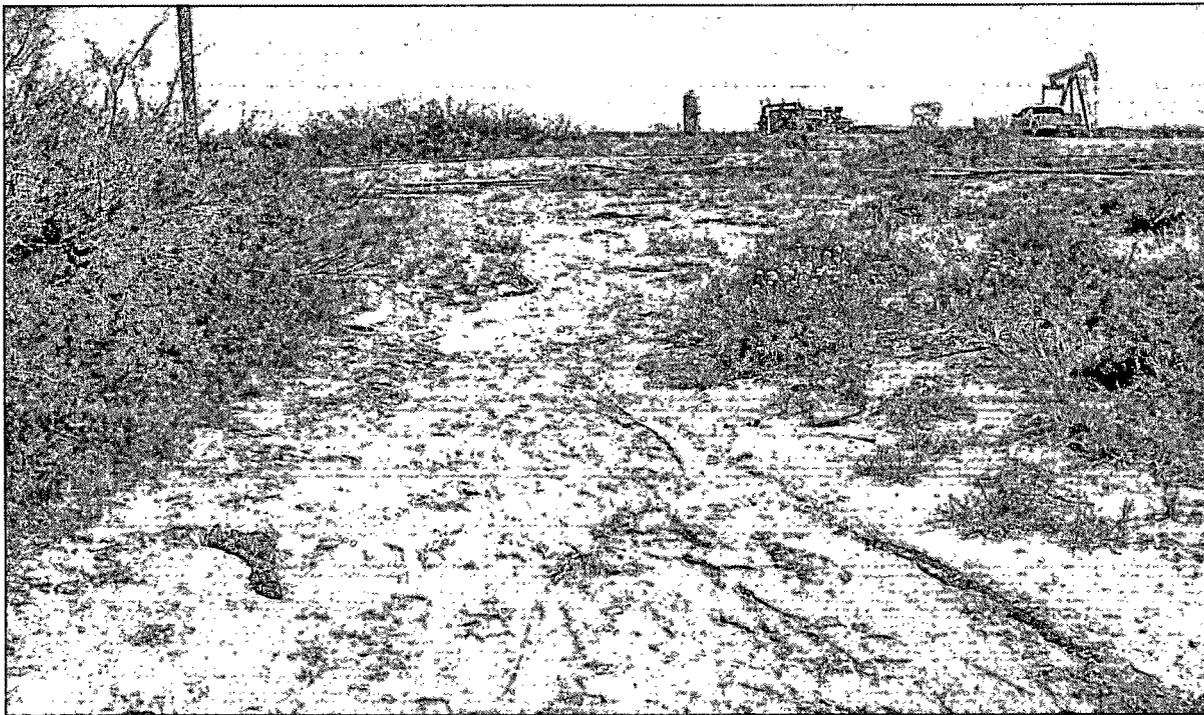
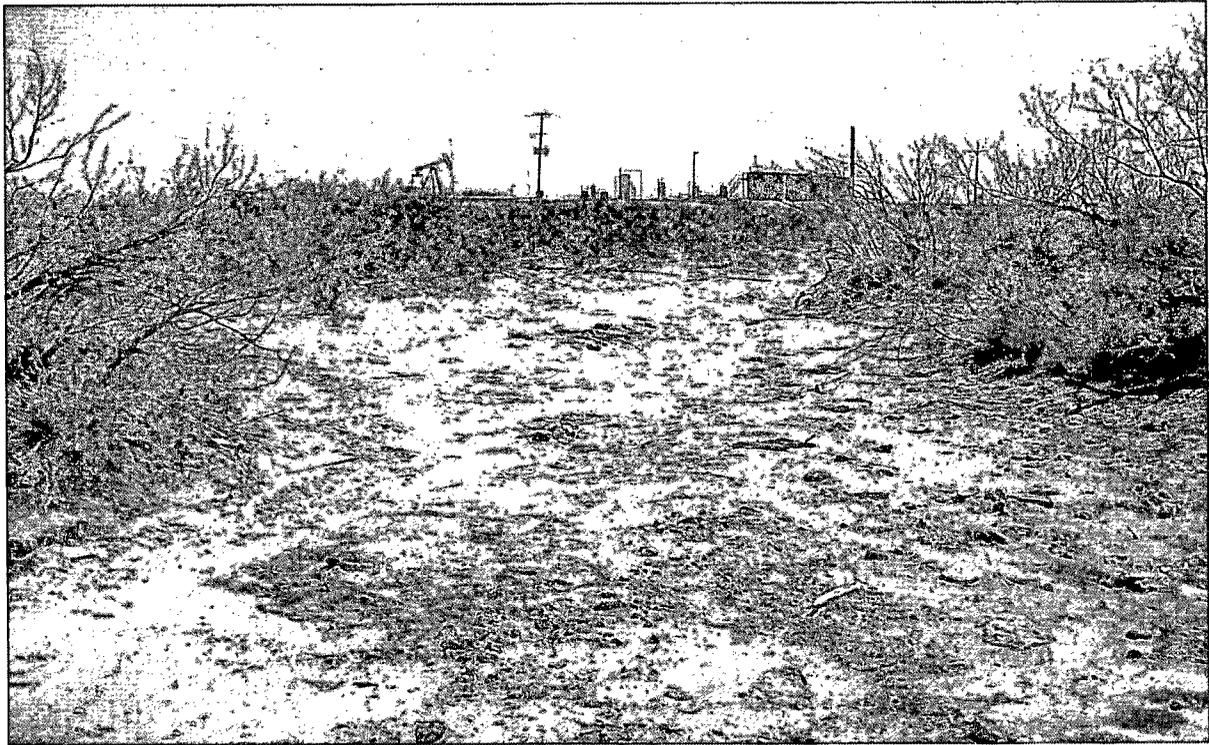
Poker Lake Unit #158 Flowline - Release Site (Run-Off Area)

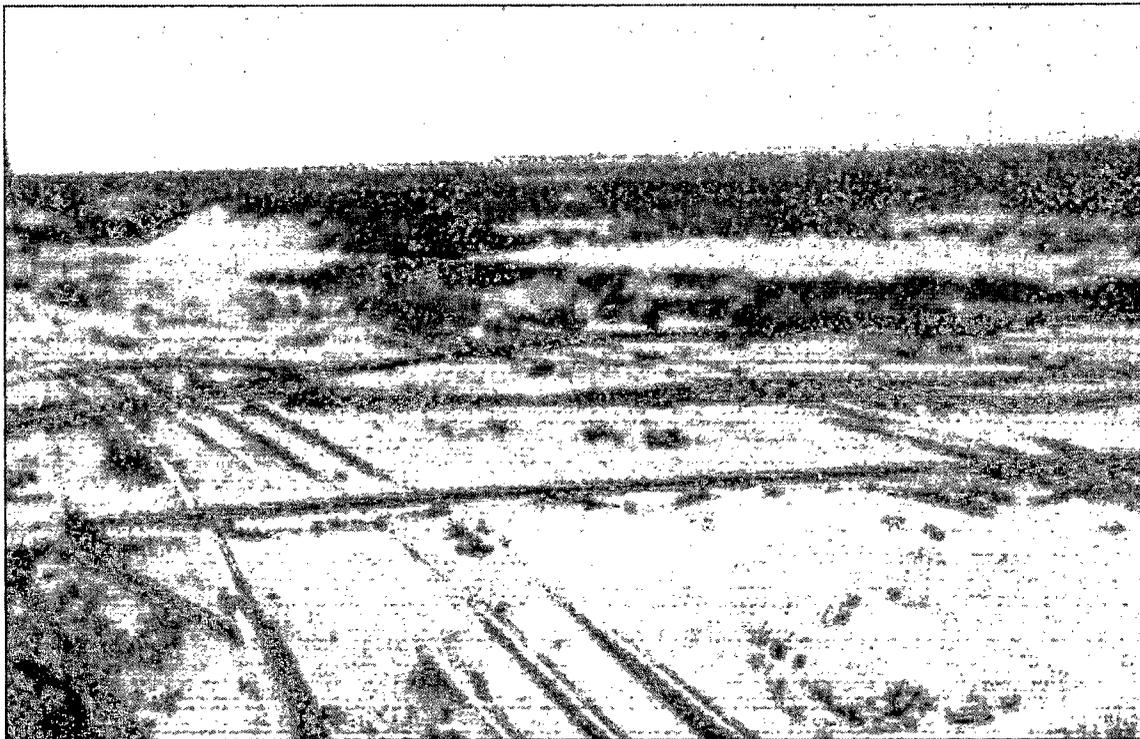
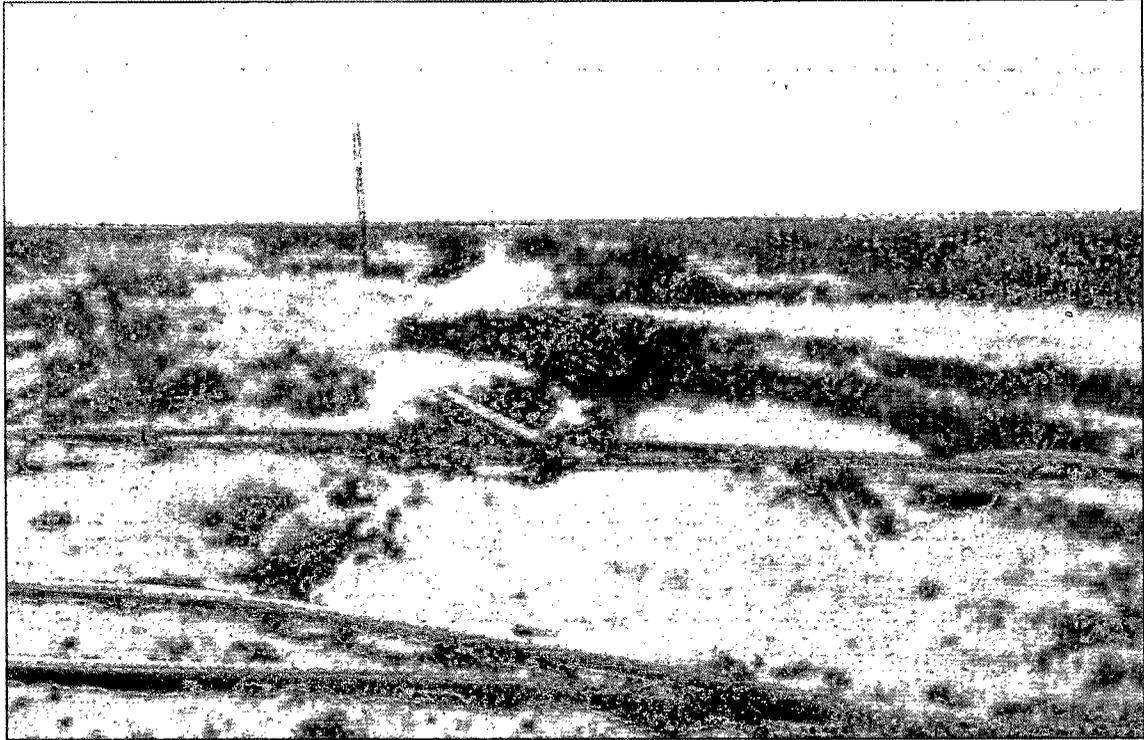
Poker Lake Unit #158 Flowline - North Excavation

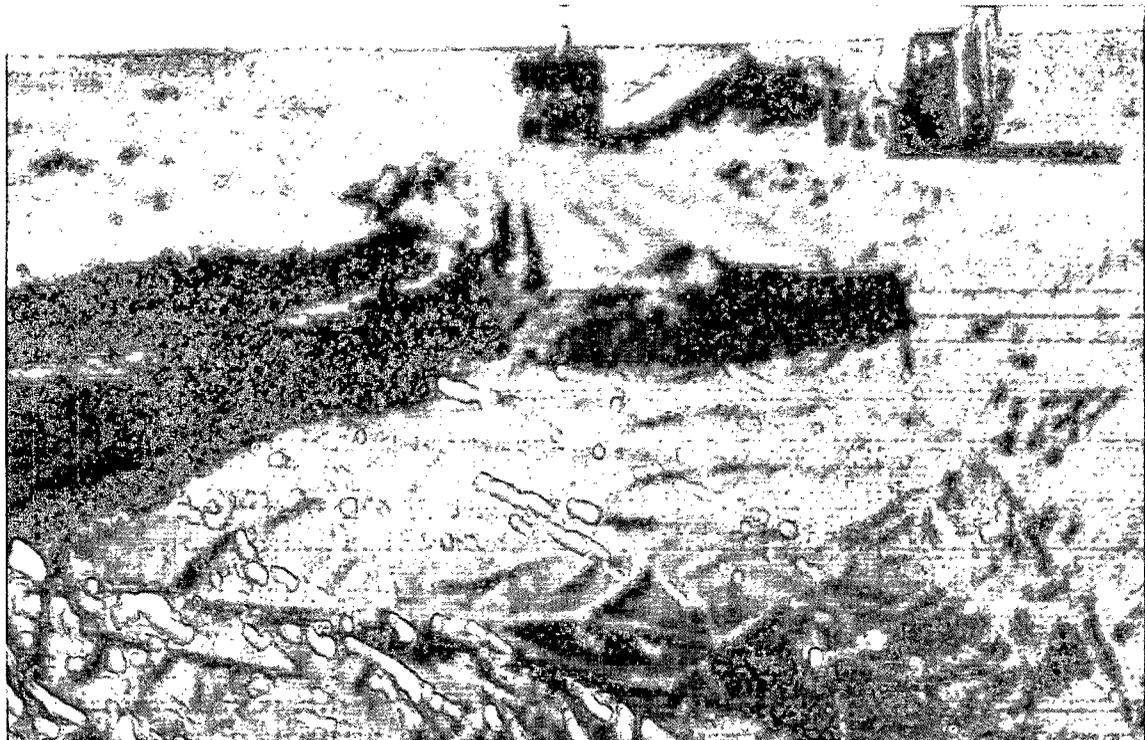
Poker Lake Unit #158 Flowline - North Excavation (During Backfilling)

From March 4 through March 7, 2011, based on results of laboratory analyses and field screens, the North Excavation and Section 3 of the South Excavation were backfilled in eighteen-inch (18") lifts, compacted, and contoured to fit the surrounding topography. Prior to backfilling, a 20 mil polyurethane liner was installed in the floor of the North Excavation at approximately five feet (5') bgs. Approximately six inches (6") of non-impacted pad sand was installed both above and below the liner to protect the liner from damage during installation and backfilling activities.

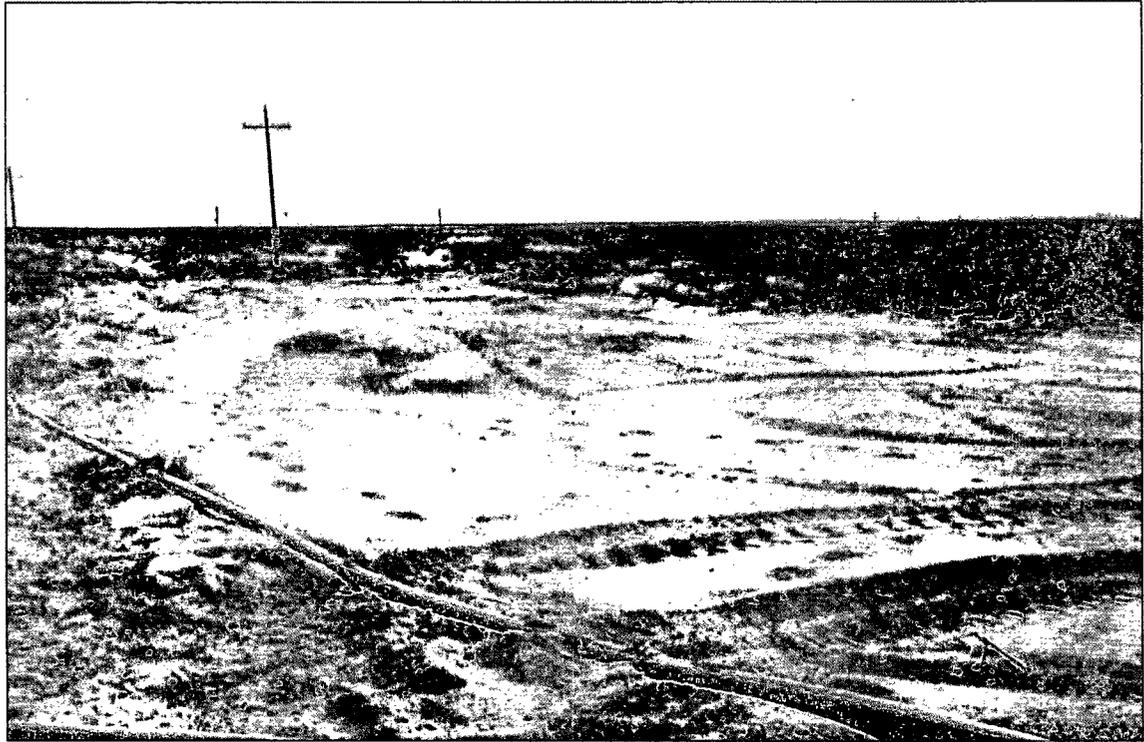
Poker Lake Unit #158 Flowline - North Excavation (Following Backfilling)

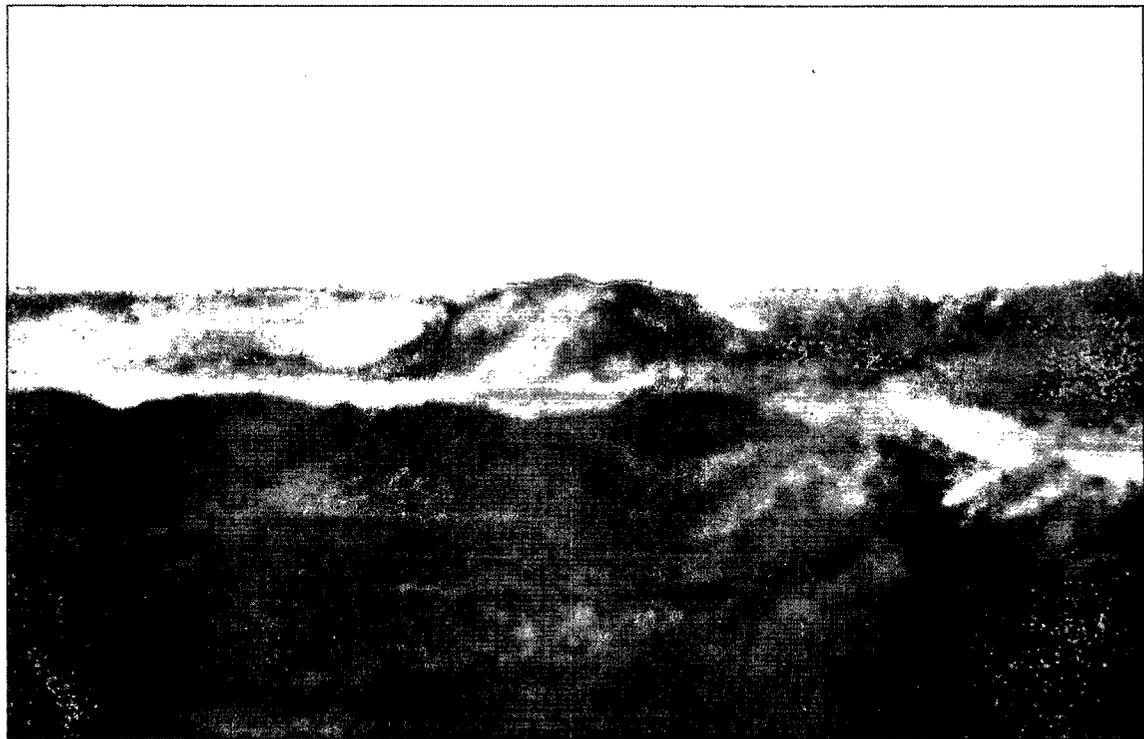
Poker Lake Unit #158 Flowline - South Excavation

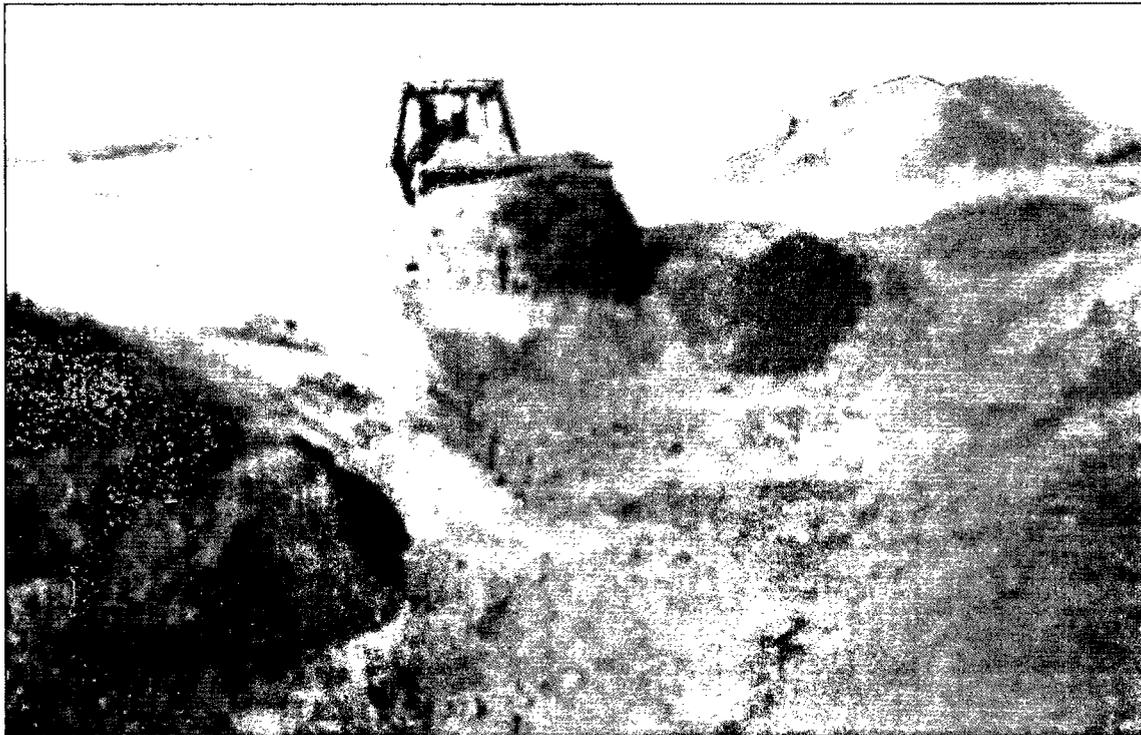
Poker Lake Unit #158 Flowline - South Excavation (During Backfilling)

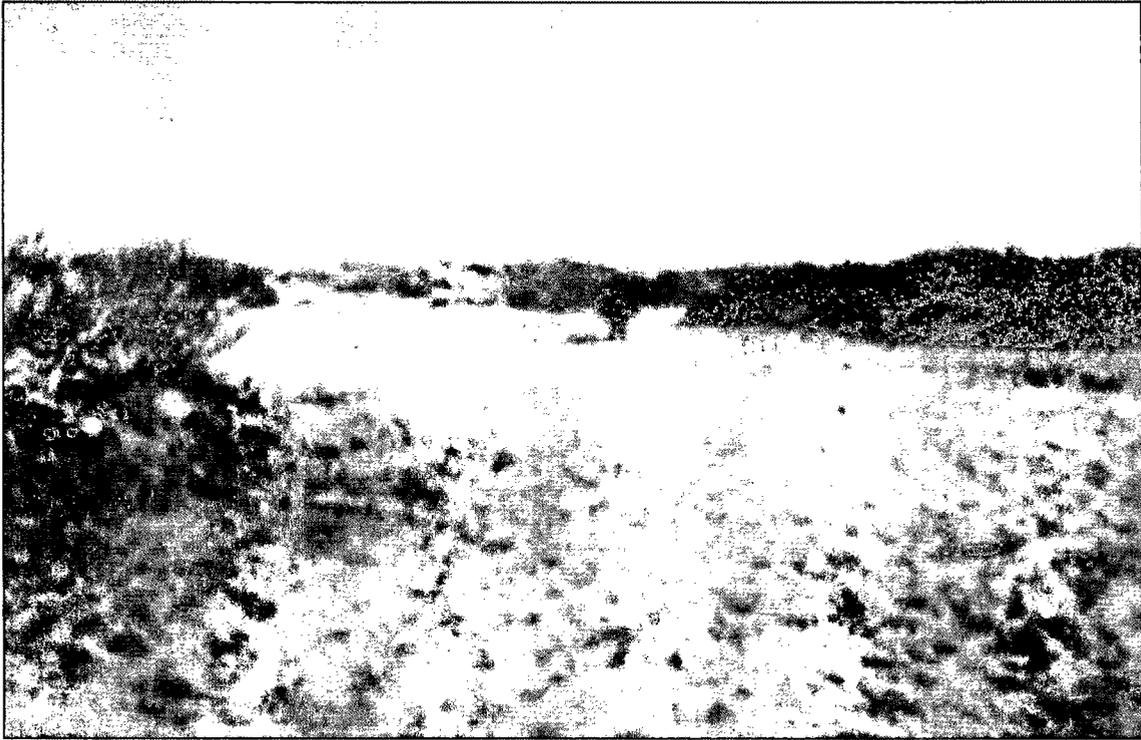
Poker Lake Unit #158 Flowline - South Excavation (Following Backfilling)
