**Re: Spill Remediation Report, Primero Operating, Inc.,
Milano #1,
Unit Letter H (SE/4, NE/4), Section 36, Township 24 South, Range 28 East,
Eddy County, New Mexico
(Latitude: N 32.17471° / Longitude: W 104.03485°)
2RP - 1867**

Site Drawing With Soil Sample Locations

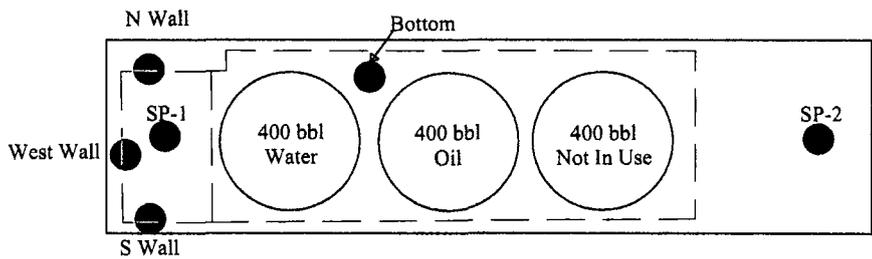
FIGURE # 2

Summary of Laboratory Results				
Sample	Depth	TPH	BTEX	CL
SP-1	0-6"	23669	<0.050	9200
SP-1	1'	3490	<0.050	4320
SP-1	2'	<20.0	<0.050	4720
SP-1	3'	*.*.*	*.*.*	2840
SP-1	4'	*.*.*	*.*.*	842
SP-1	5'	*.*.*	*.*.*	786
SP-1	6'	*.*.*	*.*.*	3380
SP-1	7'	*.*.*	*.*.*	1110
SP-1	8'	*.*.*	*.*.*	750
SP-1	9'	*.*.*	*.*.*	1340
SP-1	10'	*.*.*	*.*.*	2950
N Wall	3-4'	*.*.*	*.*.*	1780
S Wall	3-4'	*.*.*	*.*.*	1320
W Wall	3-4'	*.*.*	*.*.*	479
Bottom	2'	1310	*.*.*	788
SP-2	0-6"	*.*.*	*.*.*	784

LEGEND	
(•)	Soil Sample Location
---	Boundary of Excavation

On September 23 and 24, 2013, hydrocarbon and chloride impacted soil was excavated from an 18 by 26 foot area at the west end of the Milano #1 tank battery, to a depth of four (4) feet bgs. On September 24, 2013, composite soil samples were collected from the North, South, and West walls of the excavation and submitted to Xenco Laboratories (Xenco), of Odessa, Texas, for chloride analysis. Table 1 shows the laboratory results. Figure 2 shows the sample locations and laboratory results. Appendix C provides a copy of the laboratory reports and chain of custody documentation. Photographs are included in Appendix D.

On September 26, 2013, excavation of all impacted soil surrounding the tanks was completed (to a depth of 1.5 to 2 feet bgs), and a composite confirmation sample (Bottom) was collected. The sample was placed in a clean glass sample jar, chilled in an ice chest, and delivered to Xenco for analysis of TPH and chlorides. The laboratory reported a TPH

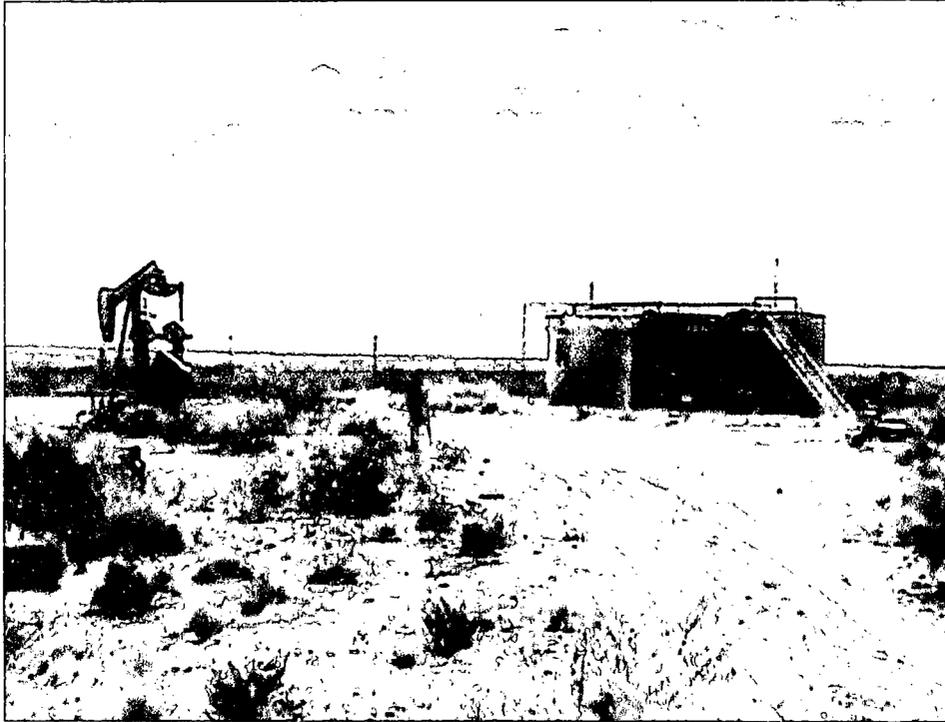
View to southeast of battery prior to remediation.

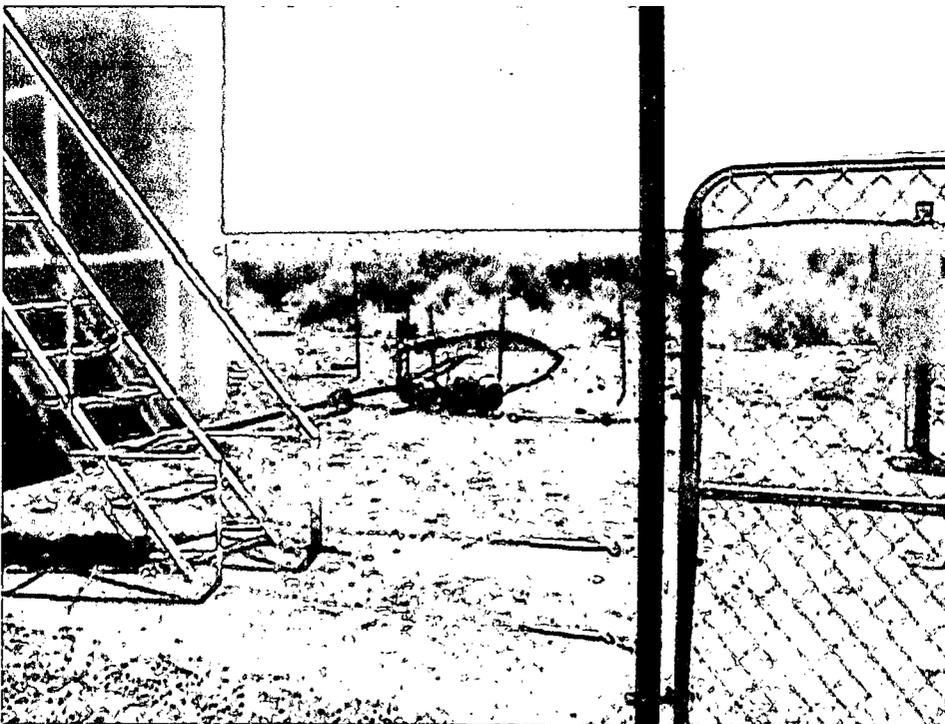
View to south of spill at west end of battery.

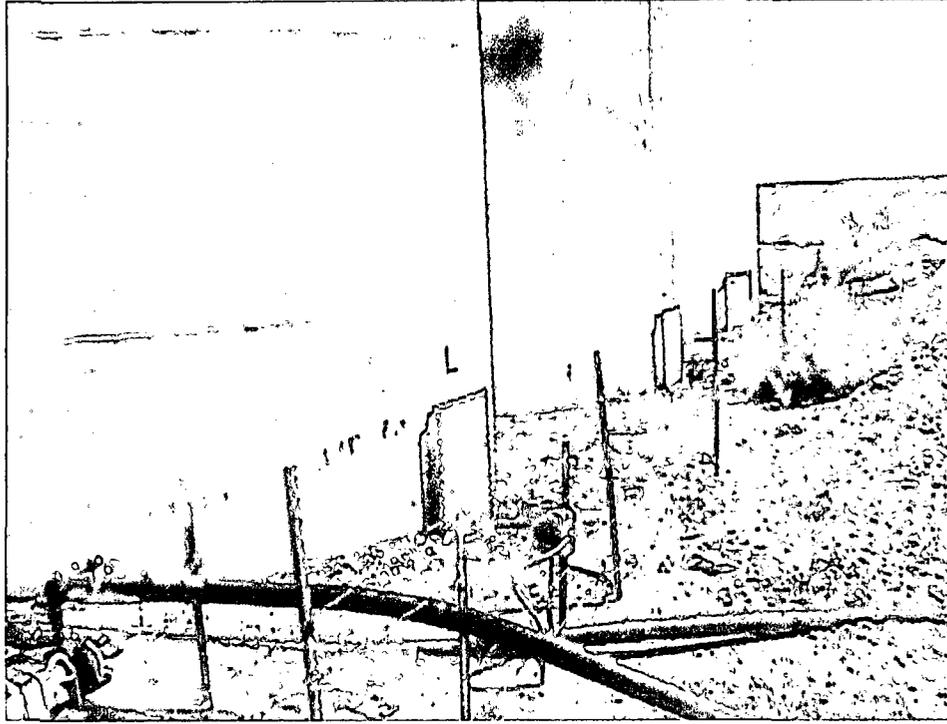
View to east of south side of battery prior to remediation.

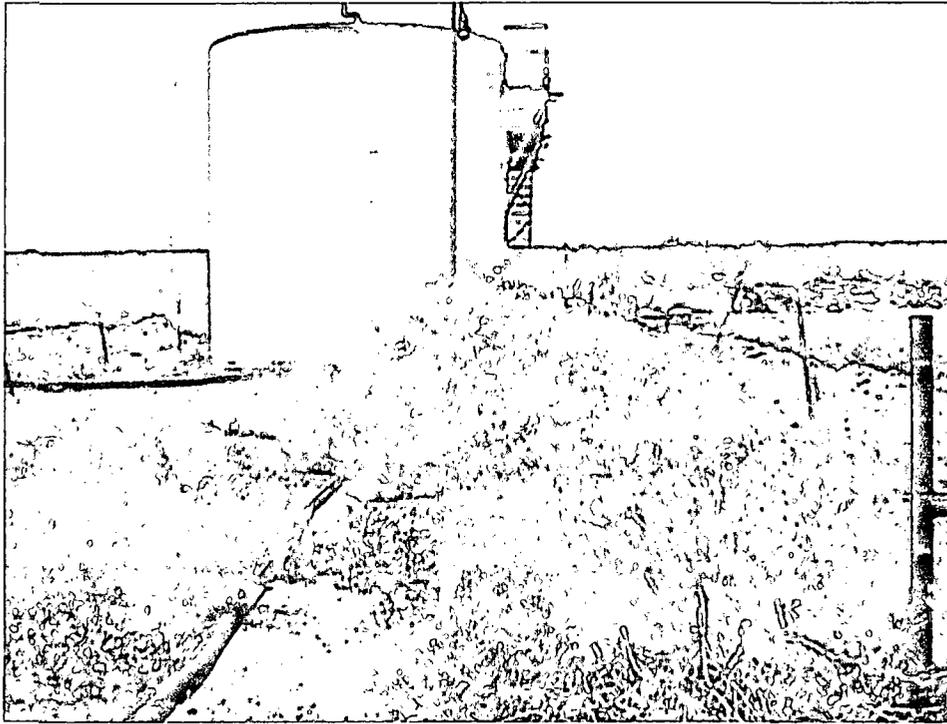
View to west of battery prior to remediation.

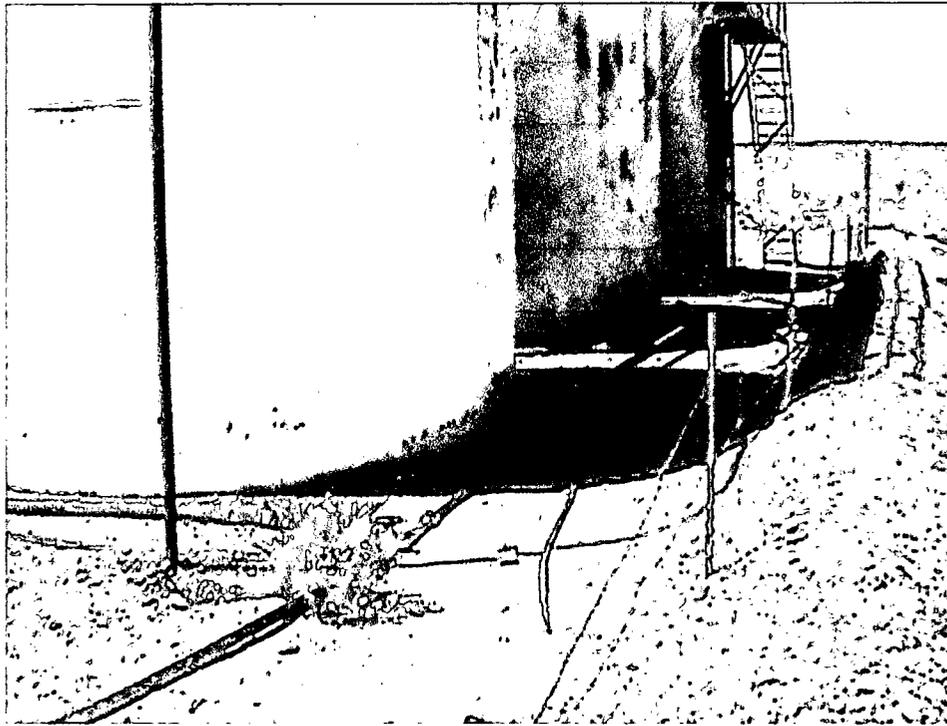
View to west of north side of battery prior to remediation.

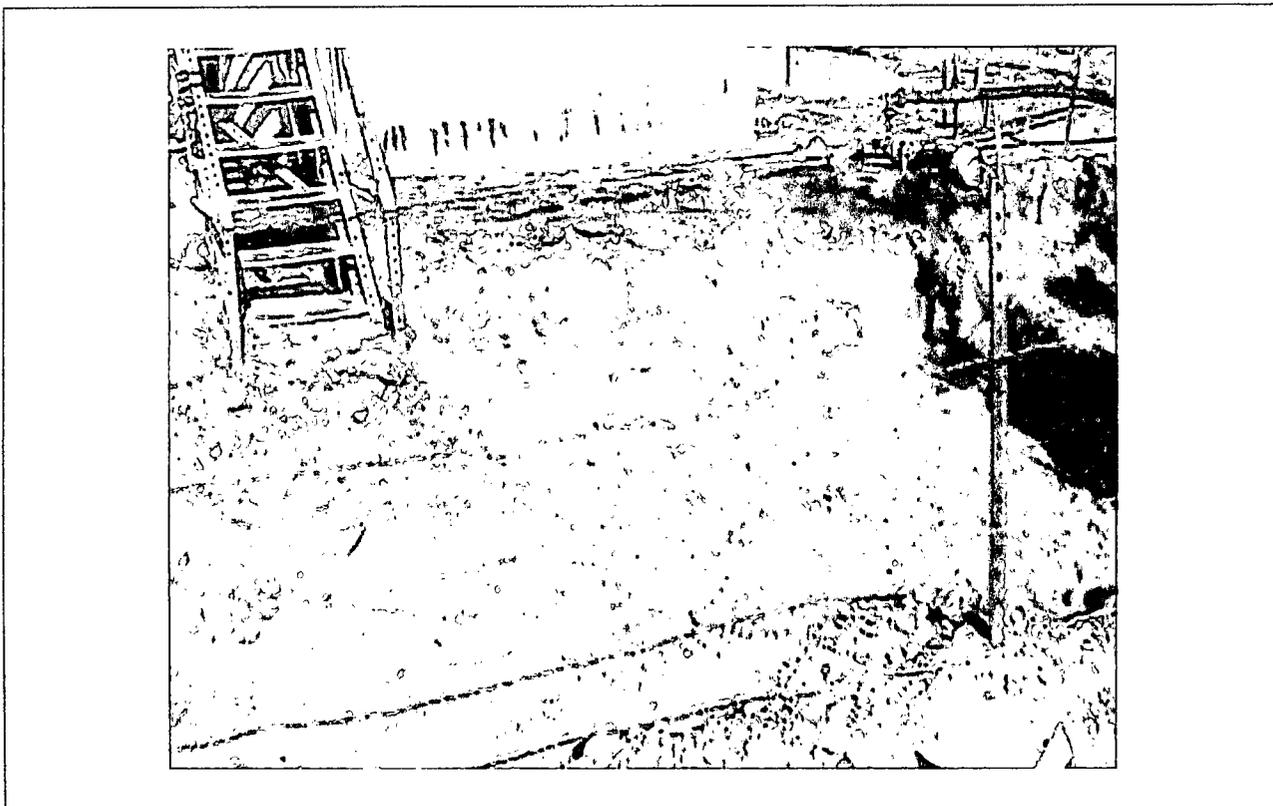
View to east of excavation at west end of battery.

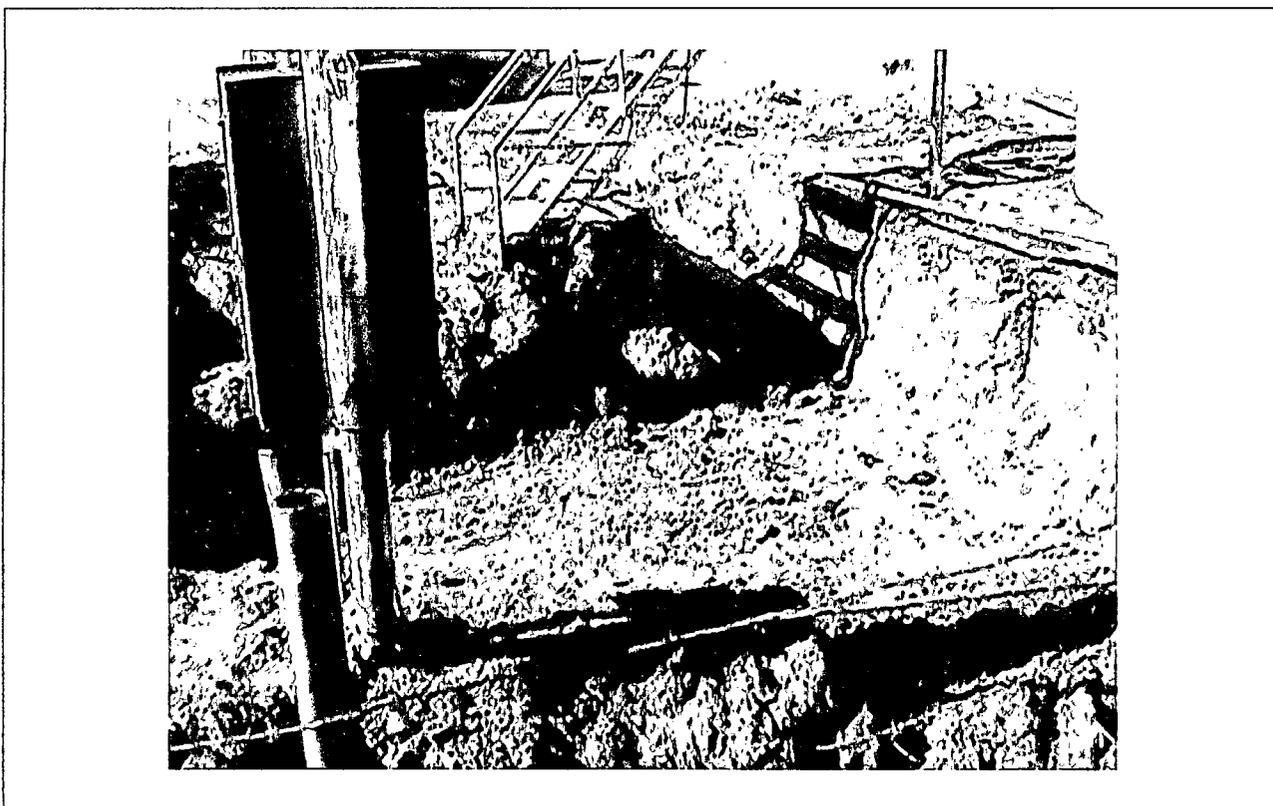
View to north of excavation at west end of battery.

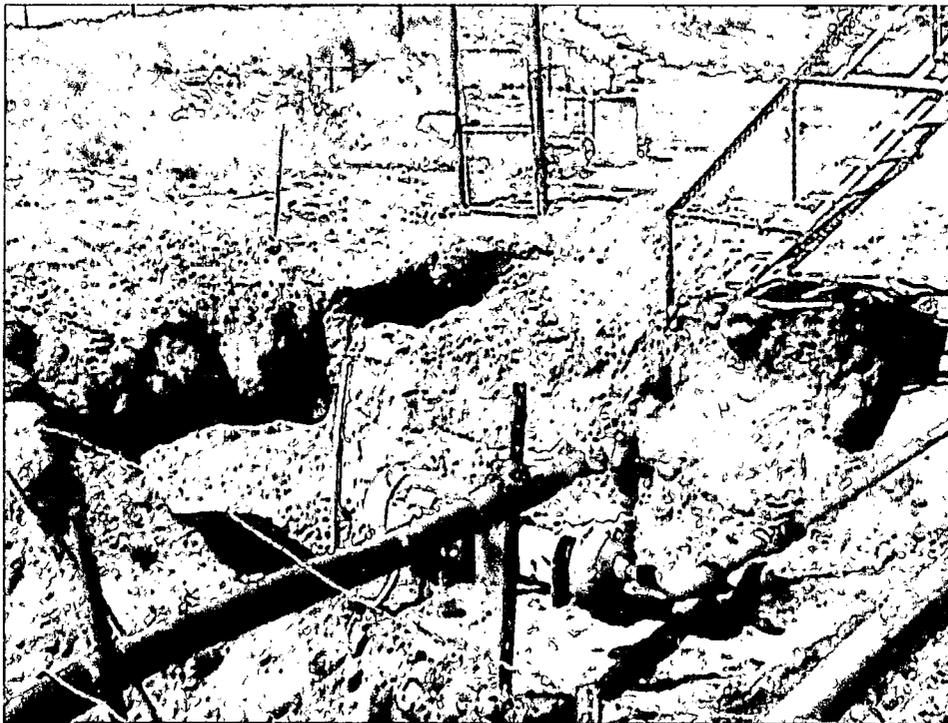
View to northwest of excavation at west end of battery.

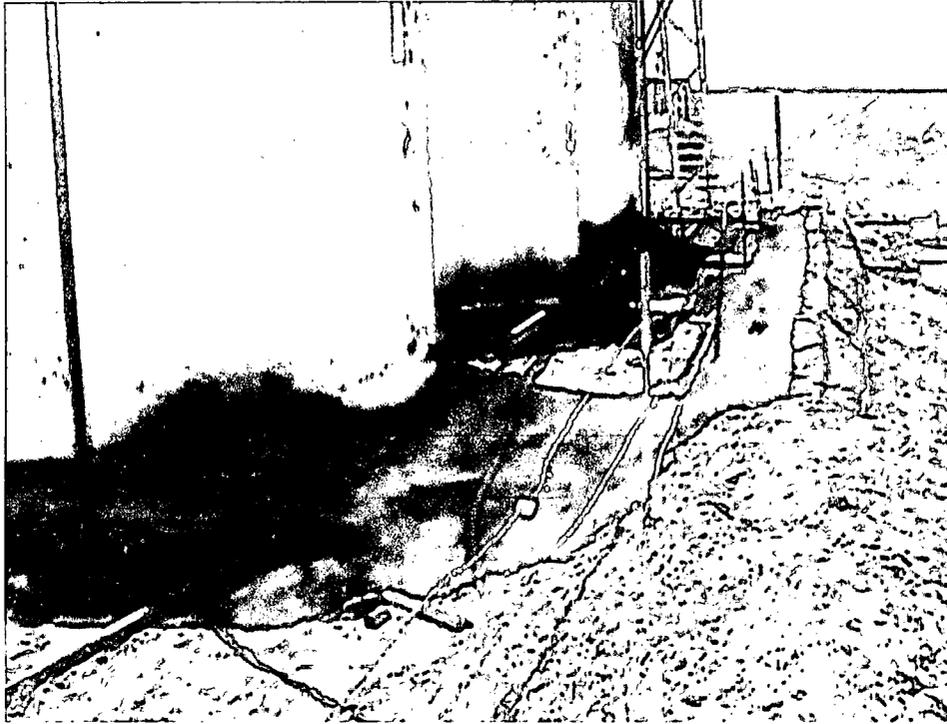
View to west of excavated area north of tanks.

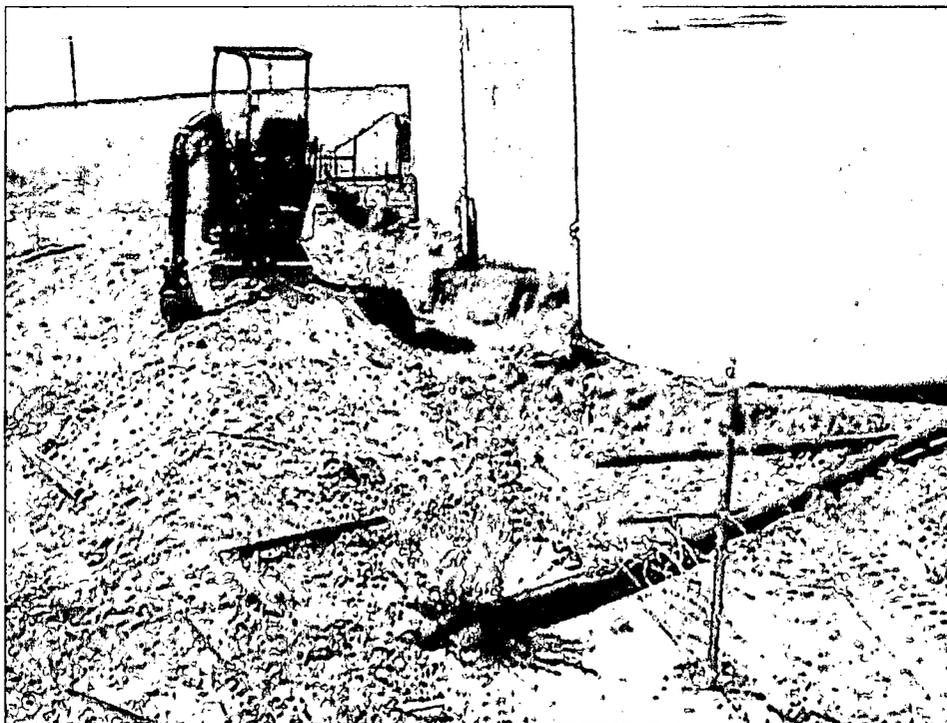
View to west of excavated area south of tanks.

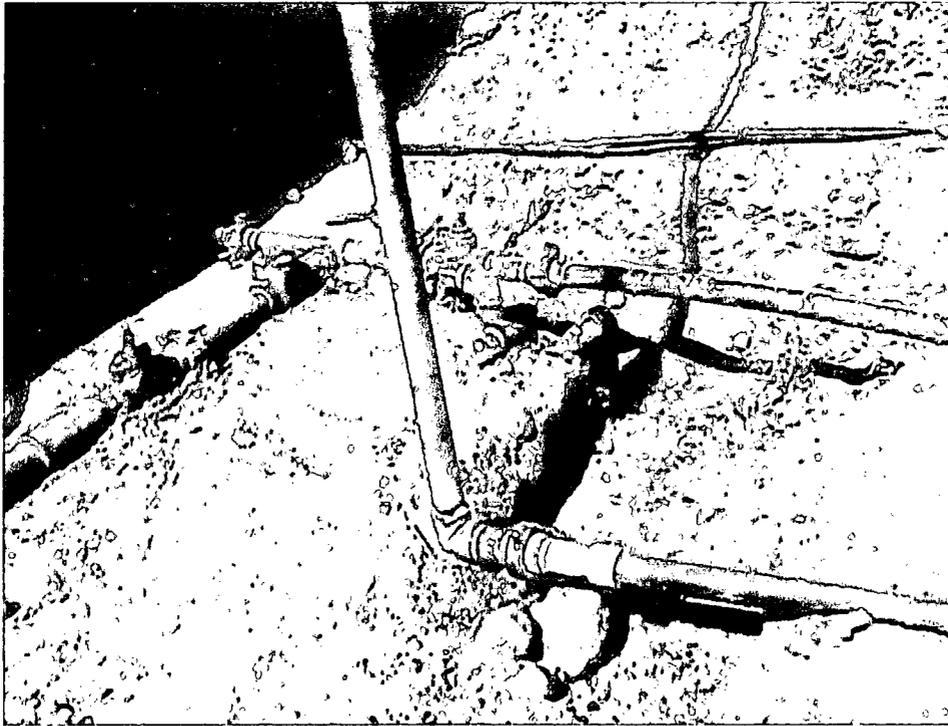
View of replaced joint and flowline.

Type of Release	Oil	Volume of Release	Unknown	Volume Recovered	None
Source of Release	Oil Tank	Date and Hour of Occurrence	Unknown	Date and Hour of Discovery	11/04/09
Was Immediate Notice Given?	<input type="checkbox"/> Yes <input type="checkbox"/> No <input checked="" type="checkbox"/> Not Required	If YES, To Whom?			
By Whom?	Date and Hour				
Was a Watercourse Reached?	<input type="checkbox"/> Yes <input checked="" type="checkbox"/> No	If YES, Volume Impacting the Watercourse.			
If a Watercourse was Impacted, Describe Fully.*					
Describe Cause of Problem and Remedial Action Taken.* The oil tank at the battery leaked and a Letter of Violation was written on 11/04/09. Impacted soil was excavated from the west end of the tank battery to a depth of four (4) feet bgs. Impacted soil was removed around the tanks to a depth of 1.5 to 2 feet bgs. Excavated soil was hauled to Lea Land for disposal, and all excavations were backfilled with clean soil obtained from Lea Land. The valve was replaced on the oil tank, and a new poly flow line was installed from the heater treater to the oil tank.

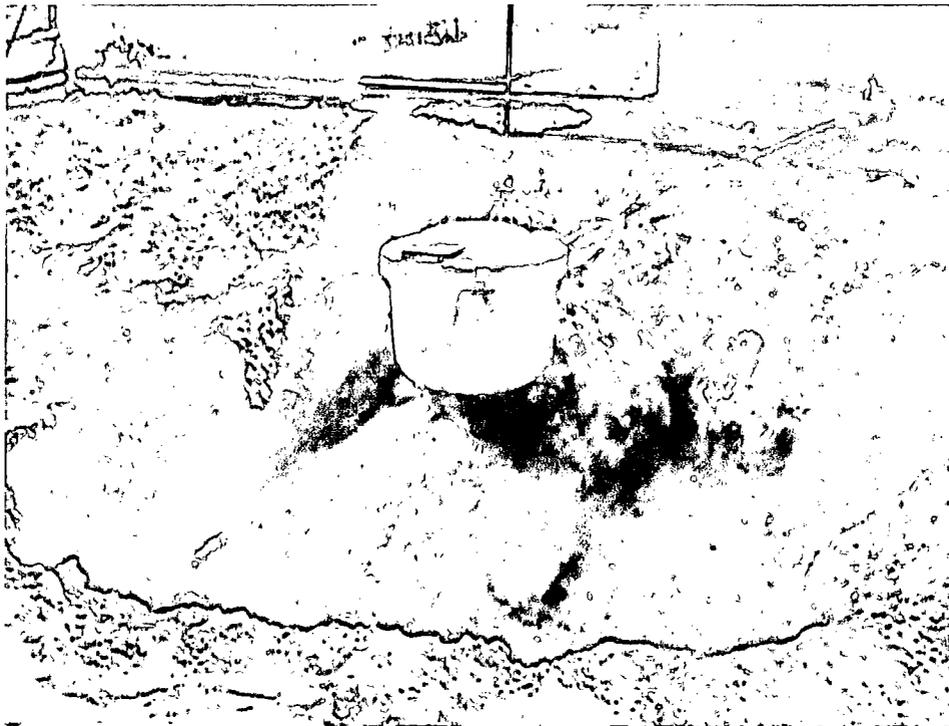
View of excavated load line area.

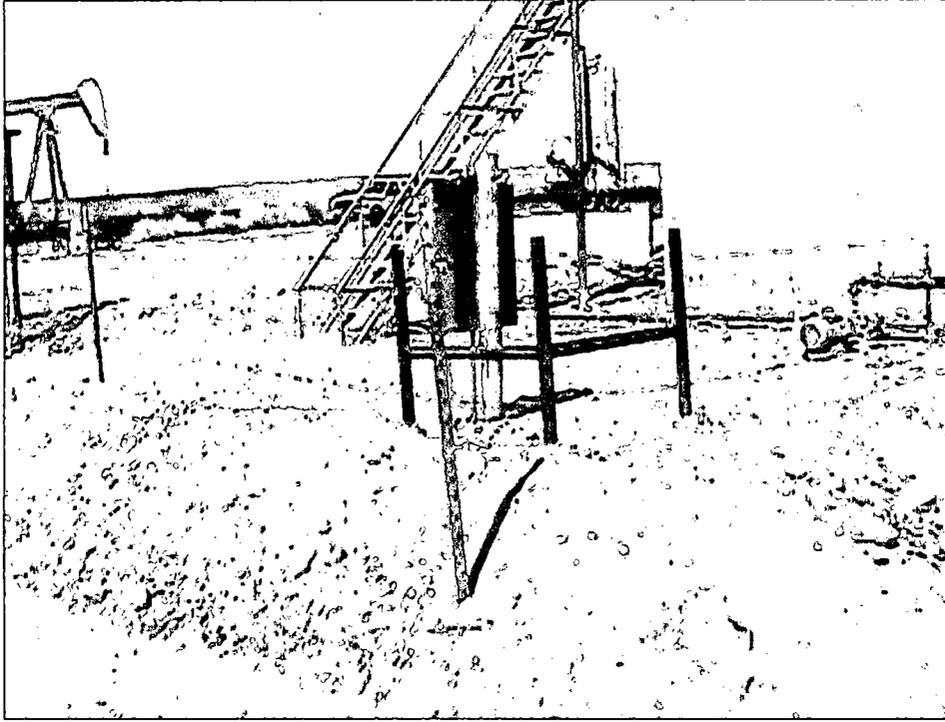
View to northeast of backfilled excavation west of tanks.

Approximately 112 yards of impacted soil was hauled to Lea Land for disposal, and all excavated areas were backfilled with clean soil obtained from Lea Land. Table 1 shows laboratory results of samples collected from the backfill soil. Appendix C provides a copy of the laboratory reports and chain of custody documentation. Appendix D provides photographic documentation of the excavation and the final remediated Site.

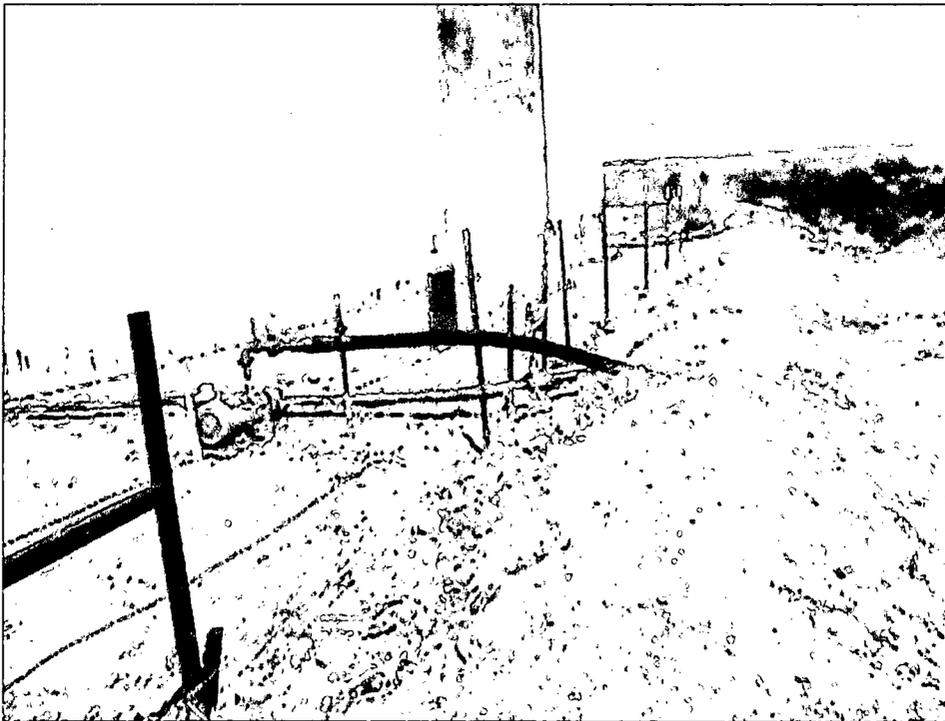
View to east of backfilled excavation south of tanks.
