Release Notification and Corrective Action

EVGSAU 0524-098

Termination Request

RE: **Termination Request**
ConocoPhillips EVGSAU 0524-098
UL/C sec. 5 T18S R35E
API No. 3002520792

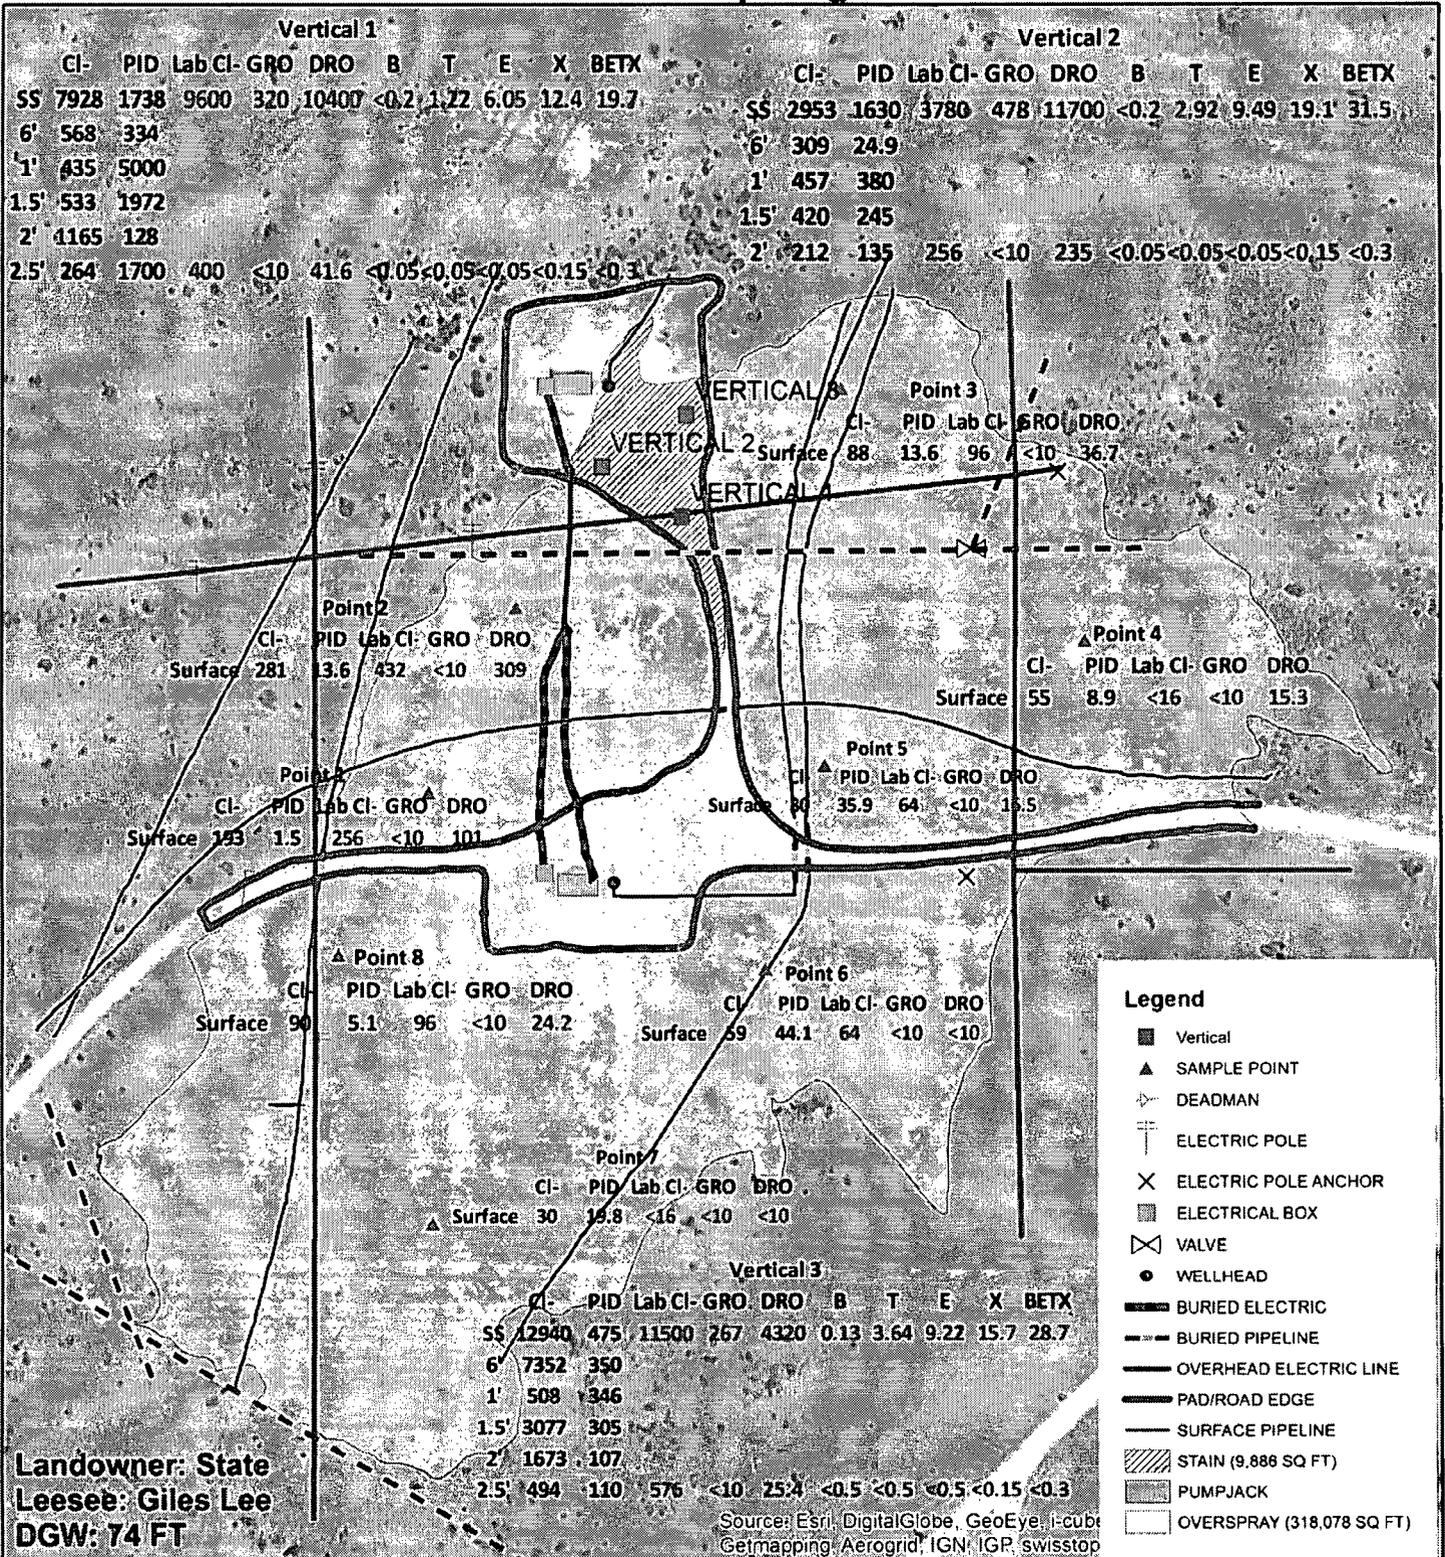
Initial Sampling Data

RECS personnel were on site beginning on March 11th, 2014 to assess the release (Figure 1). Eight samples were taken within the overspray area and three verticals were installed in the release area on the lease pad. All surface overspray samples were field tested for chlorides and organic vapors and the samples were taken to a commercial laboratory for analysis. The surface samples from the overspray returned laboratory chloride readings below 250 mg/kg except at Point 1, which had a chloride reading of 256 mg/kg and Point 2, which had a chloride reading of 432 mg/kg. Gasoline Range Organics (GRO) and Diesel Range Organics (DRO) readings for all the overspray samples were below regulatory standards (Appendix B).

Three verticals were installed in the release area on the lease pad. Vertical 1 and Vertical 3 were installed to a depth of 2.5 feet, and Vertical 2 was installed to a depth of 2 feet. As the verticals were installed, samples were taken at regular intervals and field tested for chlorides and organics

vapors. Representative samples were taken to a commercial laboratory for analysis. All three verticals returned elevated laboratory chloride readings and TPH readings at the surface of the verticals. BTEX readings at the surface of the verticals were elevated but still below regulatory standards. At the base of each vertical, the chloride values dropped substantially from the surface readings; although, they were still slightly above regulatory standards. The TPH readings and BTEX readings at the base of each vertical were below regulatory standards.

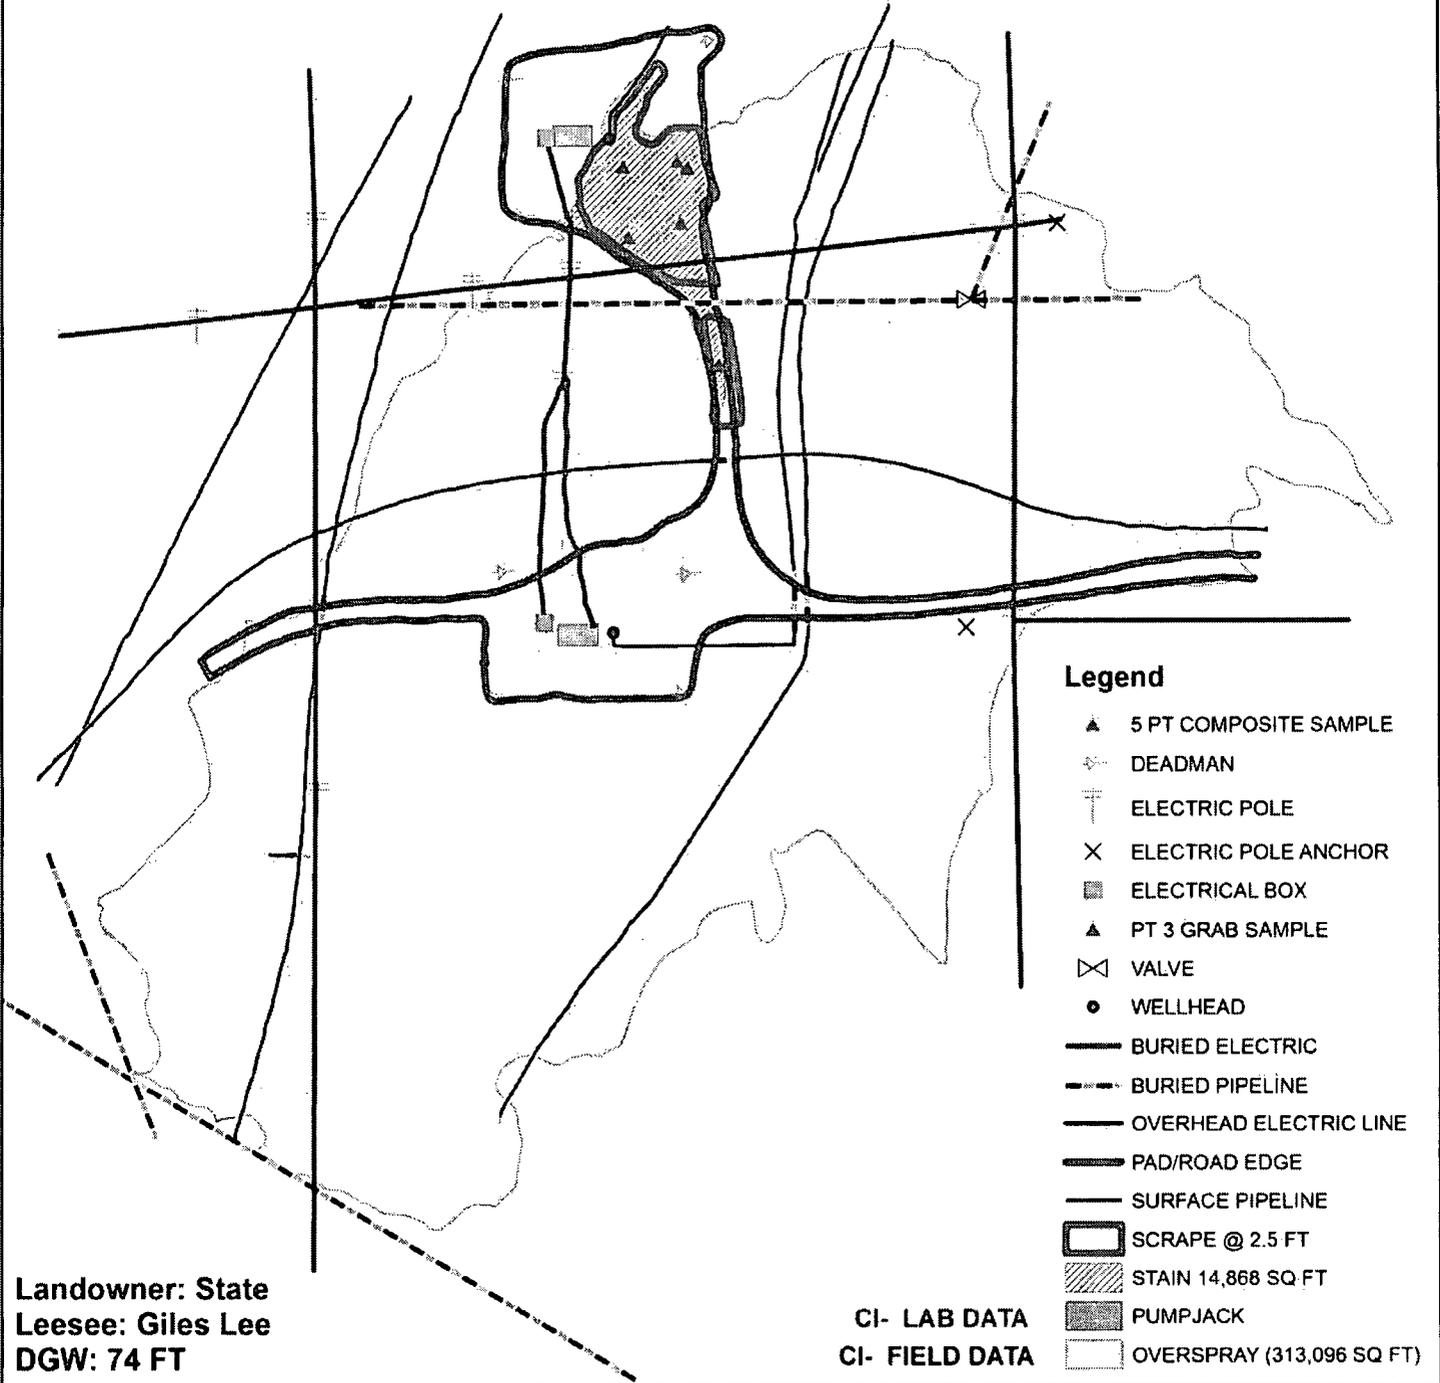
Figure 2

Excavation Data

SCRAPE AT 2.5 FT

CI-	PID	GRO	DRO
5 PT BOTTOM COMPOSITE	208	2.9	<10	<10

PT. 3 SAMPLE (N BOTTOM E END) @ 2.5 FT

CI-	GRO	DRO
256	<10	75.3

Based on the laboratory analysis, a Corrective Action Plan (CAP) was submitted to NMOCD on April 10th, 2014 and approved the same day. As part of the CAP, the release area on the pad and lease road would be scraped down to 2.5 feet bgs. All the excavated soil would be taken to a NMOCD approved facility for disposal. Clean caliche would be imported to the site to serve as backfill. A sample of the caliche would be taken to a commercial laboratory for analysis to verify chloride levels below 250 mg/kg. The 2.5 foot excavation would be backfilled with the caliche and contoured to the surrounding location.

CAP work began at the site on April 9th, 2014. Micro-Blaze was applied throughout the overspray area on three separate dates: April 9th, 2014; April 16th, 2014 and May 21st, 2014. The release area on the pad and lease road was scraped down to 2.5 feet bgs (Figure 2). A total of 1,000 cubic yards of contaminated soil was taken to a NMOCD approved facility for disposal. At the base of the scrape, a 5 point bottom composite was taken and field tested for chlorides and hydrocarbons. The sample was then taken to a commercial laboratory for analysis. The laboratory chloride reading returned a result of 208 mg/kg, and the GRO and DRO readings returned results of non-detect. As requested by NMOCD a discrete sample at Vertical 3 was taken and sent to a commercial laboratory for analysis. The sample returned a laboratory chloride reading of 256 mg/kg, a GRO reading of non-detect and a DRO reading of 75.3 mg/kg (Appendix C).

A total of 860 cubic yards of top soil and 380 cubic yards of caliche were imported to the site to serve as backfill. A sample of the imported soil was taken to a commercial laboratory and returned a chloride result of non-detect. The 2.5 ft scrape was backfilled to 6 in bgs with the top soil and then capped with 6 in of caliche.

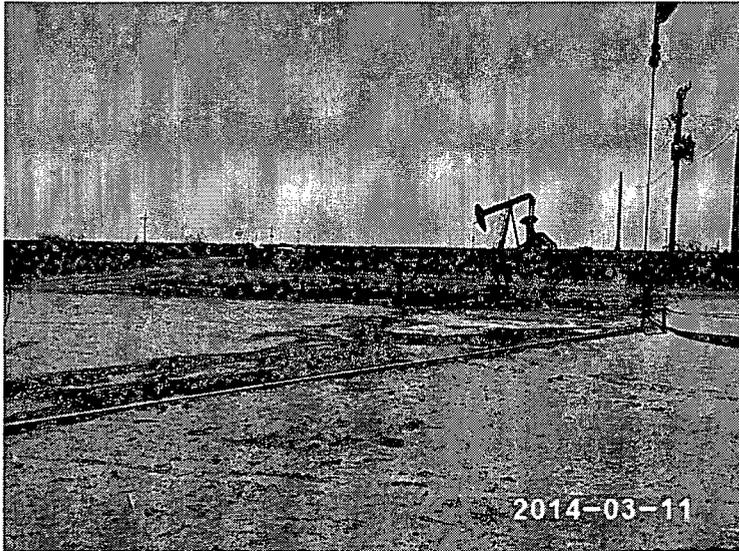
Initial release area, facing south

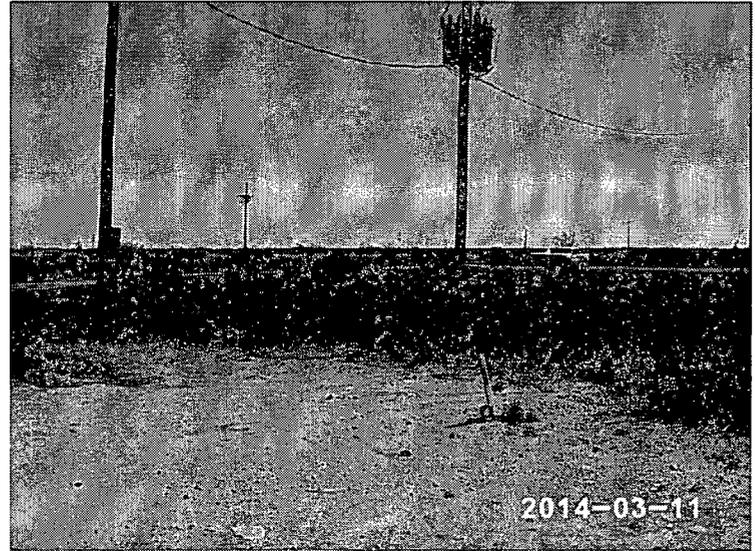
Initial release area, facing southeast

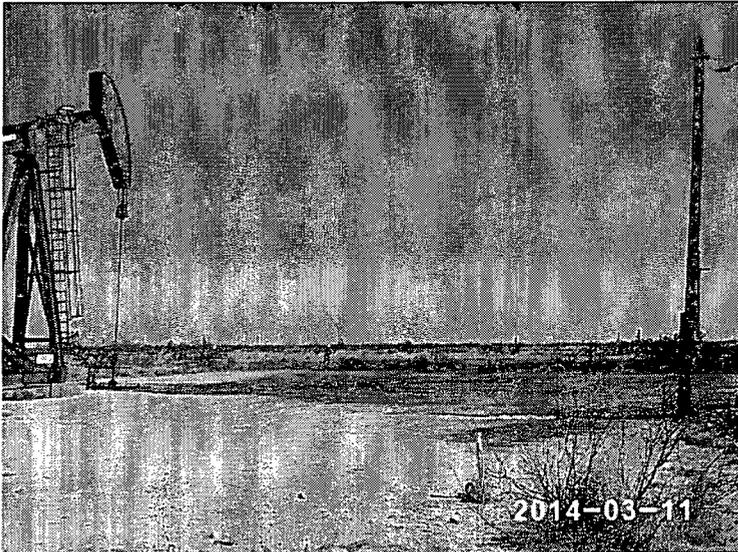
Initial release area, facing east

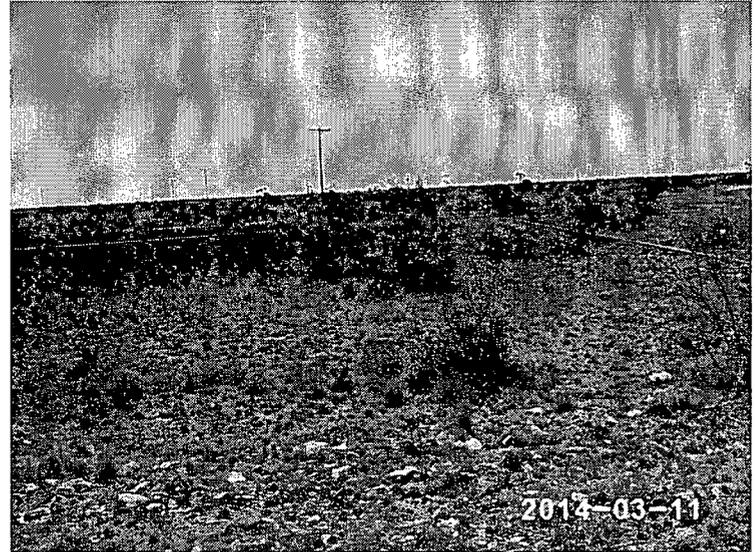
Initial release area, facing southwest

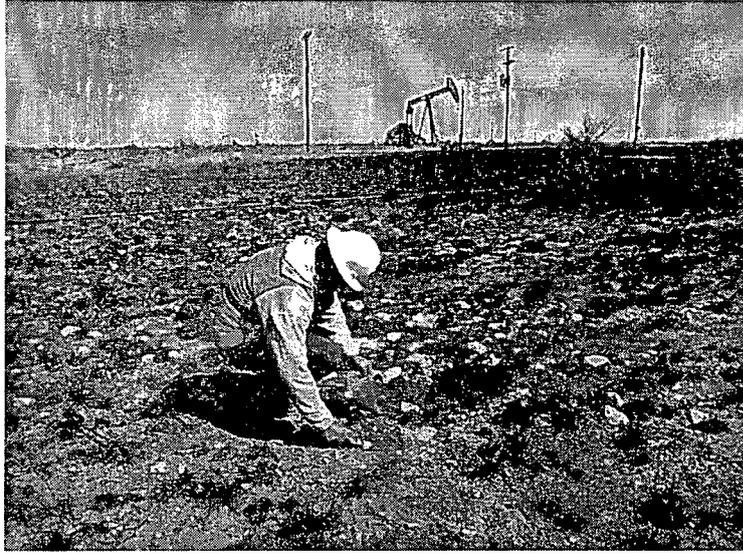
Sampling surface of release, facing northeast 3/12/14

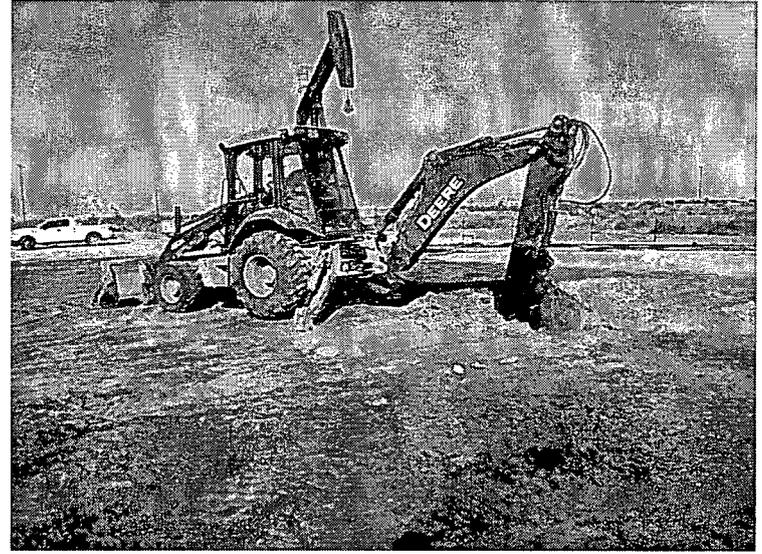
Installing vertical, facing west 3/14/14

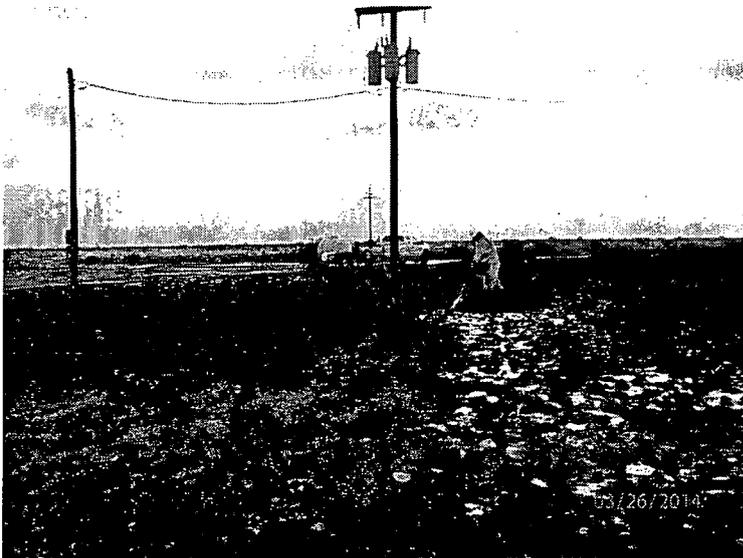
First application of Micro-Blaze, facing northeast 3/26/14

Two to three applications of Micro-Blaze would be applied over the overspray area. Micro-Blaze contains a blend of wetting agents, nutrients and several strains of safe, non-pathogenic *Bacillus* bacteria. When applied to a hydrocarbon-based or organic spill or contaminant, the wetting agent begins breaking down the contaminants into smaller molecules for more efficient degradation by the microbes, into harmless byproducts like carbon dioxide, water, and trace salts.

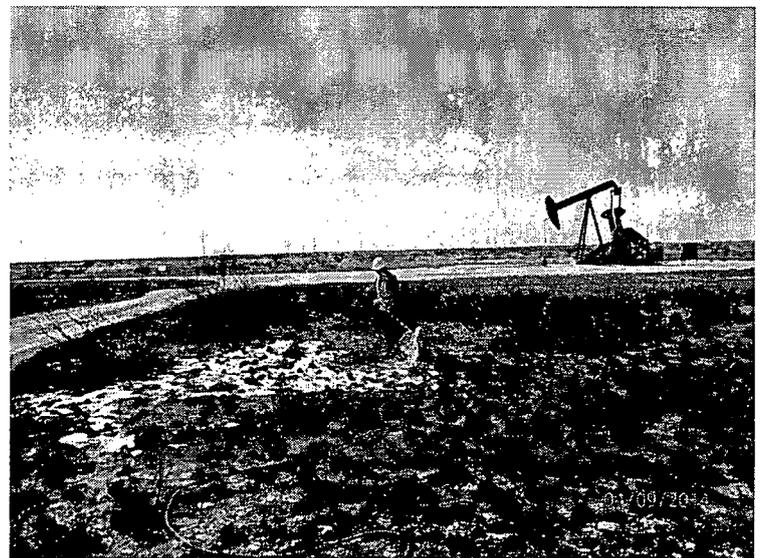
Second application of Micro-Blaze, facing south 4/9/14

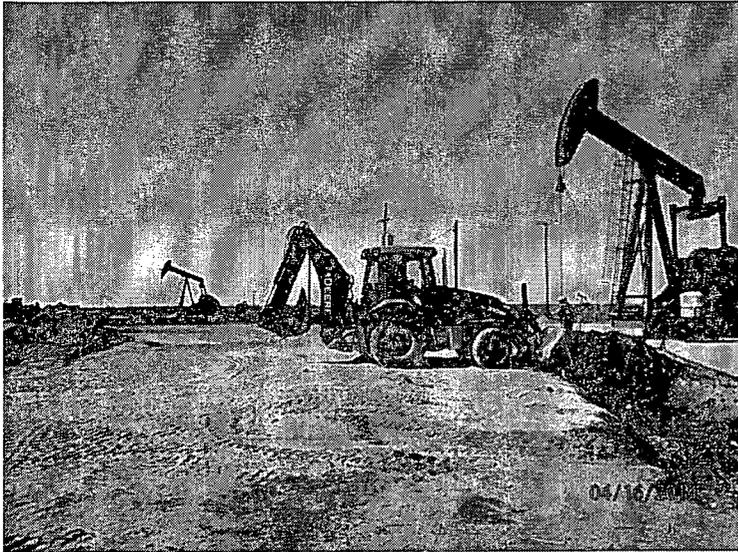
Excavating release area to 2.5 ft bgs, facing southwest 4/16/14

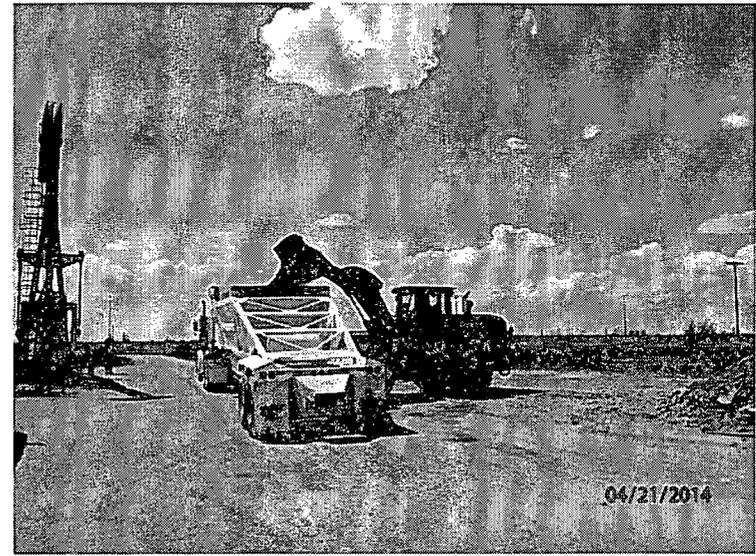
Exporting soil, facing northwest 4/21/14

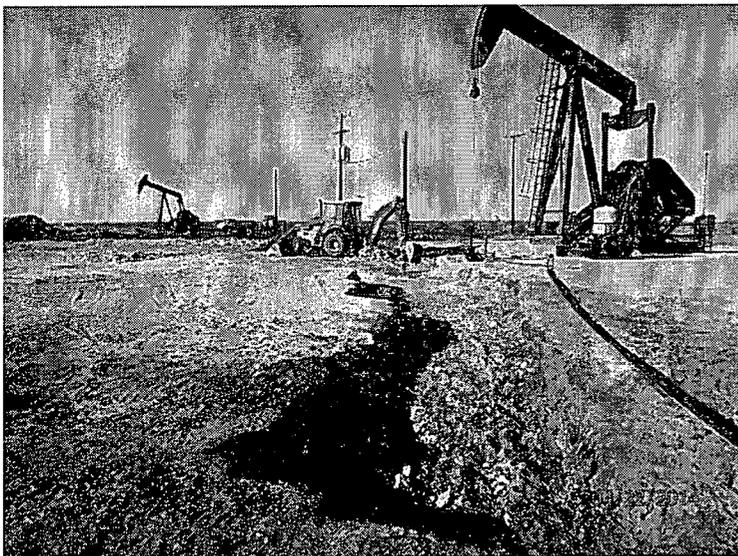
Continue excavating release area to 2.5 ft bgs, facing southwest 4/22/14

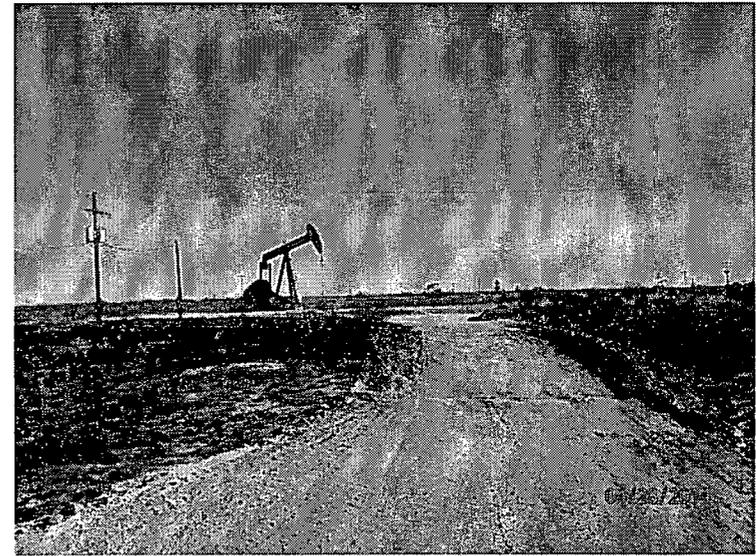
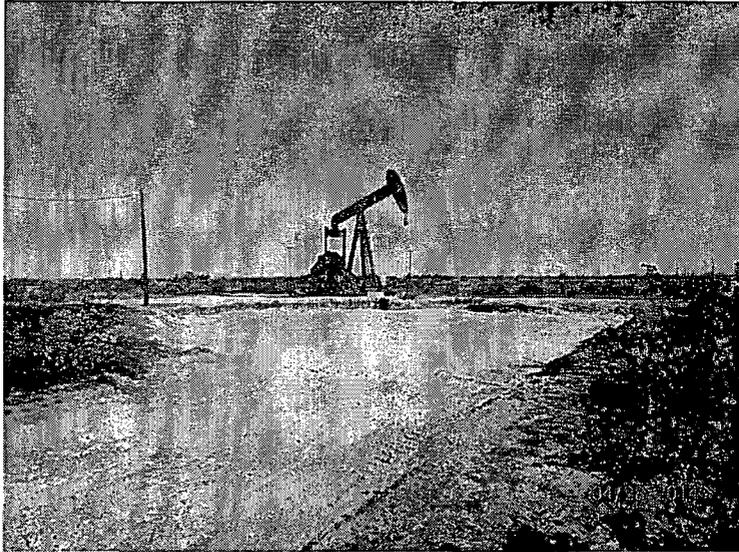
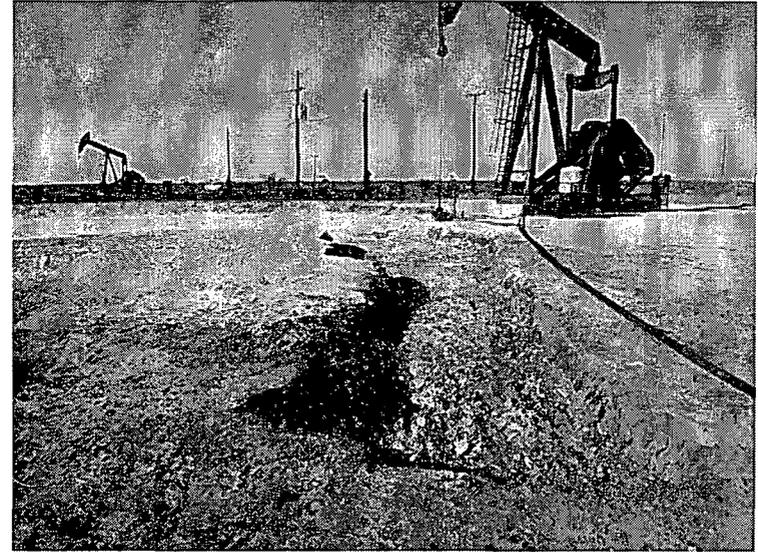
2.5 ft bgs excavation completed, facing north 4/28/14

2.5 ft bgs excavation completed, facing northwest
4/28/14

2.5 ft bgs excavation completed, facing southwest
4/28/14

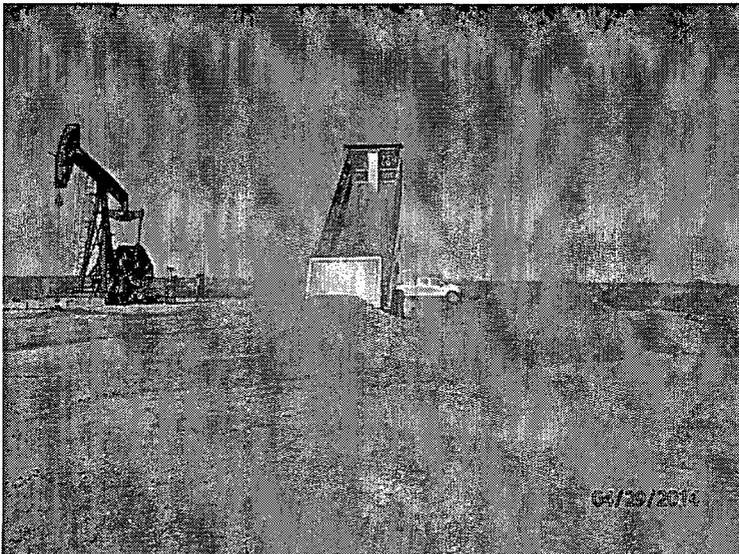
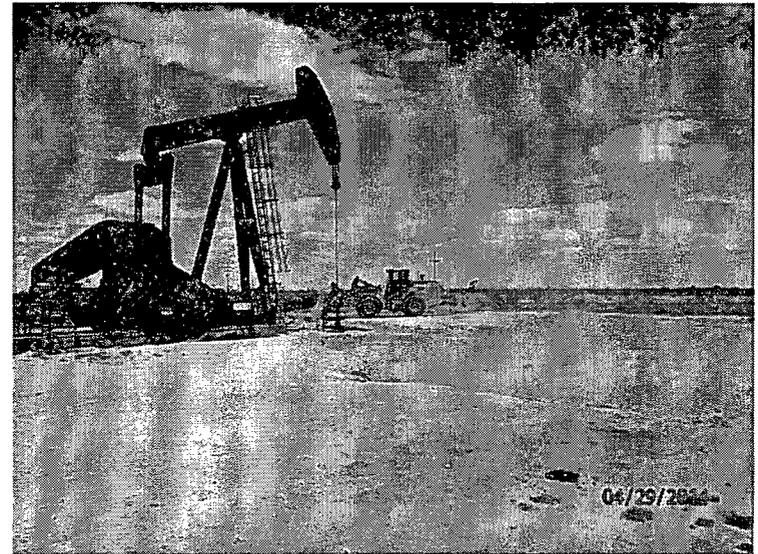
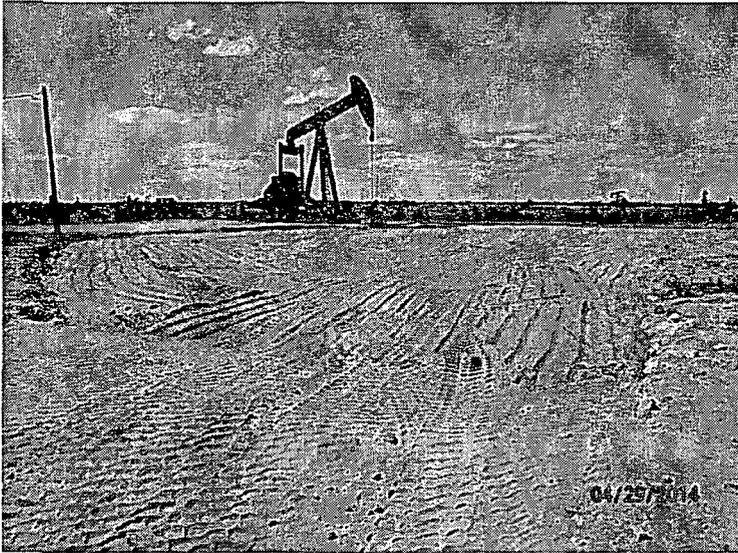
Importing top soil, facing west
4/29/14

Backfilling with top soil to 6 in bgs, facing northeast
4/29/14

Backfilling with top soil to 6 in bgs completed, facing northwest
4/29/14

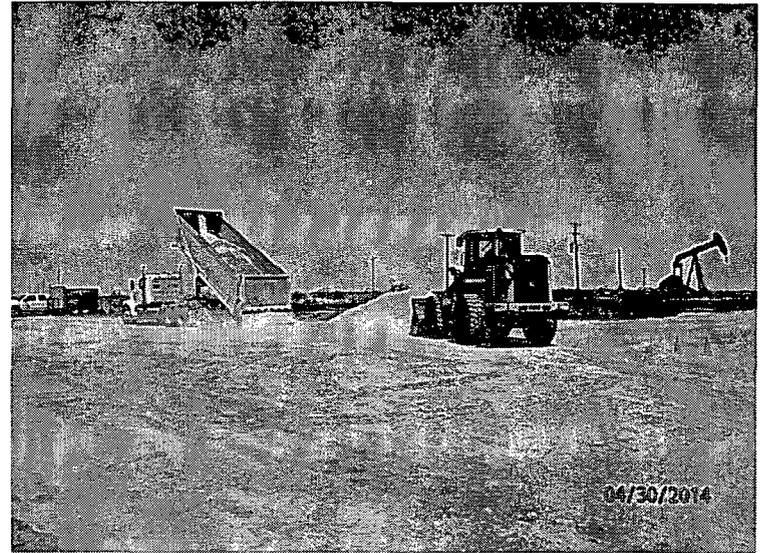
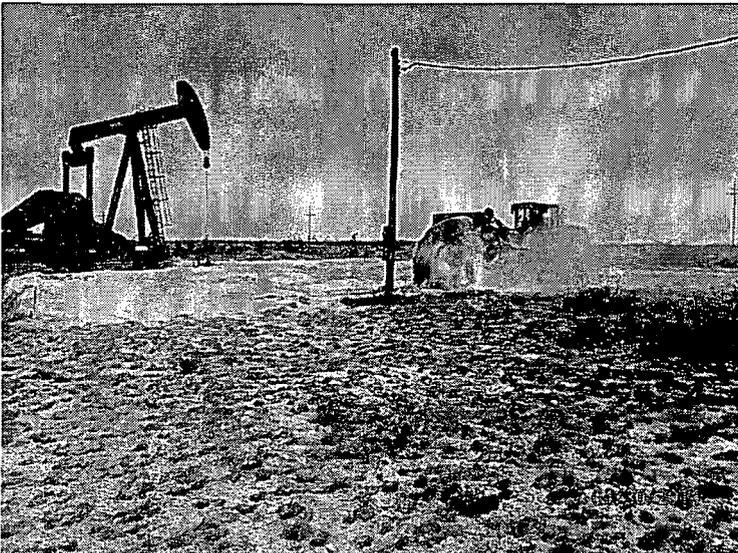
Importing caliche, facing northwest
4/30/14

Backfilling the top 6 in with caliche, facing northeast
4/30/14

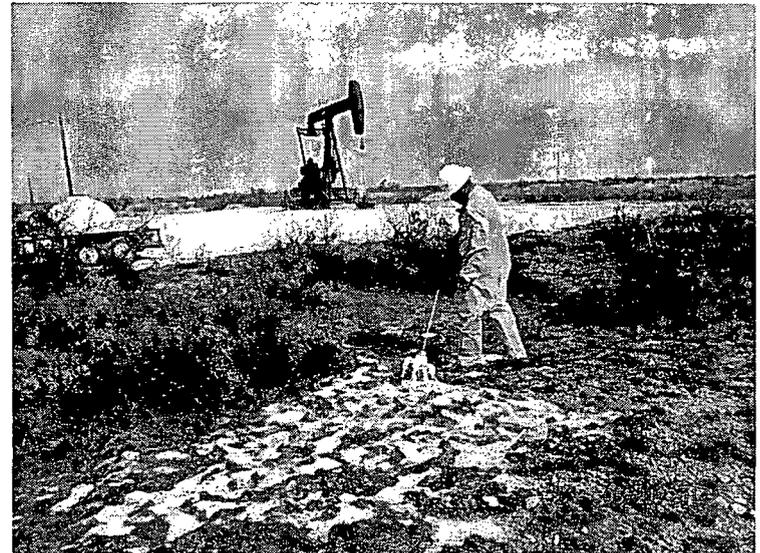
Third application of Micro-Blaze, facing northwest
5/21/14

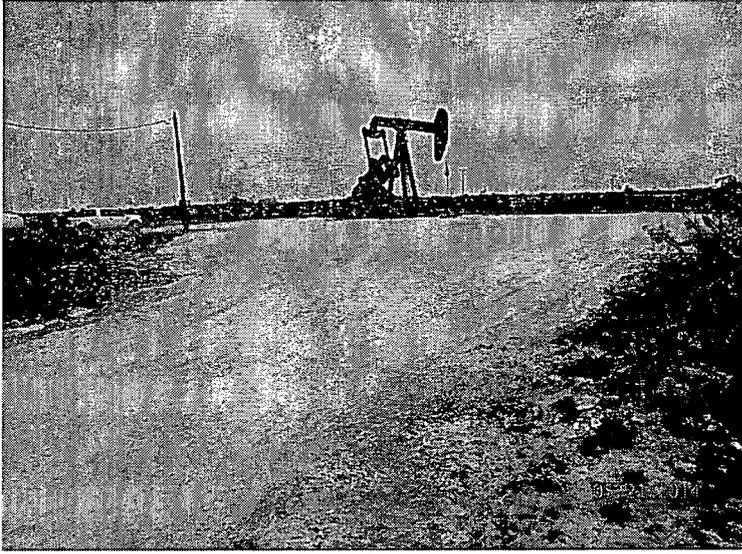
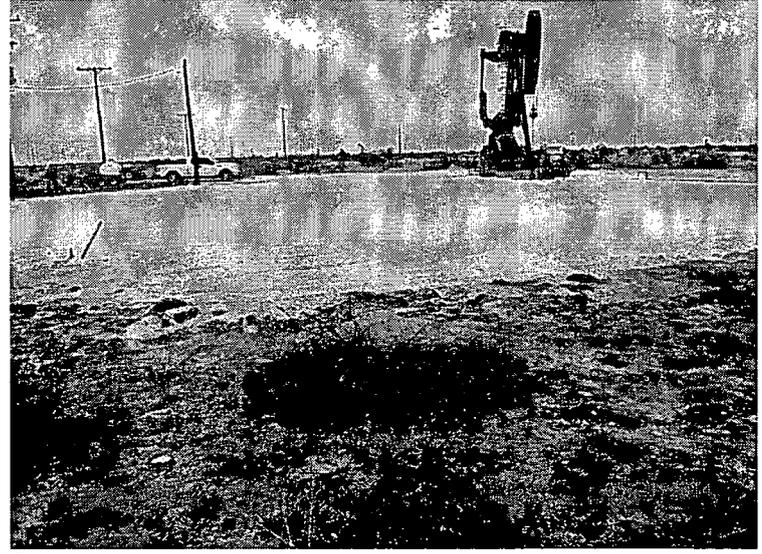
Site completed, facing northwest

Site completed, facing west
