LINN Energy – MGU 53 Corrective Action

Remediation Summary Report Form

Site Name: Maljamar Grayburg Unit (MGU) 53

Re: Corrective Action Plan
LINN Energy, Maljamar Grayburg Unit 53
API No.: 30-025-00497
Legal: E-10-17S-32E, 1980 FNL & 610 FWL, Lea Co., NM
GPS: N32.8509186628474, W103.760937452841
Depth to Groundwater: 75 feet

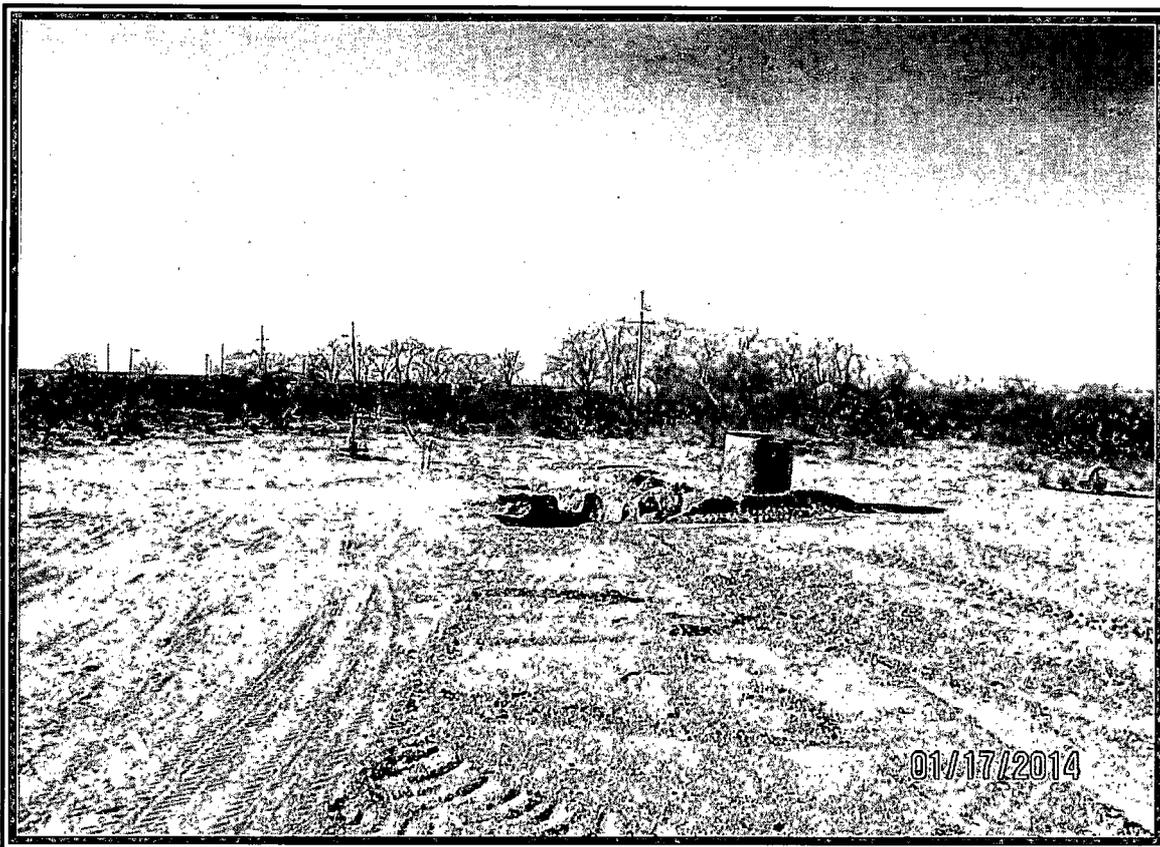
Photo 1: View of site following release and after lines had been repaired.

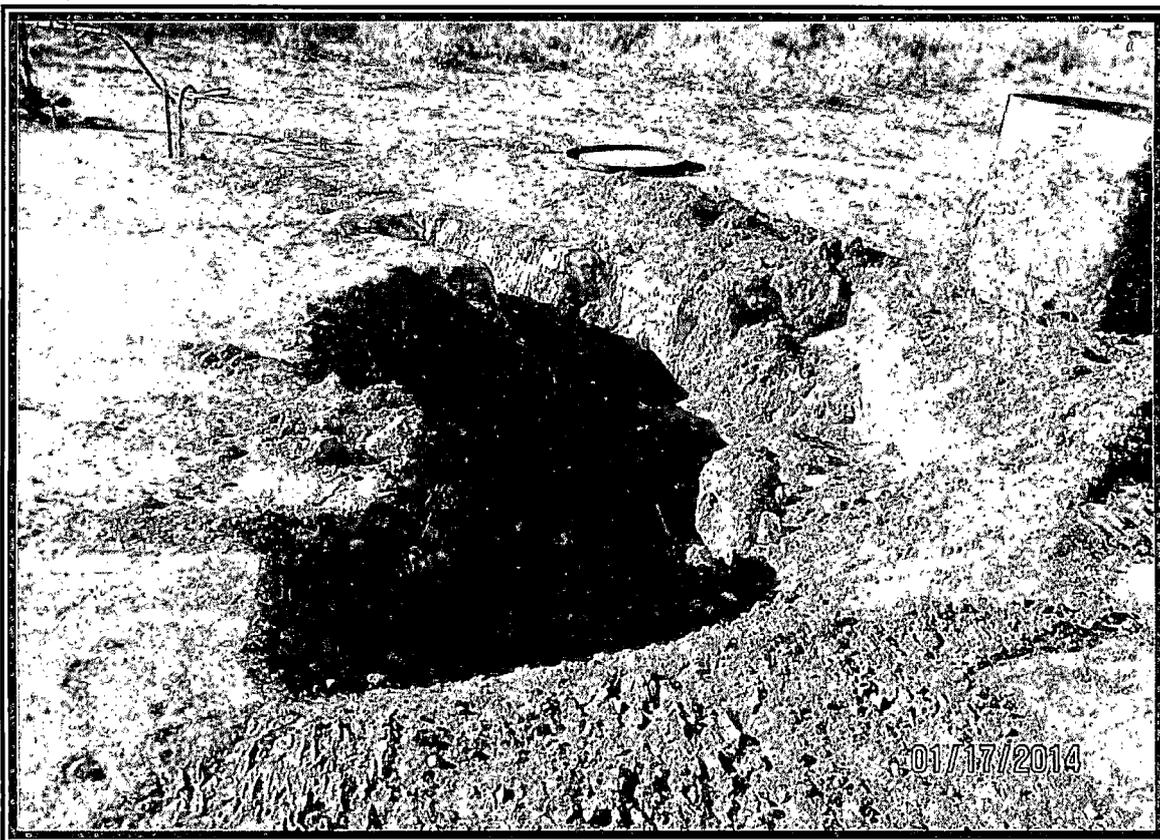
Describe Cause of Problem and Remedial Action Taken.*: Fiberglass line developed a hole next to the junction box for the well.

Photo 2: View of line repair area.

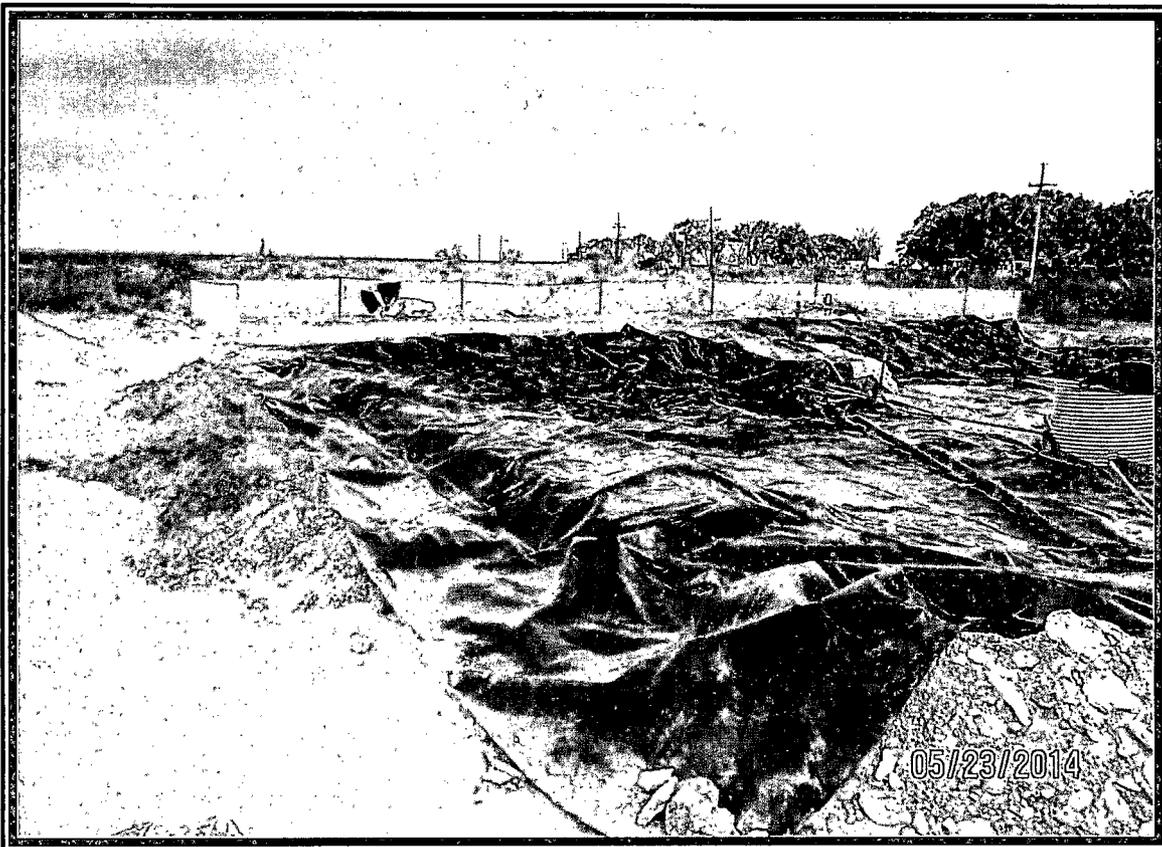
Photo 3: View of liner installation.

With the concurrence of BLM and NMOCD, a liner was installed in the bottom of the excavation. Portions of the areas outside of the center of the excavation were backfilled to assist in creating a smaller confined area in the event a new release occurred. The liner was installed underneath the injection lines and sealed against the valve box. As the line was brought up the sides, it was seated back into the sidewalls. The lined area was then backfilled with clean fill and compacted.

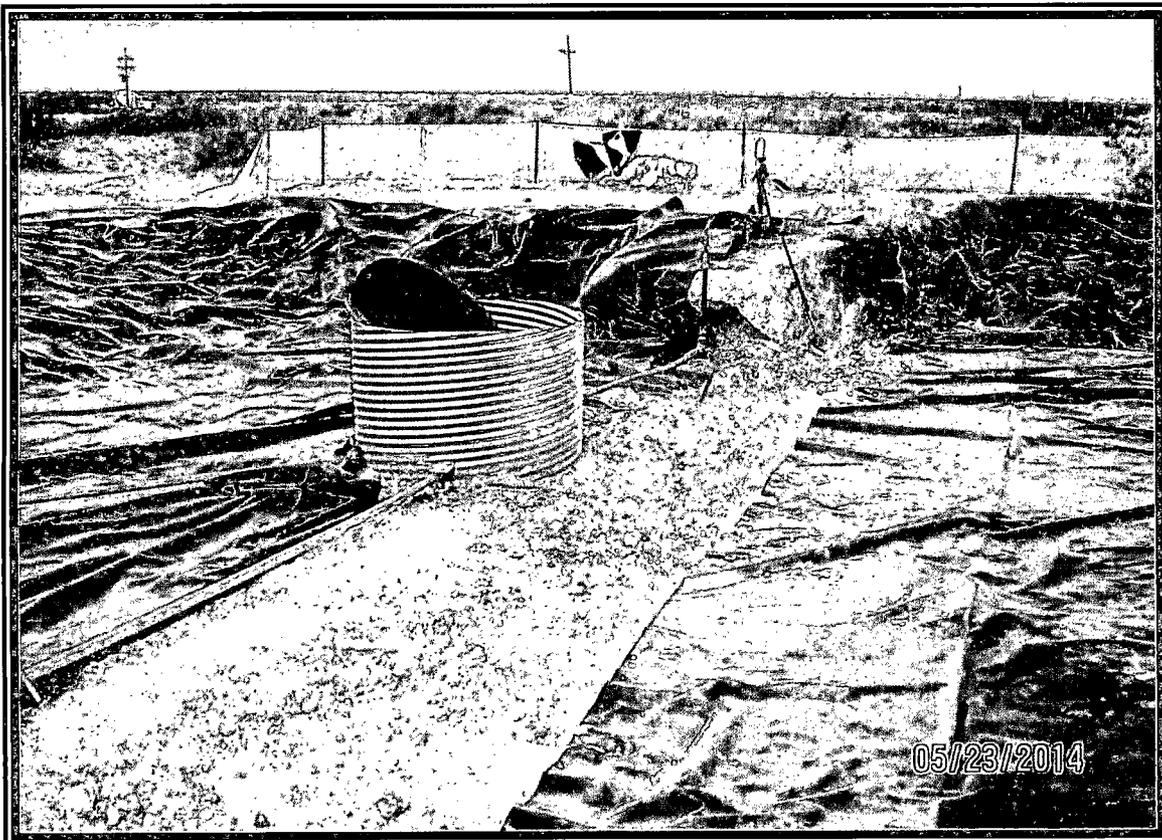
Photo 4: View of liner installation progress. Liner was installed in three sections.

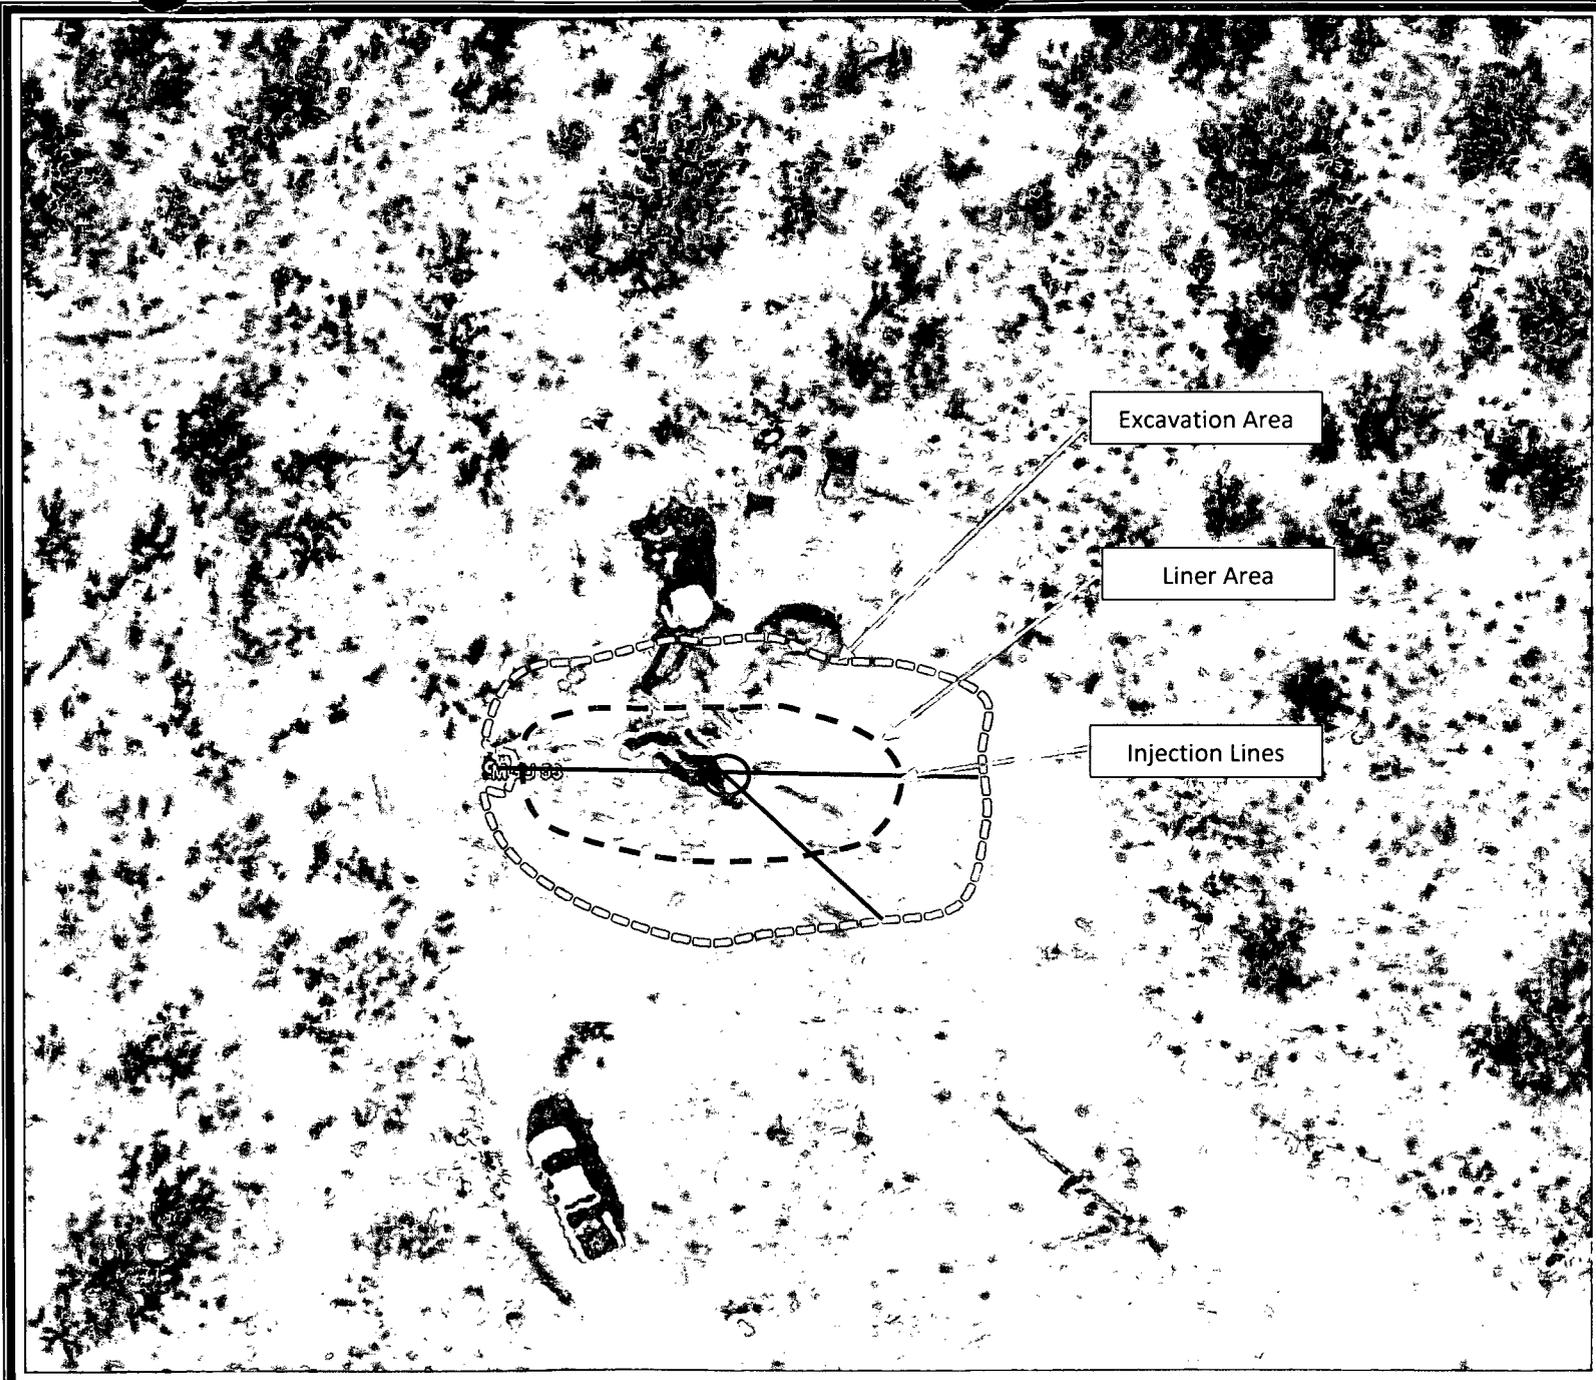
**Figure 1
Site Map**

MGU 53
Lat: 32.850918668474°
Long: -103.7609374528
Lea County, NM
