REMEDIATION SUMMARY & RISK-BASED SITE CLOSURE REQUEST

BOPCO, LP
BASS 3 FEDERAL WELL #4 SPILL SITE "A"
Eddy County, New Mexico
Unit Letter "O" (SW/SE), Section 3, Township 22 South, Range 28 East
Latitude 32.416059° North, Longitude 104.070738° West
NMOCD Reference #: 2RP-980

August 2013

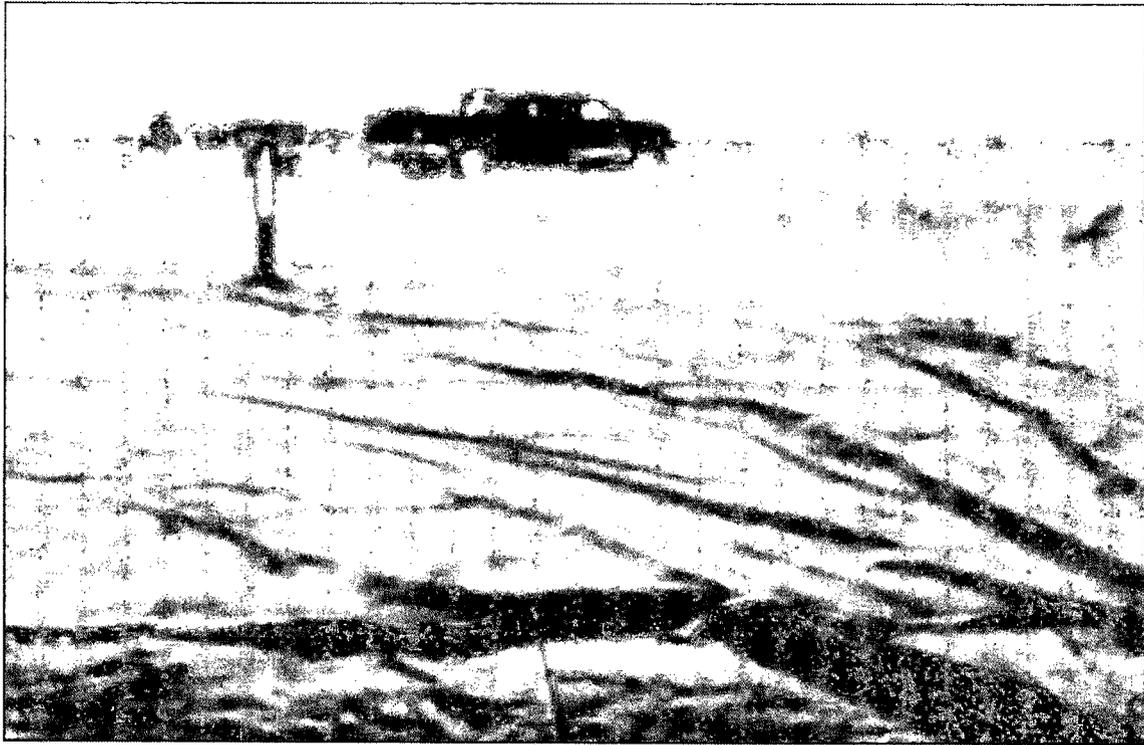
Bass 3 Federal Well #4 Spill Site "A" - Liner Installation
(Temporary Monitor Well Visible in Background)

On February 8, 2012, a twenty (20) mil polyurethane liner was installed on the floor of the excavation. A cushion of non-impacted pad sand was installed approximately one foot (1') both above and below the liner to protect the liner from damage during installation and backfilling activities.

An impermeable, twenty (20) mil polyurethane liner was installed on the floor of the excavation prior to backfilling. This engineered control will inhibit vertical migration of contaminants from below the liner to the surface, protecting the vegetative zone. In addition, the polyurethane liner will shed moisture to the edge of the liner and beyond the maximum horizontal extent of underlying impacted soil, effectively inhibiting vertical migration of contaminants to groundwater.
