3R-1011

**Release Report/ General
Correspondence**

Enterprise SJ

Enterprise Products
Lateral 3E-1/ GCU #273 Pipeline Release
Latitude North 36.62277°, Longitude West -108.14437°
Unit A Section 31 T28N R12W
San Juan County, New Mexico
July 23, 2014

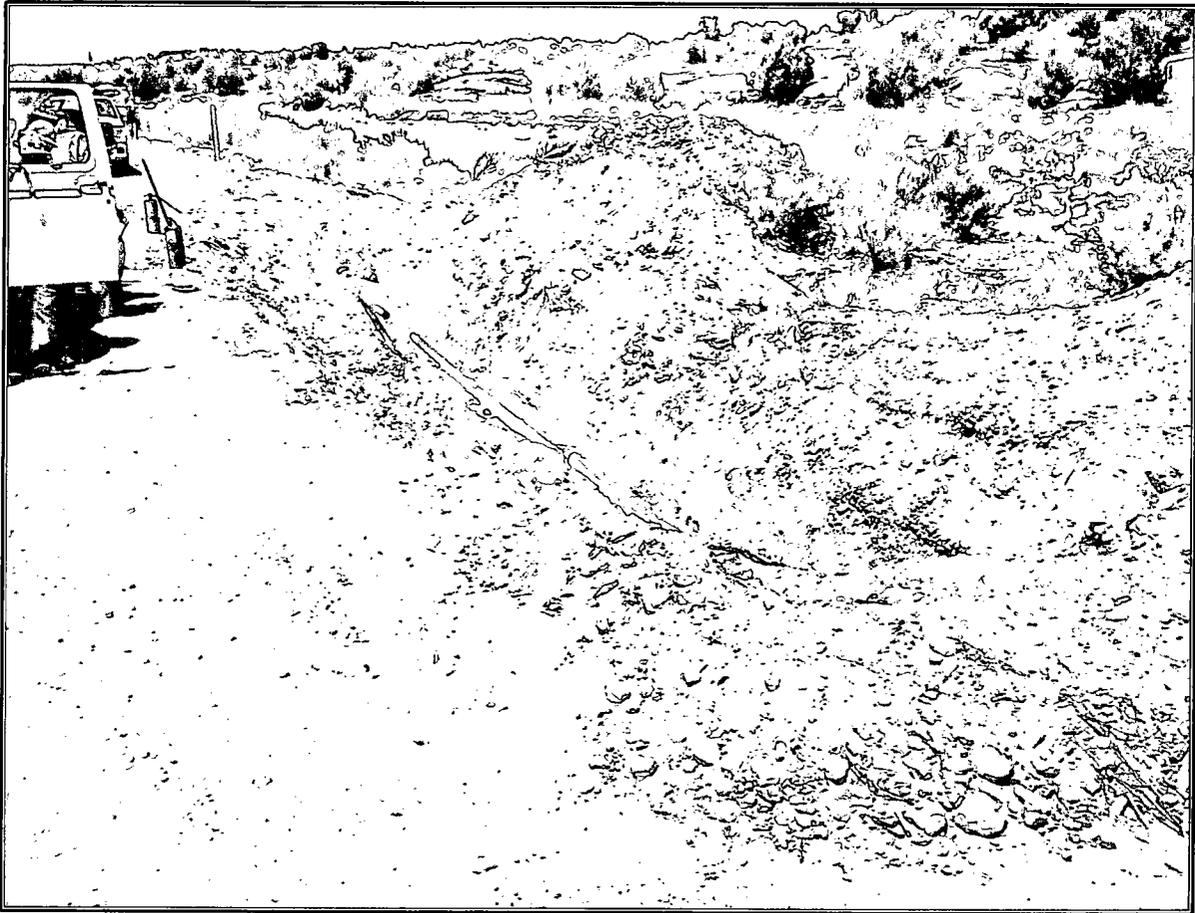
Photo 3: View of pipeline repair activities, facing northwest

Describe Cause of Problem and Remedial Action: Enterprise personnel responded a possible line leak on the GCU #273 Well Tie/Lateral 3E-1 pipeline. The leak was verified and pipeline was depressurized and applied lock out tag out was applied. A surface area of approximately two (2) feet wide by six (6) feet long was affected. The repairs were completed on July 19, 2014.

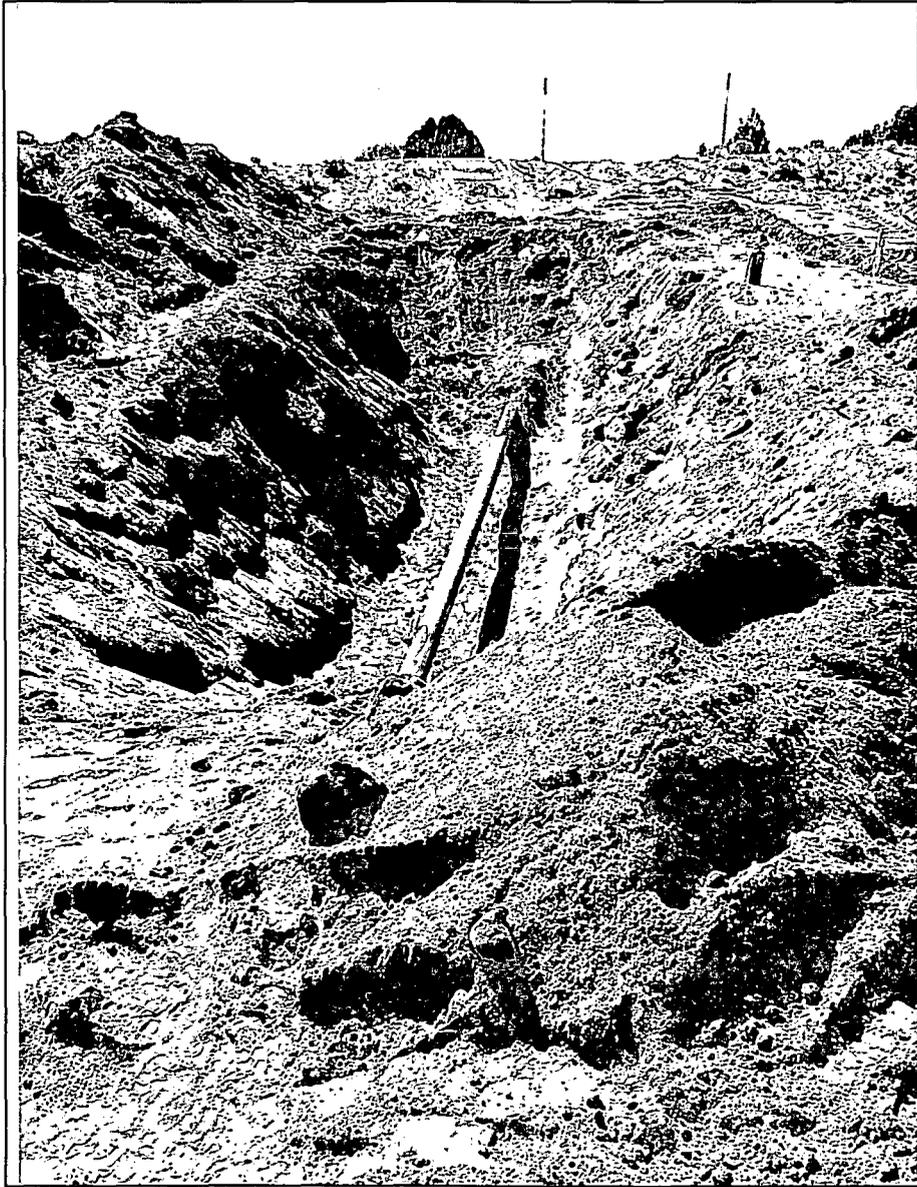
1.) General view of the final extent of excavation and repaired pipeline.

Remediation and repair activities were completed on October 21, 2013. Approximately 142 cubic yards of impacted soil was excavated and transported to a NMOCD approved land farm facility. The final excavation measured forth-five (45) feet long by ten (10) feet wide by seven (7) feet deep. A third party corrective action report is included with this "final" c-141.

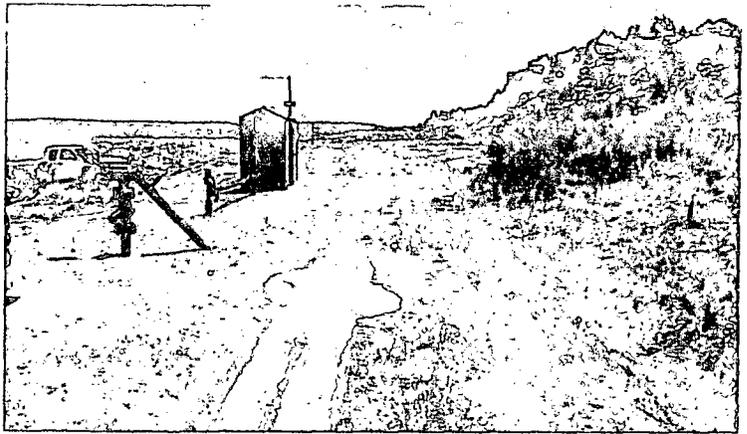
Photograph 1

View of Site, facing south, prior to corrective action activities.

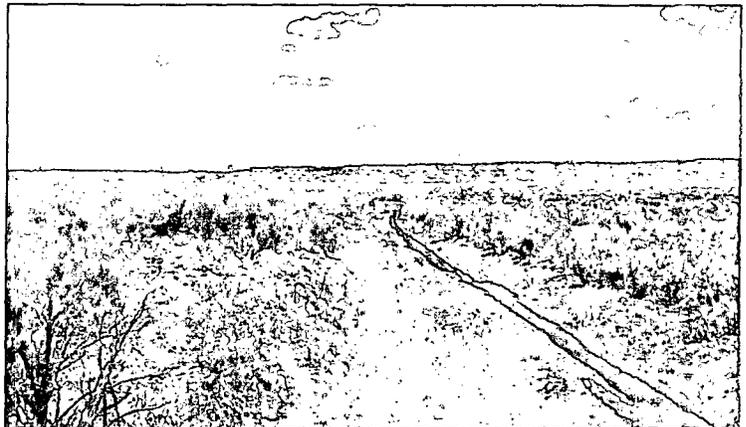
Photograph 2

View of Site, facing north, prior to corrective action activities.

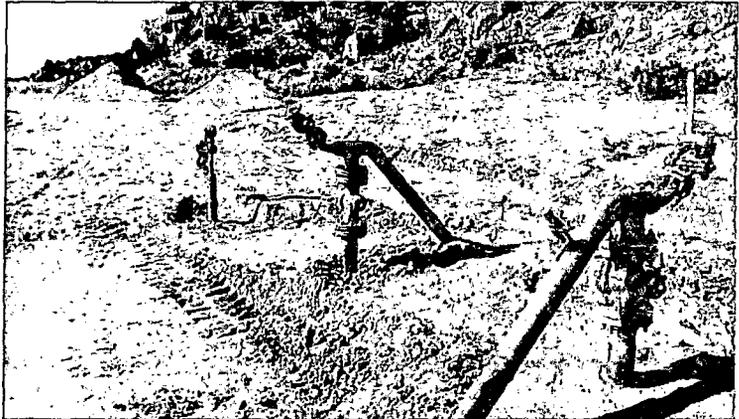
Photograph 5

View of Site subsequent to corrective action at the point of release.

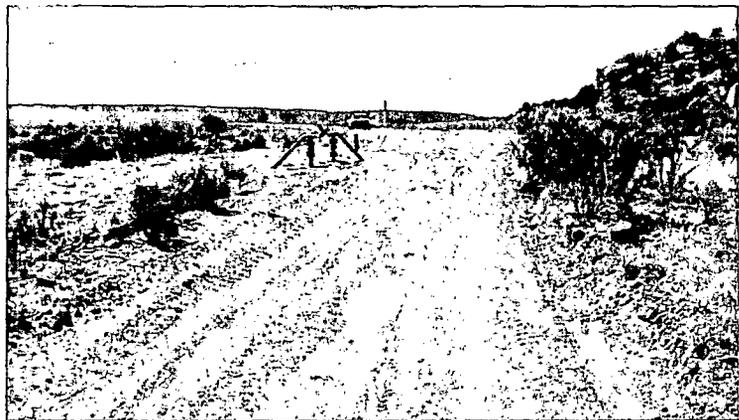
Photograph 6

View of Site subsequent to the completion of corrective actions.
