**From:** Lara Weinheimer <lweinheimer@rice-ecs.com>  
**Sent:** Wednesday, September 18, 2013 3:37 PM  
**To:** 'Burton, Michael'; Bratcher, Mike, EMNRD  
**Cc:** Warren, JeanMarie, EMNRD; 'Hack Conder'; 'Wall, Fred'; 'Jacob Kamplain'  
**Subject:** Final Report for the Linn V.L. Foster #11 2RP-1866  
**Attachments:** Final Report Linn V.L. Foster #11 2RP-1866.pdf

**LINN V.L.  
FOSTER #11**  
 LEGALS: UL/H sec. 17  
 T17S R31E  
 EDDY COUNTY, NM  
 NMOCD Case #: 2RP-1866

**Linn V.L. Foster #11**  
Unit Letter H, Section 17, T17S, R31E

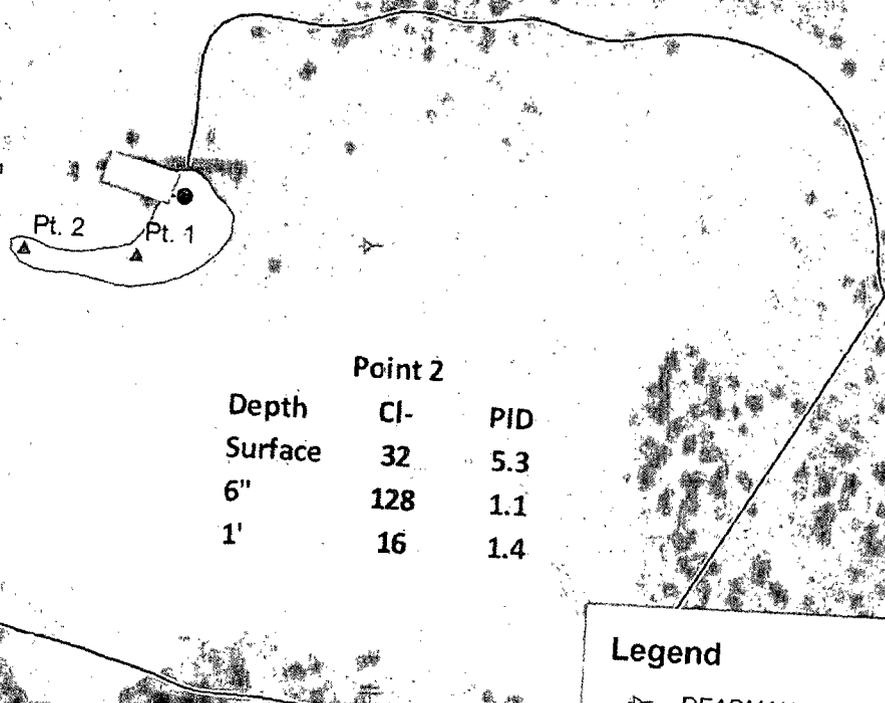
## Figure 1

# Initial Sampling Data

Point 1		
Depth	Cl-	PID
Surface	7730	1675
6"	2950	1804
1'	1609	465
1.5'	407	388
2'	64	11.5
2.5'	32	6.3

Point 2		
Depth	Cl-	PID
Surface	32	5.3
6"	128	1.1
1'	16	1.4

Cl- FIELD DATA  
Cl- LAB DATA

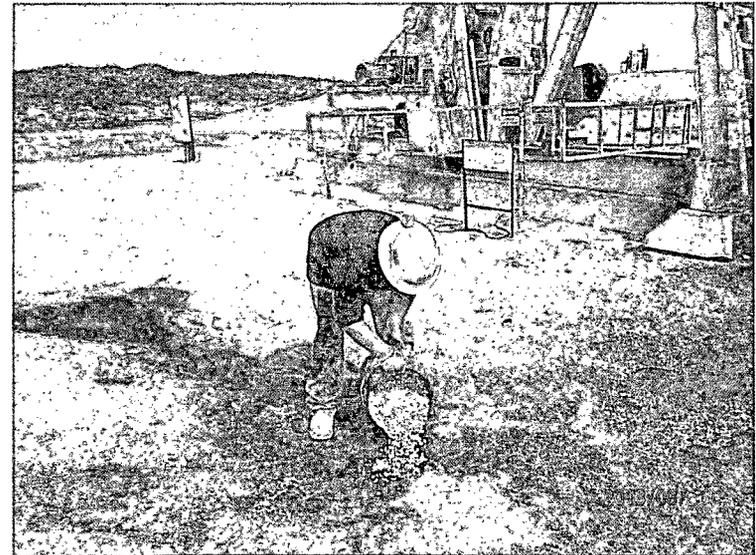
Plugging the augur in total with bentonite, facing NW 8/16/13

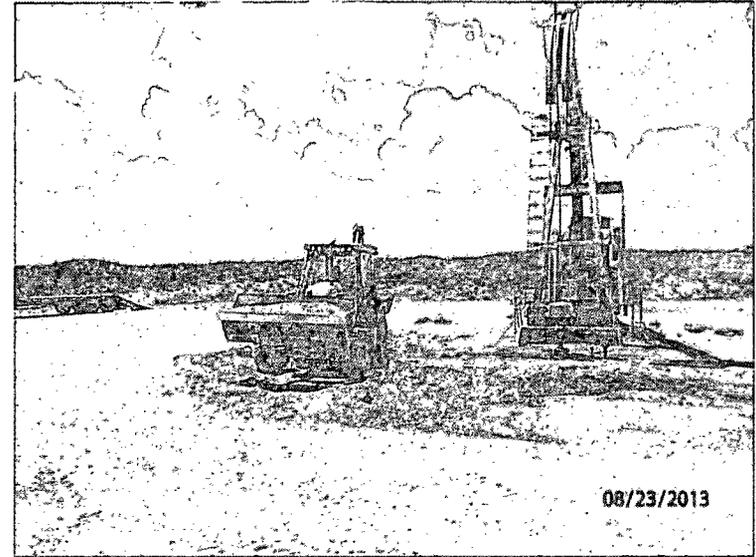
Excavating site, facing southwest

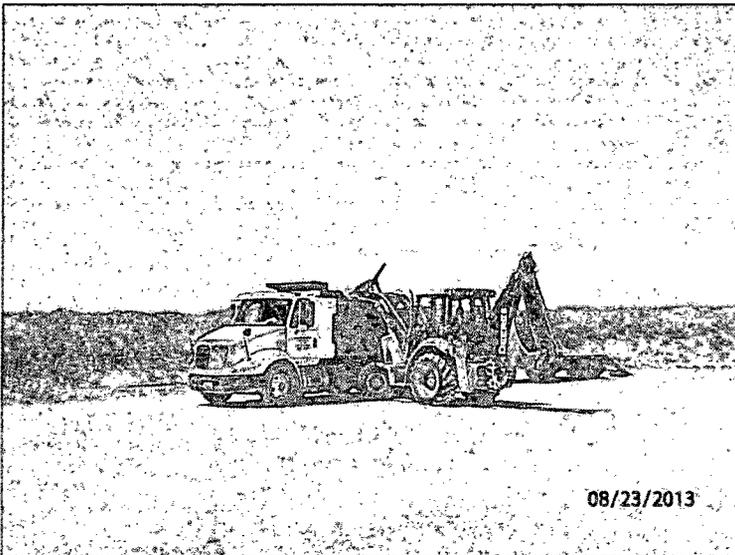
Exporting soil, facing southwest

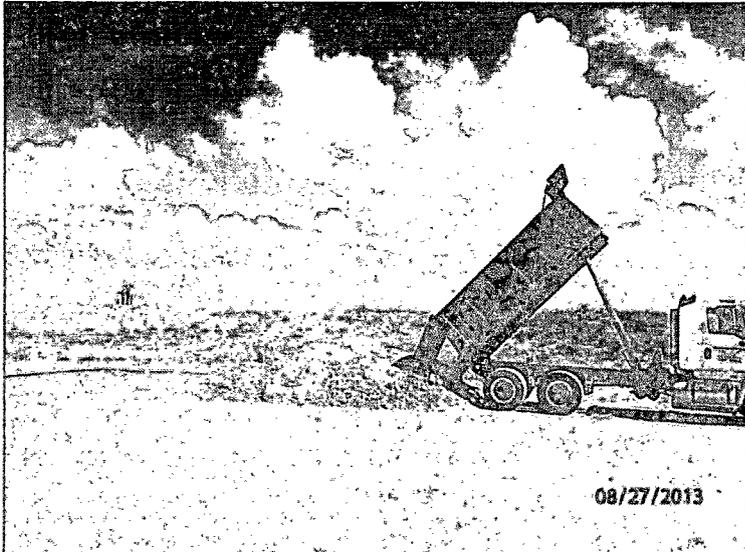
Importing caliche, facing north

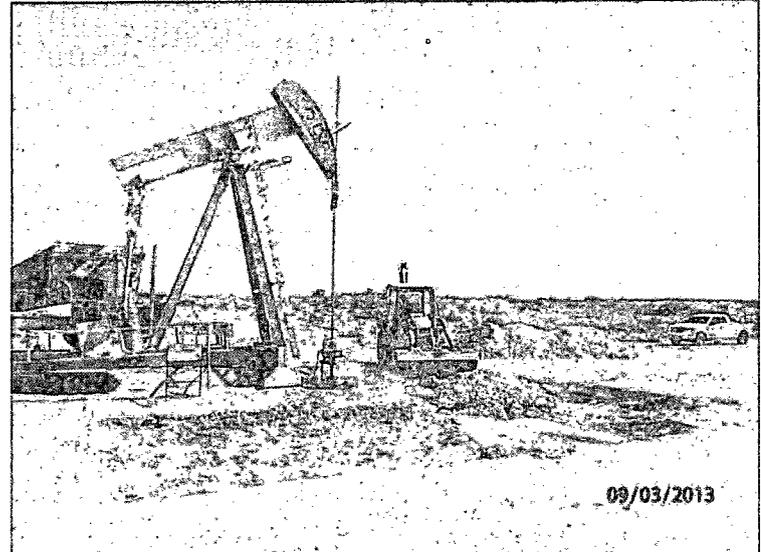
Backfilling site, facing northeast
