**Release Report/ General
Correspondence**

Enterprise SJ

**Enterprise Products
Maxey Federal #1J
Latitude North 36.714925, Longitude West -108.044920
Unit H Section 24 T29 N R12W
San Juan County, New Mexico
March 20, 2014**

Site Photographs
Enterprise Products Maxey Federal #1J Pipeline Release

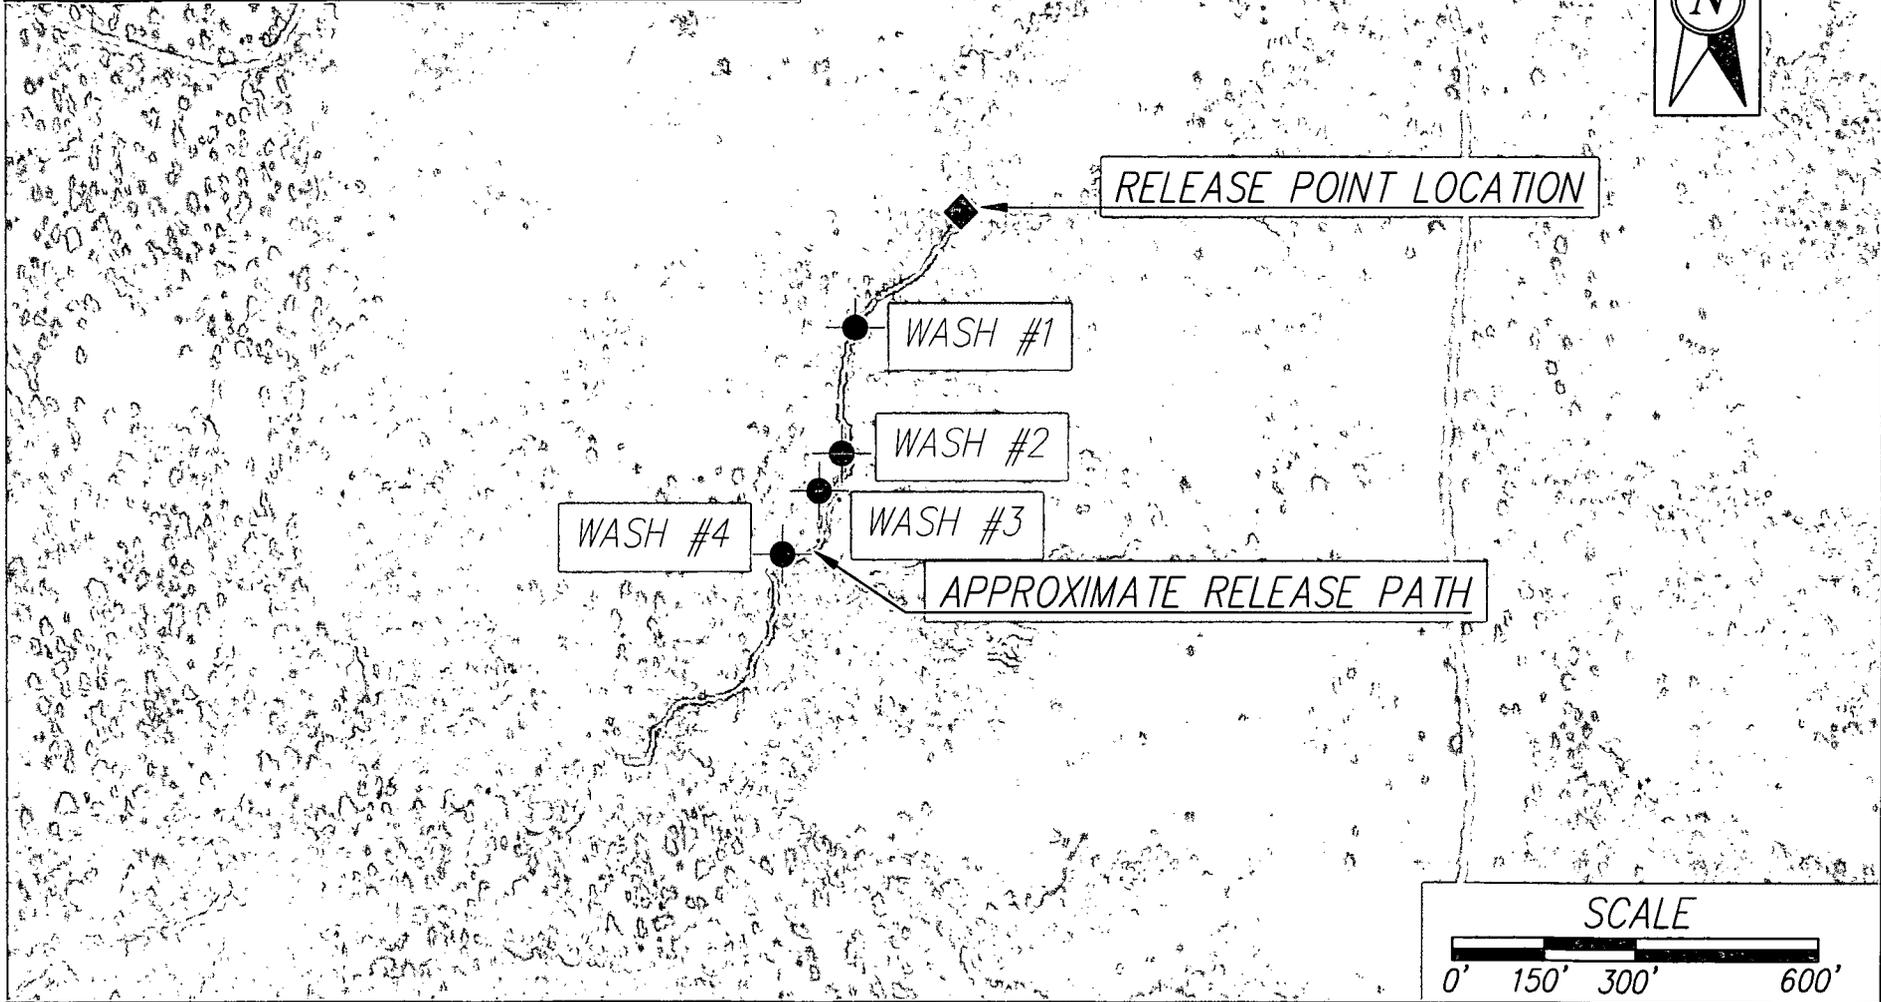
ENTERPRISE	FARMINGTON, NEW MEXICO		Designed SM	Drawn GJF	Checked RSA
SITE LOCATION AND DOWNSTREAM SAMPLE LOCATIONS MAP					
MAXEY FEDERAL #1J					
SECTION 24, T29N, R12W					
SAN JUAN COUNTY, NEW MEXICO					
Date: 3/20/2014			Scale: Horiz: 1"=200'		
Project No: 5122855			Vert: N/A		
Sheet: 2

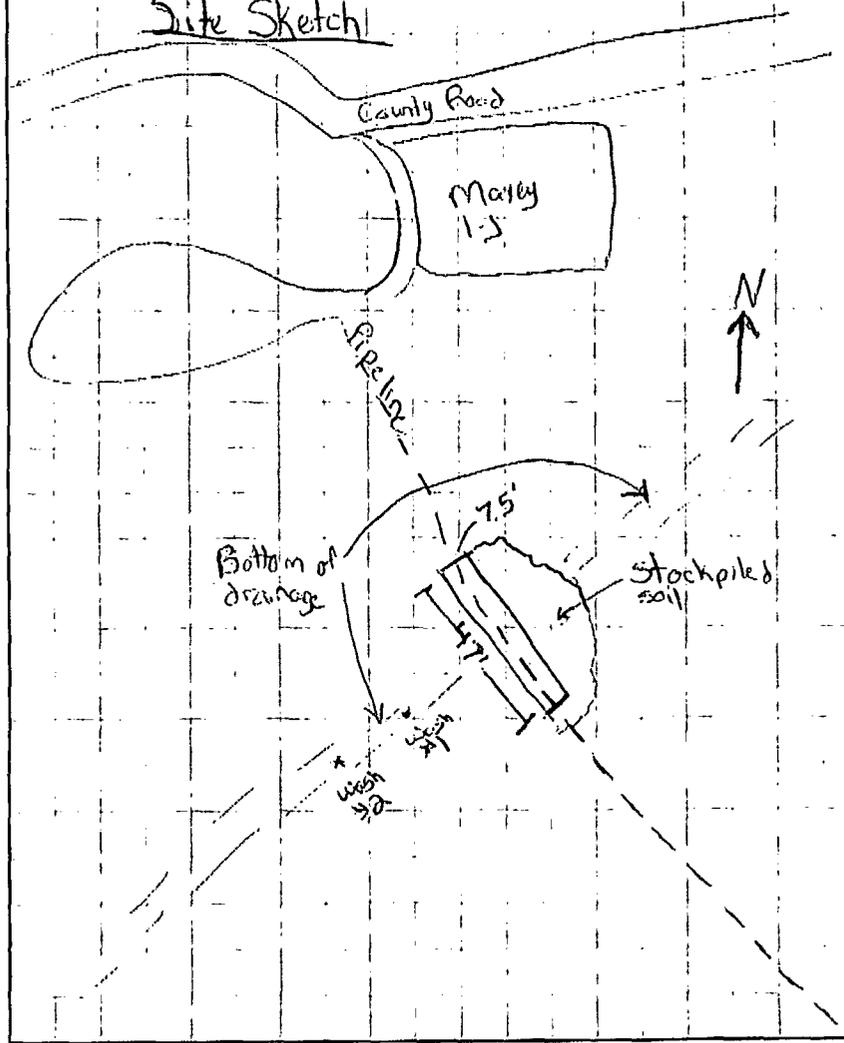
Site Sketch

47' x 7.5' 4-foot deep

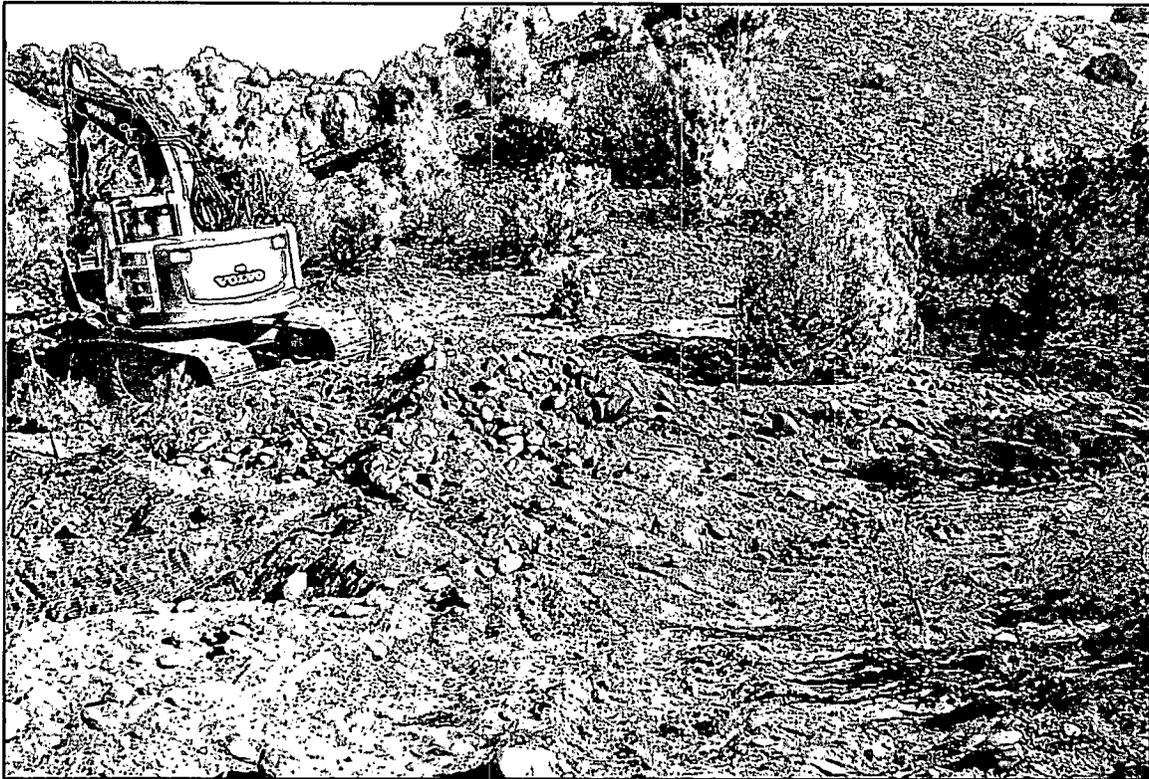
Photo 3: Early stages of the of the Maxey Federal #1J Pipeline excavation, facing north.

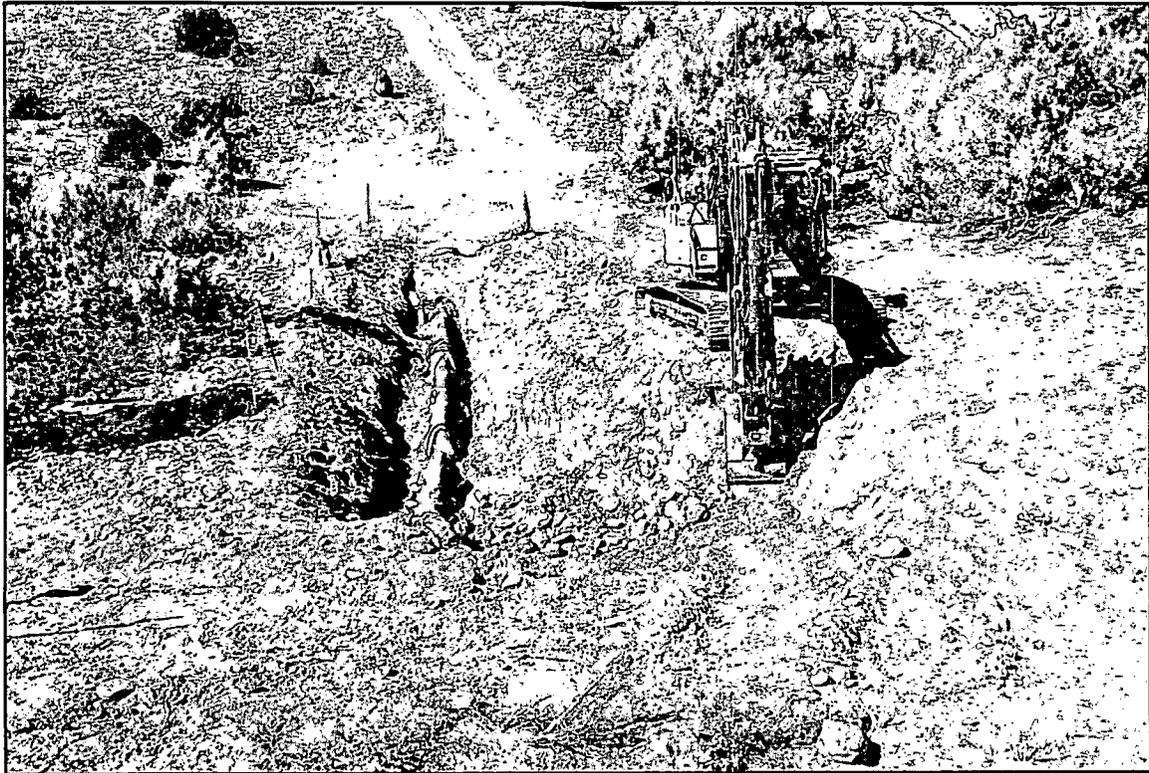
Photo 4: End of day one of the remediation excavation the Maxey Federal #1J Pipeline, facing north.

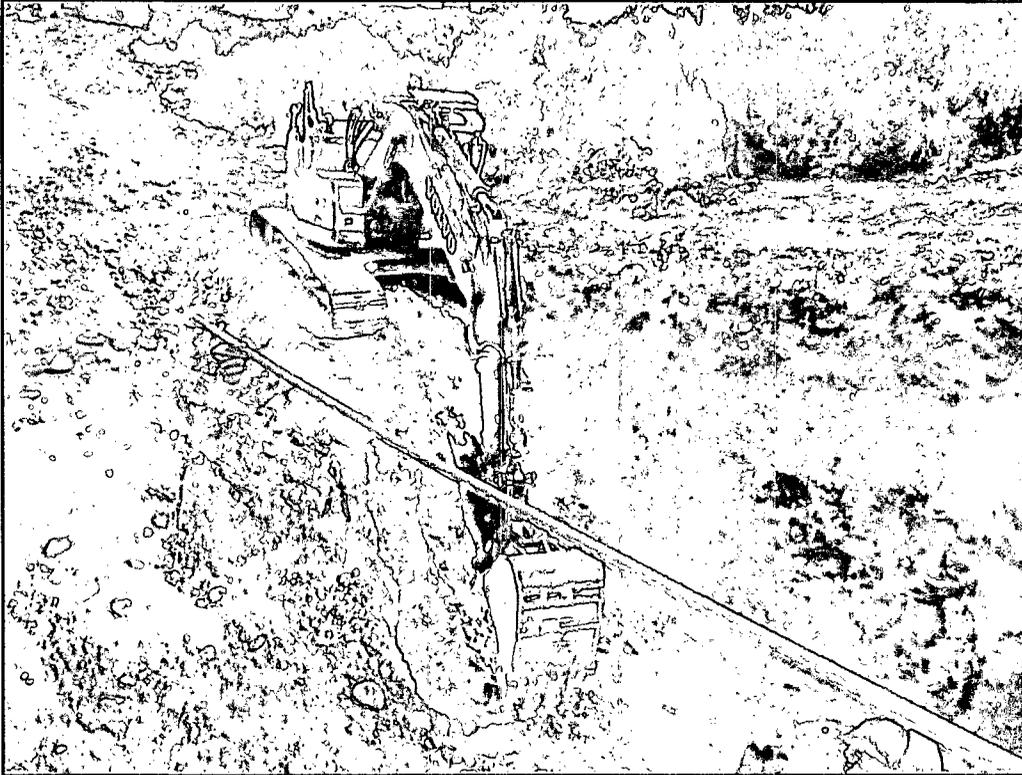
Photo 5: Day two of the Maxey Federal #1J excavation, reaching depths of approximately 15'.

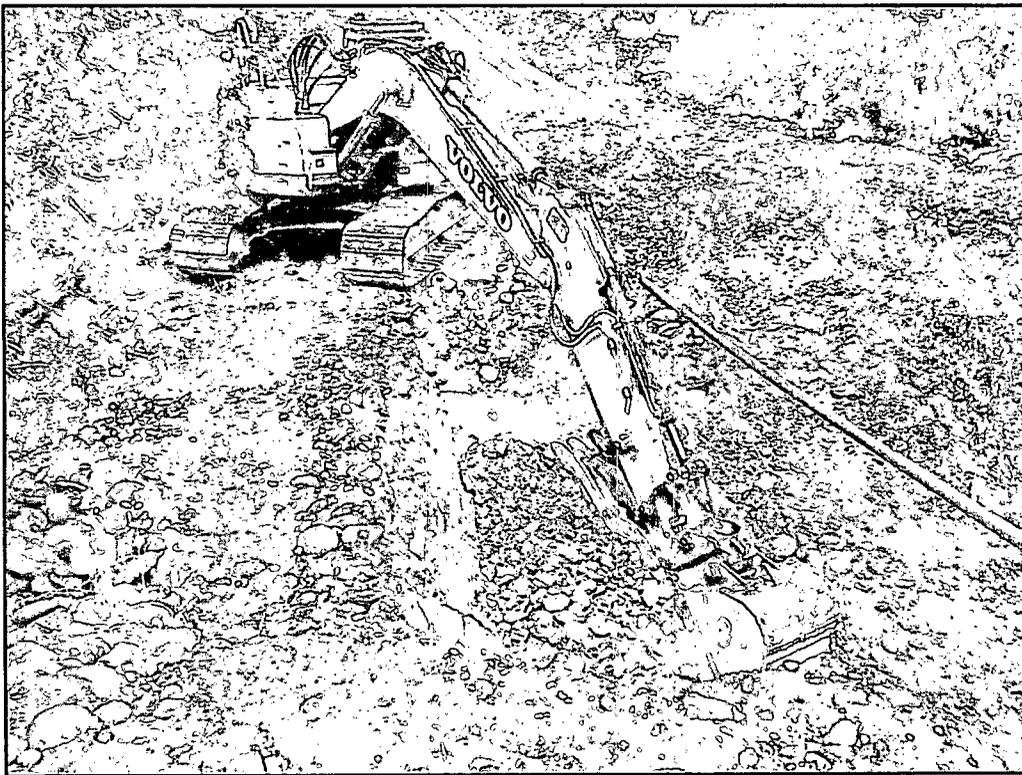
Photo 6: Excavation along the southwest portion of the pipeline remediation excavation, facing north.

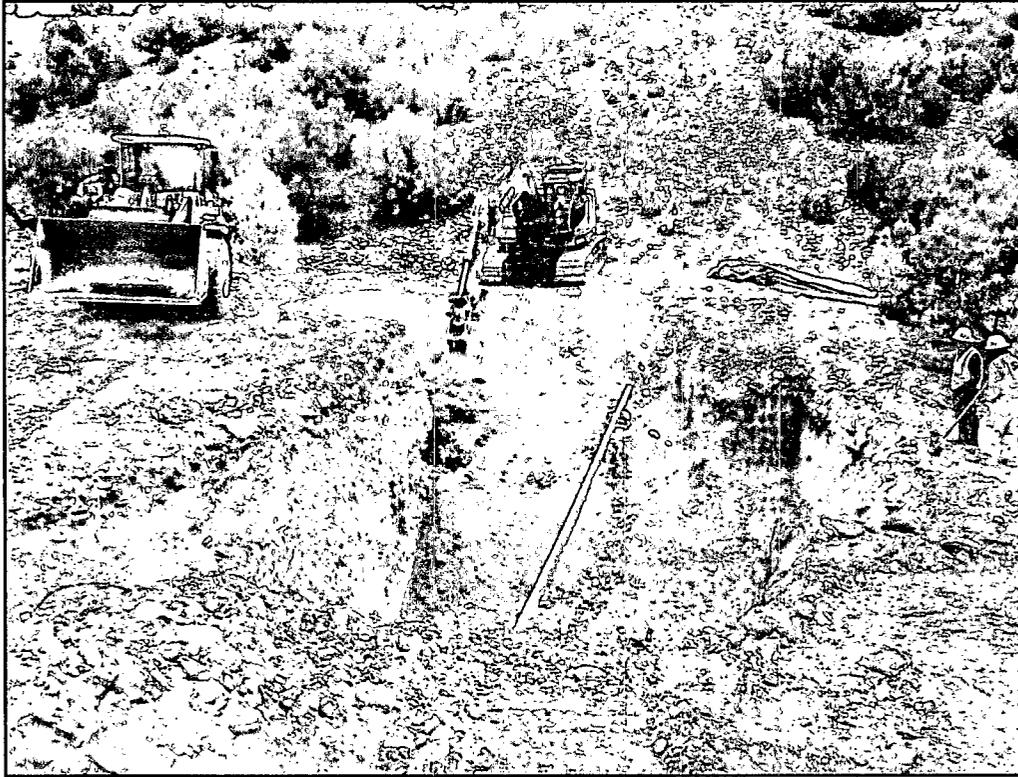
Photo 7: Beginning of Backfilling activities of the Maxey Federal #1J pipeline excavation, facing south.

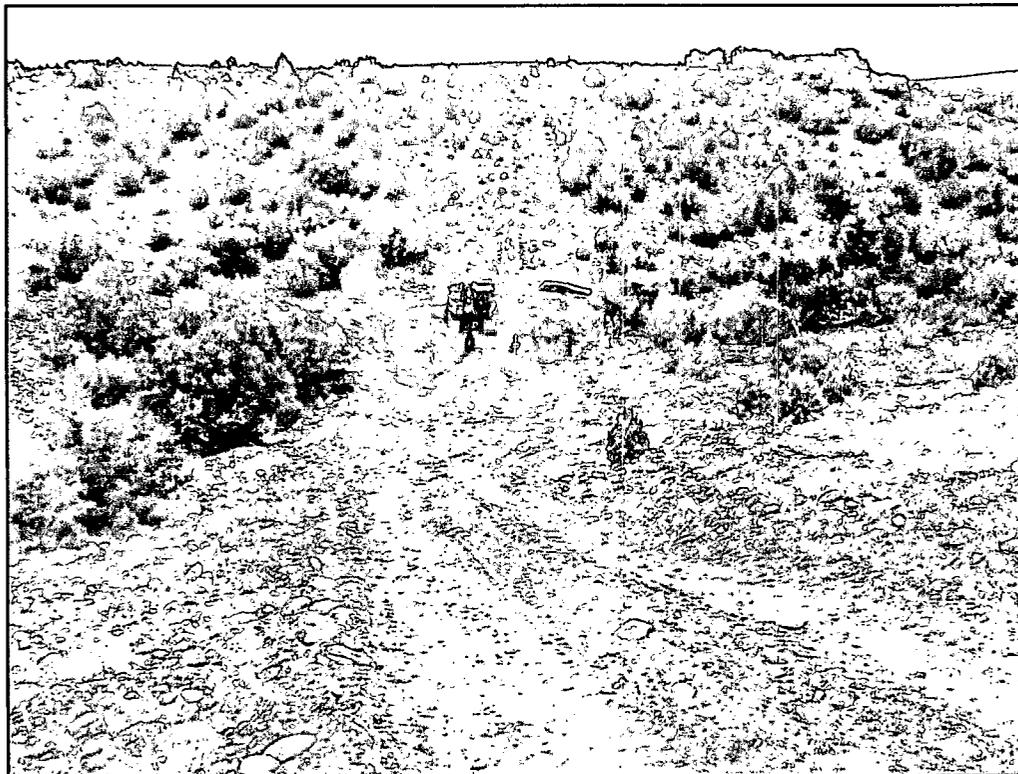
Photo 8: Final excavation and backfilling of the Maxey Federal #1J pipeline.

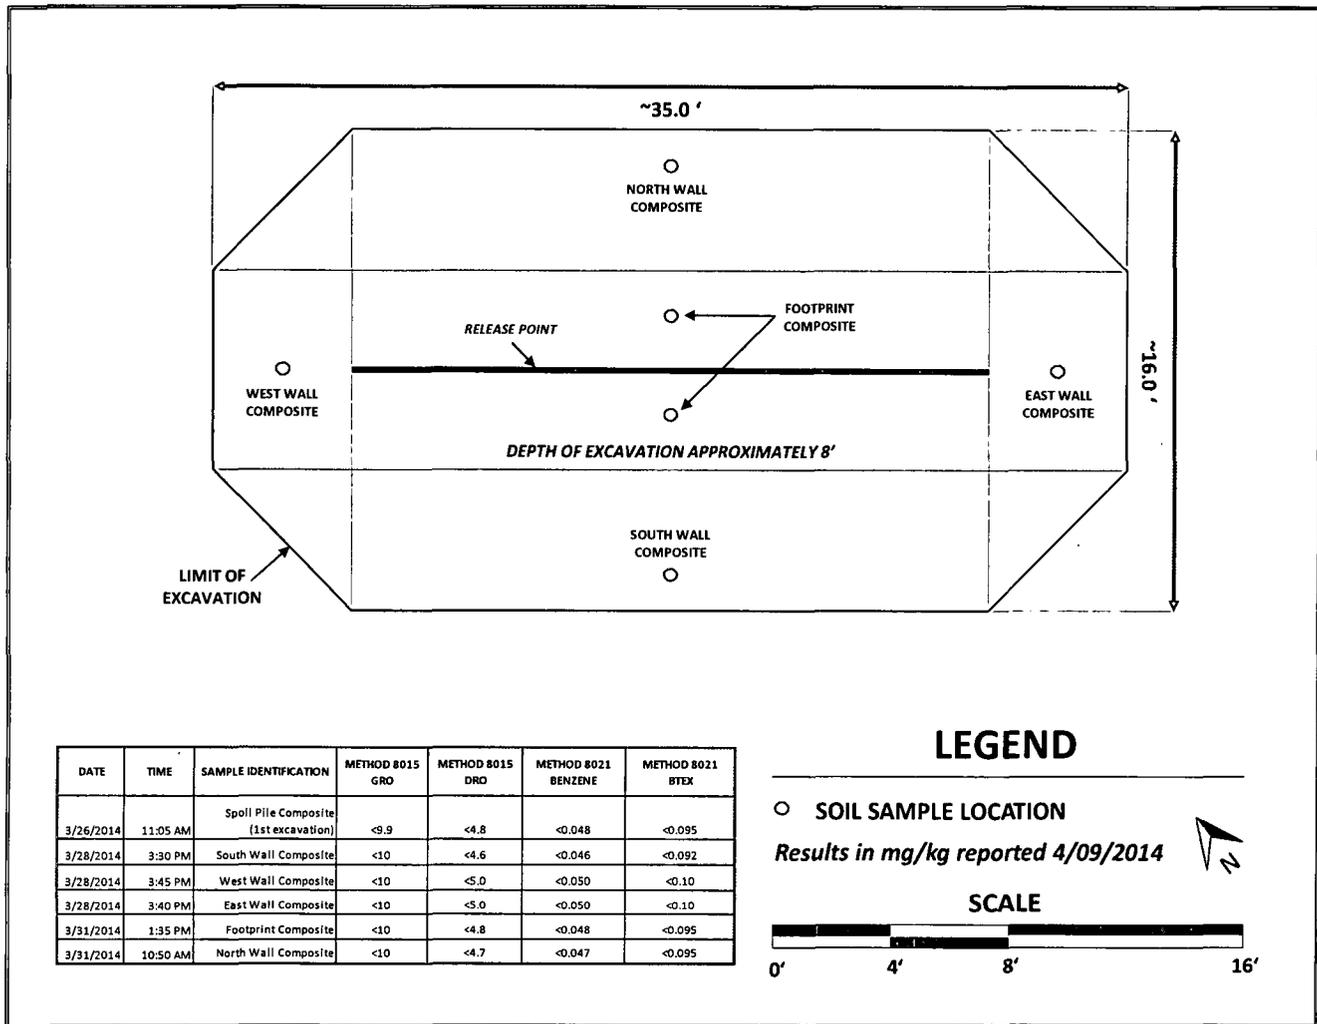
Figure 2: Soil Contamination Concentration and Sample Locations

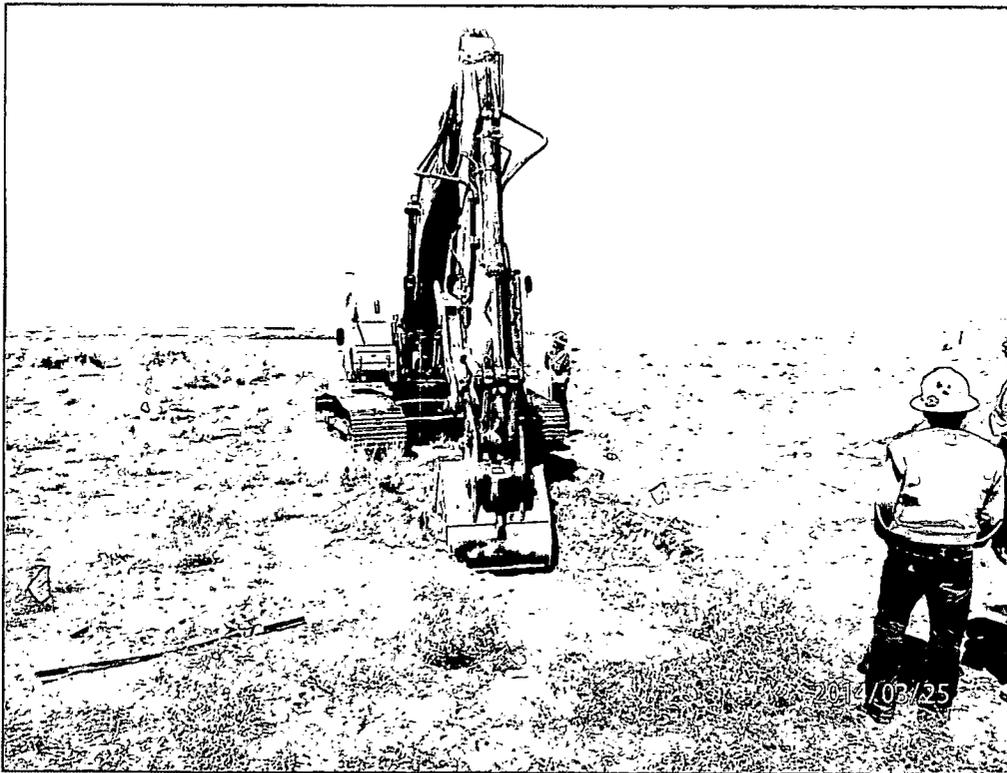
Potentially impacted area prior to full excavation.

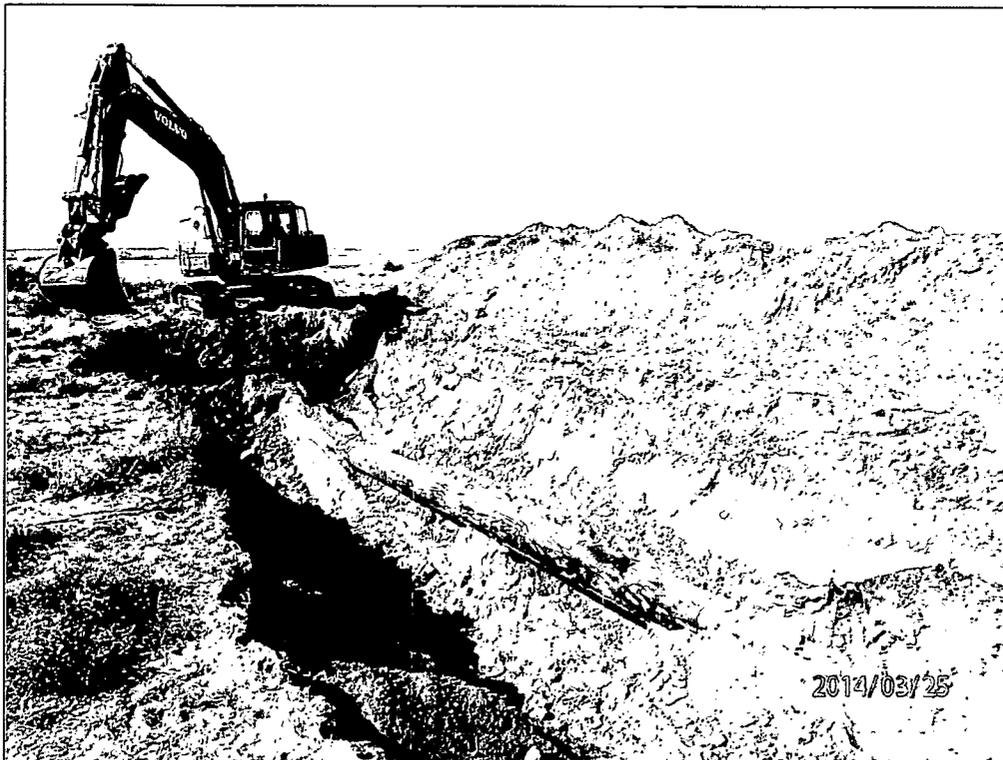
No evidence of contaminated soil upon completion of ~40' of exposed pipe.

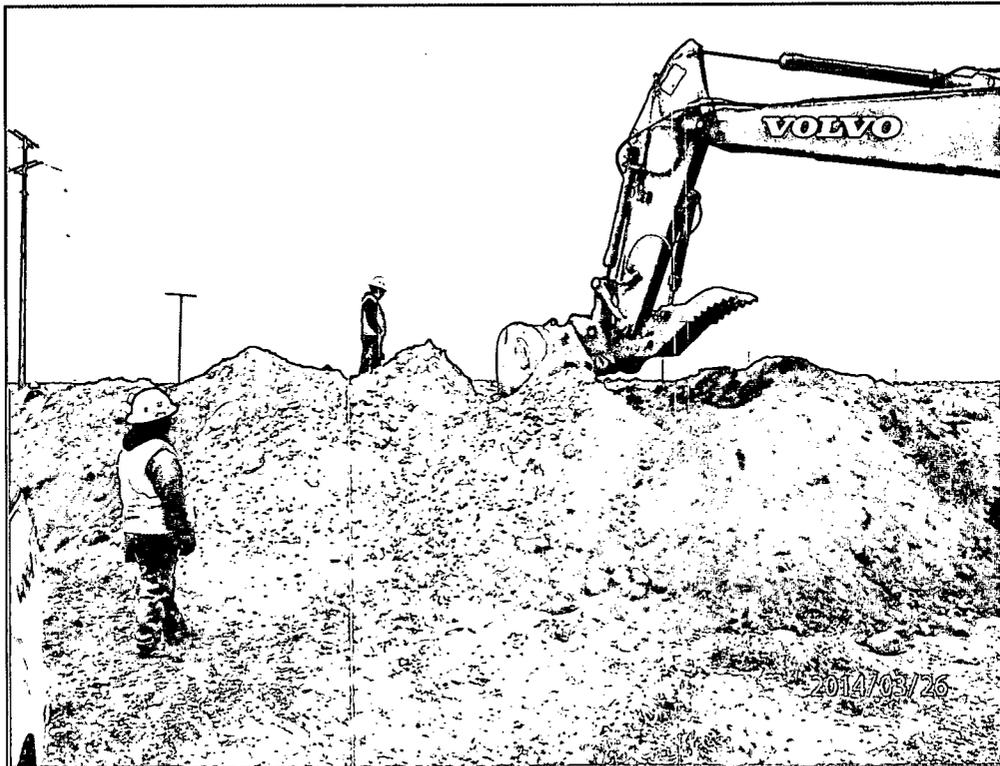
Preparation for sample collection for Total Petroleum Hydrocarbon (TPH) field screens.

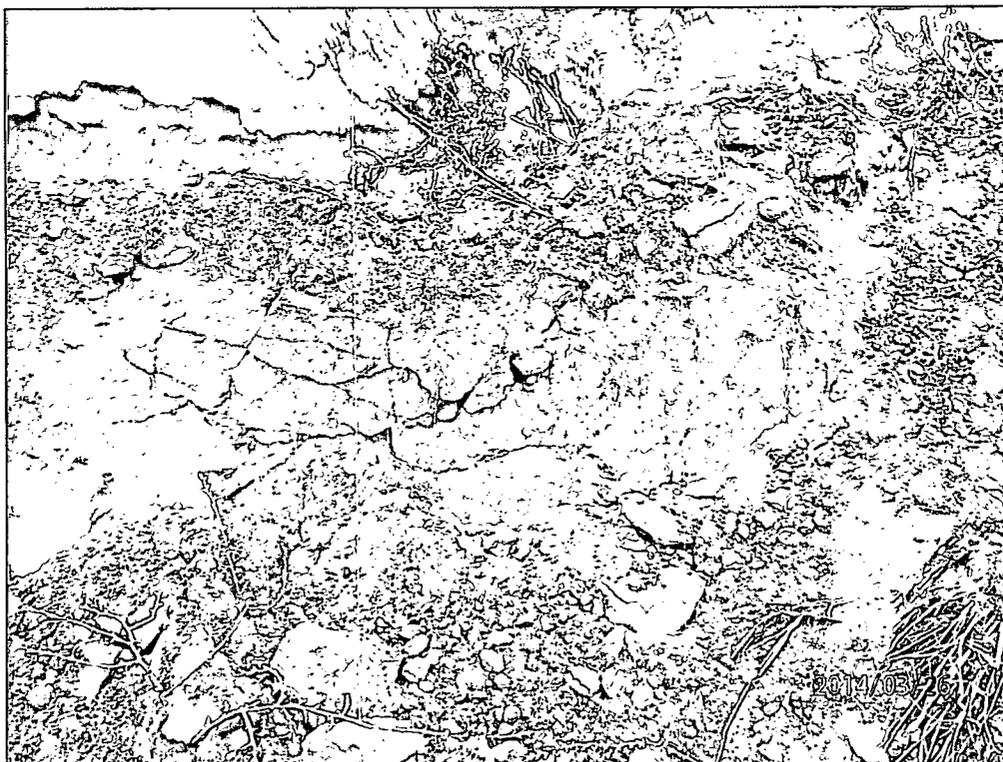
Moderately stained portion of the initial excavation, likely as a result of the adjacent line leak.

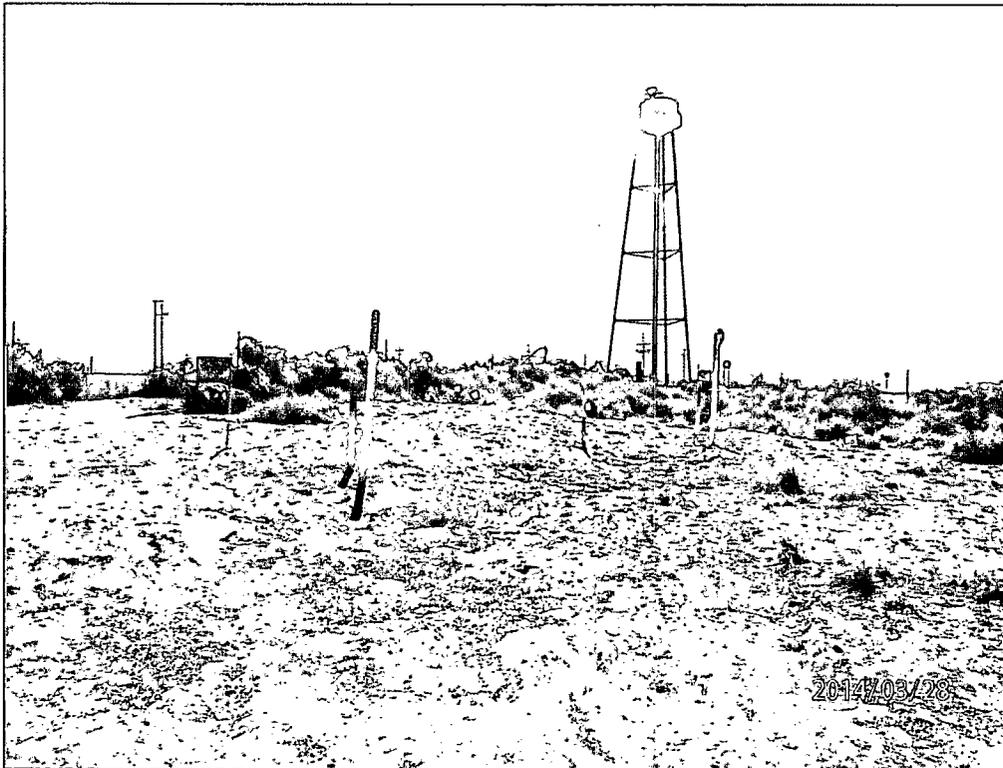
Photo looking southeast – potentially impacted area prior to excavation.

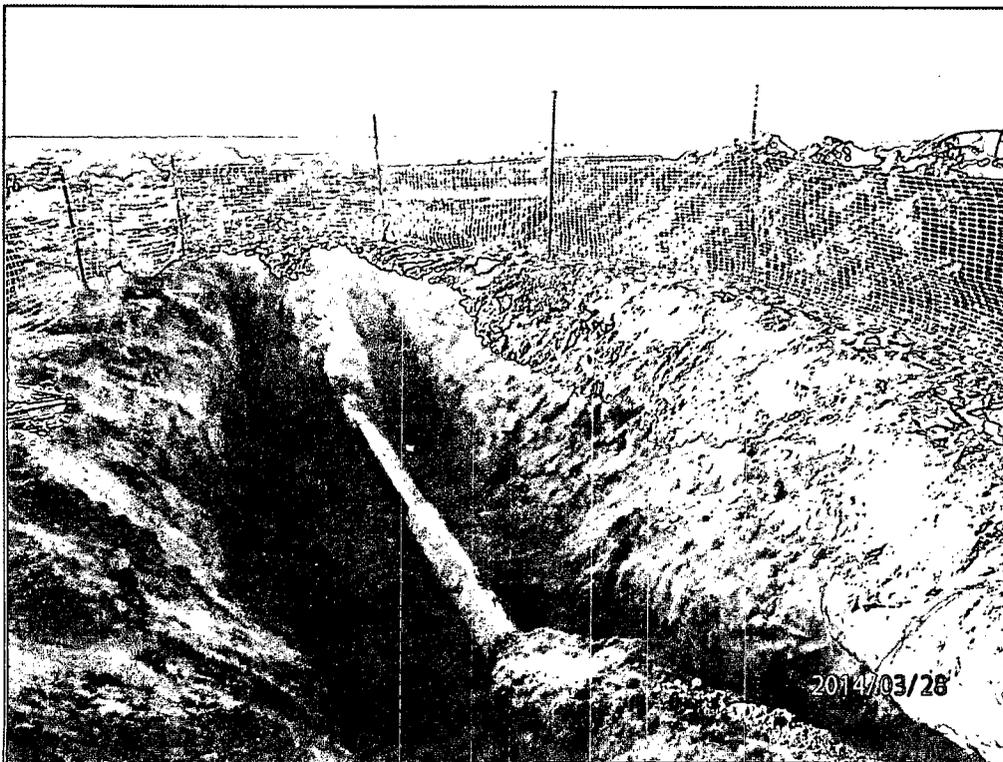
The excavation exposed ~20' of line with most of the contamination to the north side of the area.

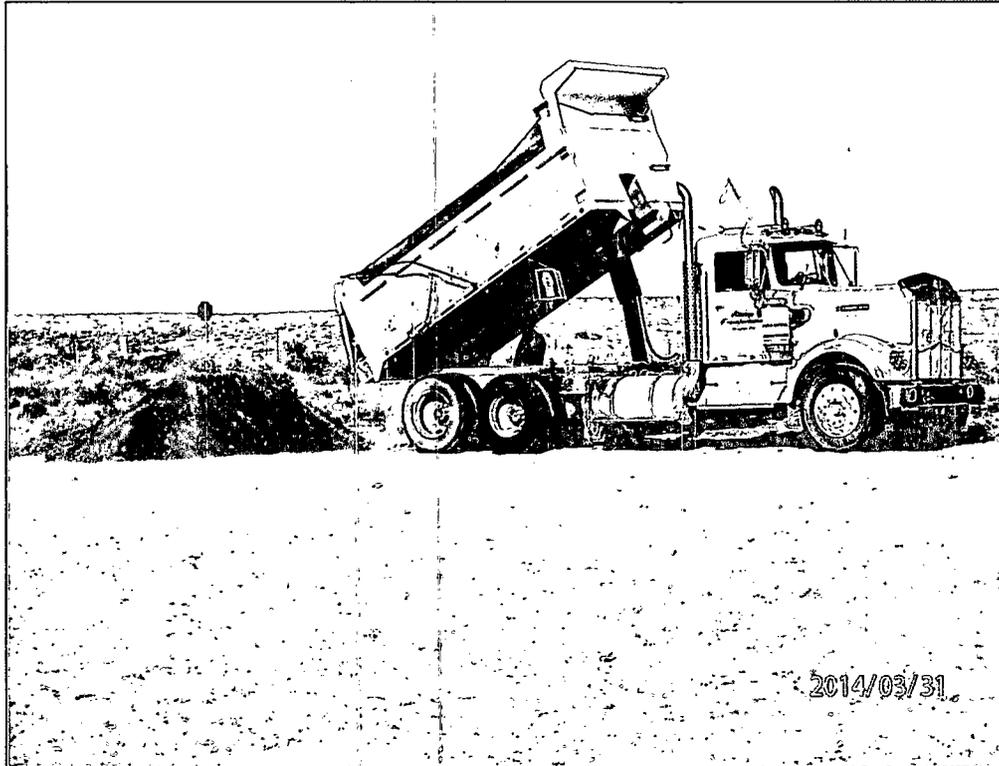
Off-loading clean soil for backfill of the pit. Trucks are also transporting the contaminated soil off location to the Envirotech, Inc. Landfarm for disposal.

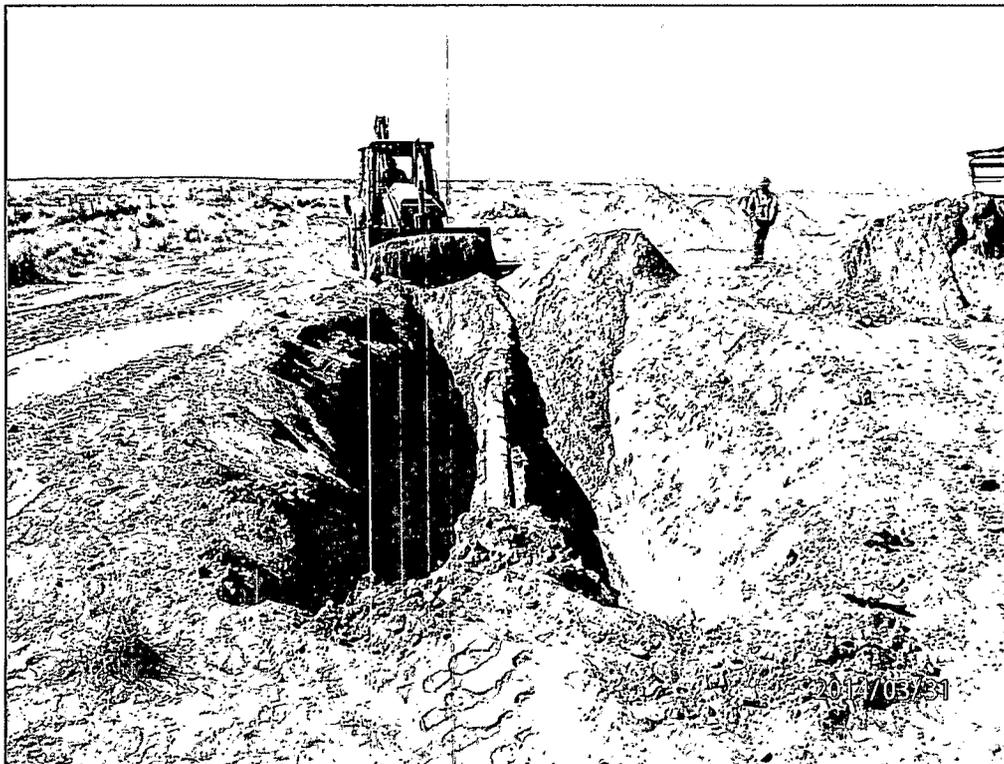
Beginning backfill operations after TPH results confirmed that all five composite samples were free of contamination by New Mexico OCD regulatory standards.

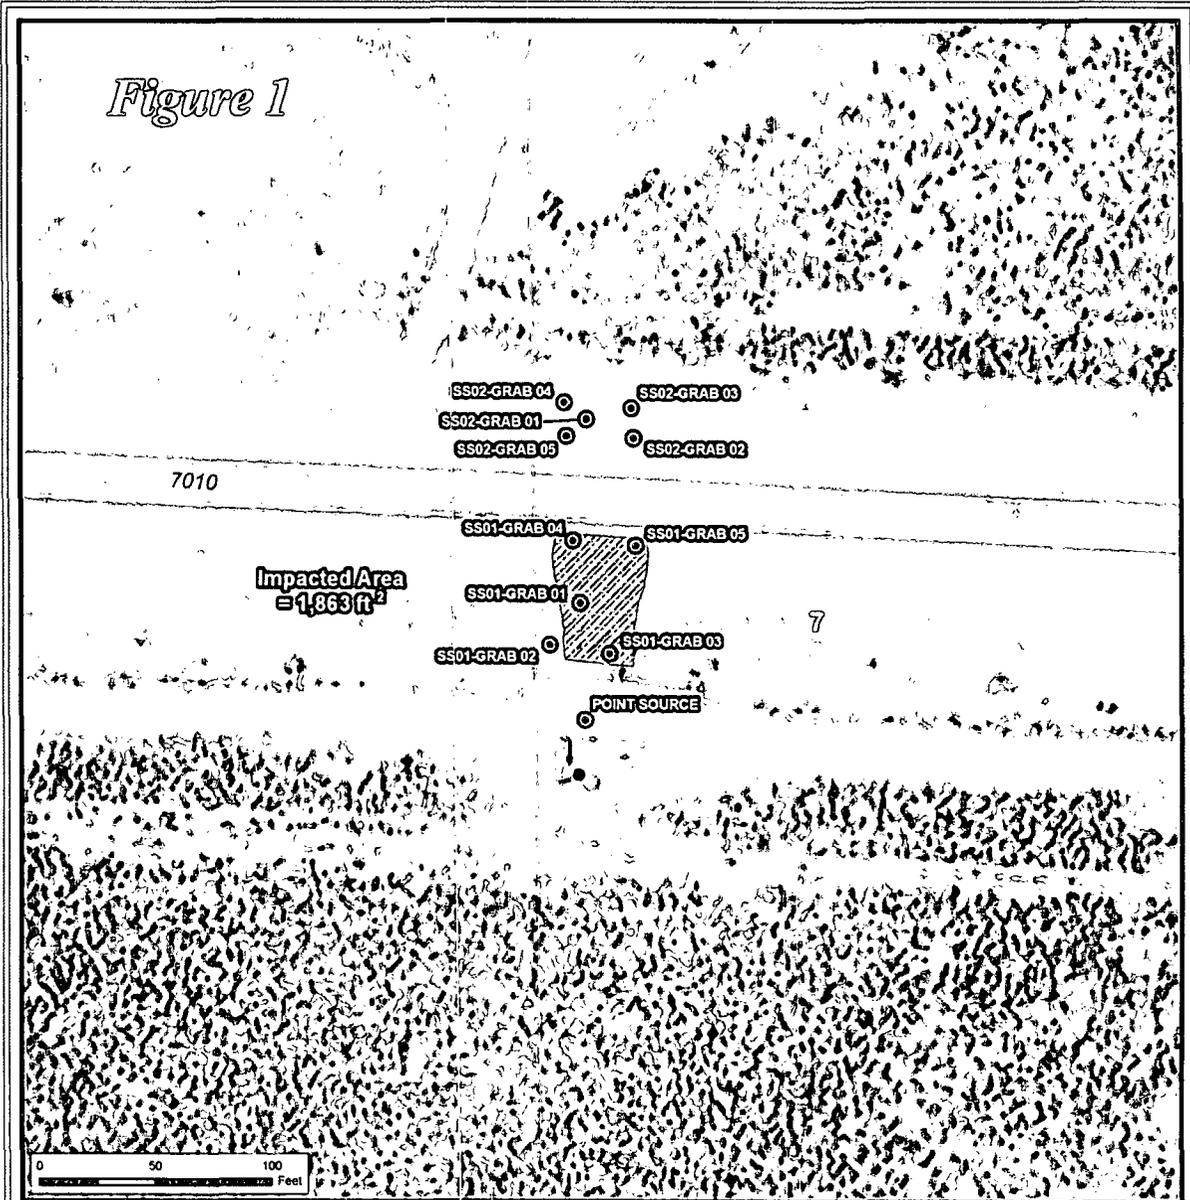
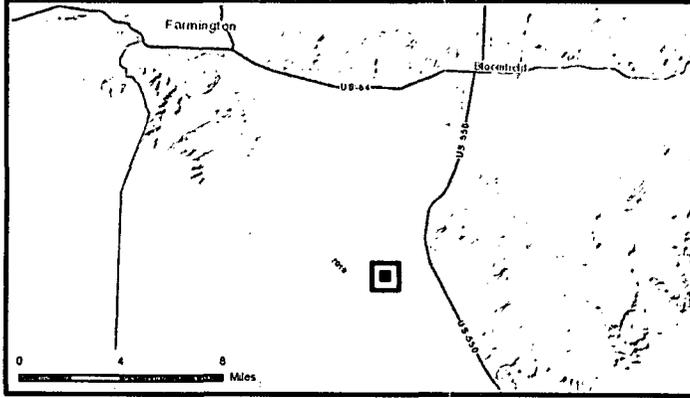
Figure 1

Enterprise Products
Sample Location Map
 Trunk 3D Release
 36.595036 -108.044602
 Section 7, Township 27 North, Range 11 West

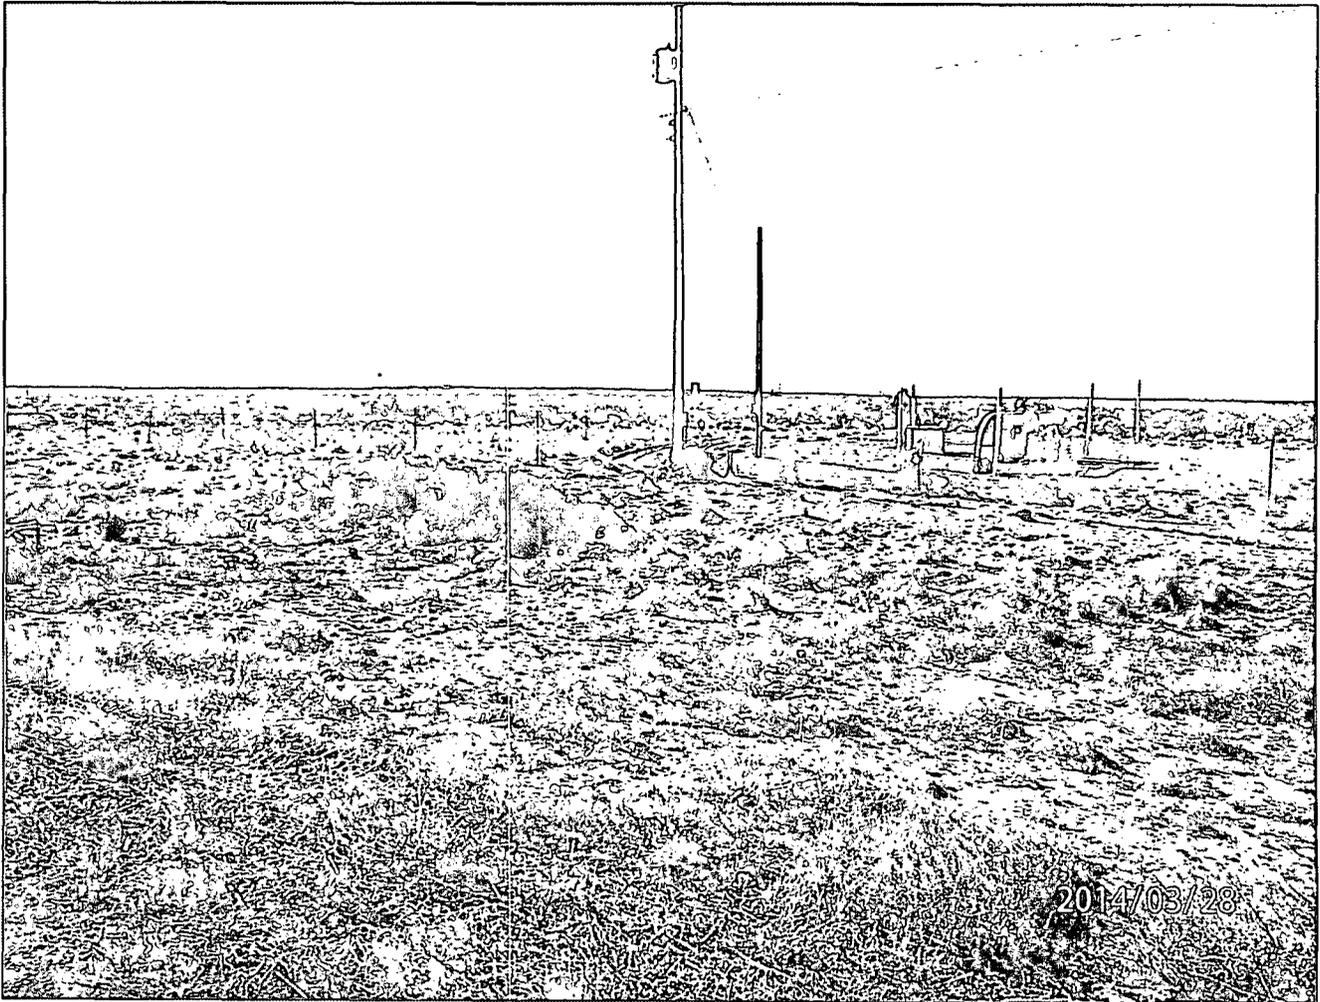
*Impacted area along south side of County Road 7010 (~1,863 ft²) prior to excavation.
Valve setting in background is the point source for the release.*

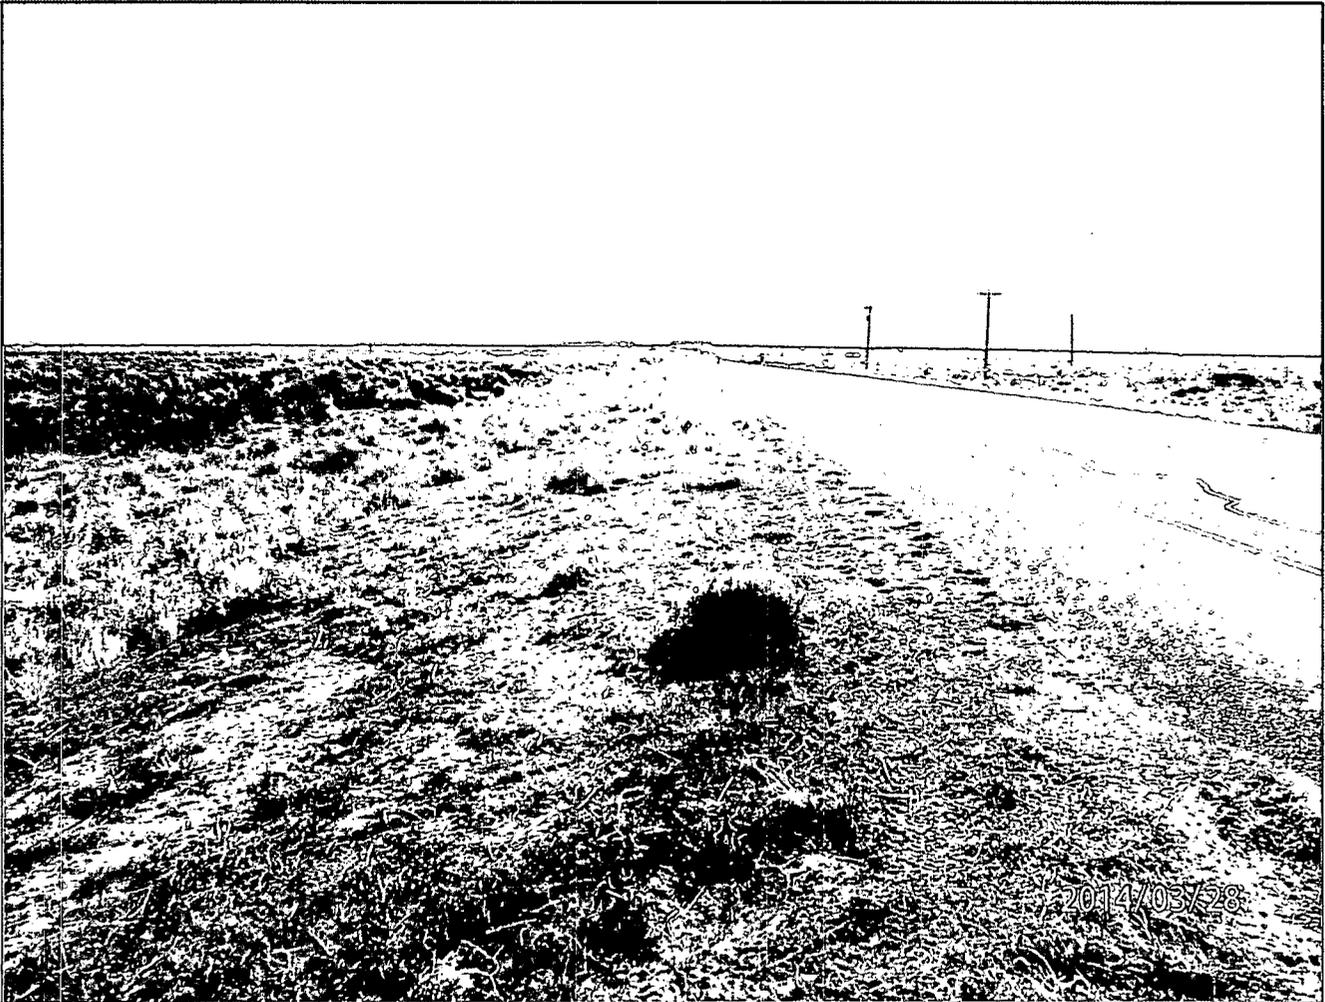
Area along north side of County Road 7010. This side was not excavated as acceptable TPH levels were recorded.

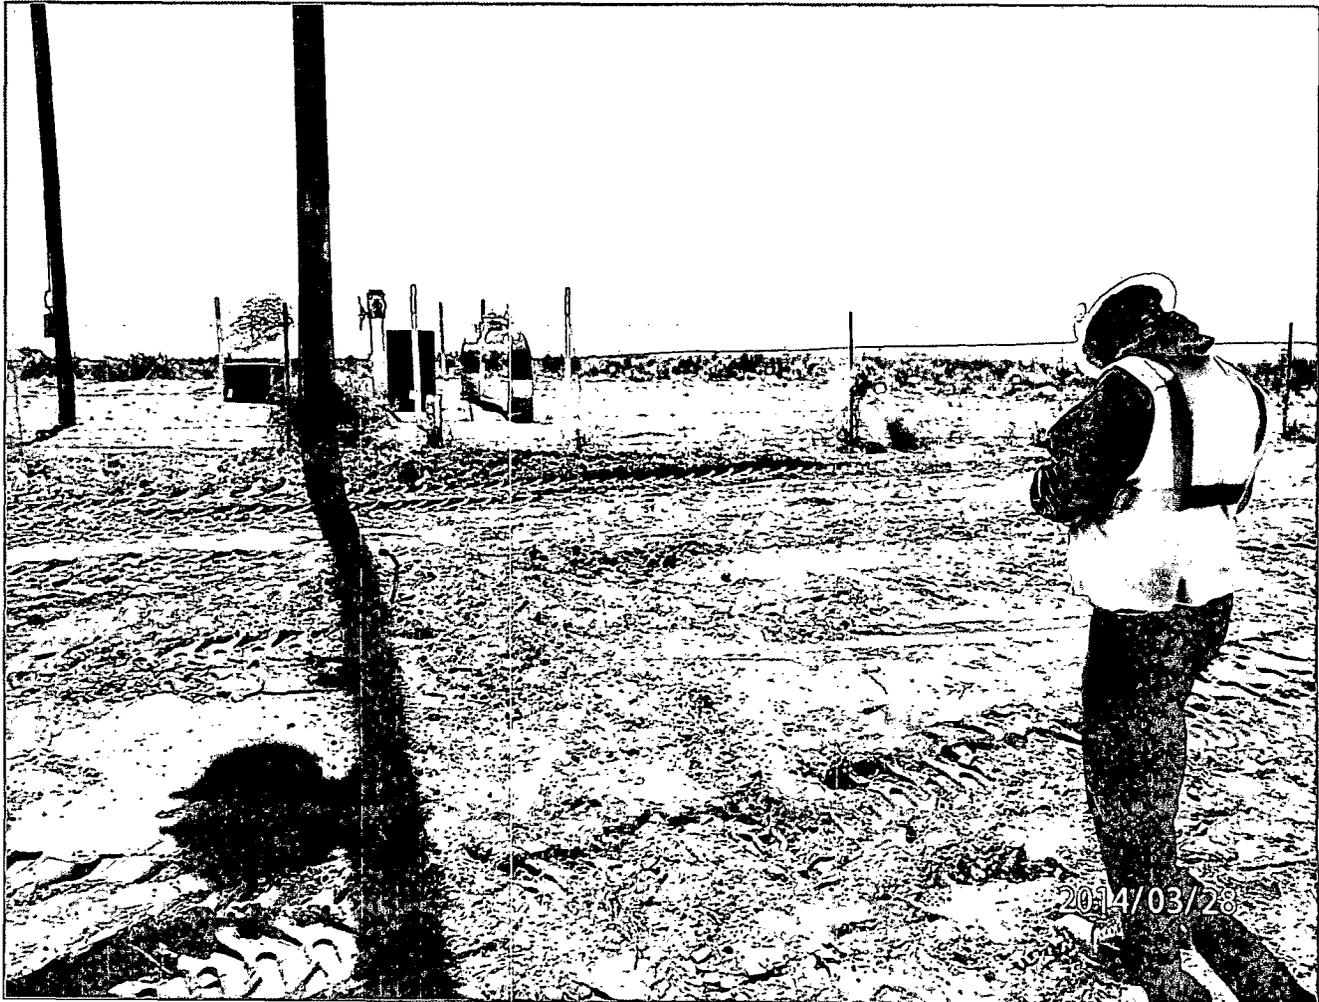
Impacted area along south side of County Road 7010 after excavation. Approximately 6" of top soil (~36 cubic yards) was removed from the release site.
