## **REMEDIATION SUMMARY & RISK-BASED SITE CLOSURE REQUEST**

**BOPCO, LP  
JAMES RANCH UNIT #29 SWD  
Eddy County, New Mexico  
Unit Letter "K" (NE/SW), Section 36, Township 22 South, Range 30 East  
Latitude 32.346284° North, Longitude 103.837459° West  
NMOCD Reference #'s: 2RP-1174 & 2RP-1265**

**May 2013**

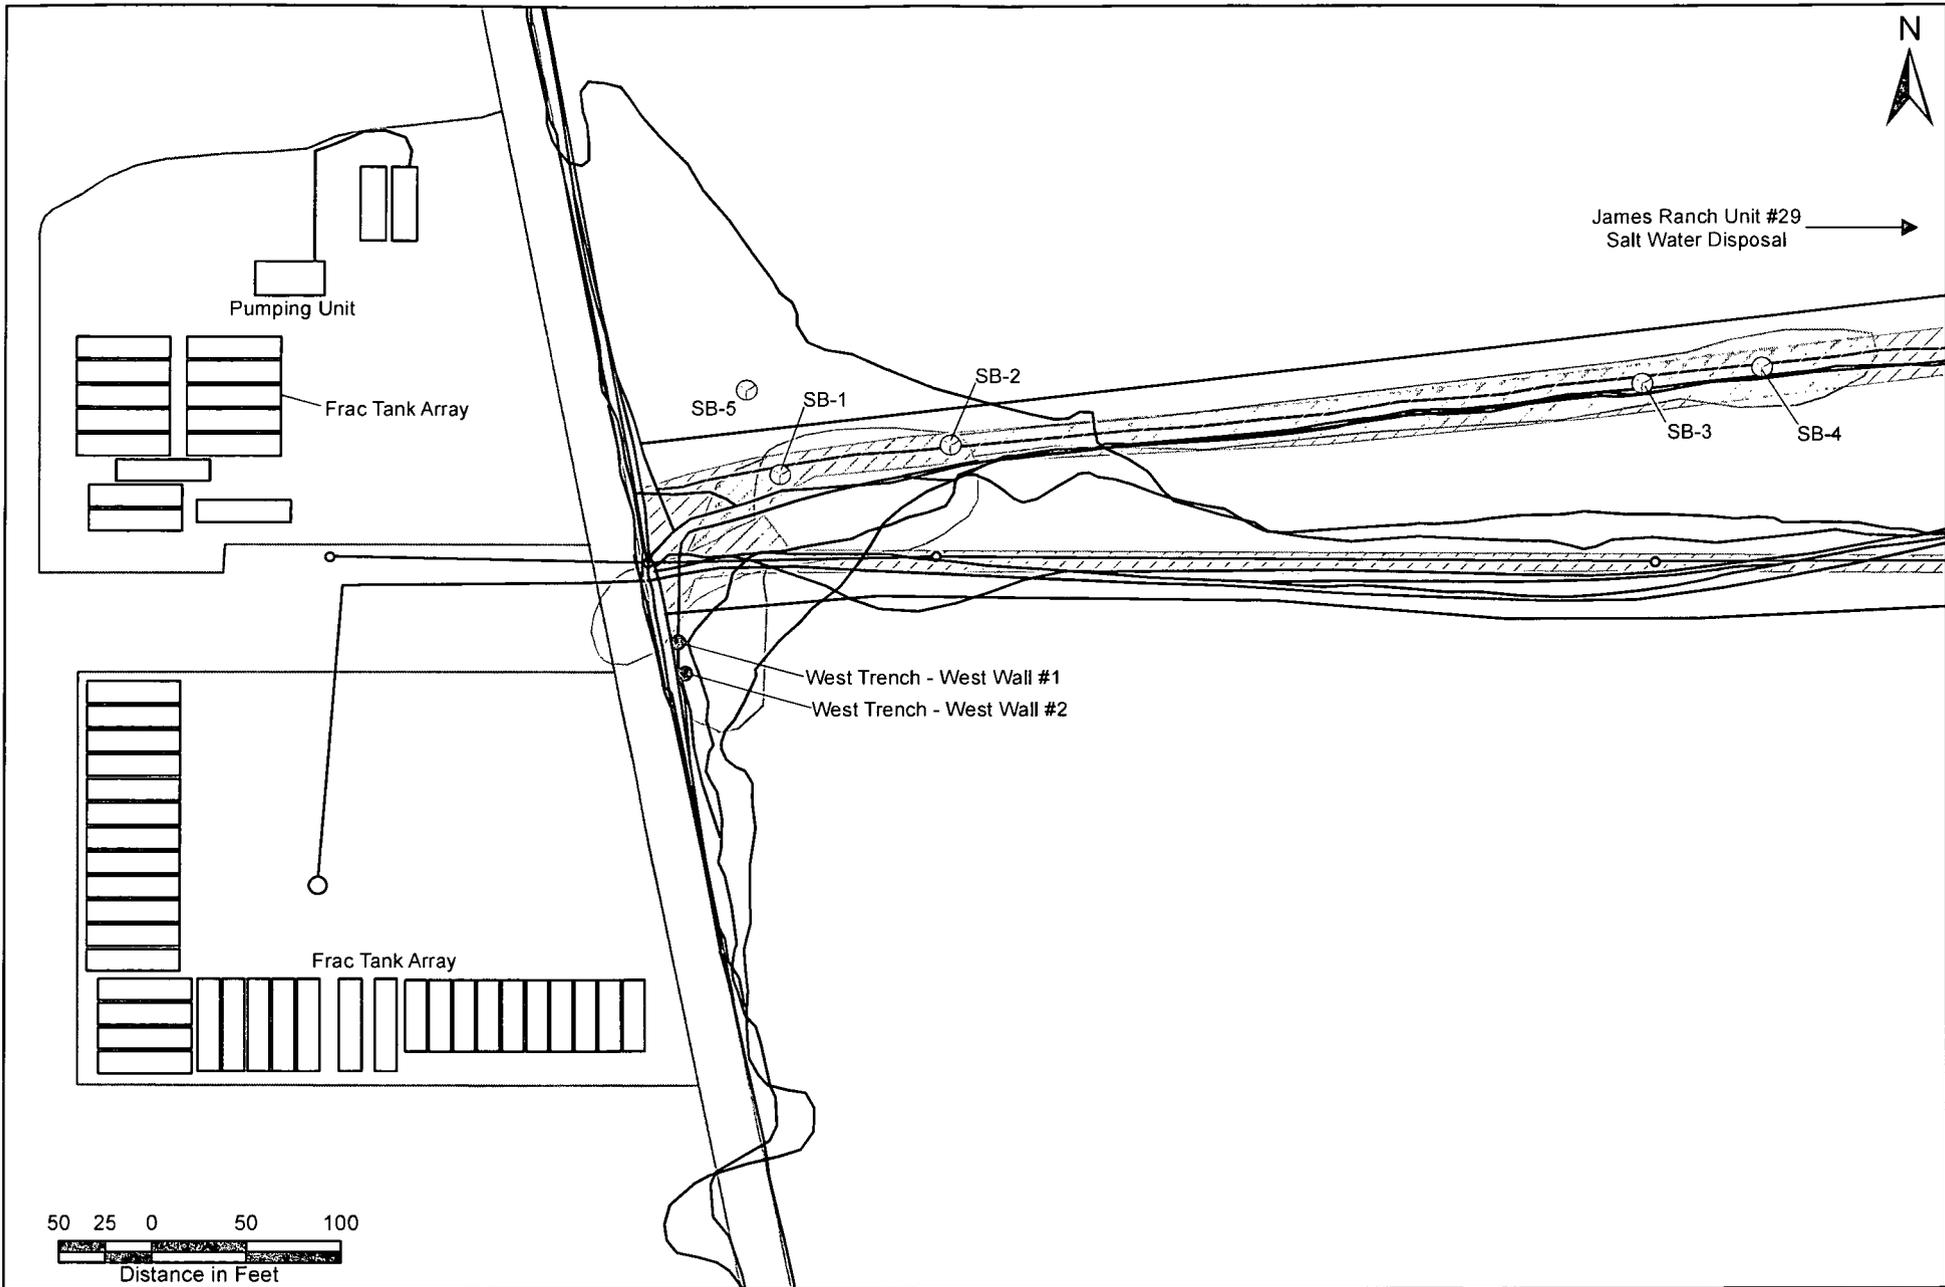
--- Excavation Extent	⊙ Soil Boring
— Pipeline	● Sample Location
— Caliche Road/Pad	□ May 2012 Release
— Power Line	□ August 2012 Release
▨ Right-of-Way

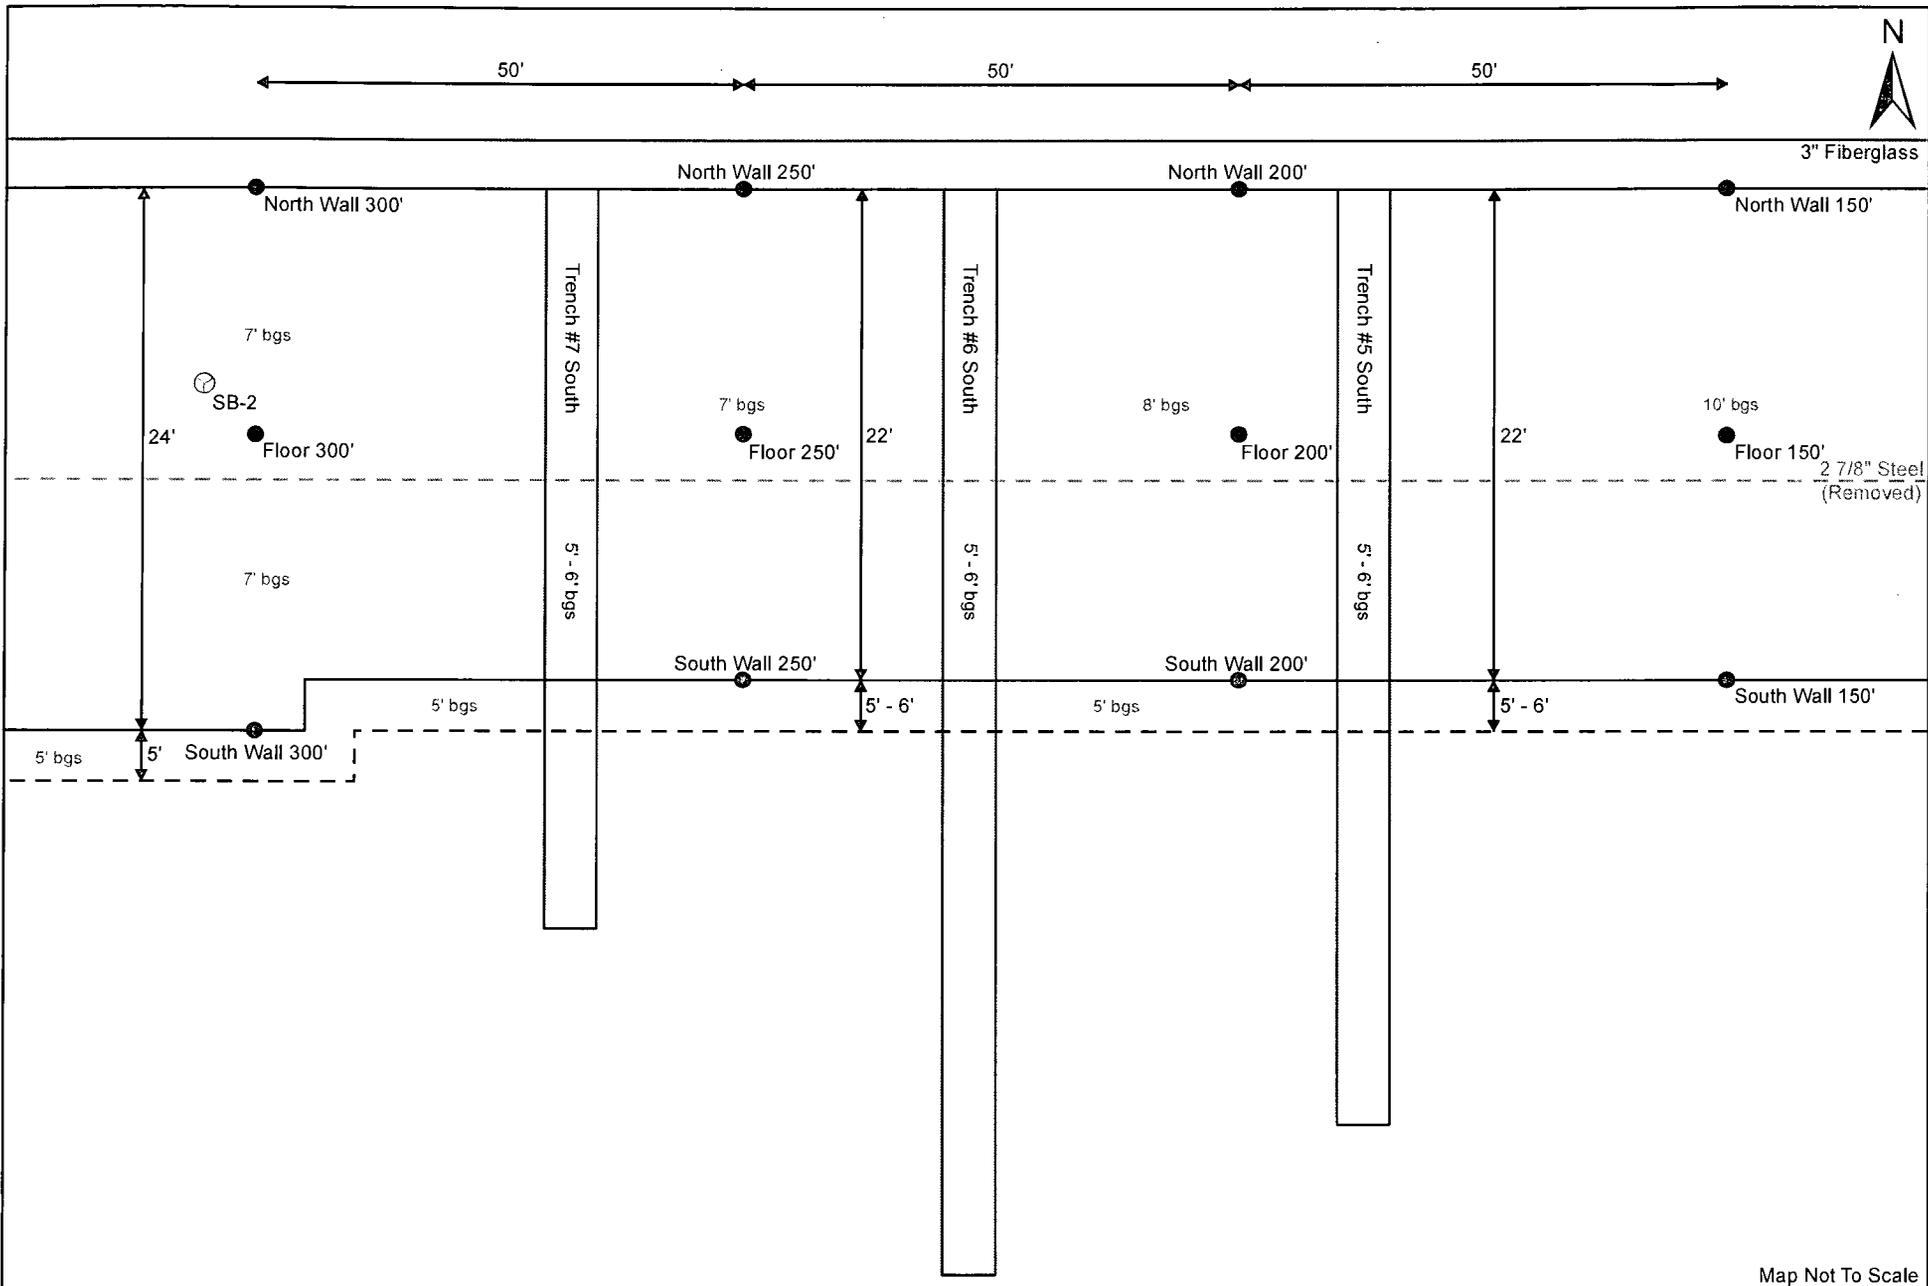
— Excavation Extent	- - - Historic Pipeline
- - - Bench	— Power Line
— Delineation Trench	⊙ Soil Boring
— Steel Pipeline	● Sample Location
— Fiberglass Pipeline	□ Polyurethane Liner

On March 4 and March 7, 2013, twenty (20) mil polyurethane liners were installed in the floors of the East and West sections of the South Excavation at approximately ten feet (10') bgs. A cushion of sand was installed approximately one foot (1') both above and below the liner to protect the liner from damage during installation and backfilling activities. In areas where further excavation was precluded by the presence of active pipelines and/or a roadway, the polyurethane liners were installed along the sidewalls of the excavation(s), to approximately one foot (1') bgs, in order to inhibit horizontal migration of contaminants.

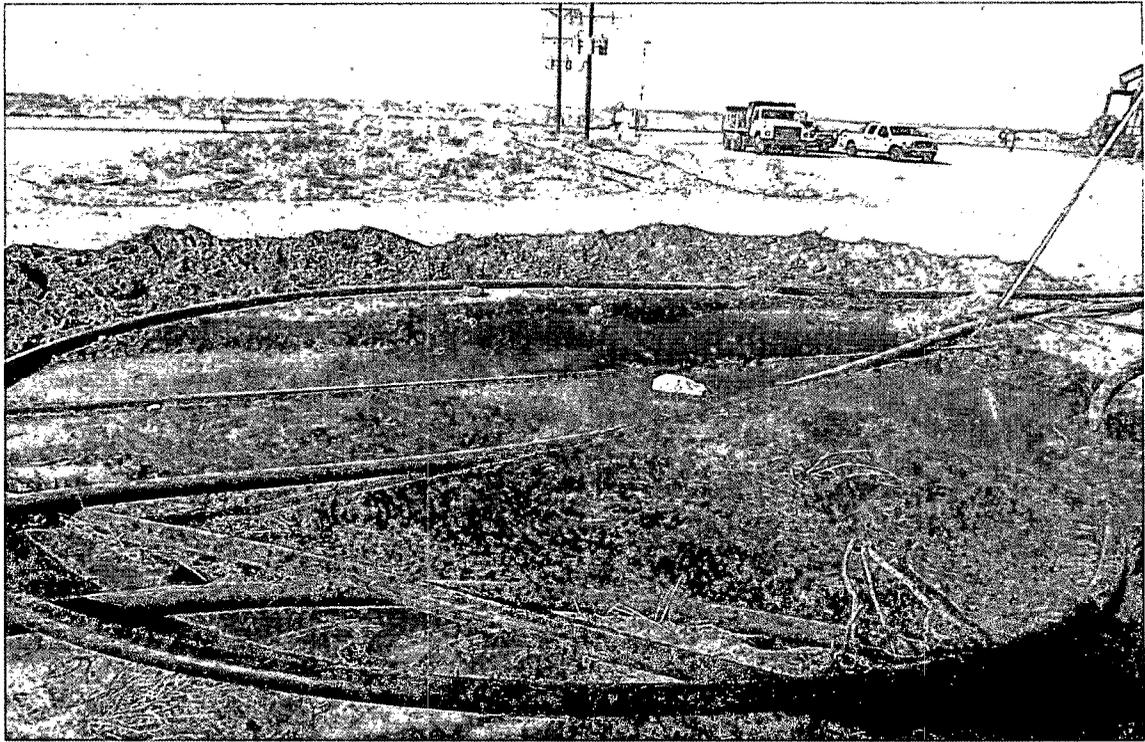
James Ranch Unit #29 SWD - Pooling Area (Looking West)

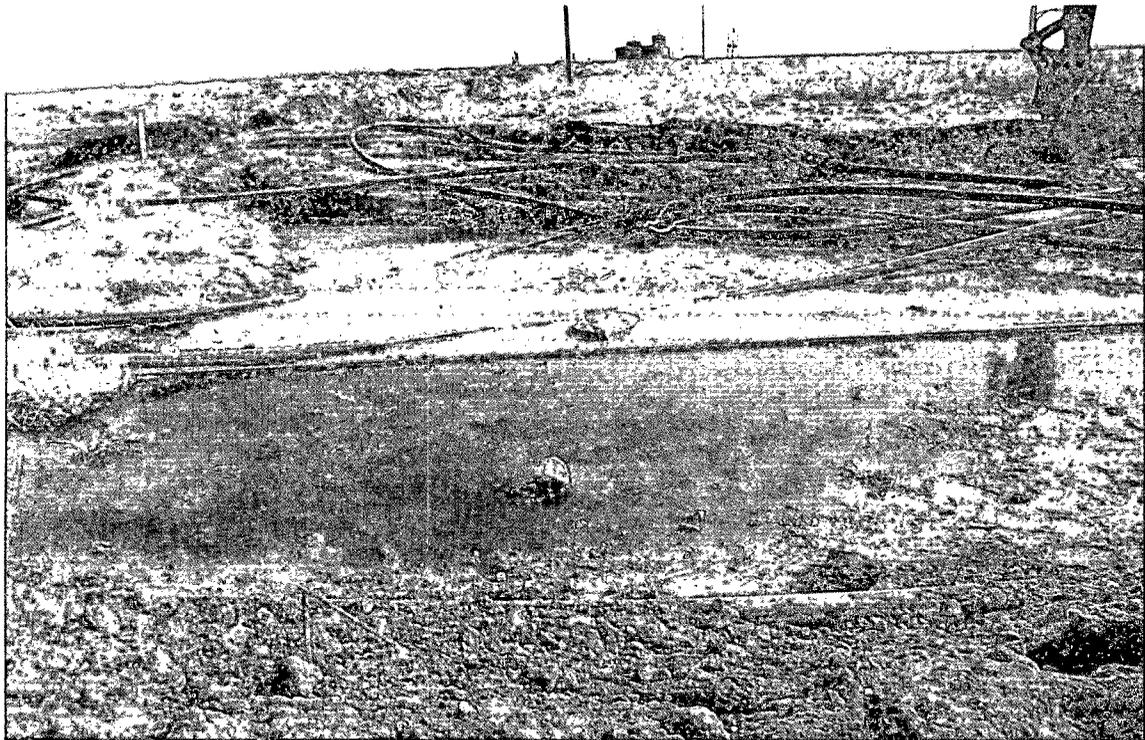
James Ranch Unit #29 SWD - Pooling Area (Looking East)

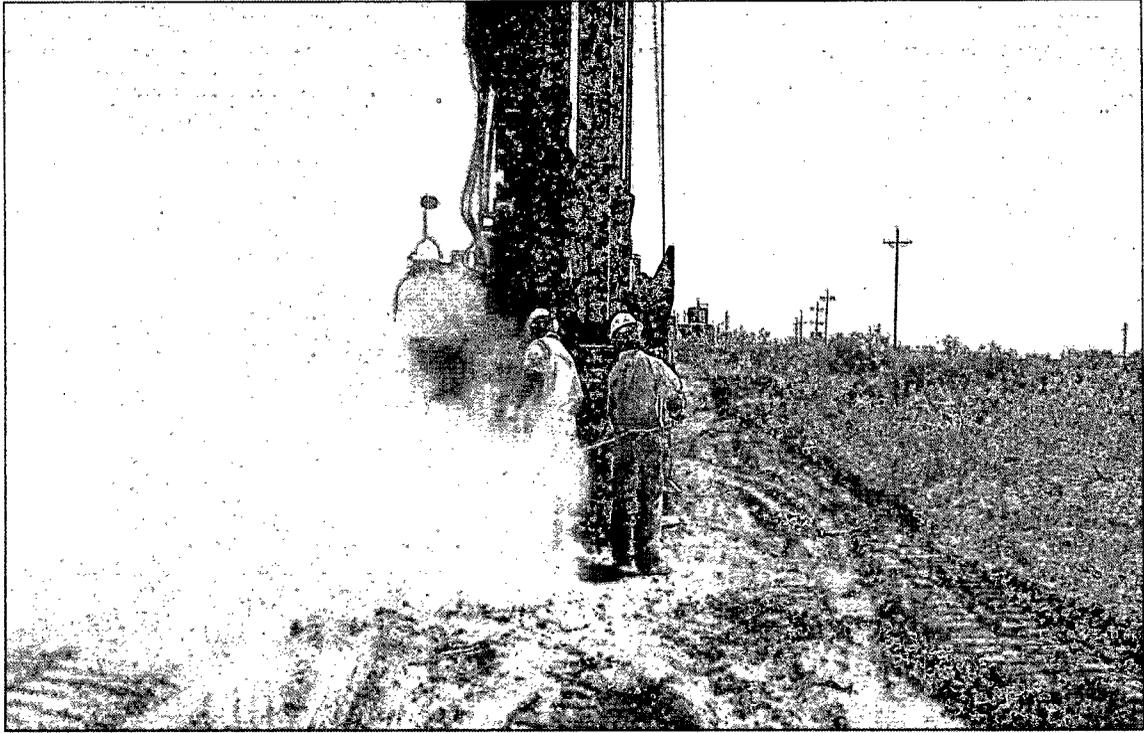
James Ranch Unit #29 SWD - Advancement of Delineation Soil Boring

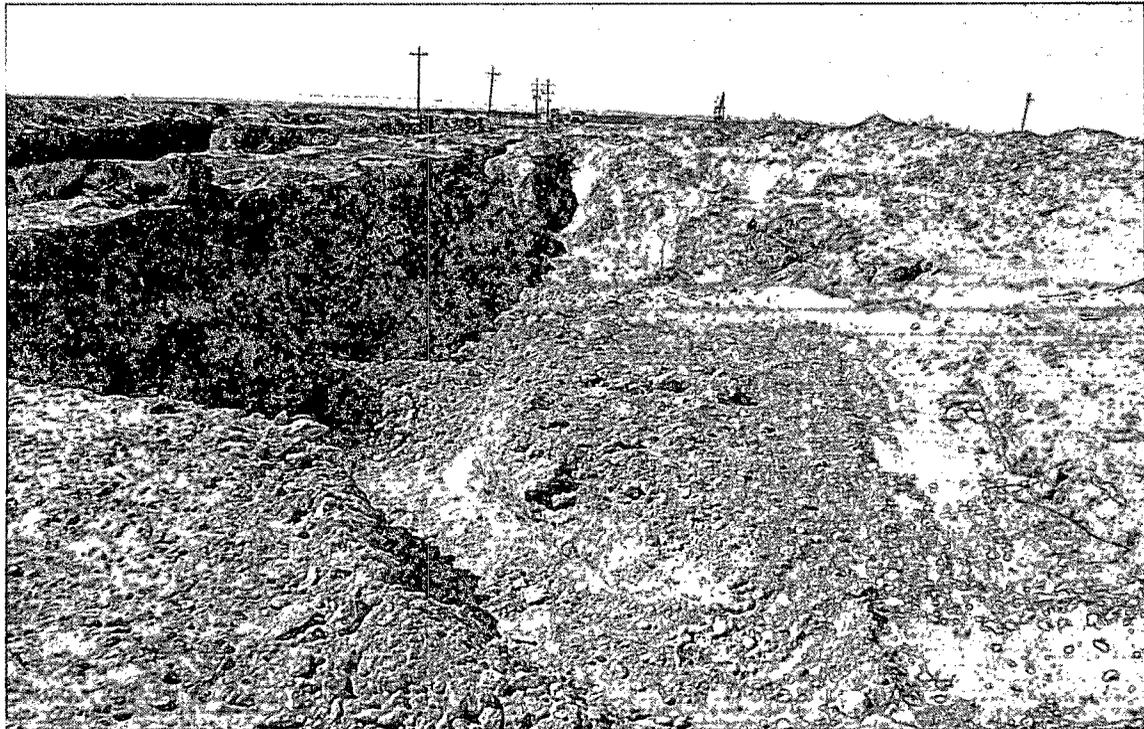
James Ranch Unit #29 SWD - North Excavation (Looking West)

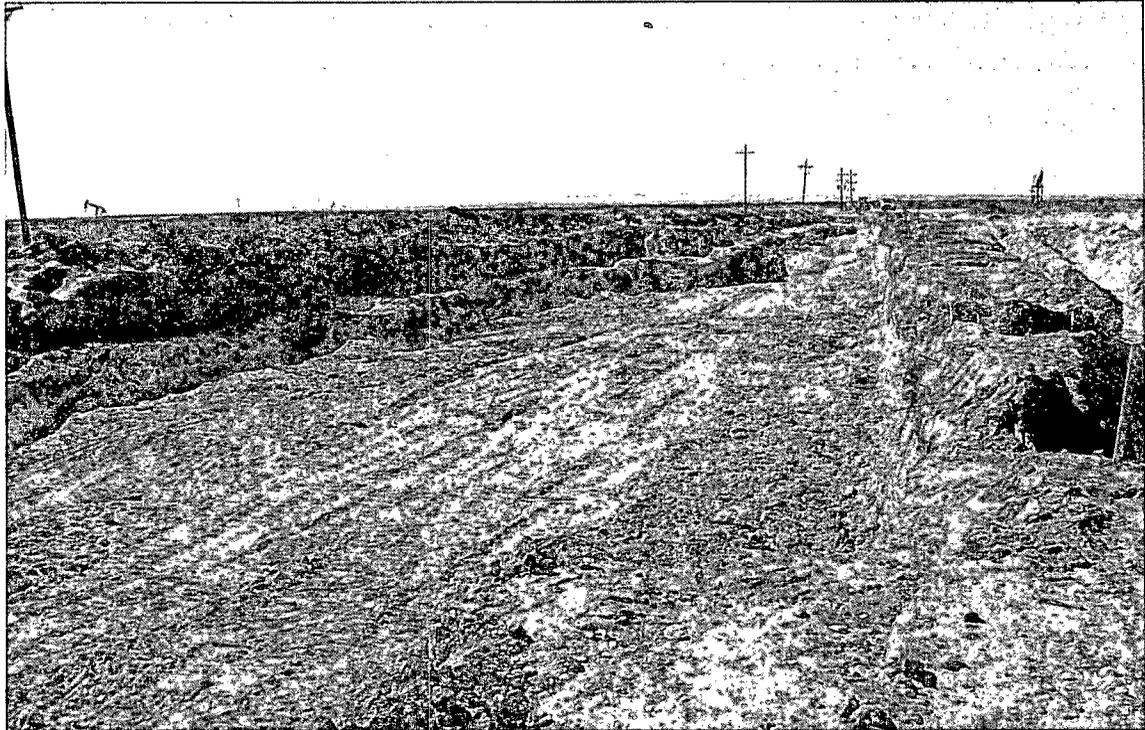
James Ranch Unit #29 SWD - South Excavation (Looking West)

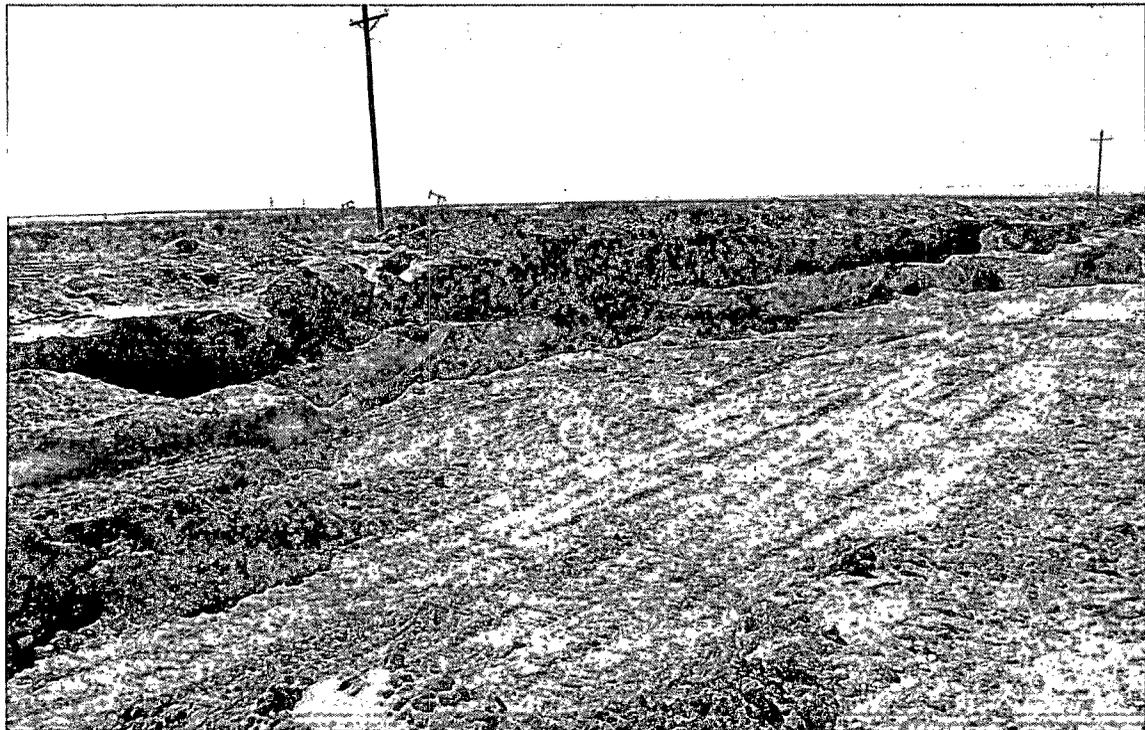
James Ranch Unit #29 SWD - South Excavation (Looking West-Southwest)

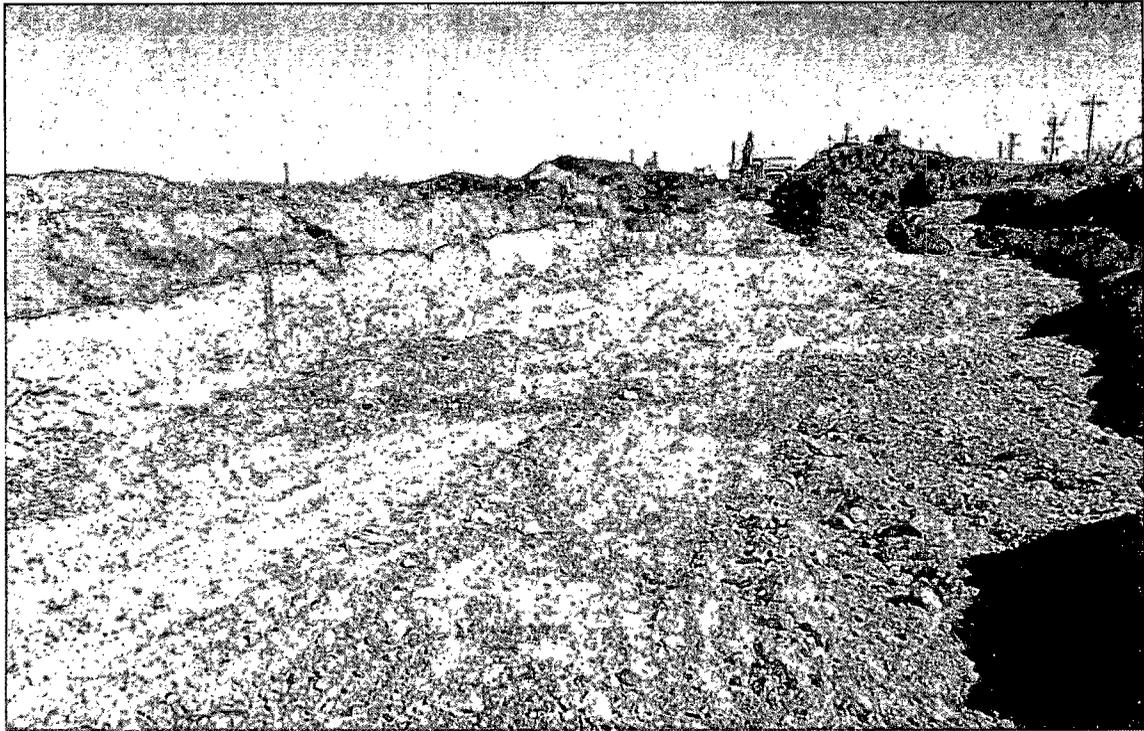
James Ranch Unit #29 SWD - South Excavation (Looking East)

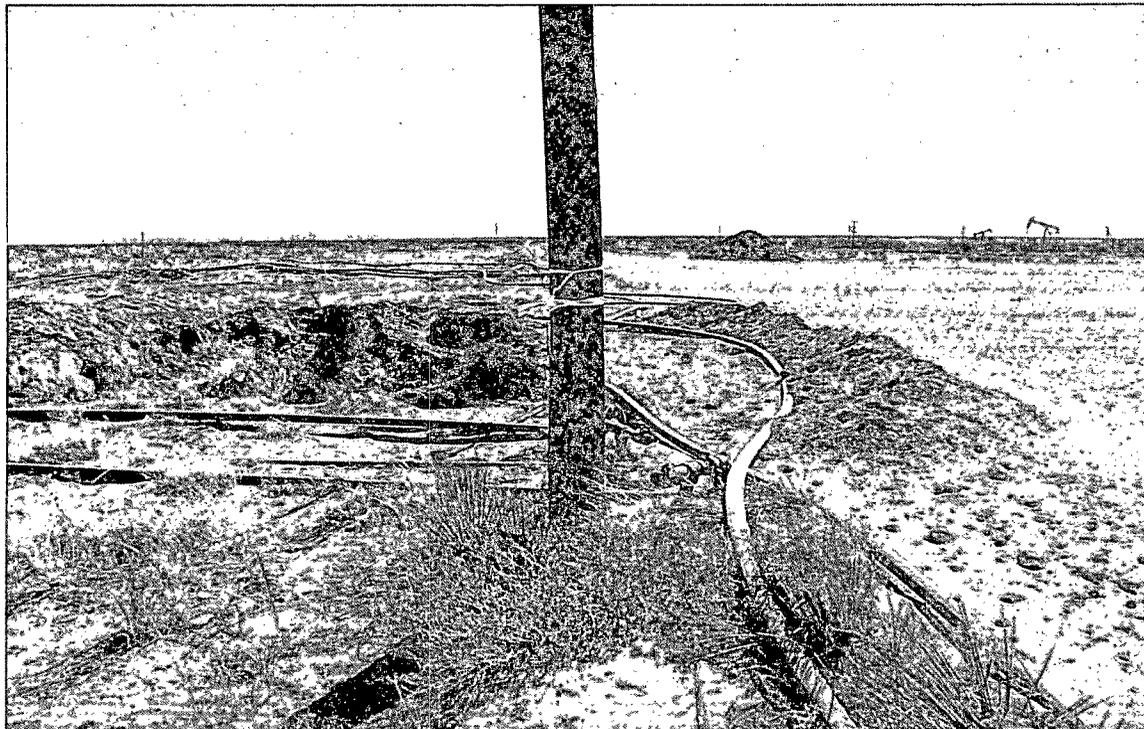
James Ranch Unit #29 SWD - Area #2 Excavation (Looking South)

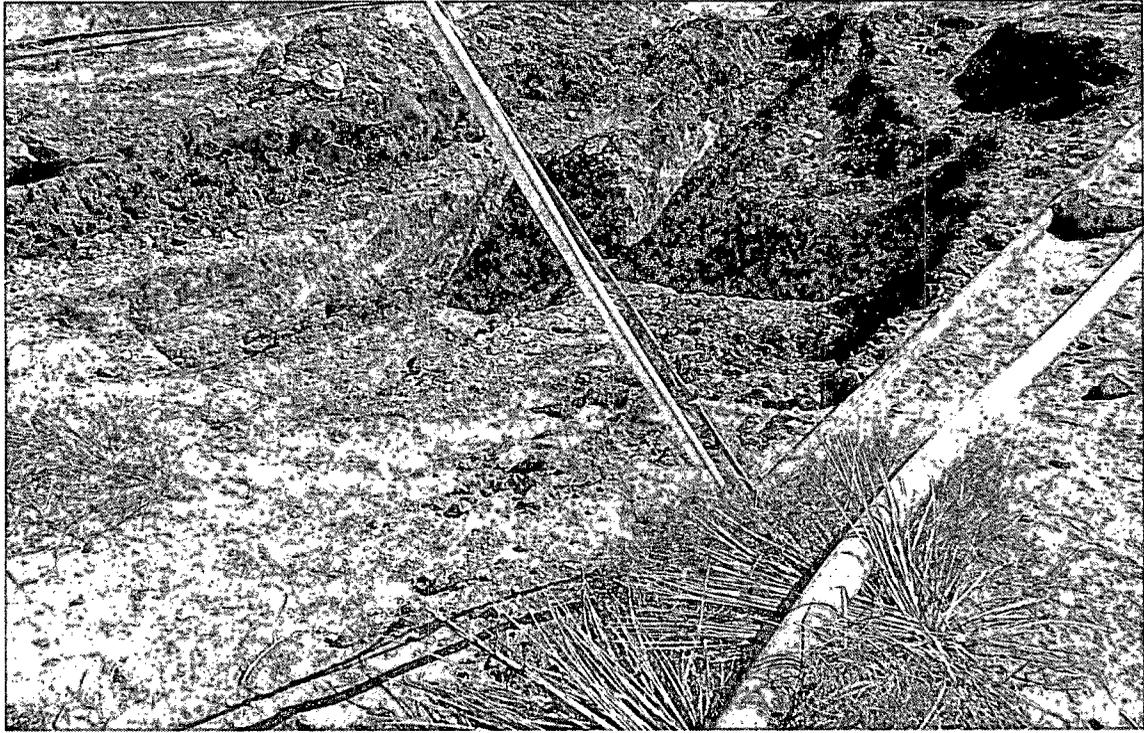
James Ranch Unit #29 SWD - Area #2 Excavation

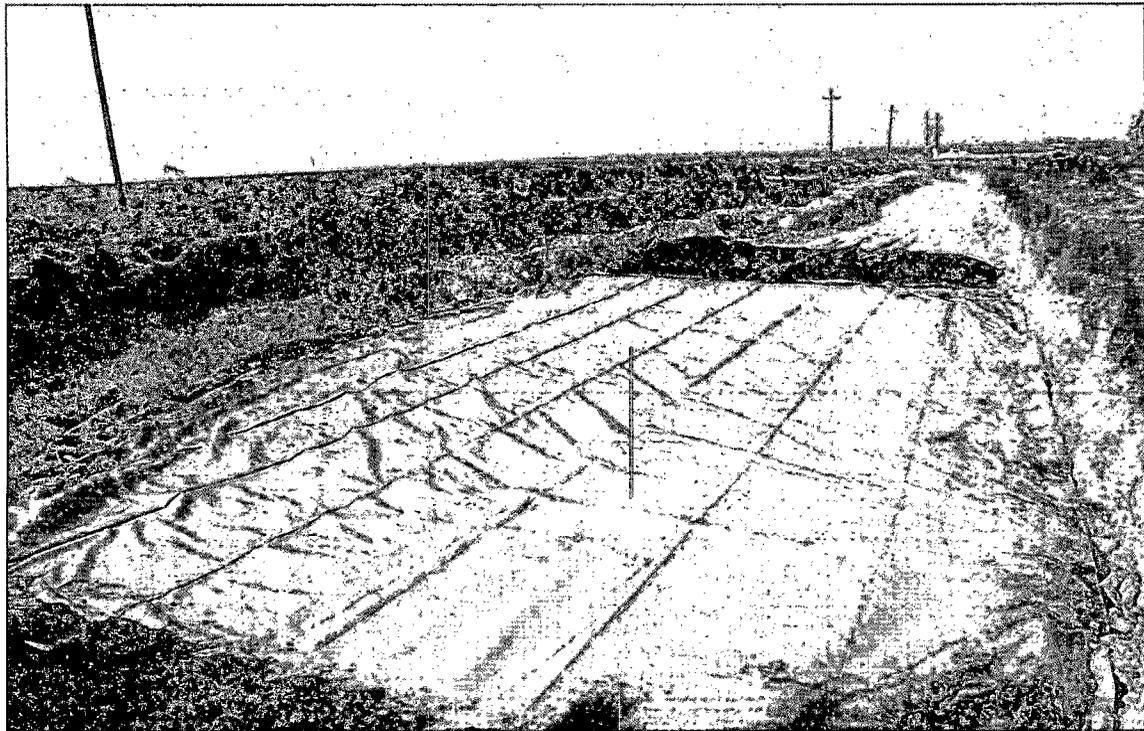
James Ranch Unit #29 SWD - South Excavation, Liner Installation (Looking West)

Impermeable, twenty (20) mil polyurethane liners were installed in the floors of the East and West sections of the South Excavation. This engineered control will inhibit vertical migration of contaminants from below the liner to the surface, protecting the vegetative zone. In addition, the polyurethane liner will shed moisture to the edge of the liner and beyond the maximum horizontal extent of underlying impacted soil, effectively inhibiting vertical migration of contaminants to groundwater.

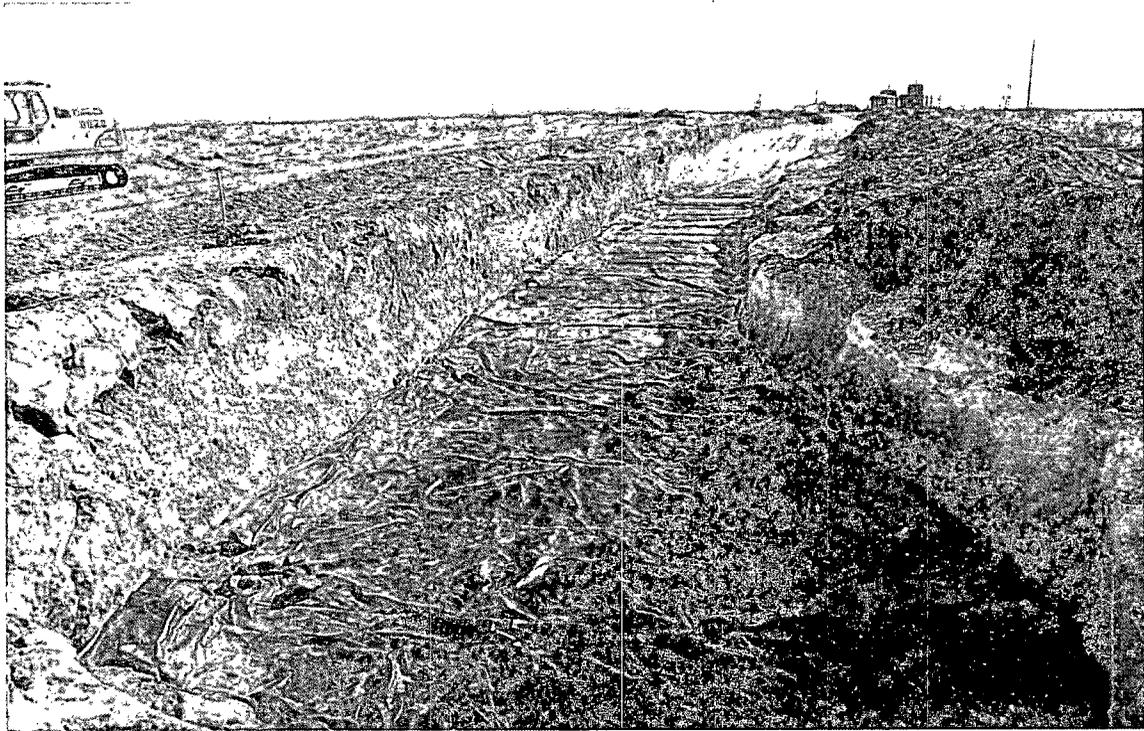
James Ranch Unit #29 SWD - South Excavation, Liner Installation (Looking East)

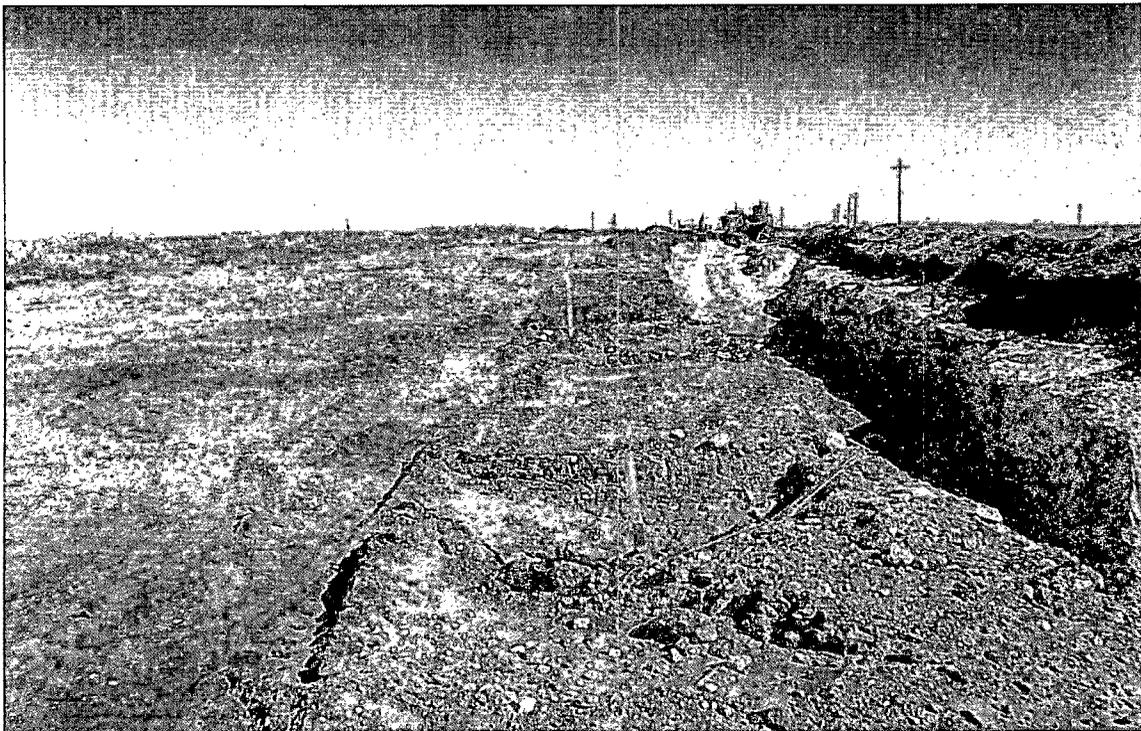
James Ranch Unit #29 SWD - North Excavation Following Backfill (On Left, Looking East)

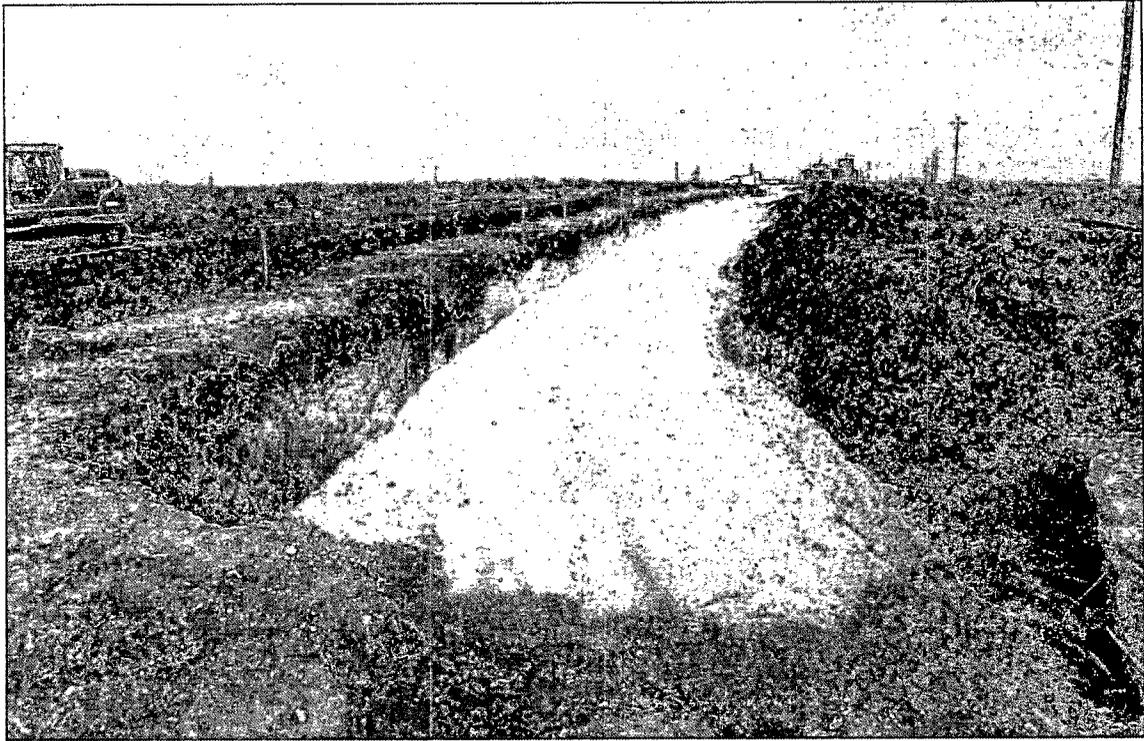
James Ranch Unit #29 SWD - South Excavation, During Backfilling (Looking East)

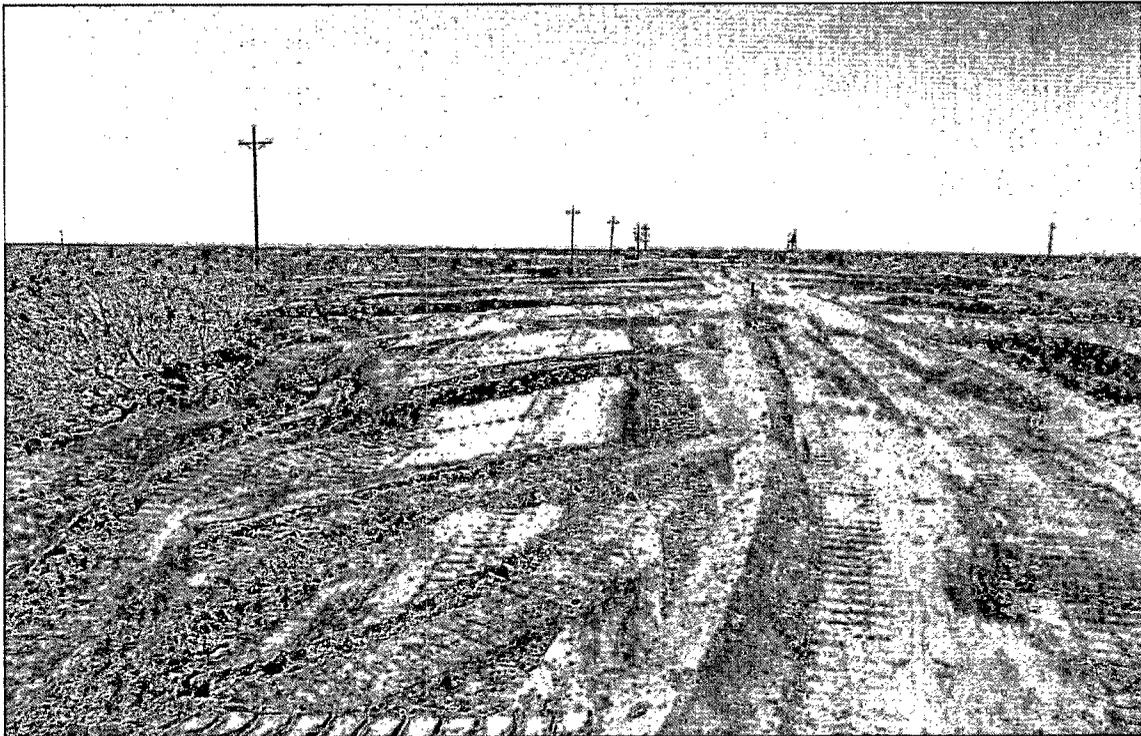
James Ranch Unit #29 SWD - North & South Excavations Following Backfill (Looking West)

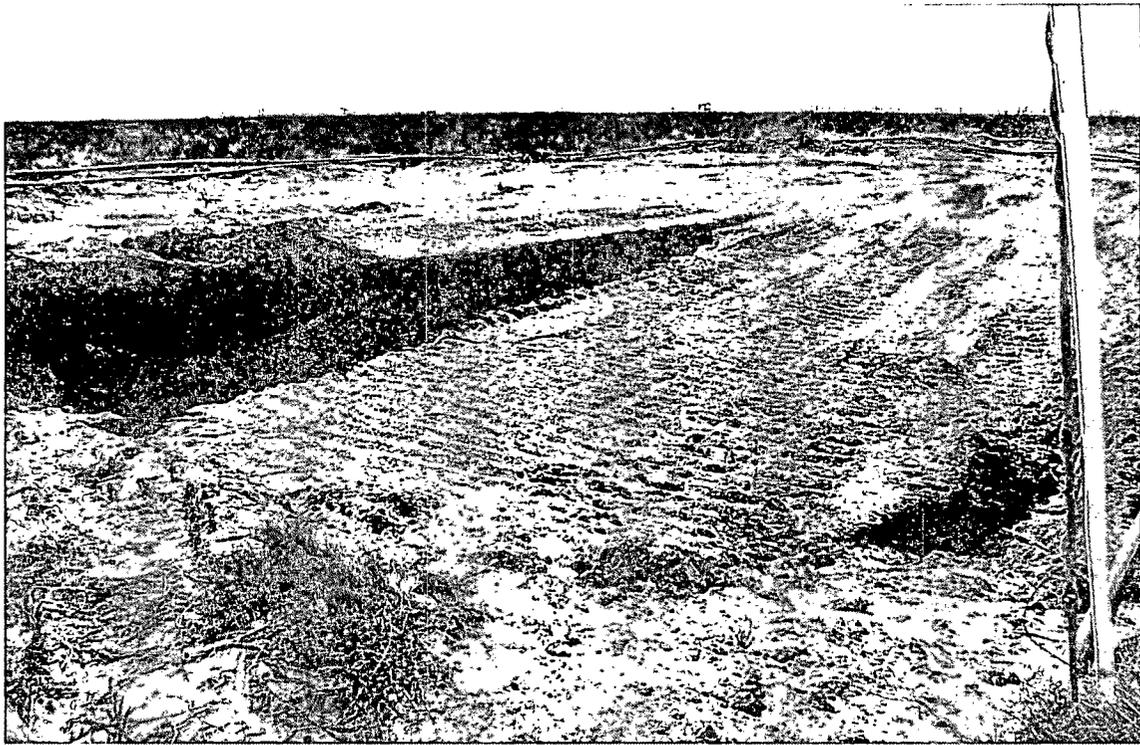
James Ranch Unit #29 SWD - Area #2 Excavation, During Backfilling (Looking Southeast)

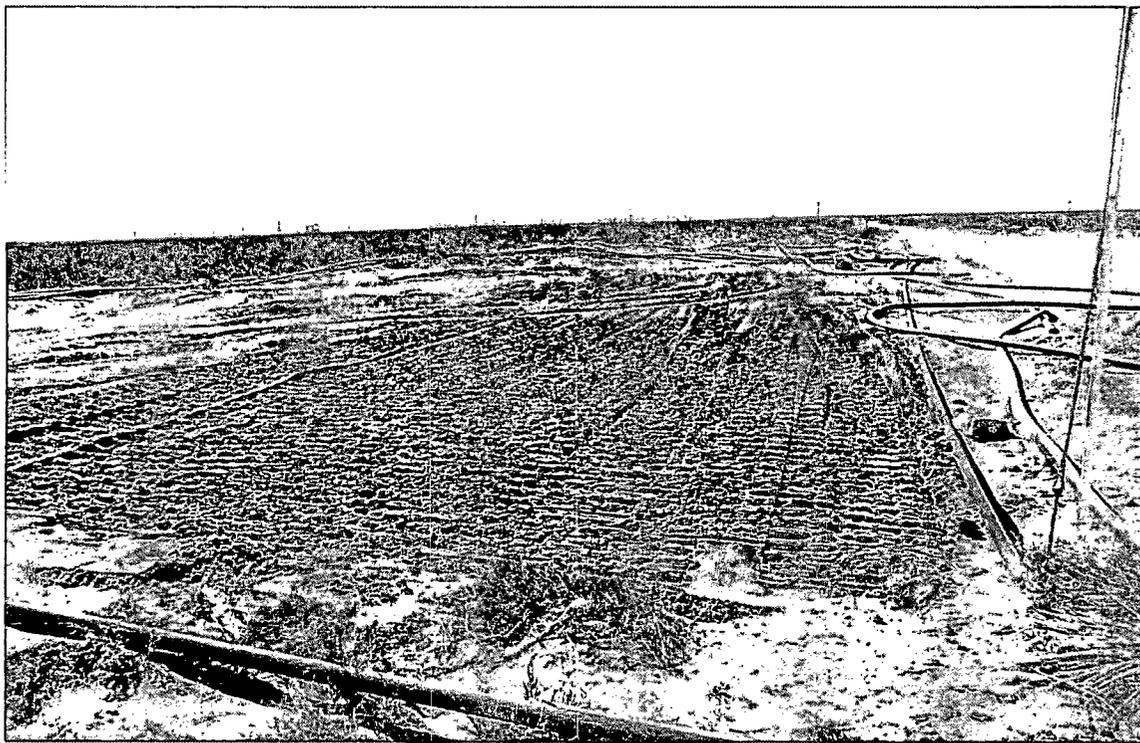
James Ranch Unit #29 SWD - Area #2 Excavation, Following Backfill (Looking Southeast)
