## **REMEDIATION SUMMARY & SITE CLOSURE REQUEST**

**BOPCO, LP**  
**BASS 3 FEDERAL BATTERY #1**  
**Eddy County, New Mexico**  
**Unit Letter "P" (NE/SE), Section 3, Township 22 South, Range 28 East**  
**Latitude 32.415370° North, Longitude 104.06990° West**

August 2013

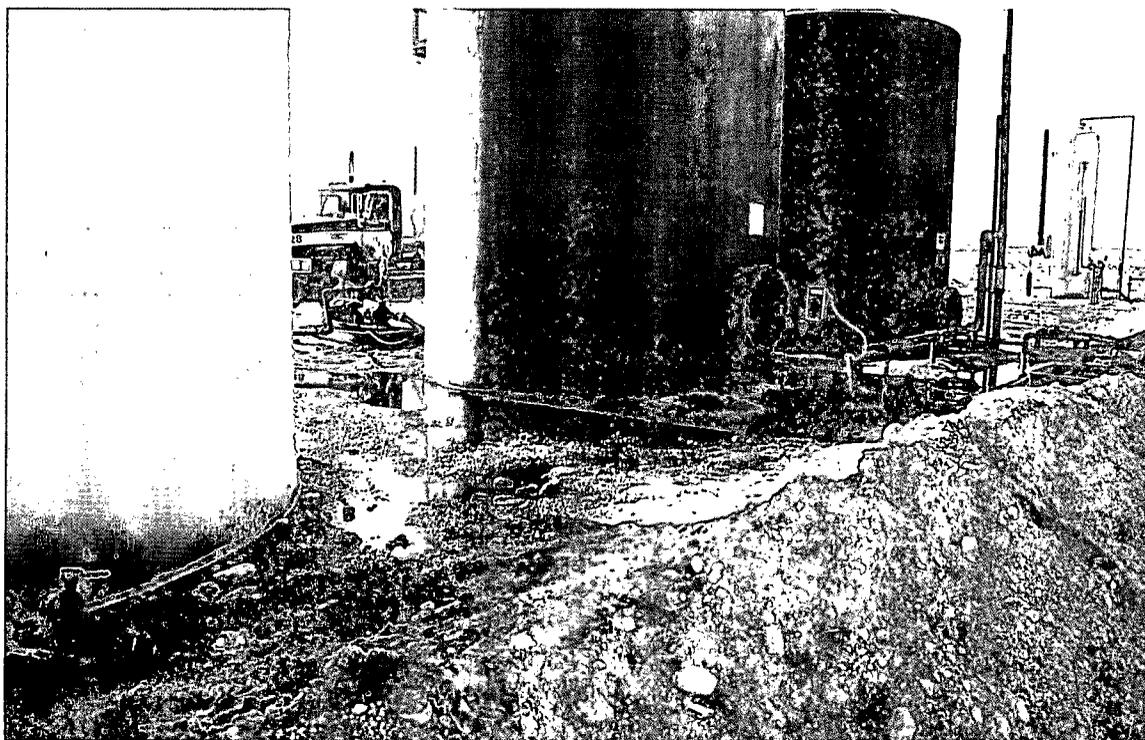
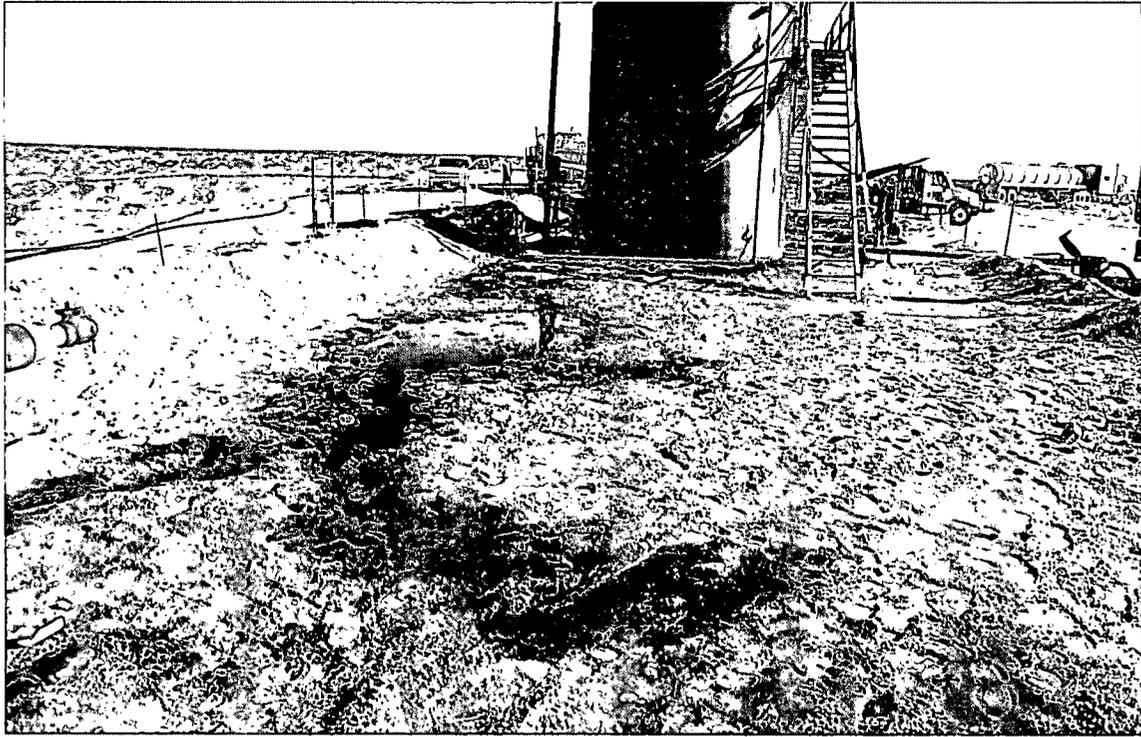
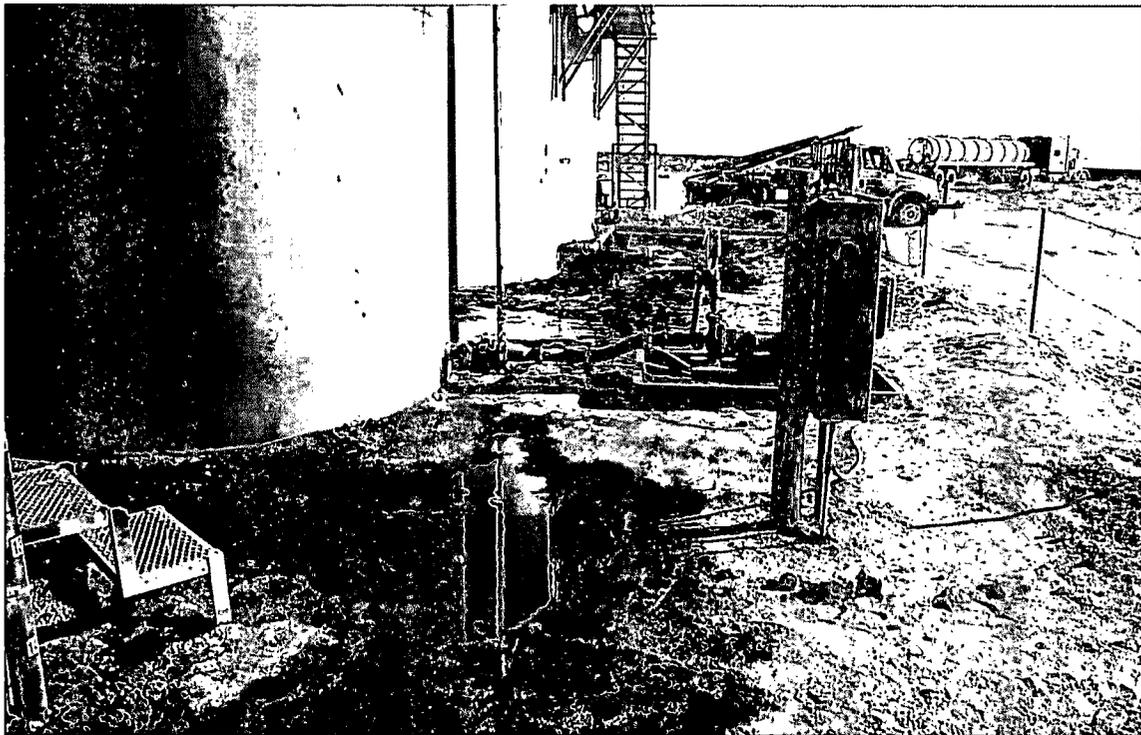
On January 3, 2012, BOPCO discovered a release (Release #1) had occurred at Bass 3 Federal Battery #1. A hole in the bottom of an on-site production tank resulted in a release of crude oil. The release was confined to the earthen containment area surrounding the tank battery.

Bass 3 Federal Battery #1 - January 4, 2012, Release

Describe Cause of Problem and Remedial Action Taken.\* A hole was discovered in the bottom of the south oil production tank. The tank was taken out of service the day of discovery. The tank was cleaned, repaired and coated on 1/6/12.

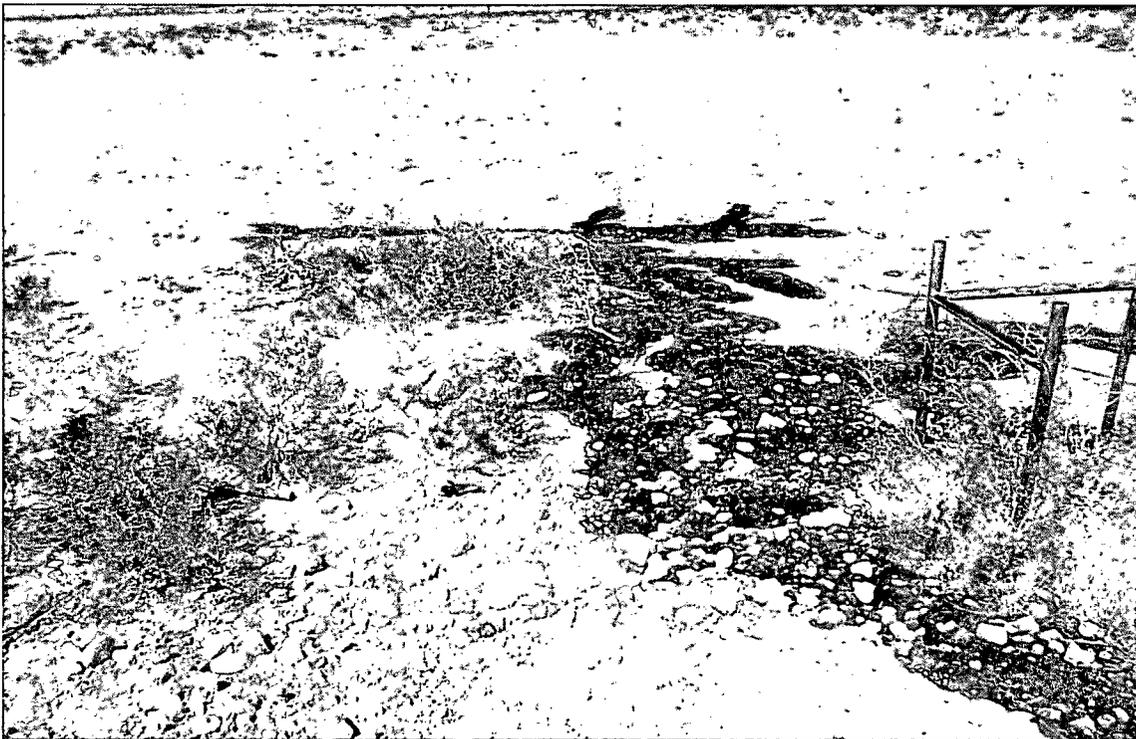
On March 27, 2012, BOPCO discovered a third release (Release #3) had occurred at Bass 3 Federal Battery #1. Two (2) loads of produced water were unloaded into the on-site produced water tank without prior approval from BOPCO. The water transfer pump malfunctioned and failed to discharge the excess water into a nearby salt water disposal system. The excess water, combined with the nightly crude oil and water production to the facility, caused an on-site storage tank to overflow, resulting in a release of crude oil.

Bass 3 Federal Battery #1 - March 27, 2012, Release

Describe Cause of Problem and Remedial Action Taken.\* Two loads of produced water were unloaded into the facility water tank without prior approval from BOPCO. The water transfer pump that would have normally pumped the water to a SWD failed to pump properly, and the daily oil/water production through the night ran the tank over.

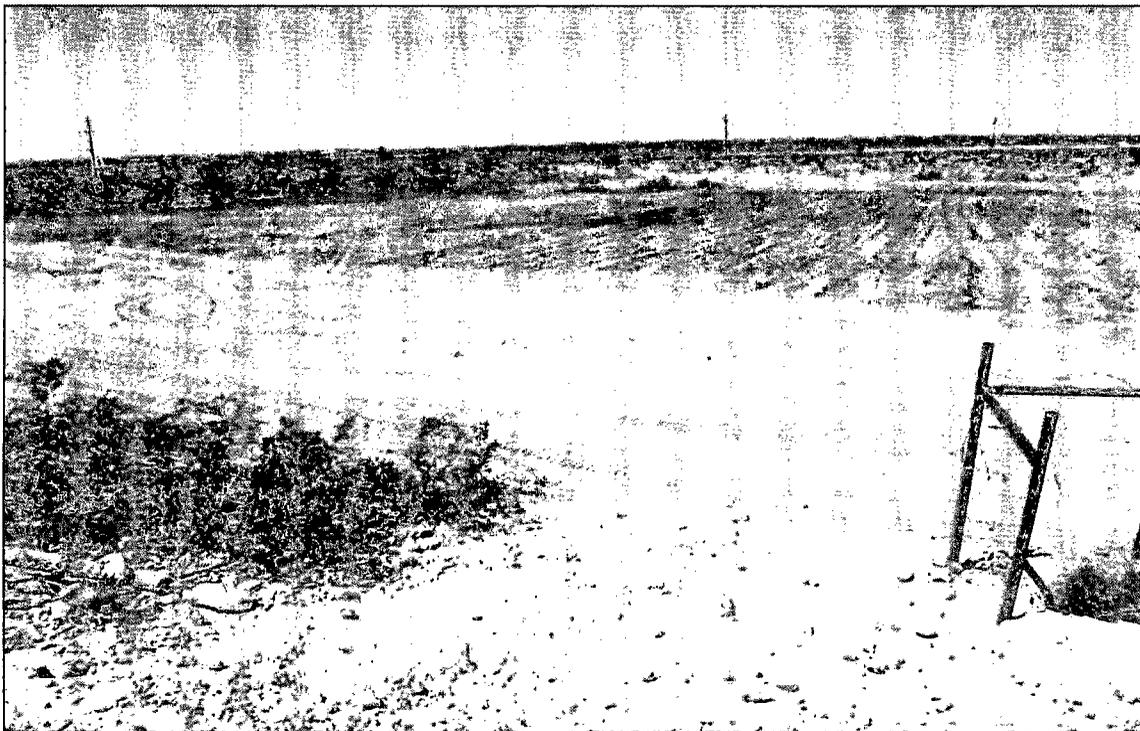
Bass 3 Federal Battery #1 - Excavation #2 (Following Backfill)

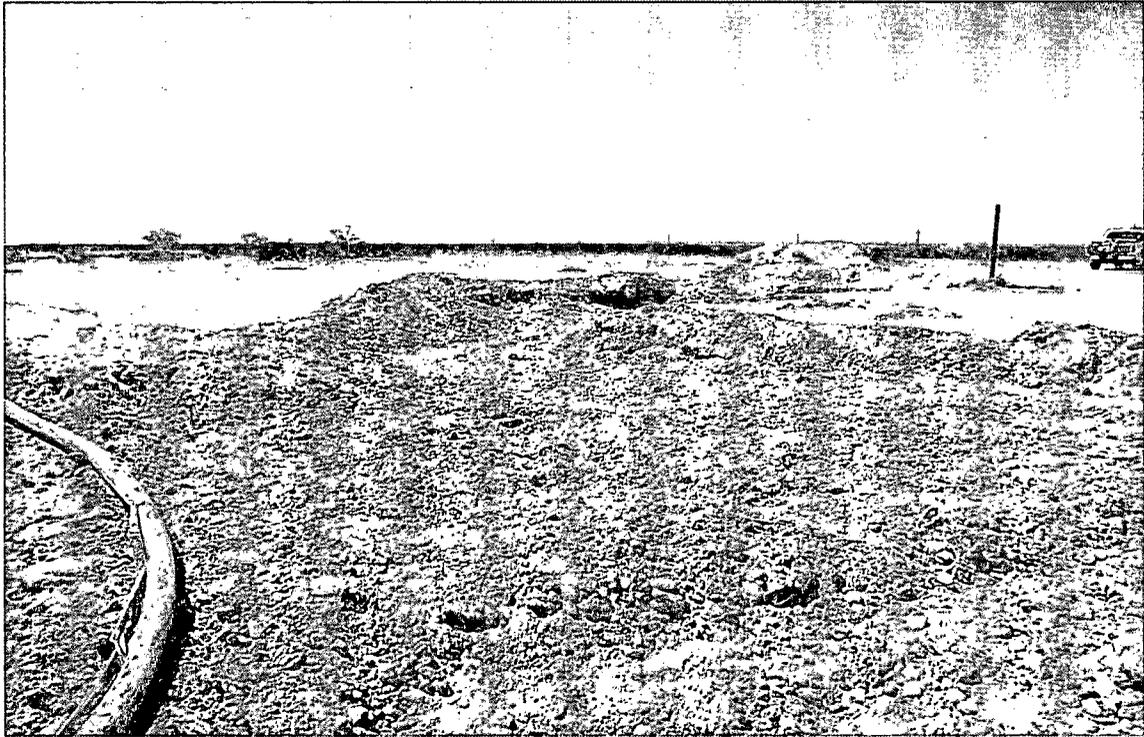
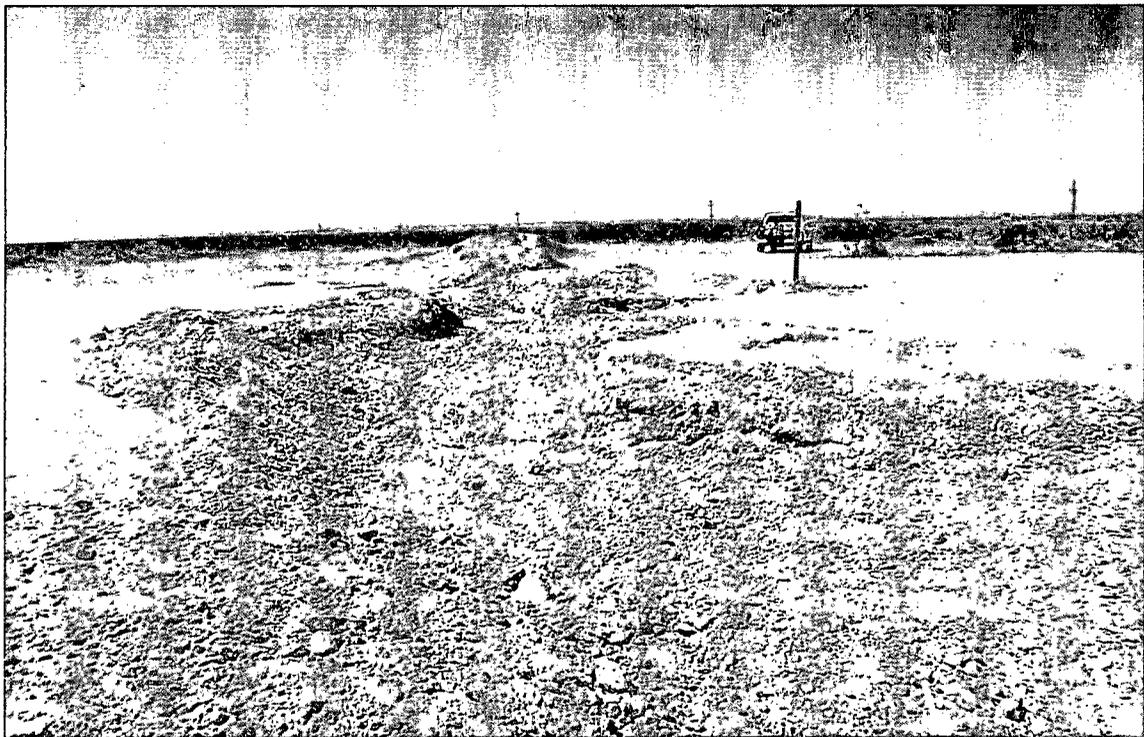
Bass 3 Federal Battery #1 - Excavation #3

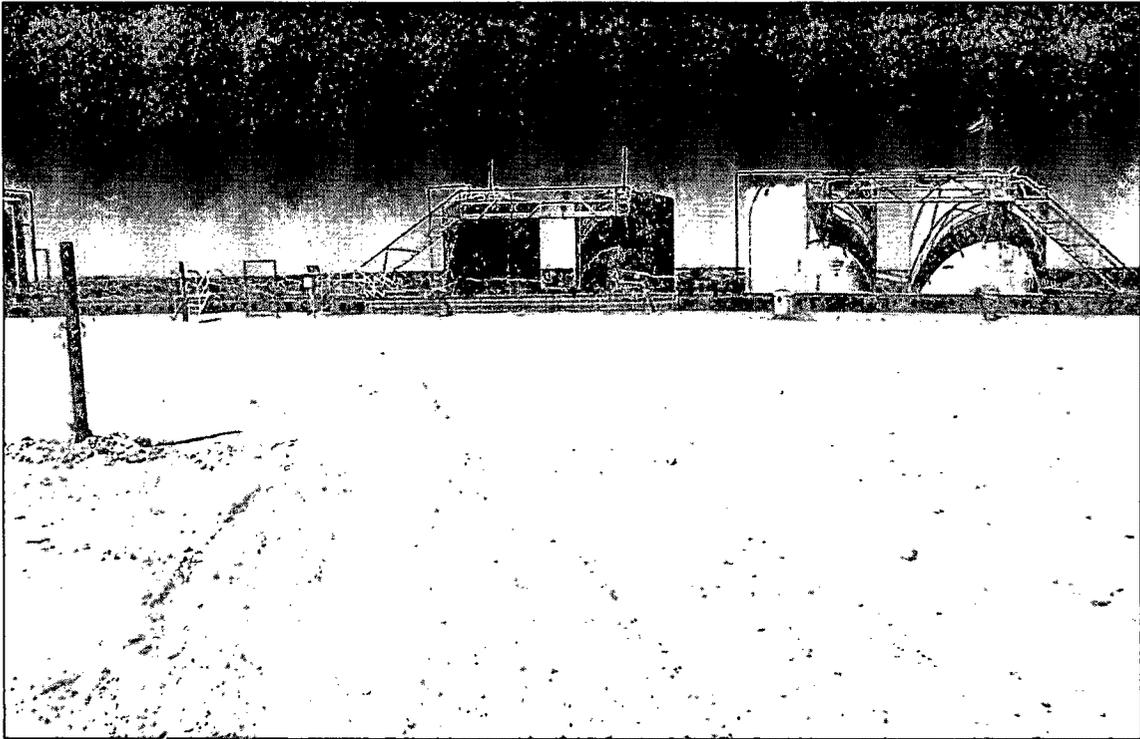
Bass 3 Federal Battery #1 - Excavation #3 (Following Backfill)
