REMEDIATION SUMMARY & SITE CLOSURE REQUEST

**BOPCO, LP
BASS 3 FEDERAL BATTERY #1
Eddy County, New Mexico
Unit Letter "P" (NE/SE), Section 3, Township 22 South, Range 28 East
Latitude 32.415370° North, Longitude 104.06990° West**

August 2013

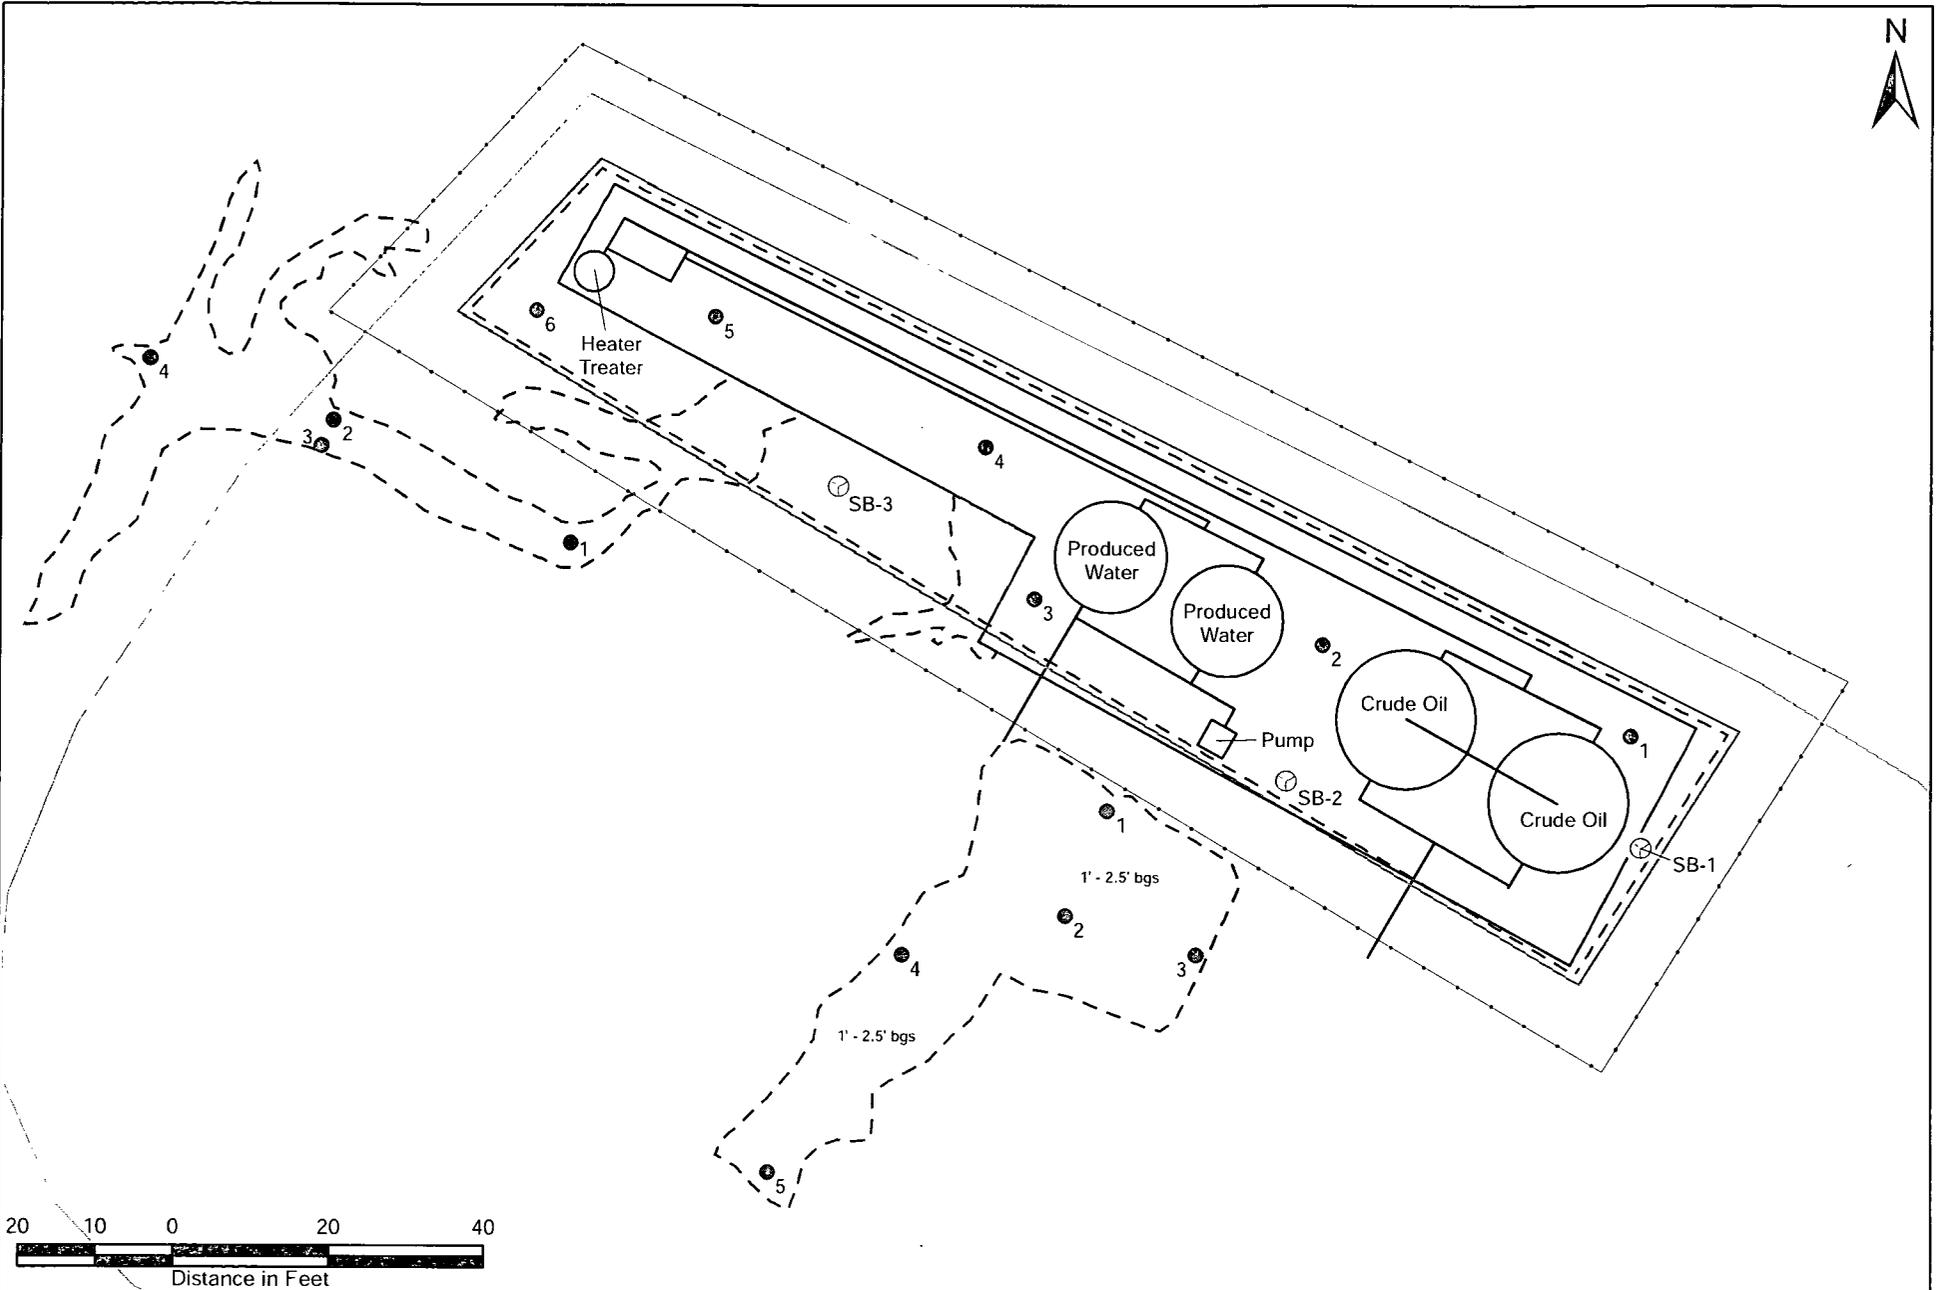
- - - Excavation 1	— Fence
- - - Excavation 2	— Caliche Pad
- - - Excavation 3	● Soil Sample (3/5/2012)
— Pipeline	● Soil Sample (3/29/2012)
— Earthen Berm	● Soil Sample (4/17/2012)
— Steel Berm	⊙ Soil Boring

On March 27, 2012, immediately following discovery of Release #3, Basin Environmental was dispatched to the location to begin excavation of the impacted soil. From March 27 through March 30, 2012, approximately two hundred and ten cubic yards (210 yd³) of visibly stained, heavily impacted soil was excavated and transported to Lea Land, Inc., for disposal. The boundaries of the excavation are depicted in Figure 2 as "Excavation 2".

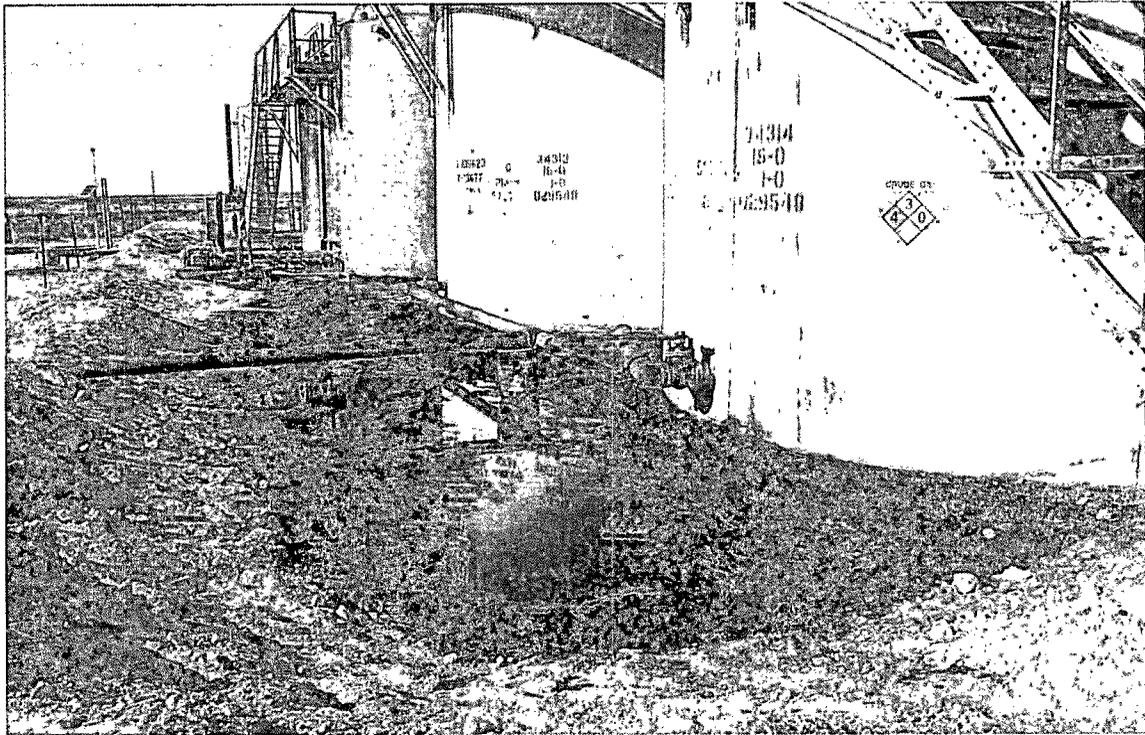
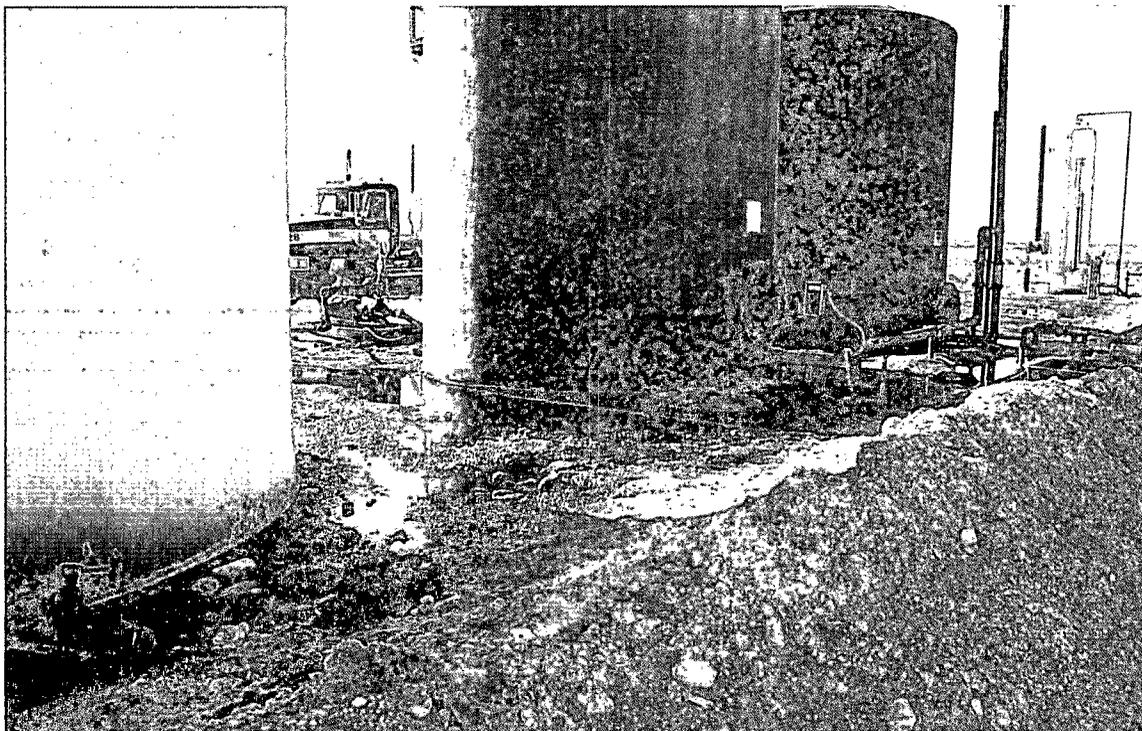
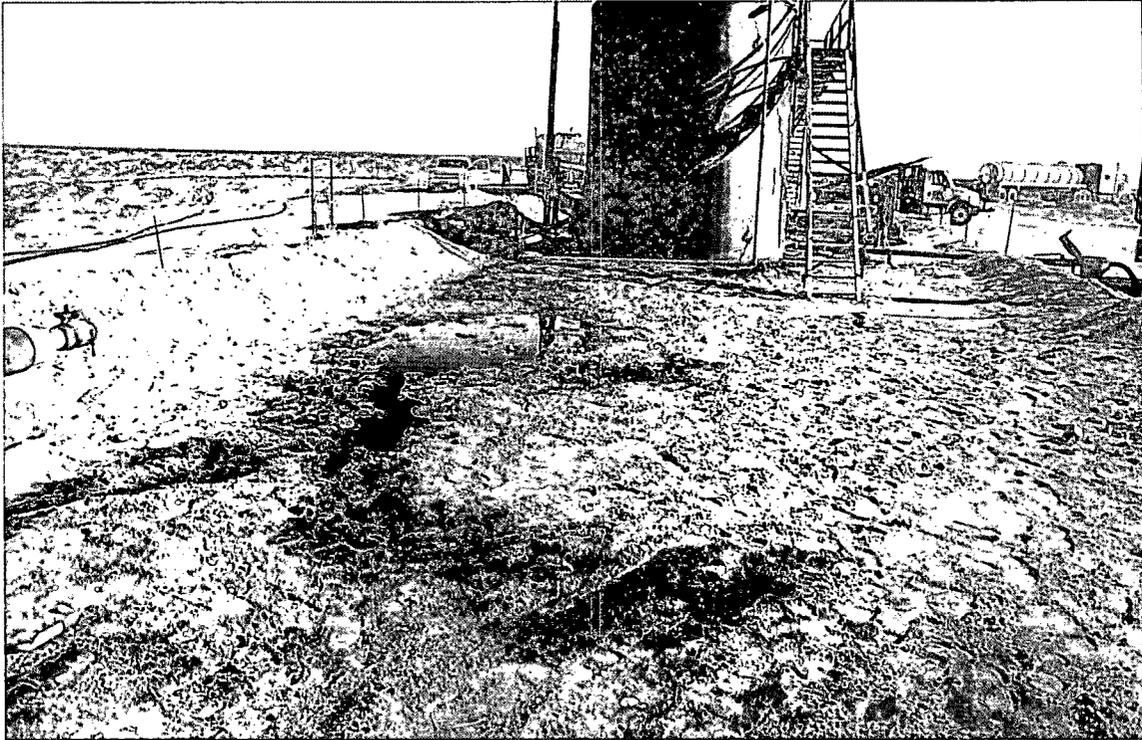
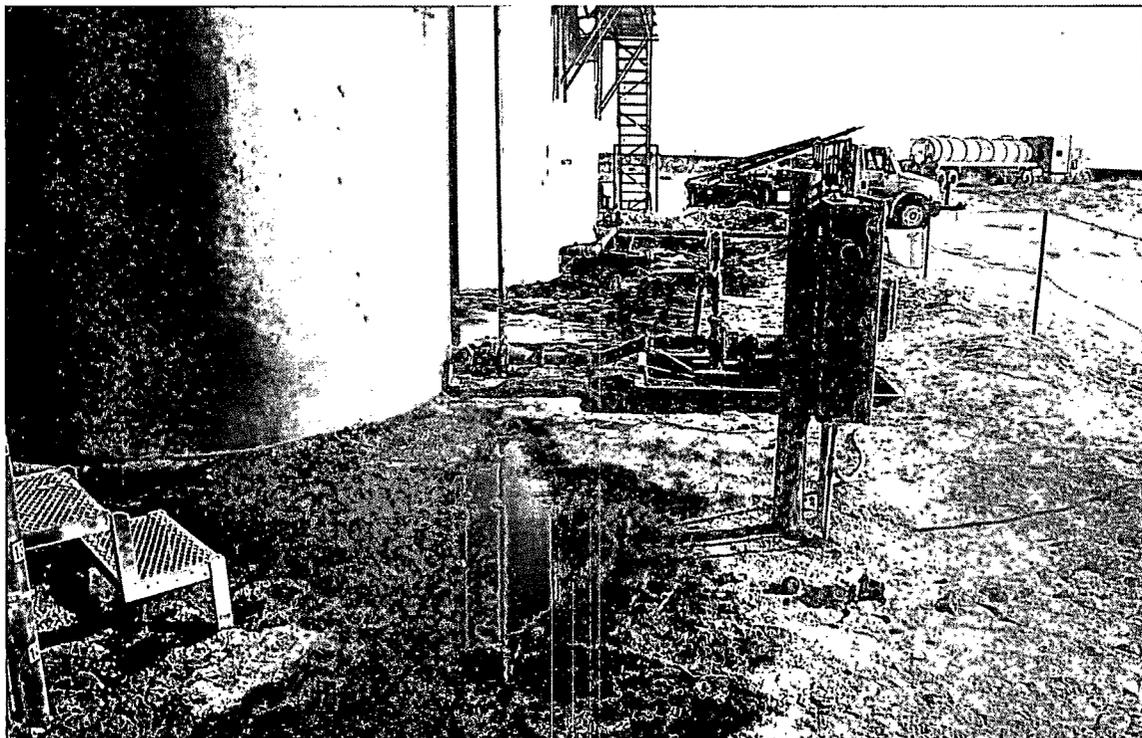
On January 3, 2012, BOPCO discovered a release (Release #1) had occurred at Bass 3 Federal Battery #1. A hole in the bottom of an on-site production tank resulted in a release of crude oil. The release was confined to the earthen containment area surrounding the tank battery.

Bass 3 Federal Battery #1 - January 4, 2012, Release

Describe Cause of Problem and Remedial Action Taken.* A hole was discovered in the bottom of the south oil production tank. The tank was taken out of service the day of discovery. The tank was cleaned, repaired, and coated on 1/6/12.

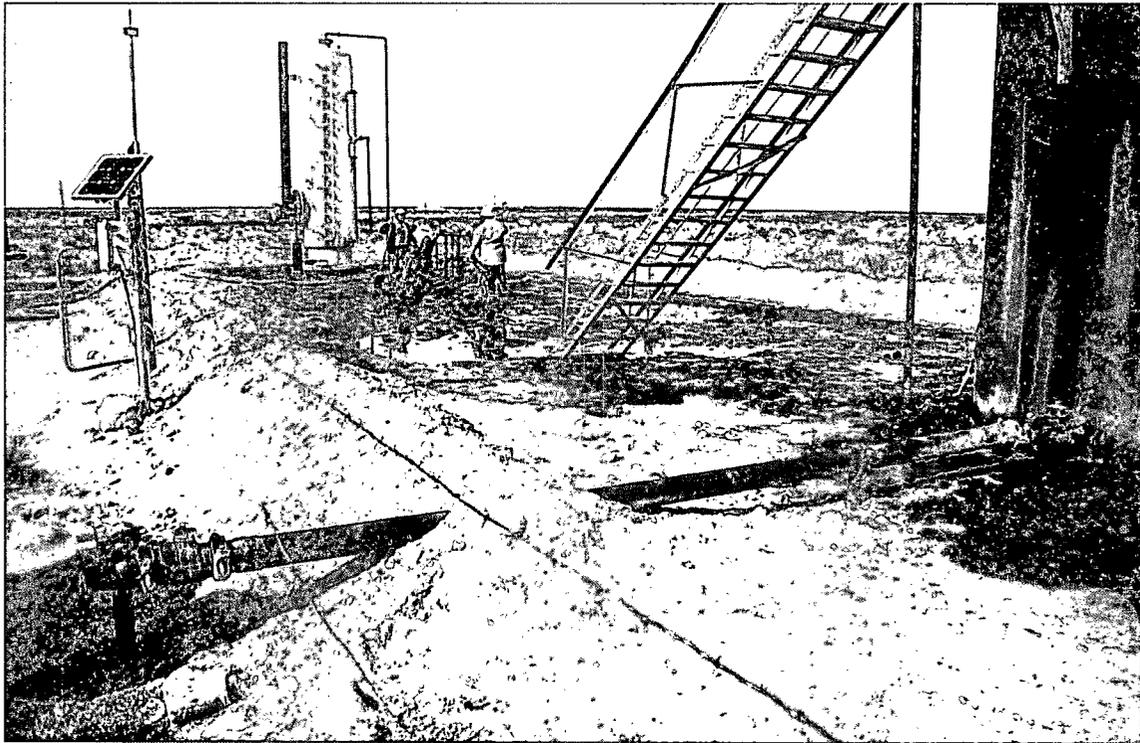
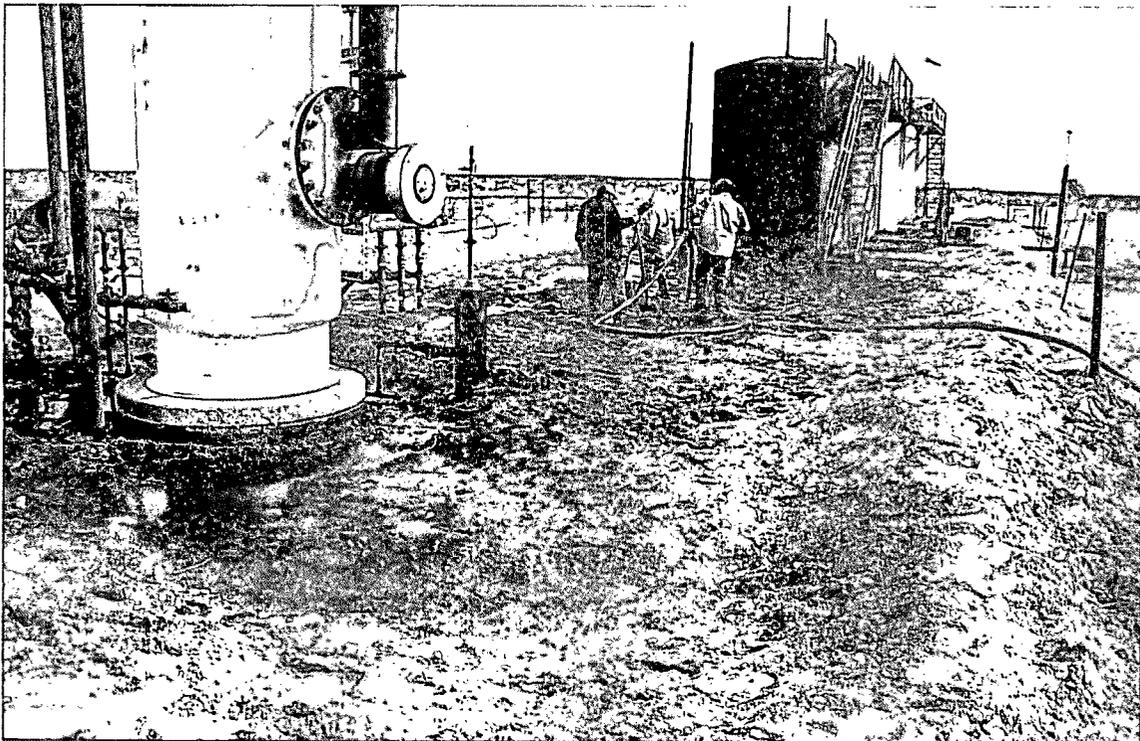
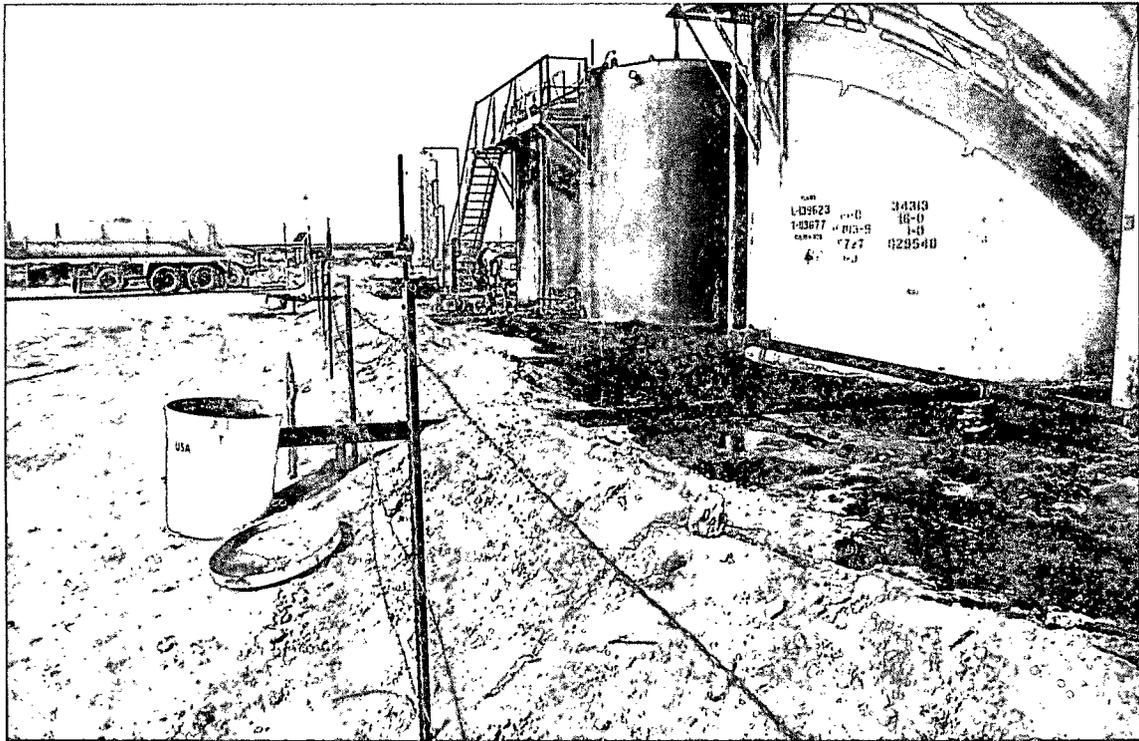
On January 11, 2012, BOPCO discovered a second release (Release #2) had occurred at Bass 3 Federal Battery #1. A two-inch (2") pipeline from the heater treater to the on-site storage tanks developed a leak, resulting in a release of crude oil and produced water. The leak was attributed to external corrosion. The release was confined to the earthen containment area surrounding the tank battery.

Describe Cause of Problem and Remedial Action Taken.* A 2" line going from the heater treater to the tanks leaked due to external corrosion. A temporary repair clamp was placed on the affected piece of pipe.

Bass 3 Federal Battery #1 - January 11, 2012, Release

Describe Cause of Problem and Remedial Action Taken.* A 2" line going from the heater treater to the tanks leaked due to external corrosion. A temporary repair clamp was placed on the affected piece of pipe.

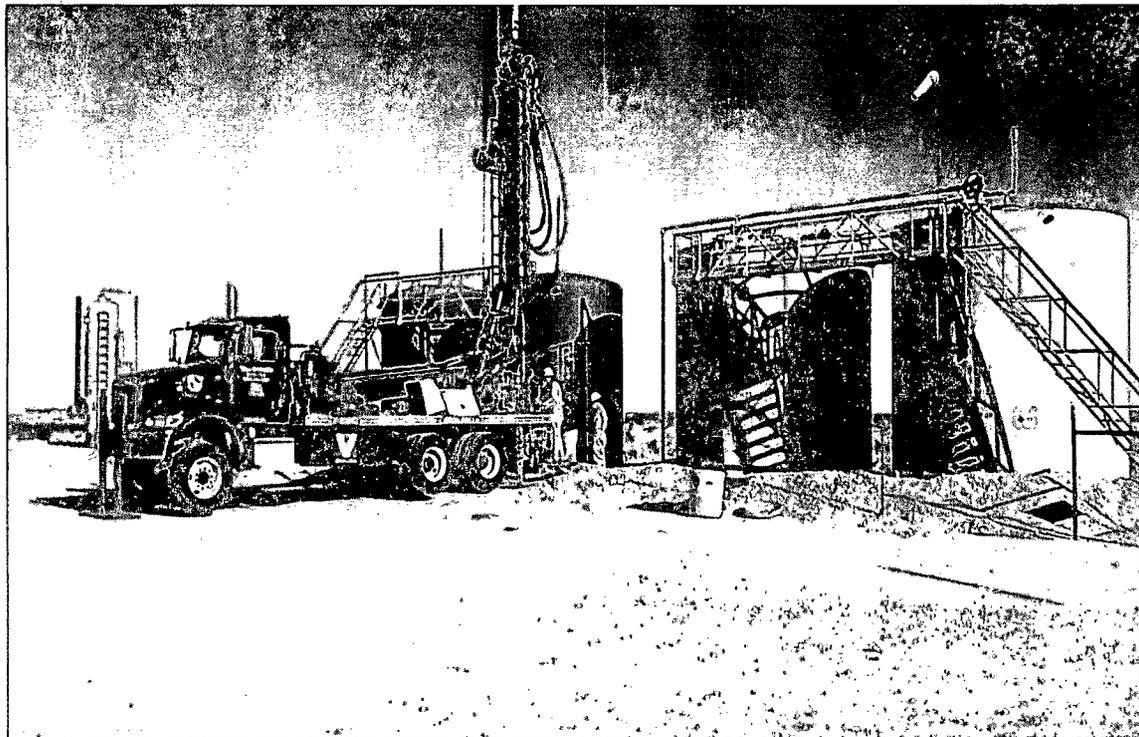
Bass 3 Federal Battery #1 - Advancement of Soil Boring SB-2

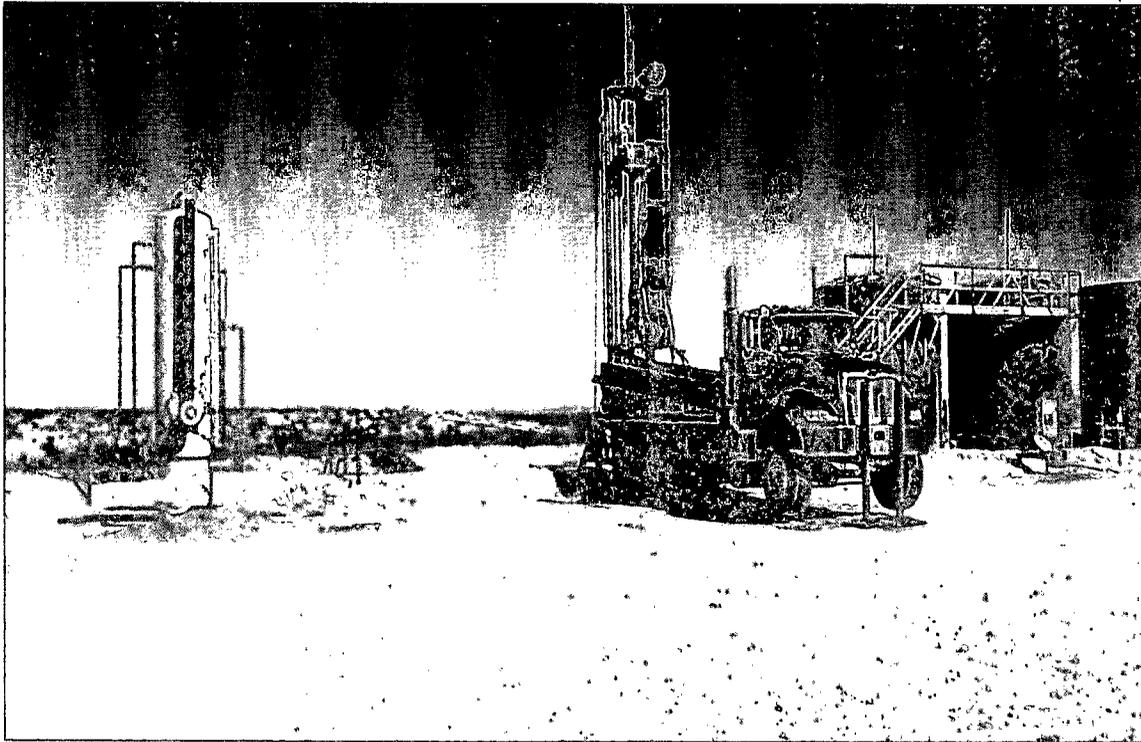
Bass 3 Federal Battery #1 - Advancement of Soil Boring SB-3

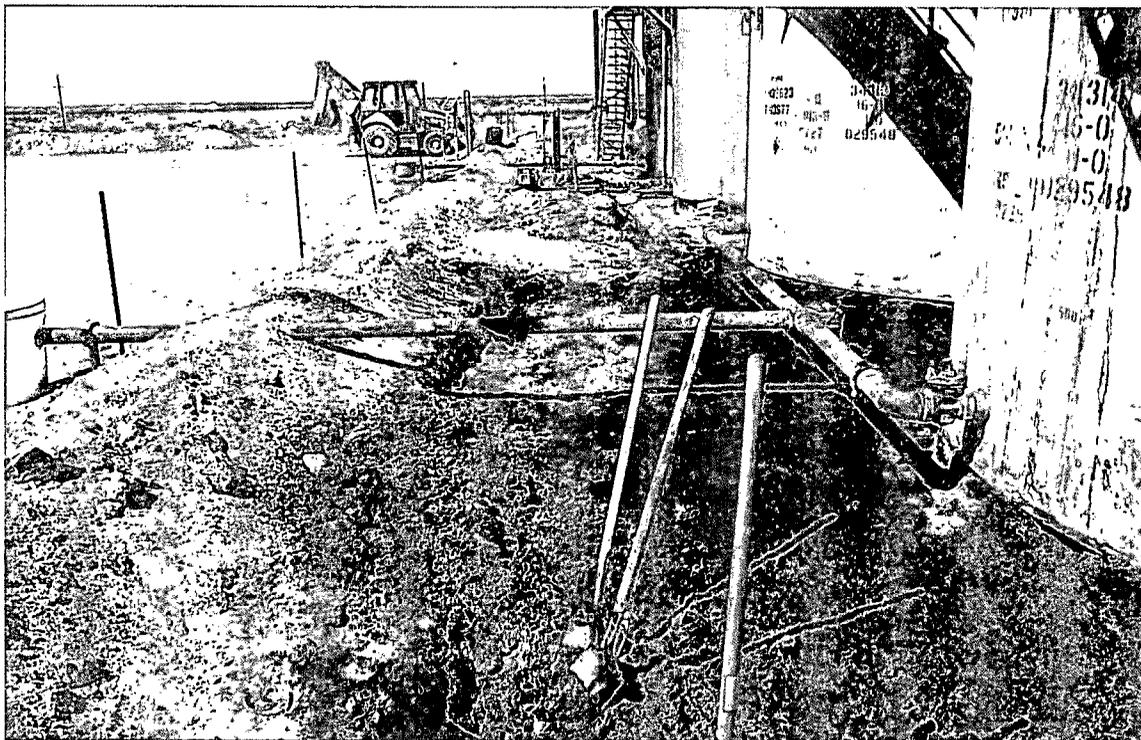
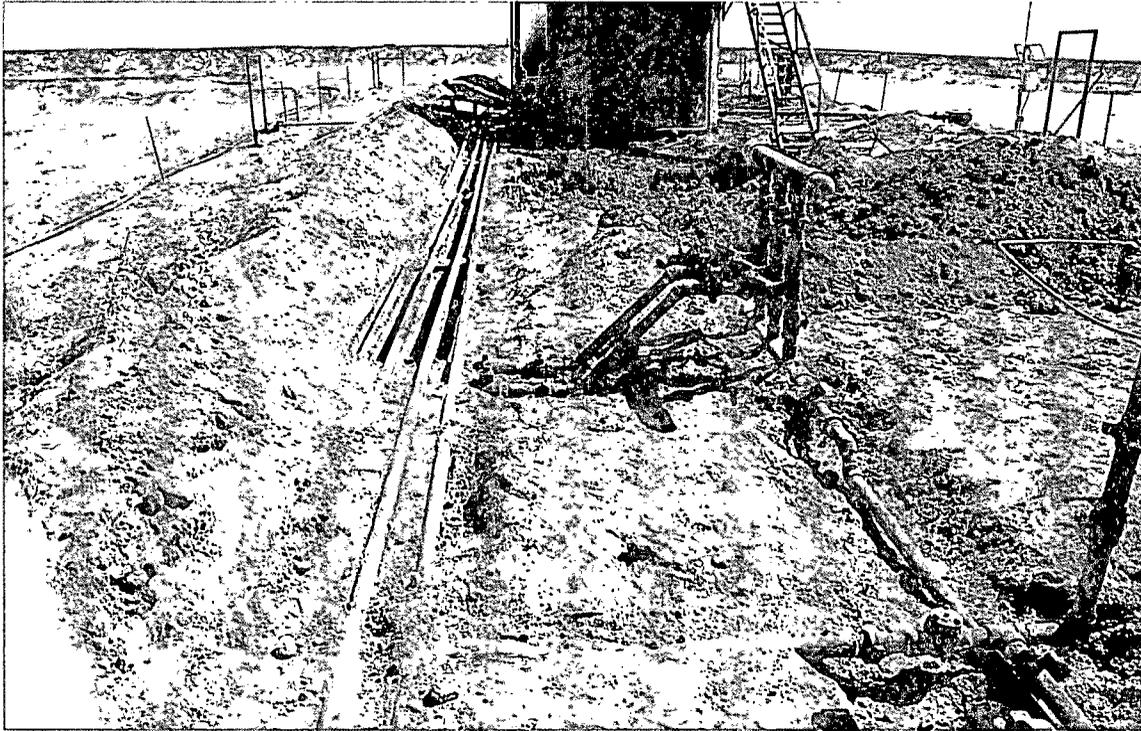
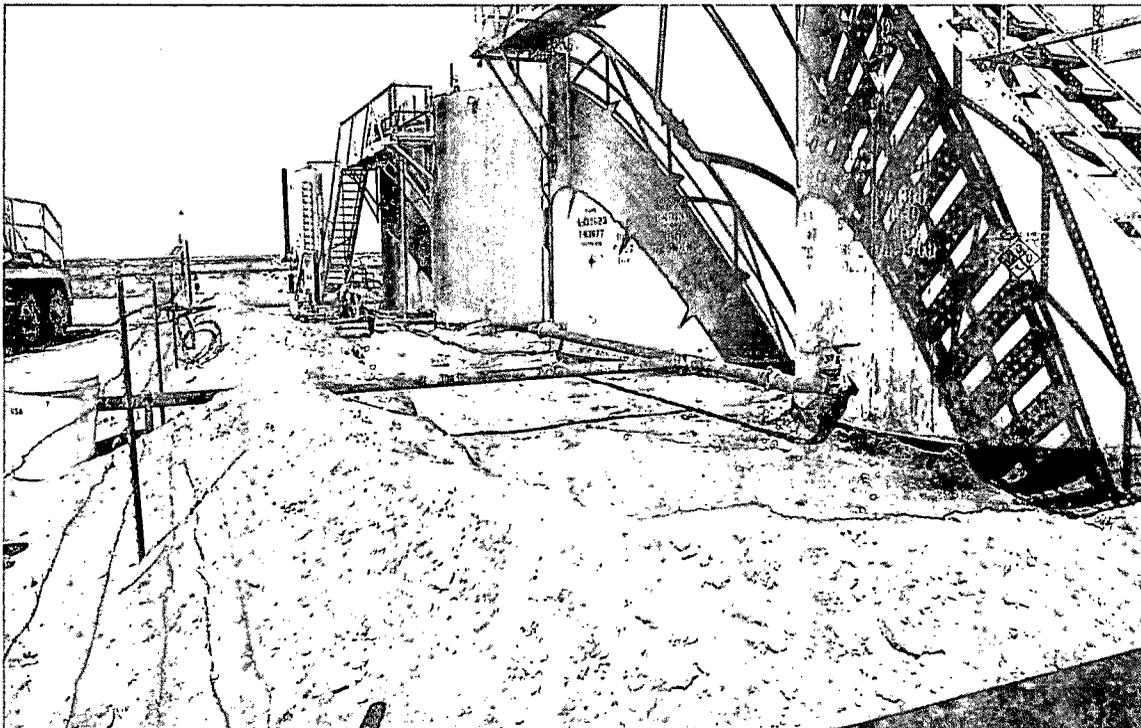
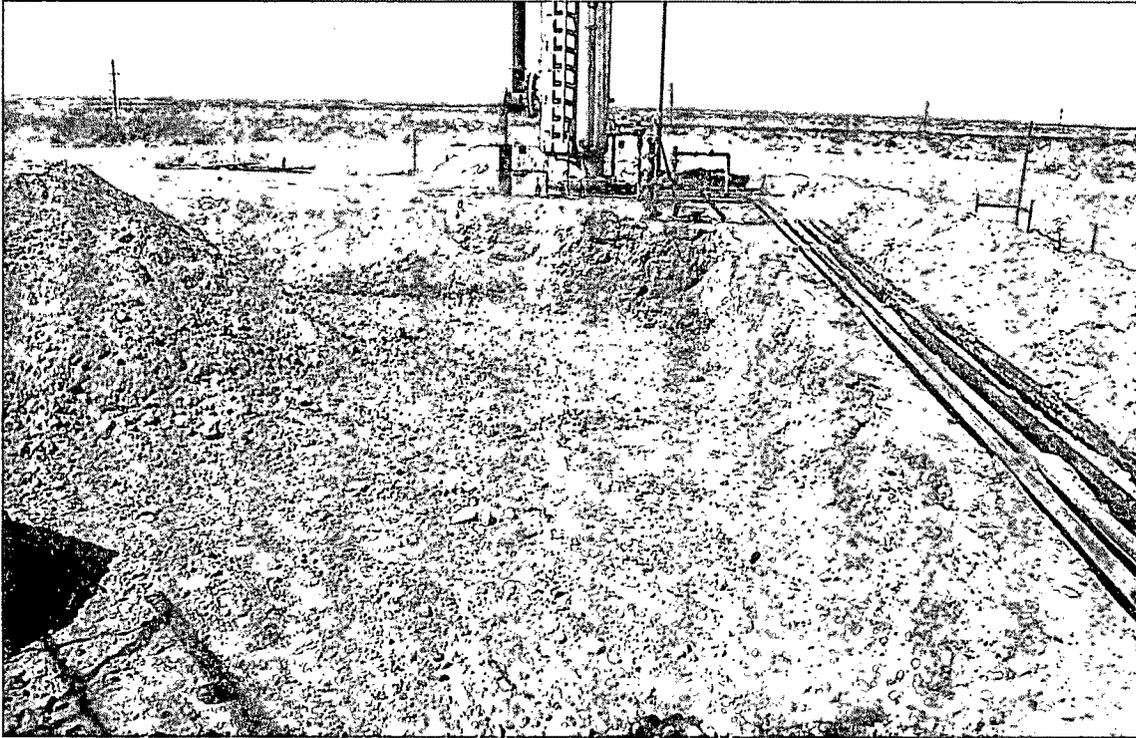
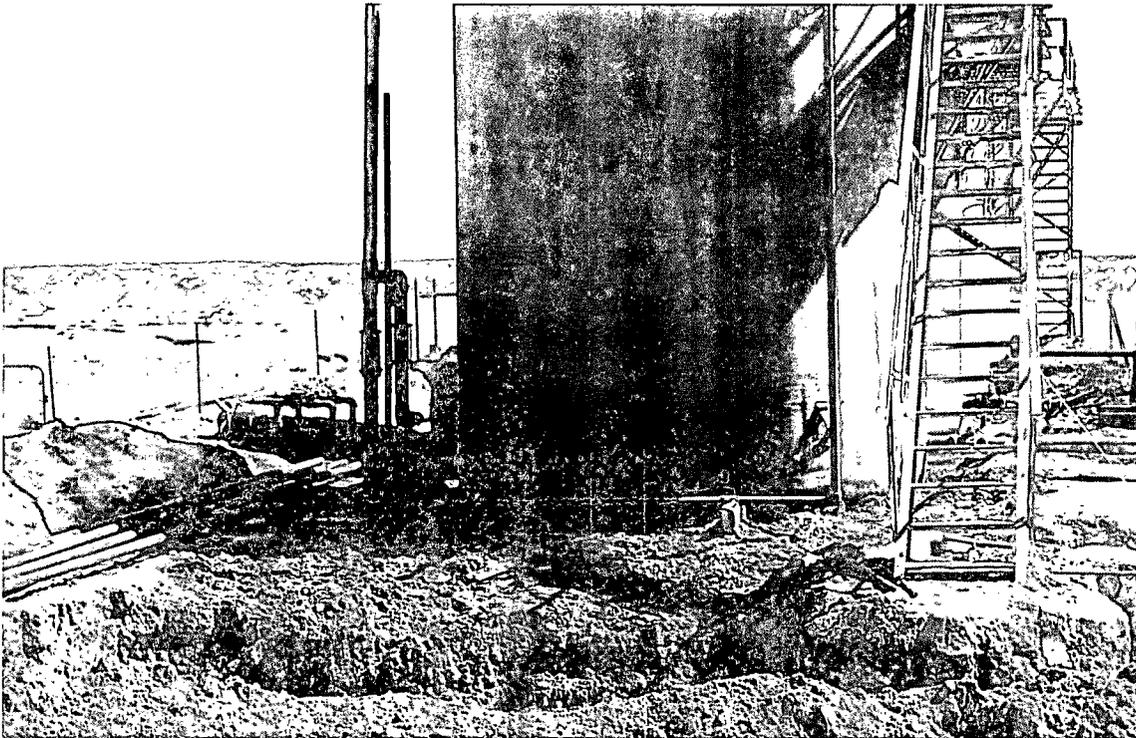
Bass 3 Federal Battery #1 - Excavation #1

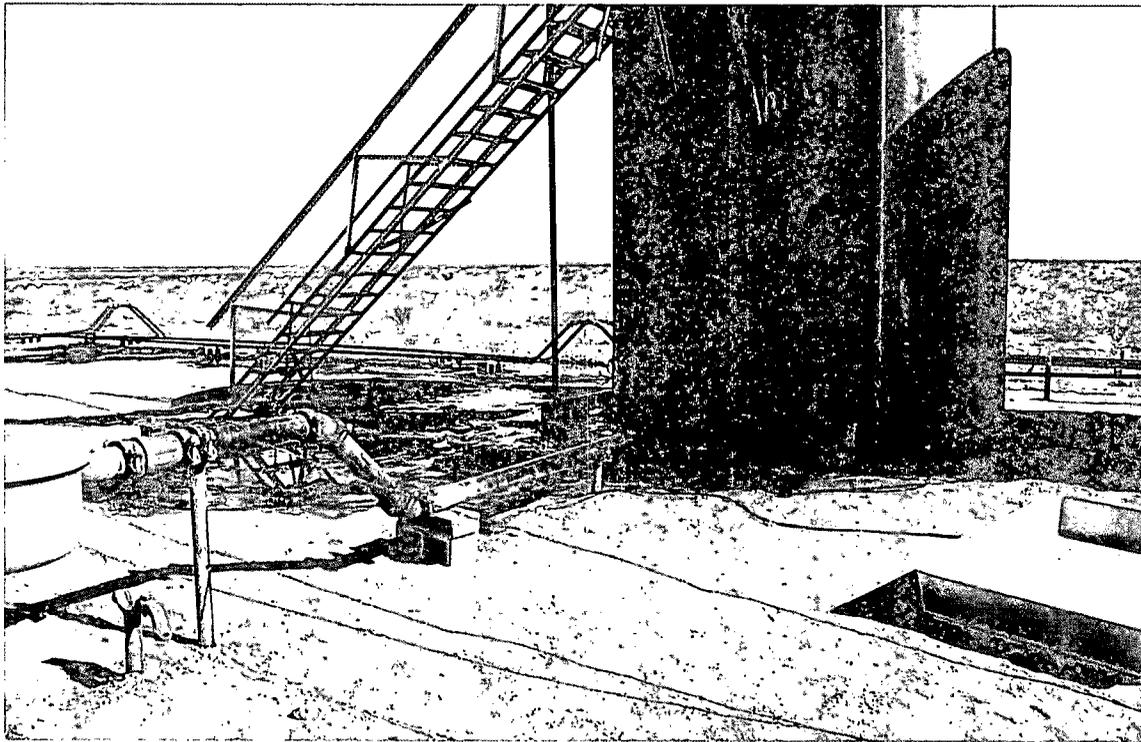
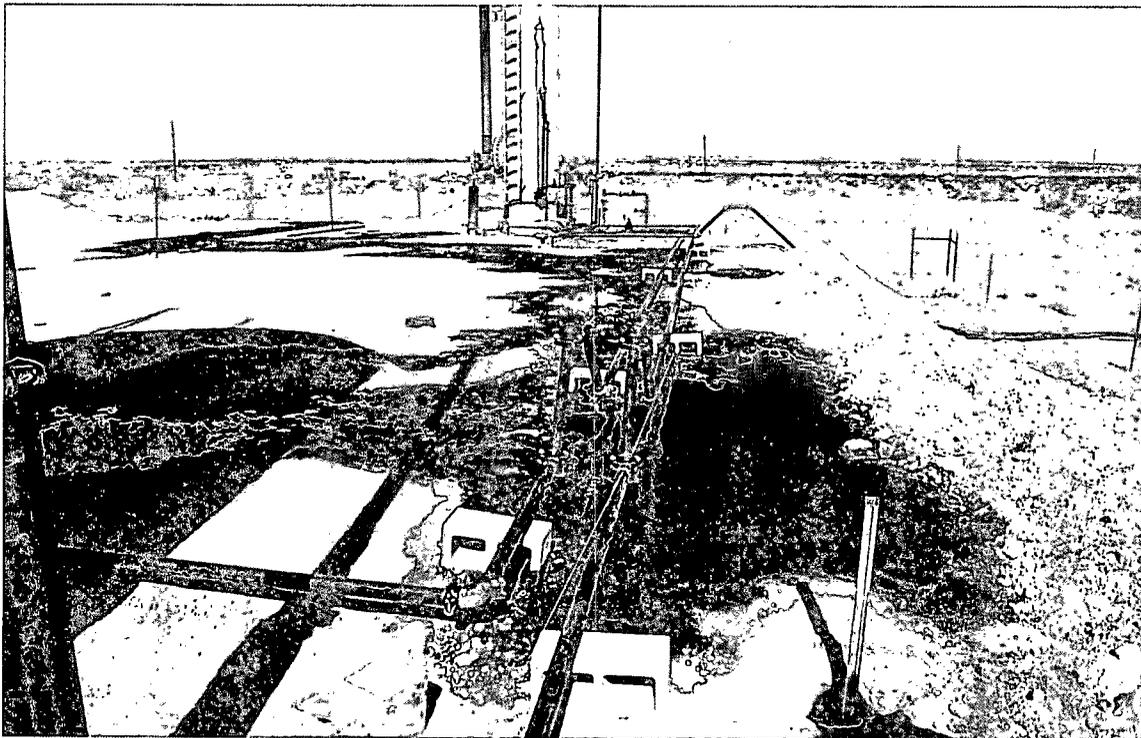
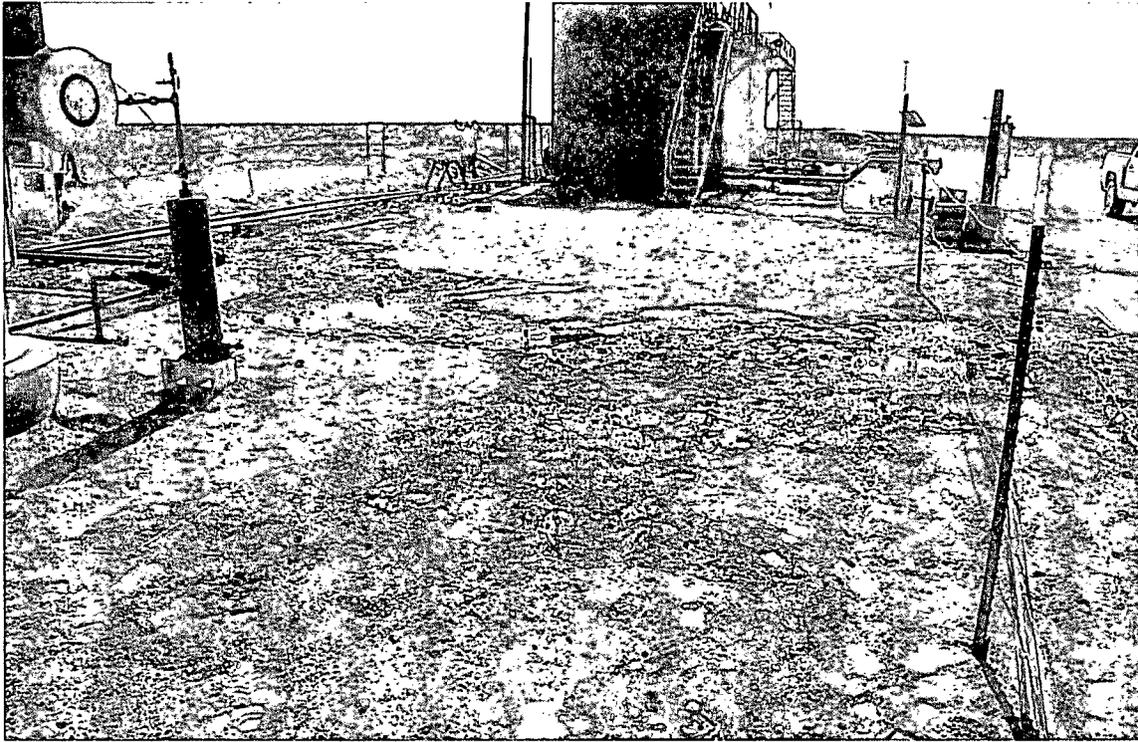
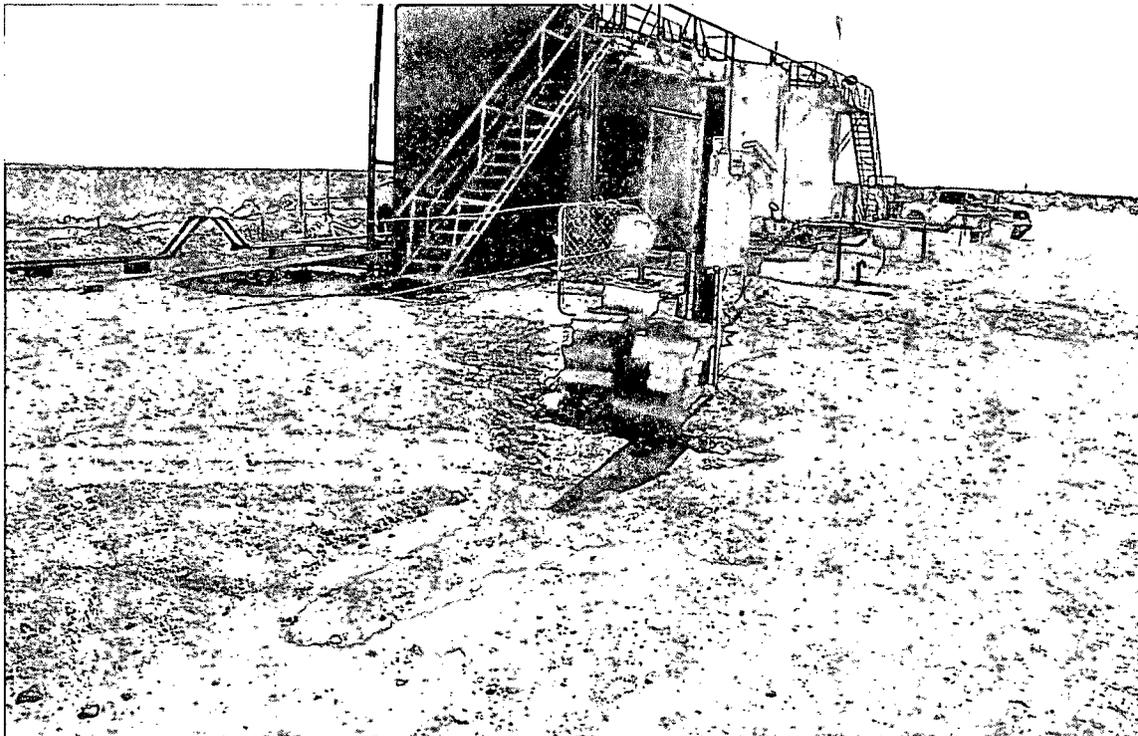
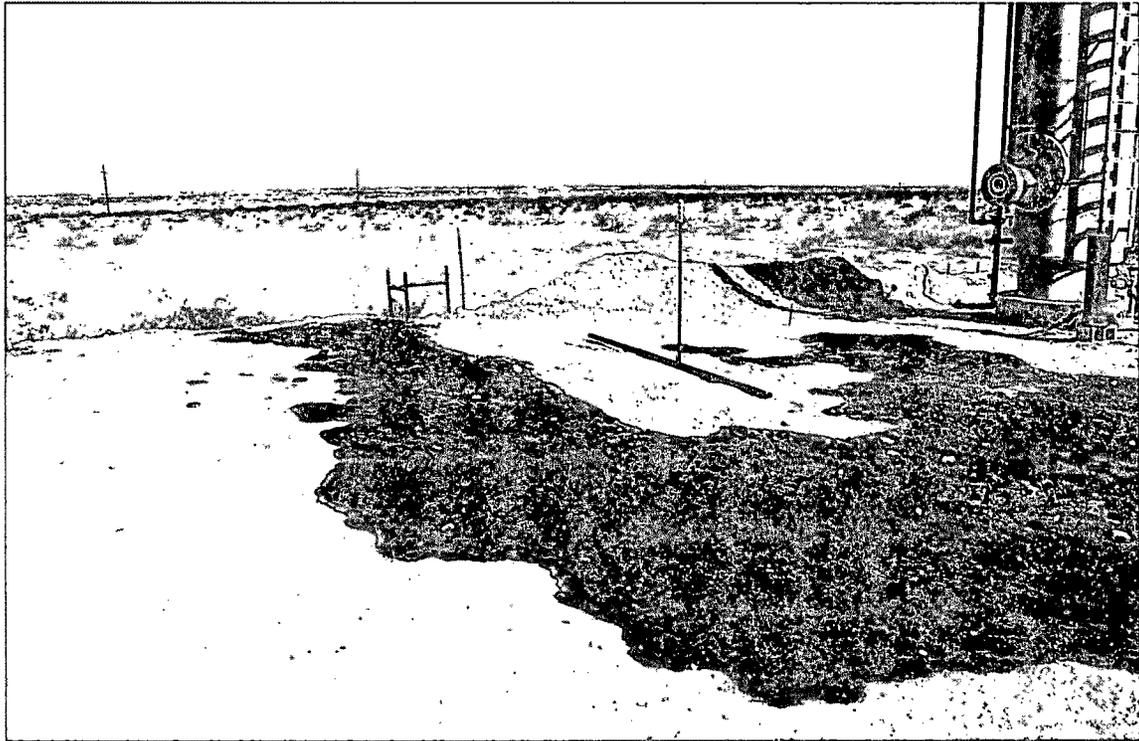
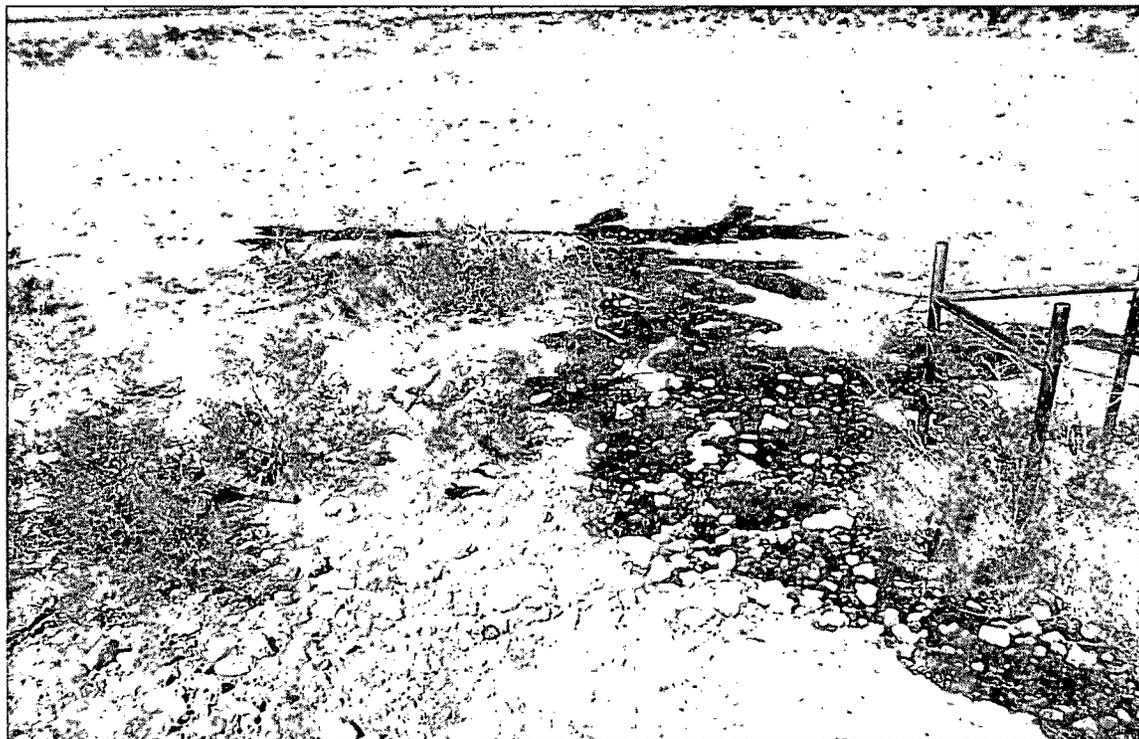
On March 27, 2012, BOPCO discovered a third release (Release #3) had occurred at Bass 3 Federal Battery #1. Two (2) loads of produced water were unloaded into the on-site produced water tank without prior approval from BOPCO. The water transfer pump malfunctioned and failed to discharge the excess water into a nearby salt water disposal system. The excess water, combined with the nightly crude oil and water production to the facility, caused an on-site storage tank to overflow, resulting in a release of crude oil.

Describe Cause of Problem and Remedial Action Taken.* Two loads of produced water were unloaded into the facility water tank without prior approval from BOPCO. The water transfer pump that would have normally pumped the water to a SWD failed to pump properly, and the daily oil/water production through the night ran the tank over.

Bass 3 Federal Battery #1 - March 27, 2012, Release
