REMEDIATION SUMMARY & SITE CLOSURE REQUEST

**BOPCO, LP
BASS 3 FEDERAL BATTERY #1
Eddy County, New Mexico
Unit Letter "P" (NE/SE), Section 3, Township 22 South, Range 28 East
Latitude 32.415370° North, Longitude 104.06990° West**

August 2013

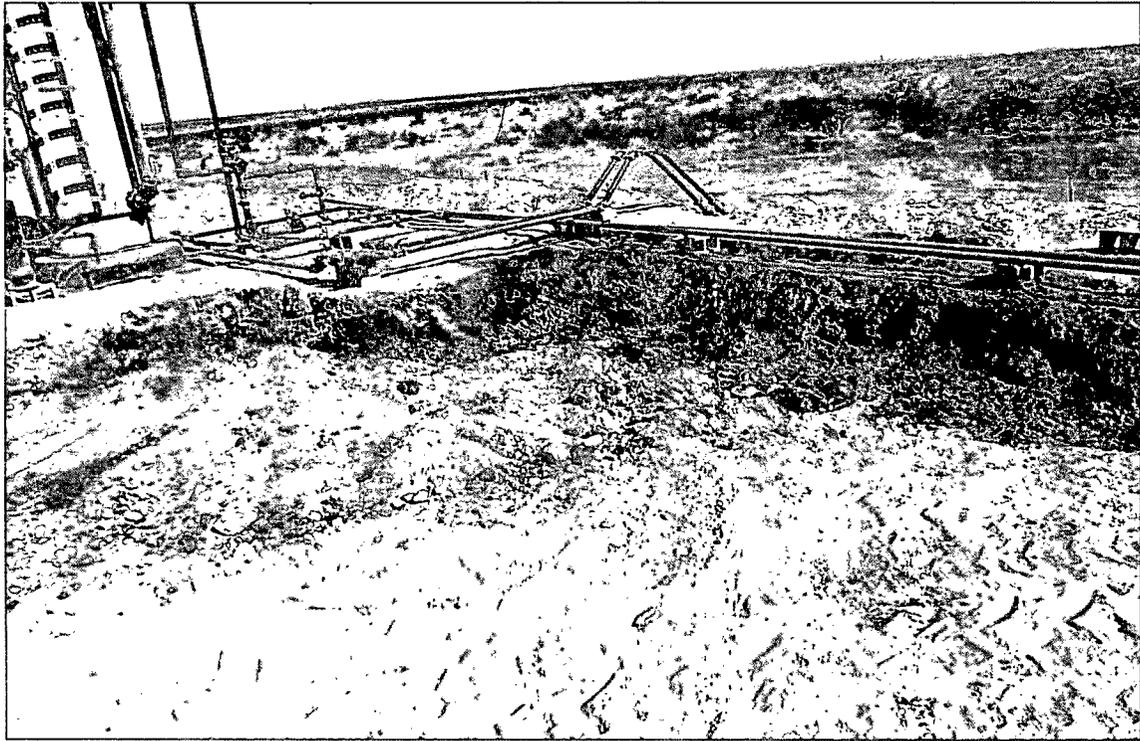
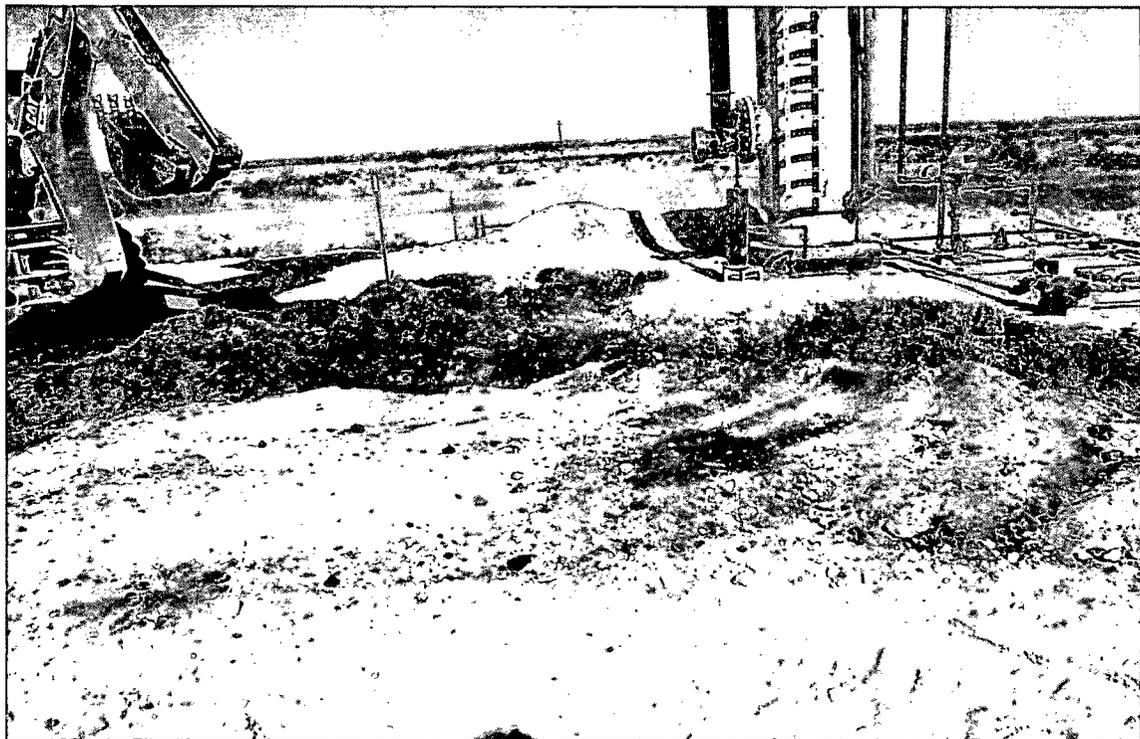
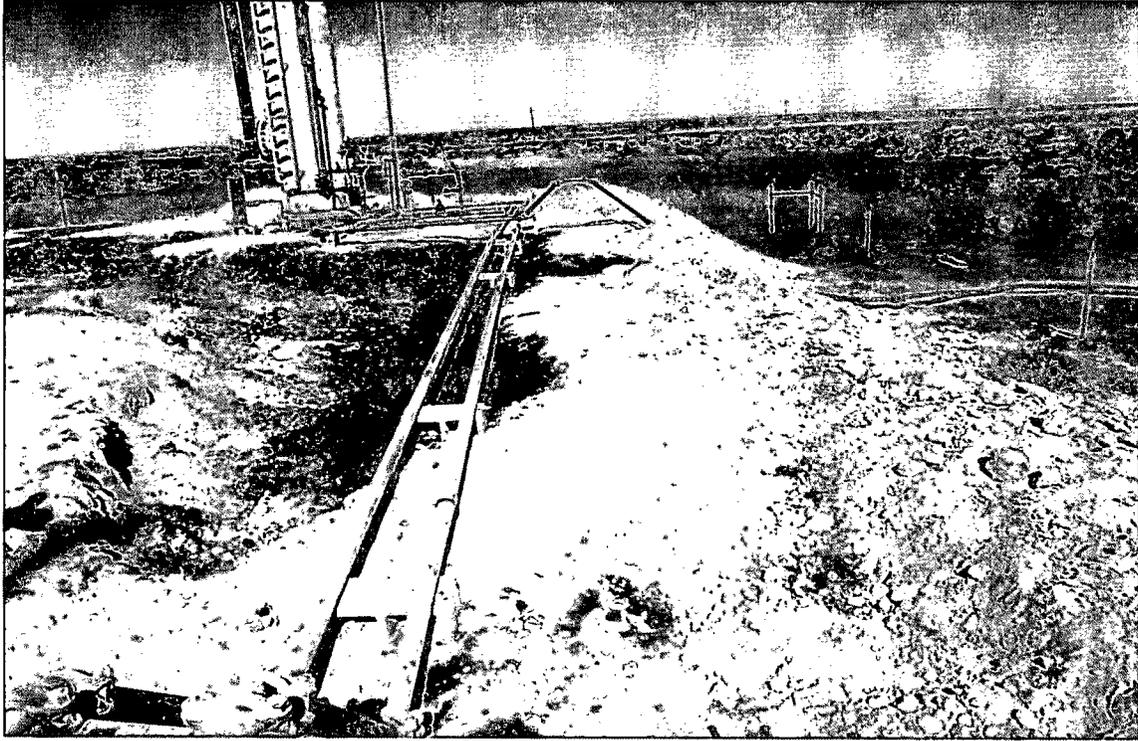
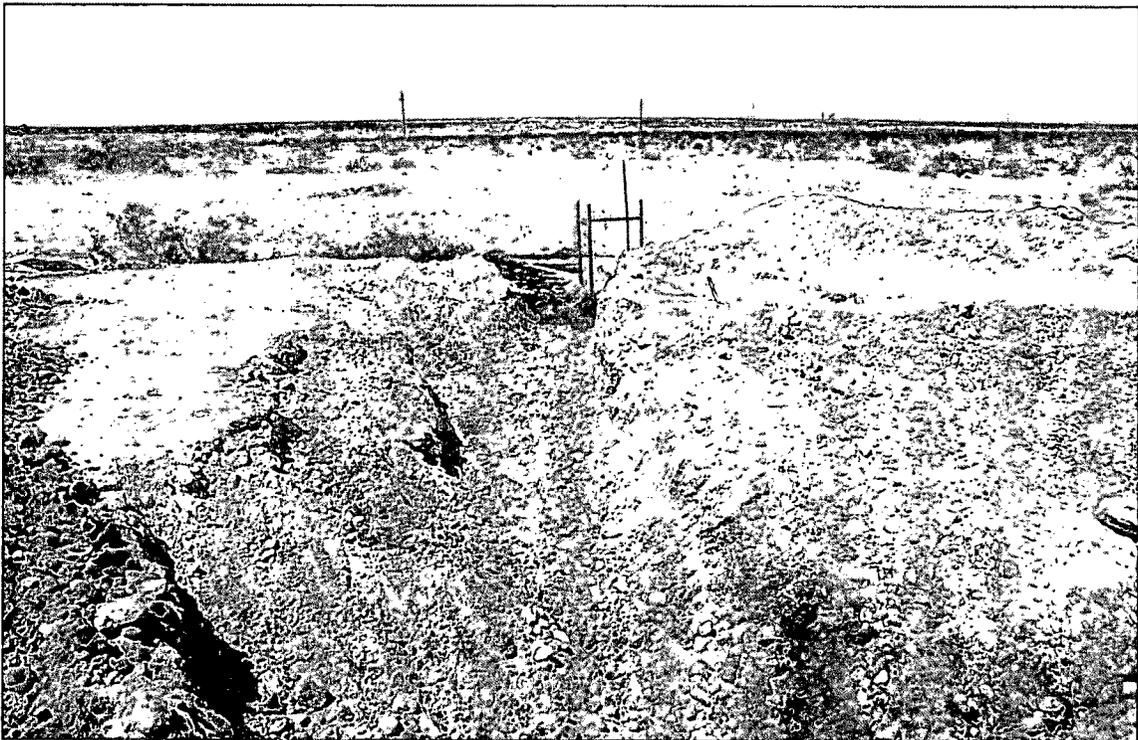
Bass 3 Federal Battery #1 - Excavation #2

On March 27, 2012, immediately following discovery of Release #3, Basin Environmental was dispatched to the location to begin excavation of the impacted soil. From March 27 through March 30, 2012, approximately two hundred and ten cubic yards (210 yd³) of visibly stained, heavily impacted soil was excavated and transported to Lea Land, Inc., for disposal. The boundaries of the excavation are depicted in Figure 2 as "Excavation 2".

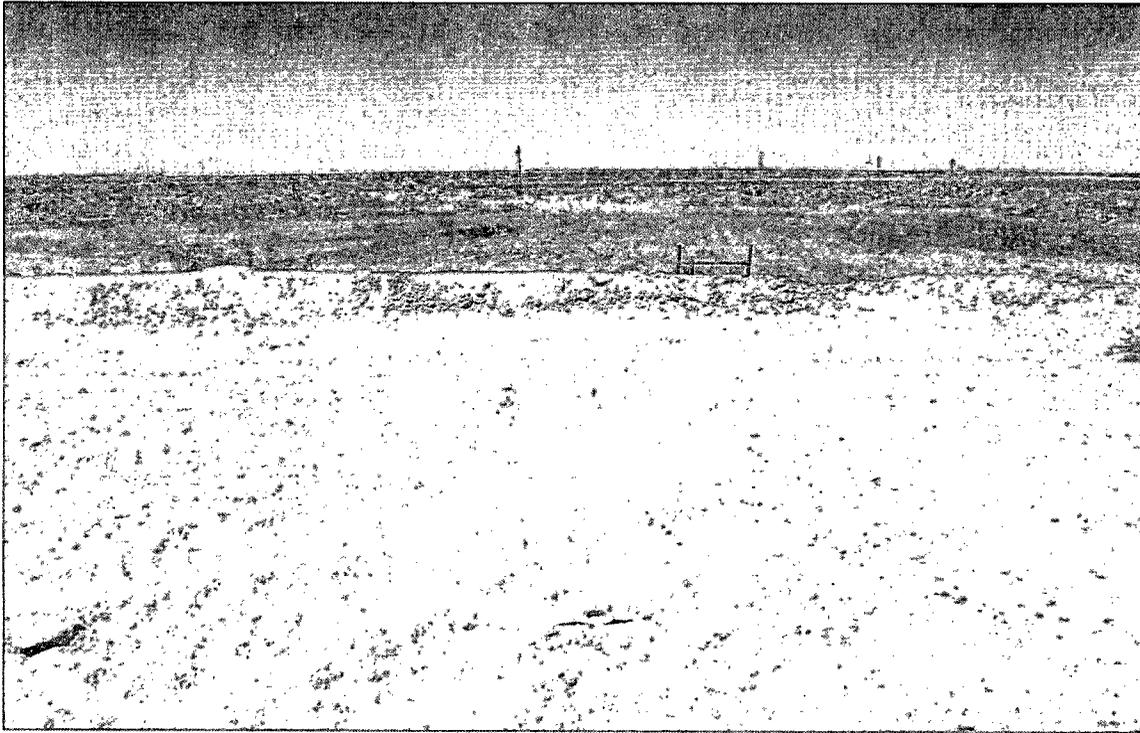
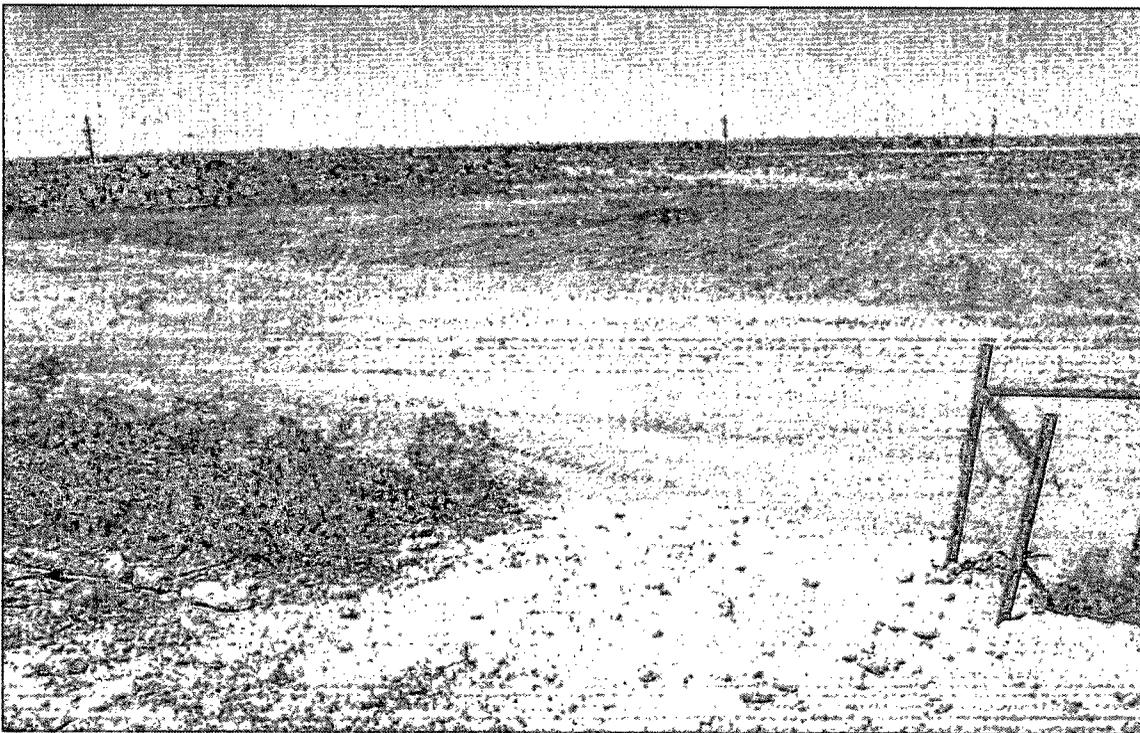
Bass 3 Federal Battery #1 - Excavation #2 (Following Backfill)

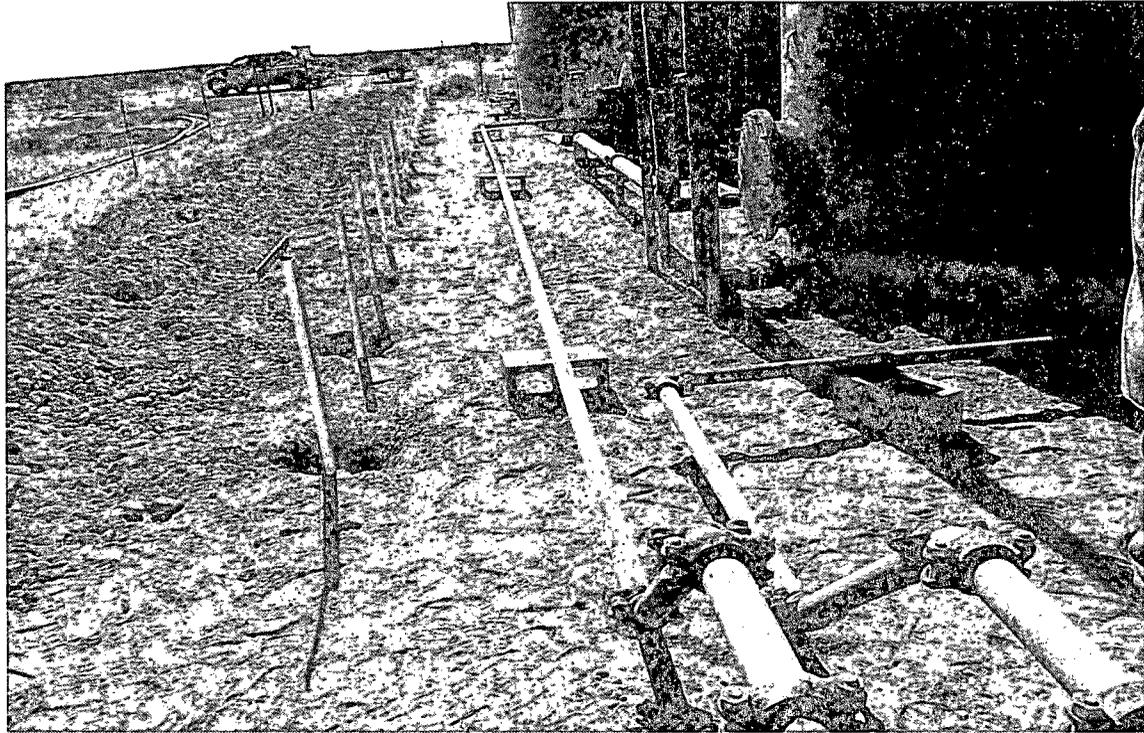
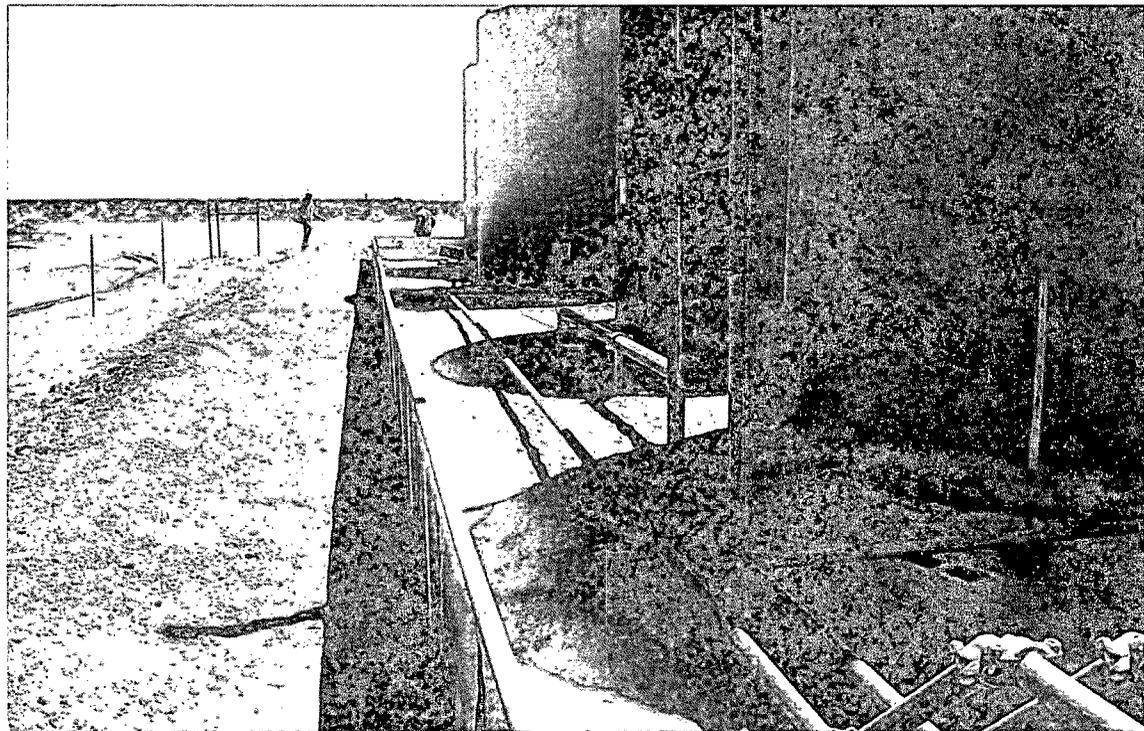
Bass 3 Federal Battery #1 - Installation of Steel Containment Area

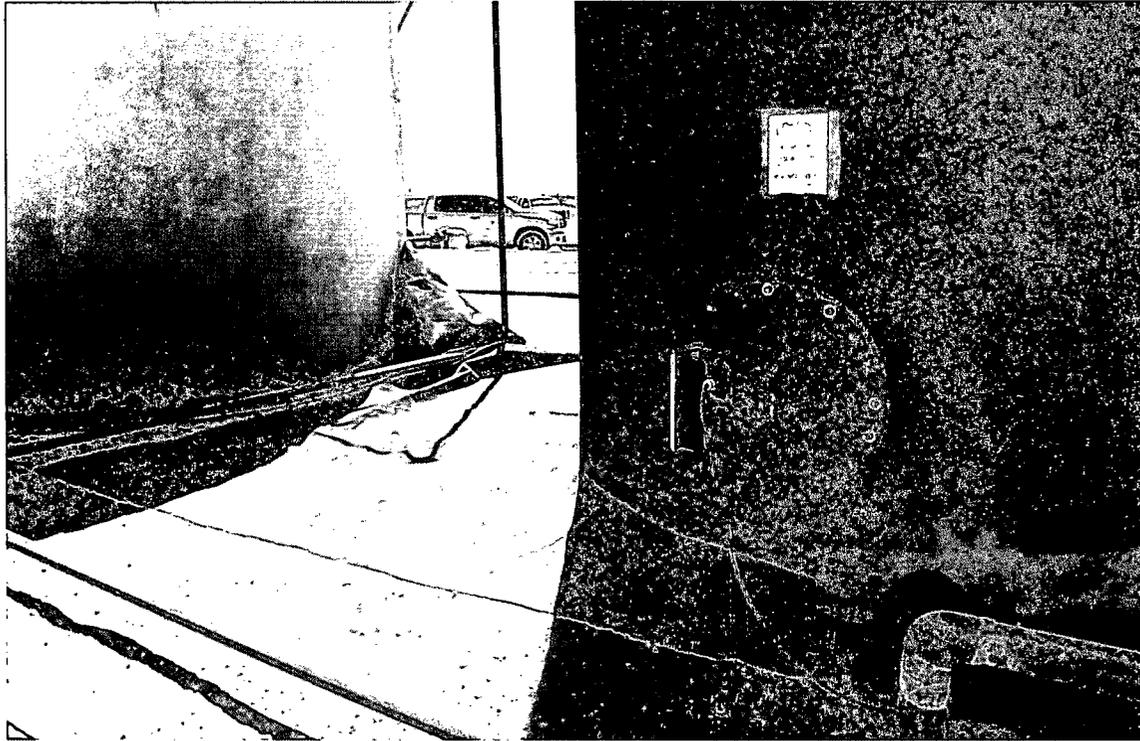
Bass 3 Federal Battery #1 - Installation of Liner & Steel Containment Area

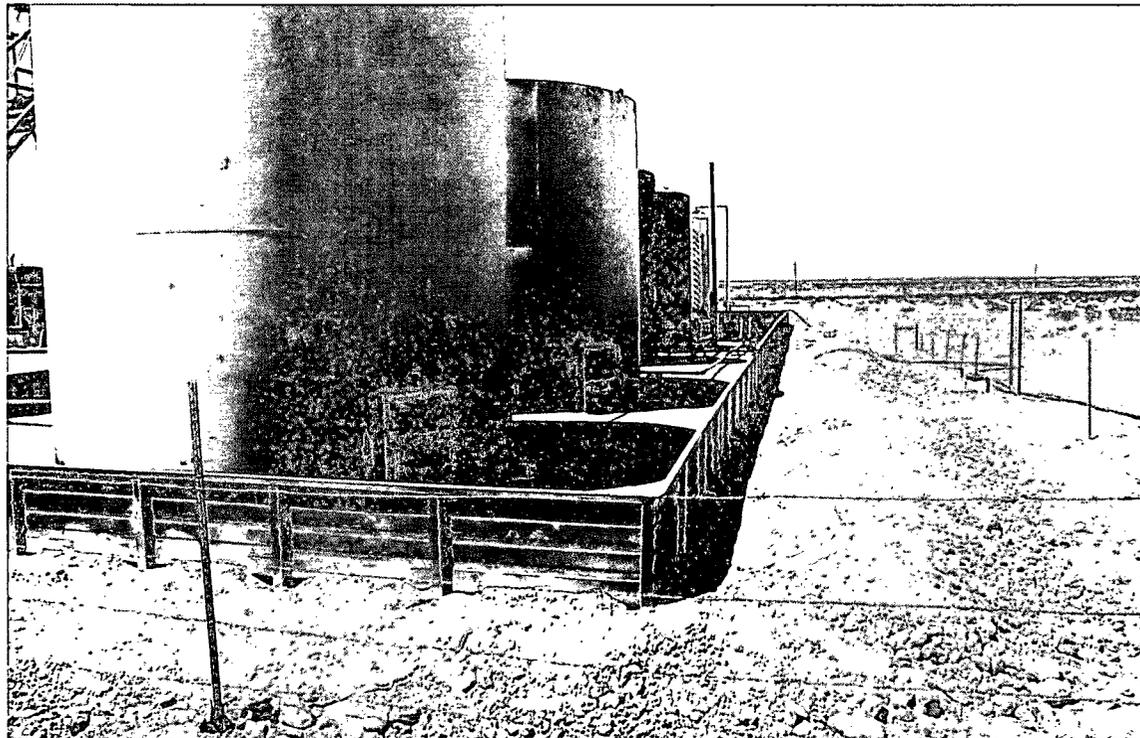
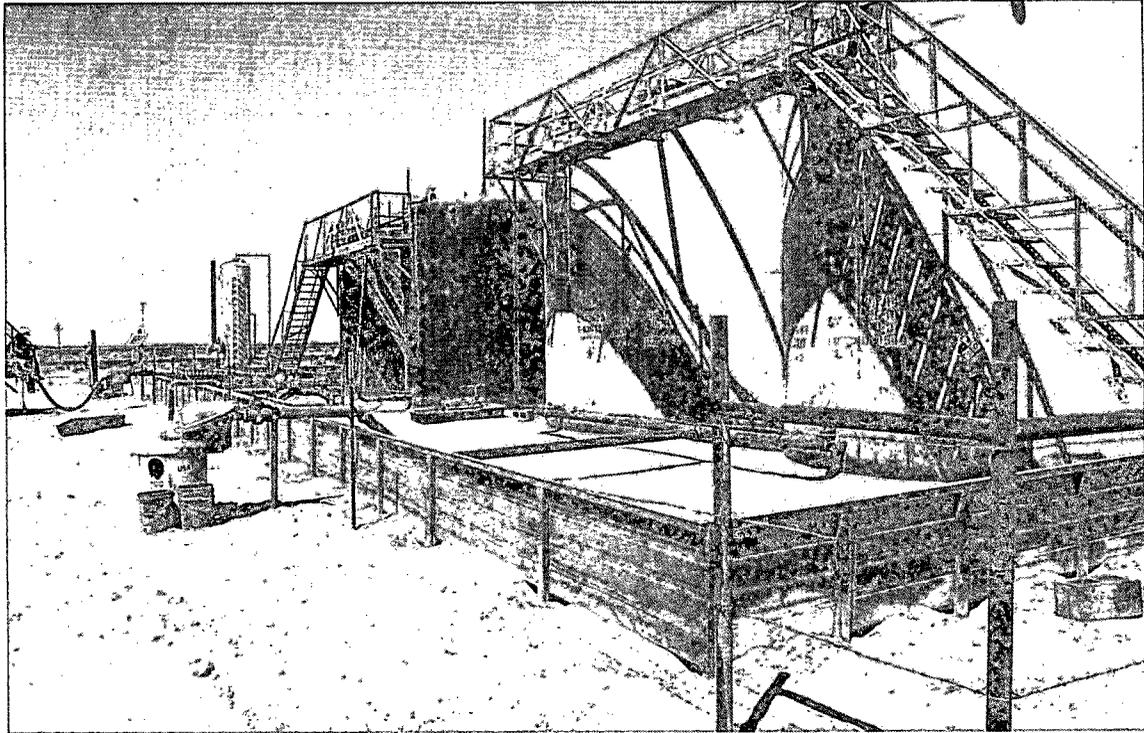
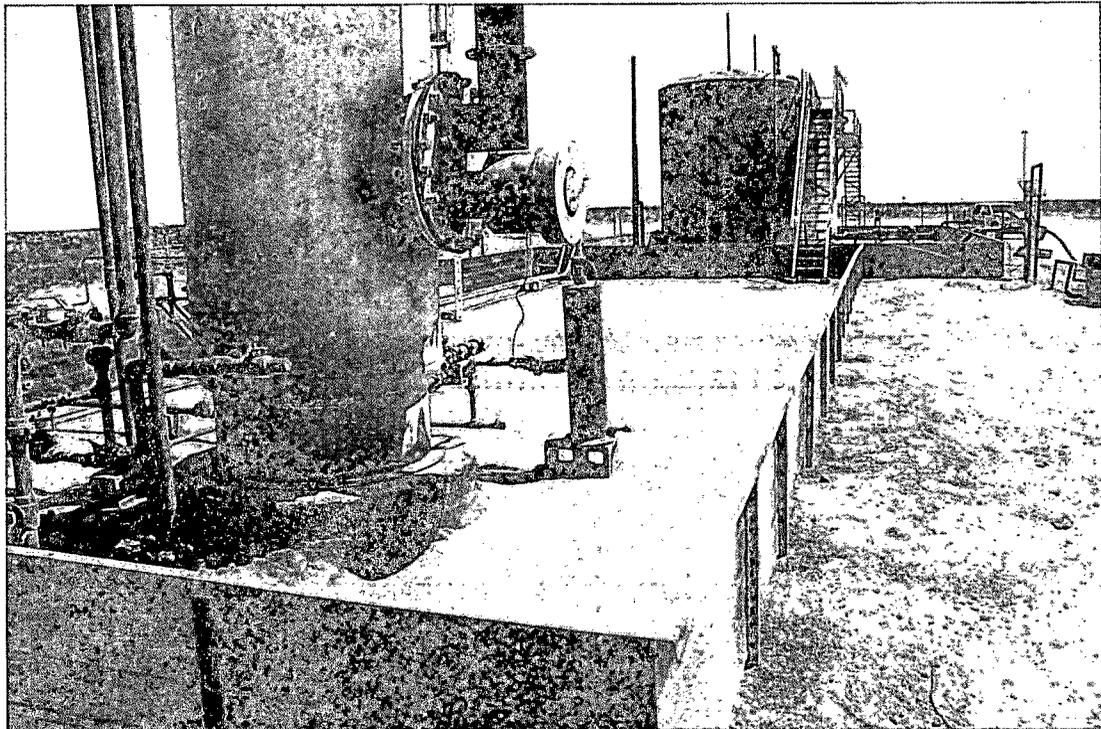
Bass 3 Federal Battery #1 - Steel Containment Area

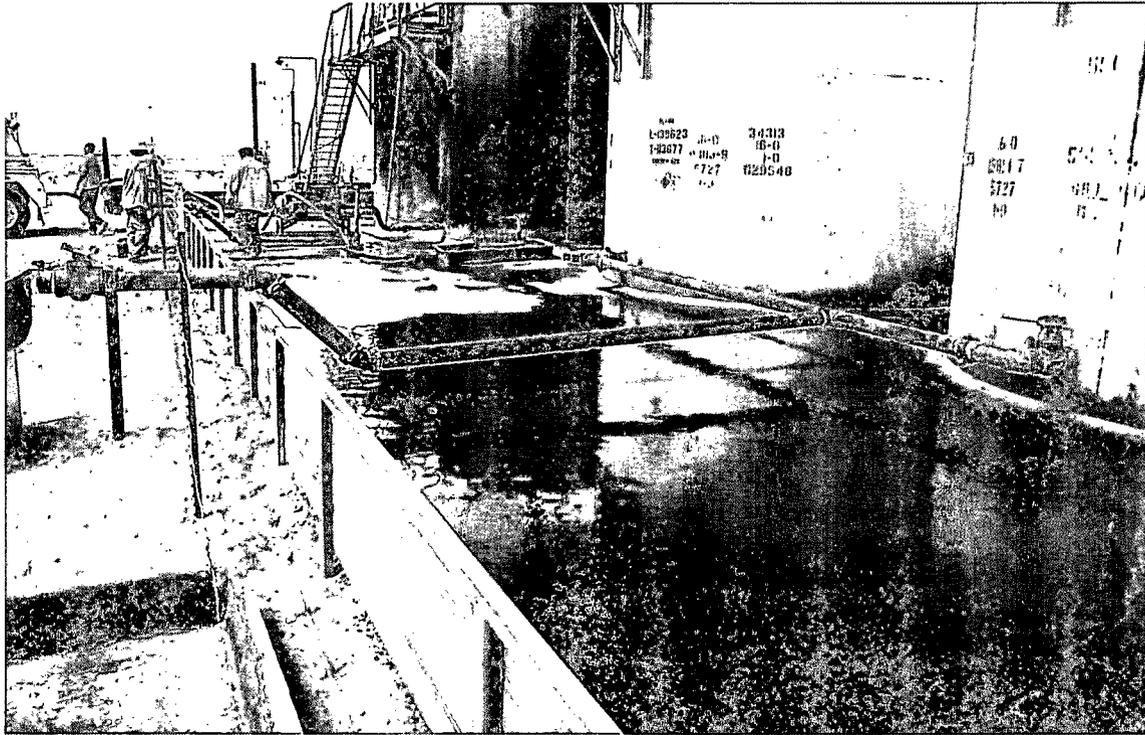
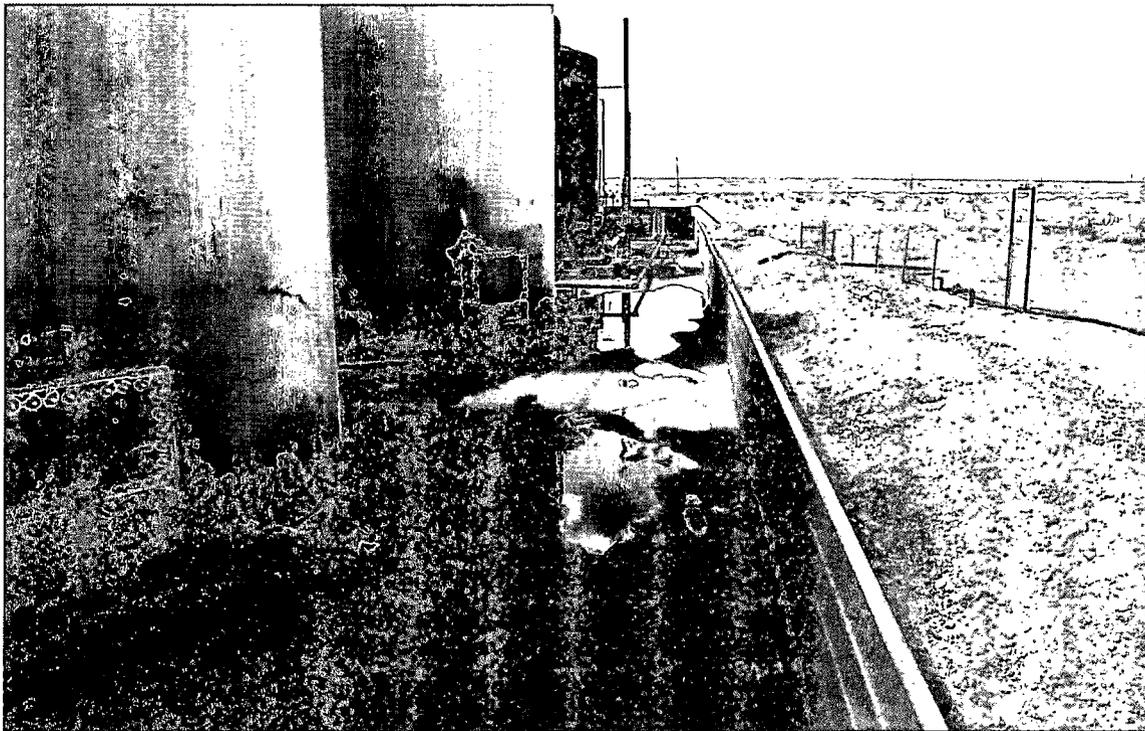
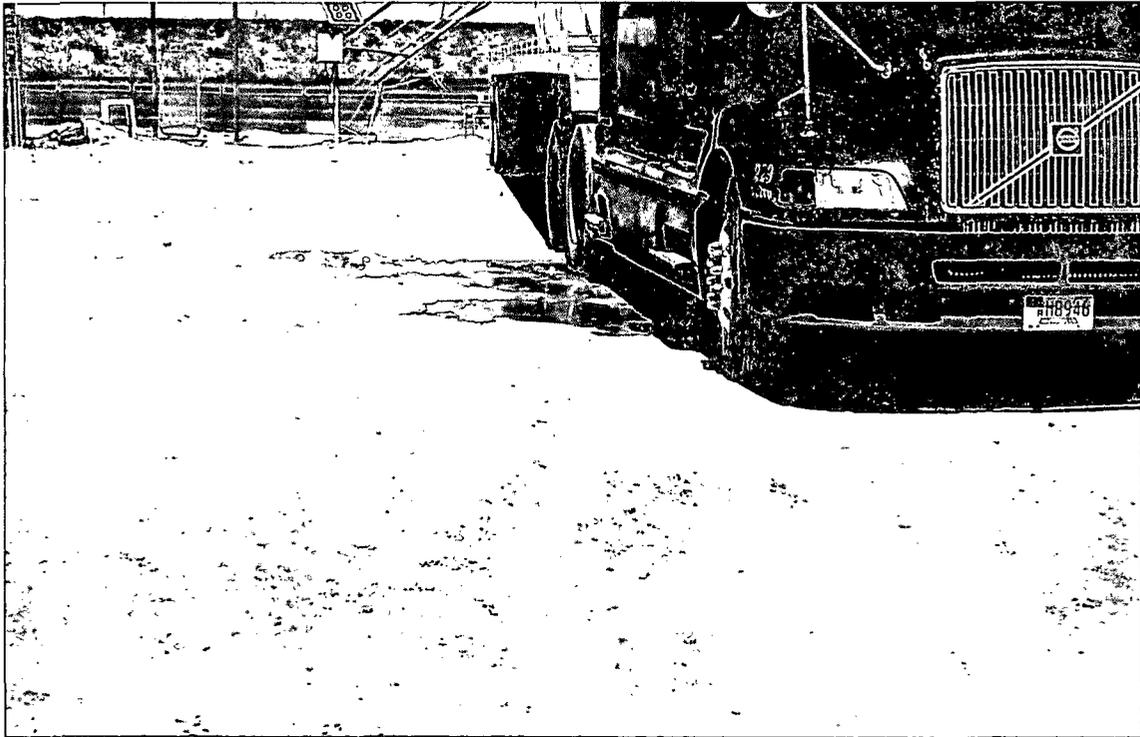
On April 3, 2012, BOPCO discovered a fourth release (Release #4) had occurred at Bass 3 Federal Battery #1. A three-quarter-inch (3/4") air eliminator on the water transfer pump broke in half due to a manufacturing defect, resulting in a release of produced water. The majority of the release was confined to the impermeable polyurethane containment area surrounding the tank battery, which had been installed at the site just prior to the release.

Describe Cause of Problem and Remedial Action Taken.* A 3/4" air eliminator on the water transfer pump broke in half due to a manufacturing defect. The part was replaced.

Bass 3 Federal Battery #1 - April 3, 2012, Release

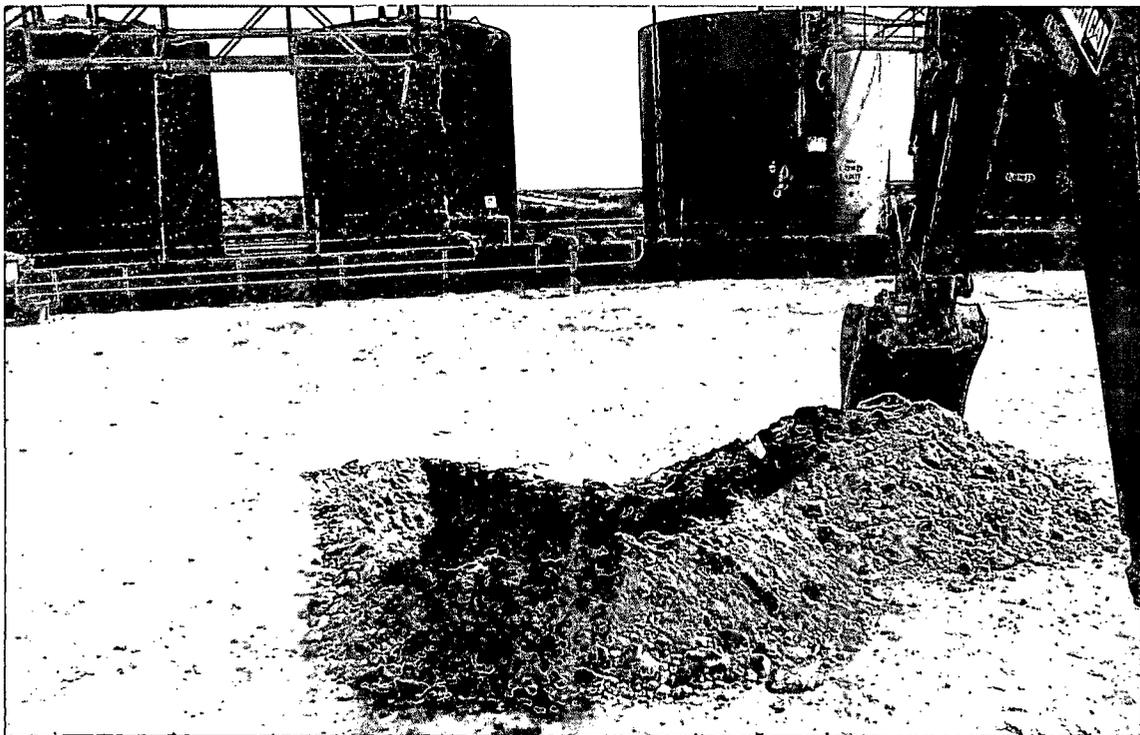
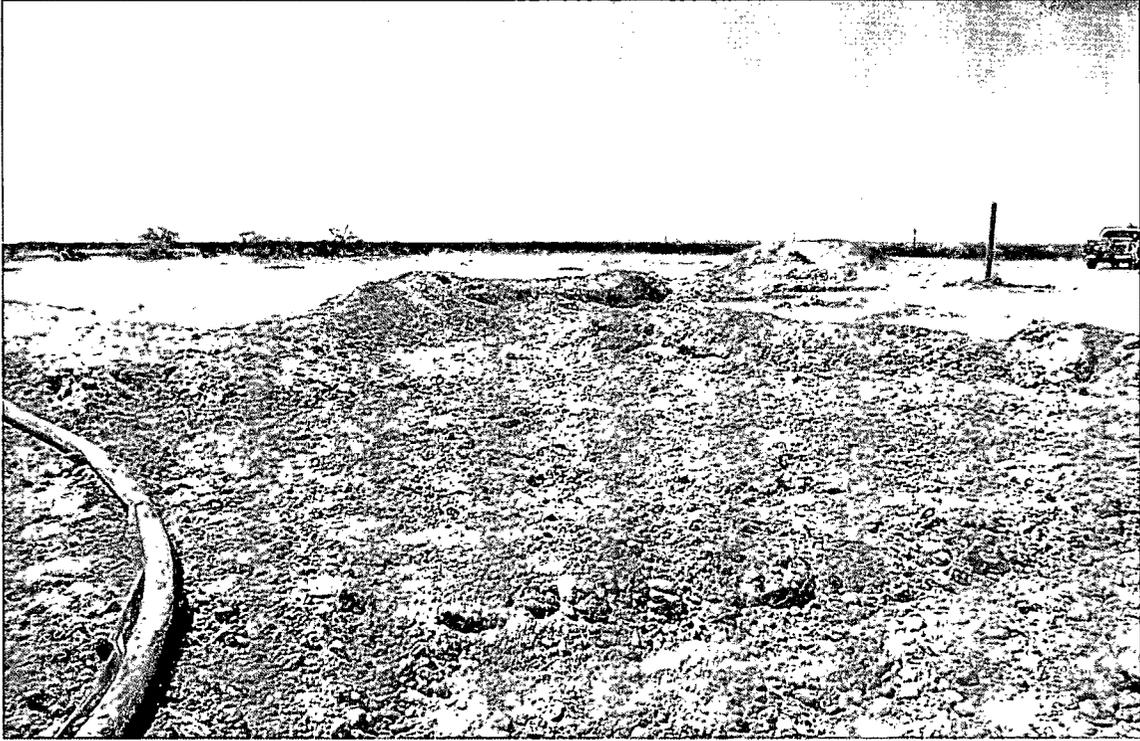
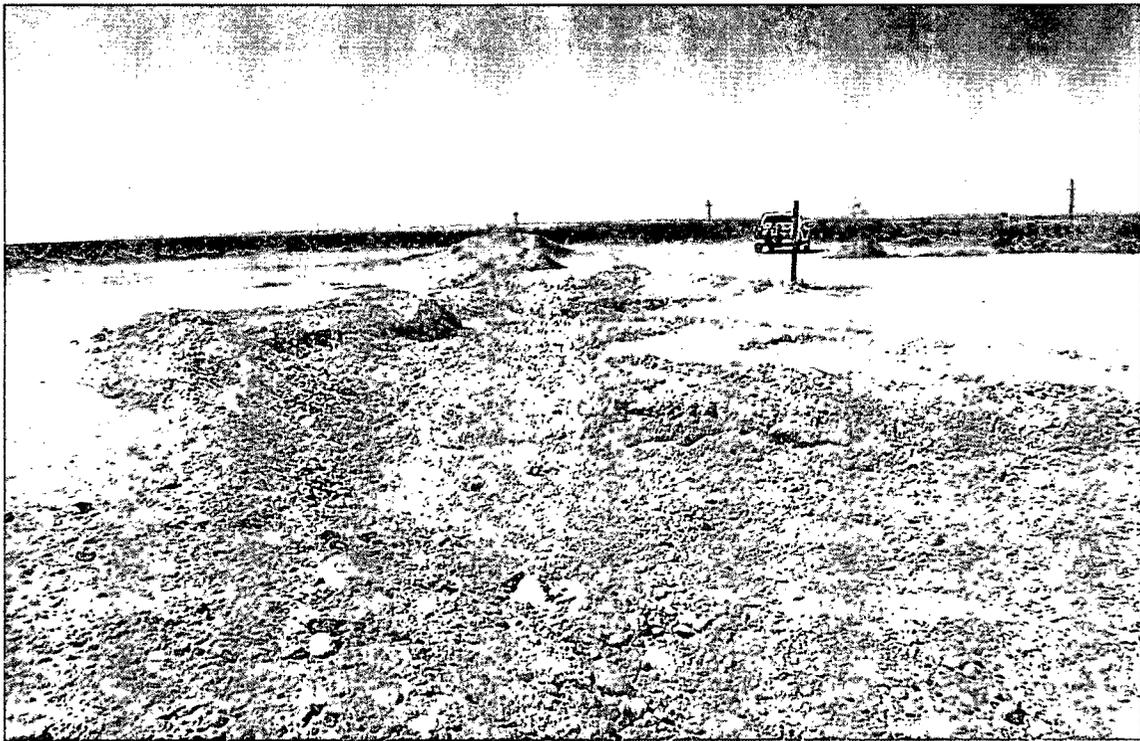
Bass 3 Federal Battery #1 - Excavation #3

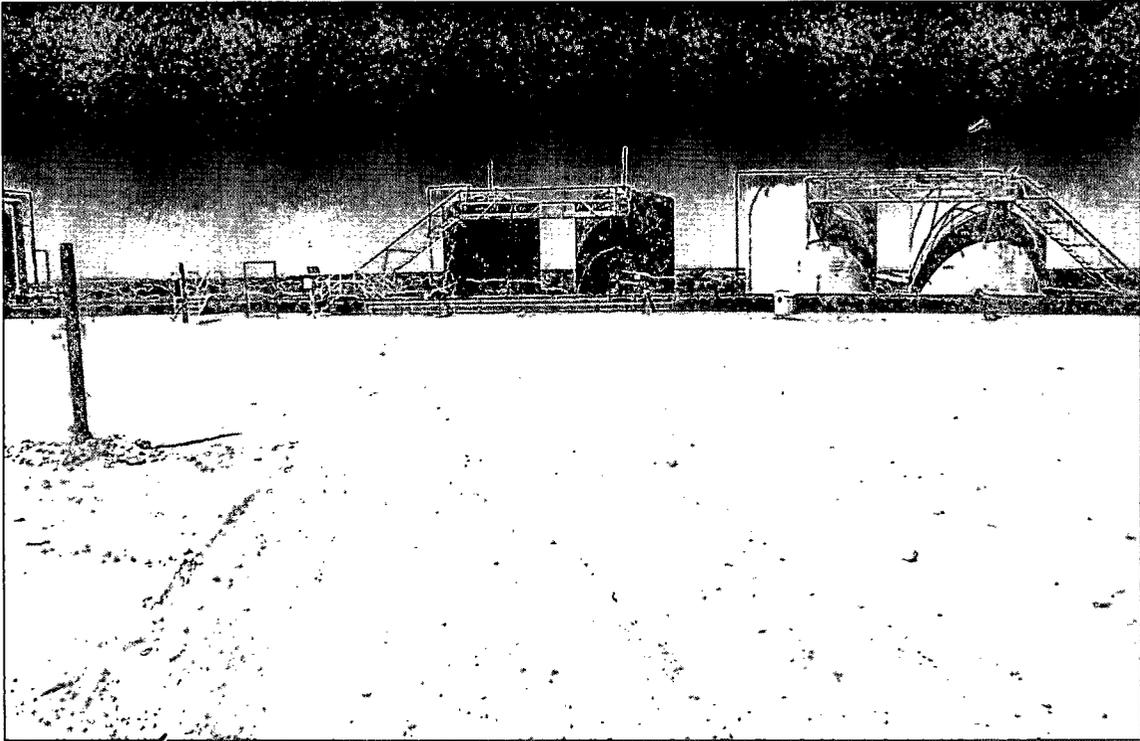
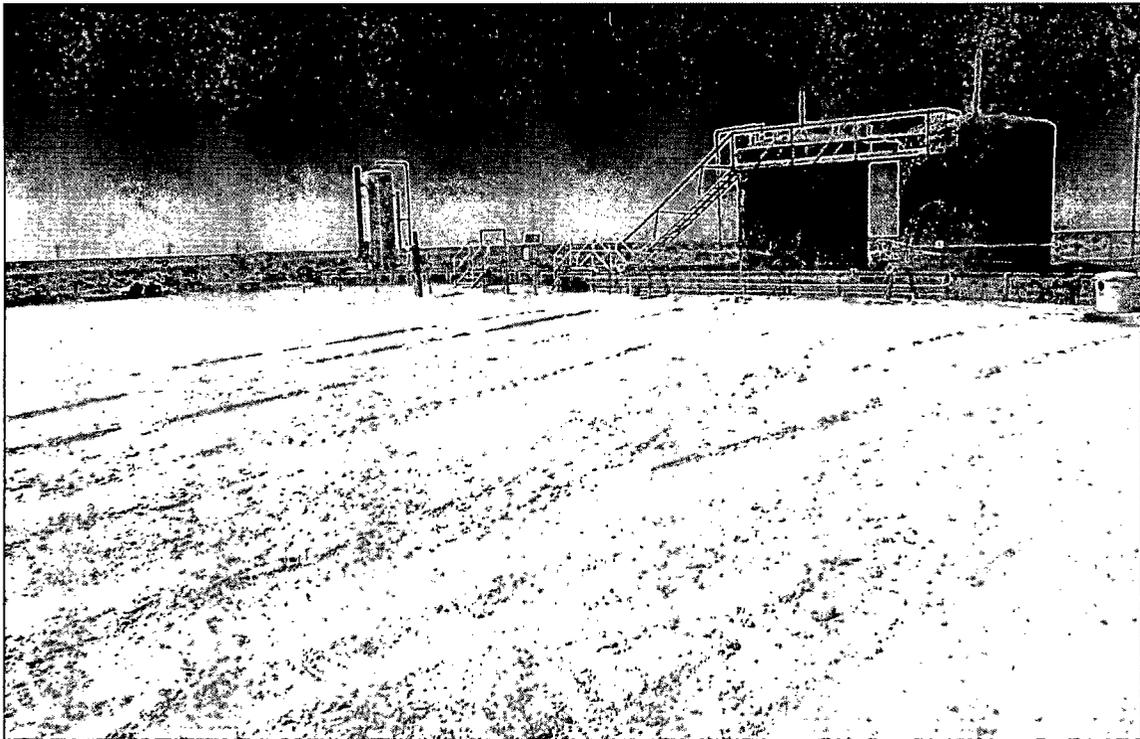
Bass 3 Federal Battery #1 - Excavation #3 (Following Backfill)
