REMEDIATION SUMMARY & SITE CLOSURE REQUEST

**BOPCO, LP
JAMES RANCH UNIT #36 TANK BATTERY
Eddy County, New Mexico
Unit Letter "G" (SW/NE), Section 1, Township 23 South, Range 30 East
Latitude 32.335615° North, Longitude 103.832117° West
NMOCD Reference #: 2RP-1204**

December 2013

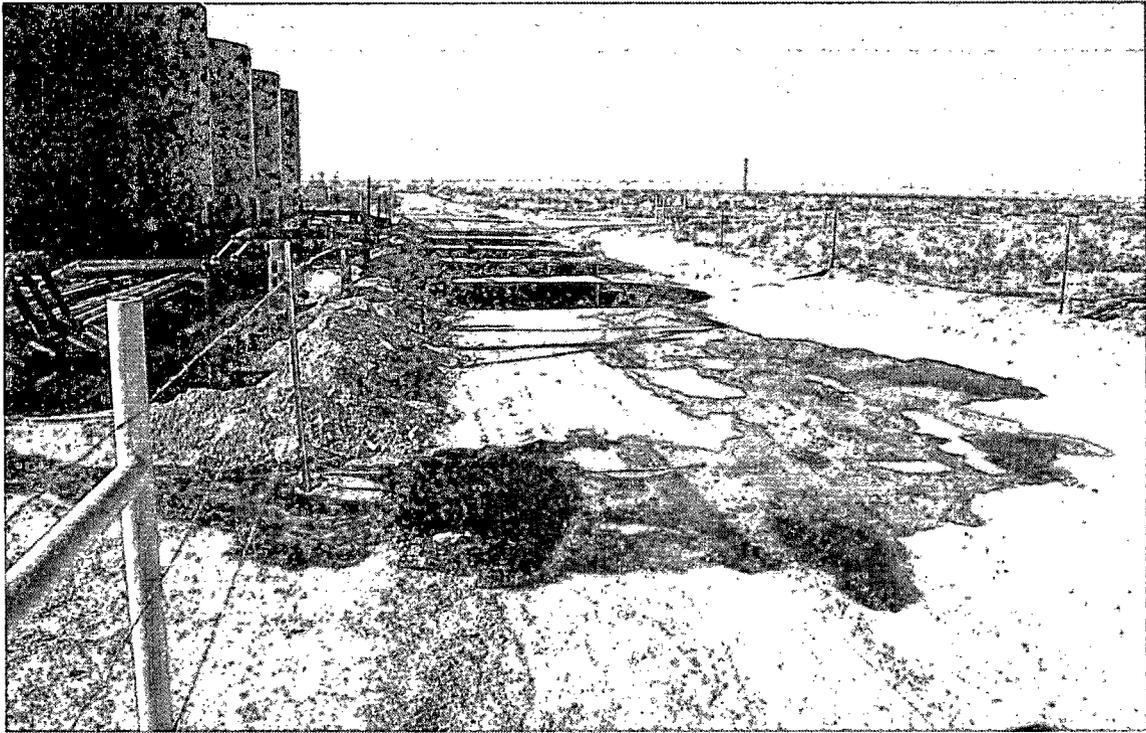
James Ranch Unit #36 Tank Battery - Release Site (Looking South)

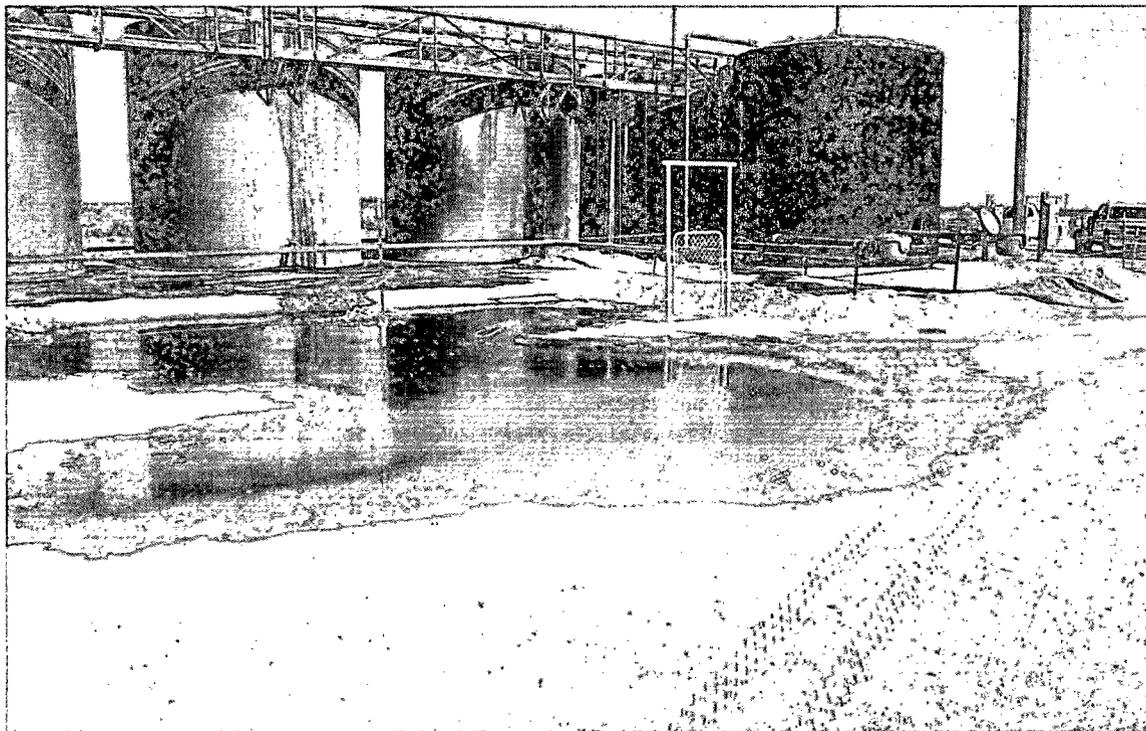
James Ranch Unit #36 Tank Battery - Release Site (Looking Northwest)

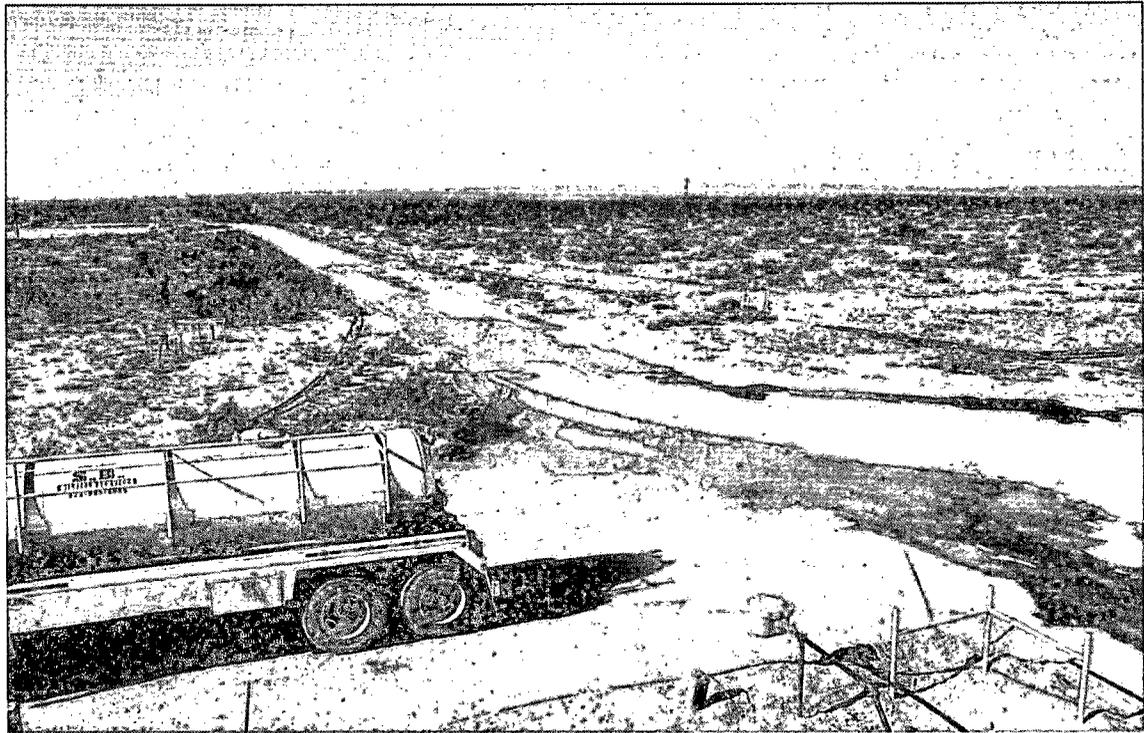
James Ranch Unit #36 Tank Battery - Flow Path (Looking Southwest)

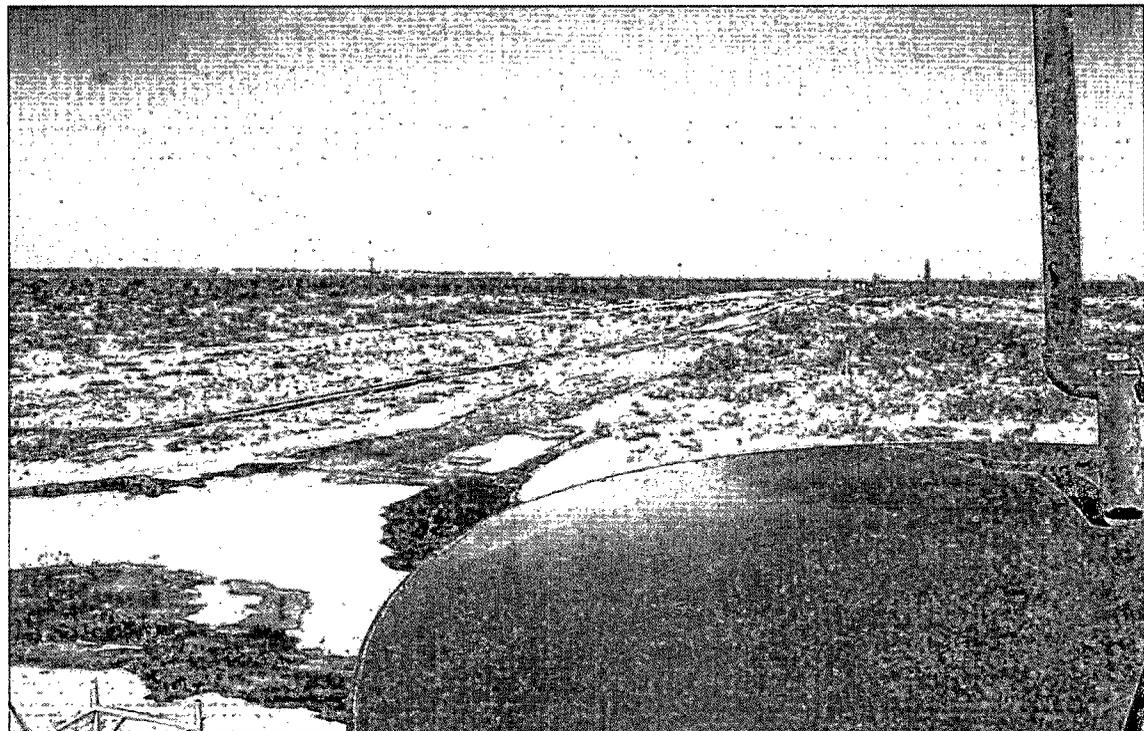
James Ranch Unit #36 Tank Battery - Flow Path (Looking West-southwest)

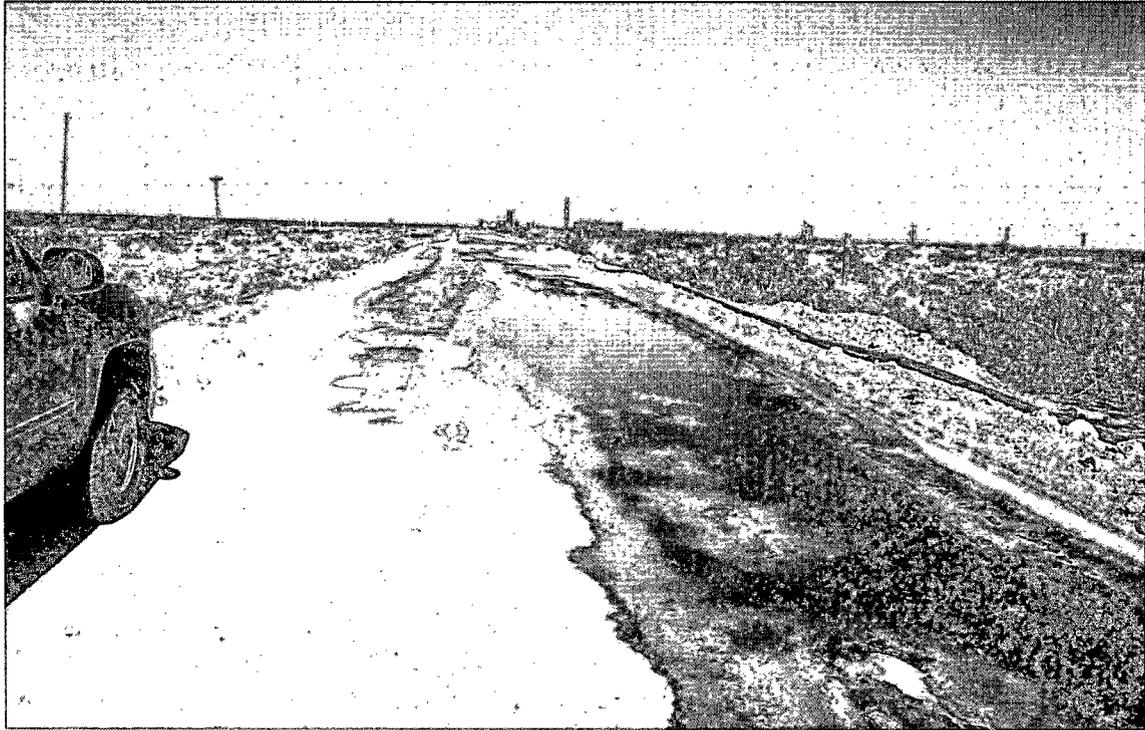
James Ranch Unit #36 Tank Battery - Flow Path (Looking West)

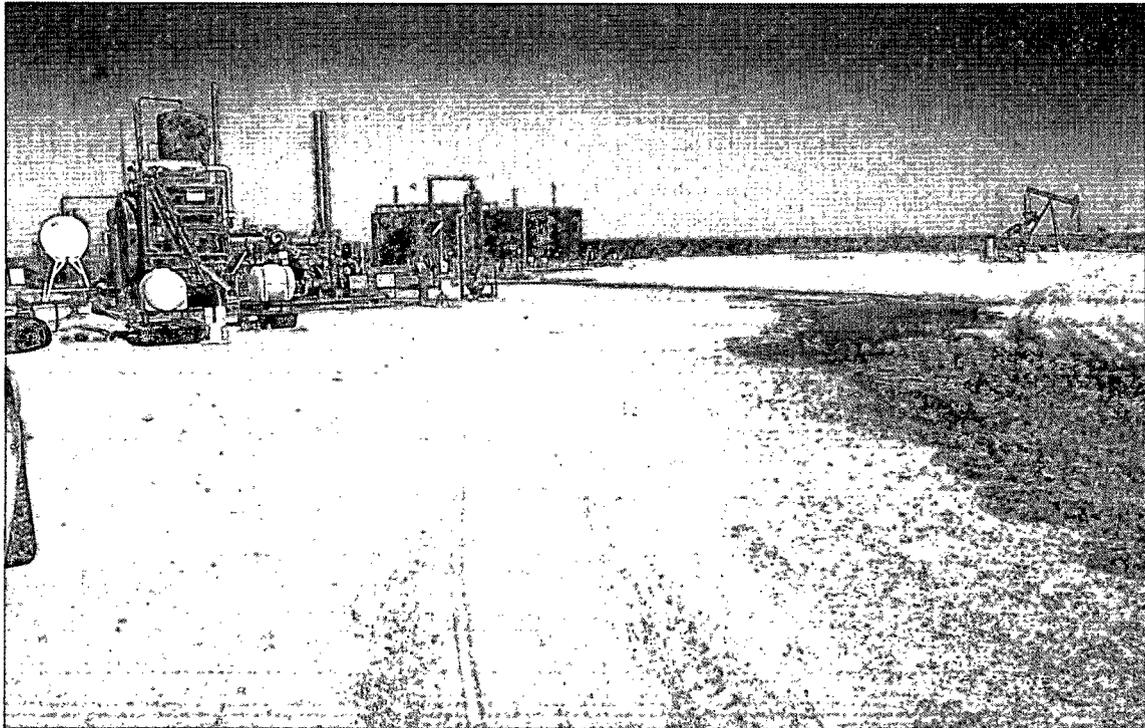
James Ranch Unit #36 Tank Battery - Flow Path at Hudson Federal Battery (Looking Northwest)

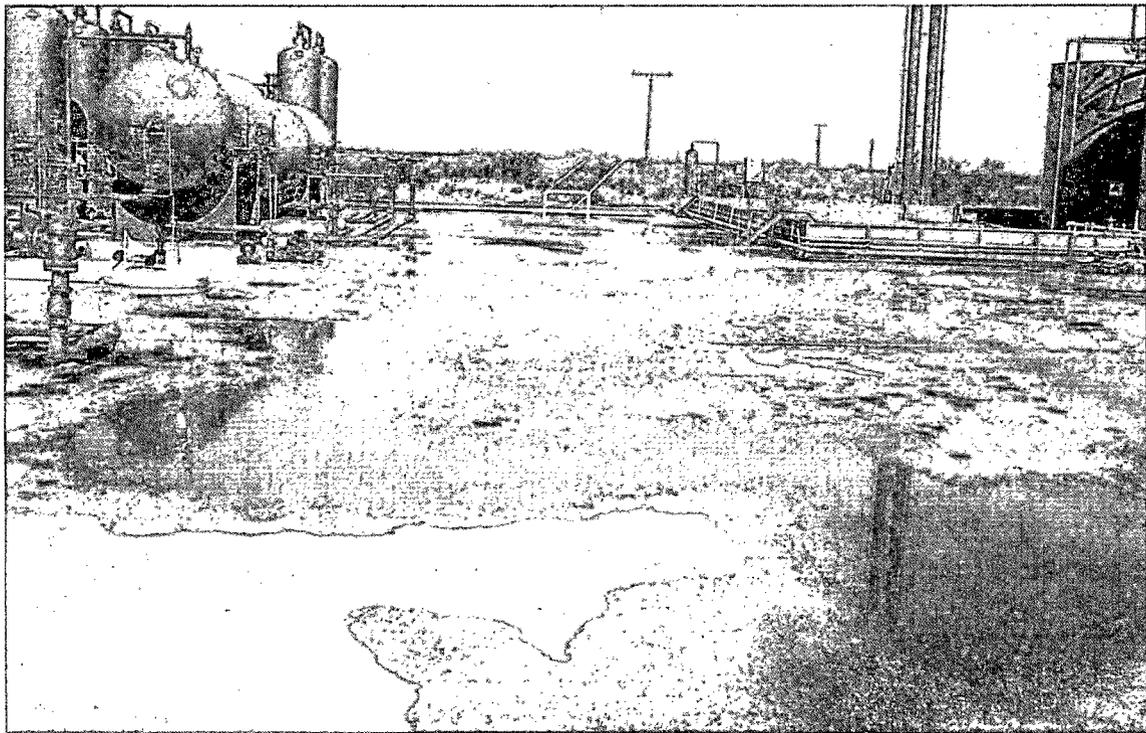
James Ranch Unit #36 Tank Battery - Pooling Area at Hudson Federal Battery (Looking West)

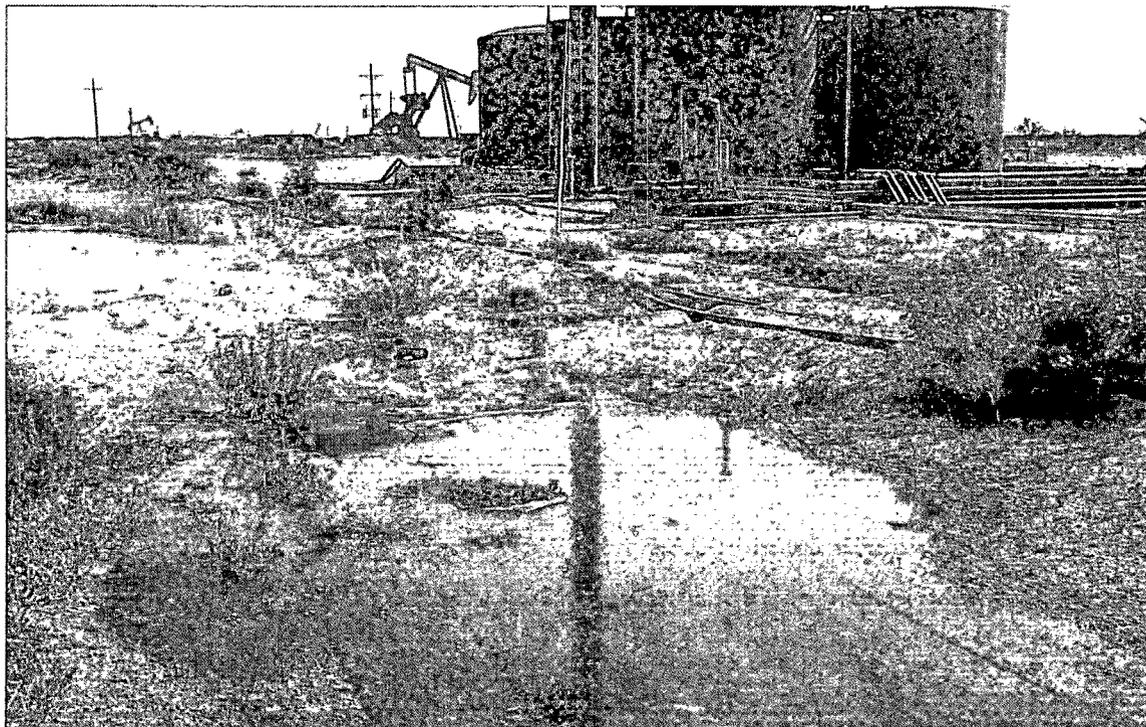
James Ranch Unit #36 Tank Battery - Pooling Area at Hudson Federal Battery
(Looking Northeast)

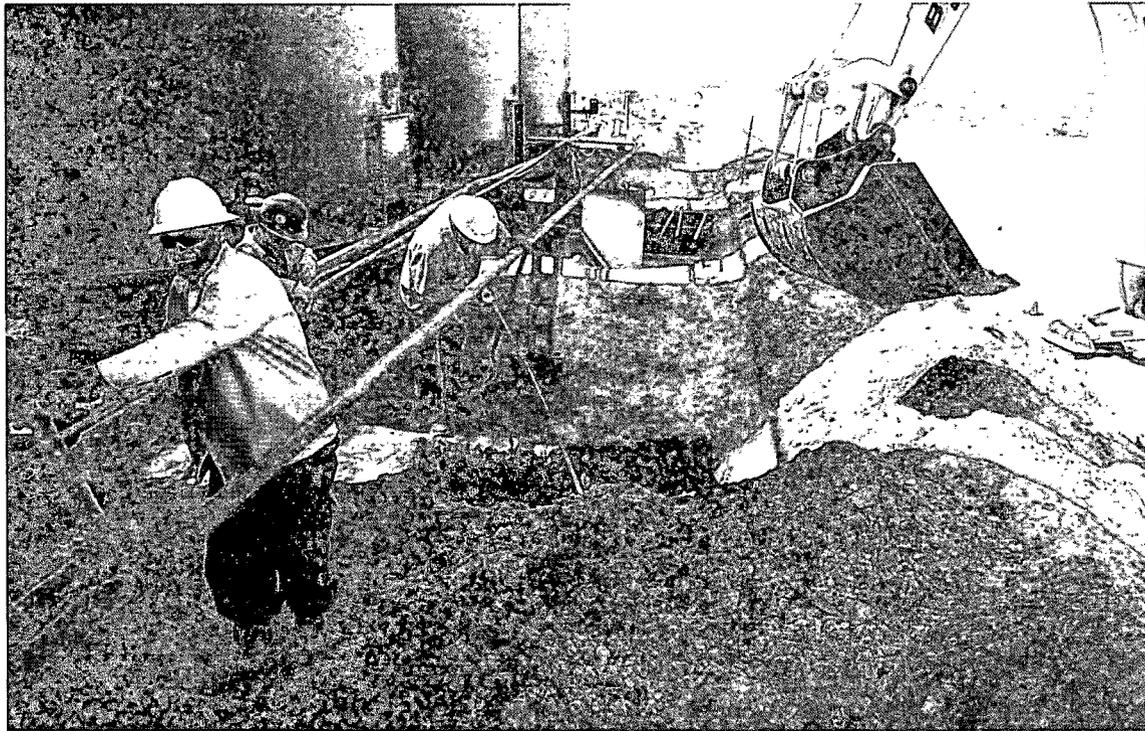
James Ranch Unit #36 Tank Battery - Excavation & Delineation Trenching

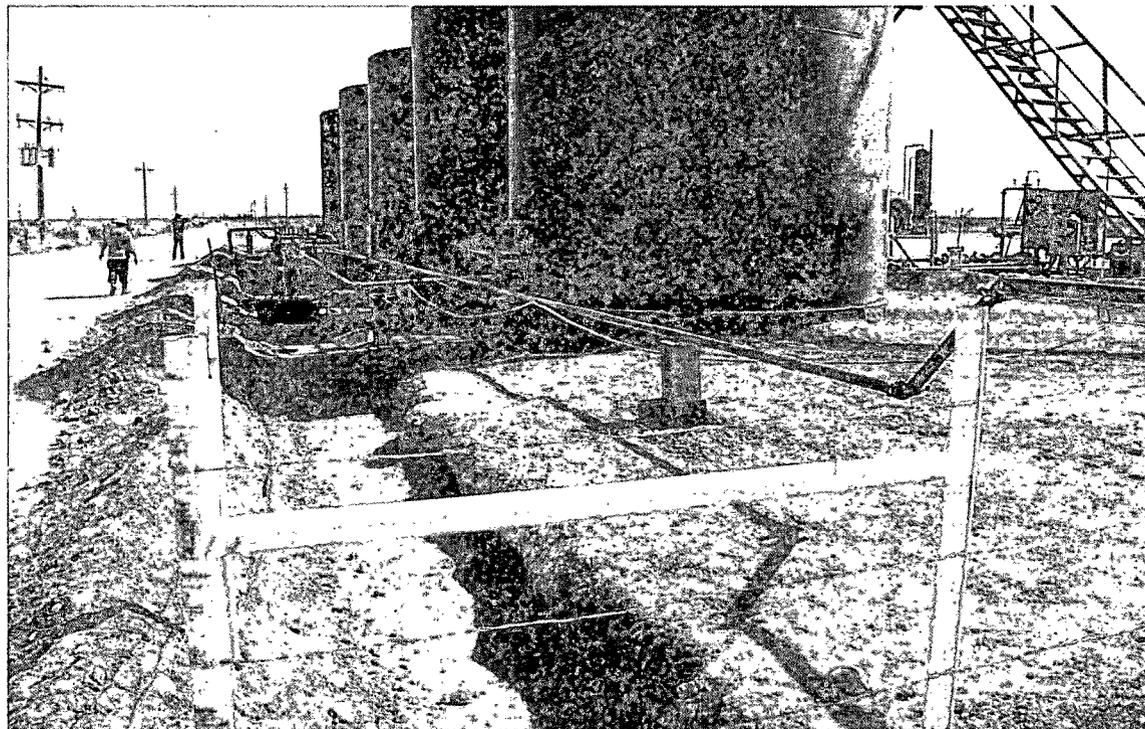
James Ranch Unit #36 Tank Battery - Excavation

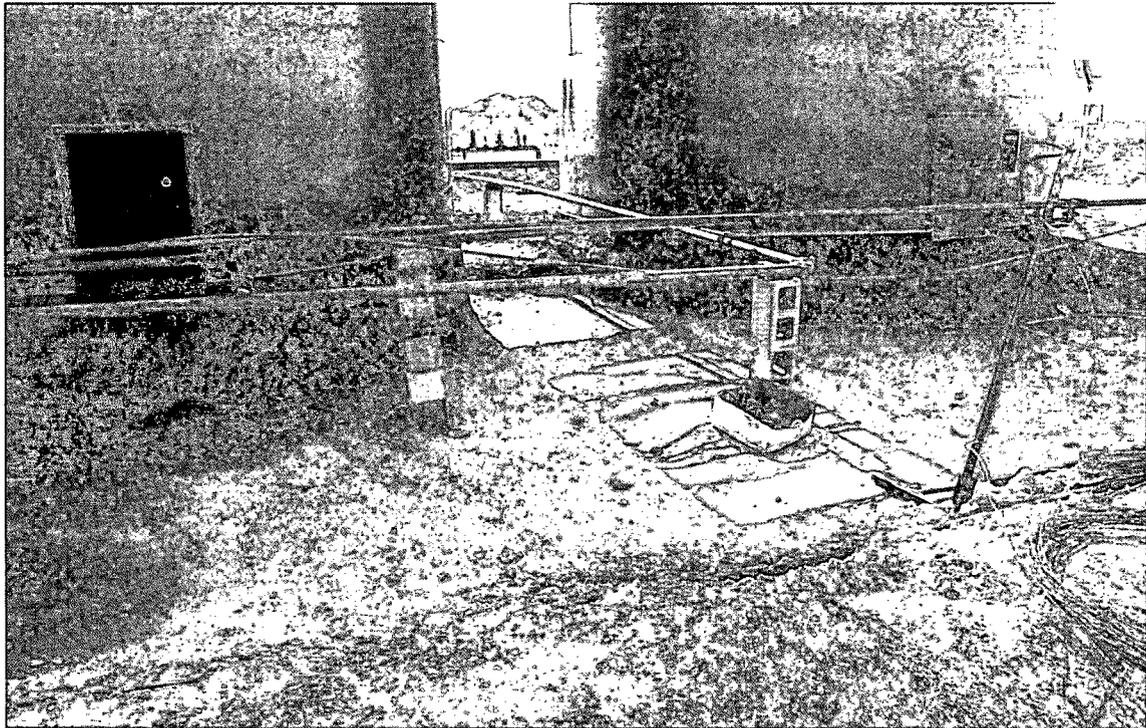
James Ranch Unit #36 Tank Battery - Excavation

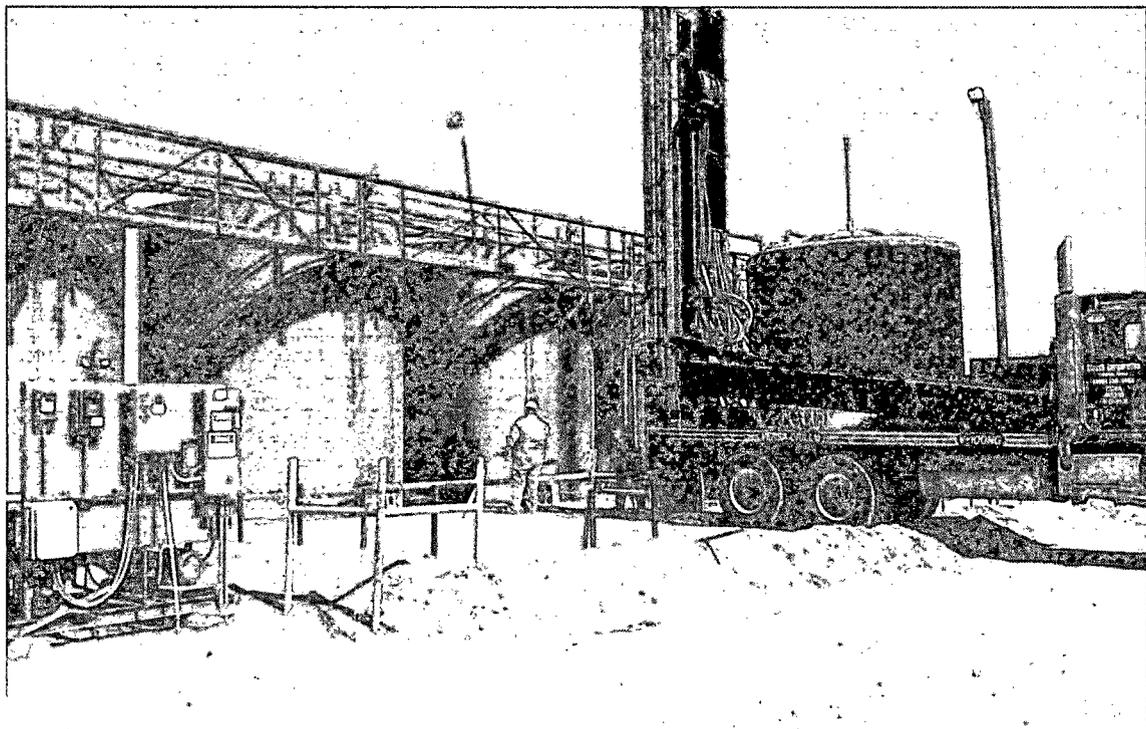
James Ranch Unit #36 Tank Battery - Advancement of Soil Boring SB-1

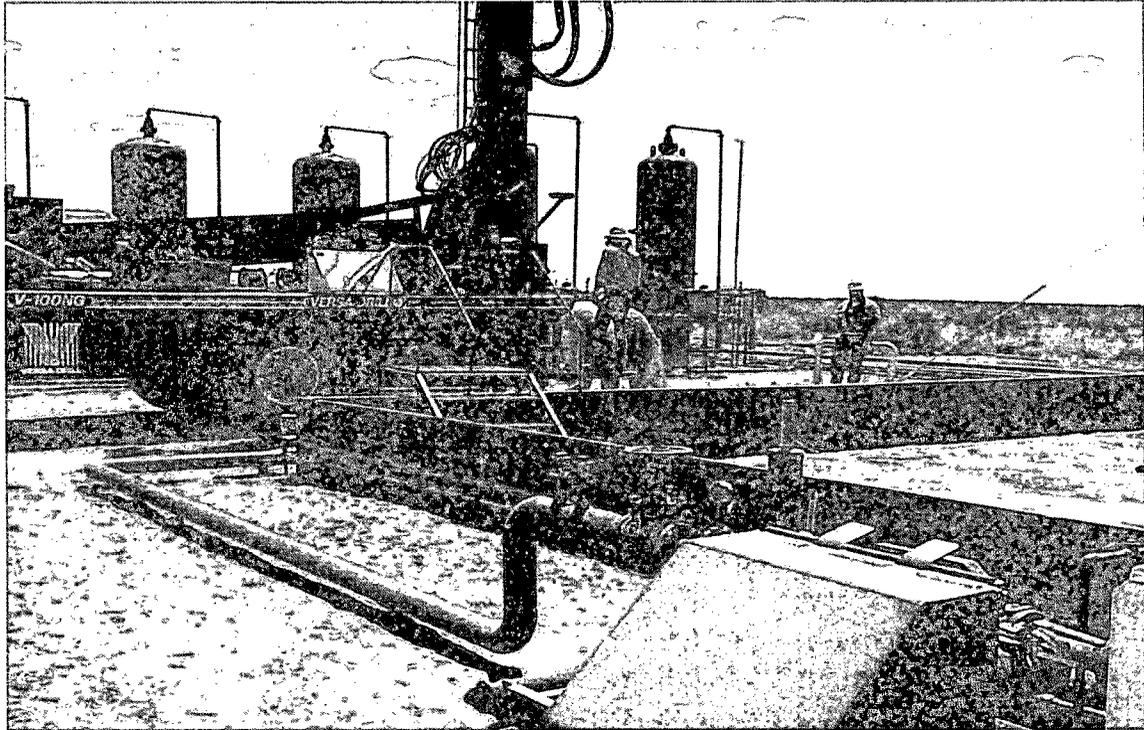
James Ranch Unit #36 Tank Battery - Advancement of Soil Boring SB-4

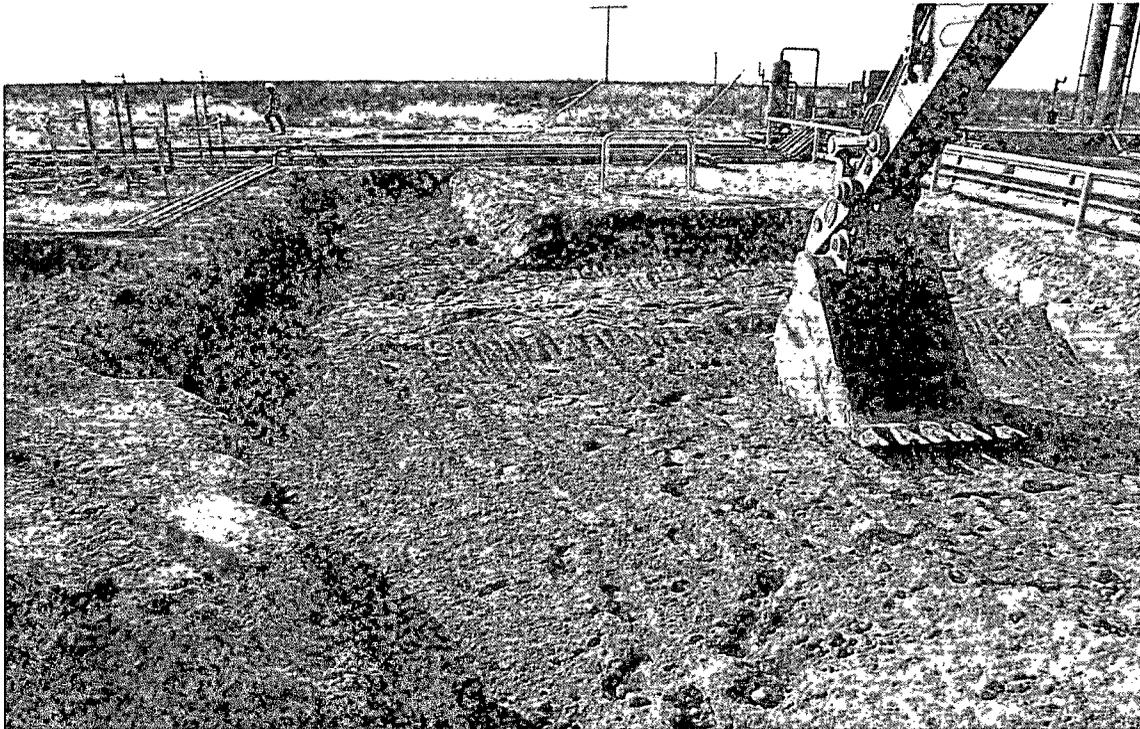
James Ranch Unit #36 Tank Battery - Hudson Federal Battery Excavation

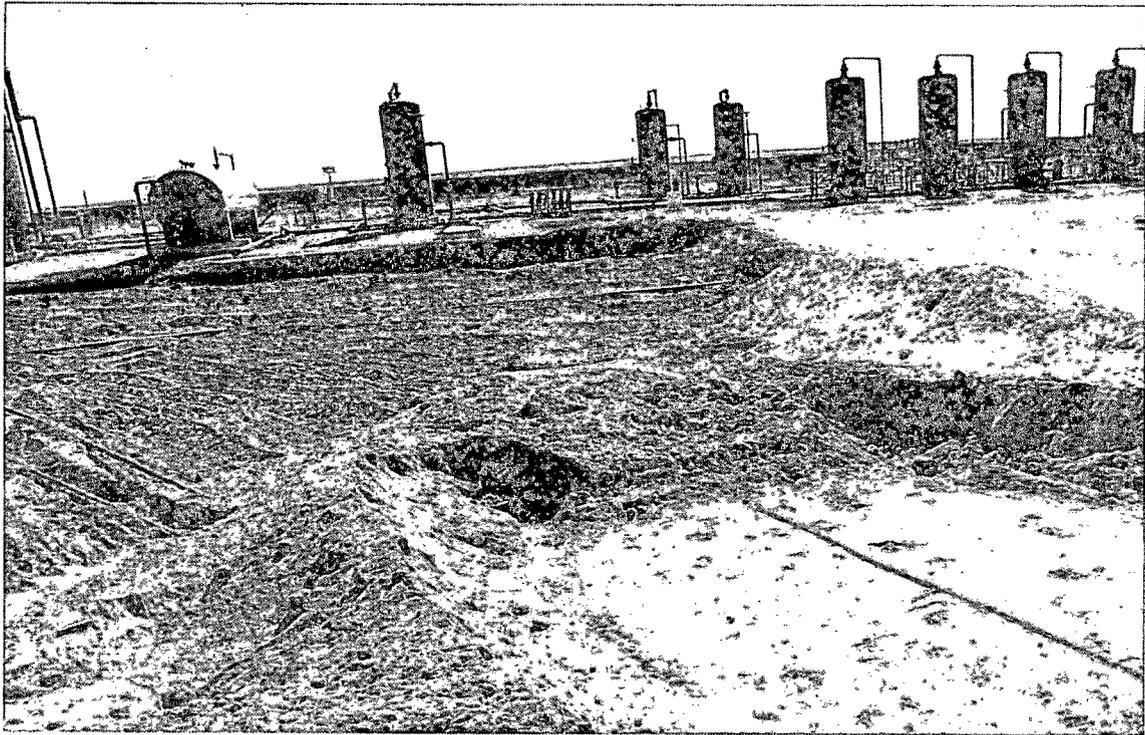
James Ranch Unit #36 Tank Battery - Hudson Federal Battery Excavation

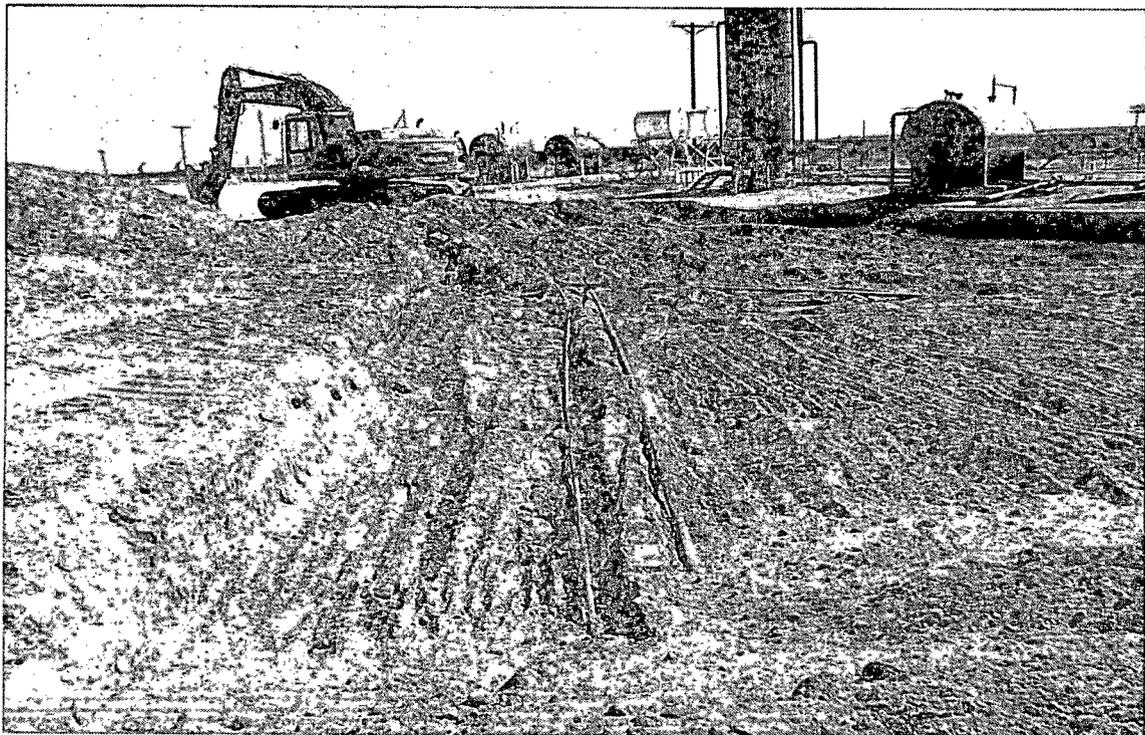
James Ranch Unit #36 Tank Battery - Hudson Federal Battery Excavation

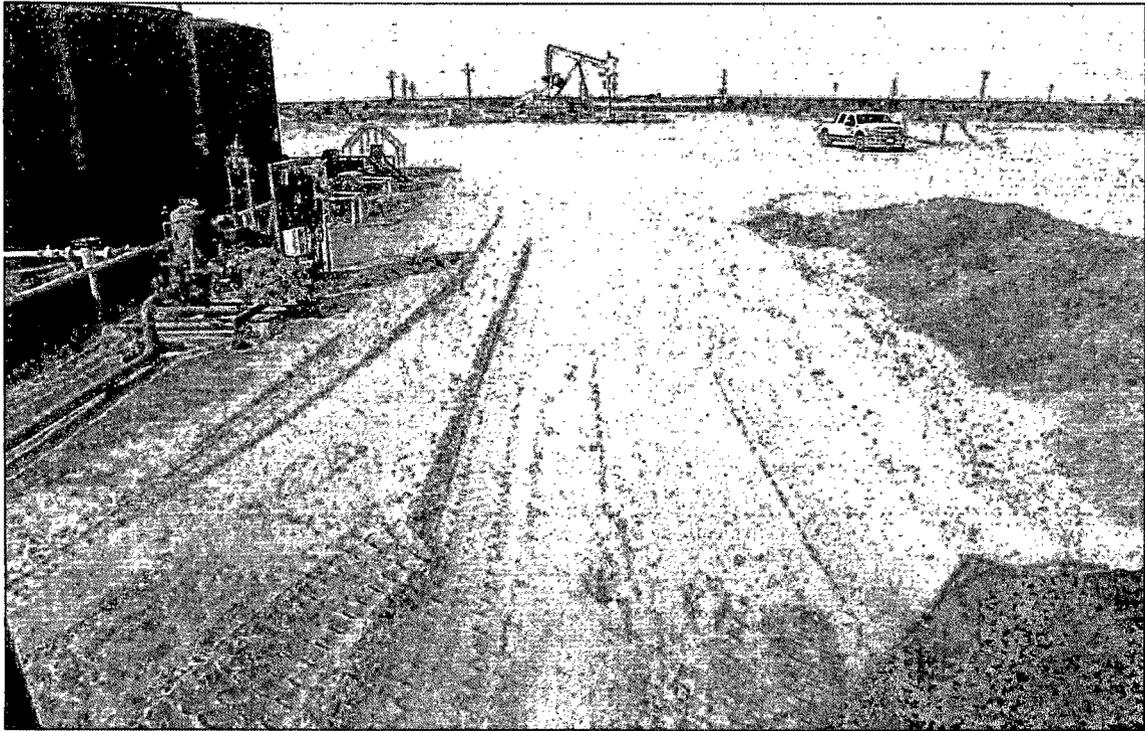
James Ranch Unit #36 Tank Battery - Hudson Federal Battery Excavation (During Backfilling)

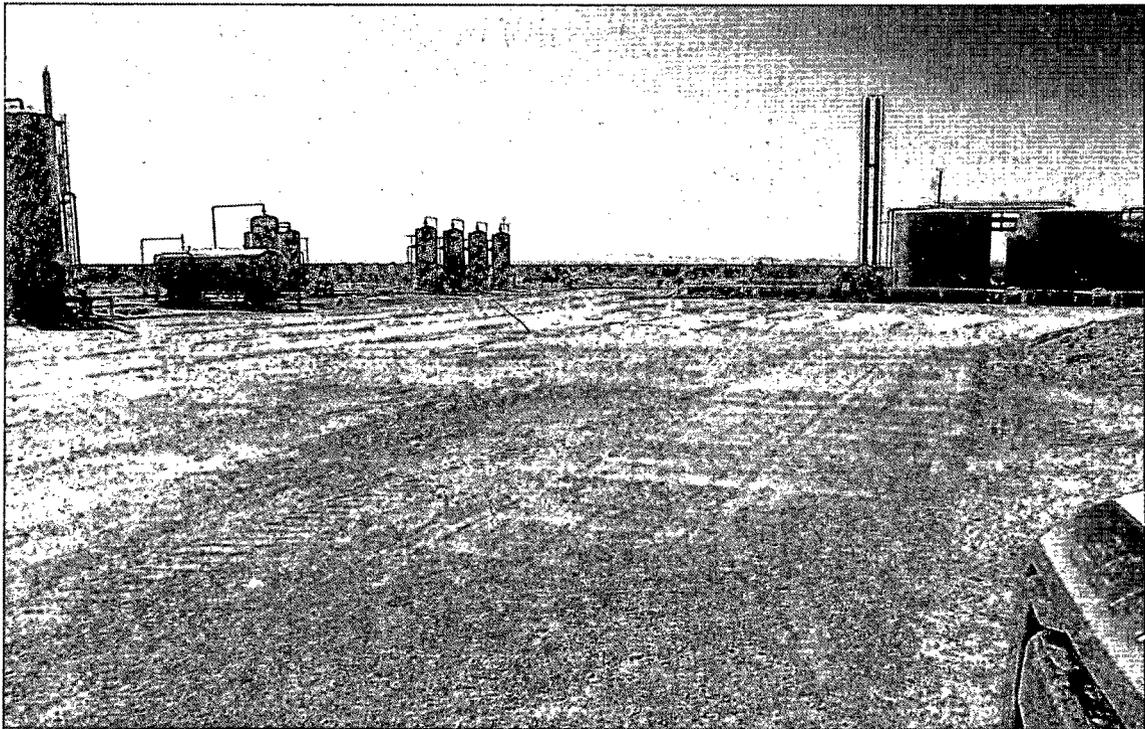
James Ranch Unit #36 Tank Battery - Hudson Federal Battery Excavation
(Following Backfilling)

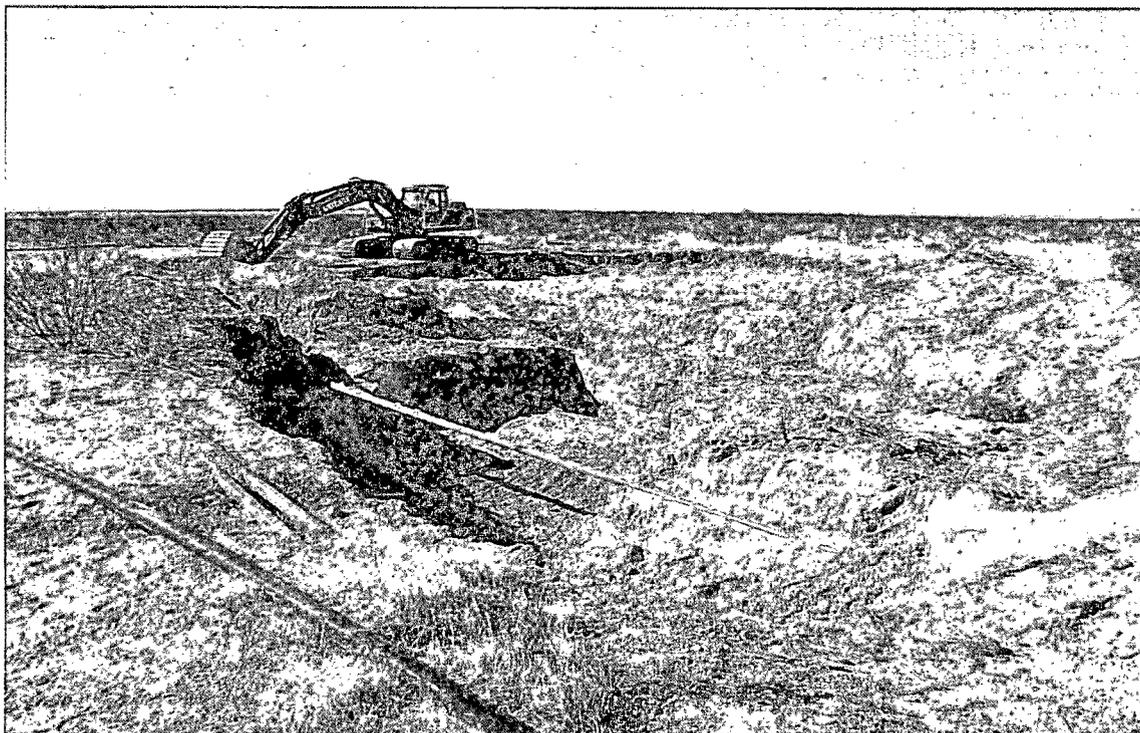
James Ranch Unit #36 Tank Battery - Pooling Area Excavation at Hudson Federal Battery

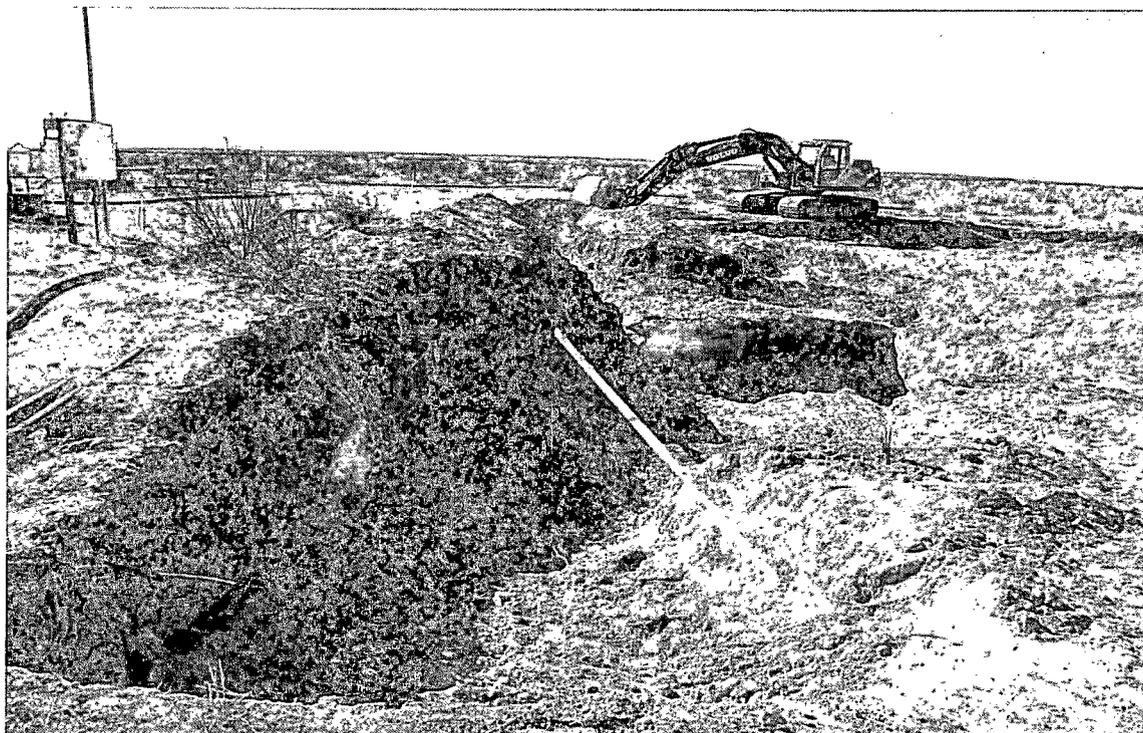
James Ranch Unit #36 Tank Battery - Pooling Area Excavation at Hudson Federal Battery

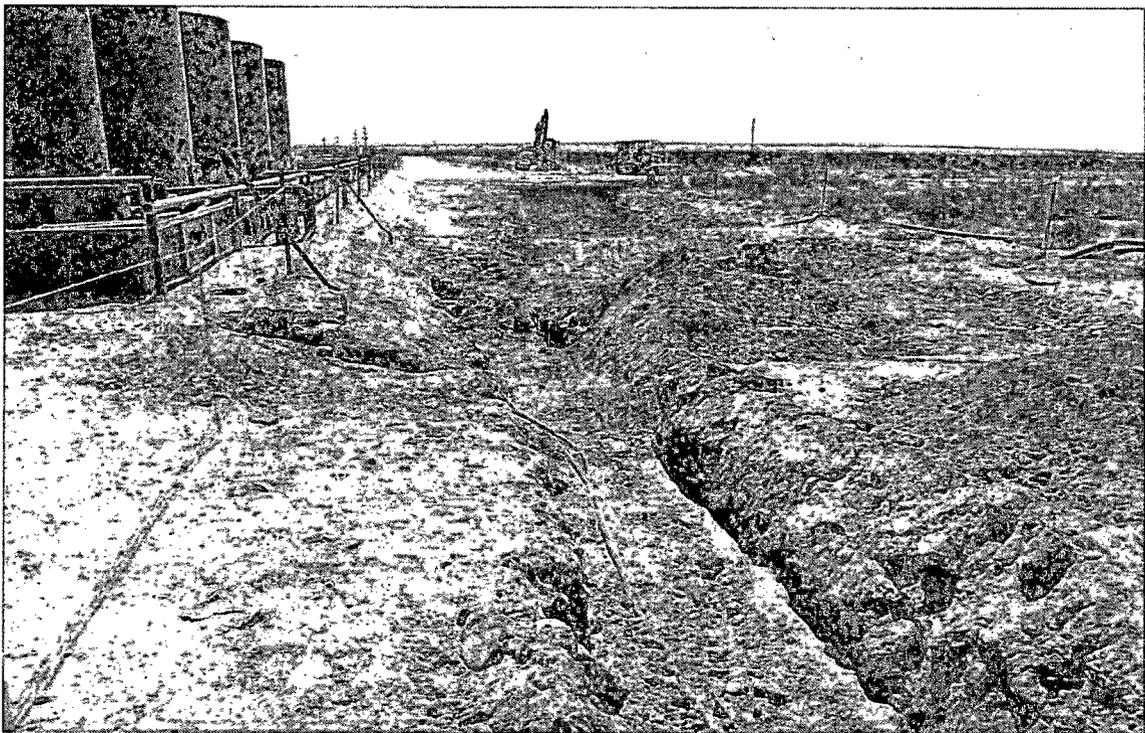
James Ranch Unit #36 Tank Battery - Excavation
(Following Installation of Steel Containment Area)
