**Permanent  
Pit**

**Closure  
Report**

## **Permanent Pit Closure Report**

**XTO Energy, Inc.  
North Vacuum Abo Unit, North Water Station  
Unit F (SE/4, NW/4), Section 14, T17S, R34E  
Lea County, NM**

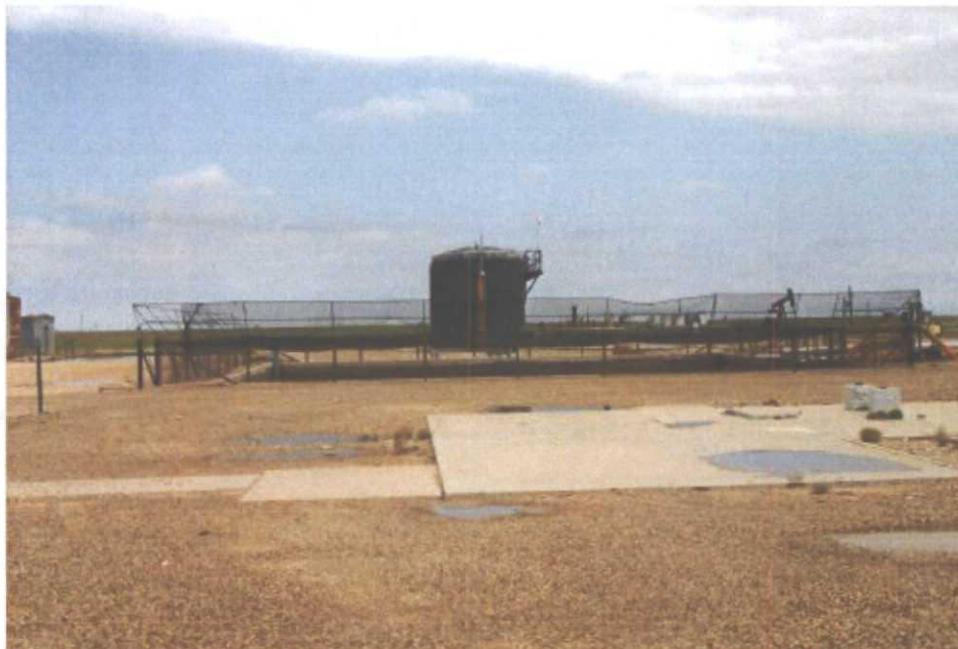
Permanent Pit Prior to Closure Activities

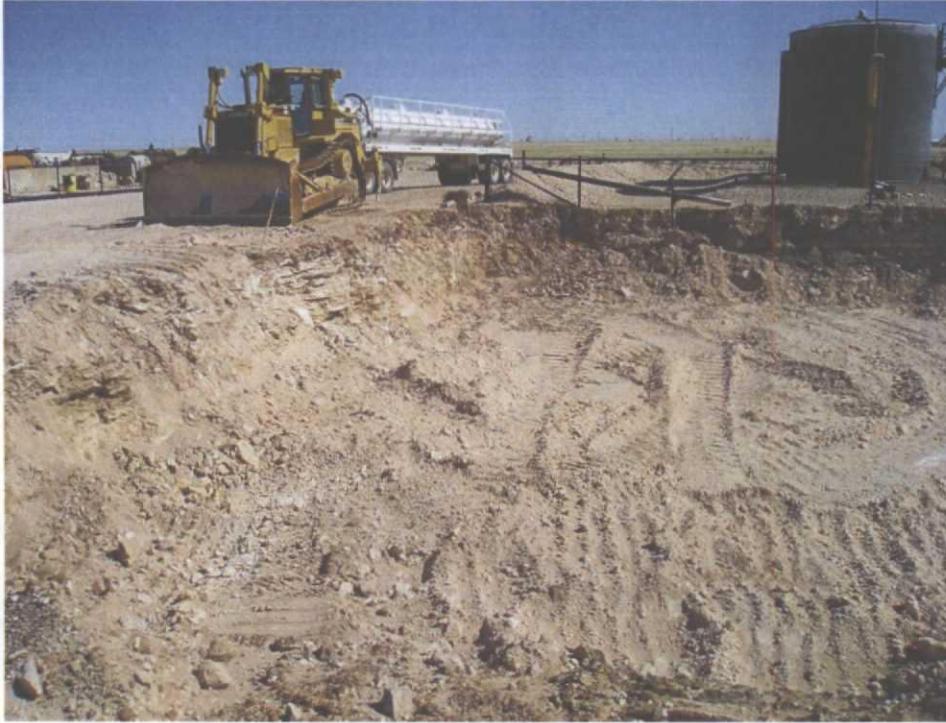
Pit Closure Following Concrete Removal

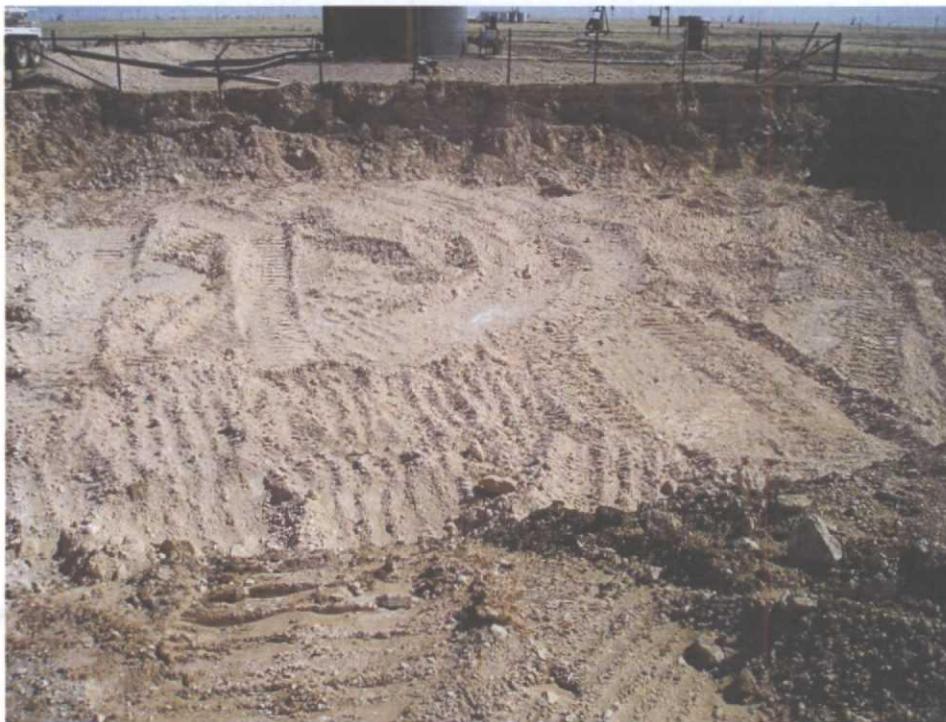
Another View of Pit Closure Following Concrete Removal

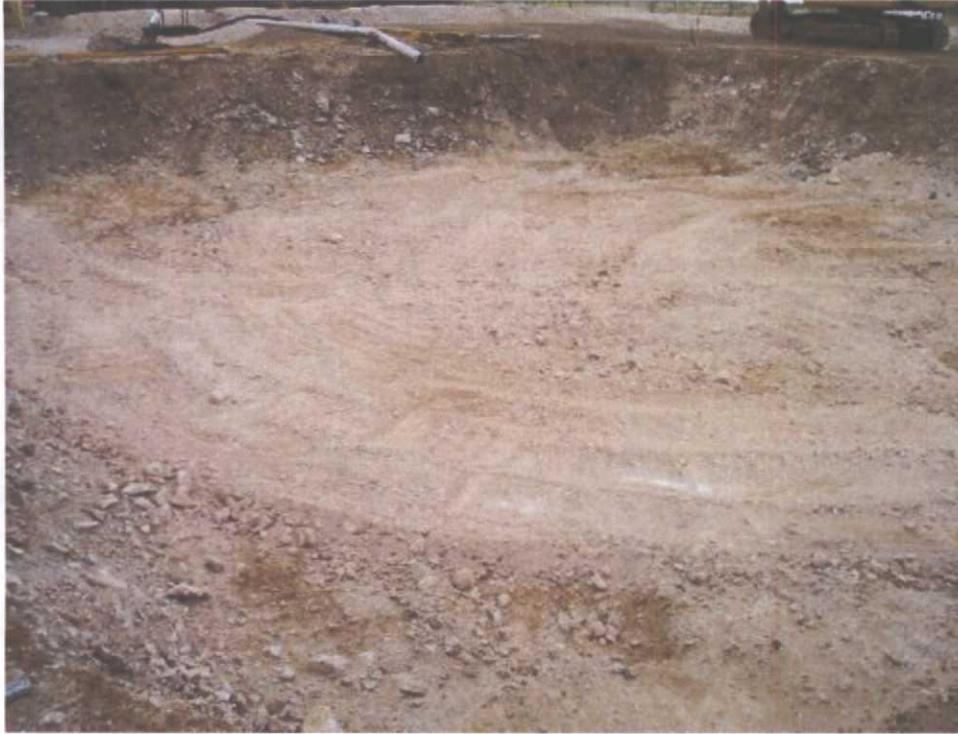
Pit Prepared for Liner Installation

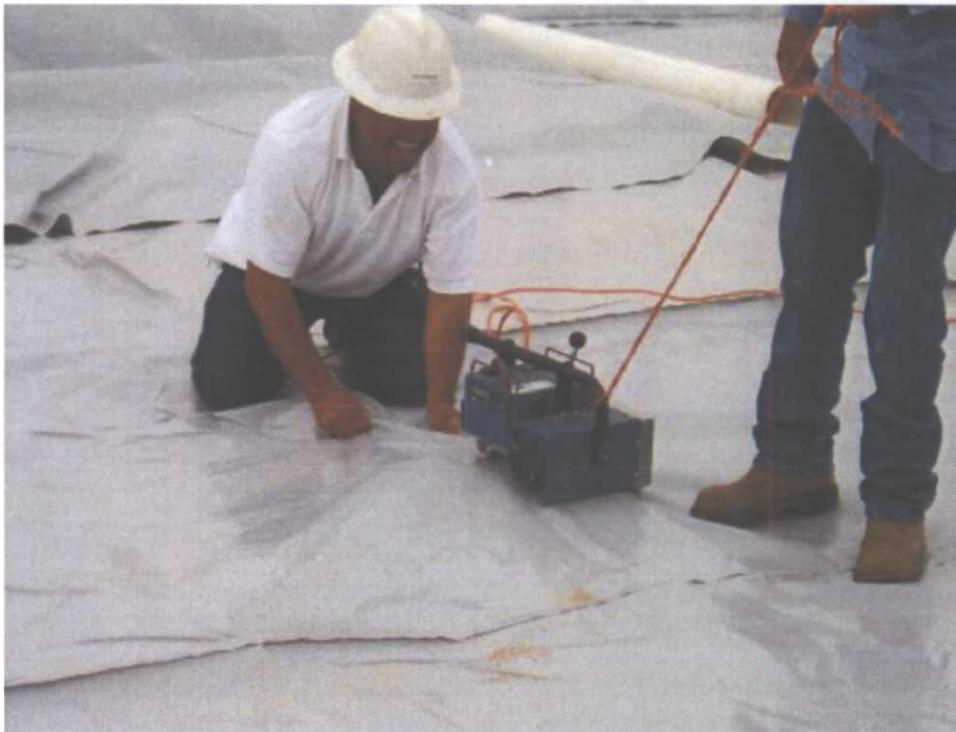
Seaming Liner for Installation

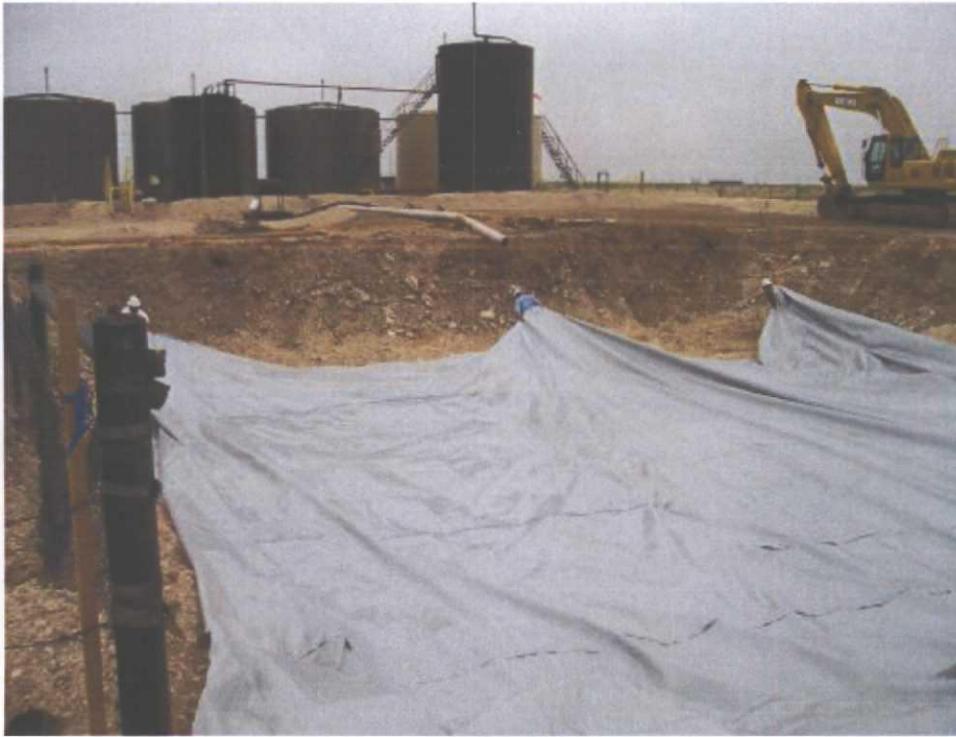
Liner Being Placed into Pit

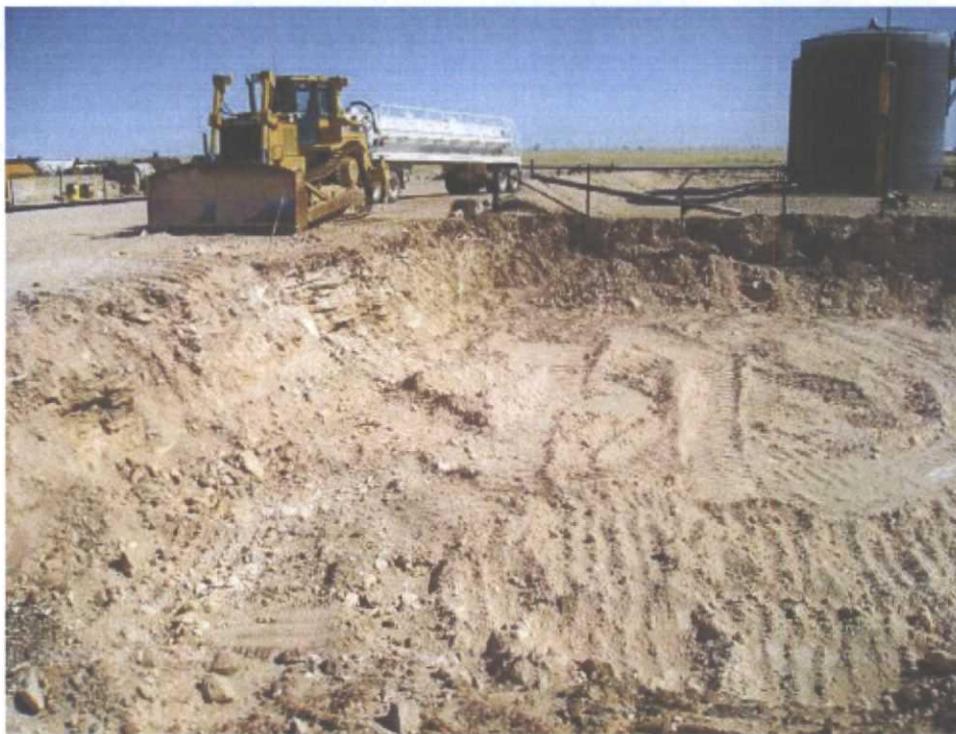
Backfilling Excavation

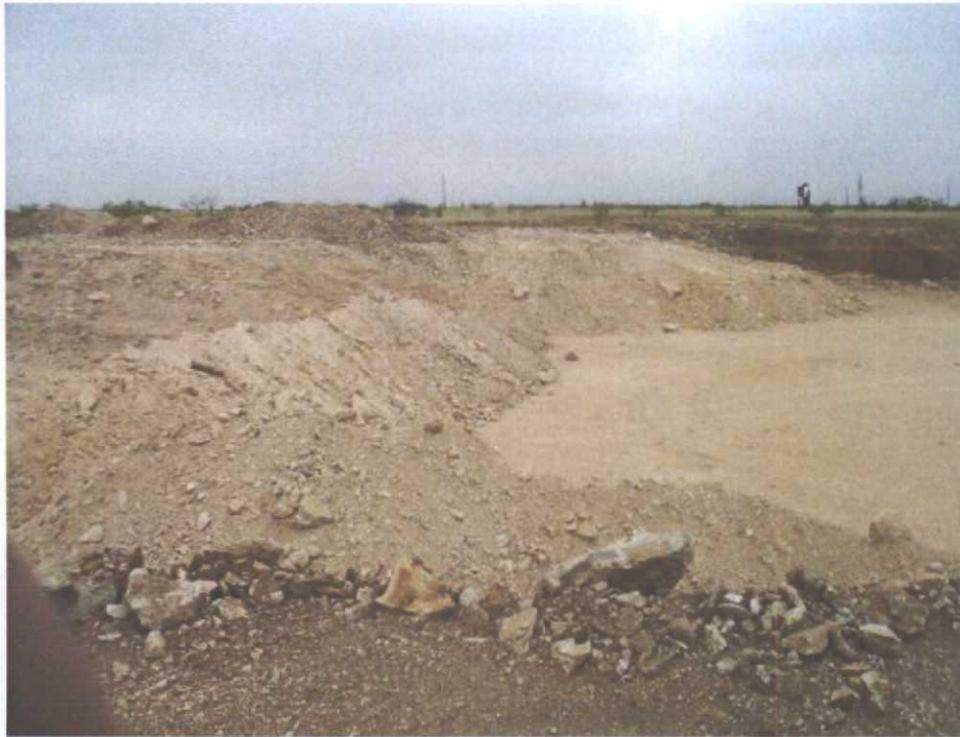
Terraforming Excavation

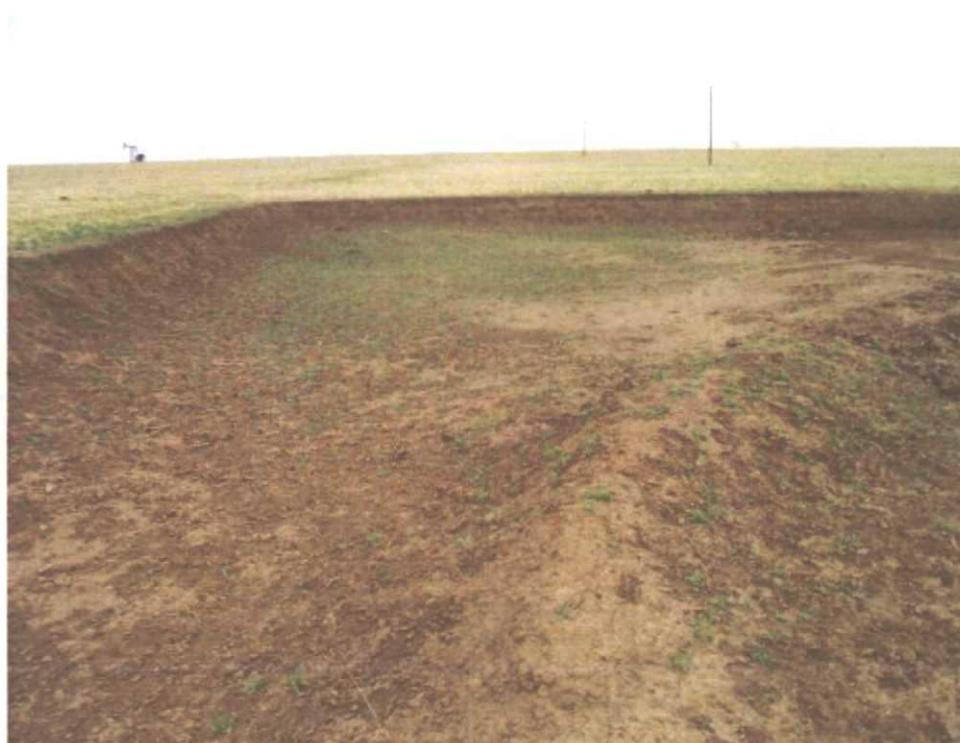
Growth on Site

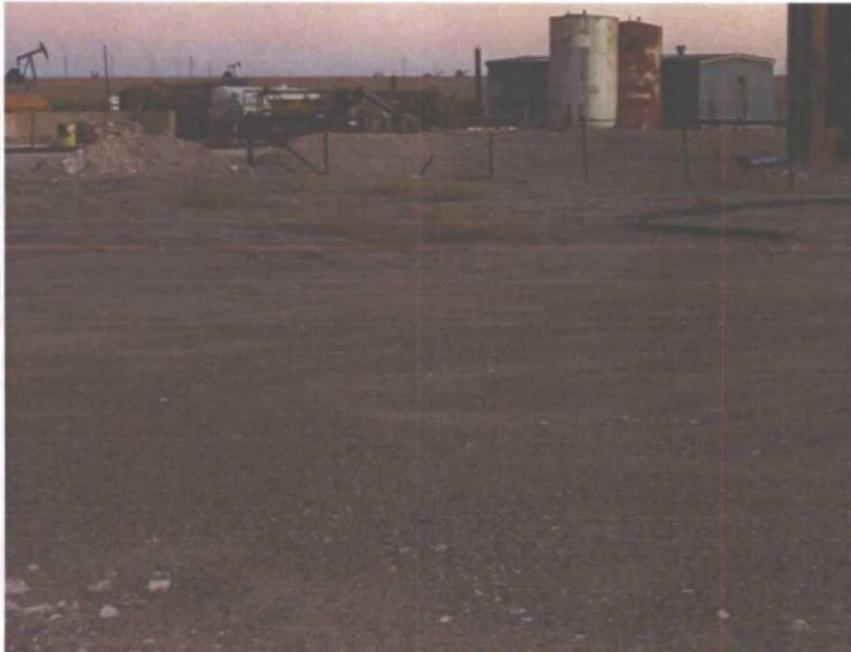
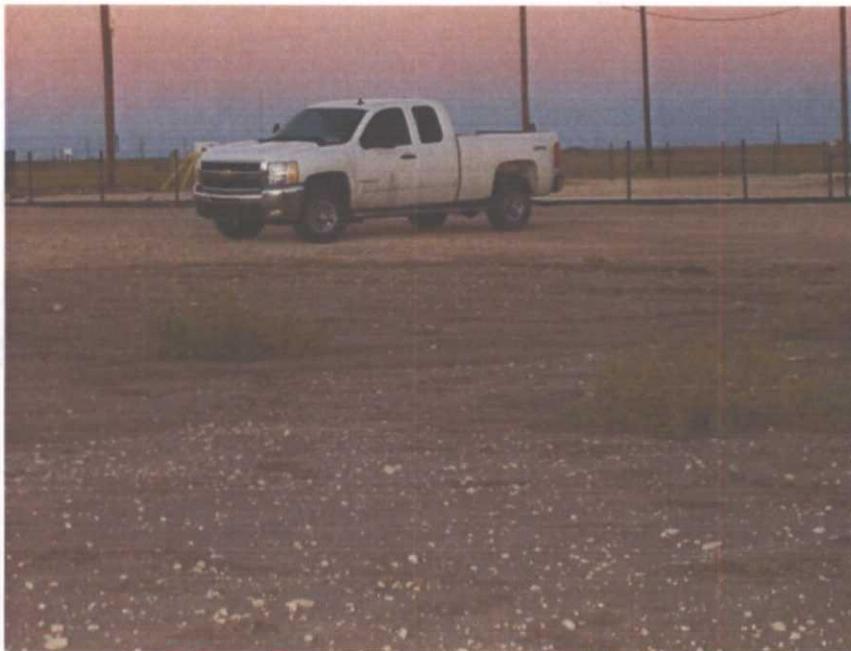
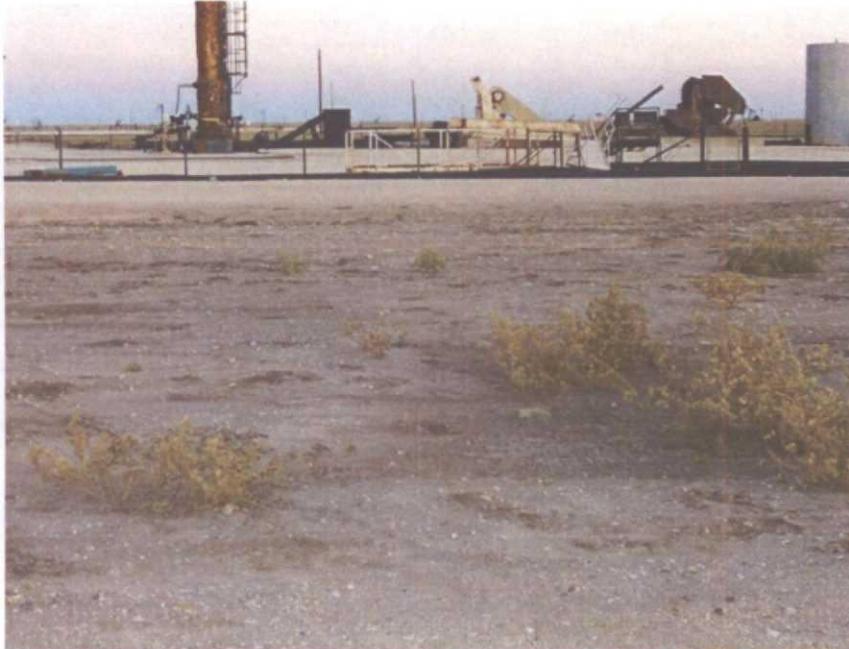
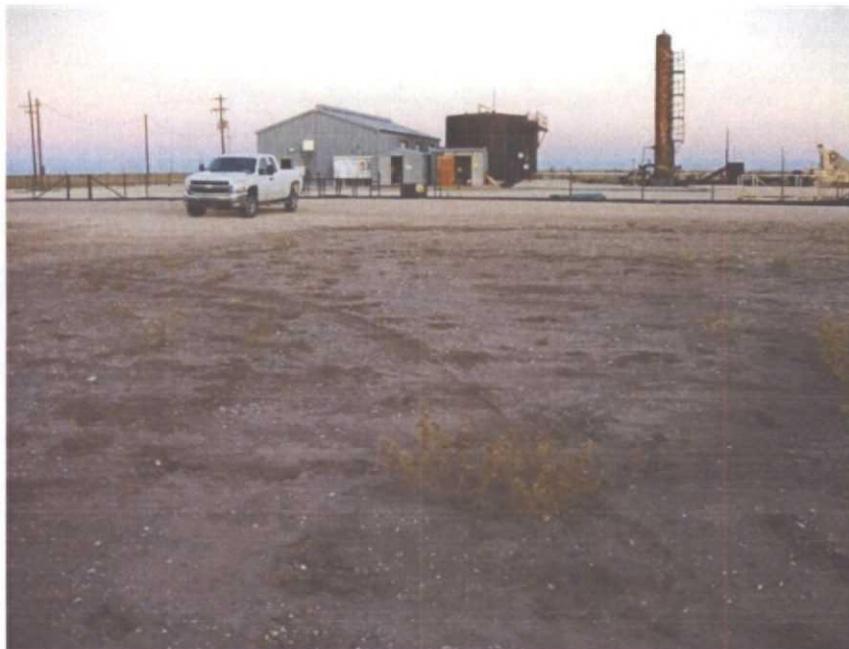
Addendum view of closed pit

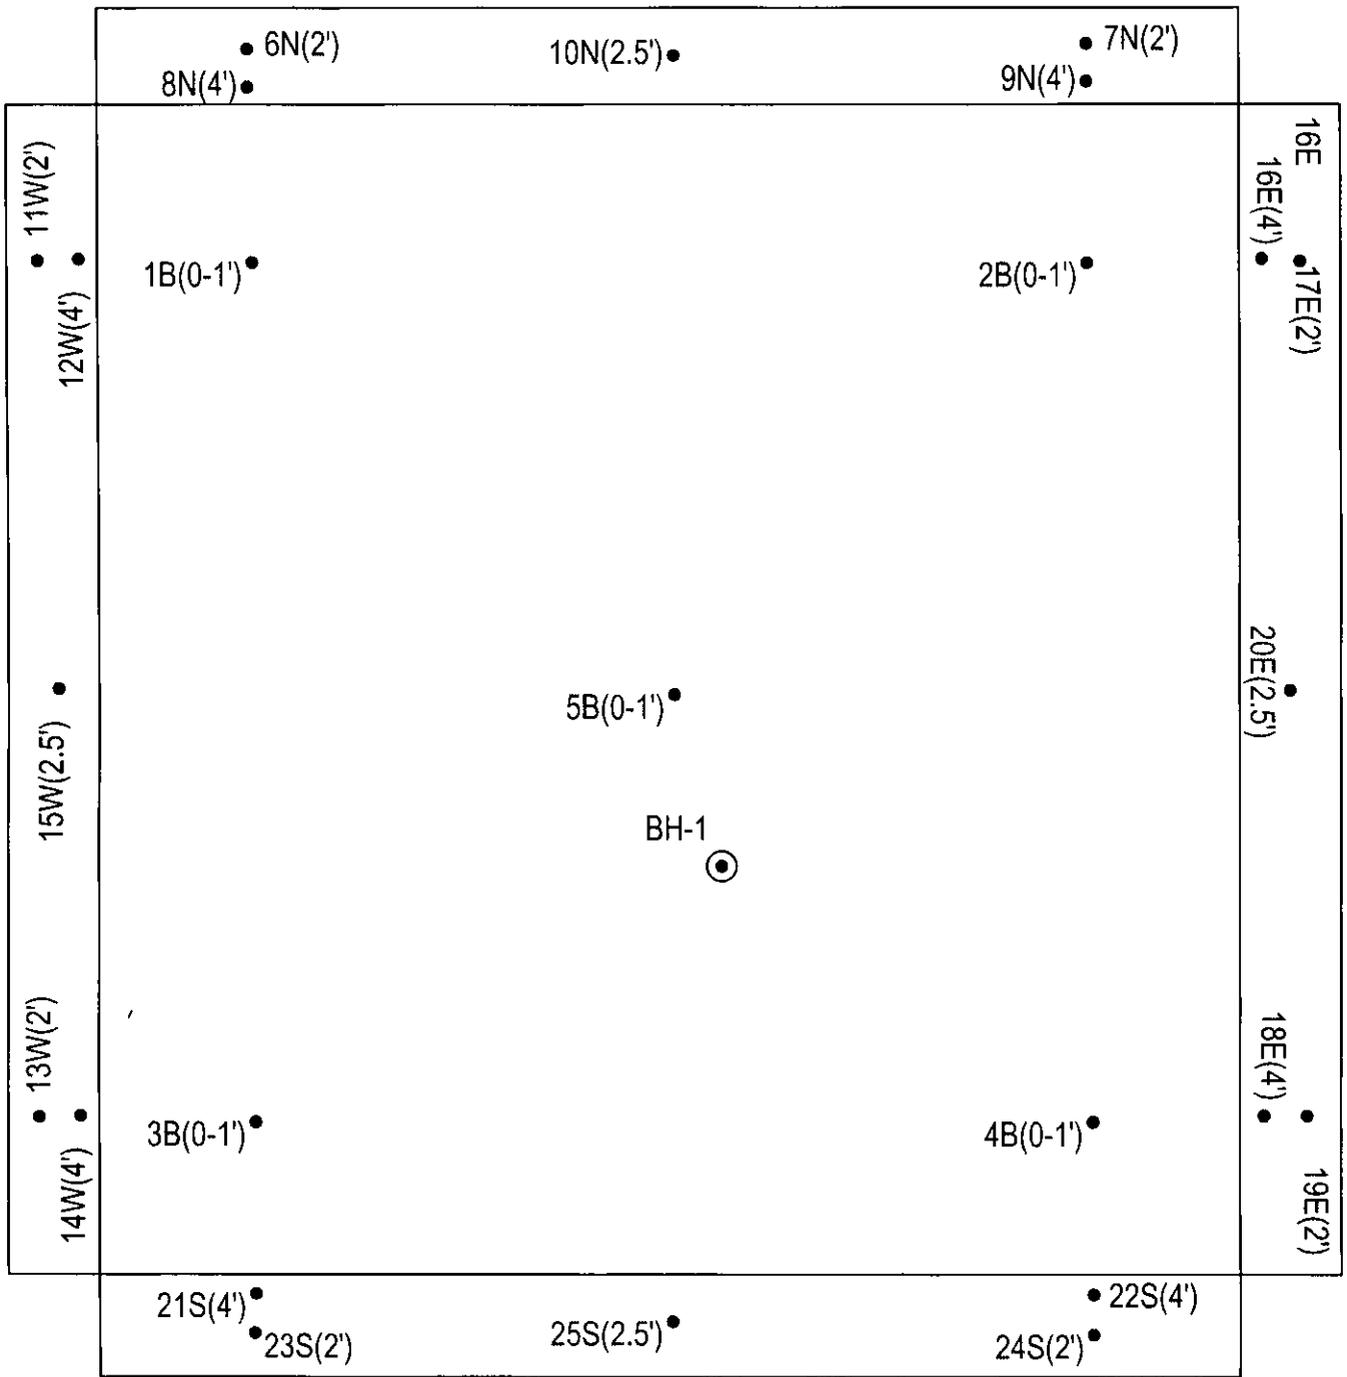
- 5B(0-1') • - Soil Sample Location And Depth, Feet
- BH-1 ⊙ - Soil Boring Location

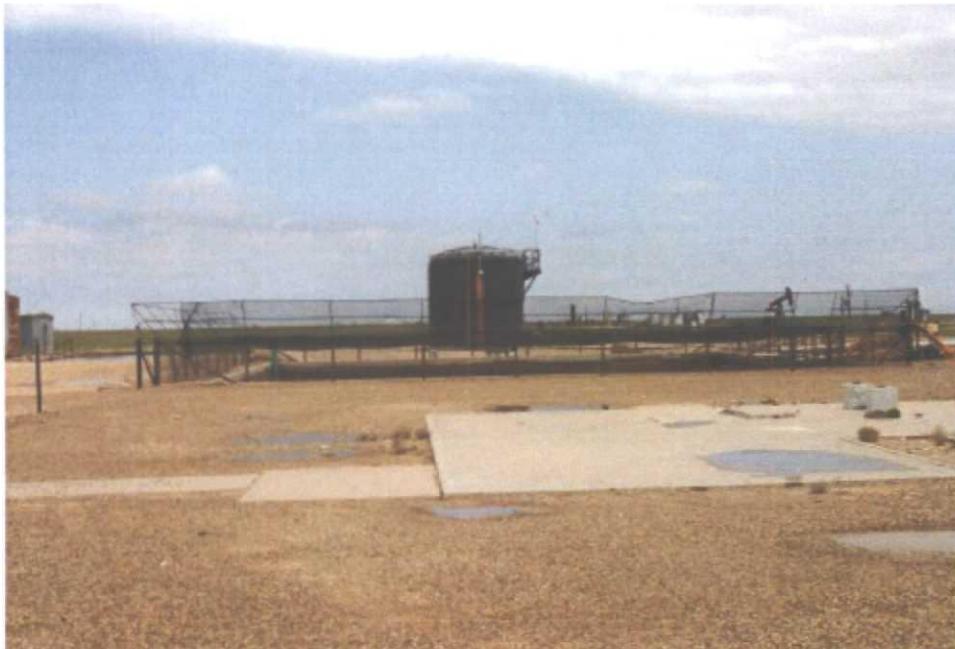
Permanent Pit Prior to Closure Activities

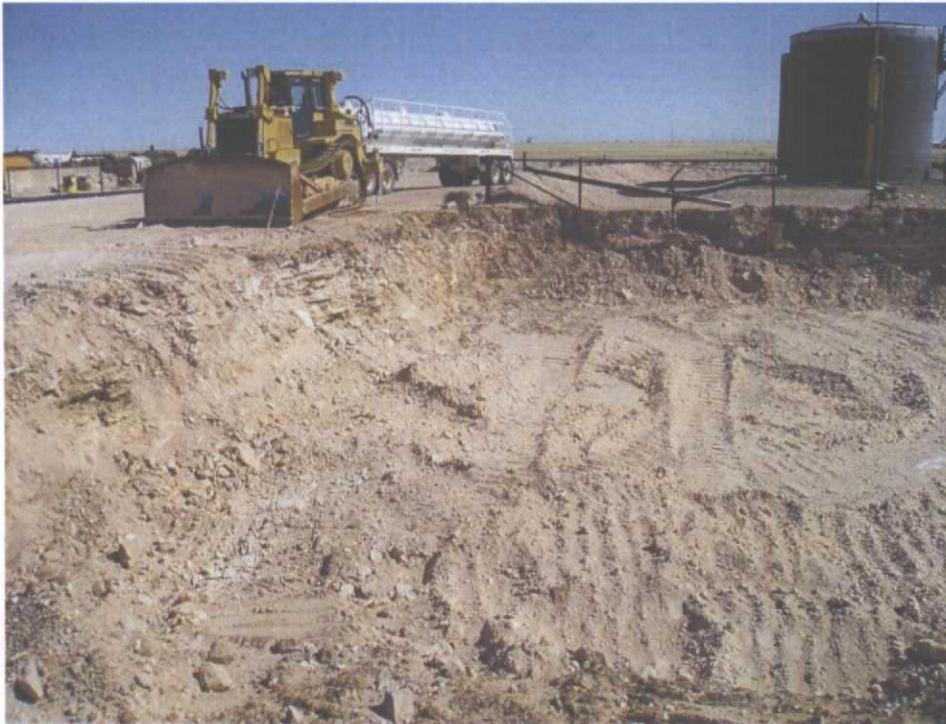
Pit Closure Following Concrete Removal

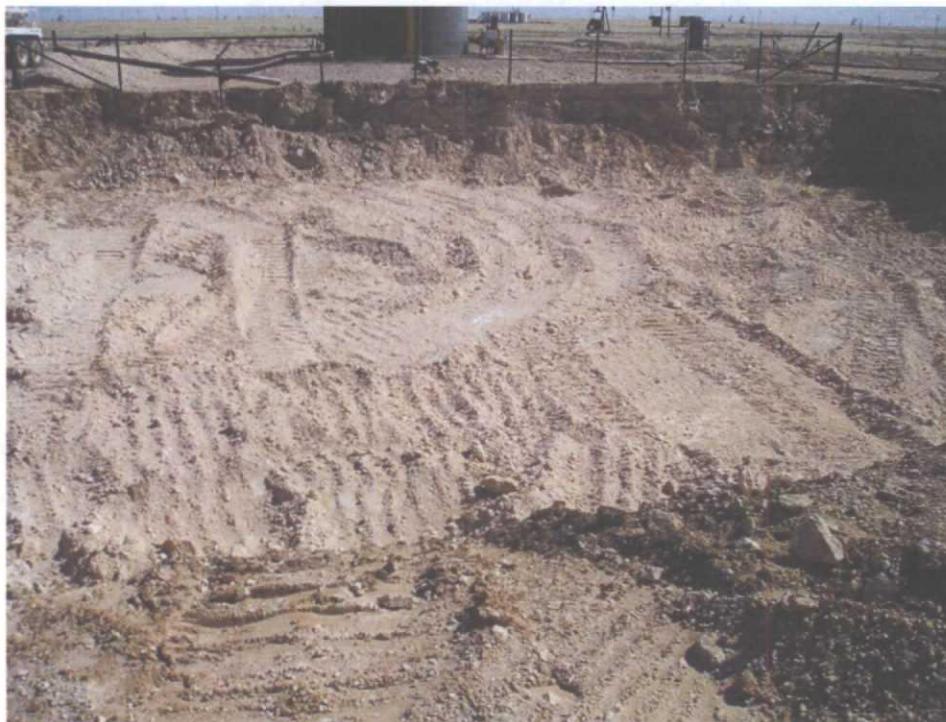
Another View of Pit Closure Following Concrete Removal

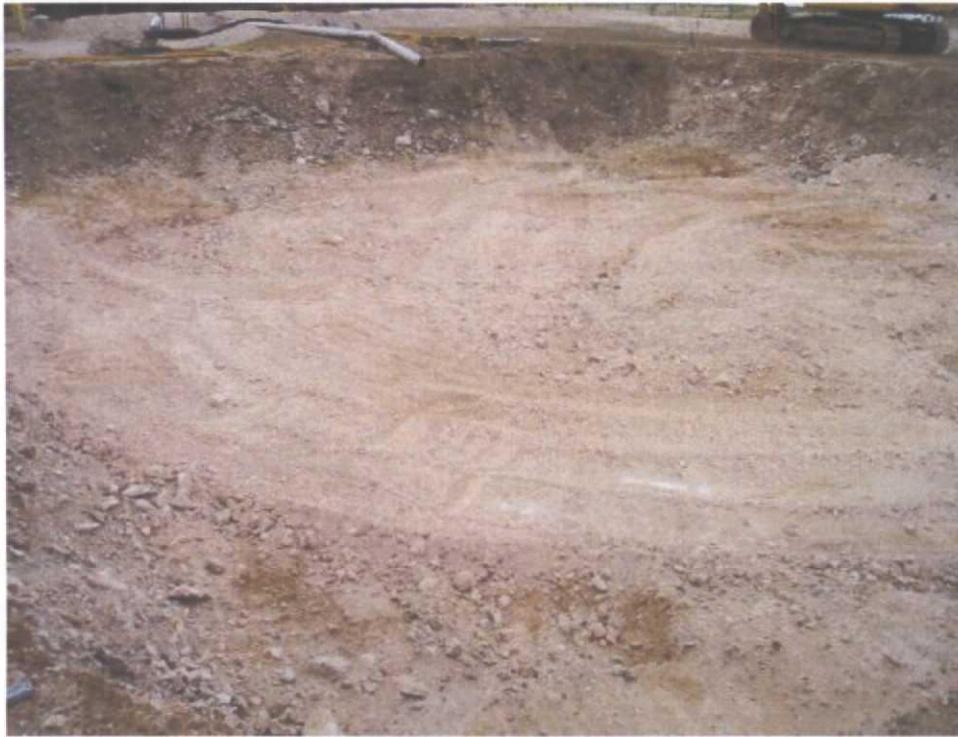
Pit Prepared for Liner Installation

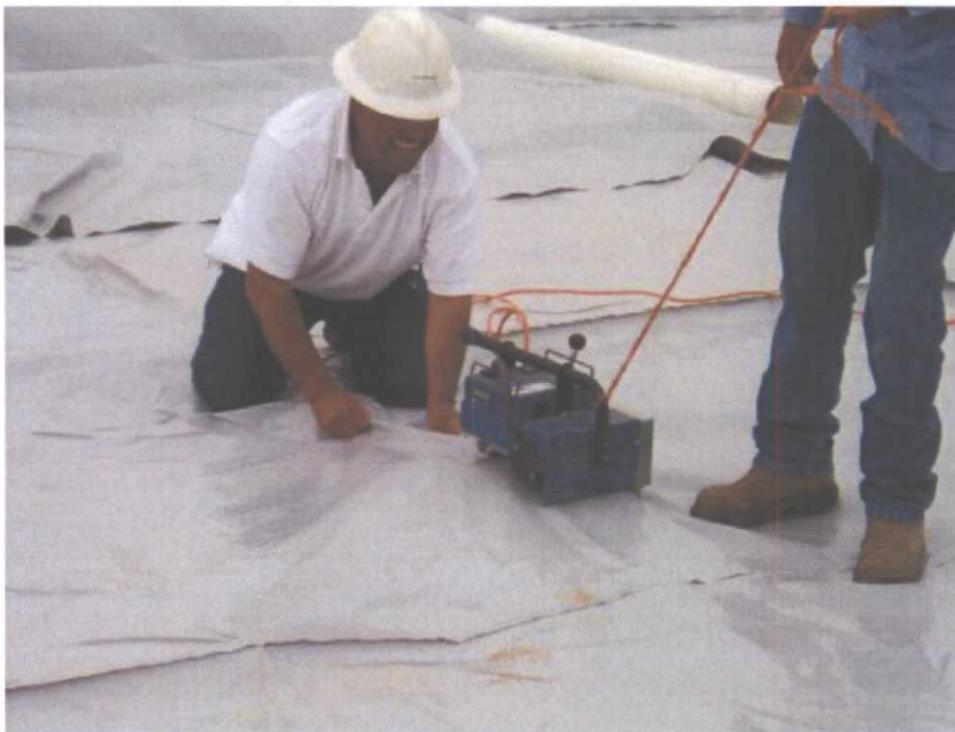
Seaming Liner for Installation

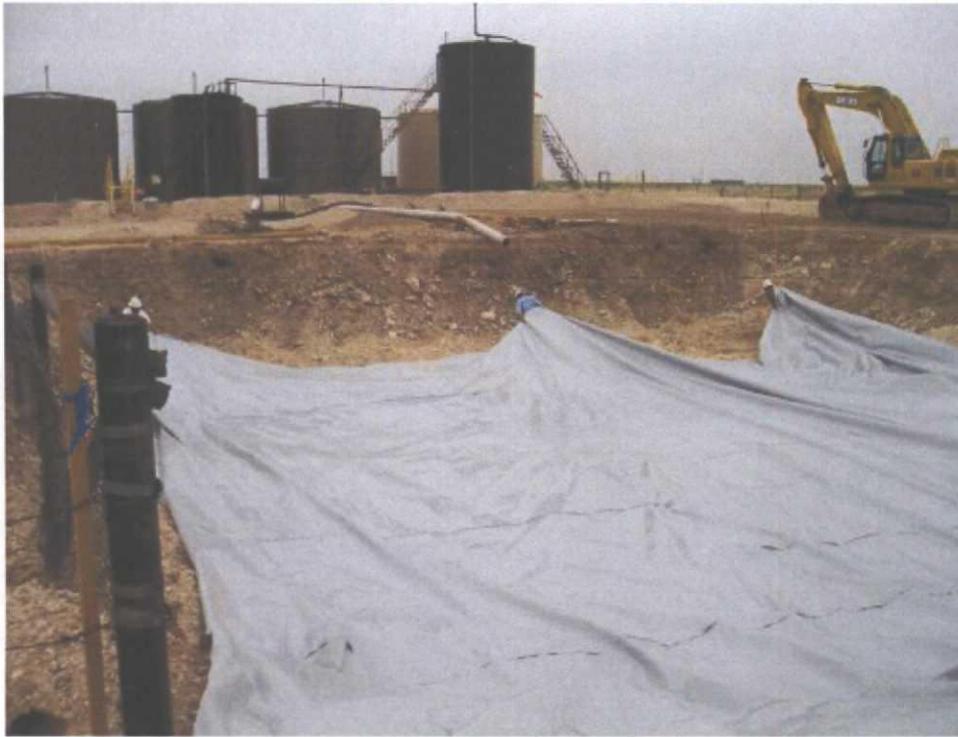
Liner Being Placed into Pit

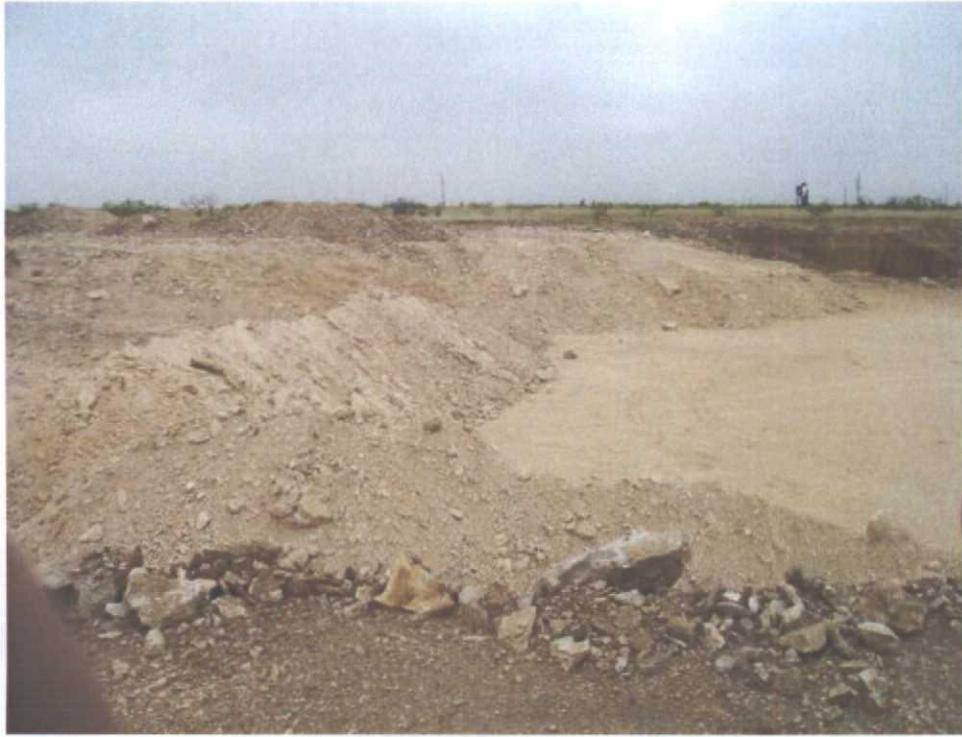
Terraforming Excavation

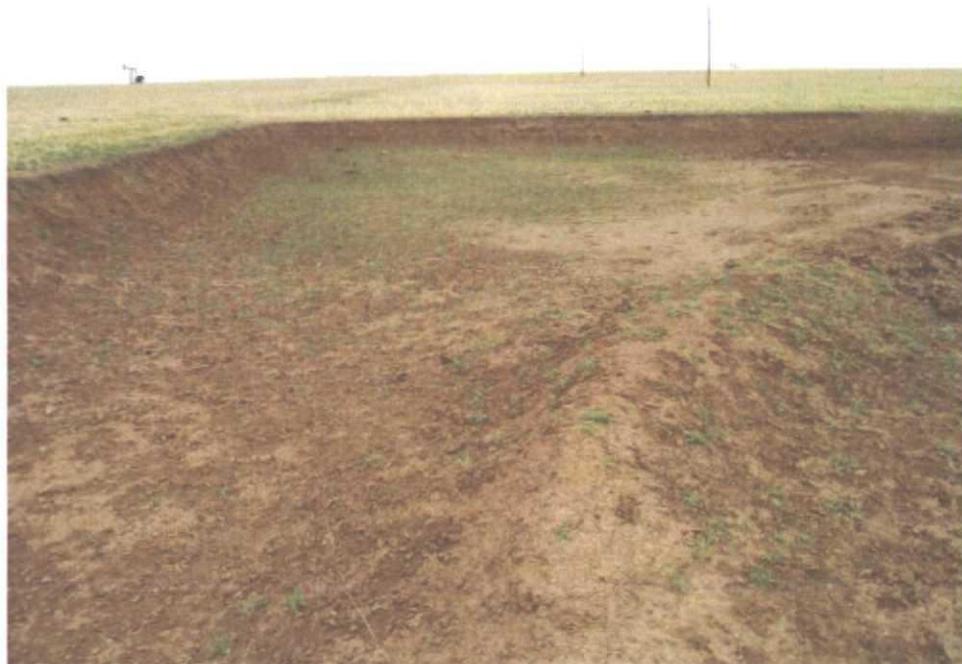
Growth on Reseeded Site
