**3R-1011**

**Release Report/ General  
Correspondence**

**Enterprise SJ**

Enterprise Products  
Lateral 2A-3 Pipeline Release  
Latitude North 36.55191, Longitude West -107.88884  
NW1/4, NW1/4 Section 27 T27N R10W  
San Juan County, New Mexico

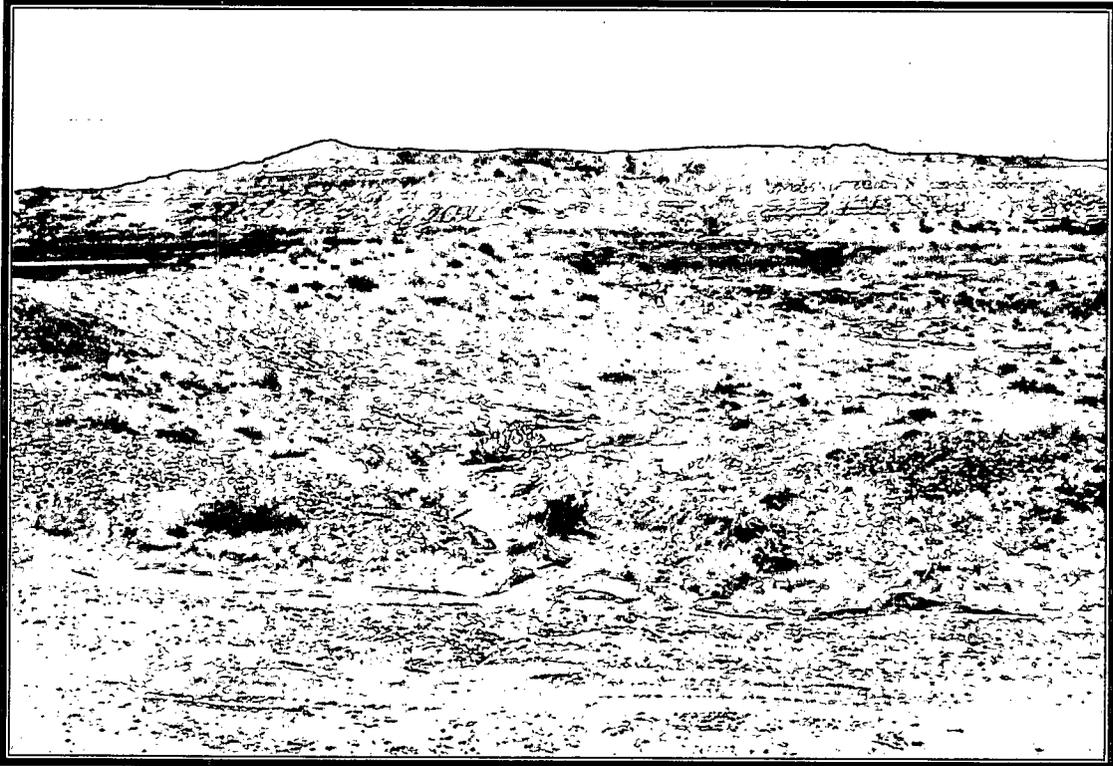
Photo 1: View of the small wash across the road from the Lateral 2A-3 excavation.

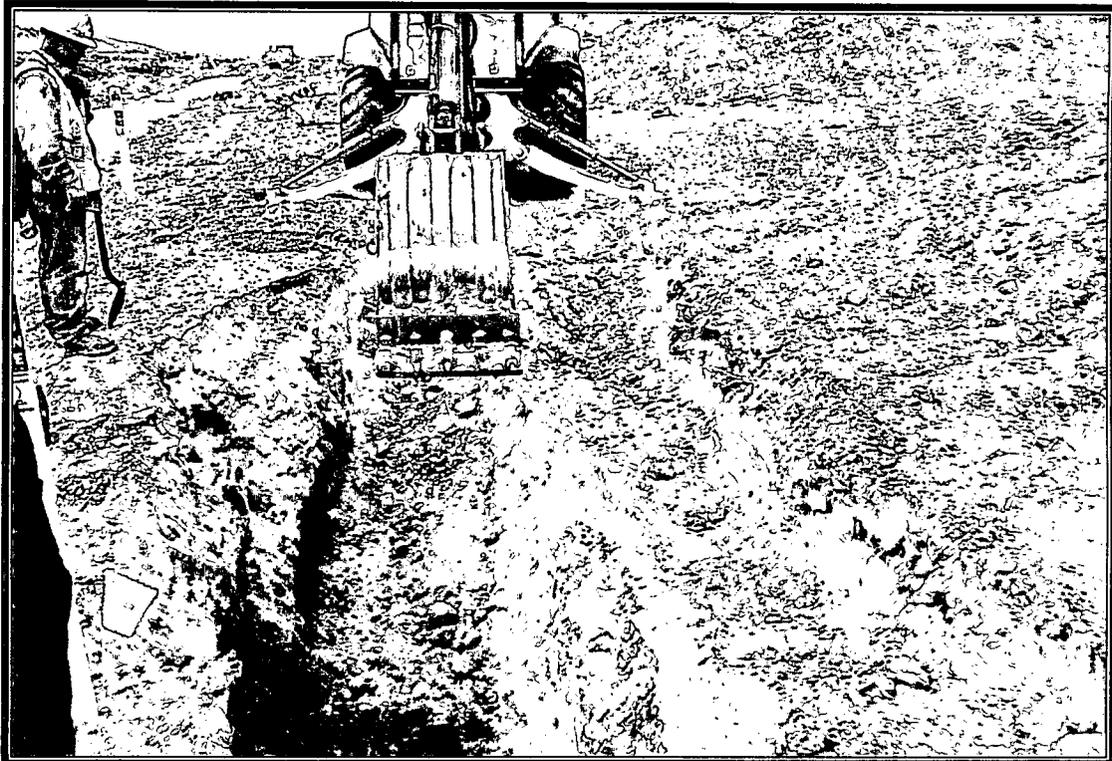
Photo 2: View of the excavation for the Lateral 2A-3 pipeline release.

On July 16, 2013, under the supervision of SMA, EMS excavated the hydrocarbon impacted soil while making repairs to the Lateral 2A-3 pipeline. SMA personnel guided the excavation activities by collecting soil samples for field screening with a calibrated photo-ionization detector (PID). Table 3 summarizes the field screening results. After field screening results indicated that the hydrocarbon impacted soil had been removed, SMA collected five composite soil samples for laboratory analysis. SMA also collected a composite sample from the southern portion of a small wash located to the west of the main excavation.

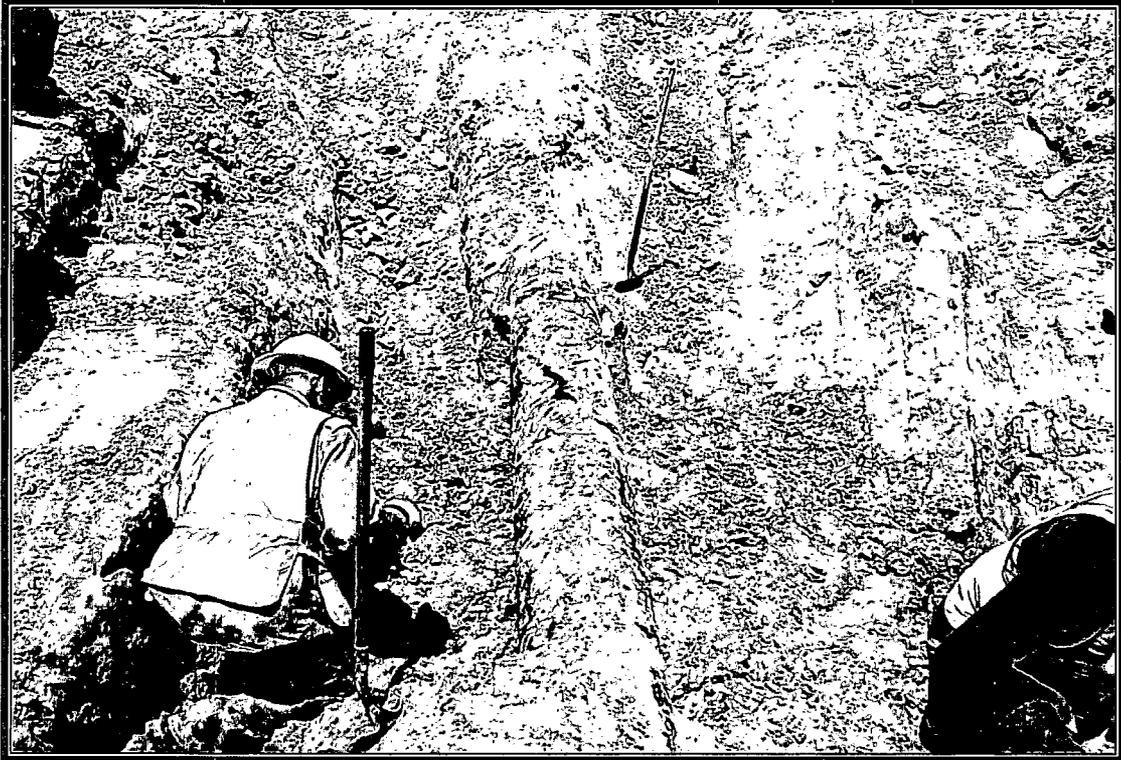
Photo 3: View of the excavation and the Lateral 2A-3 pipeline.

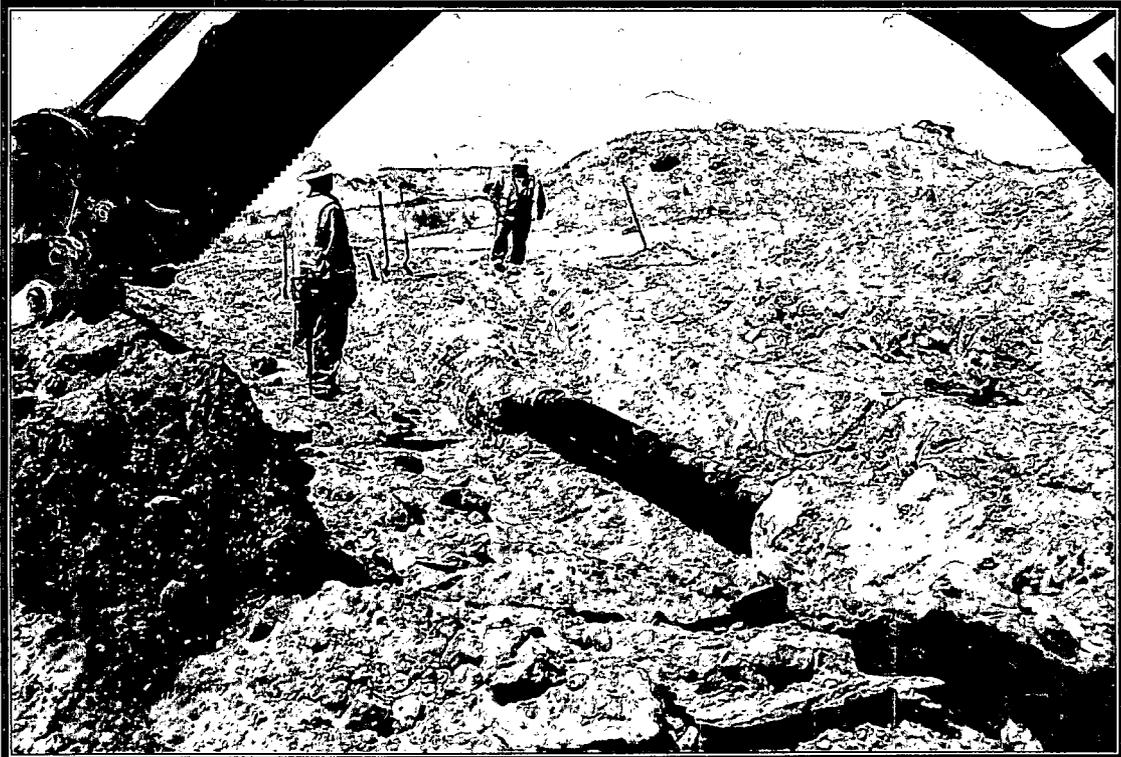
Photo 4: View of the excavation and the Lateral 2A-3 pipeline.

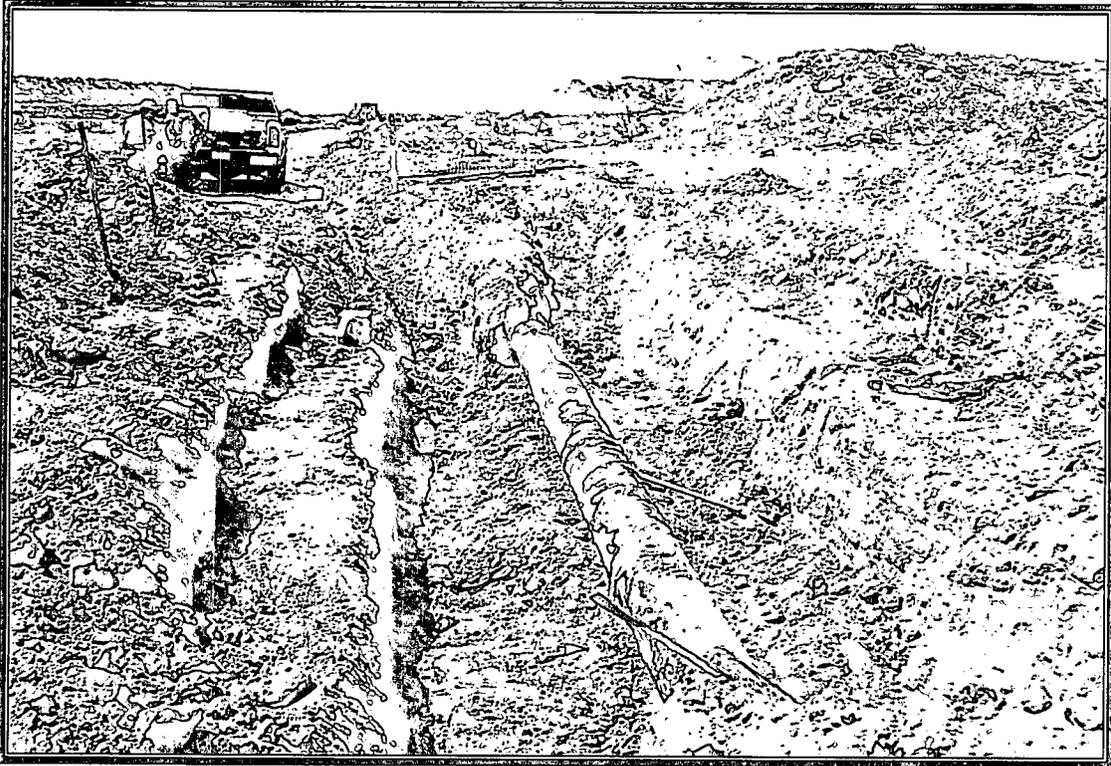
Photo 5: View of the excavation and the Lateral 2A-3 pipeline.

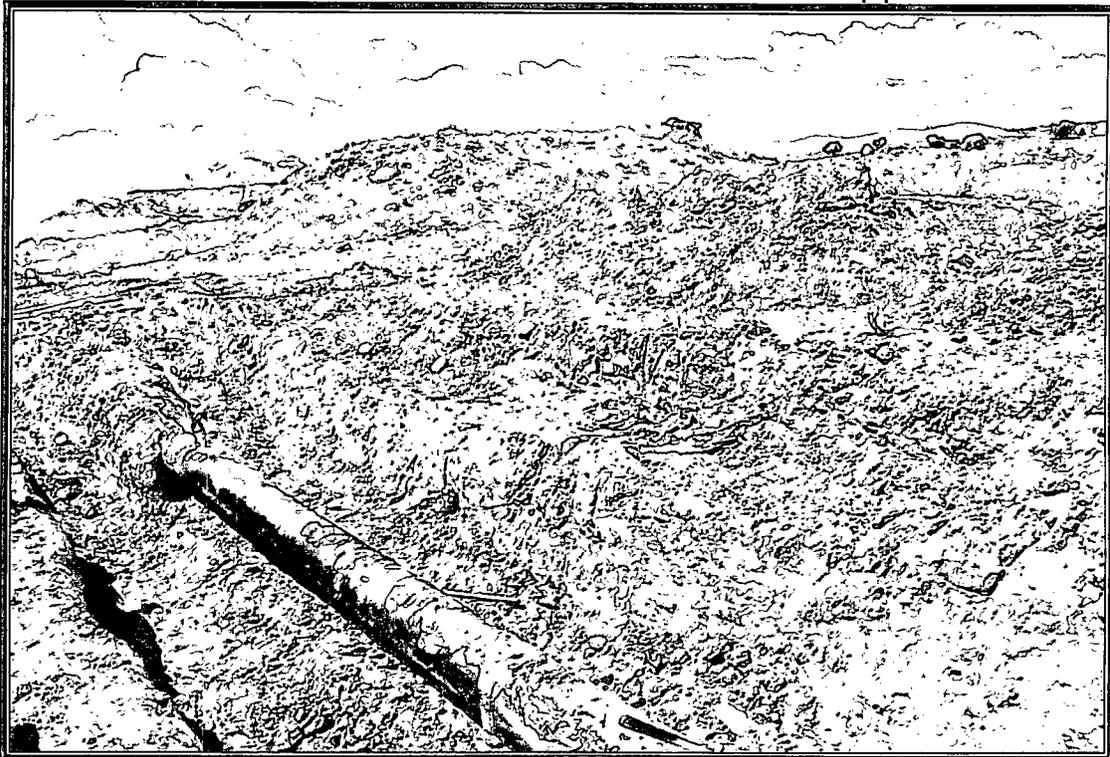
Photo 6: View of the excavation and the Lateral 2A-3 pipeline.

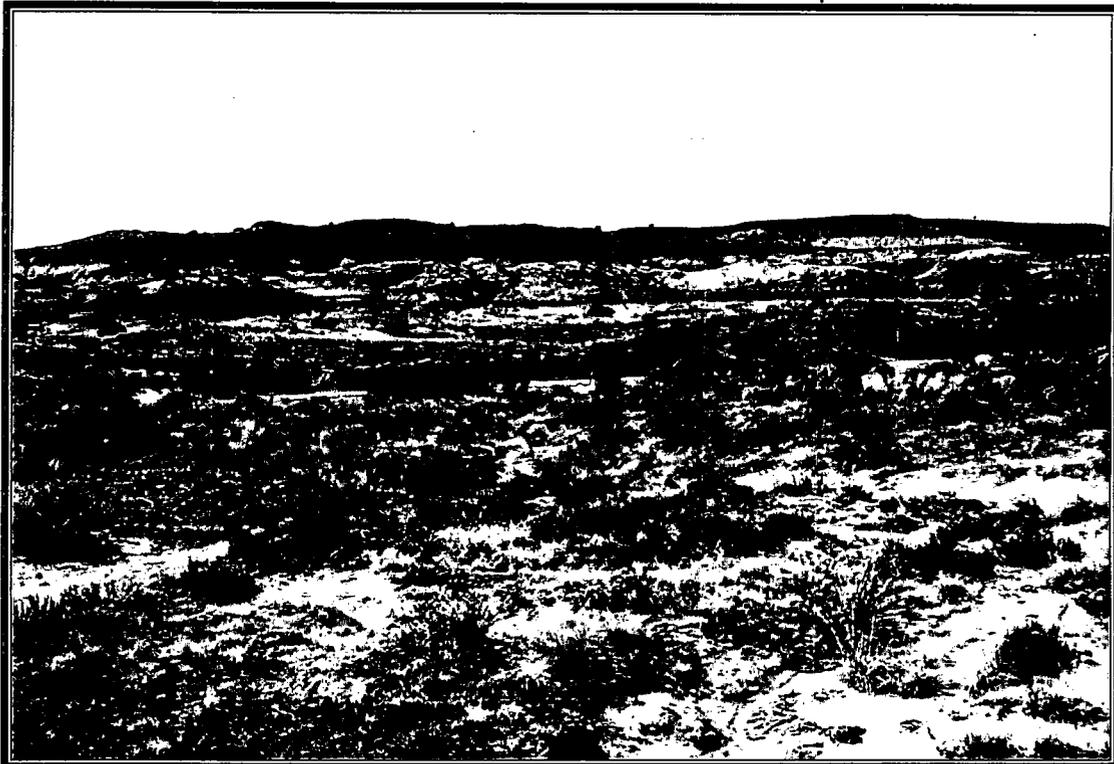
Photo 8: View of the northern wash that was sampled.

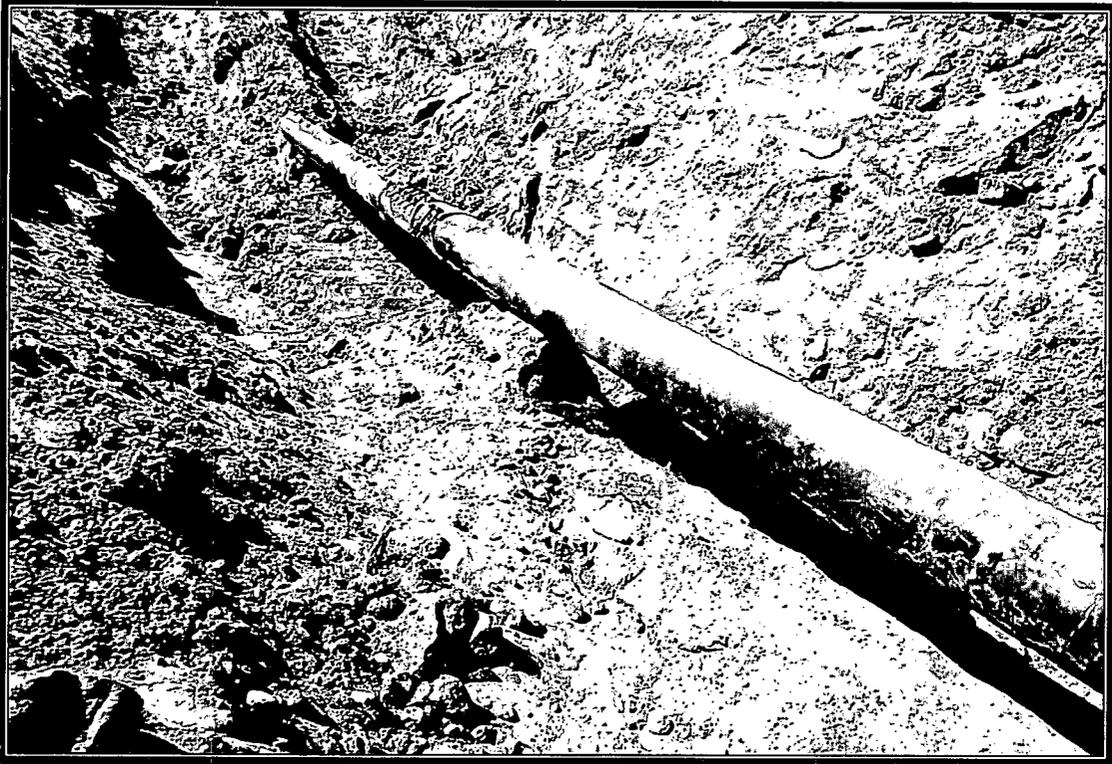
**Photo 1: View of the pipeline prior to repairs.**

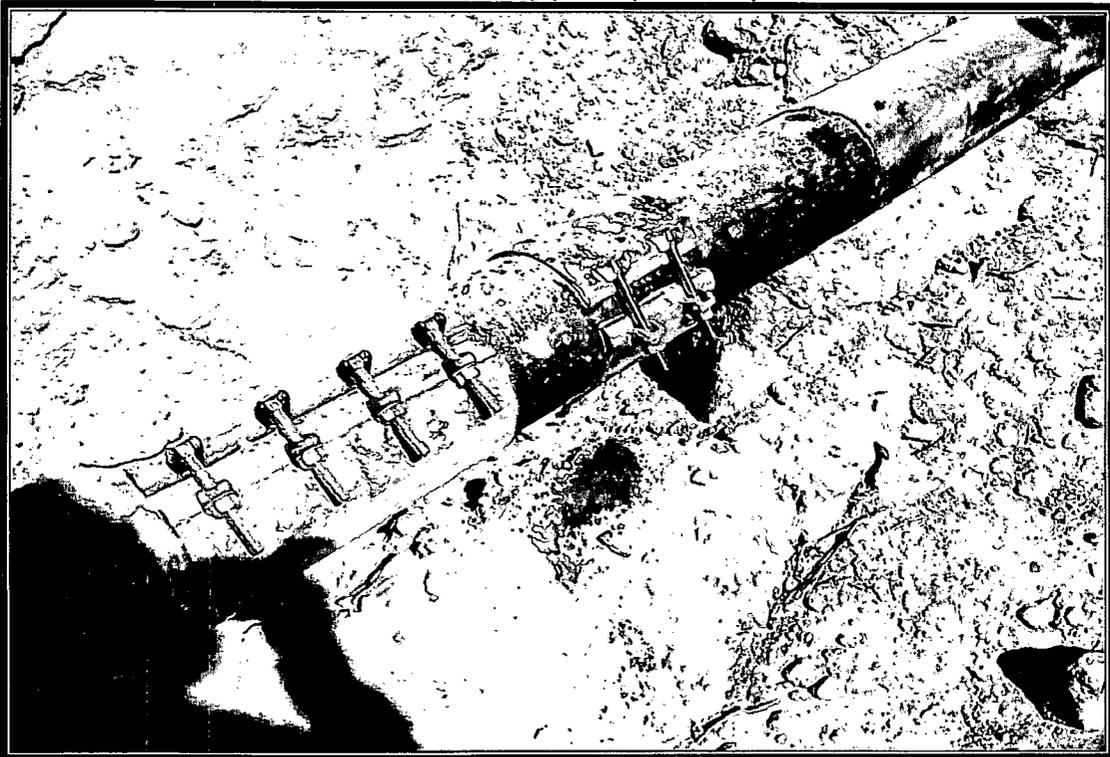
**Photo 2: View of the pipeline leaking prior to repairs**

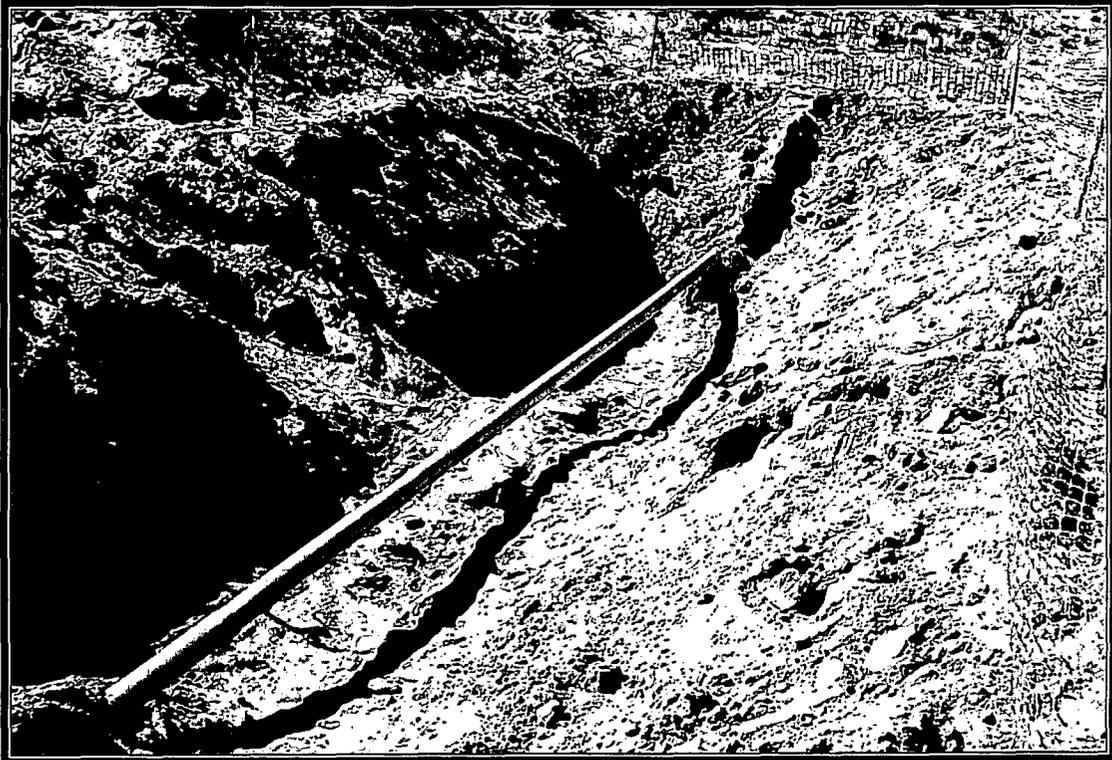
Photo 3: View of the small pipeline and excavation after repairs.

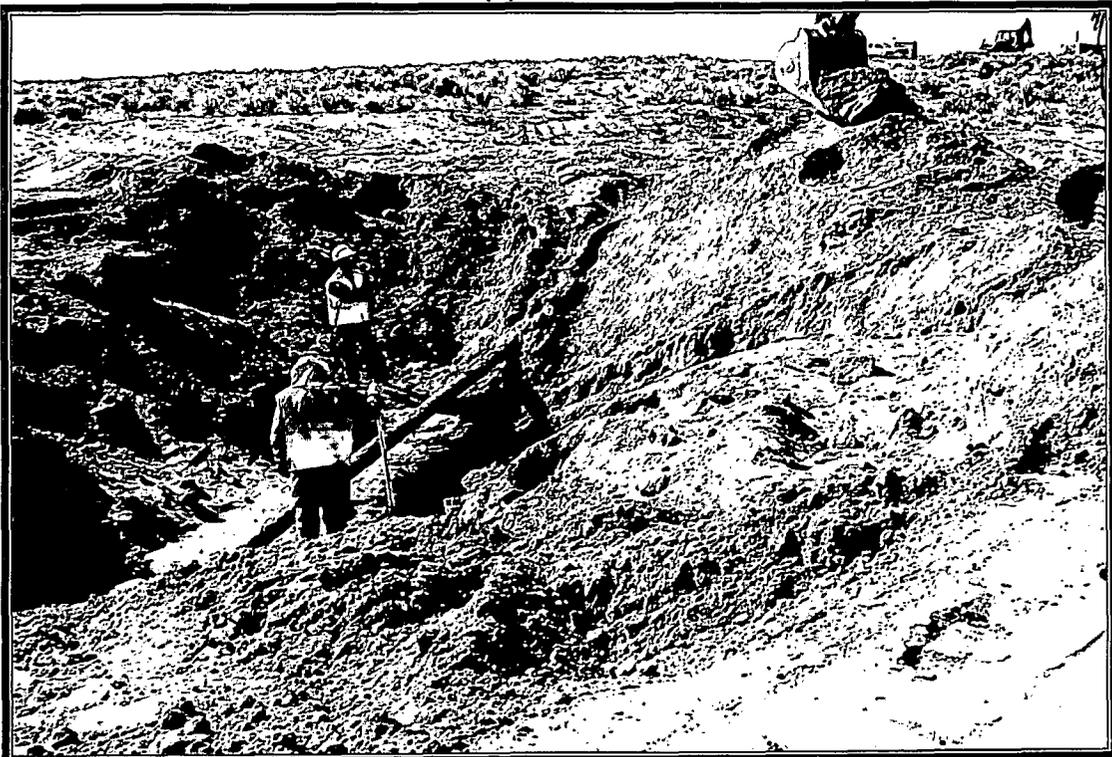
Photo 4: View of the excavation for the Lateral 10D-2 pipeline release.

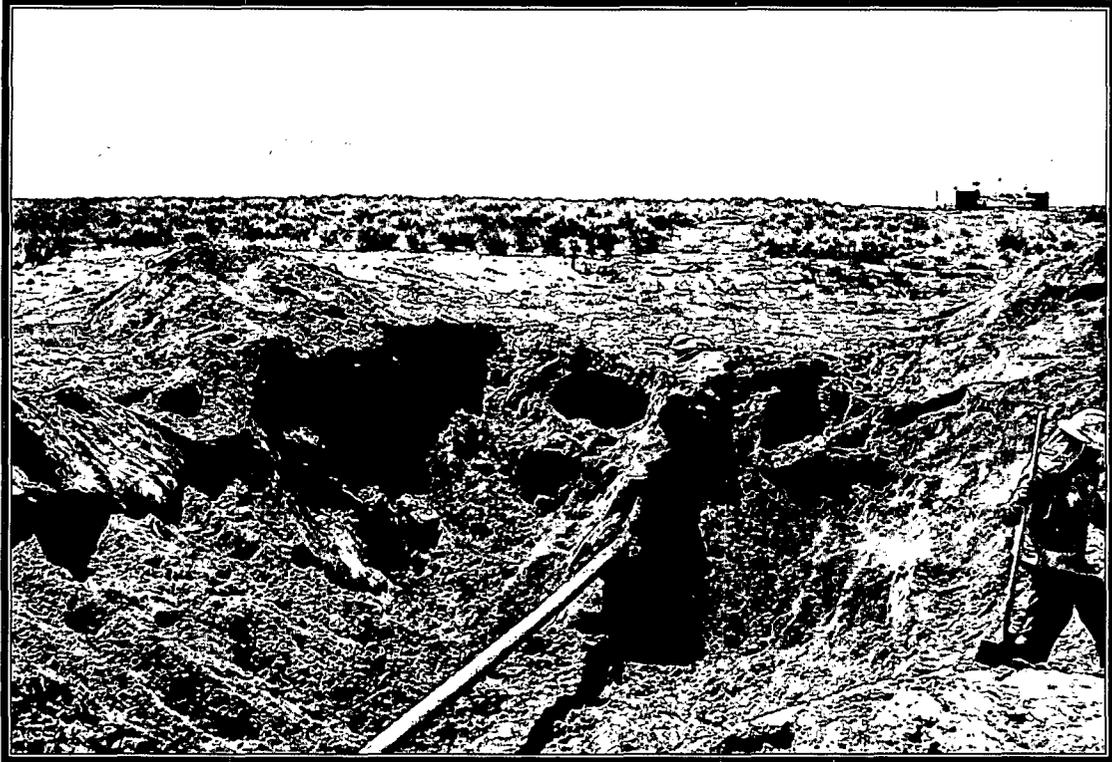
Photo 5: View of the excavation for the Lateral 10D-2 pipeline release.

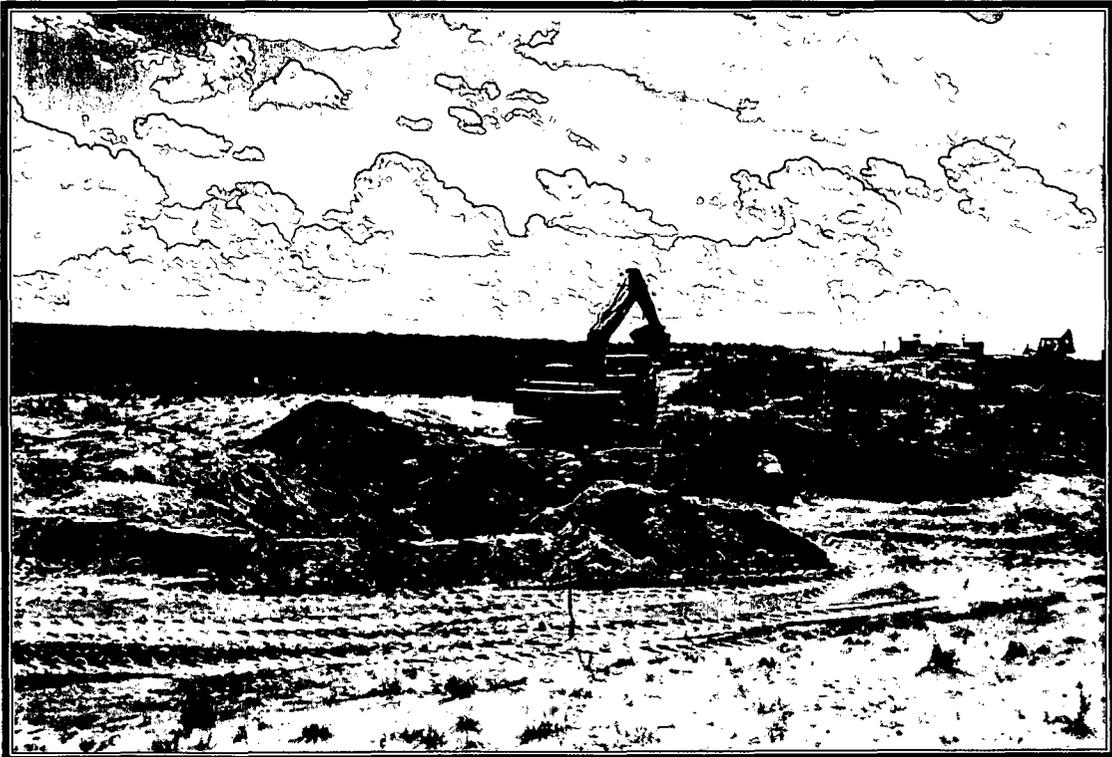
Photo 6: View of the excavation for the Lateral 10D-2 pipeline release.

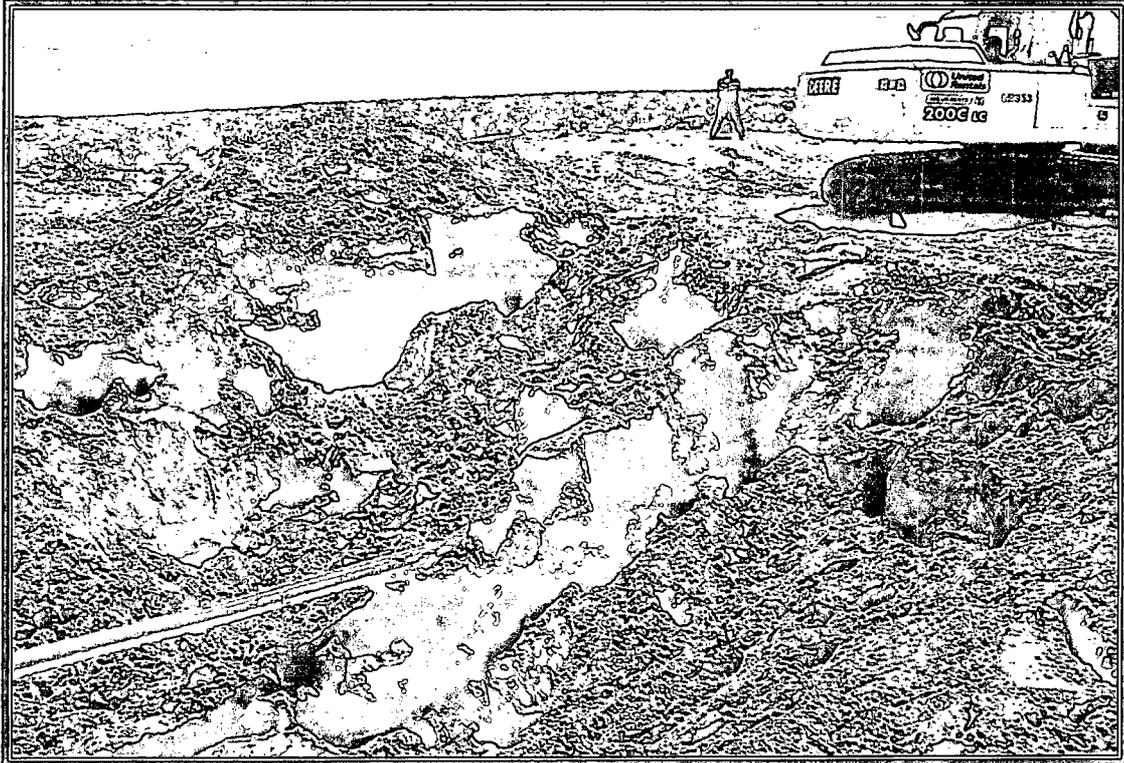
Photo 7: View of the excavation for the Lateral 10D-2 pipeline release.

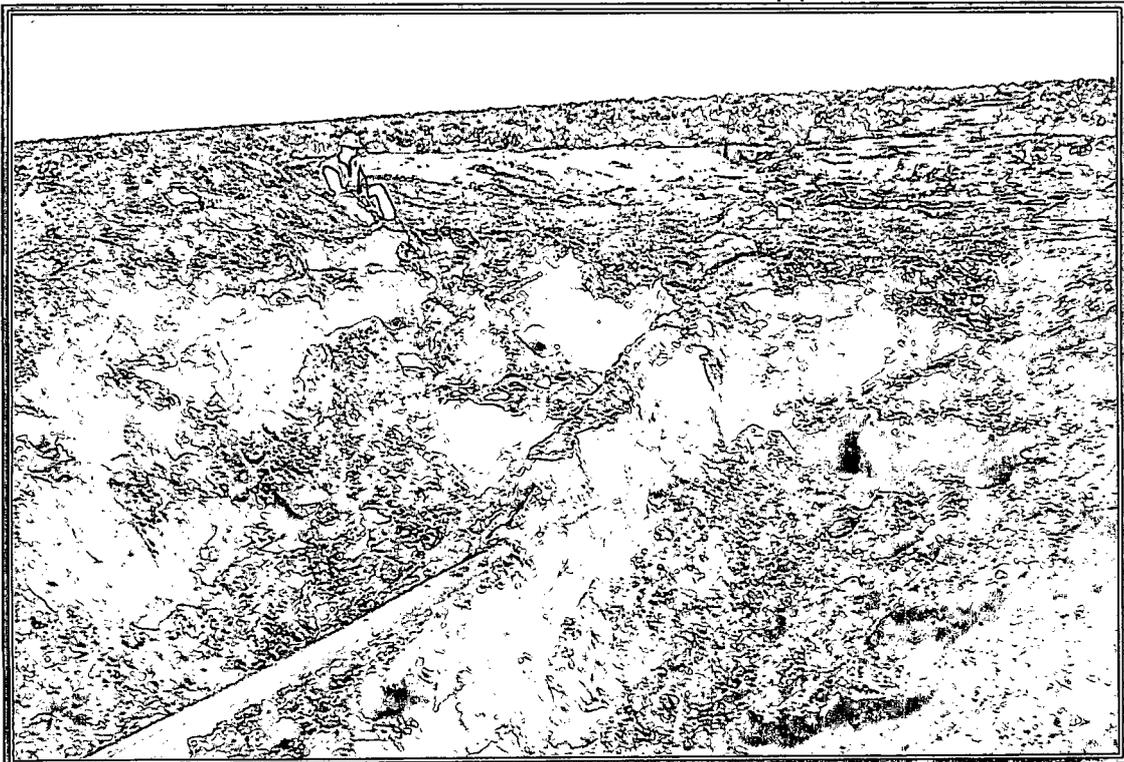
Photo 8: View of the excavation for the Lateral 10D-2 pipeline release.

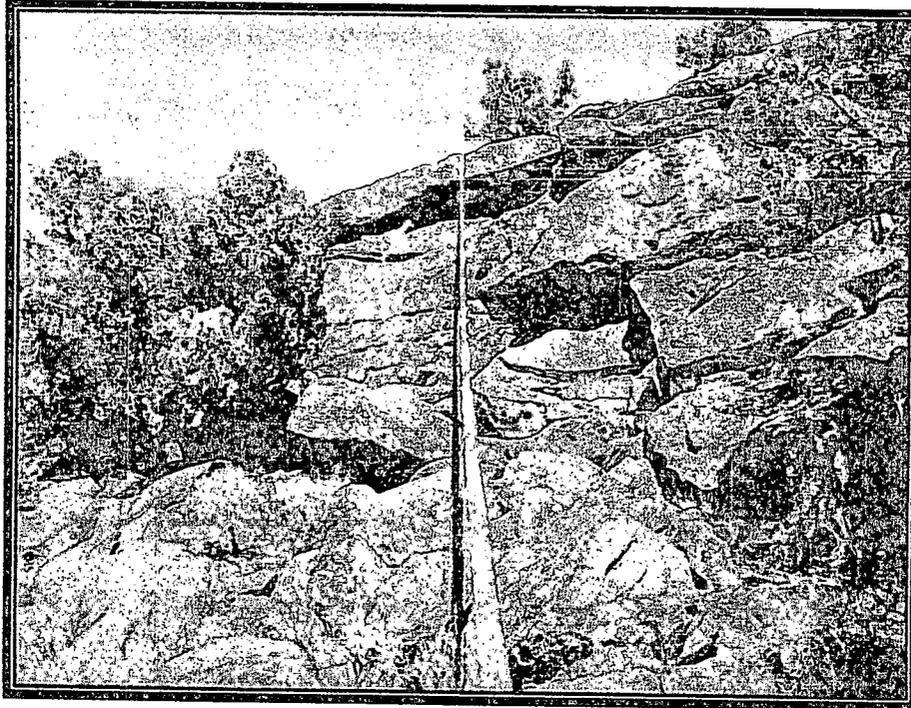
**Picture 1: Release Path on Rock Face (View 1)**

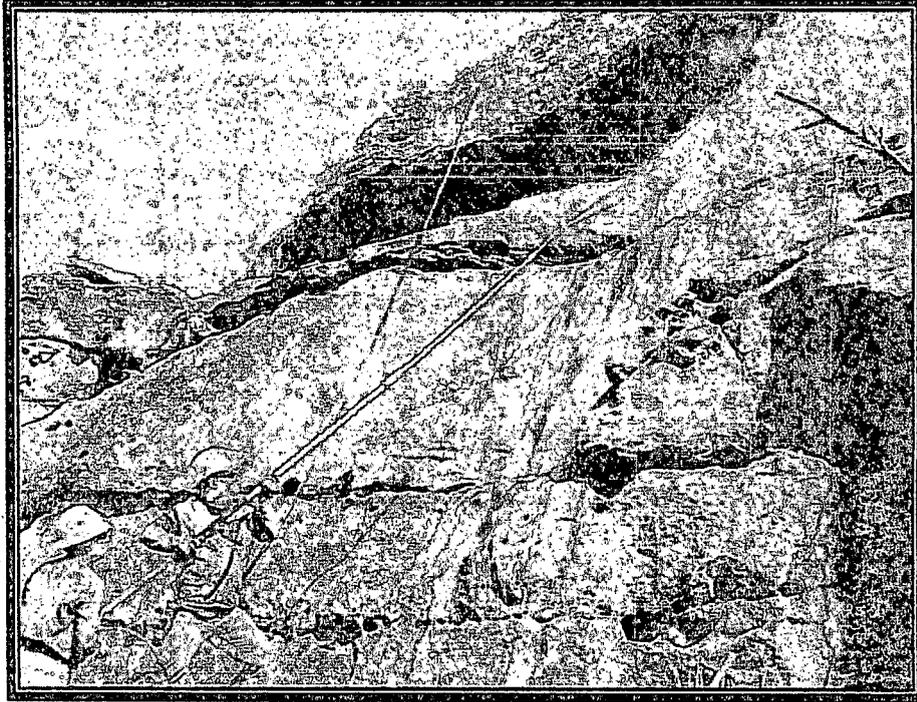
**Picture 3: Rock Face Cleanup Activities**

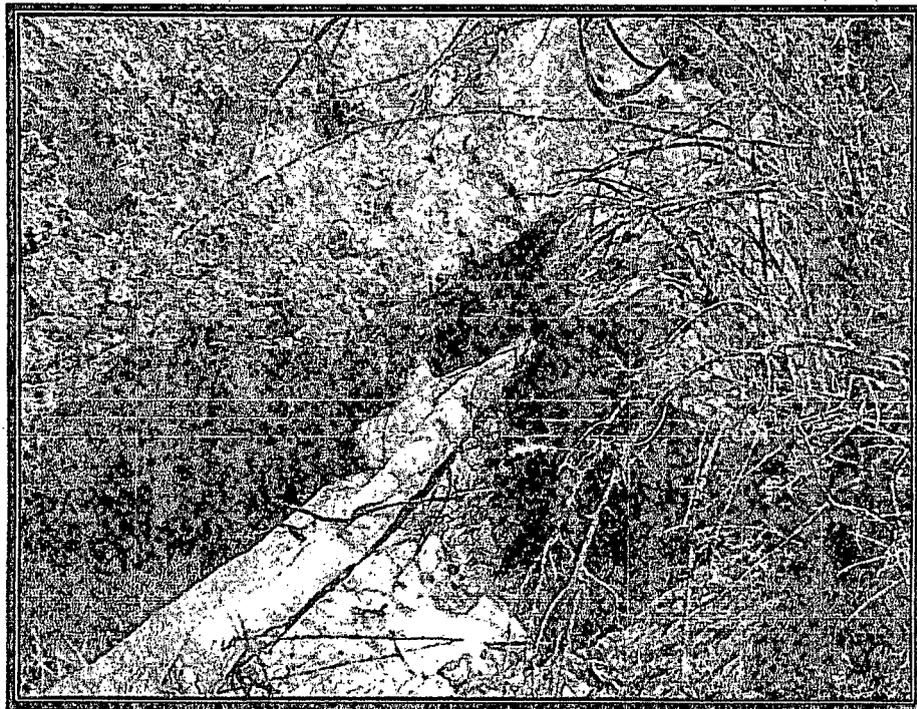
**Picture 4: Booms at the Base of the Rock Face**

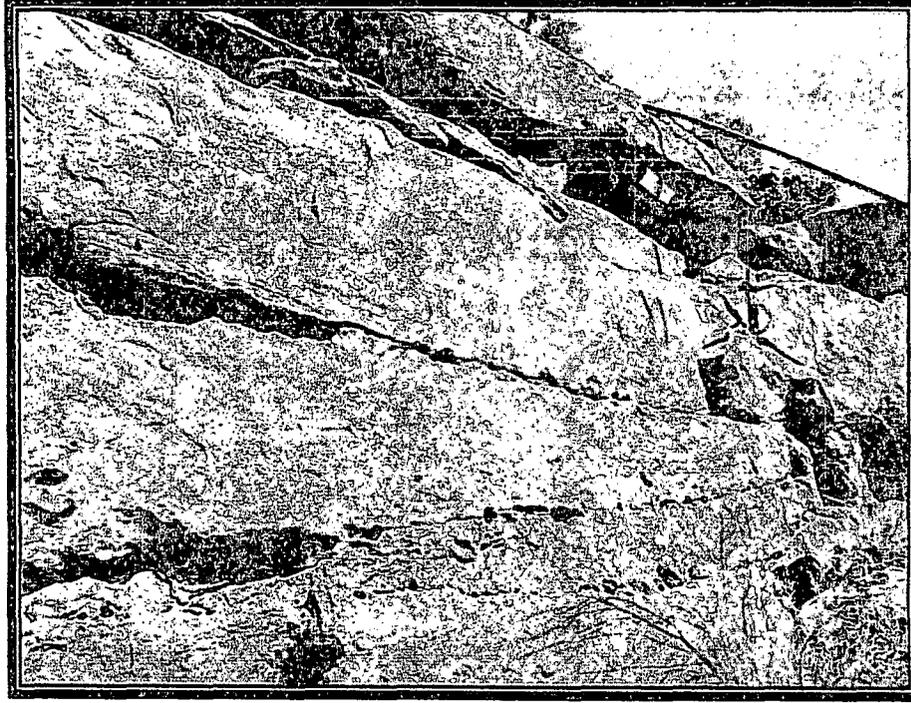
Picture 5: Rock Face after Cleanup Activities (View 1)

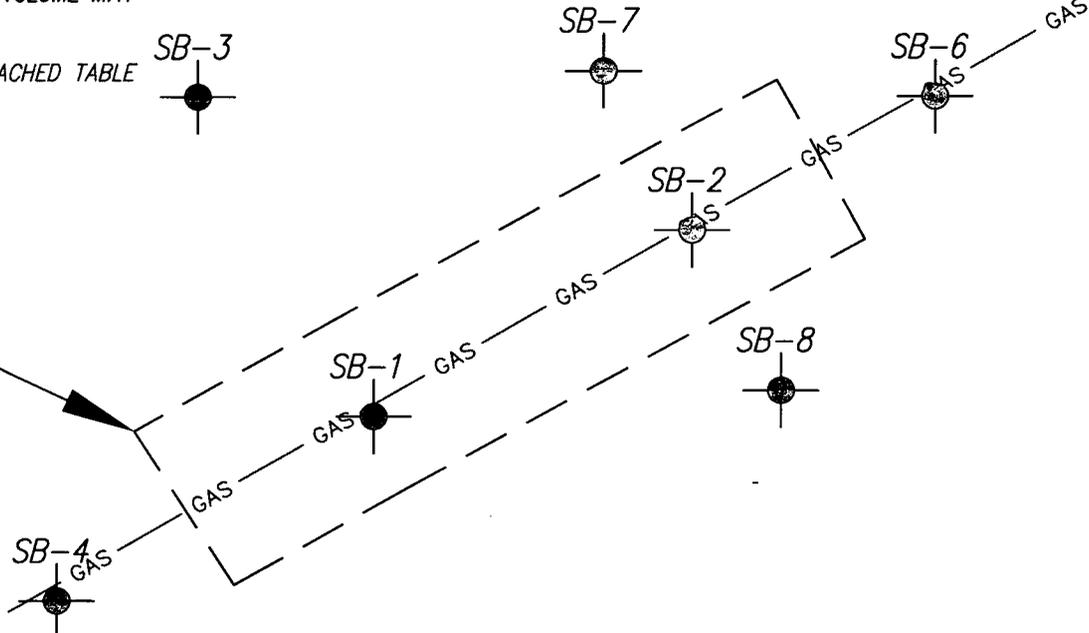
PROPOSED EXCAVATION  
 40' LONG X 10' WIDE X 10' DEEP

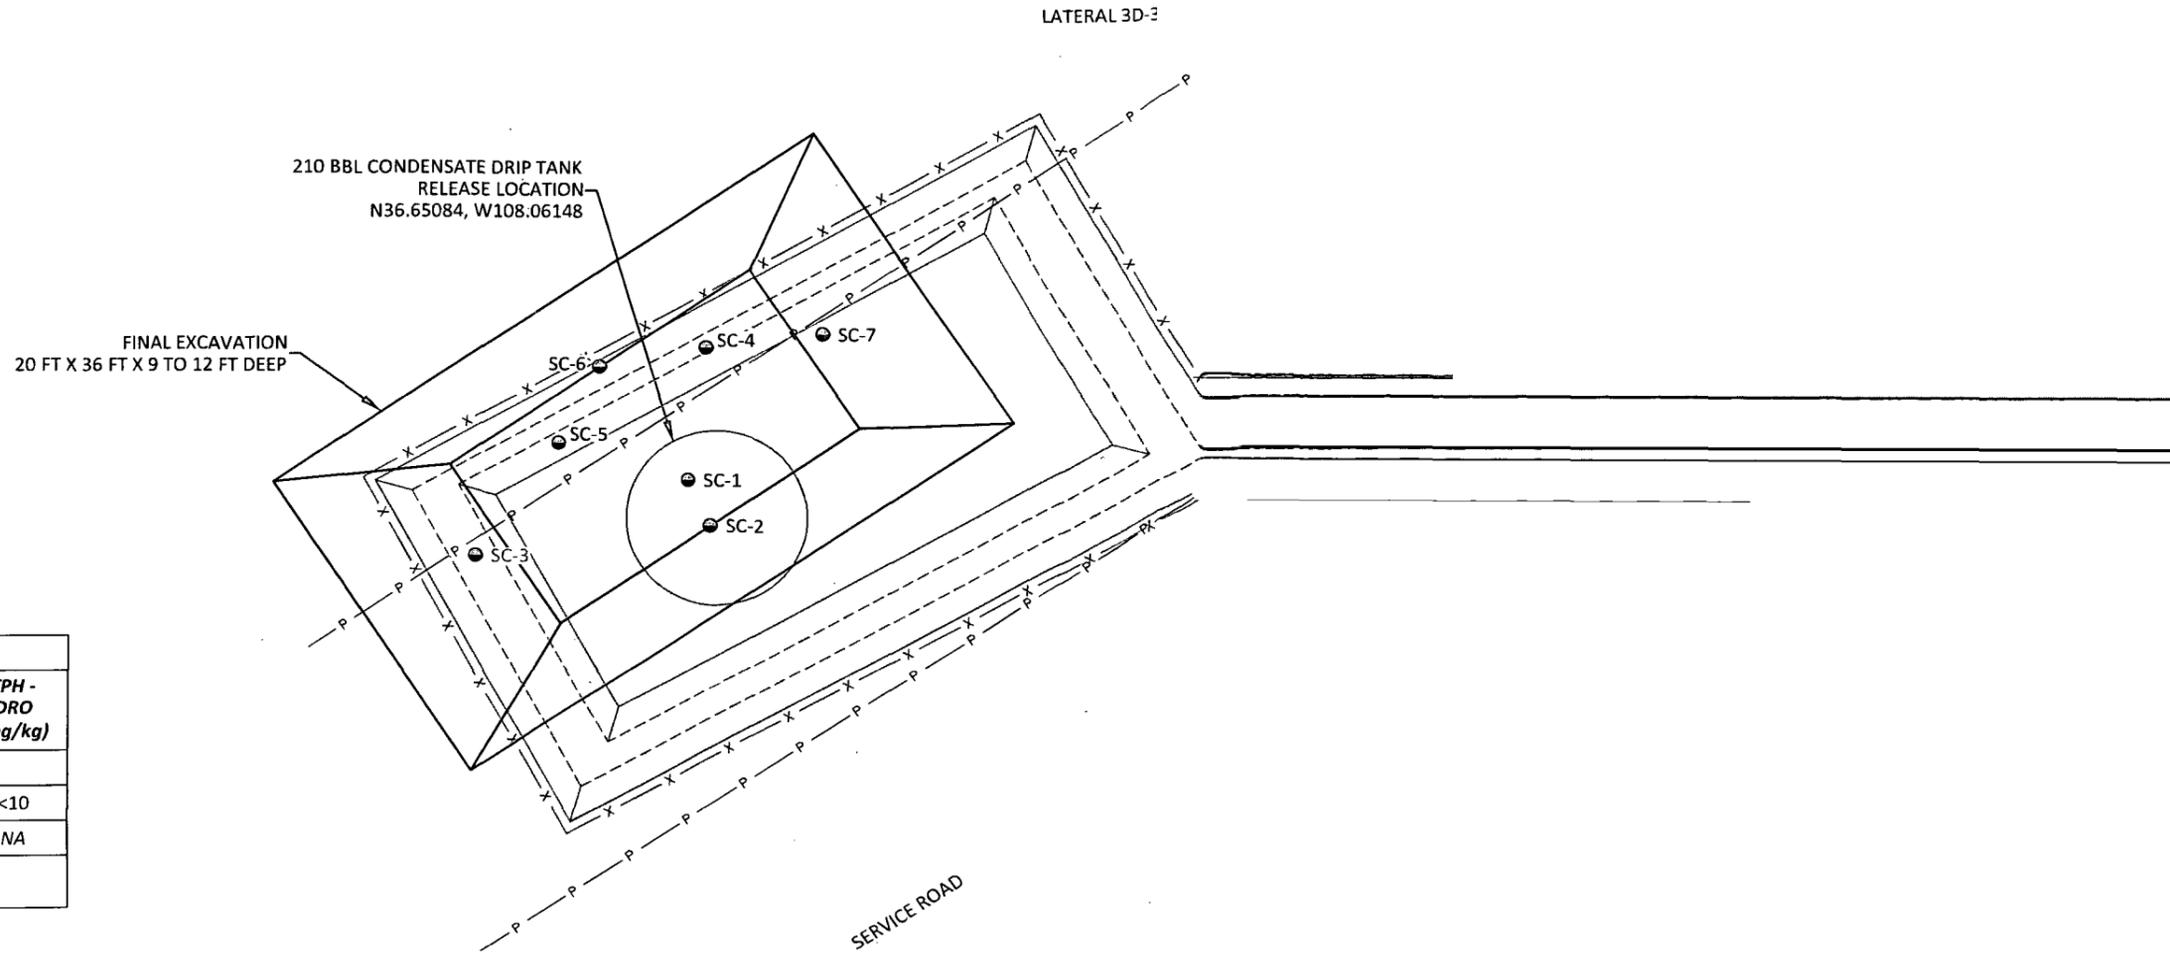
**FIGURE 4**

**FINAL EXCAVATION SAMPLE LOCATIONS AND RESULTS**  
**MAY 2013**  
 ENTERPRISE FIELD SERVICES, LLC  
 LATERAL 6B-10 CONDENSATE DRIP TANK  
 MAY 2013 RELEASE  
 SW¼ NE¼, SECTION 24, T28N R12W  
 SAN JUAN COUNTY, NEW MEXICO  
 N36.65084, W108.06148
