REMEDIATION SUMMARY AND SITE CLOSURE REQUEST

**BOPCO, LP
JAMES RANCH UNIT #112-H PUMPING WELL
Eddy County, New Mexico
Unit Letter "P" (SE/SE), Section 36, Township 22 South, Range 30 East
Latitude 32.34270° North, Longitude 103.82626° West
NMOCD Reference #2RP-_____**

May 2012

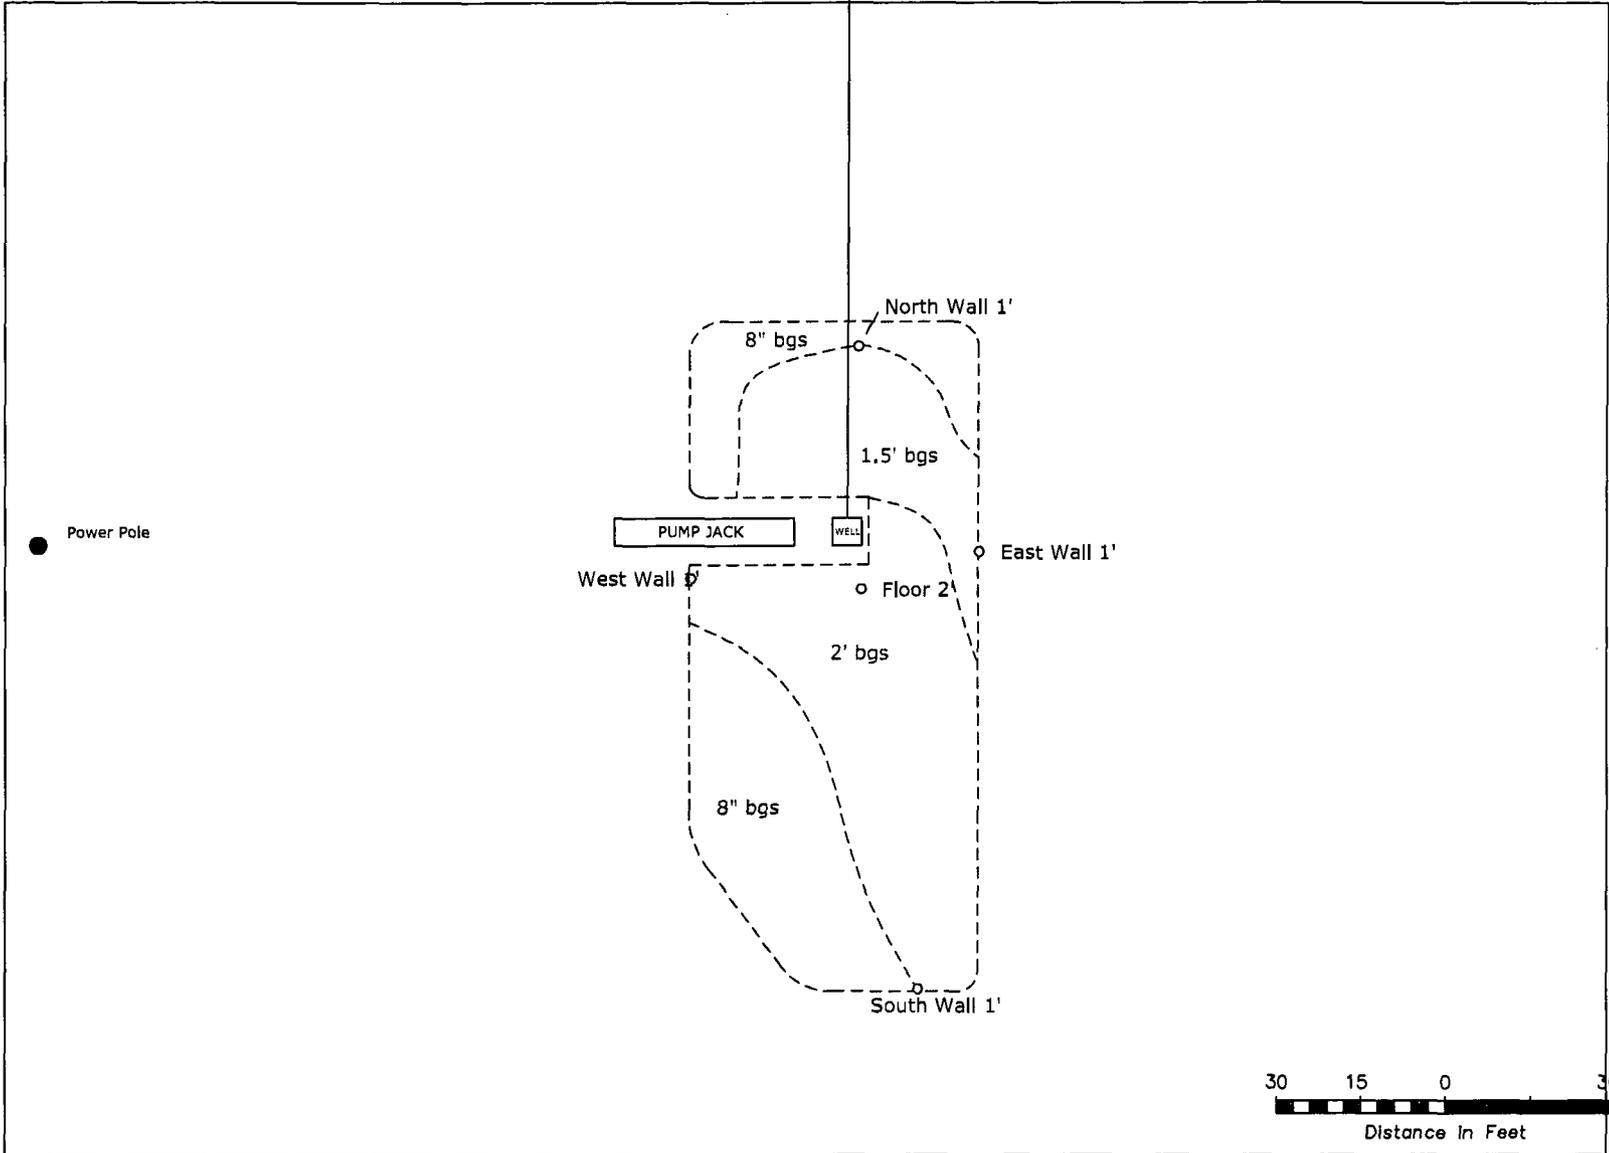
- Excavation Extent
- Pad Boundary
- Pipeline
- o Sample Location

Figure 2
Site & Sample Location Map
BOPCO, L.P.
JRU #112-H Pumping Well
Eddy County, New Mexico

On May 11, 2012, five (5) soil samples (North Wall 1', South Wall 1', West Wall 1', East Wall 1' and Floor 2') were collected from the excavation floor and sidewalls and submitted to the laboratory for analysis of TPH and chloride concentrations. Laboratory analytical results indicated TPH concentrations ranged from less than the laboratory method detection limit (MDL) for soil samples North Wall 1', South Wall 1', West Wall 1' and East Wall 1' to 168 mg/Kg for soil sample Floor 2'. Chloride concentrations ranged from 48.0 mg/Kg for soil sample East Wall 1' to 1,340 mg/Kg for soil sample South Wall 1'. Soil sample Floor 2' was also analyzed for concentrations of BTEX constituents, which were determined to be less than the appropriate laboratory MDL for each constituent. Laboratory analytical reports are provided as Appendix C.

On May 16, 2012, approximately two hundred cubic yards (200 yd³) of impacted material was transported to Lea Land, LLC (NMOCD Permit #WM-01-035), for disposal. The final dimensions of the excavation were approximately twenty-five feet (25') to forty feet (40') in width, seventy-three feet (73') in length and eight inches (8") to two feet (2') in depth. Upon receiving laboratory analytical data from confirmation soil samples, the excavated area was backfilled with locally purchased, non-impacted material, and compacted in twelve inch (12") lifts. Following the backfilling of the excavation, areas affected by the remediation activities were contoured to fit the needs of the well pad.

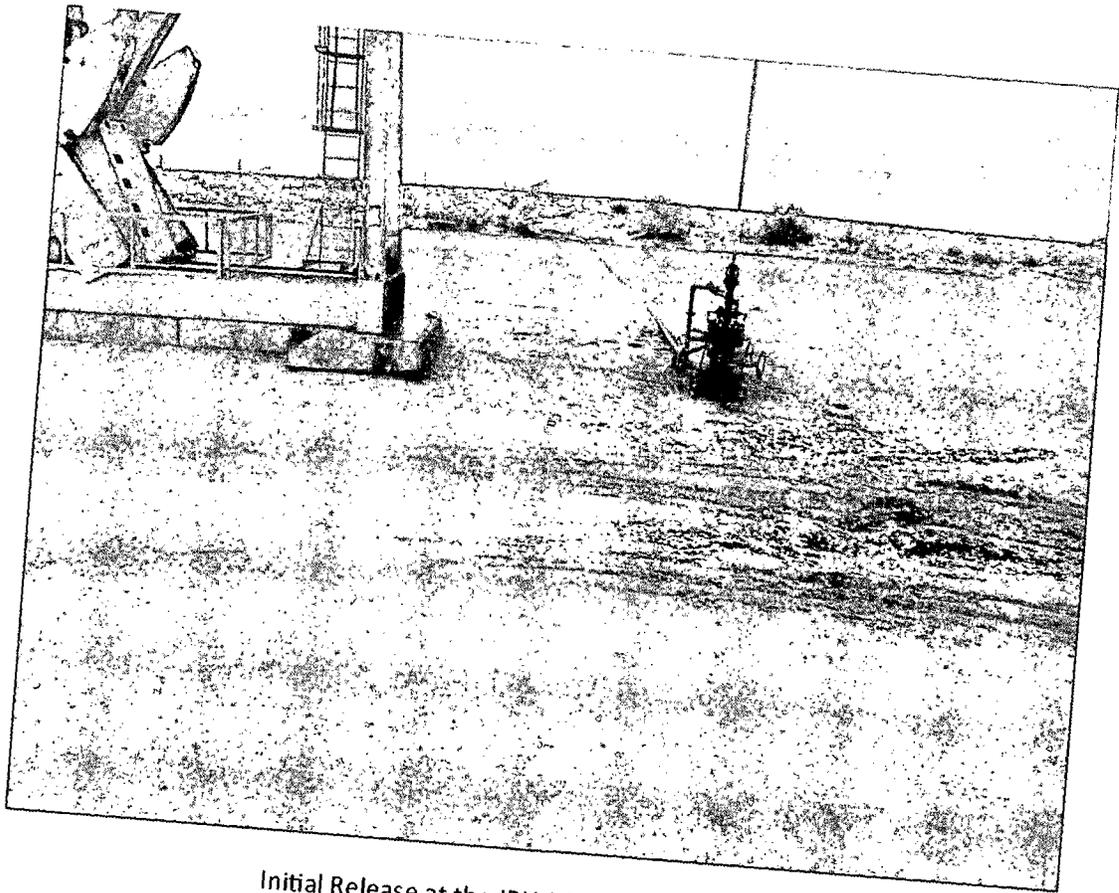
Initial Release at the JRU #112-H Pumping Well

On April 30, 2012, BOPCO discovered a release had occurred at the JRU #112-H site. The release was attributed to the failure of the stuffing box packing on a pressurized well. The pressure has since been adjusted and packing replaced. The release was reported to the New Mexico Oil Conservation Division (NMOCD) Artesia District Office on April 30, 2012. The "Release Notification and Corrective Action" (Form C-141) indicated approximately fifteen (15) barrels of crude oil and fifteen (15) barrels of produced water were released, with approximately ten (10) barrels of total fluid being recovered. During initial response activities, a vacuum truck was utilized to recover free-standing fluids. The release affected approximately one thousand, eight hundred square feet (1,800 ft²) of caliche well pad. A Form C-141 is provided as Appendix A. General Photographs of the release site are provided as Appendix B.

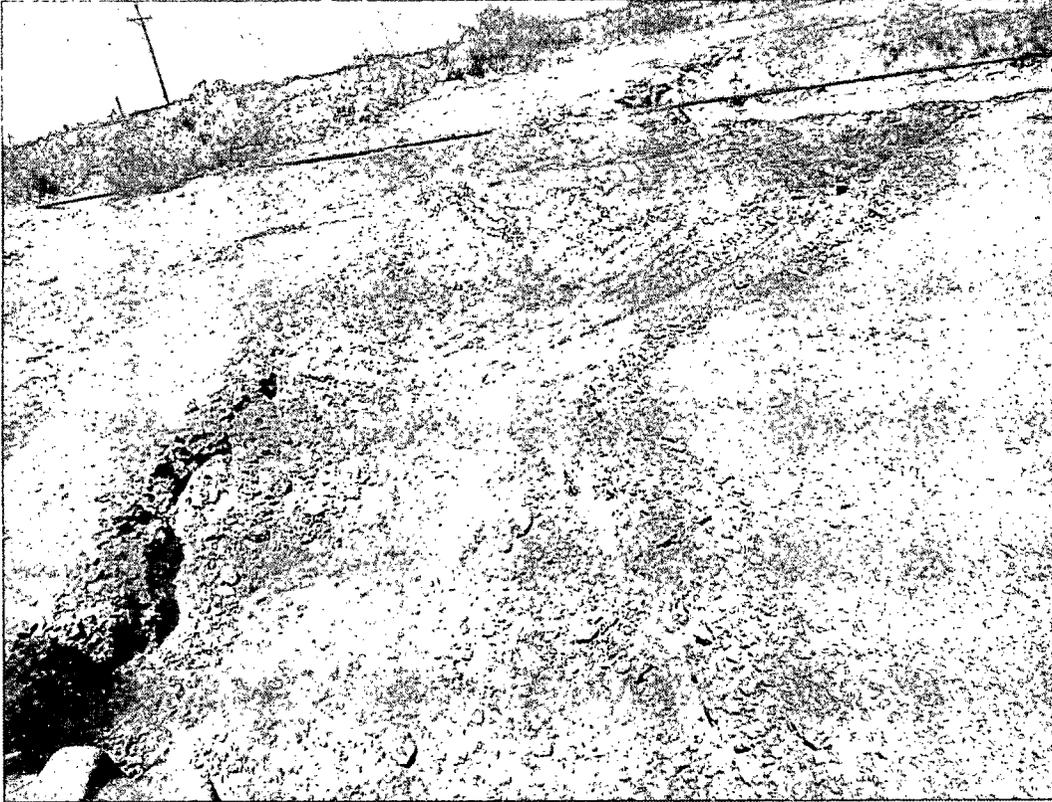
Excavation Activities at the JRU #112-H Pumping Well

On May 8, 2012, following initial response activities, excavation of impacted soil commenced at the release site. A Photo-Ionization Detector (PID) and chloride field kit were used to field screen the horizontal and vertical extent of impacted soil and to guide the excavation. Confirmation soil samples were collected and submitted to Cardinal Laboratories in Hobbs, New Mexico, for analysis of benzene, ethylbenzene, toluene, and xylene (BTEX) using EPA SW-846-8021b, total petroleum hydrocarbon (TPH) using EPA SW-846 8015M, and/or chloride concentrations using EPA method 4500 Cl-B. The excavated soil was stockpiled on-site pending final disposition.

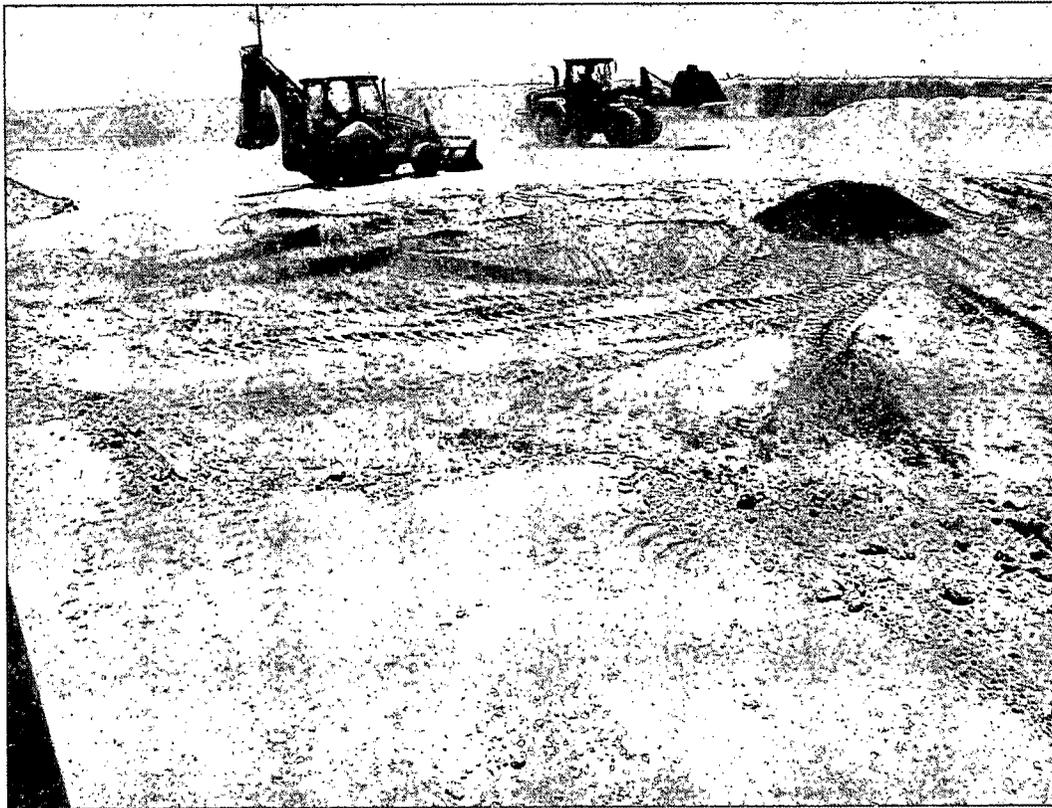
Excavation Activities at the JRU #112-H Pumping Well

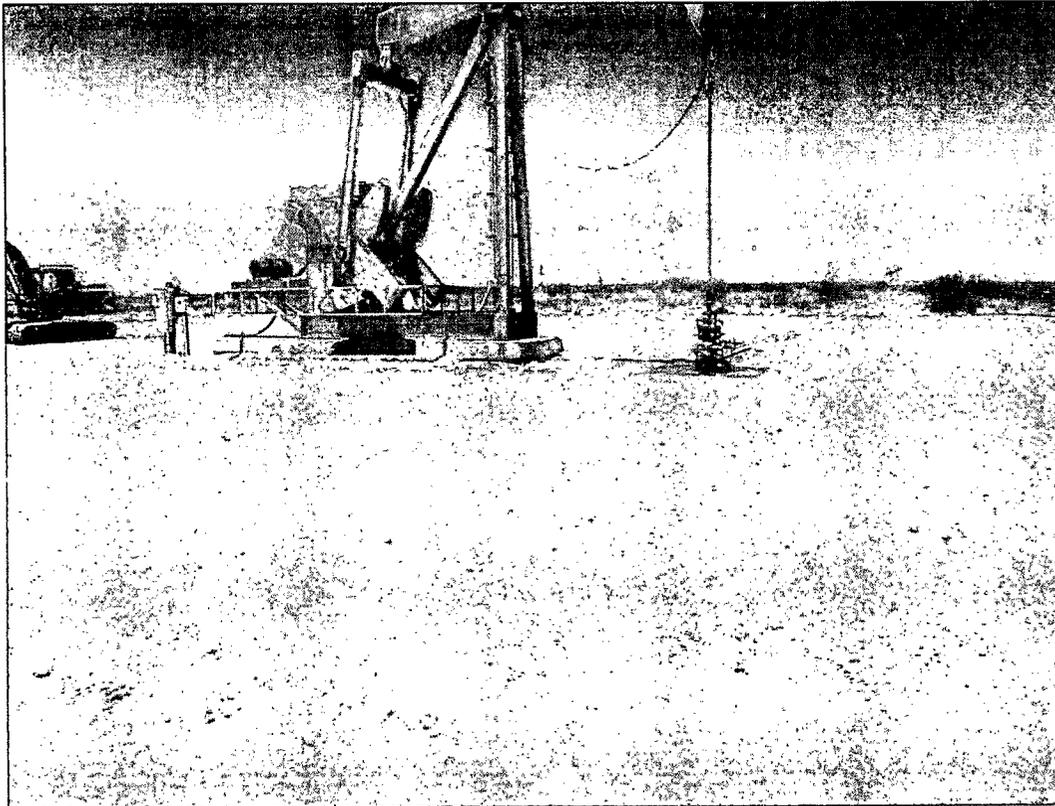
JRU #112-H Pumping Well Post Remediation Activities
