### Report Type: Closure Report

<b>Site:</b>	F.M. Robinson #1 Tank Battery						
<b>Company:</b>	COG Operating LLC						
<b>Section, Township and Range</b>	Unit E	Sec 27	T17S	R29E			
<b>Lease Number:</b>	API-30-015-22037						
<b>County:</b>	Eddy County						
<b>GPS:</b>	32.80775° N			104.06894° W			
<b>Surface Owner:</b>	State						
<b>Mineral Owner:</b>							
<b>Directions:</b>	In Loco Hills at the intersection of CR 217 and Hwy 82. Travel west on Hwy 82 for 5.1 miles, turn left (south) on CR 212 and travel 0.7 mile, turn left (east) and travel 0.1 mile to the site.

<b>Date Released:</b>	1/31/2013
<b>Type Release:</b>	Oil and Produced Water
<b>Source of Contamination:</b>	Produced Water Tank
<b>Fluid Released:</b>	210 bbls
<b>Fluids Recovered:</b>	205 bbls

**Re: Closure Request for the COG Operating LLC., F.M. Robinson #1 Tank Battery, Unit E, Section 27, Township 17 South, Range 29 East, Eddy County, New Mexico.**

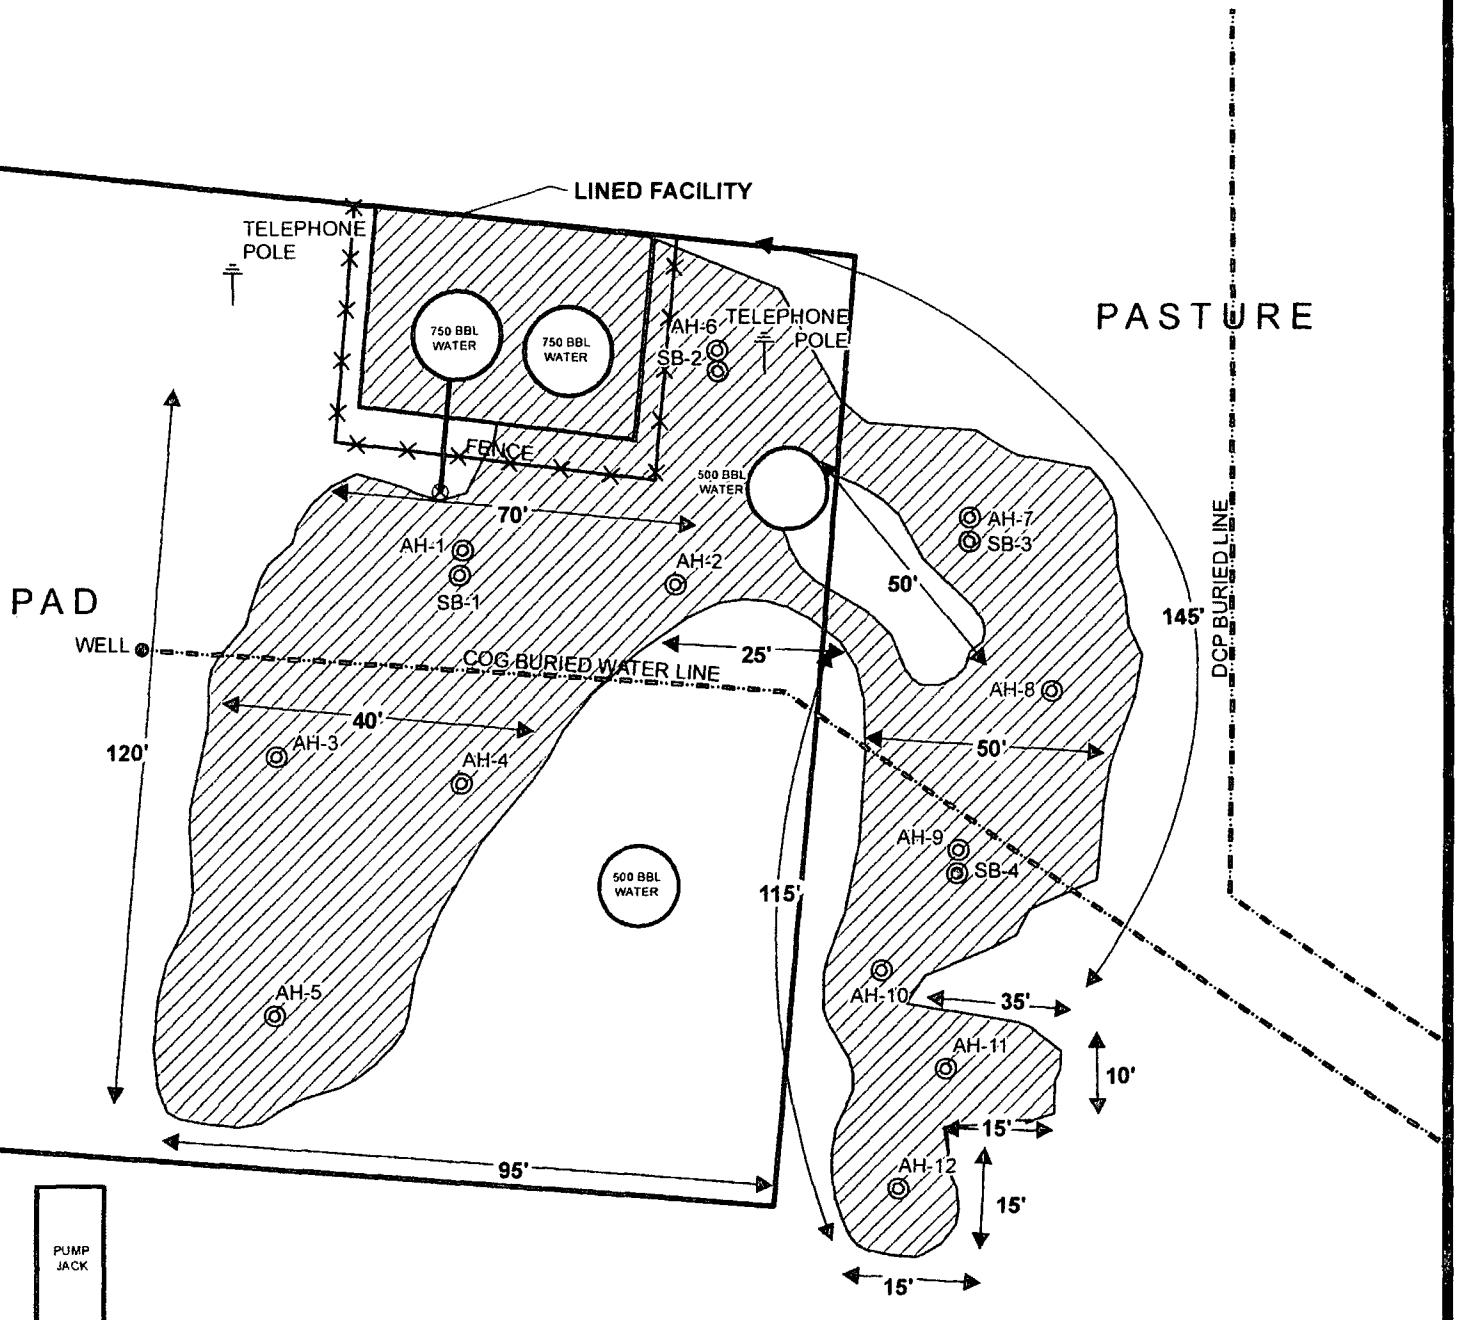
Figure 3

On February 13, 2013, Tetra Tech personnel inspected and sampled the spill area. Twelve (12) auger holes (AH-1 through AH-12) were installed using a stainless steel hand auger to assess the impacted soils. Selected samples were analyzed for TPH analysis by EPA method 8015 modified, BTEX by EPA Method 8021B and chloride by EPA method 300.0. Copies of laboratory analysis and chain-of-custody documentation are included in Appendix C. The sampling results are summarized in Table 1. The auger hole locations are shown on Figure 3.

Chloride concentrations were detected in majority of the auger holes. Auger holes (AH-8 and AH-11) did not show a significant chloride impact to the areas. A shallow chloride impact (0-1') was detected in the areas of AH-2, AH-3, AH-4 and AH-10, which declined at 1-1.5' below surface. A deeper impact was encountered in the areas of AH-1 and AH-5, but declined with depth at 3-3.5' to 82.5 mg/kg and 589 mg/kg, respectively. The area of AH-1 did show a chloride spike at 8-8.5' and 9-9.5'. The remaining areas of were not vertically defined showing bottom auger hole samples of 5,220 mg/kg (AH-6), 2,500 mg/kg (AH-7) and 3,830 mg/kg (AH-9) at 7.0' below surface.

Spill Assessment Map

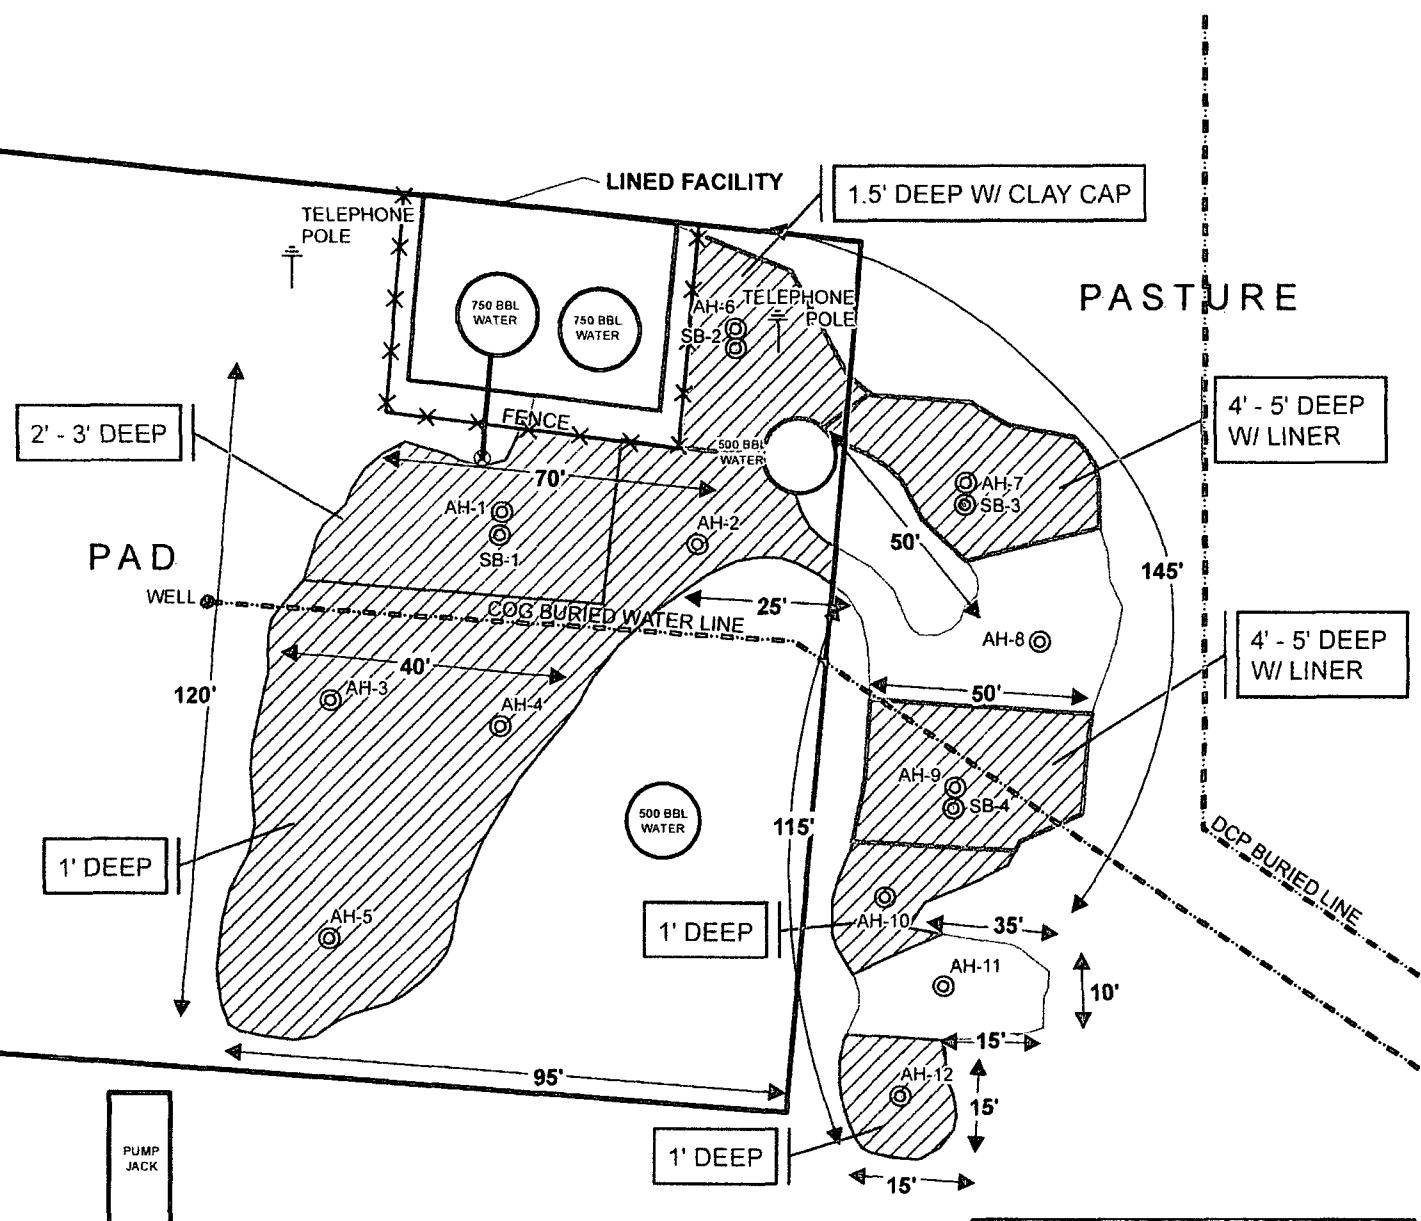
Figure 4

On May 7, 2013, Tetra Tech personnel supervised the excavation of the impacted soils. The excavated areas and depths are highlighted in Table 1 and shown on Figure 4. Approximately 640 cubic yards<sup>3</sup> of soil were removed and transported to R360 facility for proper disposal.

In order to remove the majority of the elevated chloride concentrations, the excavation depths ranged from 1.0' to 5.0' below surface. Due to the proximity of the water tank and equipment, limited excavation was performed in the area of AH-6 (depth of 1.5') due to safety concerns. Auger hole (AH-6) was capped with clay material and a 40 mil liner was installed in the areas of AH-7 and AH-9 to cap the remaining impact soil.

Excavation Areas & Depths Map

COG proposes to remove the impacted material as highlighted (green) in Table 1 and shown on Figure 4. In the areas of AH-2, AH-3, AH-4, AH-5, AH-10 and AH-12 will be excavated to a depth of approximately 1.0' below surface. The area of AH-1 (SB-1) will be excavated to a depth of 2.0' to 3.0' below surface. Due to the proximity of the facility, lines and tanks, the area of AH-6 (SB-2) on the pad will be excavated to an approximate depth of 3.0' to 4.0' and capped either clay or 40 mil liner for safety concerns.

In the areas of AH-7 (SB-3) and AH-9 (SB-4), the proposed excavation will range from 4.0' to 5.0' below surface. A COG water line is located in the area of AH-9 and performing deeper excavation is a safety concern excavating near the active line. Once excavated to the appropriate depth, the areas will be capped with a 40 mil liner at 4.0' below surface. The material will be hauled off for proper disposal and the excavation will be backfilled with clean soil to surface grade.

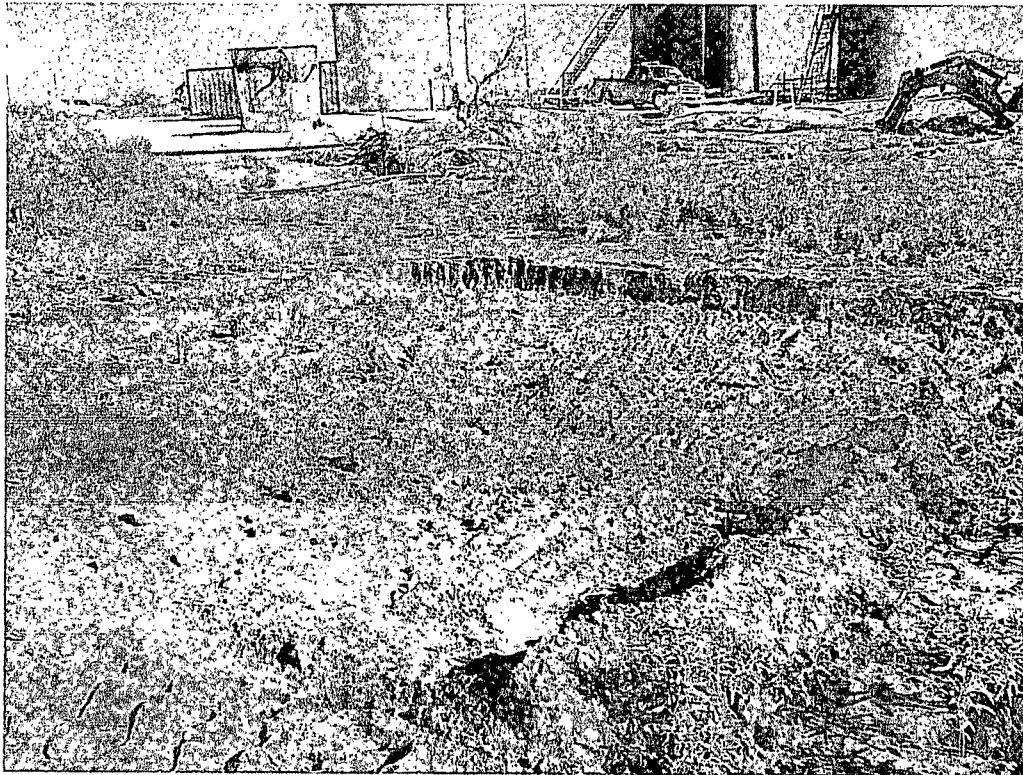
View Northeast – Area of AH-12

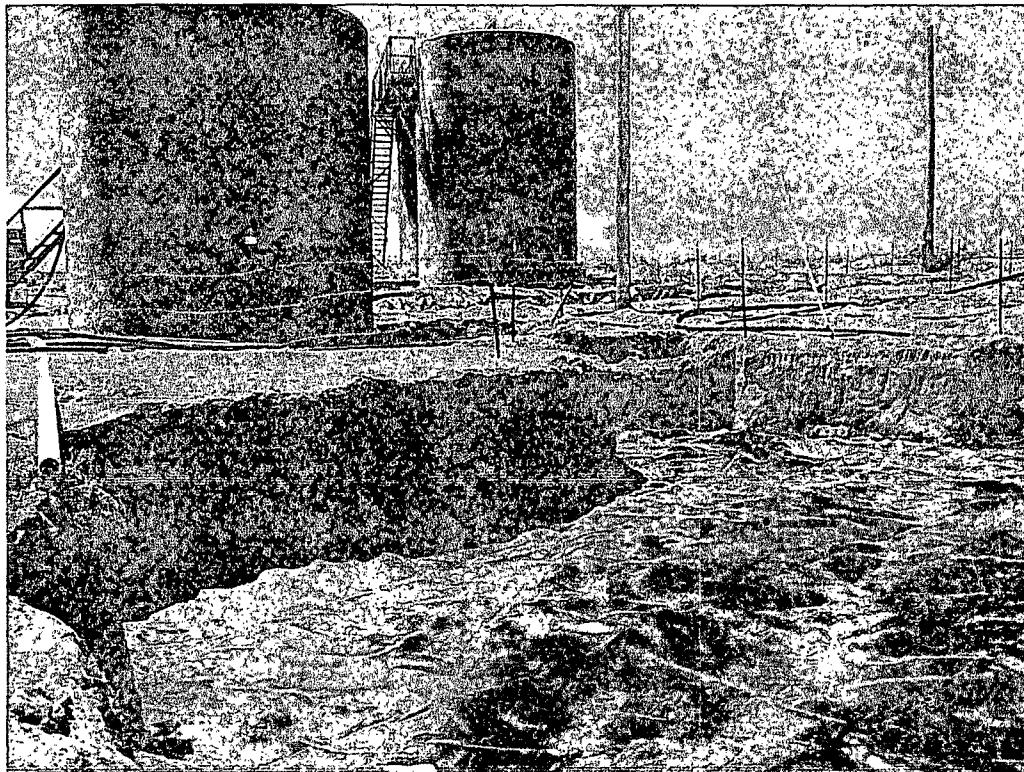
View Northeast – Liner installed in area of AH-7

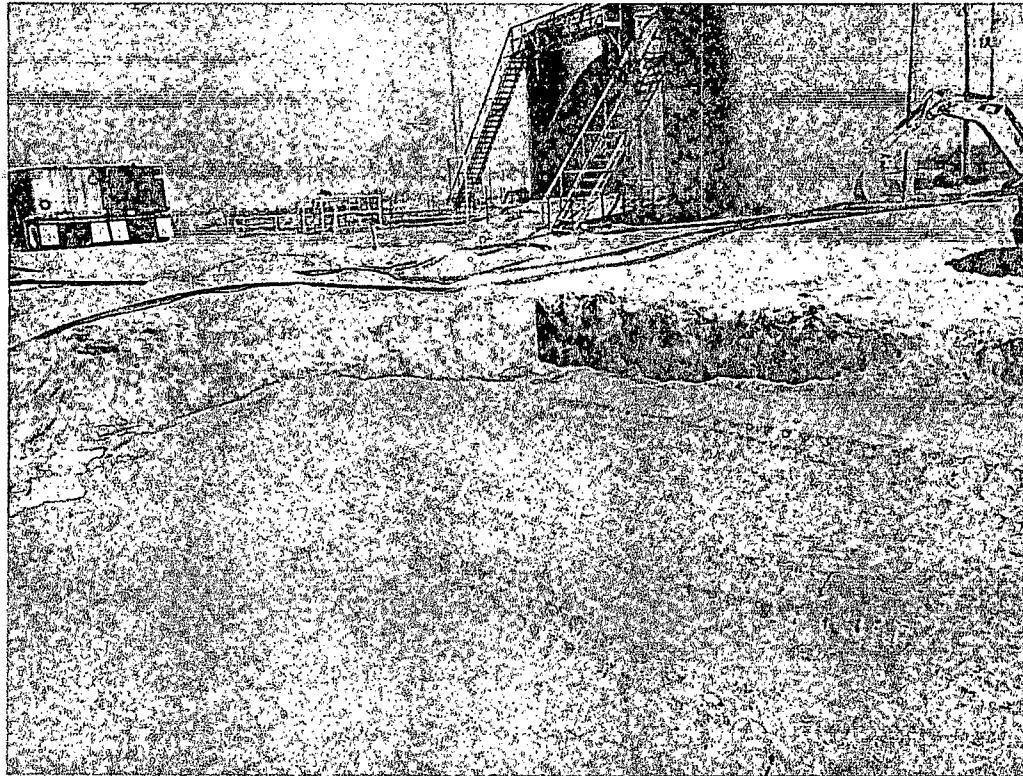
View Northeast – Backfill of AH-7
