REMEDIATION SUMMARY AND SITE CLOSURE REQUEST

**BOPCO, LP
POKER LAKE UNIT #190 FLOW LINE
Eddy County, New Mexico
Unit Letter "L" (NW/SW), Section 8, Township 24 South, Range 30 East
Latitude 32.230027° North, Longitude 103.911112° West
NMOCD Reference #2RP-1176**

March 2014

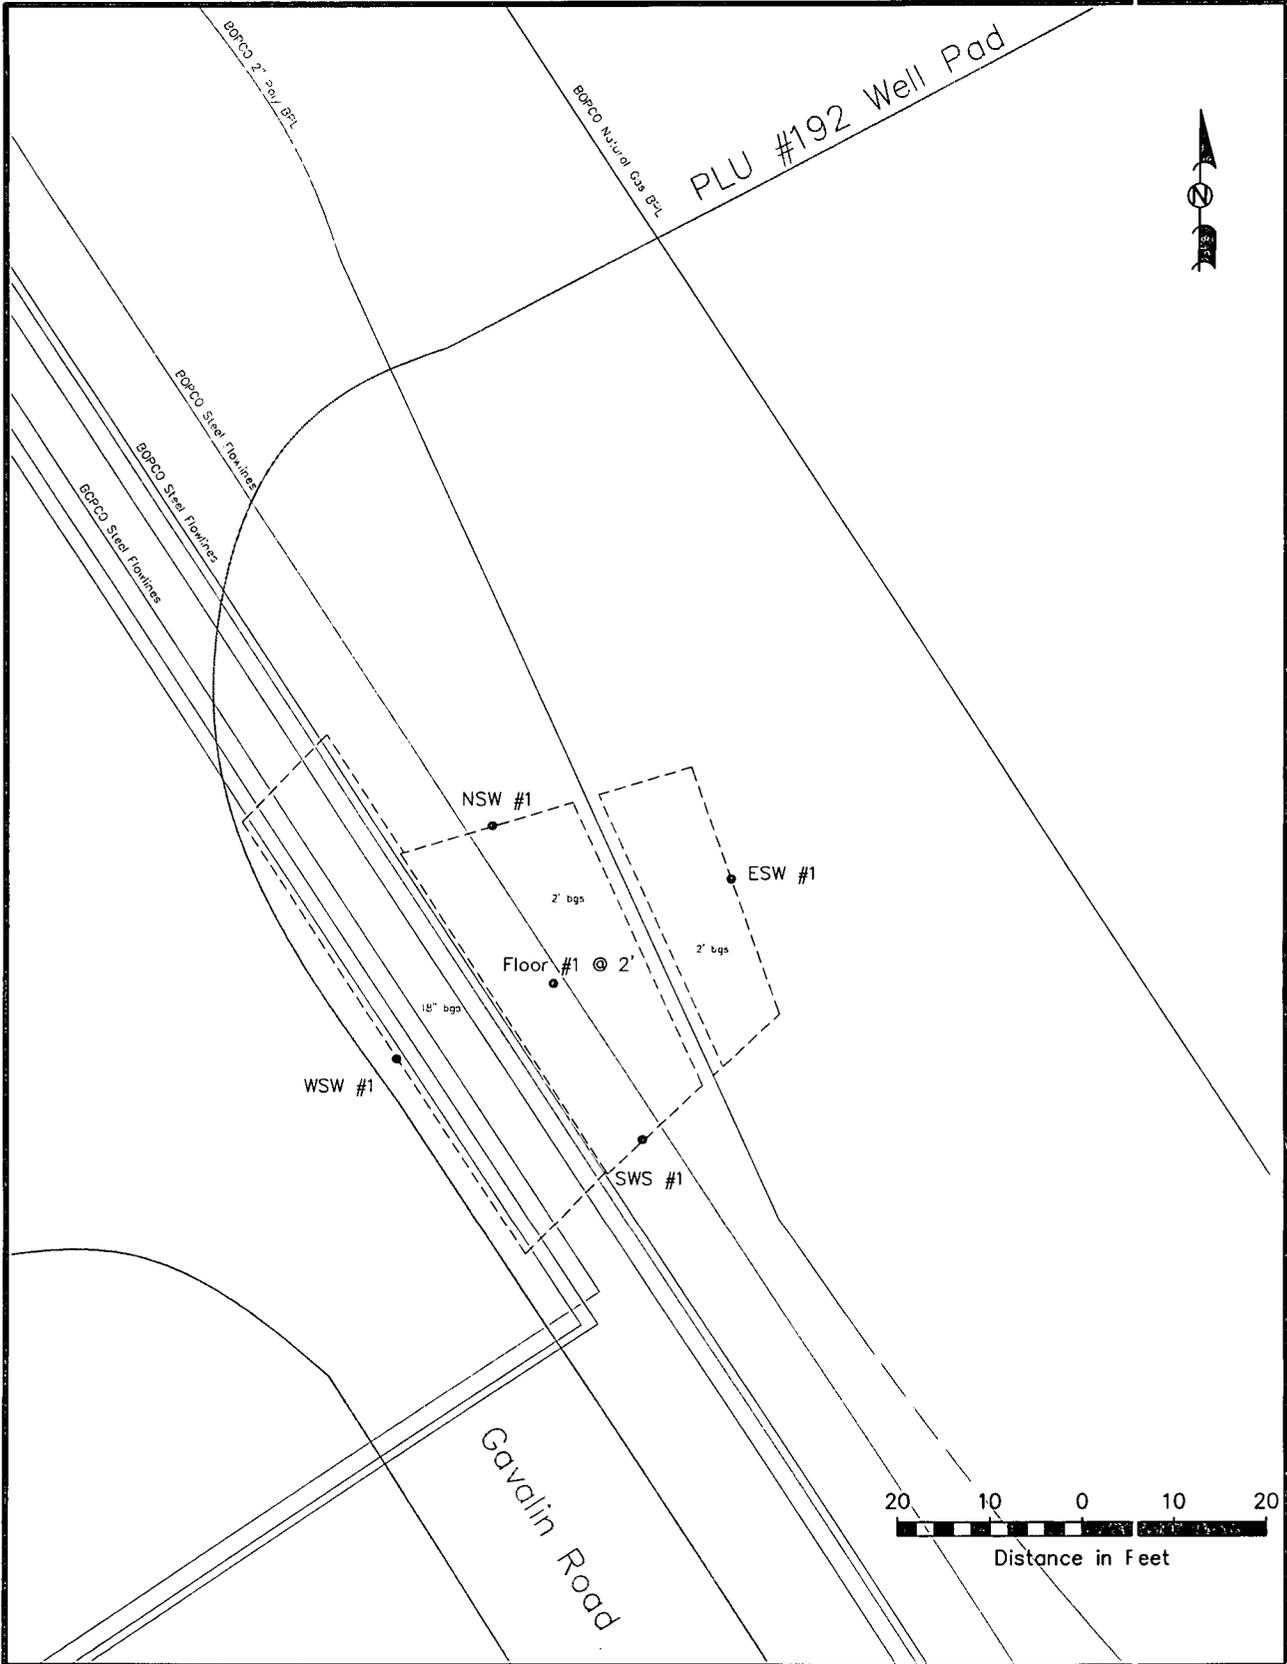
Figure 2
Site & Sample Location Map
BOPCO, L.P
PLU #190 Flowline
Eddy County, NM

— Excavation Extent	— Road
— Pipeline	
● Sample Location

On February 13, 2014, four (4) confirmation soil samples (NSW #1, ESW #1, SSW #1 and Floor #1 @ 2') were collected from the floor and sidewalls of the excavation and submitted to the laboratory for analysis of chloride concentrations. Laboratory analytical results indicated chloride concentrations ranged from 576 ppm for soil sample ESW #1 to 80.0 ppm for soil sample SSW #1. Soil sample Floor #1 @ 2' was also analyzed for concentrations of TPH and BTEX, which were determined to be less than the appropriate laboratory method detection limit (MDL). Chloride, TPH and BTEX concentrations were below NMOCD Regulatory Standards in each of the submitted soil samples. A summary of "Concentrations of Benzene, BTEX, TPH and Chloride in Soil" is provided in Table 1. A "Site and Sample Location Map" is provided as Figure 2. Laboratory analytical reports are provided as Appendix C.

On February 14, 2014, one (1) soil sample (WSW #1) was collected from the west sidewall of the excavation, adjacent to Gavalin Road. Soil sample WSW #1 was submitted to the laboratory for analysis of chloride concentrations, which were determined to be 1,960 ppm. Further excavation to the west posed a safety risk due to the presence of a heavily used oilfield access road.

The final dimensions of the excavation were approximately thirty-five feet (35') in width, forty feet (40') in length and eighteen inches (18") to two feet (2') in depth.

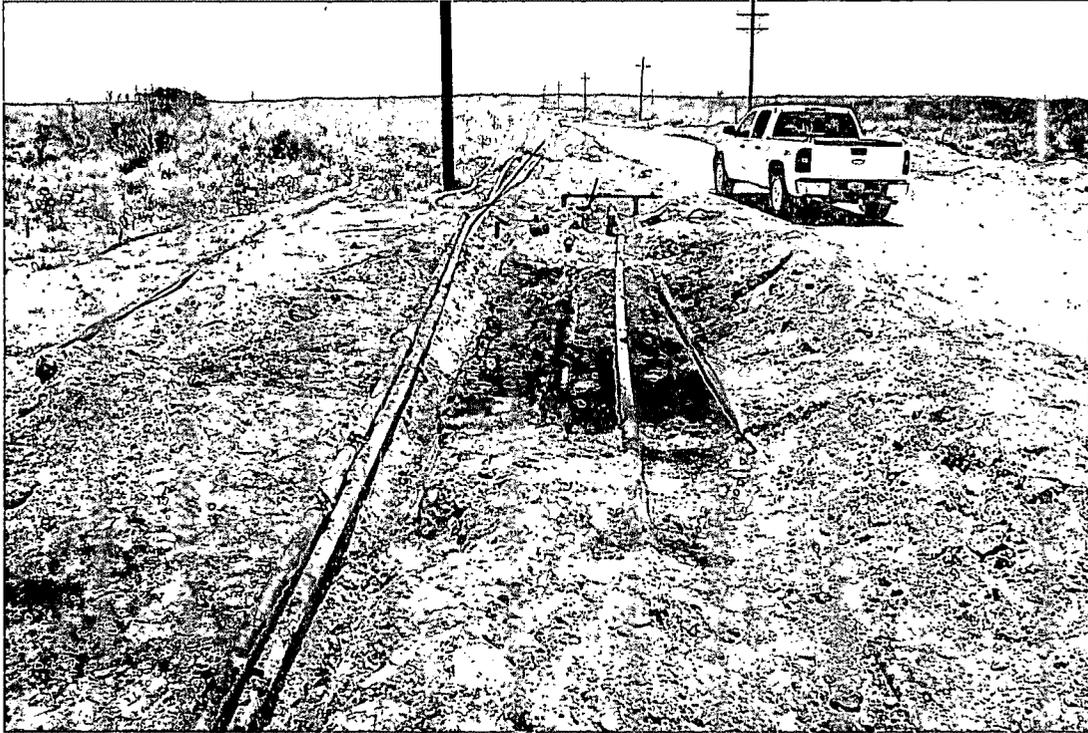
Photograph of the initial release at the PLU #190 Flow Line Release Site.

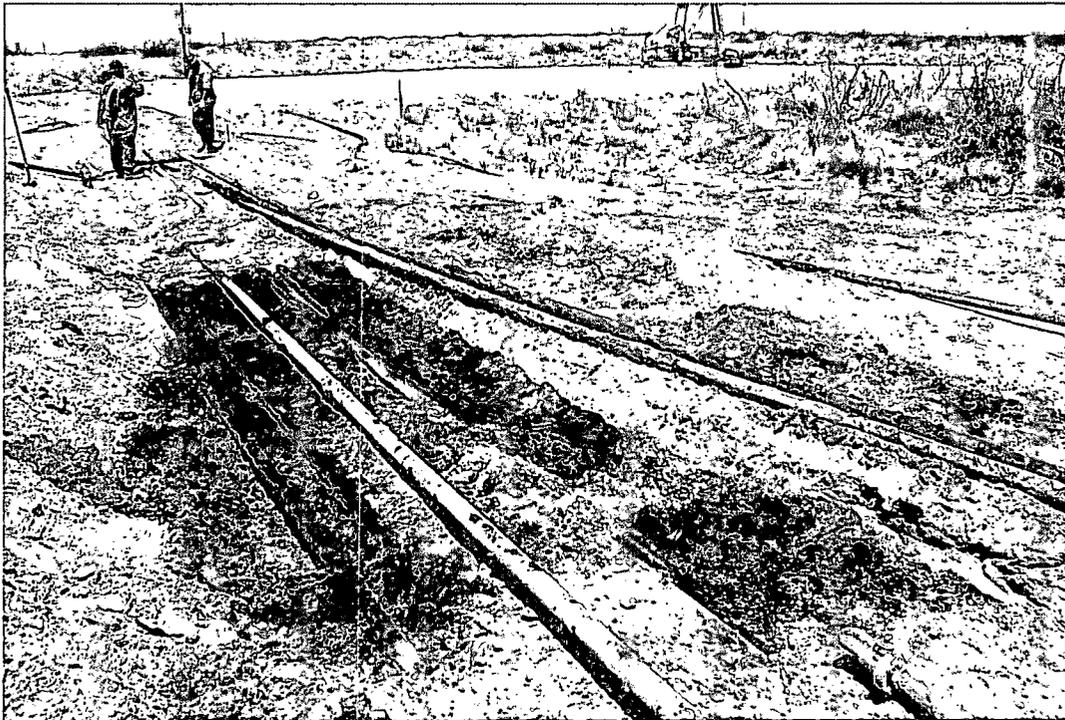
Photograph of the initial release at the PLU #190 Flow Line Release Site.

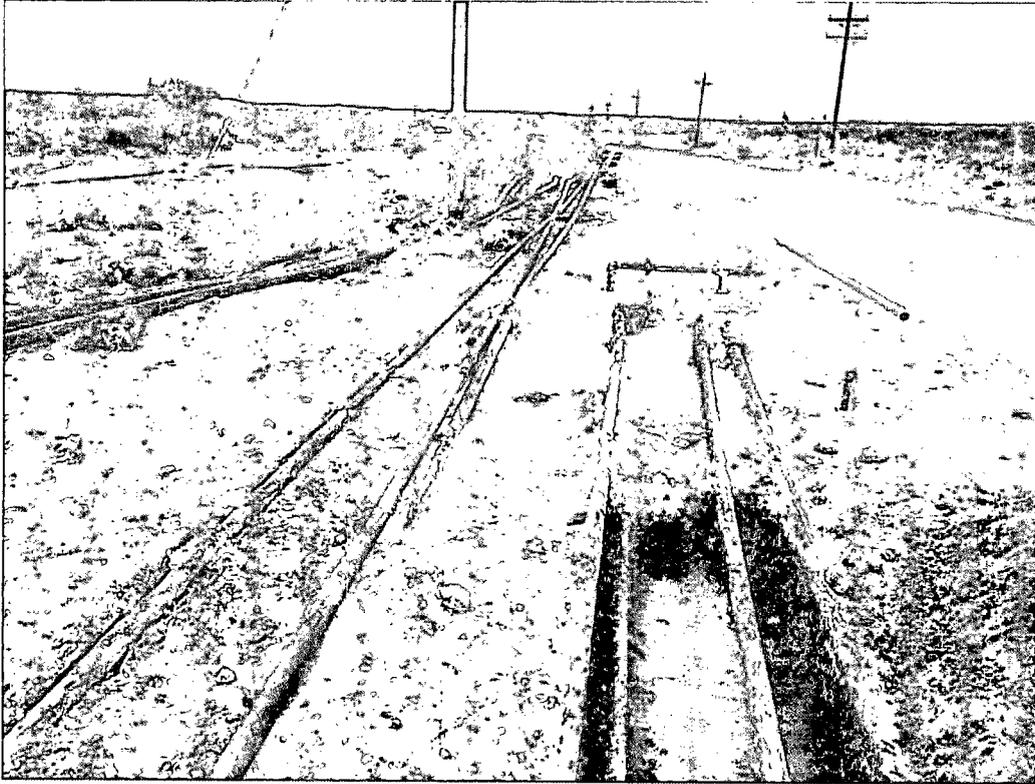
Photograph of excavation activities at the PLU #190 Flow Line Release Site.

On February 10, 2014, Basin began excavating impacted soil at the release site. The floor and sidewalls of the excavation were advanced until field tests suggested concentrations of benzene, toluene, ethylbenzene and xylene (BTEX), total petroleum hydrocarbons (TPH) and chloride were less than NMOCD Regulatory Standards. Excavated material was stockpiled on-site, pending final disposition.

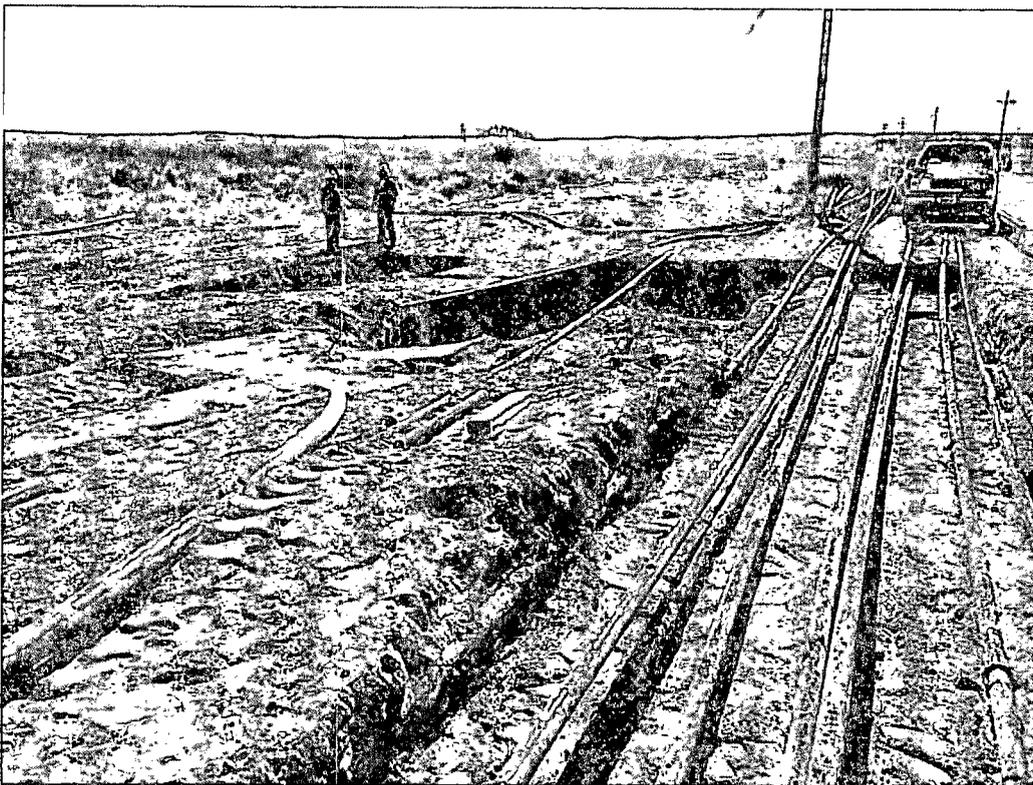
Photograph of the excavated area at the PLU #190 Flow Line Release Site.

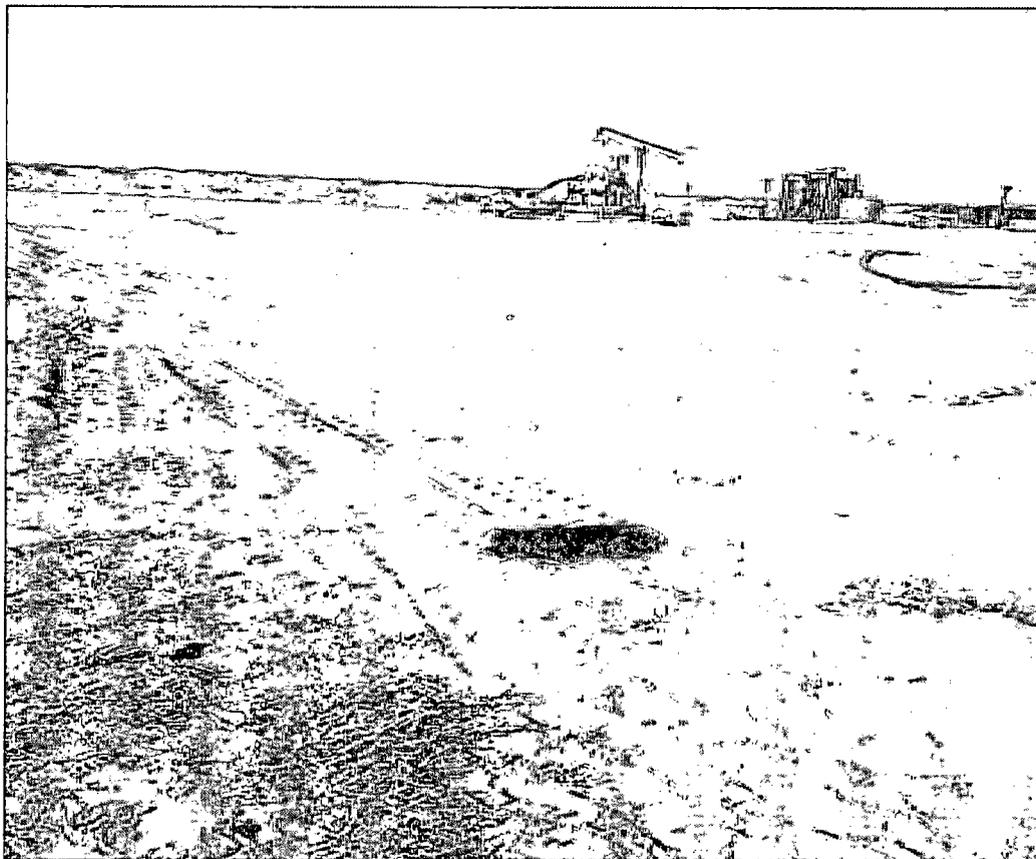
Photograph of PLU #190 Flow Line Release after remediation activities.

On February 17, 2014, upon receiving laboratory analytical data from confirmation soil samples, Basin began backfilling the excavation with locally purchased, non-impacted material. Following backfilling, areas affected by the remediation activities were contoured to fit the surrounding topography.

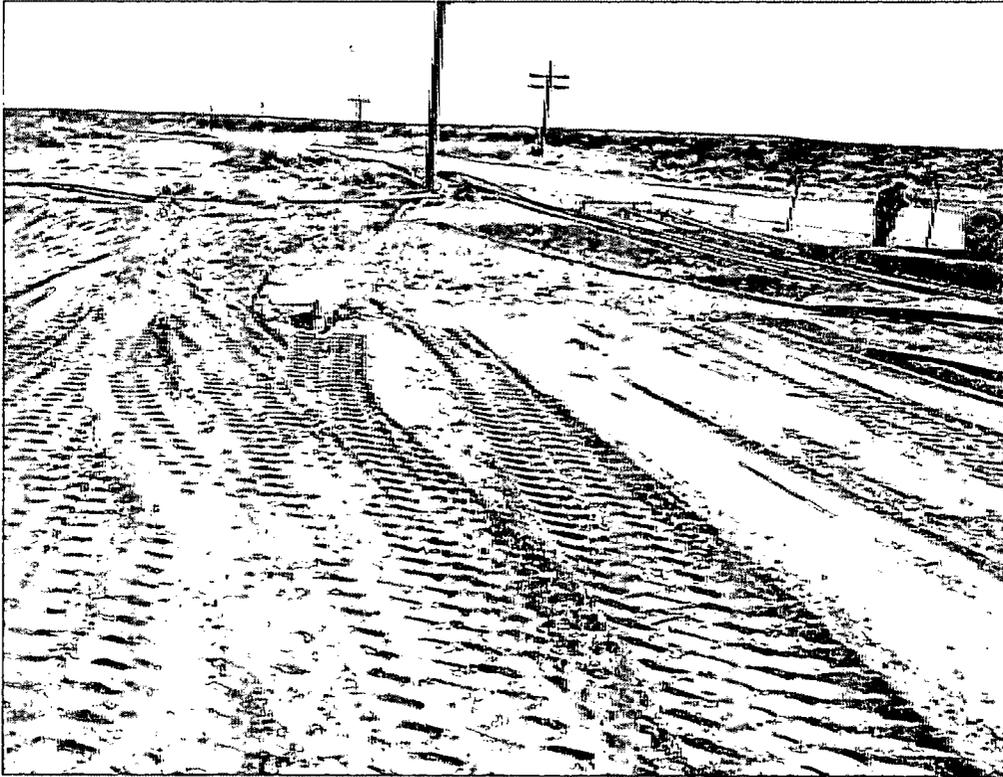
Photograph of PLU #190 Flow Line Release after remediation activities.

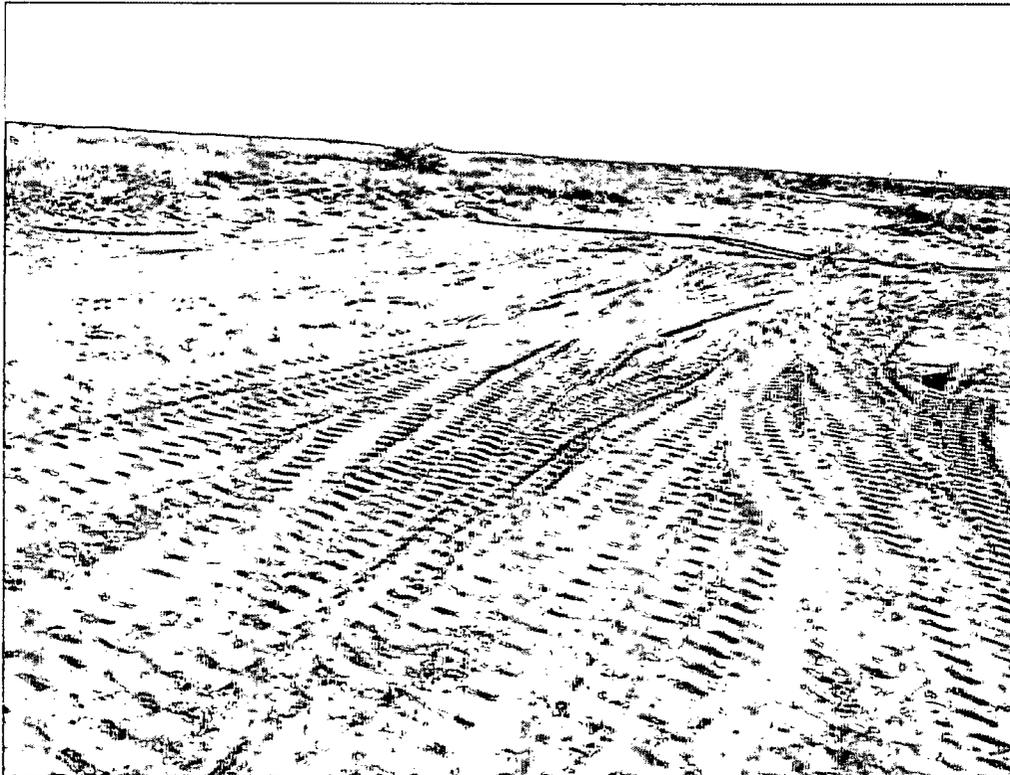
Photograph of PLU #190 Flow Line Release after remediation activities.
