REMEDIATION SUMMARY AND SITE CLOSURE REQUEST

**BOPCO, LP
POKER LAKE UNIT #154 FLOW LINE
Eddy County, New Mexico
Unit Letter "J" (NW/SE), Section 6, Township 24 South, Range 30 East
Latitude 32.244462° North, Longitude 103.920312° West
NMOCD Reference #2RP-1175**

March 2014

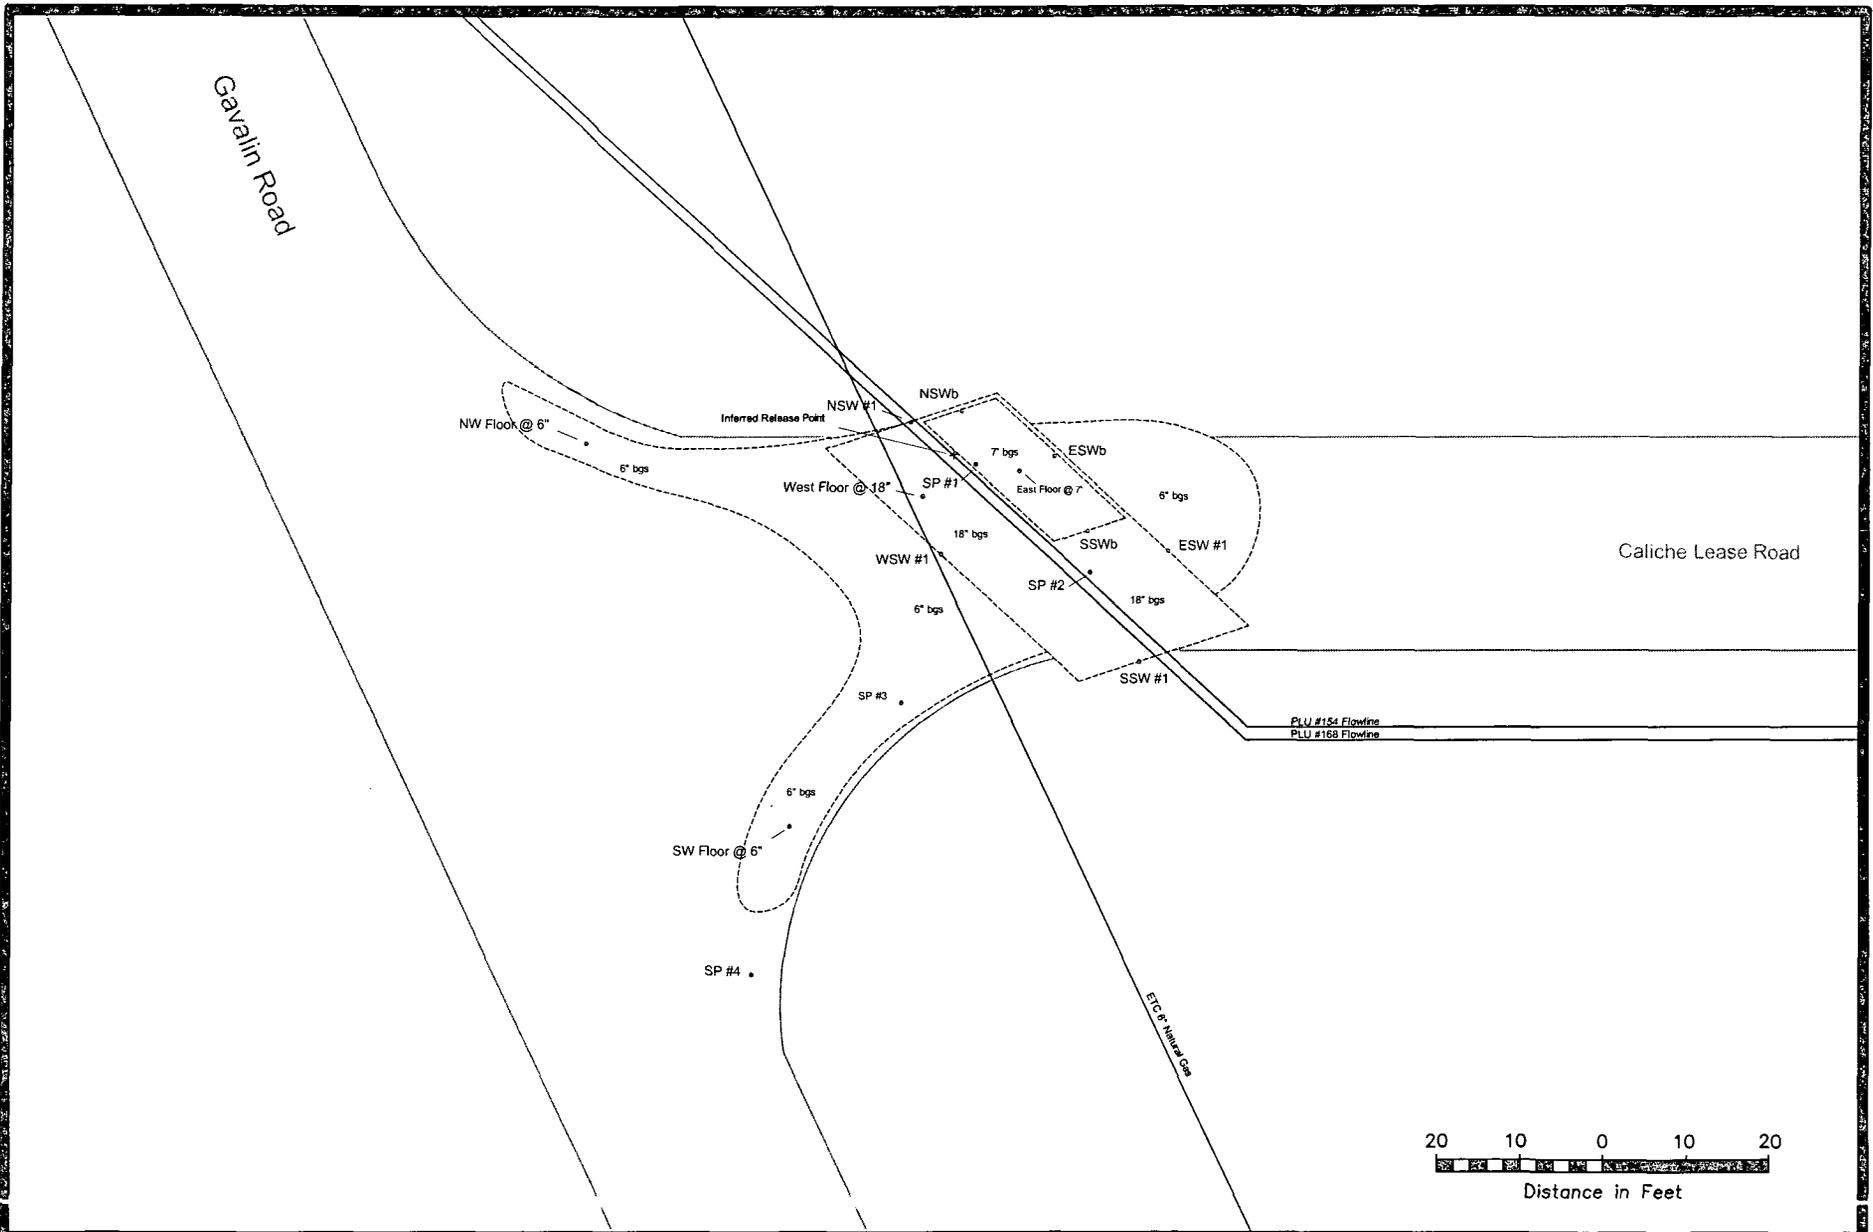
Figure 2
 Site and Sample Location Map
 BOPCO, LP
 Poker Lake Unit #154 Flow Line
 Eddy County, New Mexico

On December 3, 2013, Basin conducted an initial investigation at the release site. A series of hand-augered soil bores were advanced at the release site in an effort to determine the vertical and horizontal extent of soil impact. During the initial investigation, eight (8) soil samples (SP #1 @ 1', SP #1 @ 3', SP #2 @ 1', SP #2 @ 3', SP #3 @ 1', SP #3 @ 3', SP #4 @ 1' and SP #4 @ 3') were collected and submitted to Cardinal Laboratories, of Hobbs, New Mexico, for analysis of chloride concentrations. Laboratory analytical results indicated chloride concentrations ranged from 3,960 ppm for soil sample SP #1 @ 2' to 48.0 ppm for soil sample SP #4 @ 1'. Soil samples SP #1 @ 1', SP #1 @ 3', SP #2 @ 3', SP #3 @ 3' and SP #4 @ 3' were also analyzed for concentrations of total petroleum hydrocarbon (TPH). Laboratory analytical results indicated TPH concentrations were less than the laboratory method detection limit (MDL) in each of the submitted soil samples with the exception of soil sample SP #1 @ 3', which exhibited a TPH concentration of 11.2 ppm. Soil sample SP #1 @ 3' was also analyzed for concentrations of benzene, ethylbenzene, toluene, and xylene (BTEX), which were determined to be less than the appropriate laboratory MDL. Laboratory analytical results indicated chloride, TPH and BTEX concentrations were below NMOCD Regulatory Standards in each of the submitted soil samples with the exception of soil samples SP #1 @ 3' and SP #2 @ 1'. A summary of "Concentrations of Benzene, BTEX, TPH and Chloride in Soil" is provided in Table 1. A "Site and Sample Location Map" is provided as Figure 2. Laboratory analytical reports are provided as Appendix C.

On February 25, 2014, Basin began excavating impacted soil at the release site. The floor and sidewalls of the excavation were advanced until field tests suggested concentrations of BTEX, TPH and chloride were below NMOCD Regulatory Standards. Excavated soil was stockpiled on-site, pending final disposition. Eleven (11) soil samples (NSW #1, ESW #1, WSW #1, SSW #1, SSWb, NW Floor @ 6", SW Floor @ 6", East Floor @ 7', West Floor @ 18", NSWb and ESWb) were collected from the floor and sidewalls of the excavation and submitted to the laboratory for analysis of chloride concentrations. Laboratory analytical results indicated chloride concentrations ranged from 720 ppm for soil sample NSWb to 240 ppm for soil sample ESWb. Soil samples SW Floor @ 6", East Floor @ 7' and West Floor @ 18" were also analyzed for concentrations of TPH. Laboratory analytical results indicated TPH concentrations were less than the appropriate laboratory MDL in each of the submitted soil samples with the exception of soil sample SW Floor @ 6", which exhibited a TPH concentration of 171.9 ppm. Soil sample East Floor @ 7' was also analyzed for concentrations of BTEX, which were determined to be less than the appropriate laboratory MDL.

On February 27, 2014, approximately one hundred and twenty cubic yards (120 yd³) of impacted material was transported to Lea Land, LLC (NMOCD Permit #WM-01-035) for disposal. The final dimensions of the excavation were approximately eighteen feet (18') in width, thirty-five feet (35') in length and eighteen inches (18") to seven feet (7') in depth. Upon receiving laboratory analytical data from confirmation soil samples, the excavated area was backfilled with locally purchased, non-impacted material. Following backfilling, areas affected by the remediation activities were compacted and contoured to match the existing caliche road.

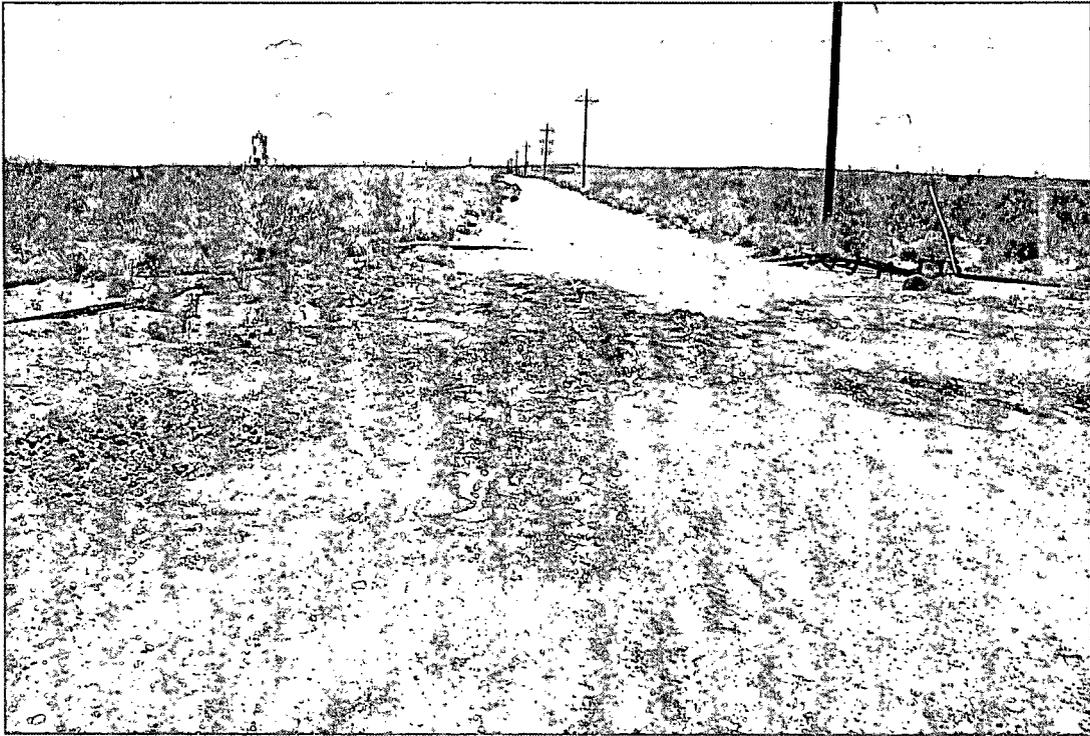
On May 21, 2012, BOPCO discovered a release had occurred on the Poker Lake Unit #154 flow line. Failure of a section of two and seven-eighths-inch (2 7/8") flow line resulted in a release of produced water and crude oil. The "Release Notification and Corrective Action" (Form C-141) indicated approximately ten barrels (10 bbls) of produced water and five barrels (5 bbls) of crude oil were released, affecting approximately seven hundred and twenty square feet (720 ft²) of caliche road and six hundred square feet (600 ft²) of pasture land. During initial response activities, a repair clamp was placed on the affected area of the pipe to mitigate the release. The failure was attributed to external corrosion. The Form C-141 is provided as Appendix A. General photographs of the release site are provided as Appendix B.

Photograph of the initial release at the PLU #154 Flow Line Release Site.

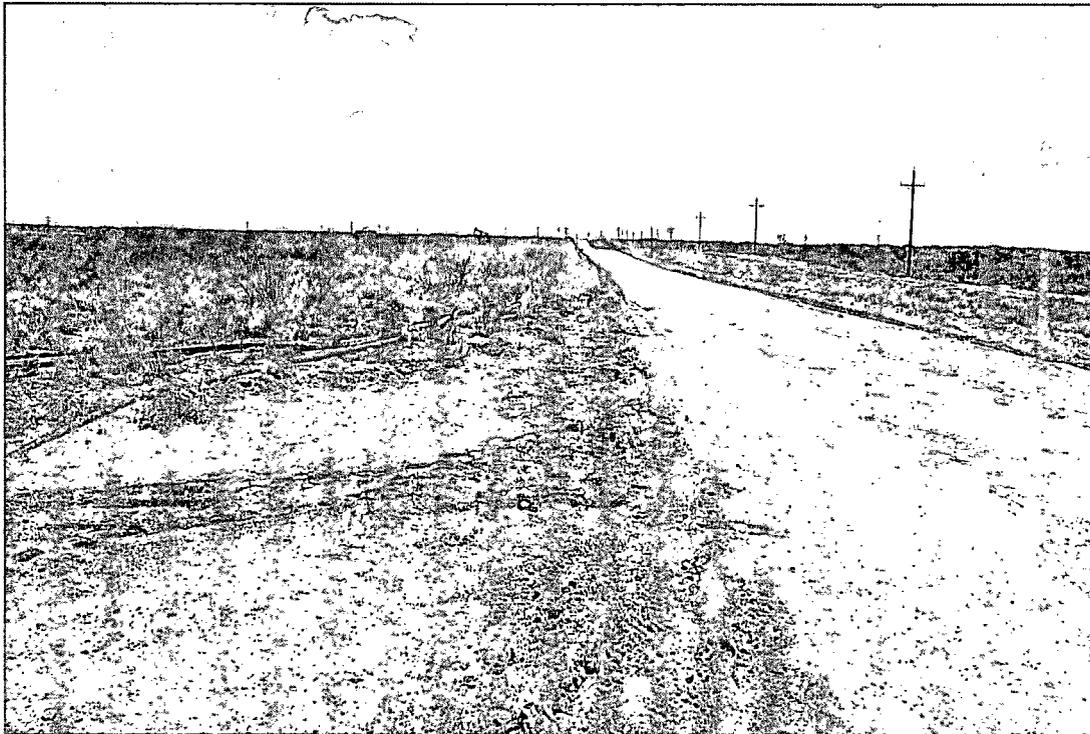
Photograph of the initial release at the PLU #154 Flow Line Release Site.

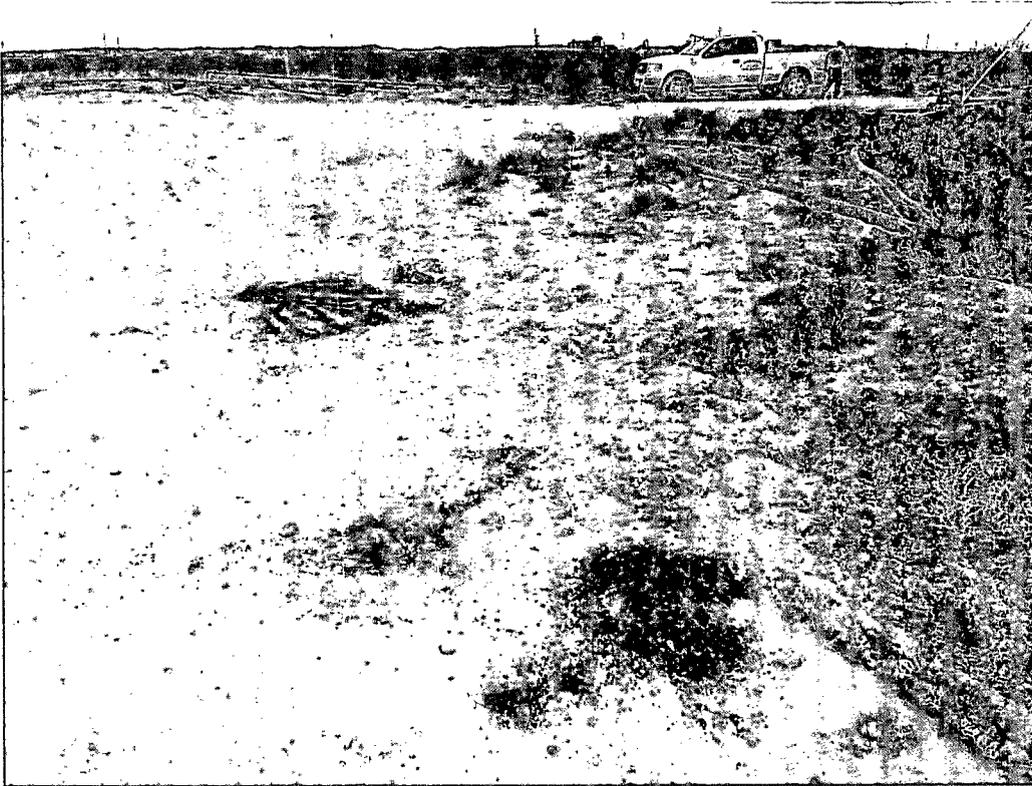
Photograph of initial investigation activities at the PLU #154 Flow Line Release Site.

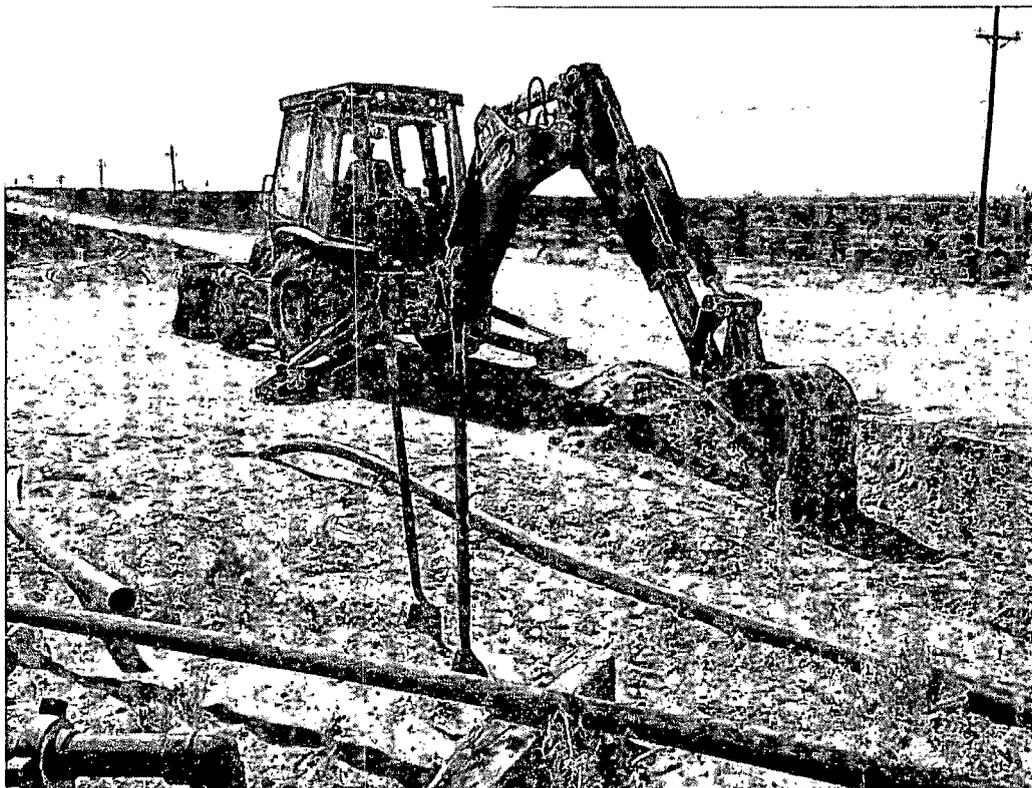
Photograph of excavation activities at the PLU #154 Flow Line Release Site.

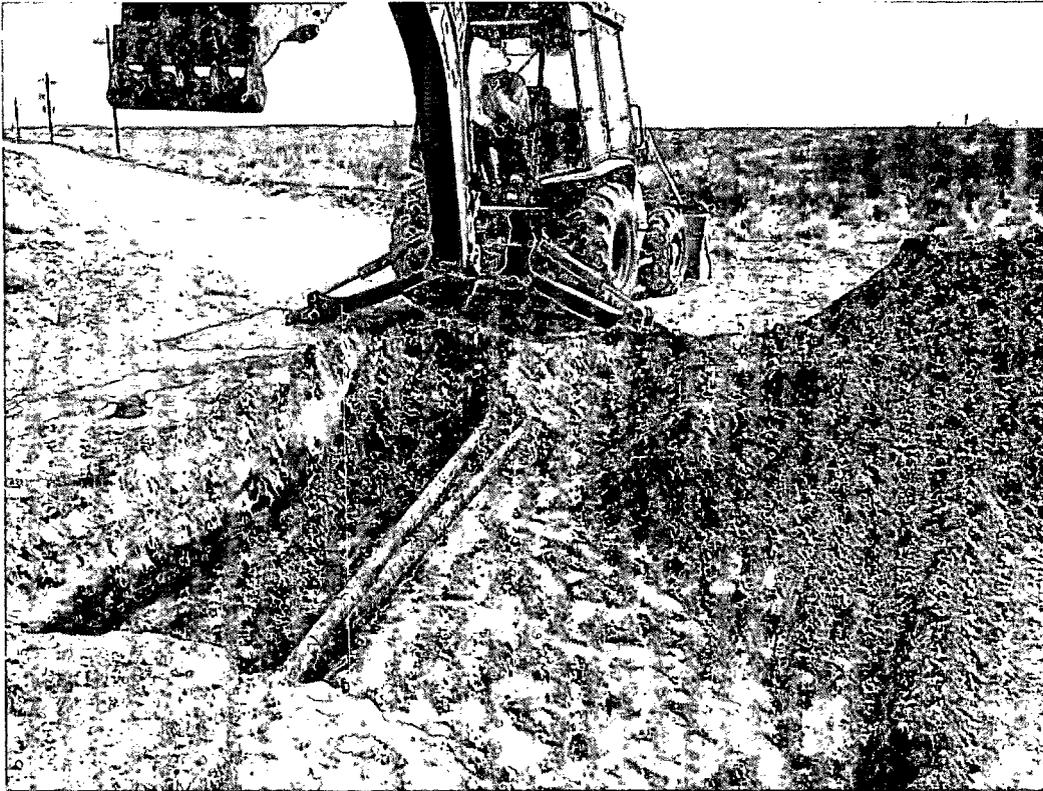
Photograph of excavation activities at the PLU #154 Flow Line Release Site.

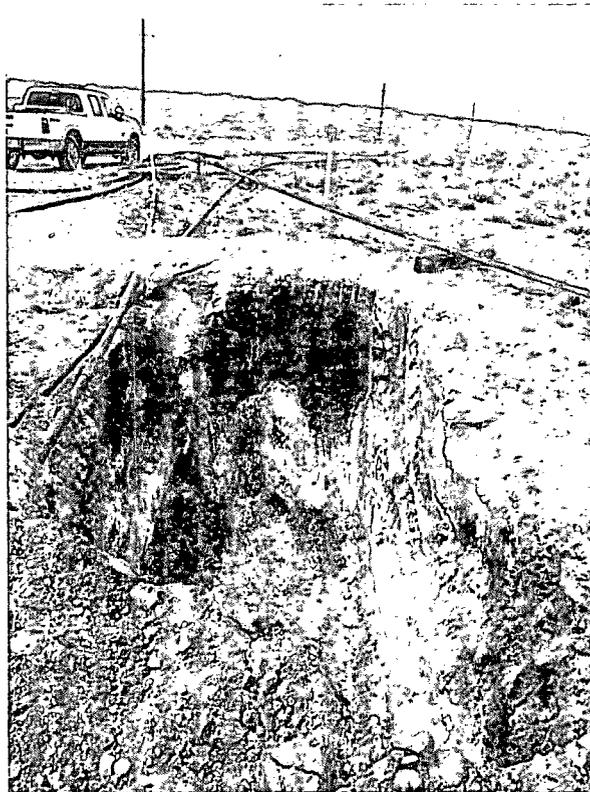
Photograph of excavation activities at the PLU #154 Flow Line Release Site.

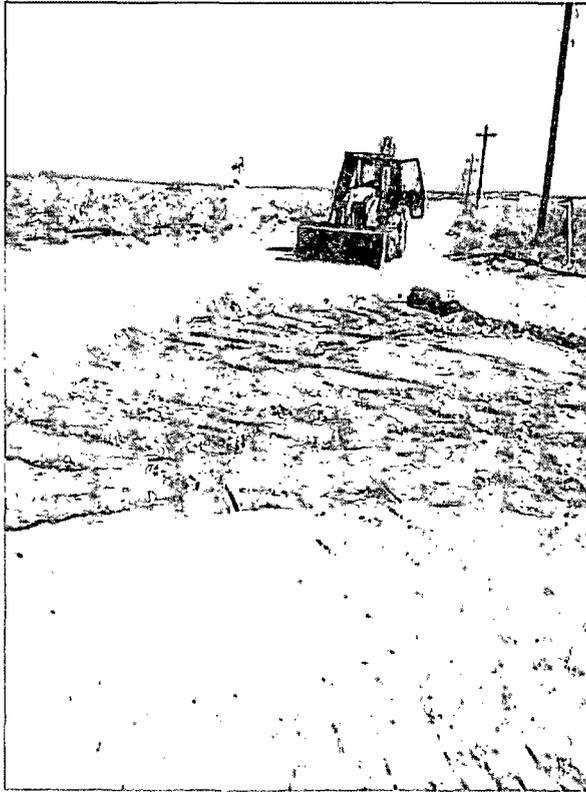
Photograph of backfilling activities at the PLU #154 Flow Line Release Site.

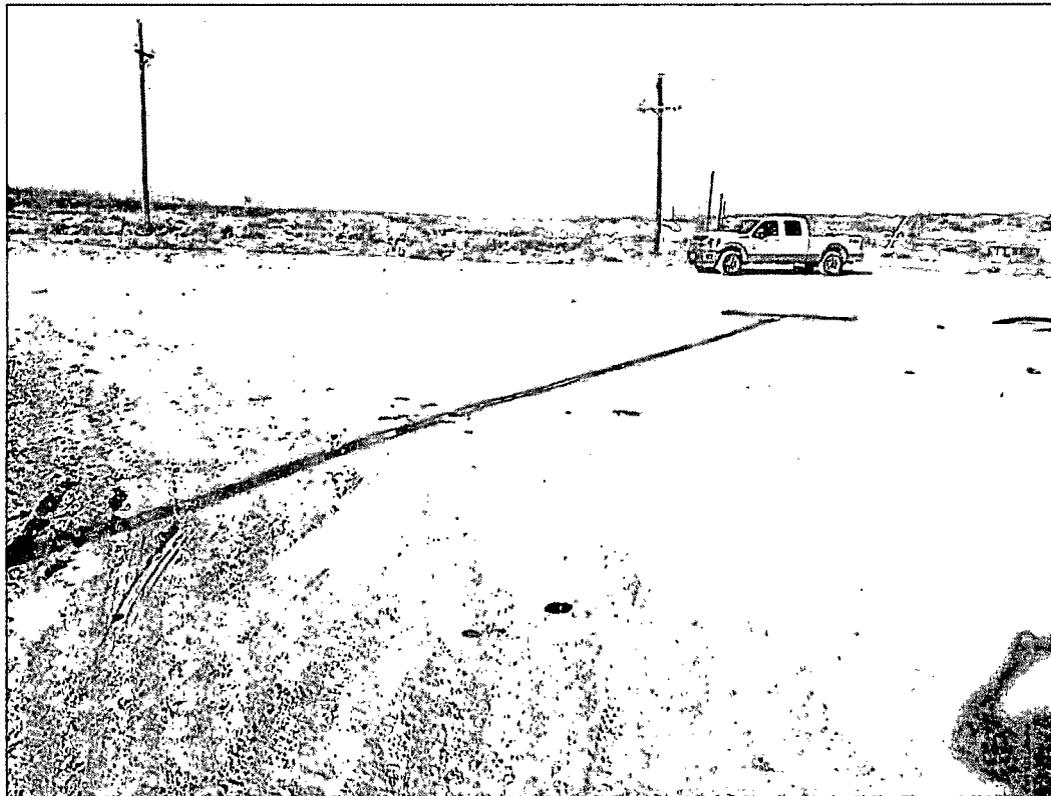
Photograph of PLU #154 Flow Line Release after remediation activities.
