REMEDIATION SUMMARY AND RISK- BASED SITE CLOSURE REQUEST

**BOPCO, LP
POKER LAKE UNIT WELL #149
Eddy County, New Mexico
Unit Letter "I" (NE/SE), Section 31, Township 23 South, Range 30 East
Latitude 32.260954° North, Longitude 103.914777° West
NMOCD Reference #2RP-1206**

January 2014

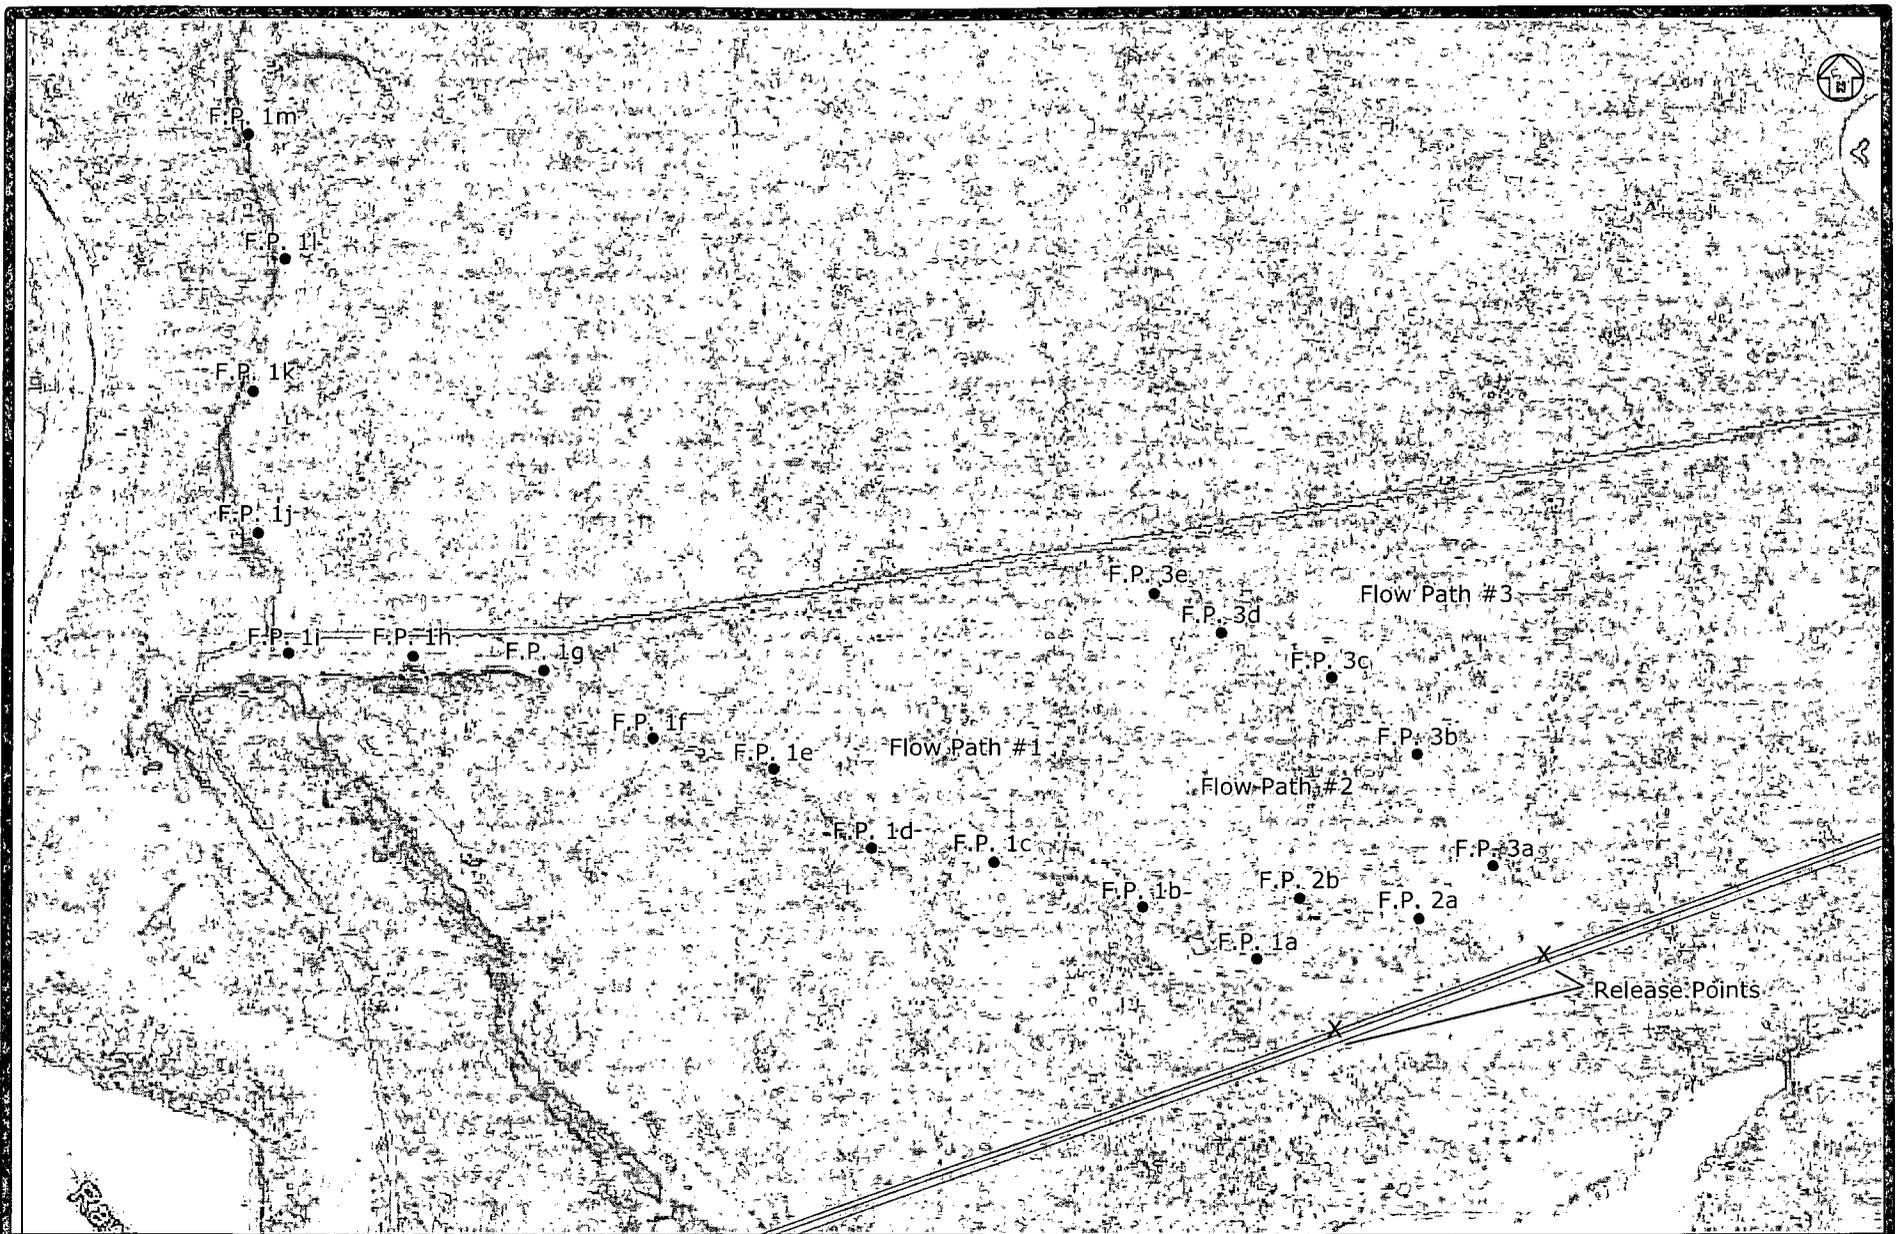
Figure 2

Initial Investigation Map
 BOPCO, L.P.
 Poker Lake Unit #149
 Eddy County, New Mexico

On July 27, 2012, Basin conducted an initial investigation at the release site in an effort to determine the nature and extent of soil impact. During the initial investigation, a hand auger was utilized to collect forty-two (42) soil samples from three (3) dry drainages (Flow Path #1, Flow Path #2 and Flow Path #3) north of the release point. Soil samples collected at the surface and at two feet (2') bgs were field-screened for concentrations of chloride using a Hach Quantab® Field Test Kit. Field test results suggested soil impact above NMOCD Regulatory Standards was only present in Flow Path #1. A summary of “Chloride Field Test Results” is provided as Table 1. An “Initial Investigation Map” is provided as Figure 2.

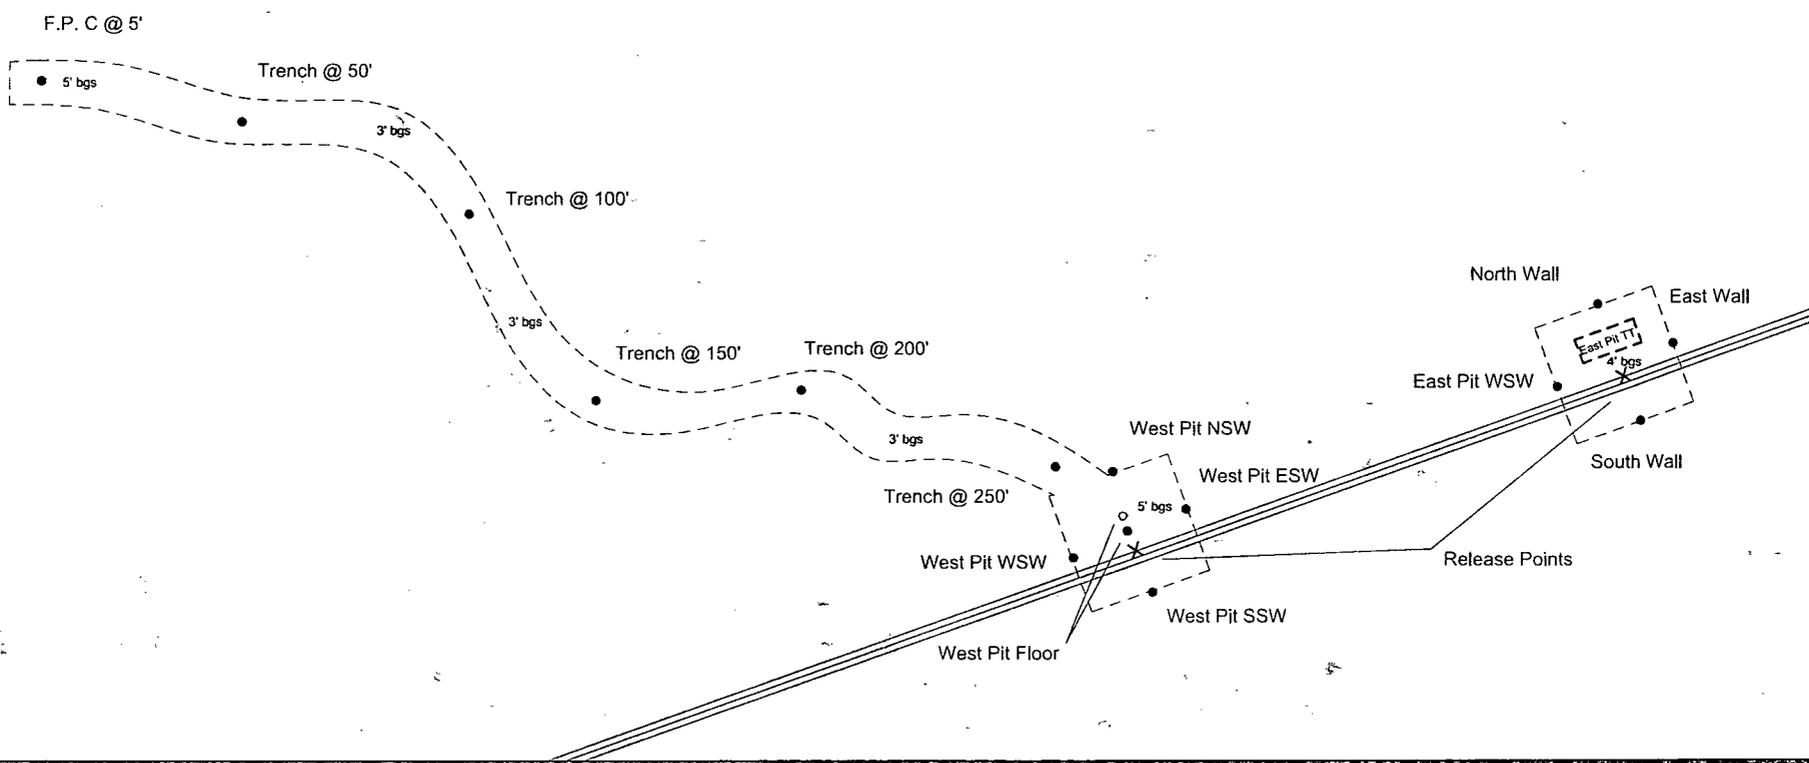
Figure 3

Site & Sample Location Map
 BOPCO, L.P.
 Poker Lake Unit #149
 Eddy County, New Mexico

On December 18, 2013, Basin began remediation activities at the release site. The floor and sidewalls of the primary excavation in the western portion of the remediation site were advanced until field tests suggested concentrations of BTEX, TPH and chloride were less than NMOCD Regulatory Standards. A historical release site east of the primary excavation was also remediated during this time. Excavated material was stockpiled on-site, pending final disposition.

On December 19, 2013, three (3) confirmation soil samples (East Wall, South Wall and North Wall) were collected from the sidewalls of the excavation in the eastern portion of the remediation site and submitted to Cardinal Laboratories, of Hobbs, New Mexico, for analysis of chloride concentrations by EPA Method 4500 Cl-B. Laboratory analytical results indicate chloride concentrations ranged from 752 ppm for soil sample South Wall to 400 ppm for soil sample East Wall. A summary of “Concentrations of Benzene, BTEX, TPH and Chloride in Soil” is provided in Table 2. Laboratory analytical reports are provided as Appendix C.

On December 26, 2013, five (5) confirmation soil samples (West Pit WSW, West Pit NSW, West Pit ESW, West Pit SSW, and West Pit Floor @ 3') were collected from the floor and sidewalls of the primary excavation in the western portion of the remediation site and submitted to the laboratory for analysis of chloride concentrations. Laboratory analytical results indicated chloride concentrations ranged from 720 ppm for soil sample West Pit WSW to 96.0 ppm for soil sample West Pit SSW. Soil sample West Pit Floor @ 3' was also analyzed for concentrations of BTEX and TPH, which were determined to be less than the laboratory MDL and 5,874 ppm respectively. Based on laboratory analytical results the floor of the excavation was advanced an additional two (2') feet.

On December 31, 2012, a twenty-millimeter (20-mil) polyurethane liner was installed on the floor of the eastern excavation at approximately four feet (4') bgs. This engineering control was designed to inhibit the vertical migration of contaminants left in-situ. A one-foot (1') layer of pad sand was installed below and above the liner to maintain its integrity during backfilling activities. The remaining portion of the excavation was backfilled with locally purchased, non-impacted material and contoured to match the surrounding topography. The final dimensions of the excavation in the eastern portion of the remediation site were approximately forty feet (40') in width, forty feet (40') in length and four feet (4') in depth.

On January 10, 2014, in accordance with BLM requests, approximately three hundred linear feet (300') of Flow Path #1 was excavated to approximately three feet (3') bgs. Three (3) confirmation soil samples (F.P. C @ 5', Trench @ 50' and Trench @ 100') were collected from the floor of the trench and submitted to the laboratory for analysis of chloride concentrations. Laboratory analytical results indicated chloride concentrations ranged from 608 ppm for soil sample Trench @ 50' to 320 ppm for soil sample F.P. C @ 5'. Soil sample F.P. C @ 5' was also analyzed for concentrations of TPH, which were determined to be less than the laboratory MDL.

On January 13, 2014, three (3) confirmation soil samples (Trench @ 150', Trench @ 200' and Trench @ 250') were collected from the floor of the trench and submitted to the laboratory for analysis of chloride concentrations. Laboratory analytical results indicated chloride concentrations ranged from 304 ppm for soil sample Trench @ 200' to 112 ppm for soil sample Trench @ 250'.

Between December 27, 2013, and January 16, 2014, approximately seven hundred and forty cubic yards (740 yd³) of impacted material was transported to Lea Land, LLC (NMOCD Permit #WM-01-035) for disposal. The final dimensions of the primary excavation in the western portion of the remediation site were approximately forty feet (40') in width, forty feet (40') in length and five feet (5') in depth.

Approximately three hundred feet (300') of a narrow flowpath traveling north from the primary release point was excavated to approximately three feet (3') bgs. Upon receiving laboratory analytical data from confirmation soil samples, the excavated areas were backfilled with locally purchased, non-impacted material. River rock was installed in the affected drainage in an effort to mitigate erosion. Following backfilling, areas affected by the remediation activities were contoured to fit the surrounding topography.

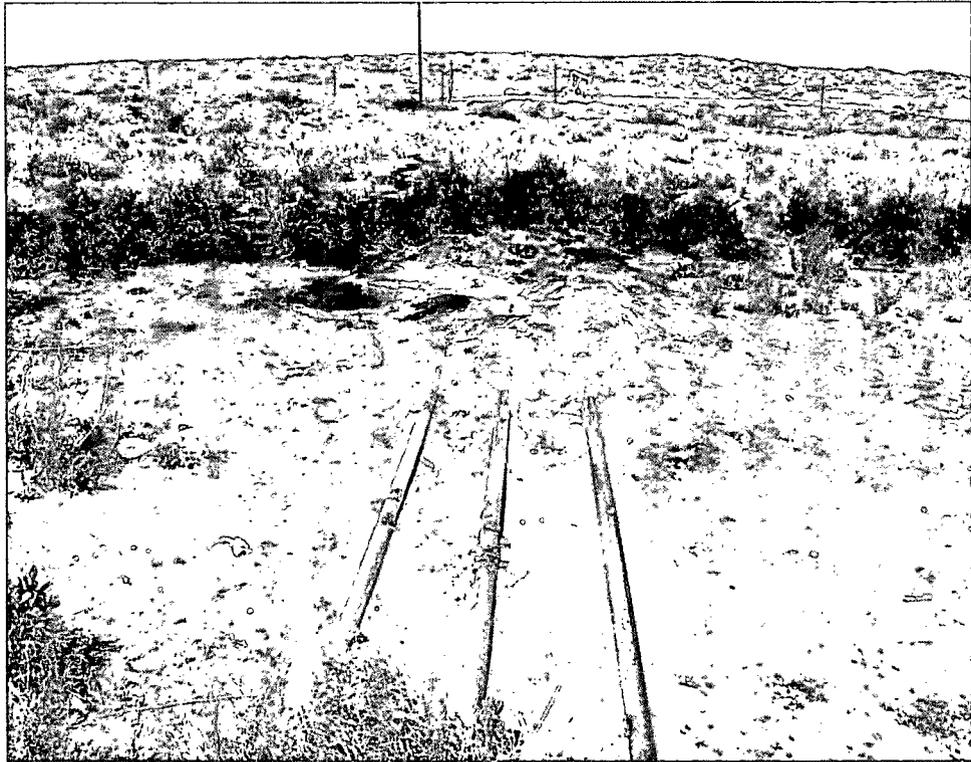
Photograph of the initial release at the PLU #149.

On May 29, 2012, BOPCO discovered a release had occurred on the PLU #149 Flow Line. The release was attributed to the failure of a section of two and seven-eighths-inch (2 7/8") flow line. The release was reported to the New Mexico Oil Conservation Division (NMOCD) Artesia District Office immediately. The "Release Notification and Corrective Action" (Form C-141) indicated approximately thirty barrels (30 bbls) of produced water and fifteen barrels (15 bbls) of crude oil were released, with no recovery. The initial Form C-141 indicated the release affected approximately two thousand square feet (2,000 ft²) of pasture land. The release occurred on top of an area previously impacted by at least two (2) prior flow line releases. There was also an area in the impact zone that had exposed plastic from a reserve pit location. During initial response activities, a temporary repair clamp was placed on the pipe. The affected segment has since been replaced. The Form C-141 is provided as Appendix A. General photographs of the release site are provided as Appendix B.

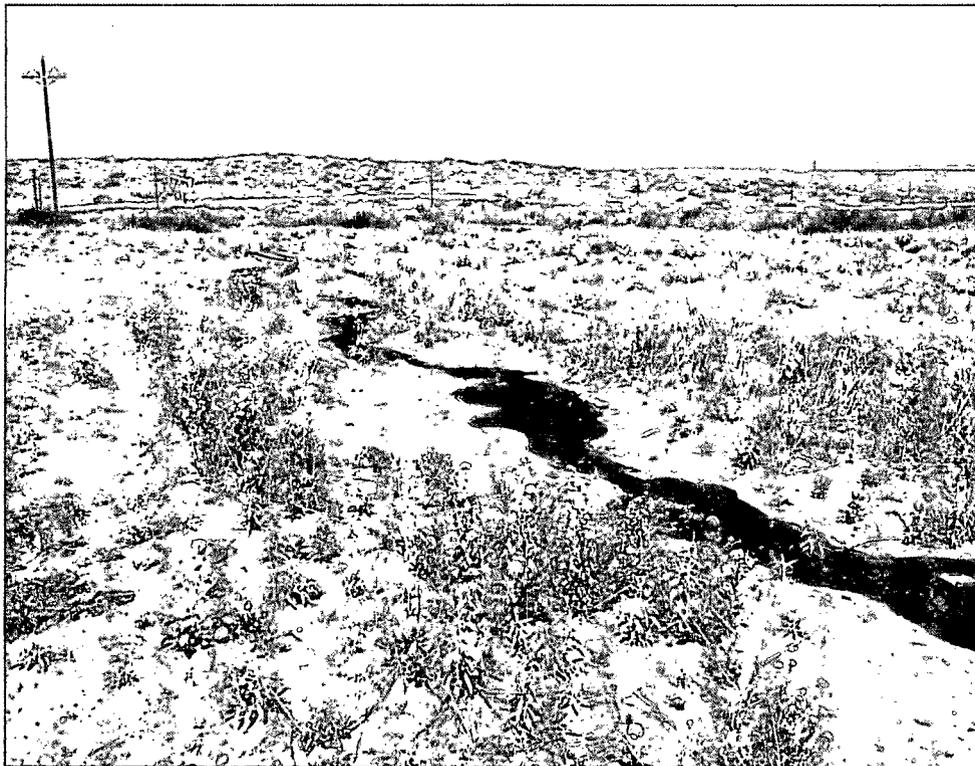
Photograph of the initial release and narrow flowpath at the PLU #149.

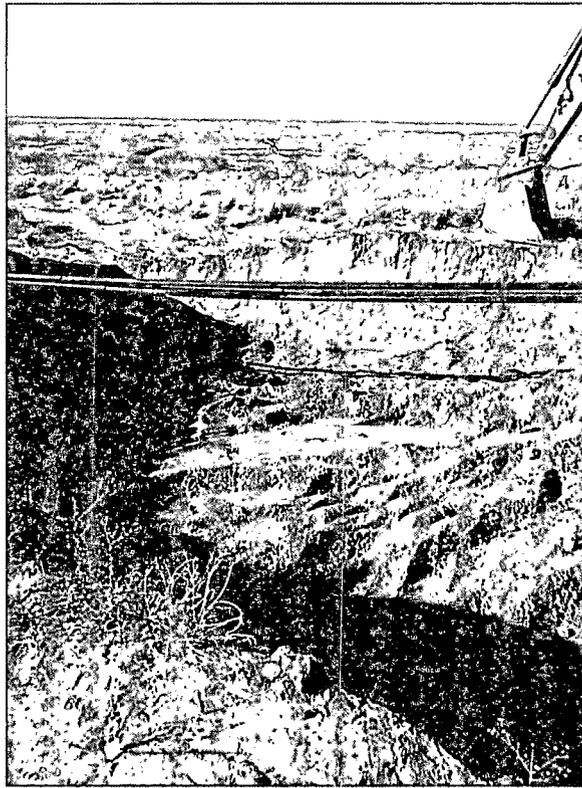
Photograph of excavation in the eastern portion of the remediation site at the PLU #149.

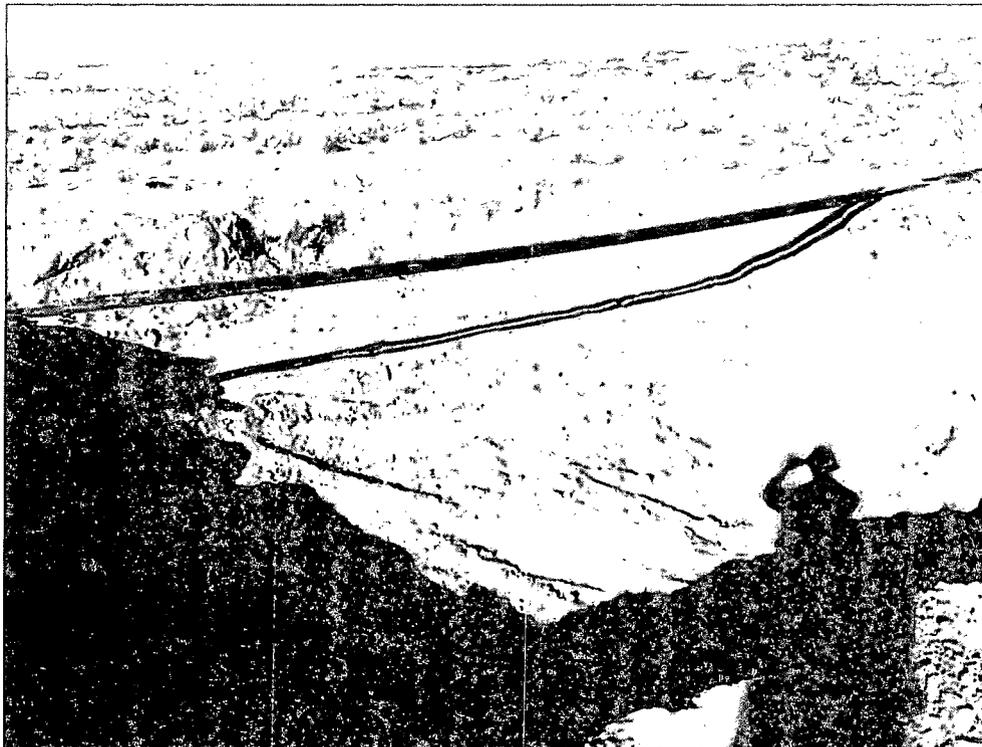
Photograph of the excavated release point (West Pit) at the PLU #149 Release Site.

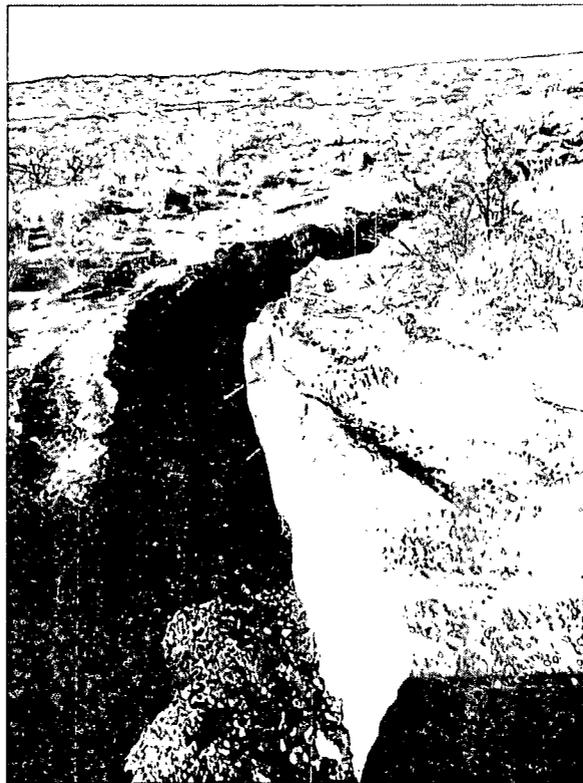
Photograph of the excavated flow path at the PLU #149.

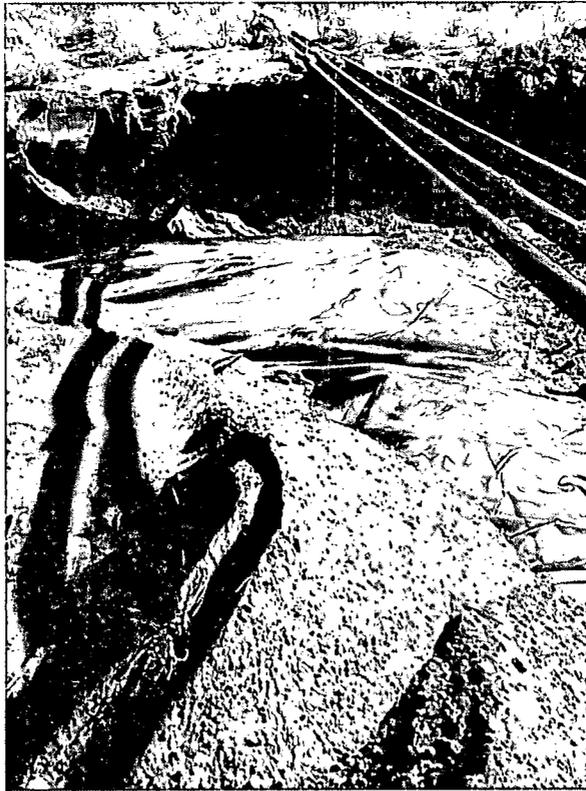
Photograph of backfilling activities at the PLU #149 Release Site.

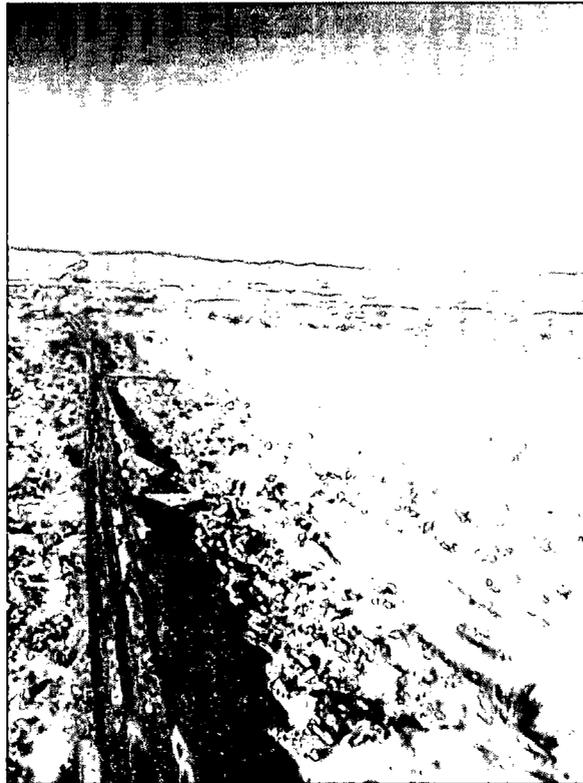
Photograph of PLU #149 Release Site after remediation activities.

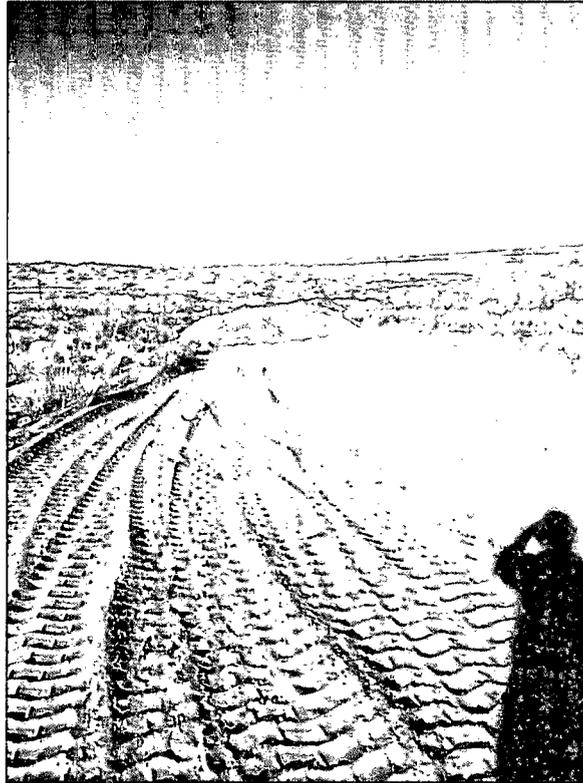
Photograph of PLU #149 Release Site after remediation activities.

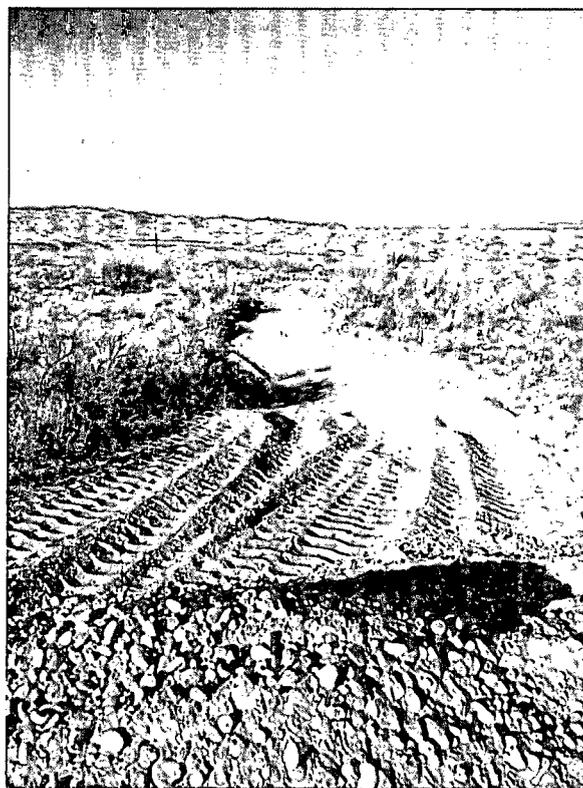
Photograph of narrow flowpath at the PLU #149 Release Site after remediation activities.
