REMEDIATION SUMMARY & SITE CLOSURE REQUEST

**BOPCO, LP
POKER LAKE UNIT 152 Pumping Well
Eddy County, New Mexico
UNIT LTR "H" (SE/NE), Section 6, Township 24 South, Range 30 East
Latitude 32.248470° North, Longitude 103.914220° West**

December 2011

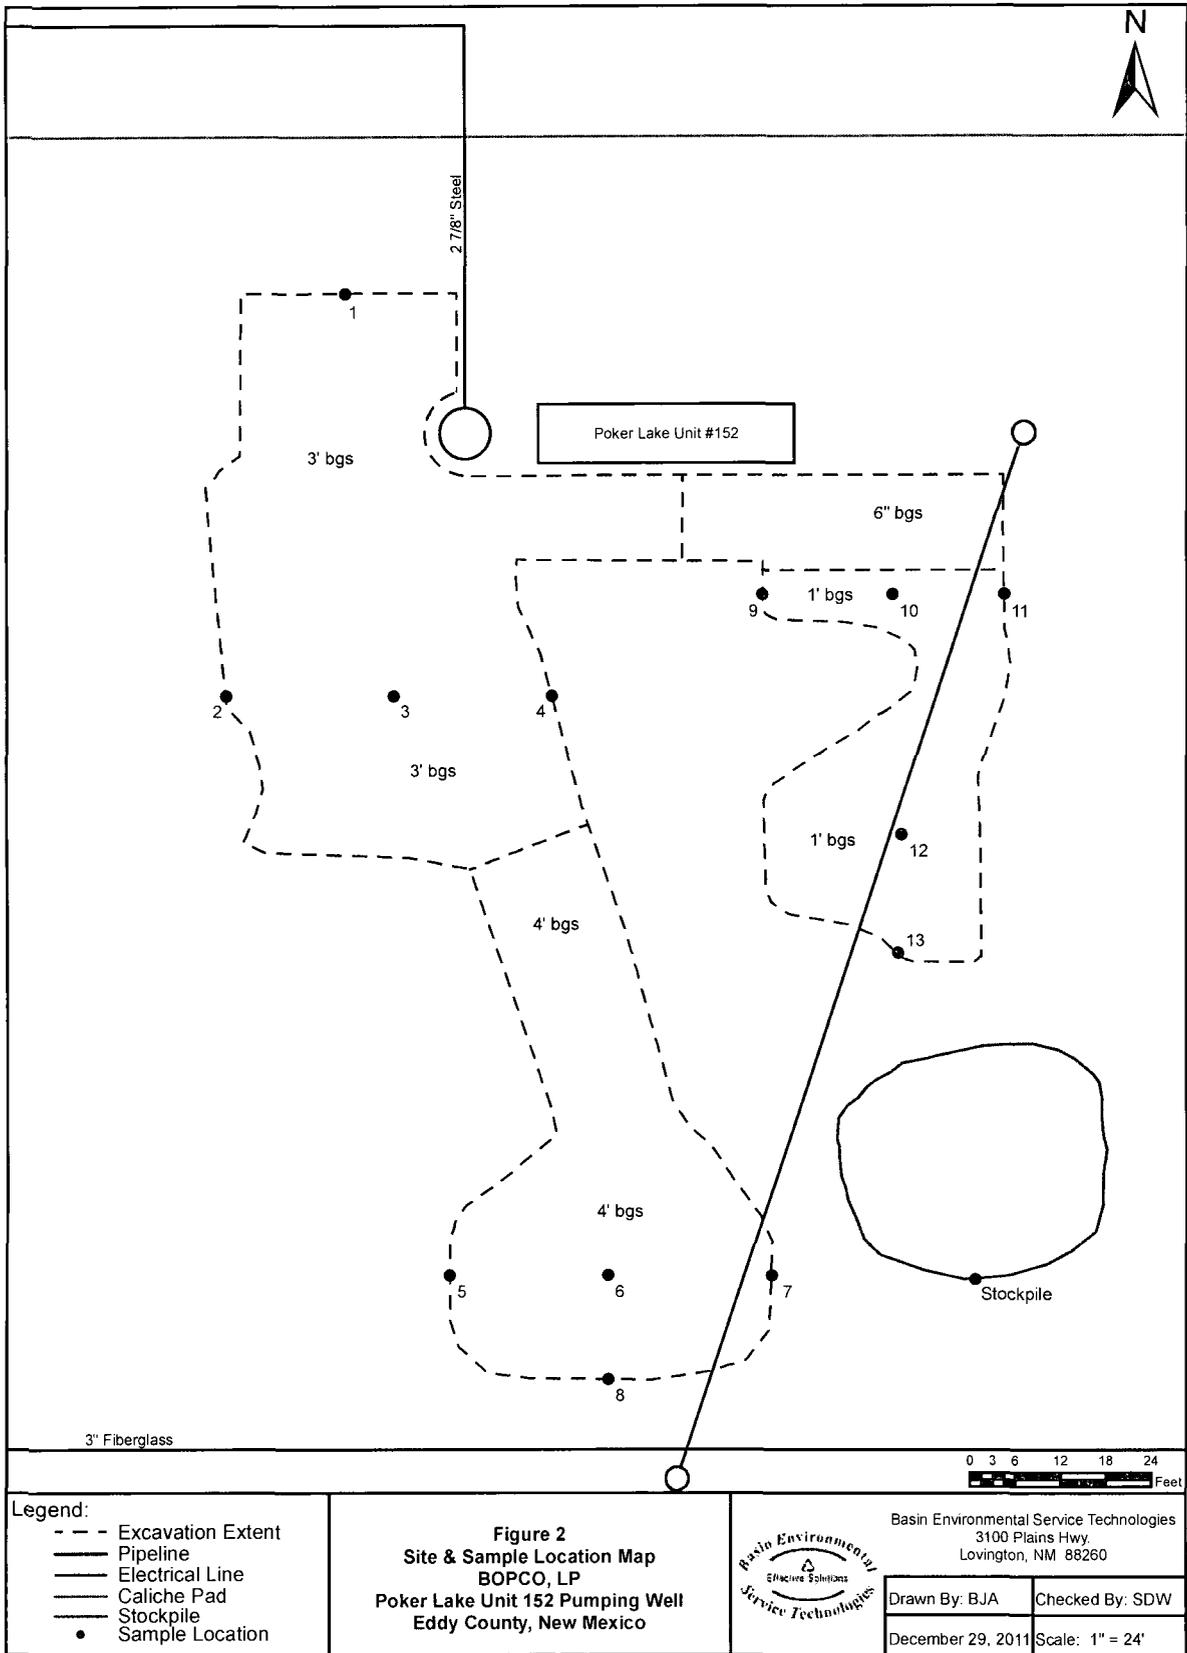
Figure 2 – Site & Sample Location Map

On September 12, 2011, thirteen (13) soil samples (Sample 1 through Sample 13) were collected from the floor and sidewalls of the excavation and submitted to Cardinal Laboratories (Hobbs, New Mexico) for analysis of benzene, toluene, ethylbenzene, and xylenes (BTEX), total petroleum hydrocarbons (TPH), and/or chlorides using EPA methods SW-846 8021b, SW-846 8015M, and 4500 Cl-B, respectively. Table 1 summarizes the "Concentrations of Benzene, BTEX, TPH & Chlorides in Soil". A "Site & Sample Location Map" is provided as Figure 2. Laboratory analytical reports are provided as Appendix C.

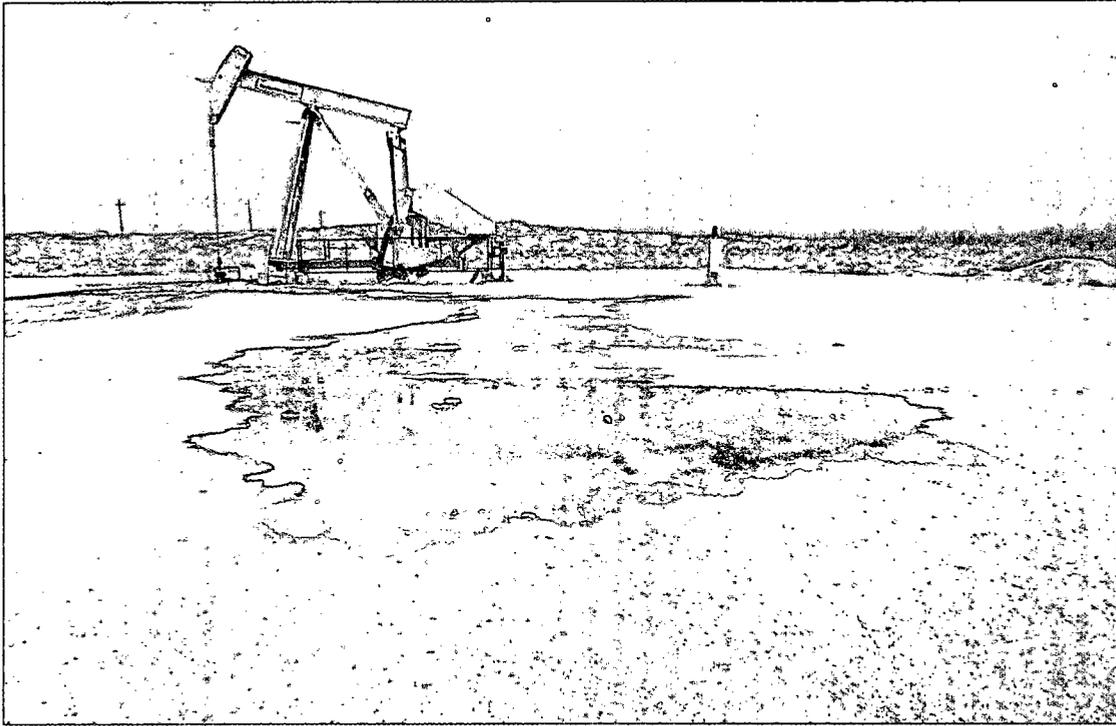
Poker Lake Unit 152 Pumping Well - Release Site

On August 15, 2011, BOPCO discovered a release had occurred at the Poker Lake Unit 152 Pumping Well. The stuffing box rubbers on the wellhead failed, resulting in a release of produced water and crude oil. The release was reported to the New Mexico Oil Conservation Division (NMOCD) Artesia District Office on August 22, 2011. The "Release Notification and Corrective Action" (Form C-141) indicated approximately ten barrels (10 bbls) of produced water and five barrels (5 bbls) of crude oil was released, with no recovery. During initial response activities, the stuffing box rubbers were replaced, and heavily saturated soil was excavated and stockpiled on-site, pending final disposition.

The release was confined to the caliche pad surrounding the Poker Lake Unit 152 Pumping Well and affected an area measuring approximately three thousand square feet (3,000 ft²). The Form C-141 is provided as Appendix A. General photographs of the release site are provided as Appendix B.

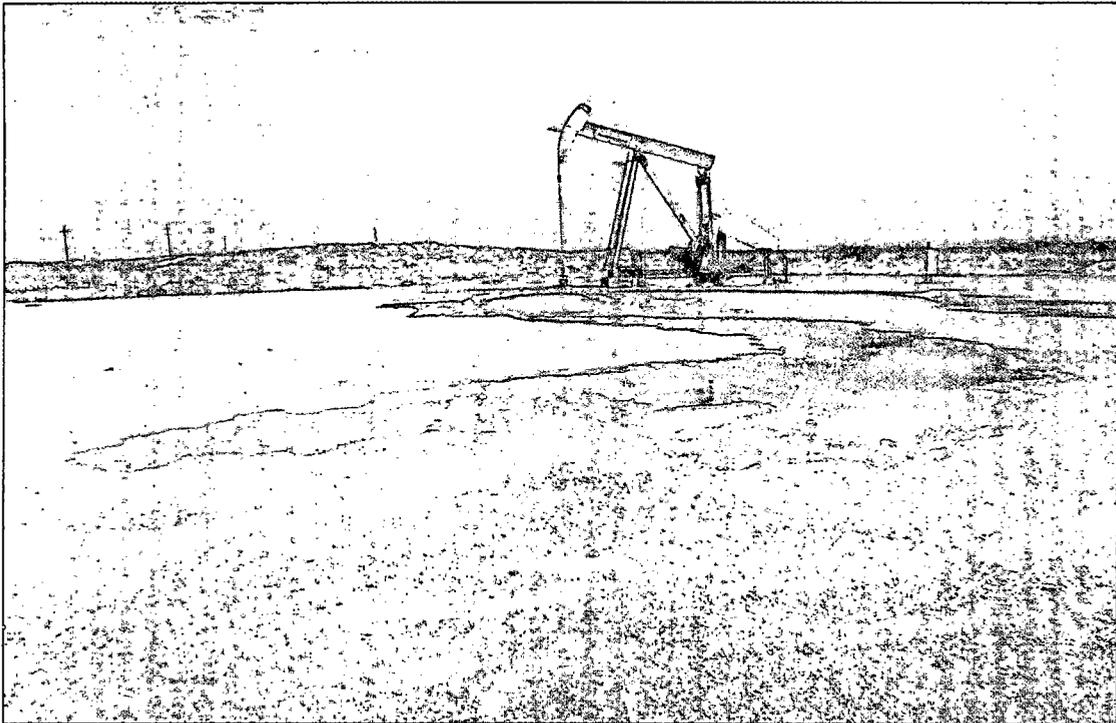
Poker Lake Unit 152 Pumping Well - Release Site

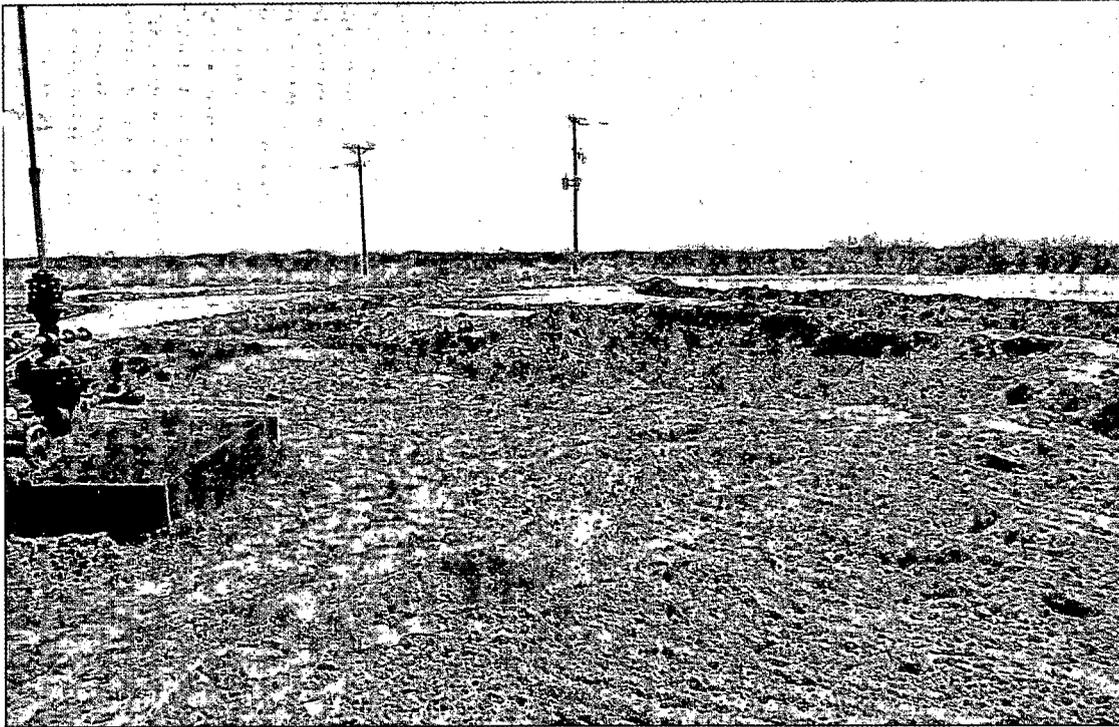
Poker Lake Unit 152 Pumping Well - Excavation (Looking South)

Following initial response activities, on August 15, 2011, excavation of impacted soil commenced at the site. Hach Quantab chloride titrators were used to field-screen the horizontal and vertical extent of impacted soil and to guide the excavation. From August 16 through August 30, 2011, excavated soil was stockpiled on-site, pending final disposition.

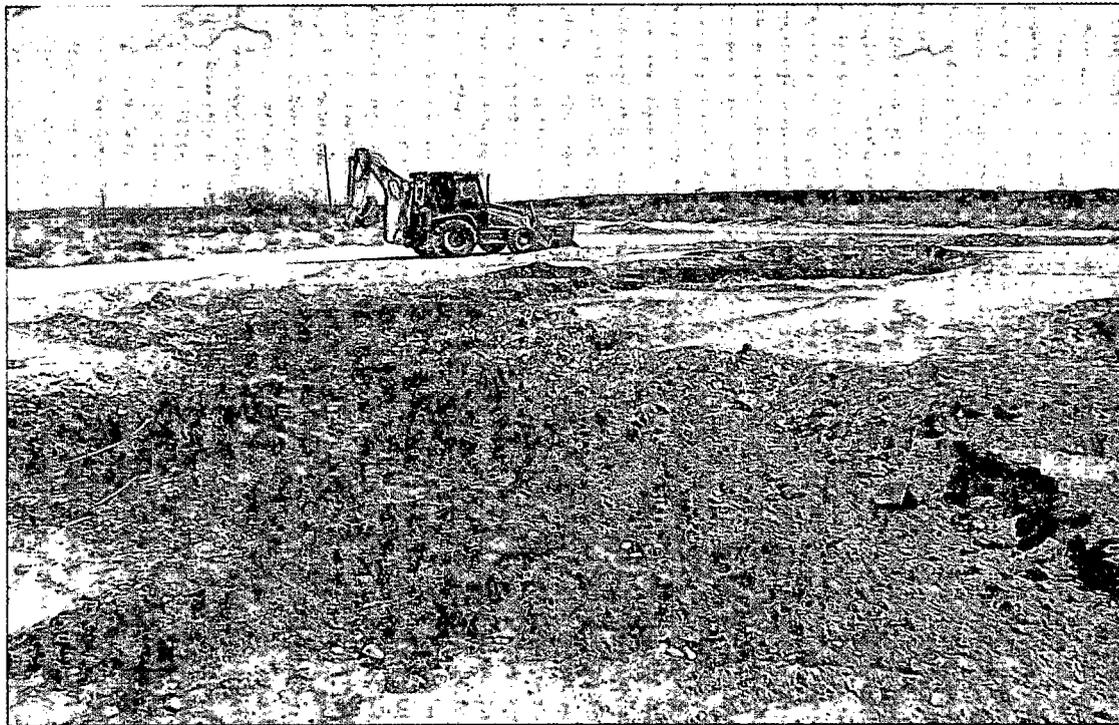
Poker Lake Unit 152 Pumping Well - Excavation

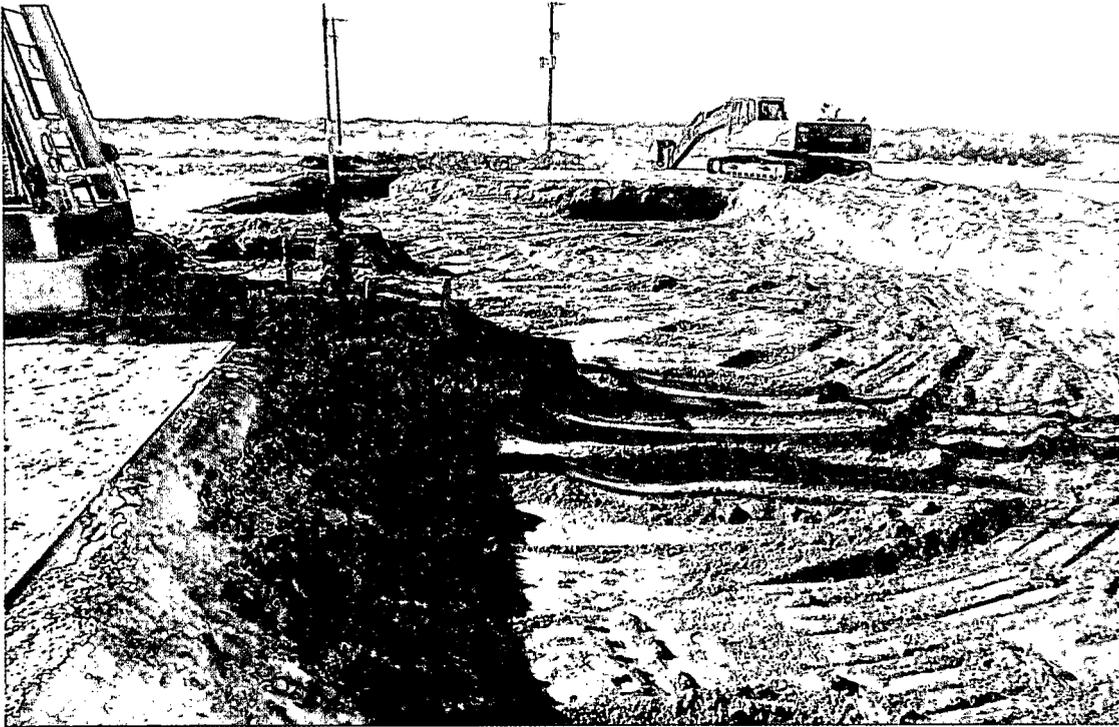
Poker Lake Unit 152 Pumping Well - Excavation (Looking South)

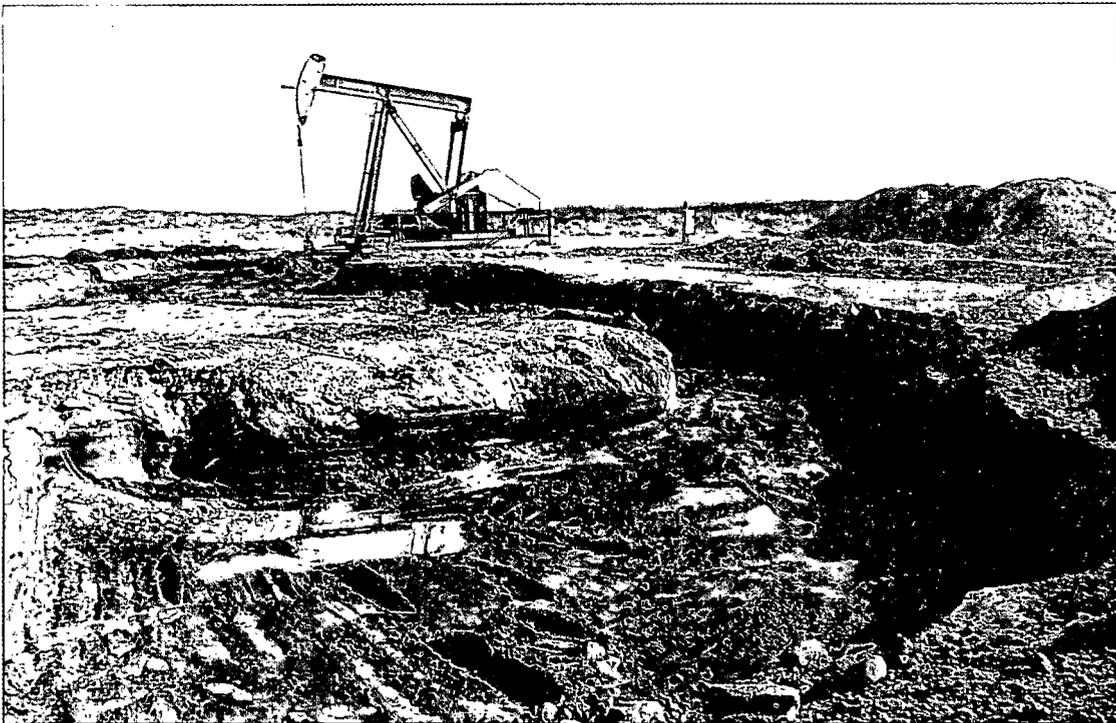
Poker Lake Unit 152 Pumping Well - Excavation (Looking Northeast)

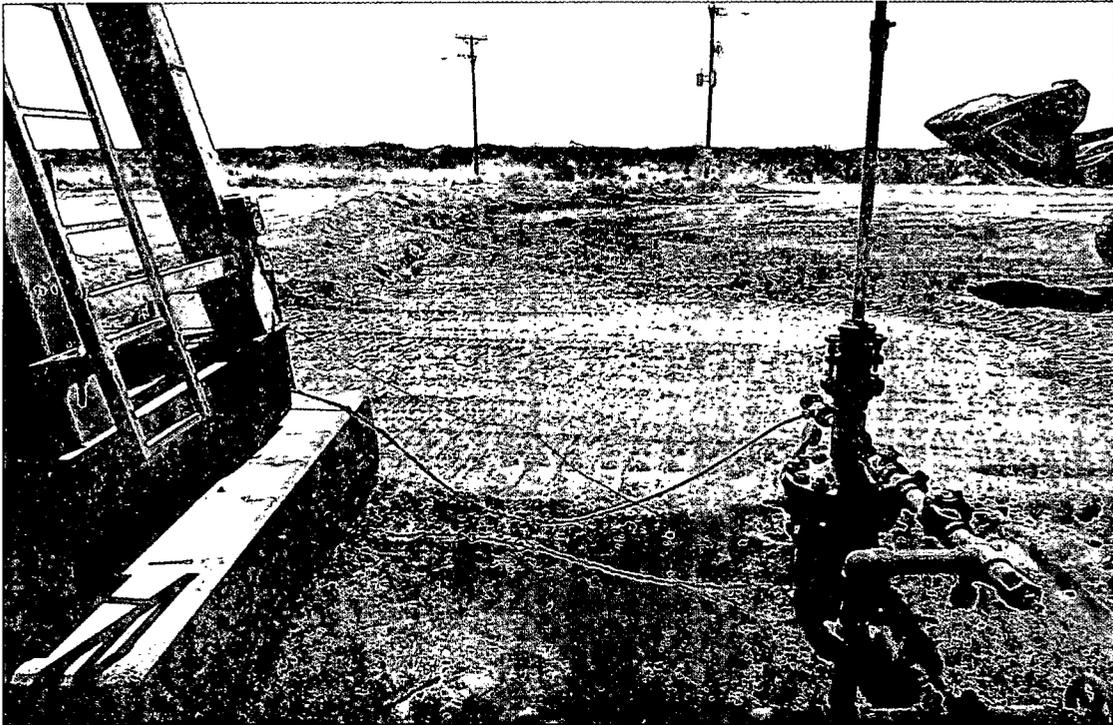
Poker Lake Unit 152 Pumping Well - Excavation (During Backfill, Looking South)

Based on laboratory analytical results and field-screens, from September 19 through September 23, 2011, the excavation was backfilled in eighteen inch (18") lifts, compacted, and contoured to fit the surrounding topography. Final dimensions of the excavation were approximately one hundred and thirty-four feet (134') in length, approximately seventy-four feet (74') in width, and ranging in depth from approximately six inches (6") to three feet (3') bgs.

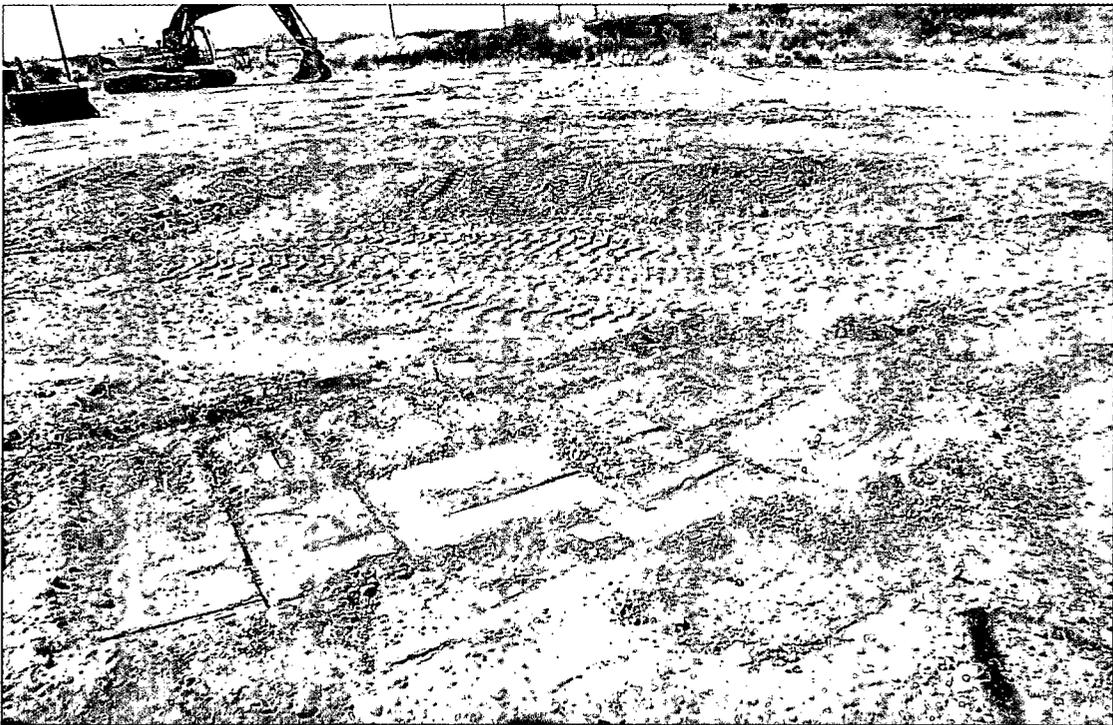
Poker Lake Unit 152 Pumping Well - Excavation (Following Backfill)
