Report Type: Closure Report

Site:	SENM SWD System (Northwest Central)		
Company:	COG Operating LLC		
Section, Township and Range	Unit N - Sec. 17 - T-17S - R-30E		
Lease Number:	NMNM-86025		
County:	Eddy Conty		
GPS:	32.83047° N	103.99600° W	
Surface Owner:	Federal		
Mineral Owner:			
Directions:	From Loco Hills at the intersection of Hwy 82 and CR-217 (Hagerman Cutoff), travel north on CR-217 0.6 mi, turn left 0.4 mi, turn right 300' to location.		
	30-015-04180		30-015-20972

Re: Closure Report for the COG Operating LLC., Northwest Central (SENM SWD System), Unit N, Section 17, Township 17 South, Range 30 East, Eddy County, New Mexico

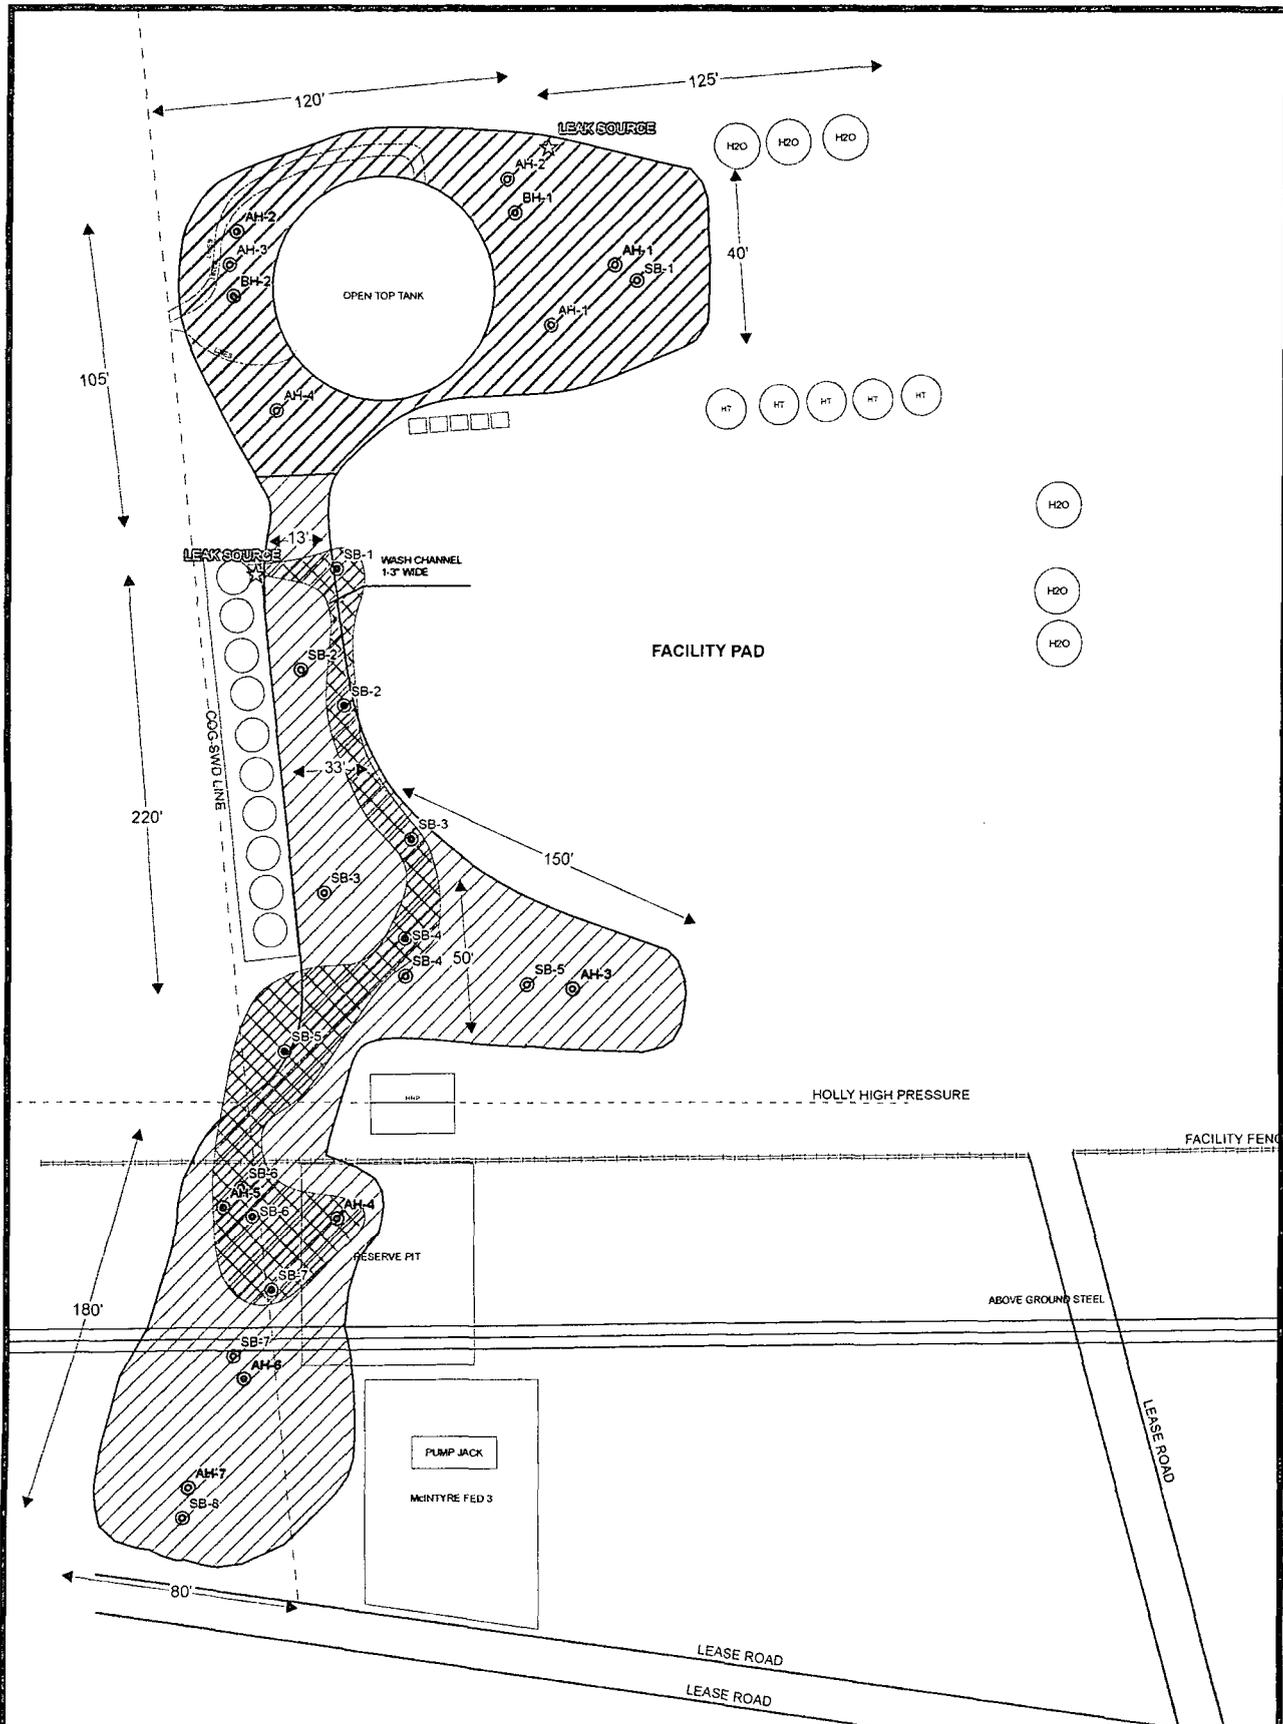
Figure 3
 Northwest Central TB
 Spill Assessment Map
 Eddy County, New Mexico

On June 23, 2010, Tetra Tech personnel inspected and sampled the spill area. A total of seven (7) auger holes (AH-1 through AH-7) were installed using a stainless steel hand auger to assess the impacted soils. Auger holes were not installed east of the tanks, due to the dense surface caliche in the area. In addition, the area of AH-4 appears to be near a closed reserve pit area. Selected samples were analyzed for TPH analysis by EPA method 8015 modified, BTEX by EPA Method 8021B and chloride by EPA method 300.0. Copies of laboratory analysis and chain-of-custody documentation are included in Appendix C. The results of the sampling are summarized in Table 1. The spill area and auger hole locations are shown on Figure 3.

On August 17, 2010, Tetra Tech supervised the installation of eight (8) soil borings (SB-1 through SB-8). In the area north of the facility, additional soil borings were not installed due to the buried electrical lines and active underground lines in the area. Copies of laboratory analysis and chain-of-custody documentation are included in Appendix C. The sampling results are summarized in Table 2. The soil boring locations are shown on Figure 3.

On December 15, 2010, a second spill occurred at the site when the tank overflowed east of the tank battery and flowed south encompassing part of the spill #1 footprint. On February 25, 2011, Tetra Tech supervised the installation of seven (7) soil borings (SB-1 through SB-7). Selected samples were analyzed for TPH analysis by EPA method 8015 modified, BTEX by EPA Method 8021B and chloride by EPA method 300.0. Copies of laboratory analysis and chain-of-custody documentation are included in Appendix C. The sampling results are summarized in Table 2. The spill area and auger hole locations are shown on Figure 3.

On July 31, 2012, Tetra Tech personnel inspected and sampled the spill area. A total of four (4) auger holes (AH-1 through AH-4) were installed using a stainless steel hand auger to assess the impacted soils. Selected samples were analyzed for TPH analysis by EPA method 8015 modified, BTEX by EPA Method 8021B and chloride by EPA method 300.0. Copies of laboratory analysis and chain-of-custody documentation are included in Appendix C. The results of the sampling are summarized in Table 1. The spill area and auger hole locations are shown on Figure 3.

On September 31, 2012, Tetra Tech supervised the installation of two (2) soil borings (SB-1 and SB-2). Copies of laboratory analysis and chain-of-custody documentation are included in Appendix C. The sampling results are summarized in Table 3. The soil boring locations are shown on Figure 3.

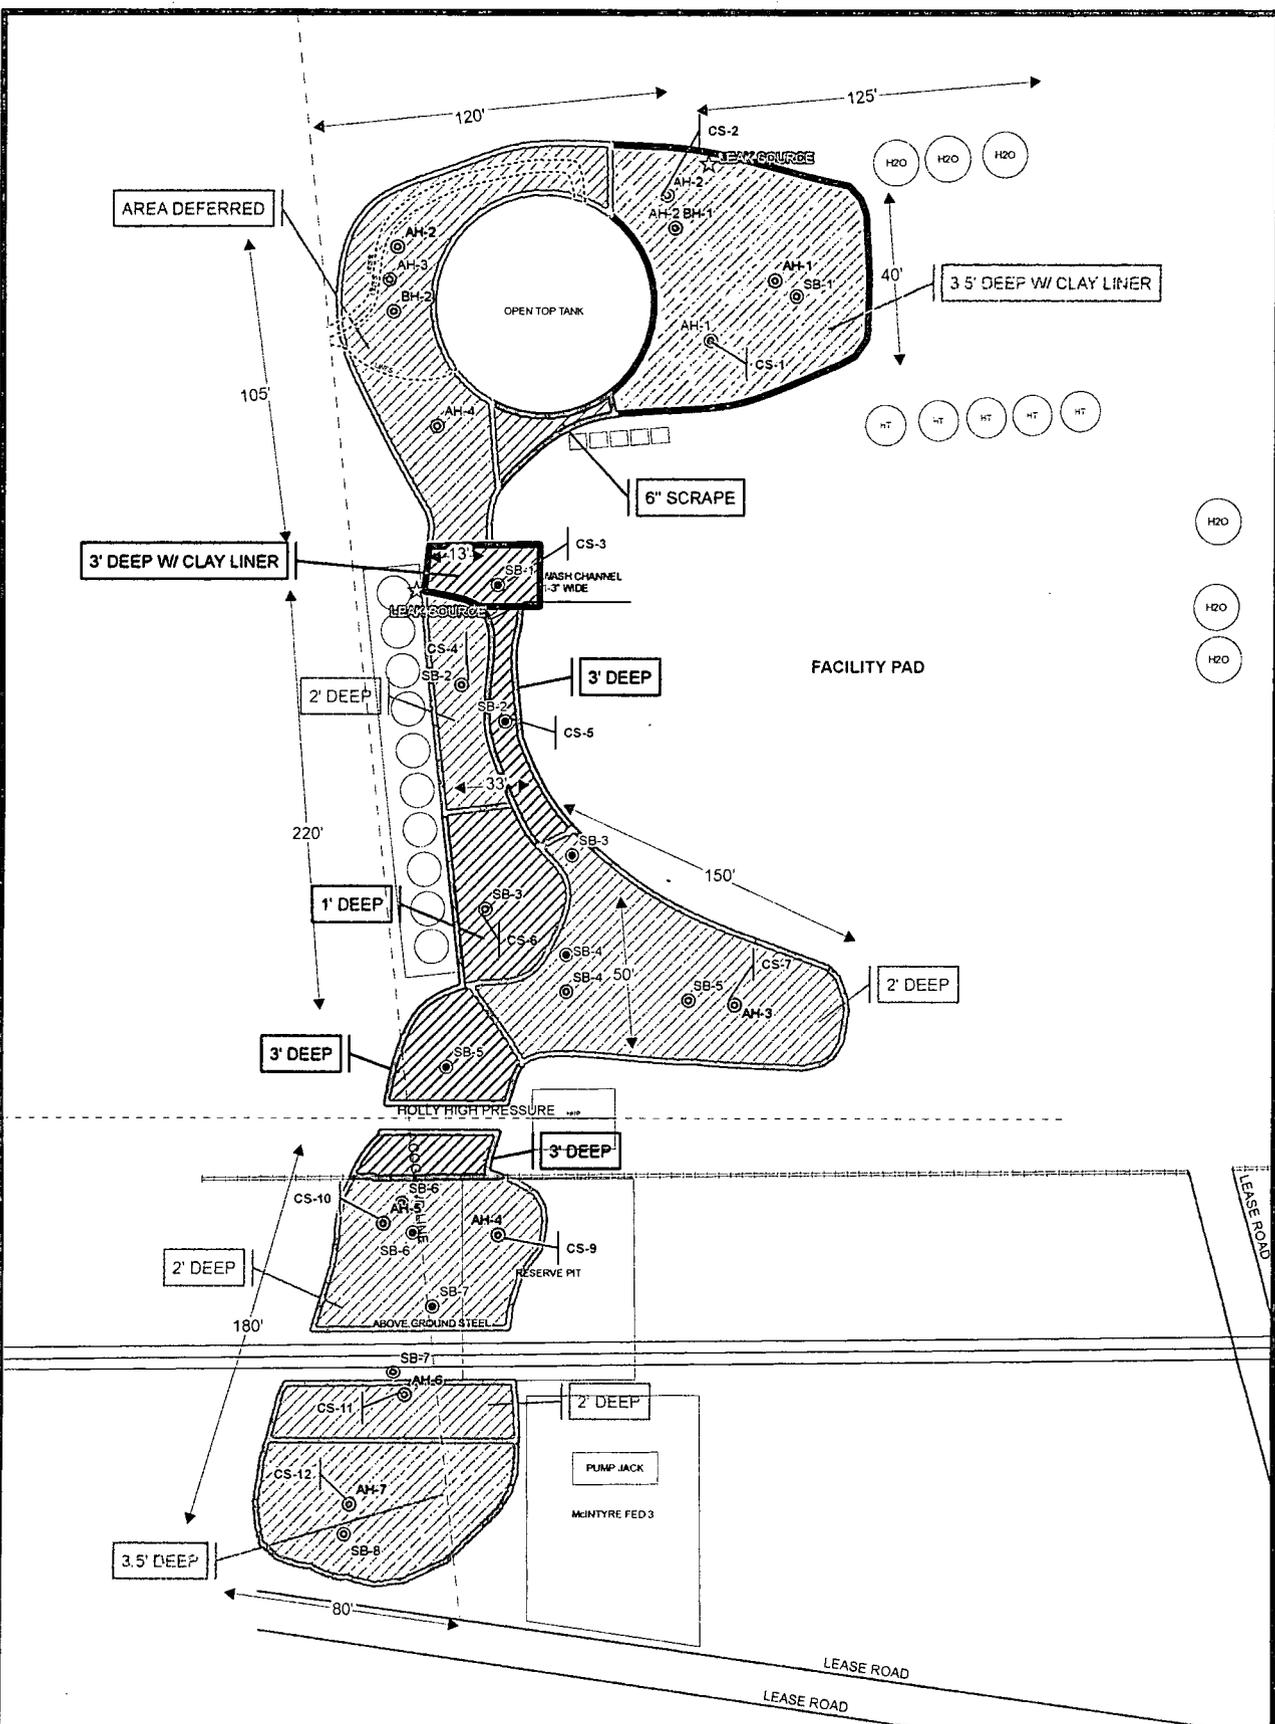
Figure 4
Northwest Central TB
Excavation Areas & Depths Map
Eddy County, New Mexico

On February 17, 2014, Tetra Tech supervised the removal of impacted material as highlighted (green) in Table 1, 2 and 3 and shown on Figure 4. In order to remove the elevated chloride concentrations, the excavations ranged from 1.0' to 3.5' below surface.

Two areas (east and south) of water tank were capped with a clay material as shown on Figure 4. Due to numerous lines and equipment west of the water tank, the area was not excavated due to safety concerns. In this case, the impacted soil will be deferred until the abandonment of the facility. In addition, some of the proposed depths were not achieved due to limited access, lines and structures in the area. Once excavated, Tetra Tech collected confirmation samples from the excavation bottom holes and sidewalls. The sampling results are shown on Table 4.

Approximately 2,260 cubic yards of excavated soil was transported to proper disposal. Once excavated to the appropriate depths, the excavation was backfilled with clean soil.

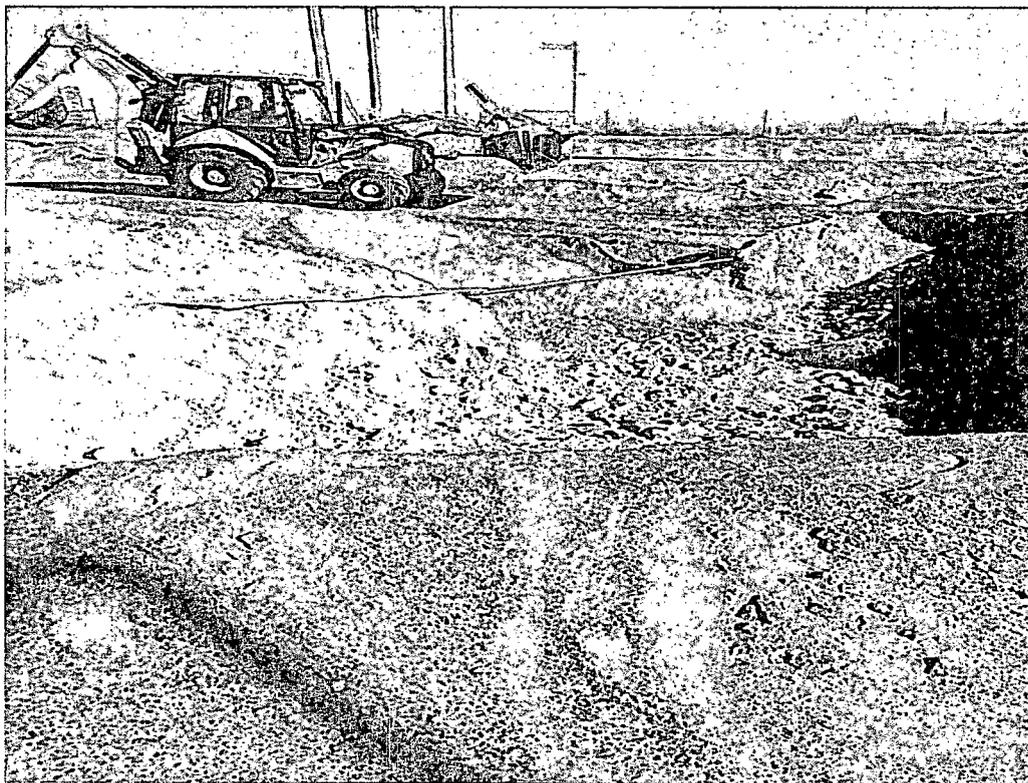
View North – Area of AH-2 (Spill 3) being Backfilled

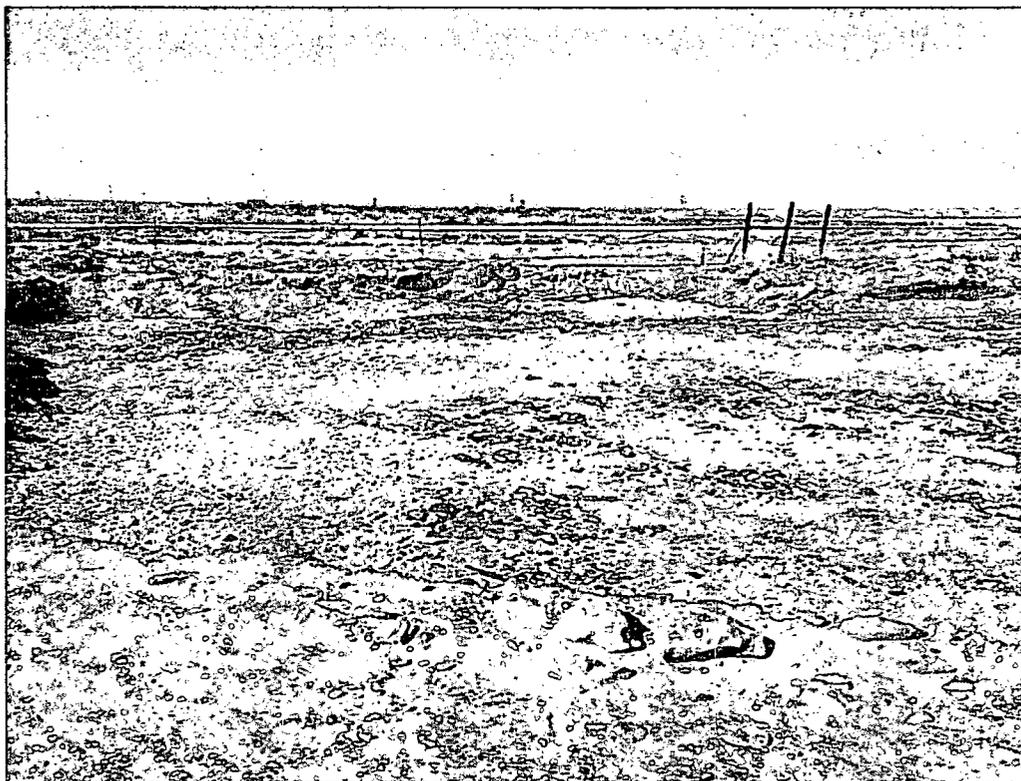
View West – Areas of AH-4 and AH-5 (Spill 2) at 3.0'

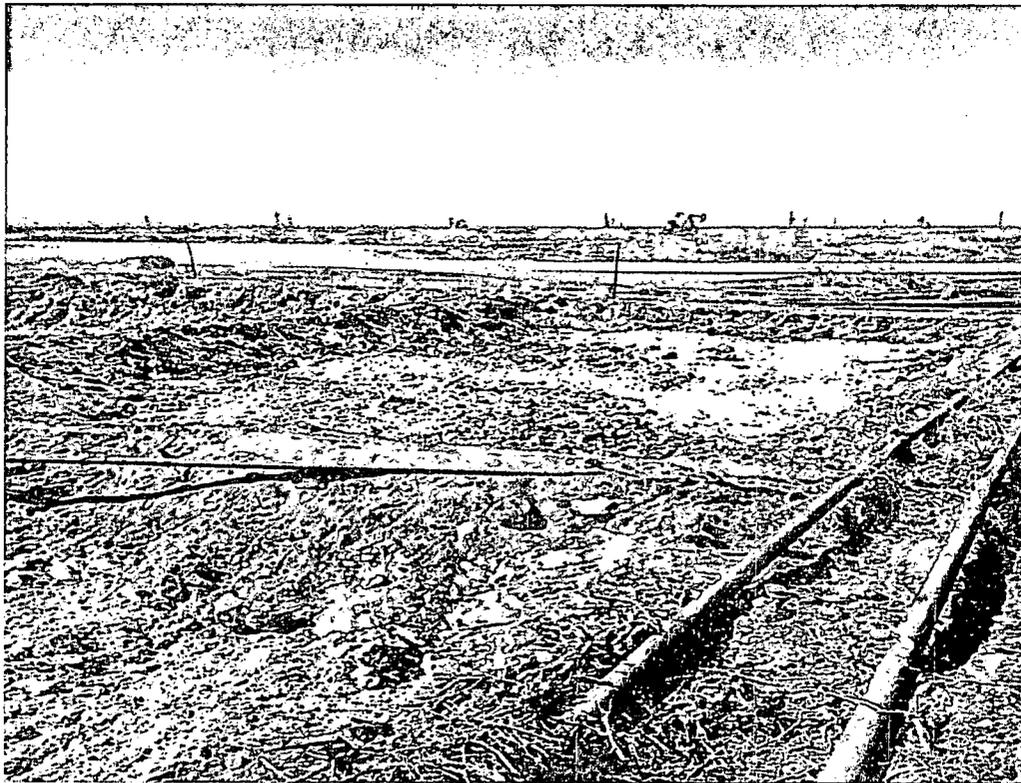
View East – Area of SB-7 (Spill 1) at 2.0'
