Remediation Summary Report Form

Client: LINN Energy

Site Name: Turner B 80

State Report No.: 2RP-890

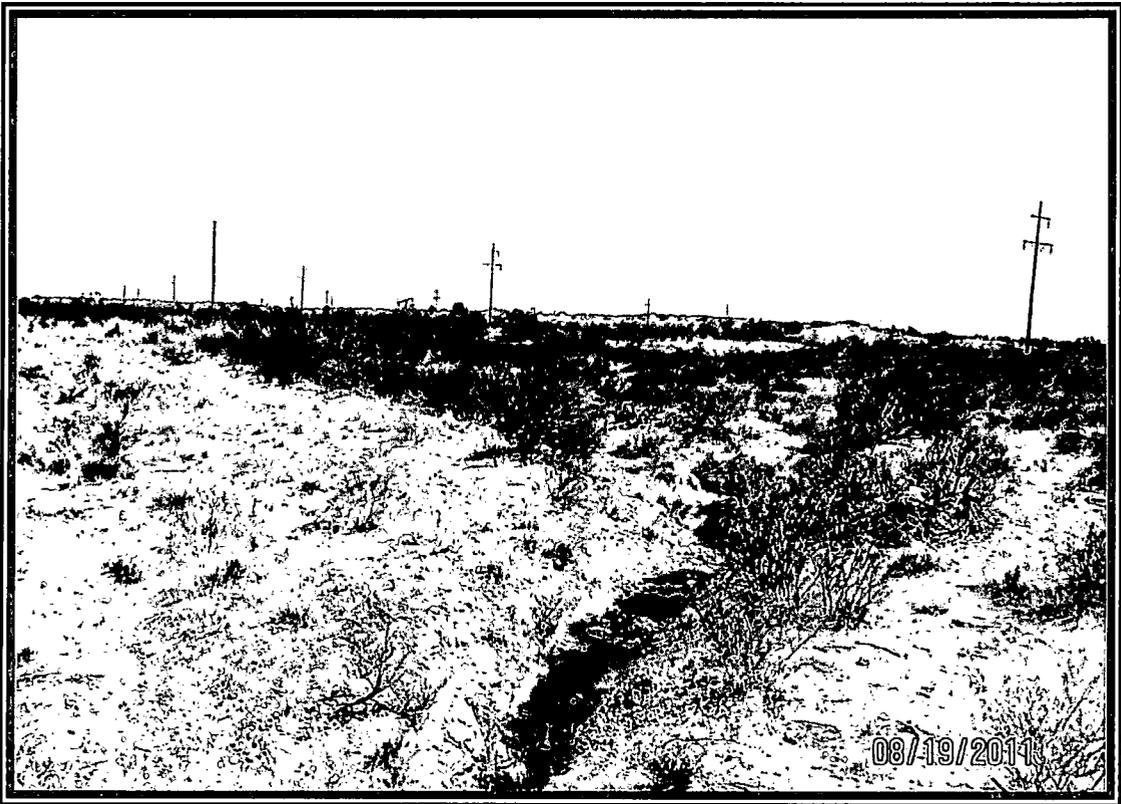
View of the spill area in the pasture before excavation.

Impacted soils above regulatory threshold levels were manually and mechanically excavated from the spill area. During the course of excavation soil samples were screened on site to determine the progress of the remediation.

Impacted soils were transported off-site for disposal at Lea Land Landfill. Once the impacted soils were removed to acceptable levels, the pasture area was backfilled with like materials and smoothed to grade, then seeded with a BLM mix #2 & #4. Water bars were installed to prevent wind and water erosion.

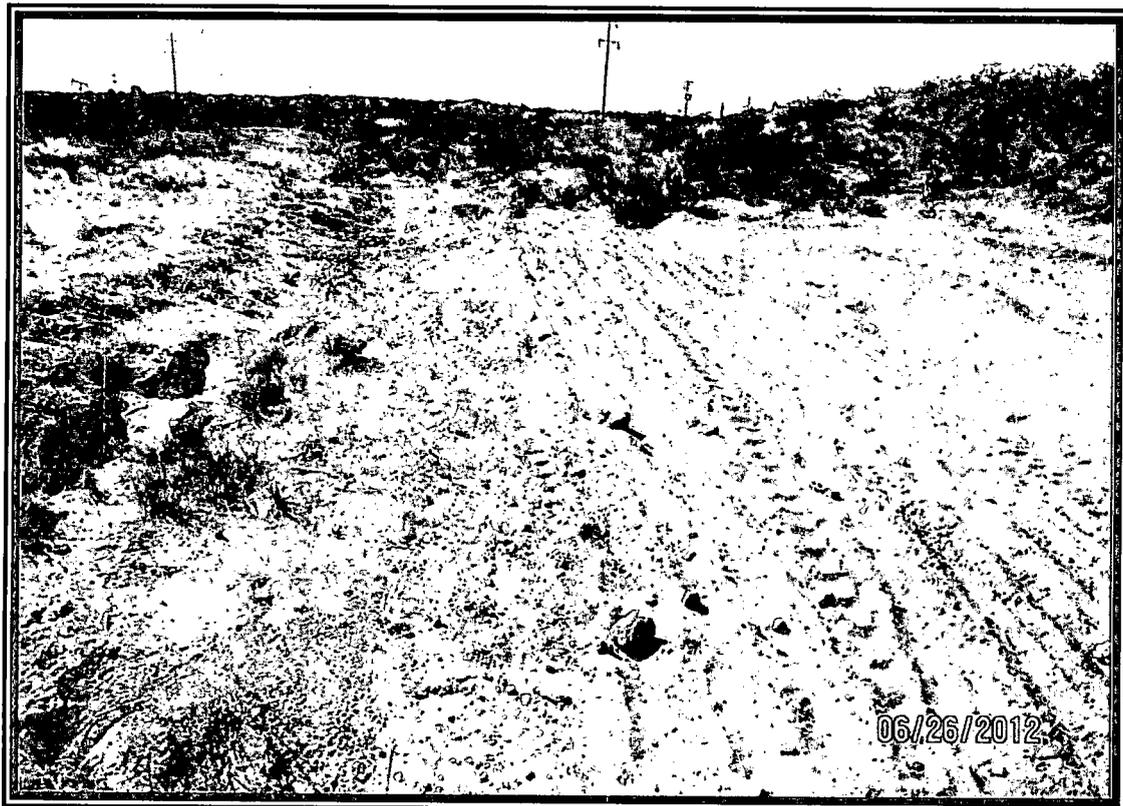
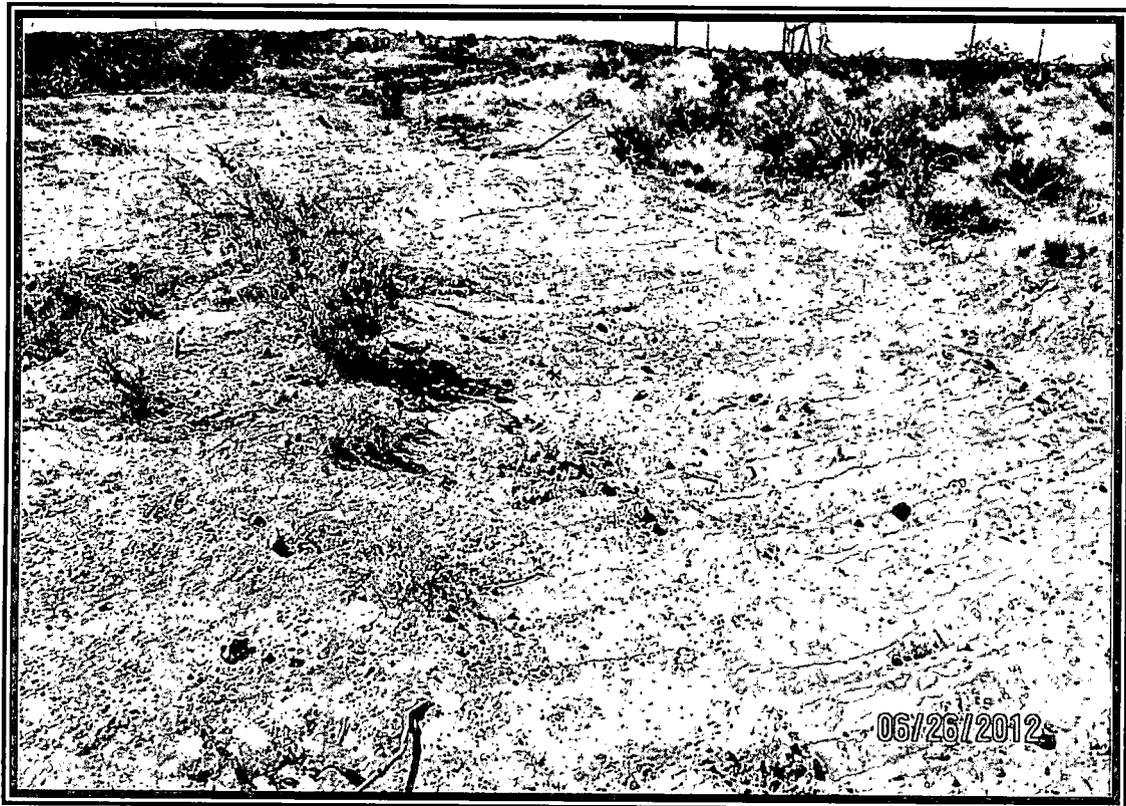
View of spill area after backfill, seeding and water bars were installed.

View of the spill area after backfill, seeding and water bars were installed.
