H.E. West A #028 (2RP-1216)

Termination Request

RE: Termination Request

Linn Energy – H.E. West A #028 AD

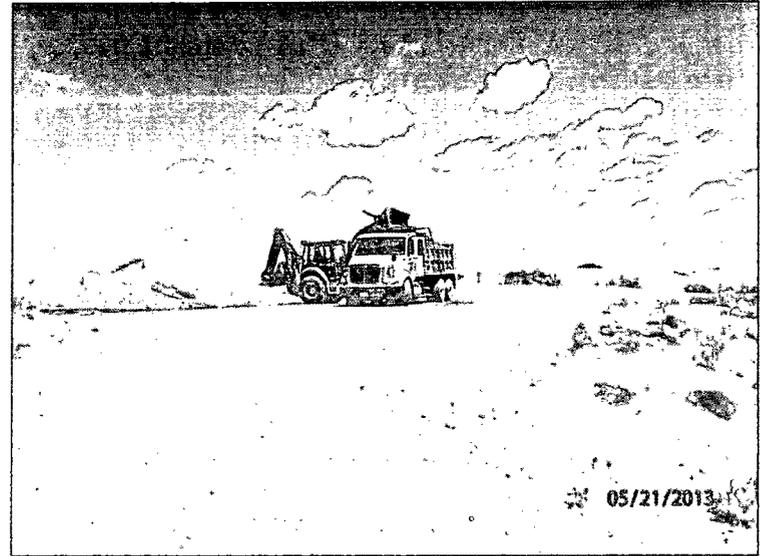
Exporting soil, facing north 5/21/13
