## Geronimo 28 State #1

# Closure Report

API 30-015-31829

**RE: TERMINATION REQUEST  
Apache – Geronimo 28 State #1 AD  
UL/J sec. 28 T17S R28E  
API No. 30-015-31829**

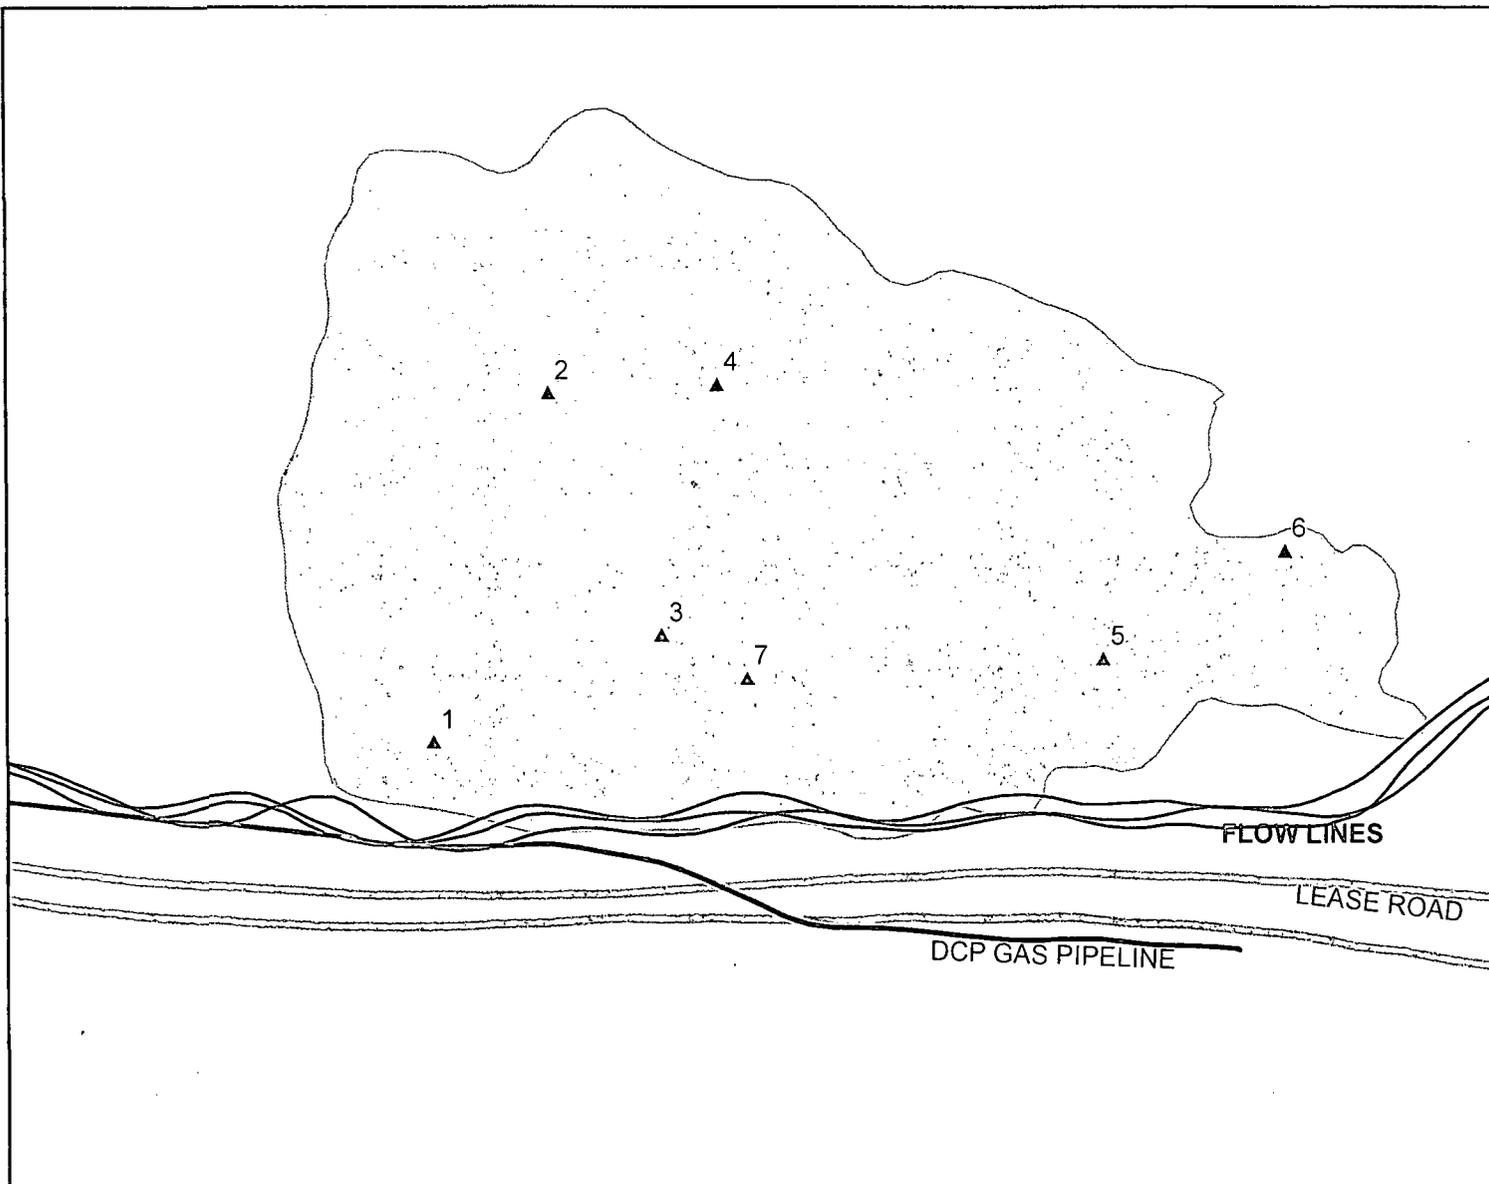
## Figure 1

## INITIAL SAMPLING LAB DATA

Sample Description	Cl-	GRO	DRO
Pt. 1	25,200	473	26,100
Pt. 2	19,600	96.2	1,800
Pt. 3	31,200	15.2	109
Pt. 4	19,600	233	14,400
Pt. 5	31,600	14.7	54.3
Pt. 6	32,000	<10	122
Pt. 7	33,200	16.8	294

On August 25, 2011, RECS personnel initiated work on the Geronimo 28 State #1 (Figure 1). Surface soil samples were collected and field tested for chloride. Headspace measurements were also taken in the field using a Photo Ionization Detector (PID). The samples were submitted to a commercial laboratory for chloride and TPH (GRO/DRO) analyses (Appendix C). Chloride ranged from 19,600 ppm (parts per million or mg/kg) to 33,200 ppm. GRO ranged from <10.0 ppm to 473 ppm and DRO ranged from 54.3 ppm to 26,100 ppm.

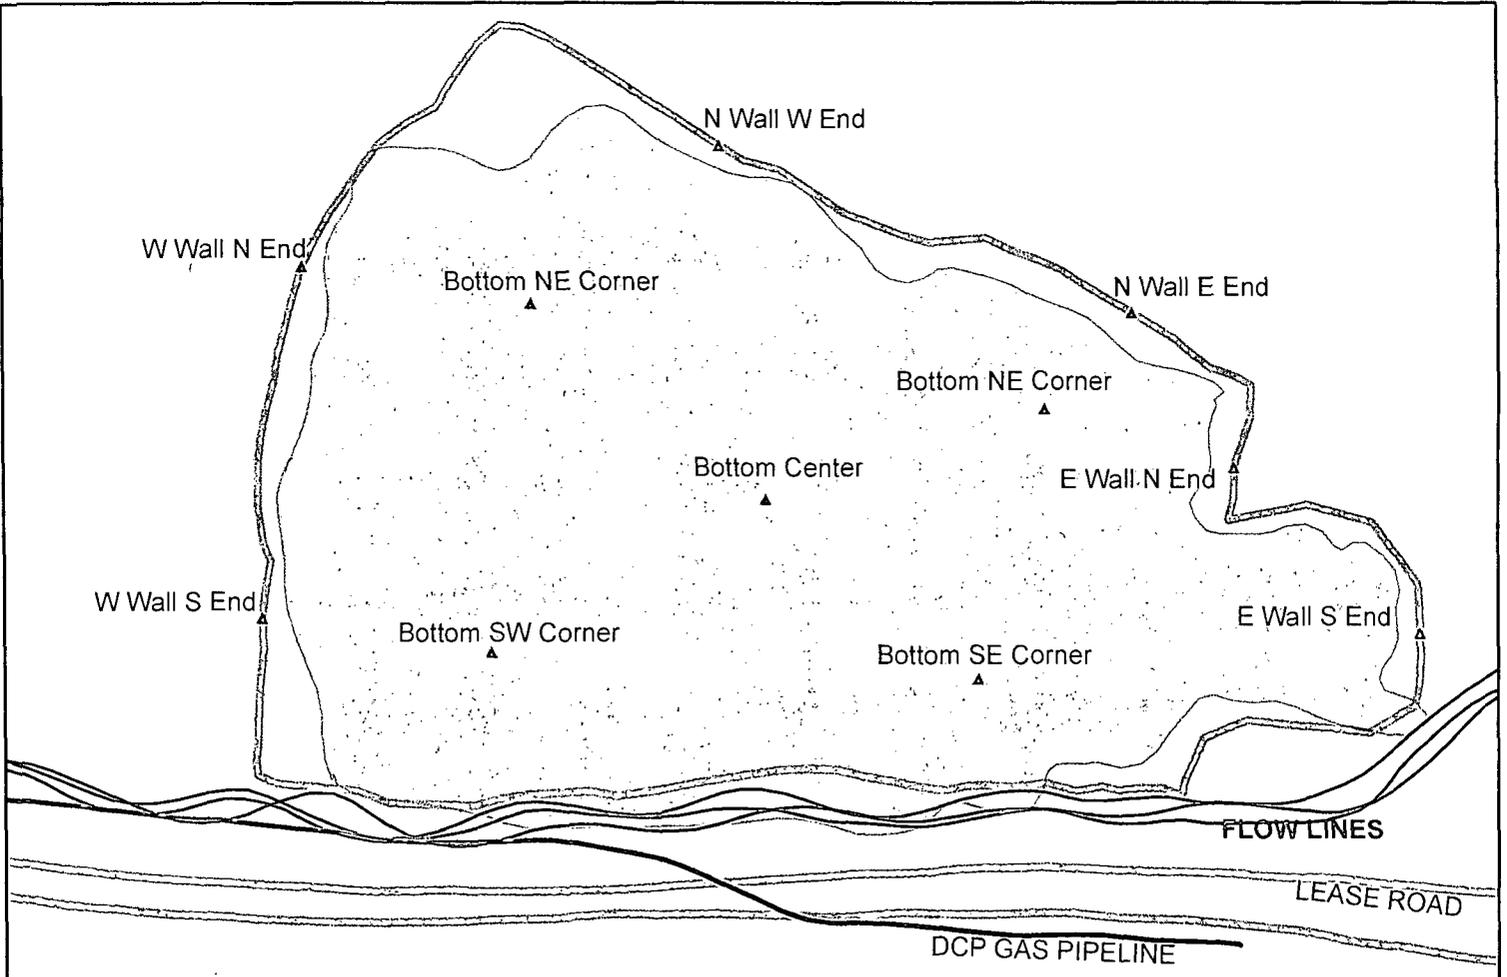
**Figure 2**

**FINAL EXCAVATION LAB DATA**

Sample Description	Cl-	GRO	DRO
Bottom Center	240	<10	<10
Bottom NW Corner	48	<10	<10
Bottom SE Corner	<16	<10	<10
Bottom NE Corner	<16	<10	<10
Bottom SW Corner	160	<10	17.1
W Wall S End	<16	<10	<10
W Wall N End	<16	<10	<10
N Wall E End	<16	<10	<10
E Wall N End	<16	<10	<10
N Wall W End	32	<10	<10
E Wall S End	<16	<10	<10

The impacted area was excavated to 1 ft. below ground surface (bgs), however, a gas line and several flow lines running along the south edge of the area prevented safe excavation activities along the south wall. On August 30, 2011, RECS personnel collected and field tested representative grab samples from the north, west, and east walls and the floor of the excavation (Figure 2). The samples were submitted to a commercial laboratory for chloride and TPH analyses (Appendix C). Chloride did not exceed 240 ppm in all samples. TPH did not exceed 17.1 ppm in all samples.

Impacted soils were removed from the excavation and transported to a NMOCD approved disposal facility with the exception of impacted soils near the south edge of the leak area. The excavation was backfilled with clean topsoil and contoured to the surrounding area. See Appendix B for photographs of field activities.

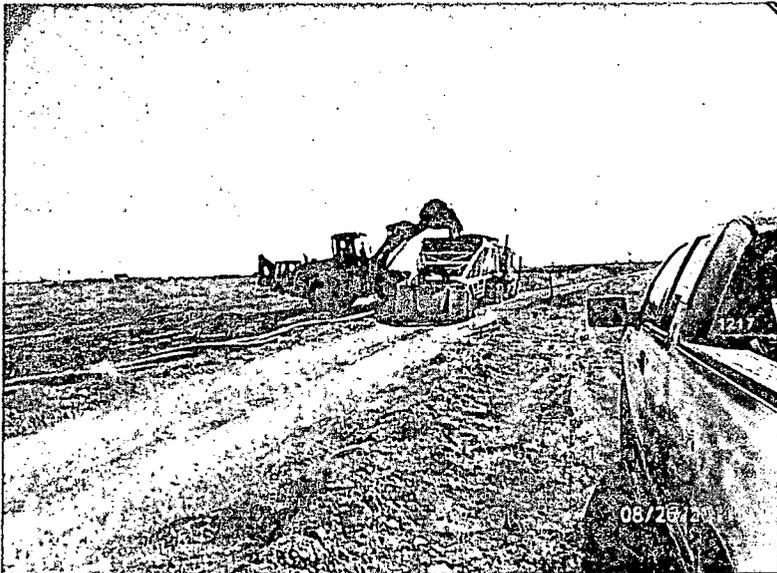
Exporting soil, facing northeast

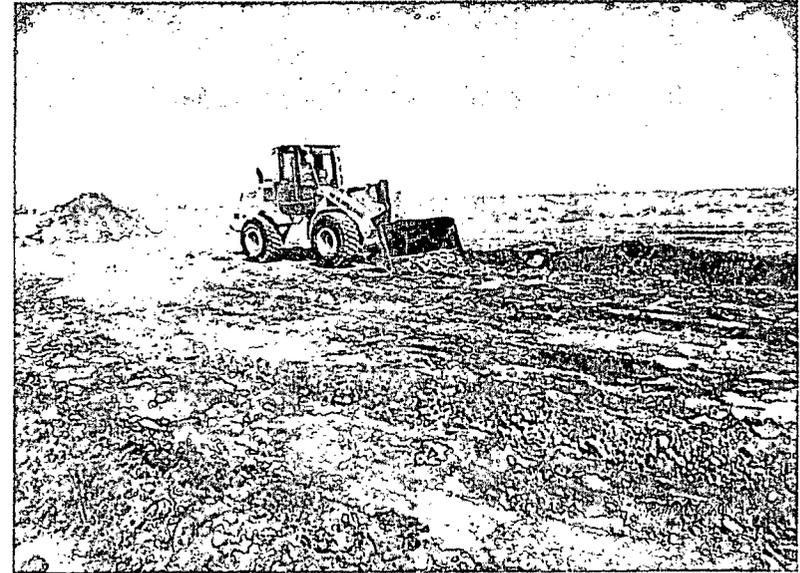
Scraping, facing northwest
