## Empire Abo Unit C49 SWD

### Closure Report

2RP-1153

**RE: TERMINATION REQUEST  
Apache – Empire Abo Unit C-49 SWD AD  
UL/K sec. 29 T17S R29E  
API No. 30-015-03184  
2RP-1153**

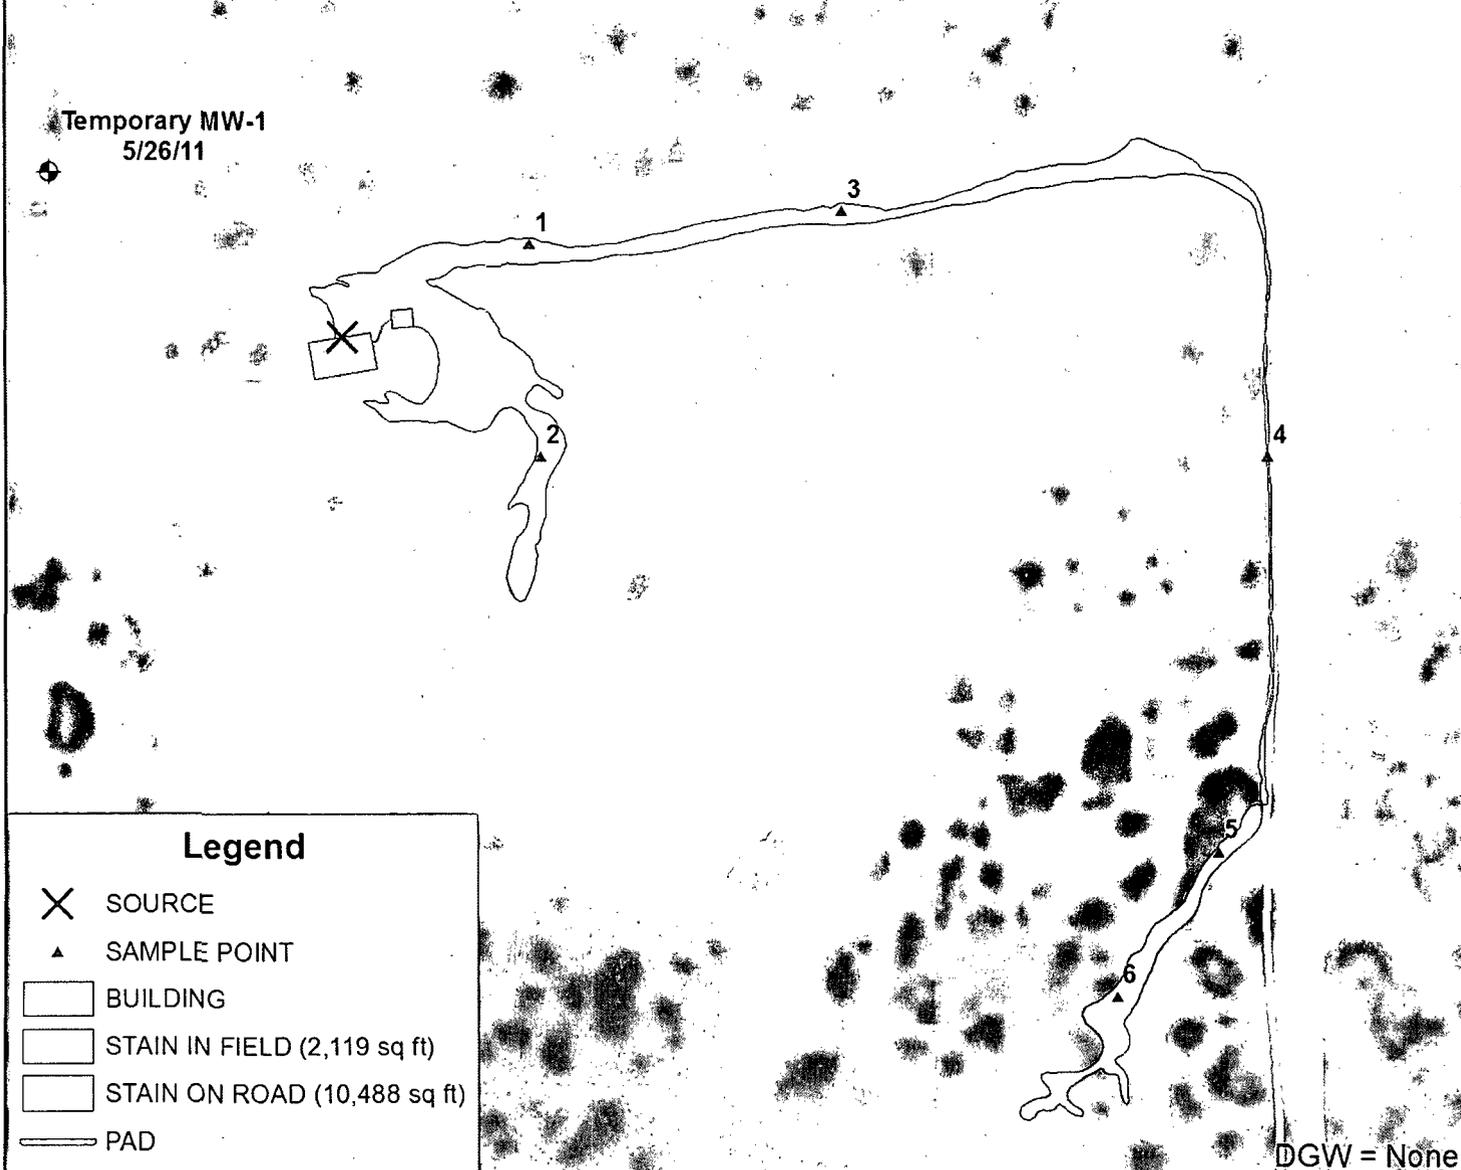
**Figure 1**

Point 1			
Sample Description	Cl-	GRO	DRO
PT.1 SURFACE	6800	19.9	13.8

Point 2			
Sample Description	Cl-	GRO	DRO
PT.2 SURFACE	5200	<10	<10

Point 3			
Sample Description	Cl-	GRO	DRO
PT.3 SURFACE	7520	19.6	36.2

Point 4			
Sample Description	Cl-	GRO	DRO
PT.4 SURFACE	5520	<10	<10

Point 5			
Sample Description	Cl-	GRO	DRO
PT.5 SURFACE	2720	<10	<10

Point 6			
Sample Description	Cl-	GRO	DRO
PT.6 SURFACE	4800	<10	<10

On May 21, 2012, RECS personnel initiated work on the Empire Abo Unit C-49 SWD (Figure 1). Soil samples from ground surface were field tested for chloride and headspace measurements were also taken in the field using a Photo Ionization Detector (PID). The samples were submitted to a commercial laboratory for chloride and TPH (GRO/DRO) analyses (Appendix C). Chloride ranged from 2,720 mg/kg to 7,520 mg/kg and TPH ranged from <10 mg/kg to 55.8 mg/kg.

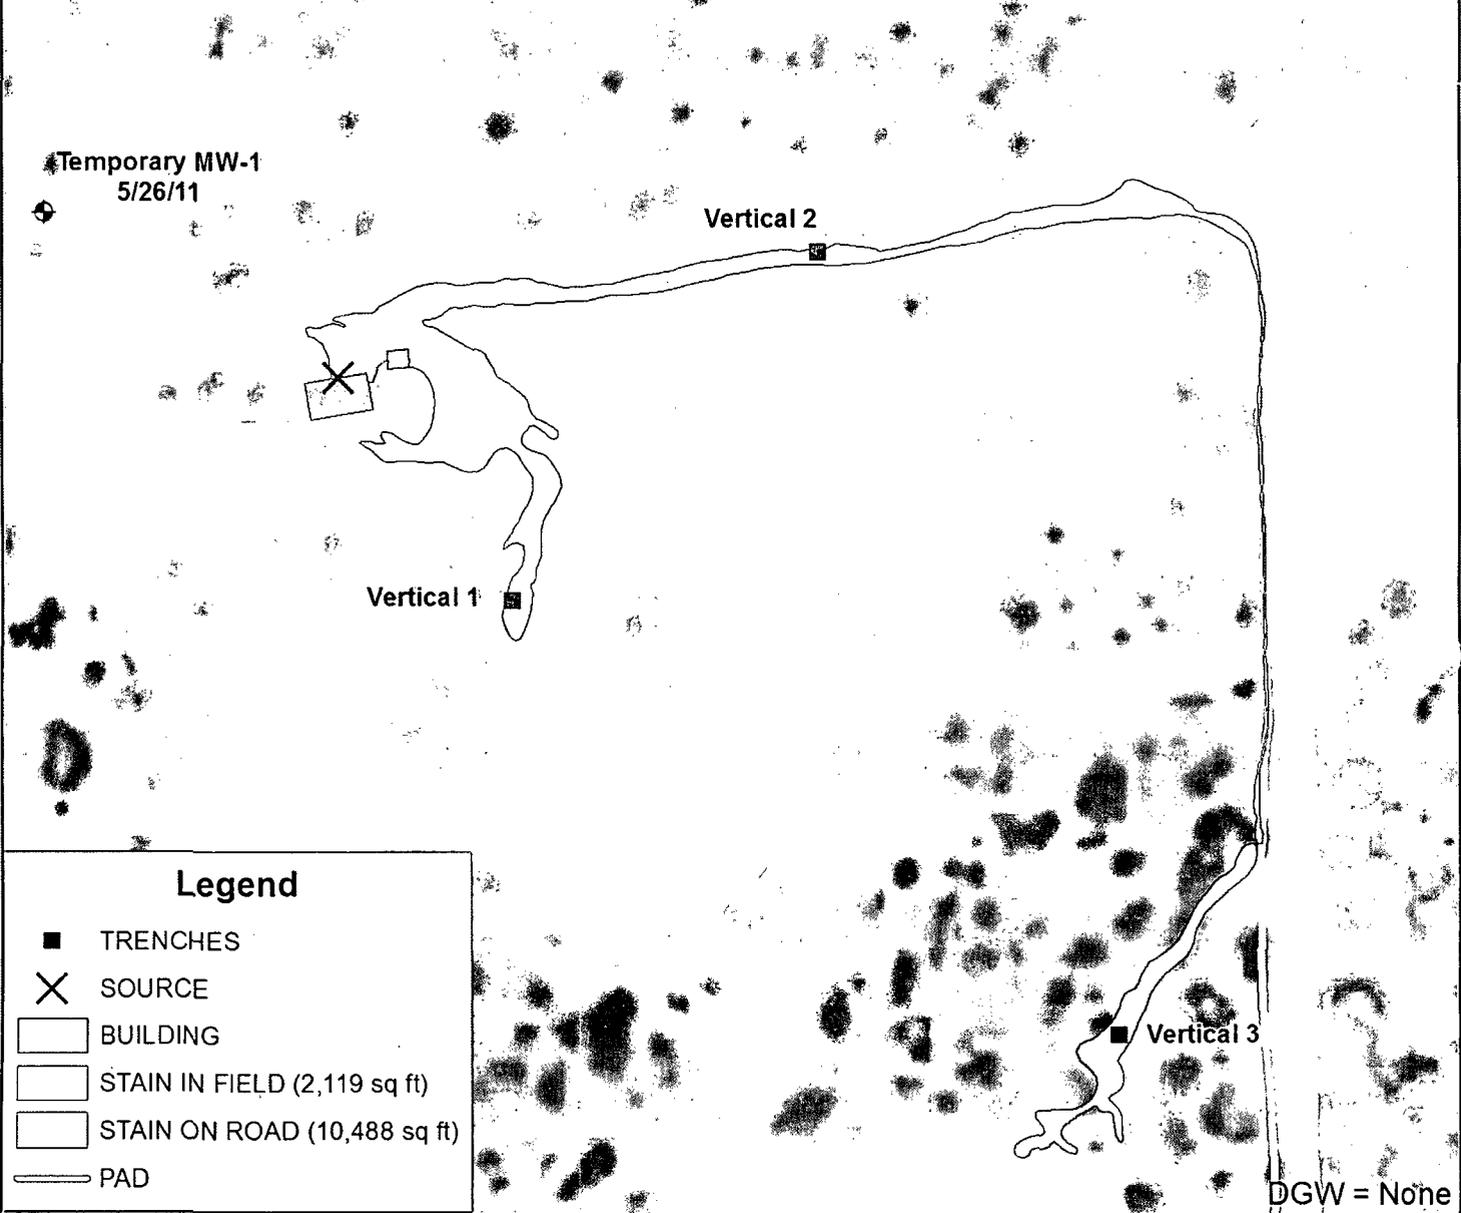
**Figure 2**

VERTICAL #1			
Sample Description	Cl-	GRO	DRO
Vertical #1 @ Surface	14,400	<10	<10
Vertical #1 @ 5'	160	<10	<10
Vertical #1 @ 6'	256	<10	<10

VERTICAL #3			
Sample Description	Cl-	GRO	DRO
Vertical #3 @ 4'	176	<10	<10
Vertical #3 @ 5'	192	<10	<10

VERTICAL #2			
Sample Description	Cl-	GRO	DRO
Vertical #2 @ 1'	16	<10	<10
Vertical #2 @ 2'	80	<10	19.7

On May 29, 2012, RECS personnel returned to the site and collected samples from the leak area at depth (Figure 2). Samples were field tested and submitted to a laboratory for analyses. At Vertical #1 in the pooled area just southeast of the leak point, the sample from 6' below ground surface (bgs) contained 256 mg/kg chloride and <10 mg/kg TPH. At Vertical #2 in the lease road, the sample from 2' bgs contained 80 mg/kg chloride and 19.7 mg/kg TPH. At Vertical #3 in the south pasture area, the sample from 5' bgs contained 192 mg/kg chloride and <10 mg/kg TPH.

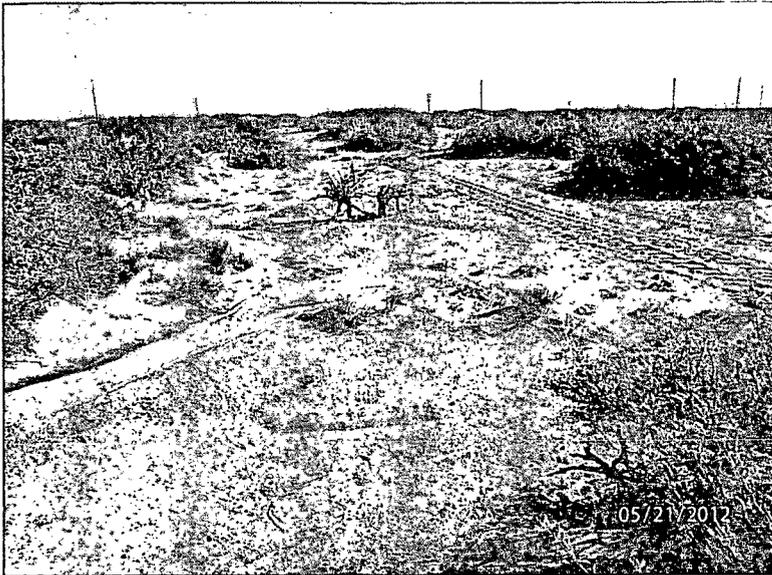
Initial release in pasture, facing north 5/21/2012

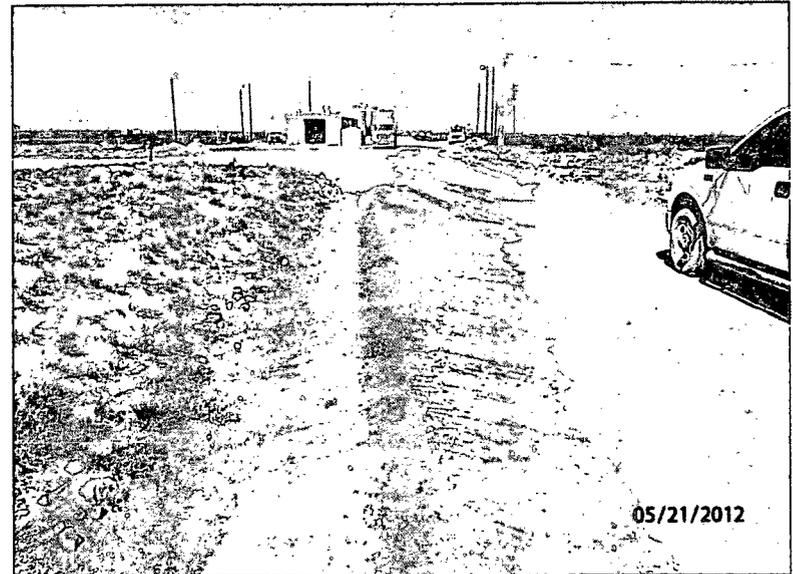
Initial release, facing west 5/21/2012

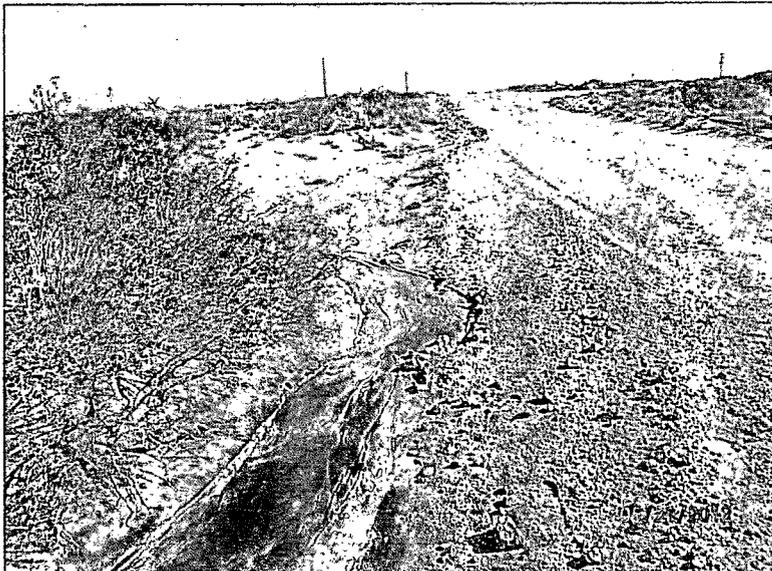
Initial release, facing north 5/21/2012

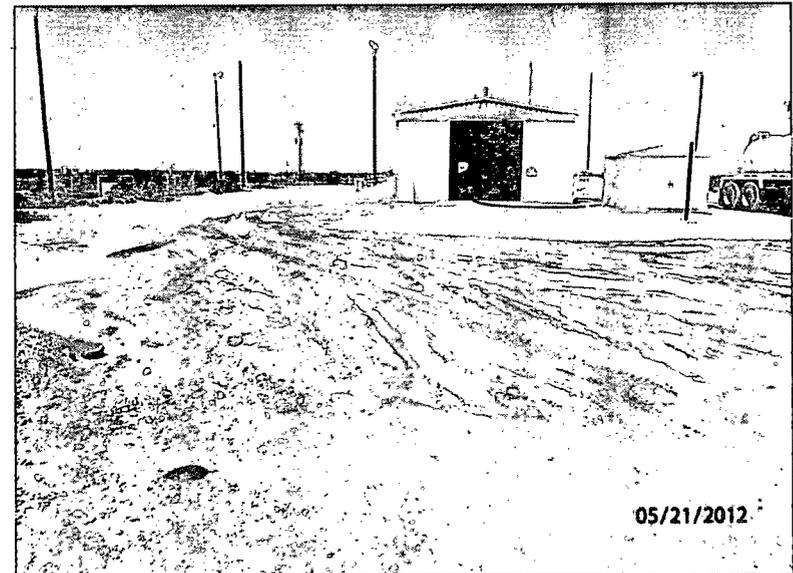
Initial release, facing west 5/21/2012

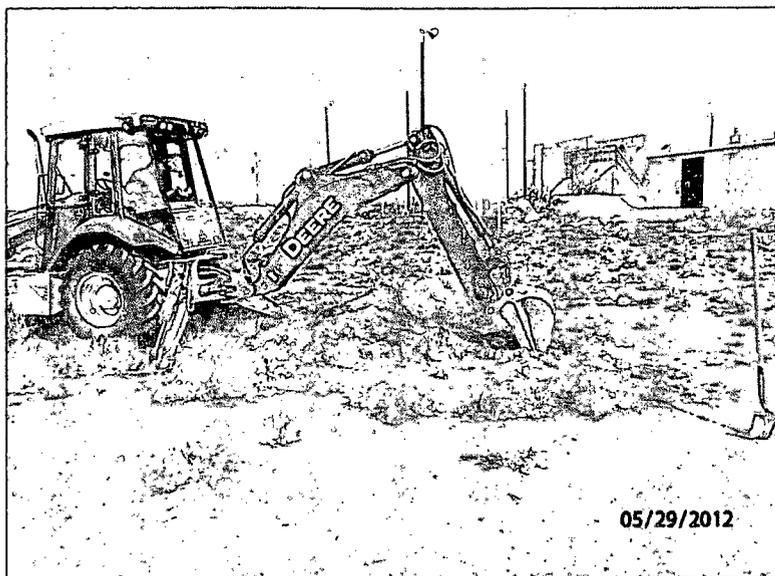
Excavating Vertical #1, facing west 5/29/2012

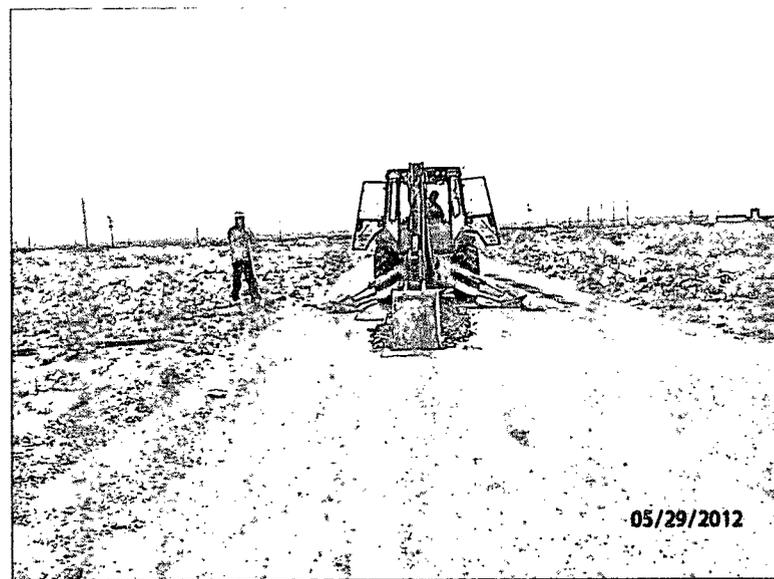
Excavating Vertical #2, facing east 5/29/2012

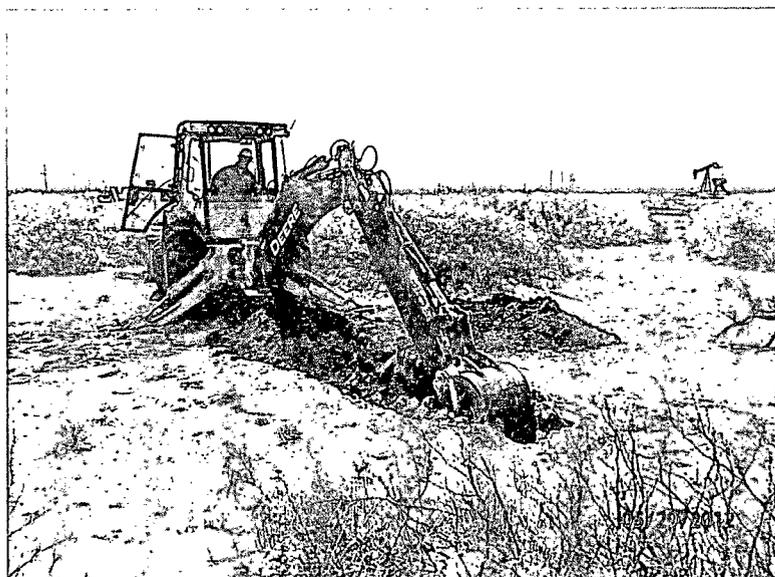
Excavating Vertical #3, facing east 5/29/2012

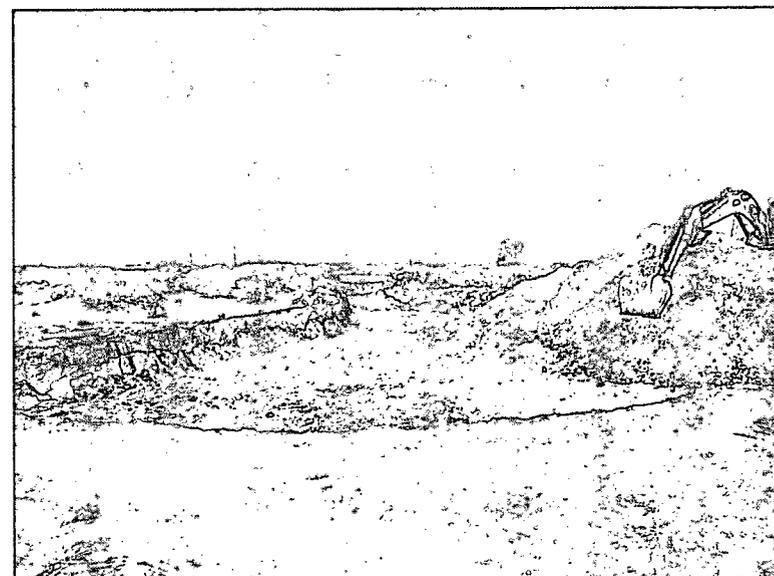
Excavating in pasture, facing northeast 6/1/2012

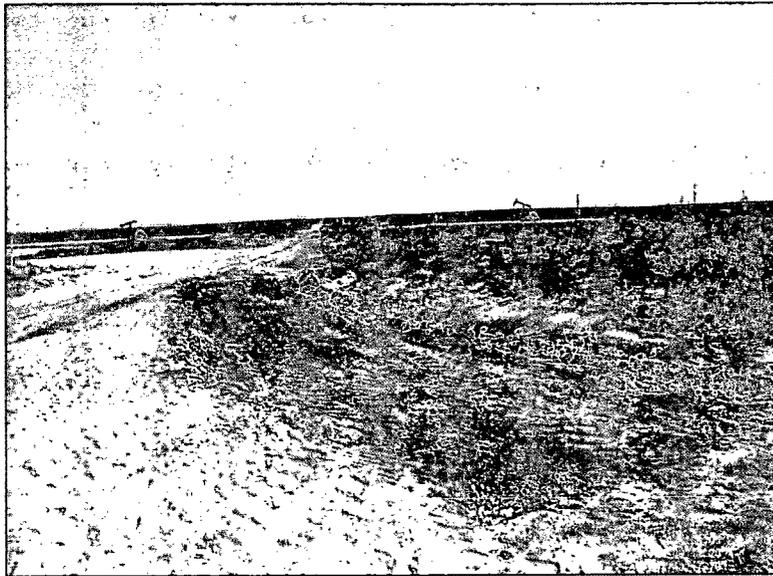
Road excavation complete, facing southwest 6/5/2012

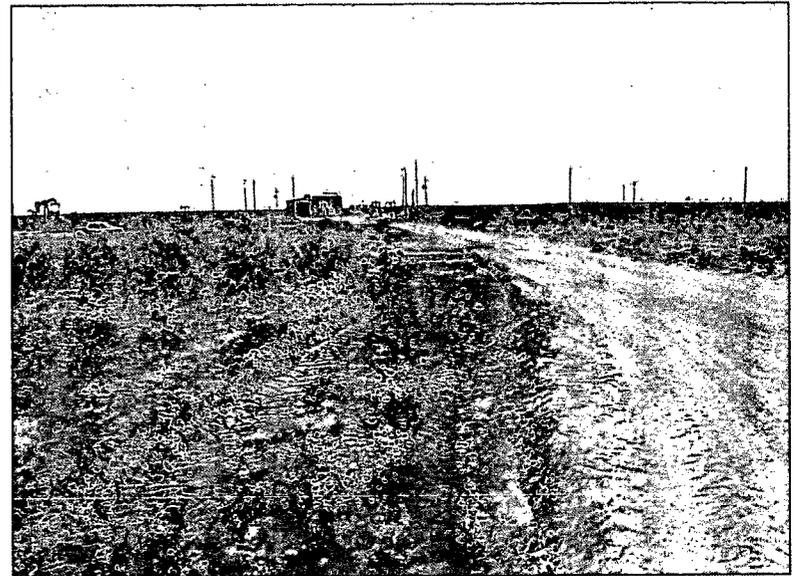
Road excavation complete, facing west 6/5/2012

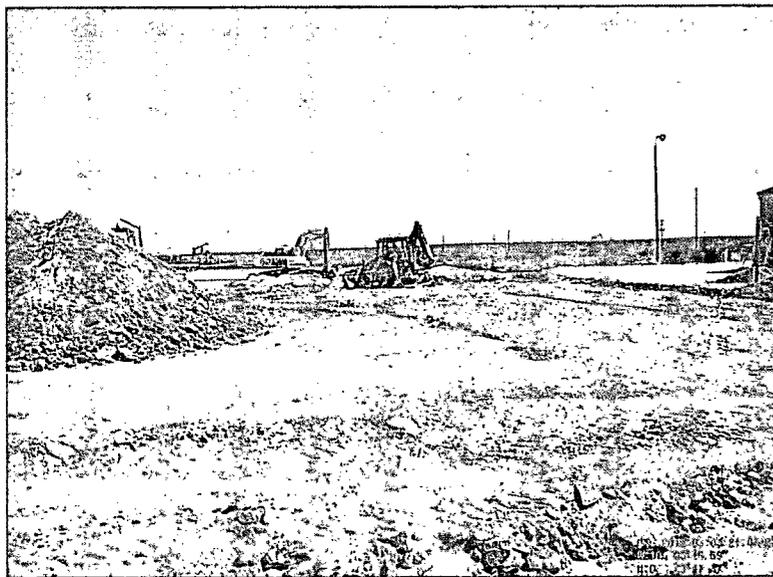
Excavating pad, facing southwest 6/6/2012

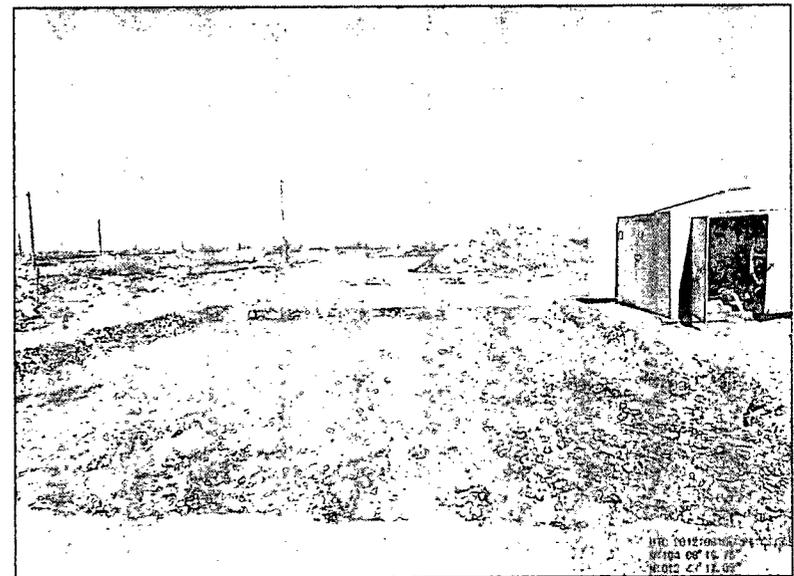
Pad excavation complete, facing east 6/6/2012

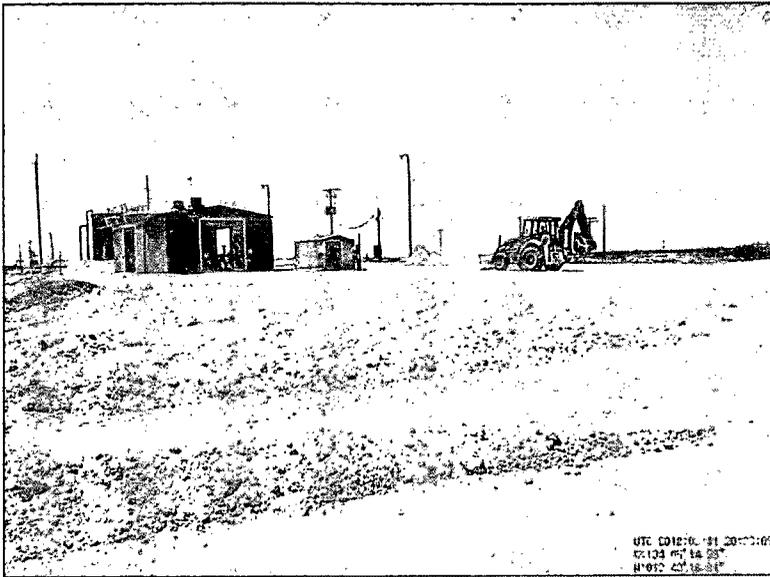
Backfilling with caliche, facing northwest 6/11/2012

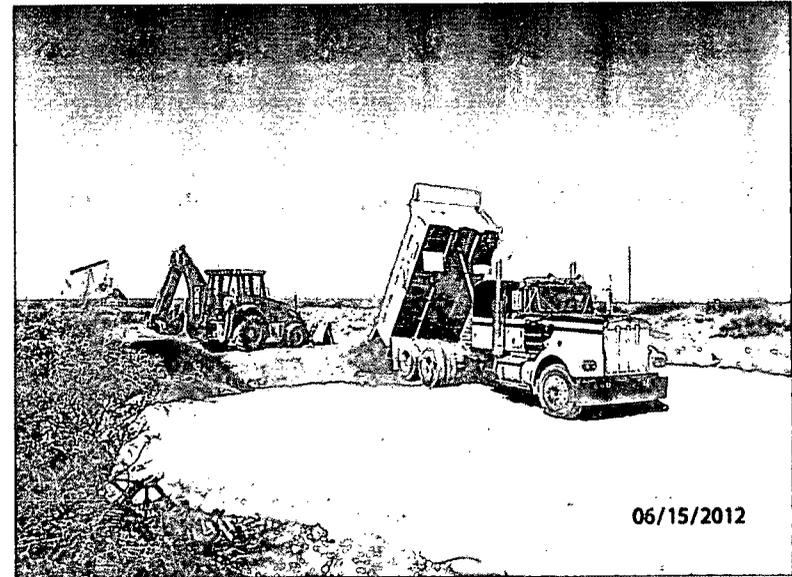
Placing topsoil in pasture, facing southwest 6/22/2012

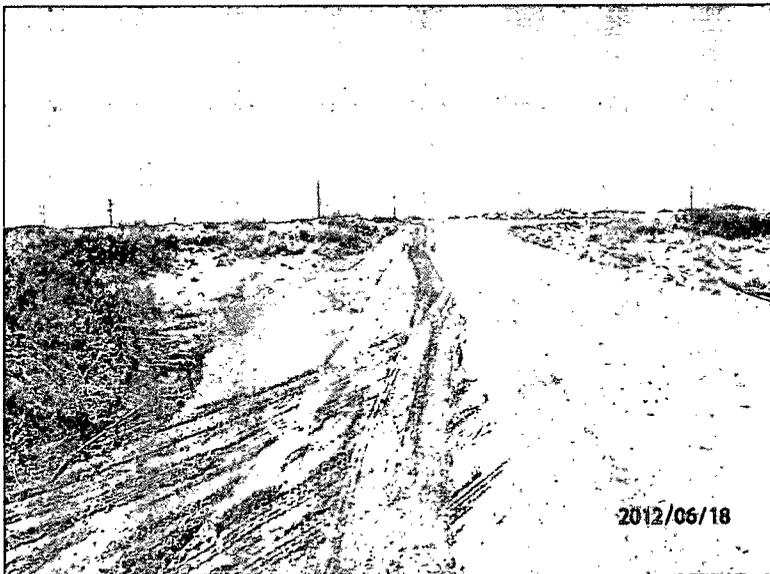
Road backfilled, facing north 6/18/2012

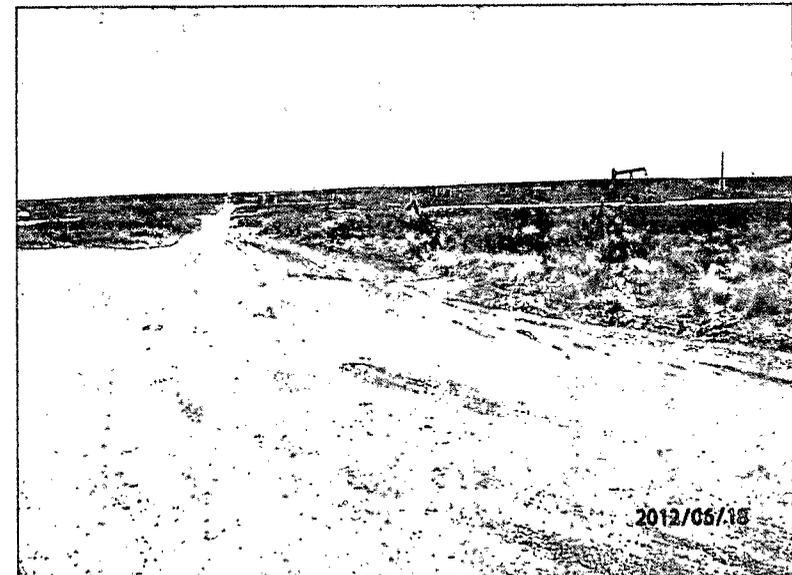
Road backfilled, facing south 6/18/2012

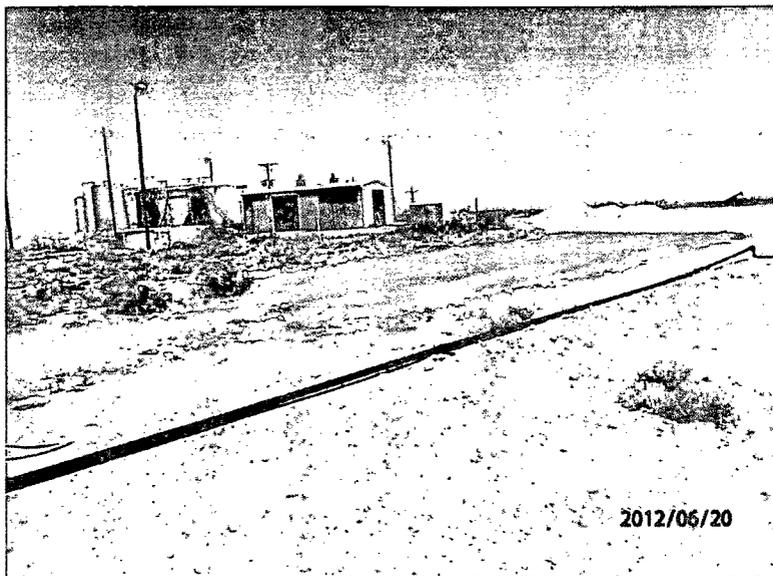
Topsoil backfill complete, facing north 6/20/2012

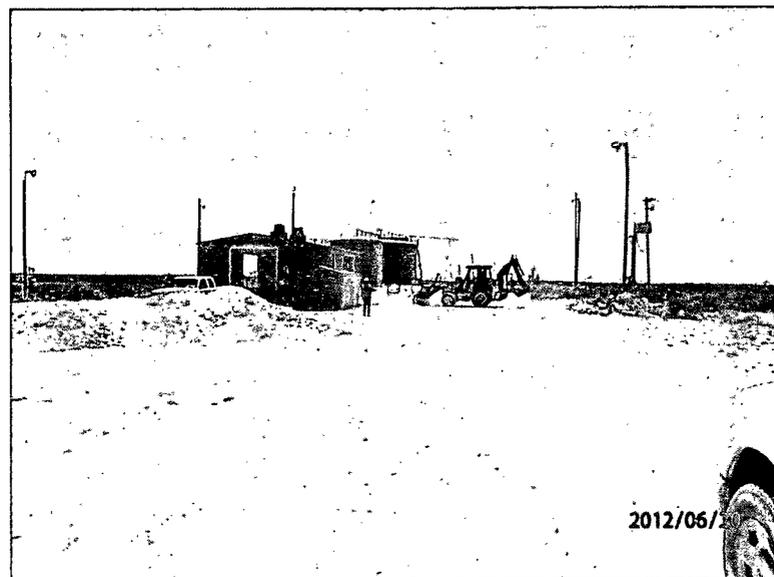
Building berms, facing west 6/20/2012

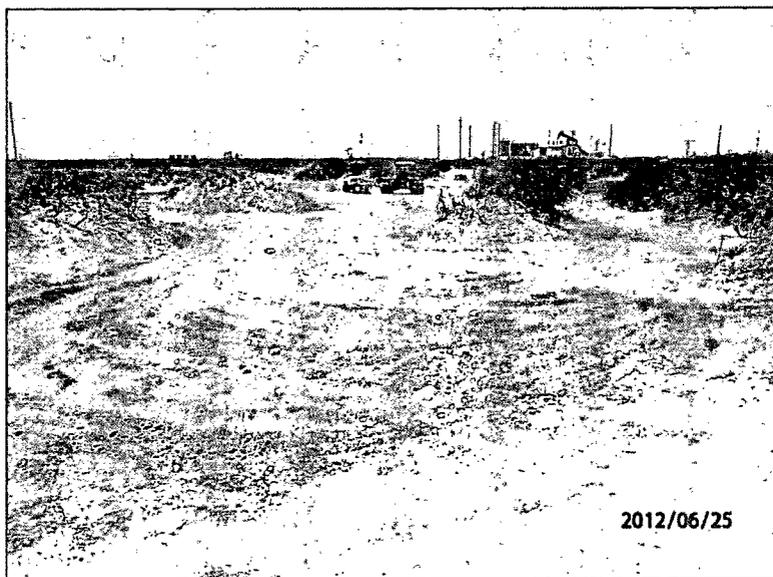
Seeding pasture, facing west 6/25/2012

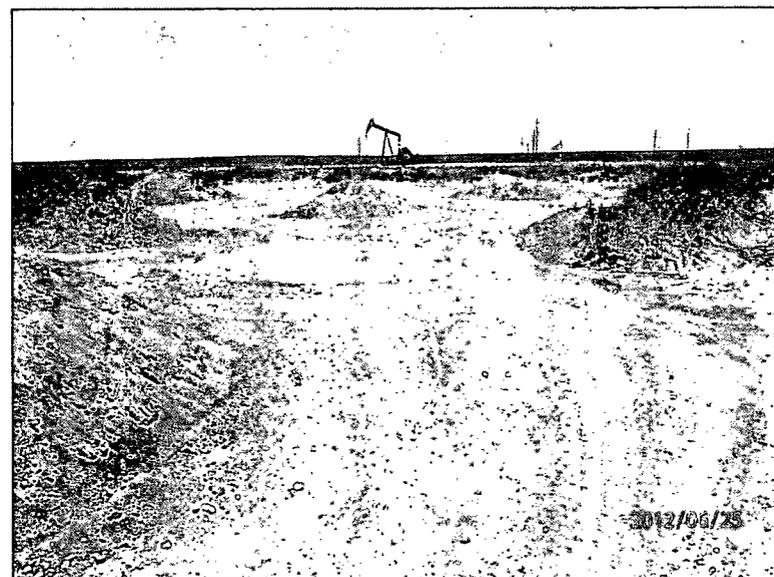
Site complete, facing south 6/25/2012
