## Tony Federal Battery AD

### Closure Report

2RP-1477

**RE: TERMINATION REQUEST**

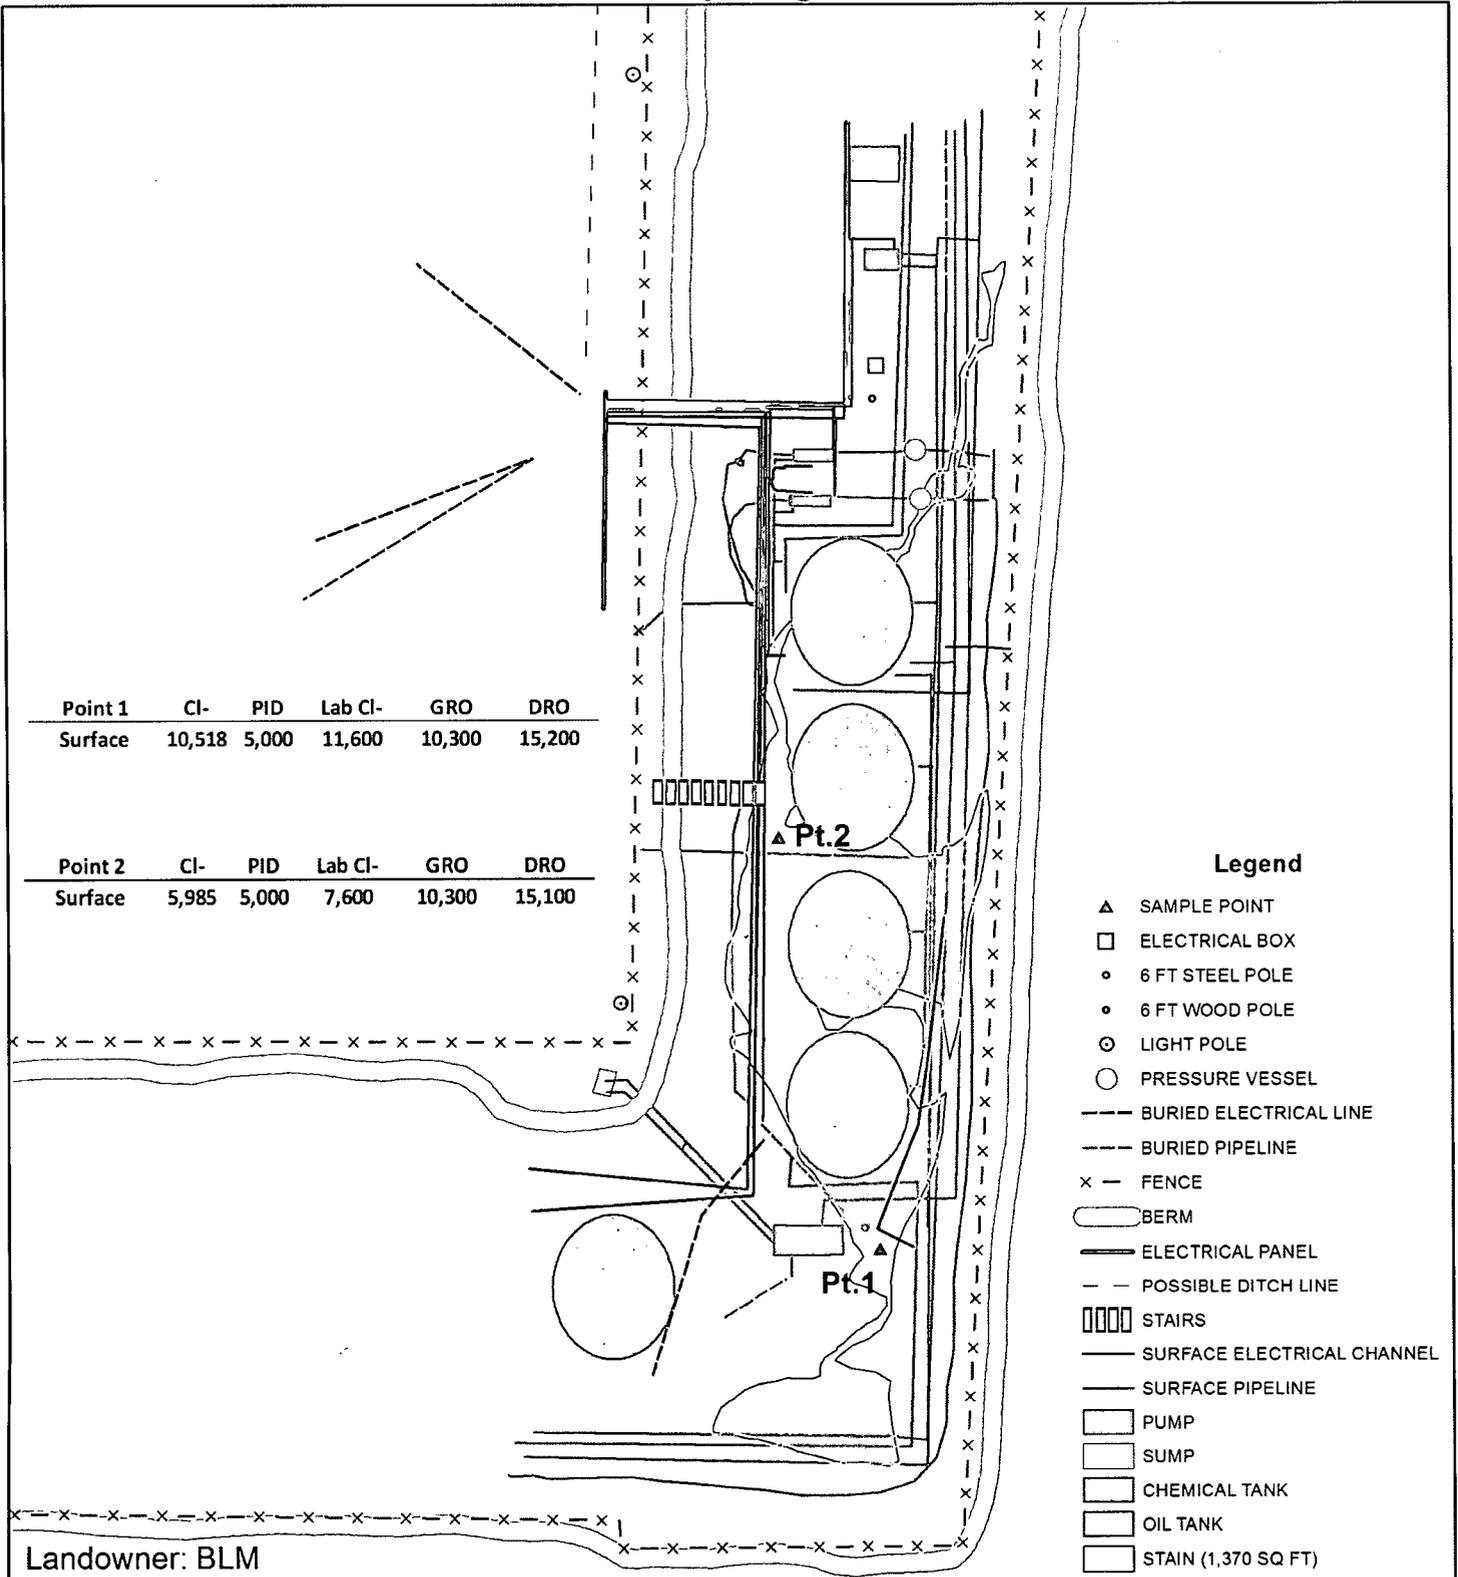
Figure 1

On November 26, 2012, RECS personnel initiated work at the Tony Federal Battery (Figure 1). Soil samples taken from two points at ground surface to 1.5 ft. below ground surface (bgs) were field tested for chloride. Headspace measurements were also taken in the field using a Photo Ionization Detector (PID). The surface samples were submitted to a commercial laboratory for chloride and TPH (GRO/DRO) analyses (Appendix C). The samples contained 11,600 and 7,600 mg/kg chloride, 10,300 mg/kg GRO, and 15,200 and 15,100 mg/kg DRO.

# Initial Sampling Data

Point 1	Cl-	PID	Lab Cl-	GRO	DRO
Surface	10,518	5,000	11,600	10,300	15,200

Point 2	Cl-	PID	Lab Cl-	GRO	DRO
Surface	5,985	5,000	7,600	10,300	15,100

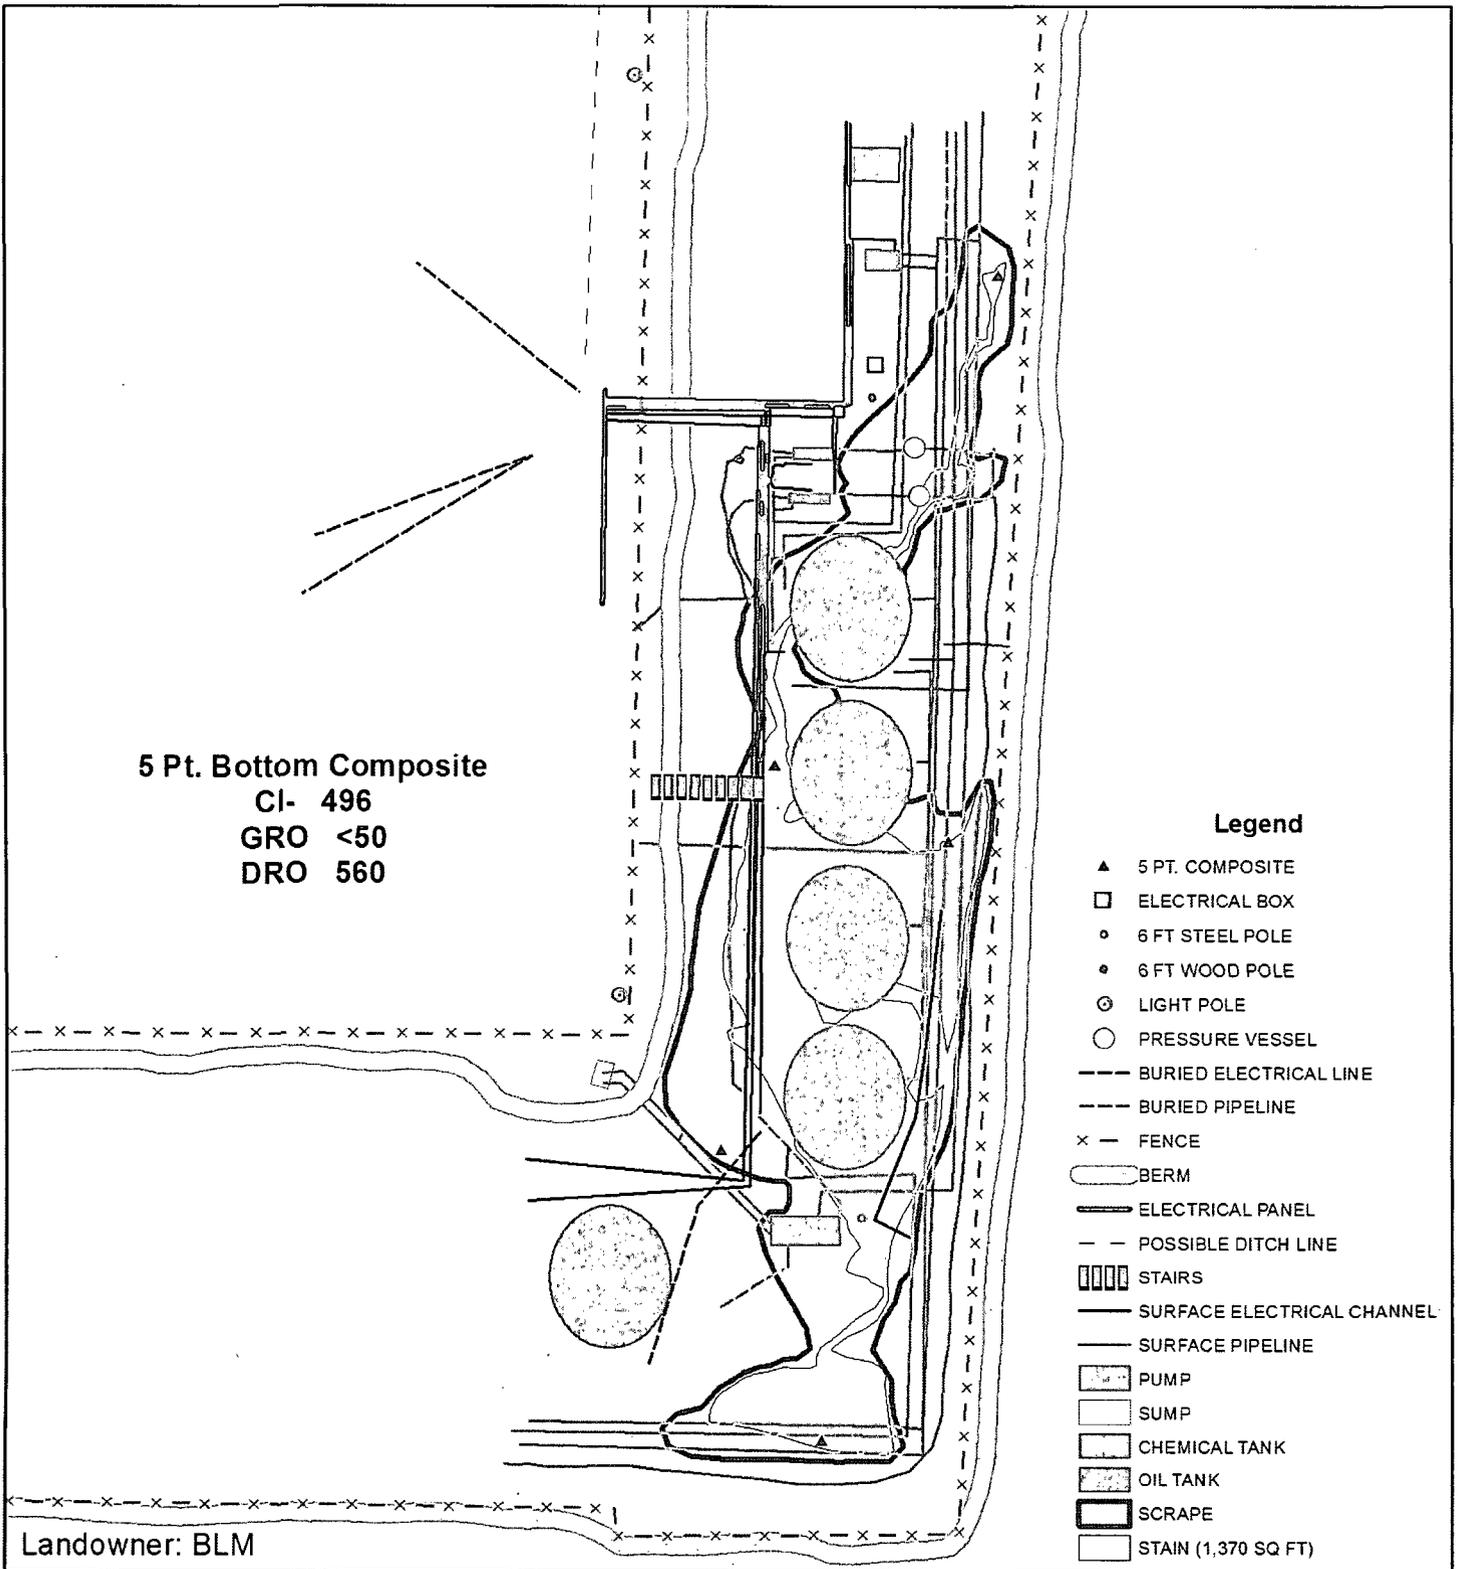
**Figure 2**

The leak area was excavated by hand to 1 ft. below ground surface (Figure 2). On December 27, 2012, a representative composite sample was collected from the excavation floor and submitted to a laboratory for chloride and TPH analyses (Appendix C). The sample contained 496 mg/kg chloride, <50 mg/kg GRO, and 560 mg/kg DRO.

# Final Excavation Lab Data

Excavated soils were removed to a NMOCD approved disposal facility. The excavation was backfilled with clean caliche (128 mg/kg chloride, Appendix C), and the site was leveled. See Appendix B for photographs of field activities.

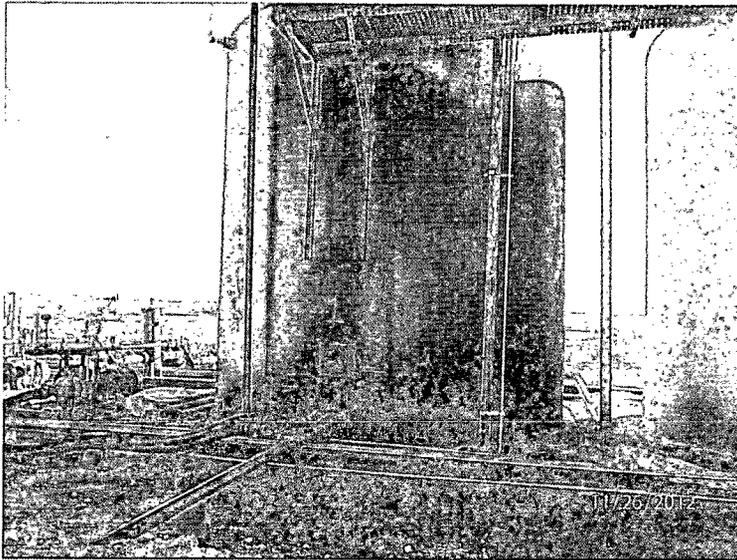
Source of release, facing east

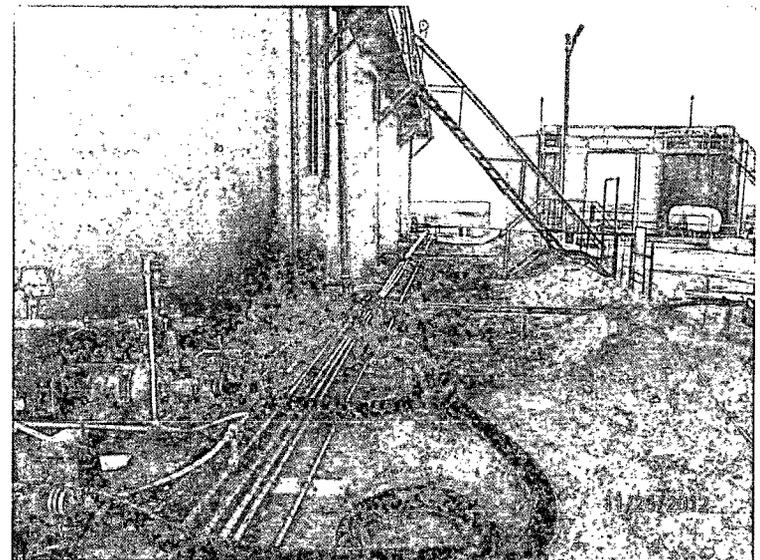
Release area, facing south

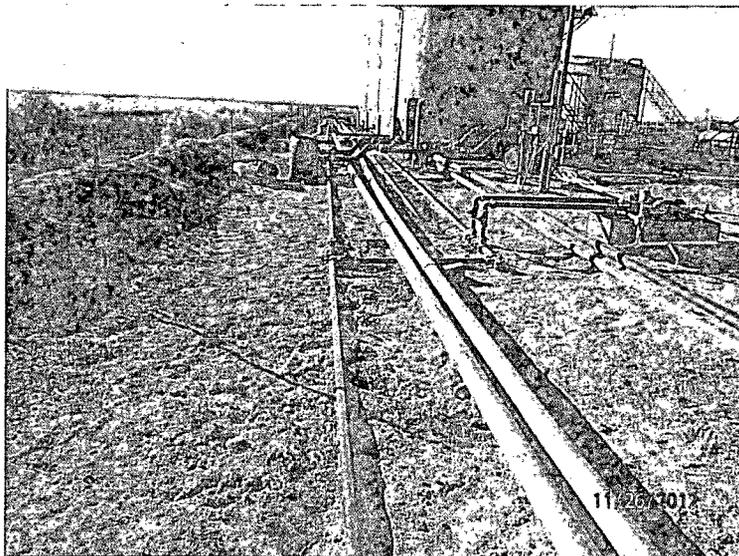
Release area, facing south

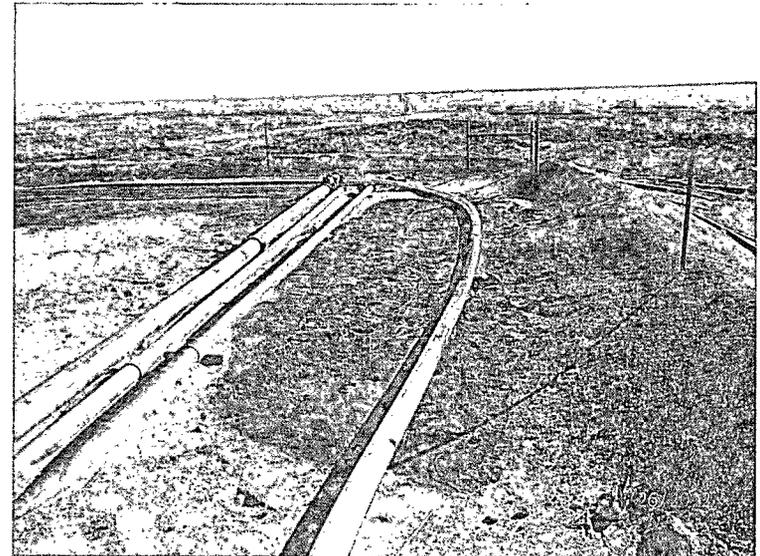
Initial release area, facing east

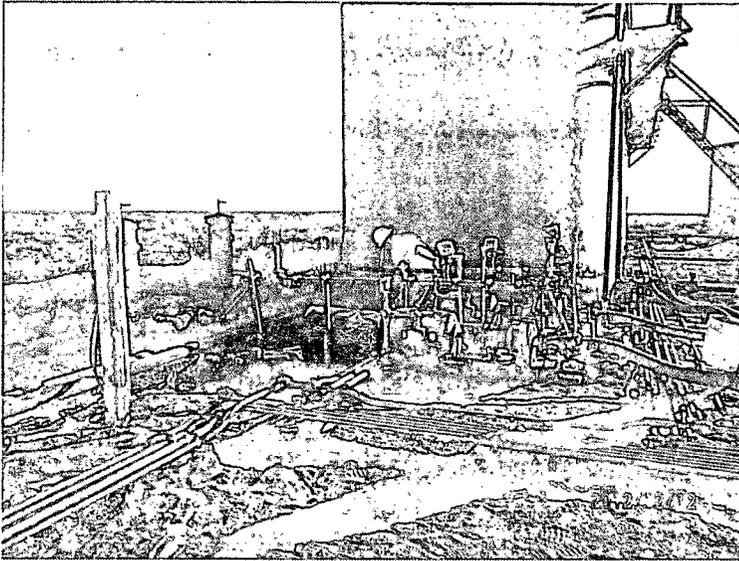
Excavating, facing southwest

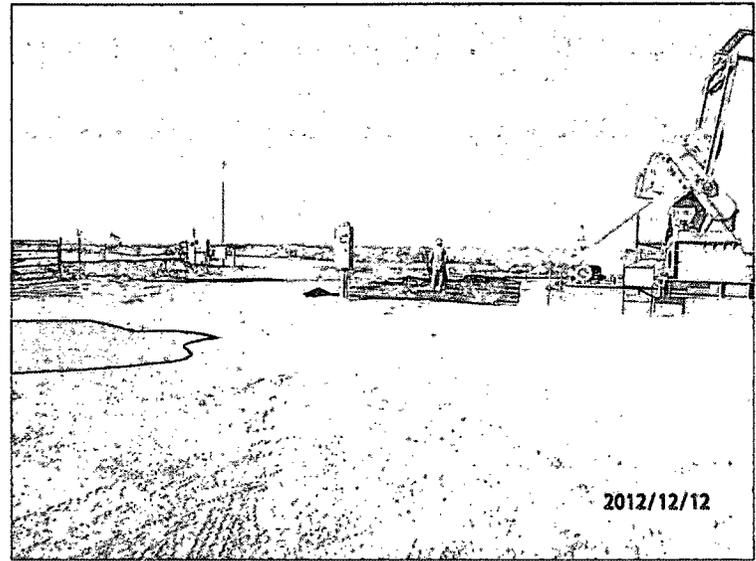
Stockpiling on plastic, facing east

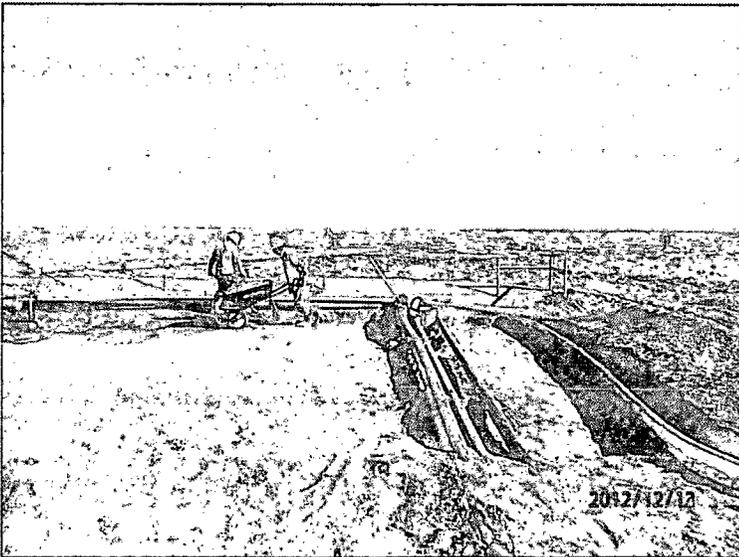
Excavating, facing east

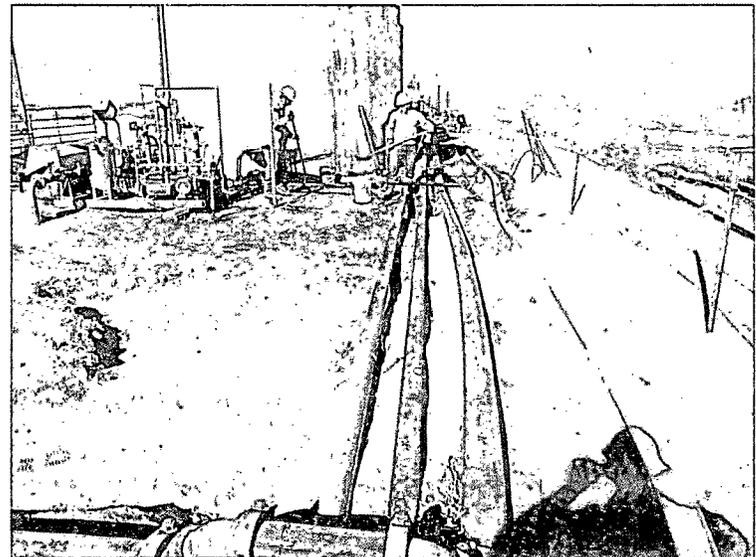
Excavating, facing north

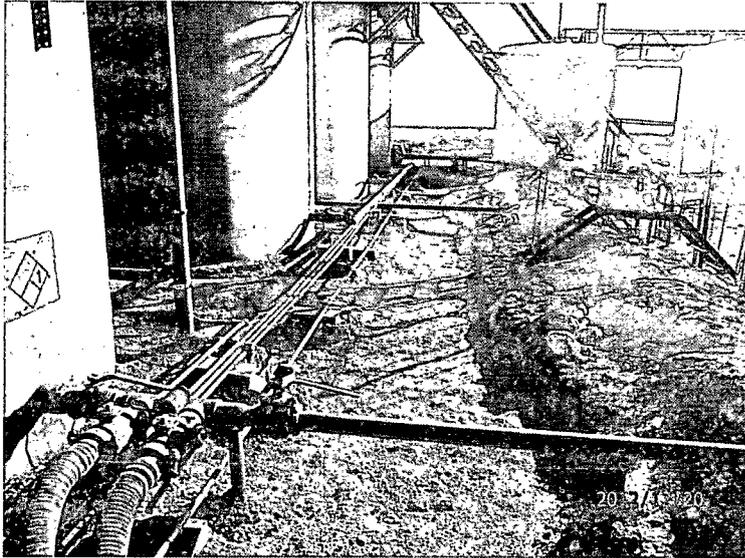
Excavation complete, facing south

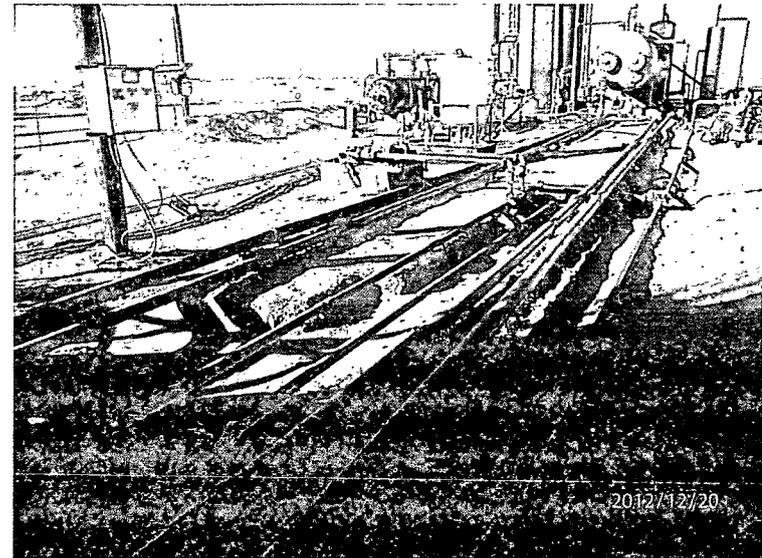
Excavation complete, facing north

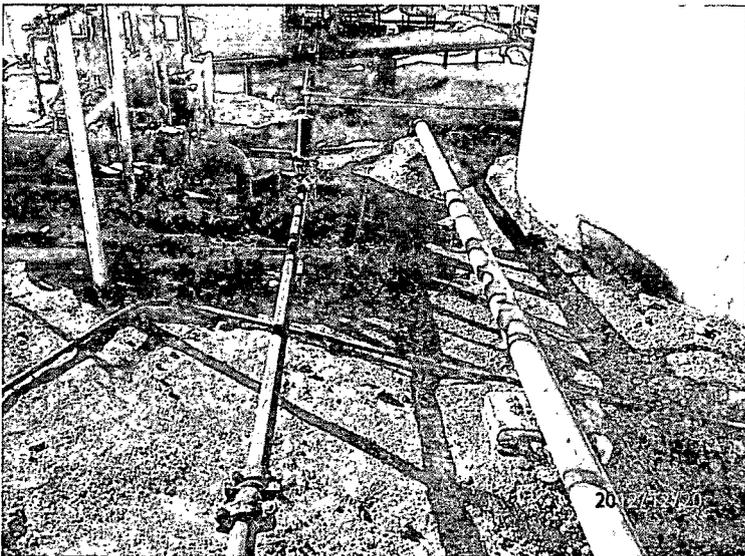
Excavation complete, facing west

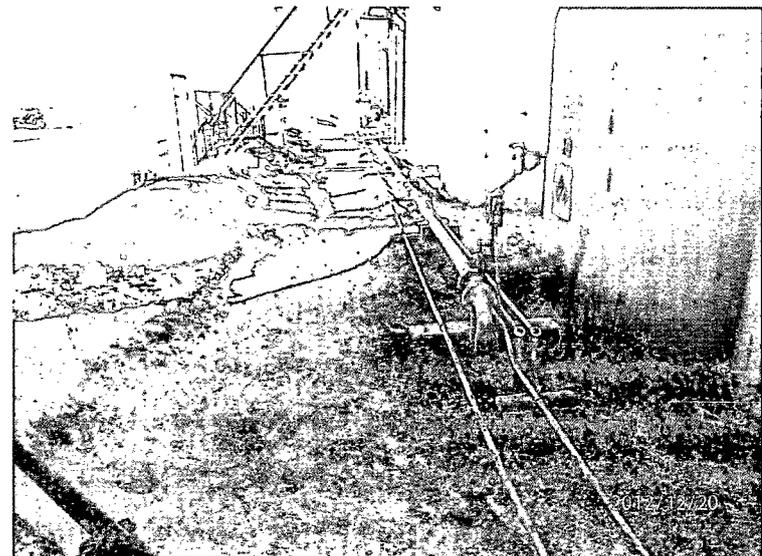
Excavation complete, facing north

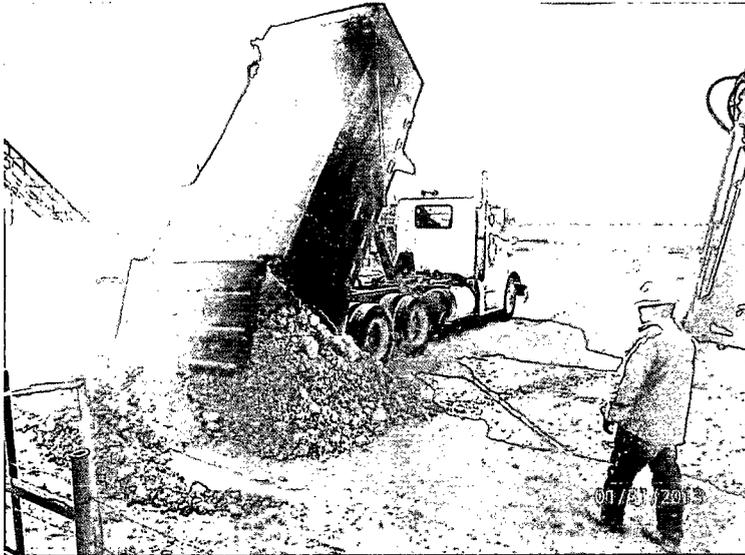
Importing backfill, facing south

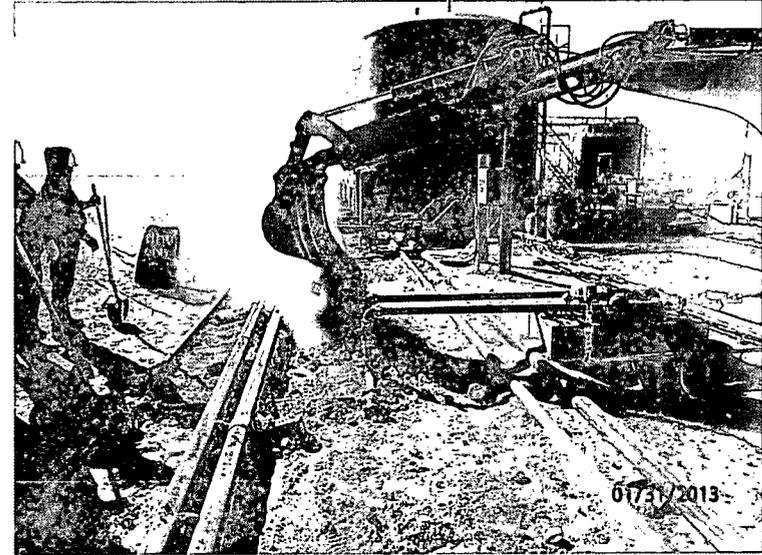
Backfilling, facing south

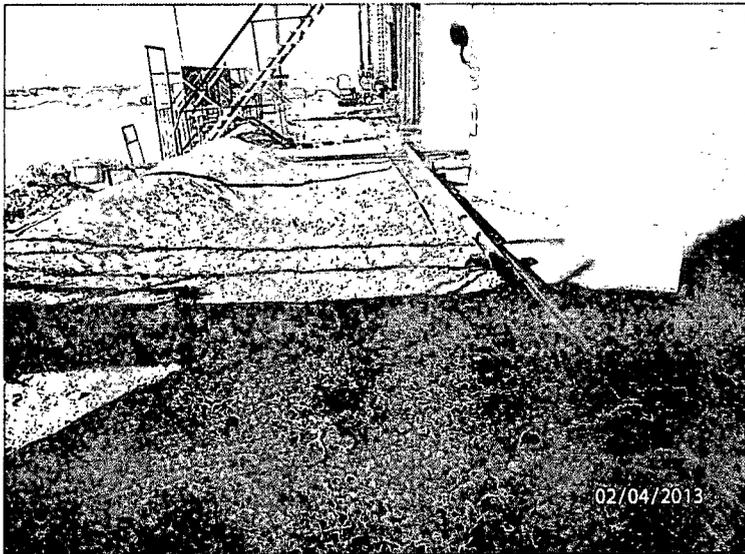
Backfill complete, facing north

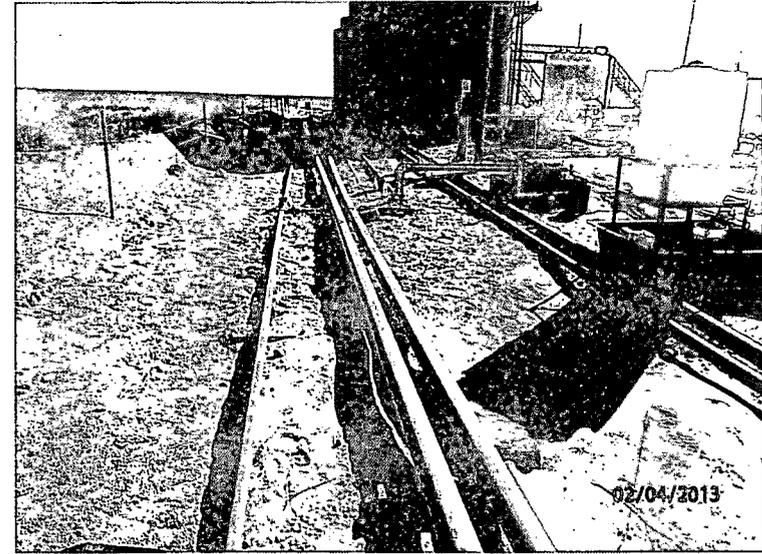
Backfill complete, facing south
