**Beeline Gas Systems
Martin Whitaker #58
Lateral**

Release Notification and Corrective Action

**RE: Release Assessment Report
AXI H-12 Well Tie Pipeline Release
NW¼ NW¼, Section 9, T23N, R5W
Rio Arriba County, New Mexico**

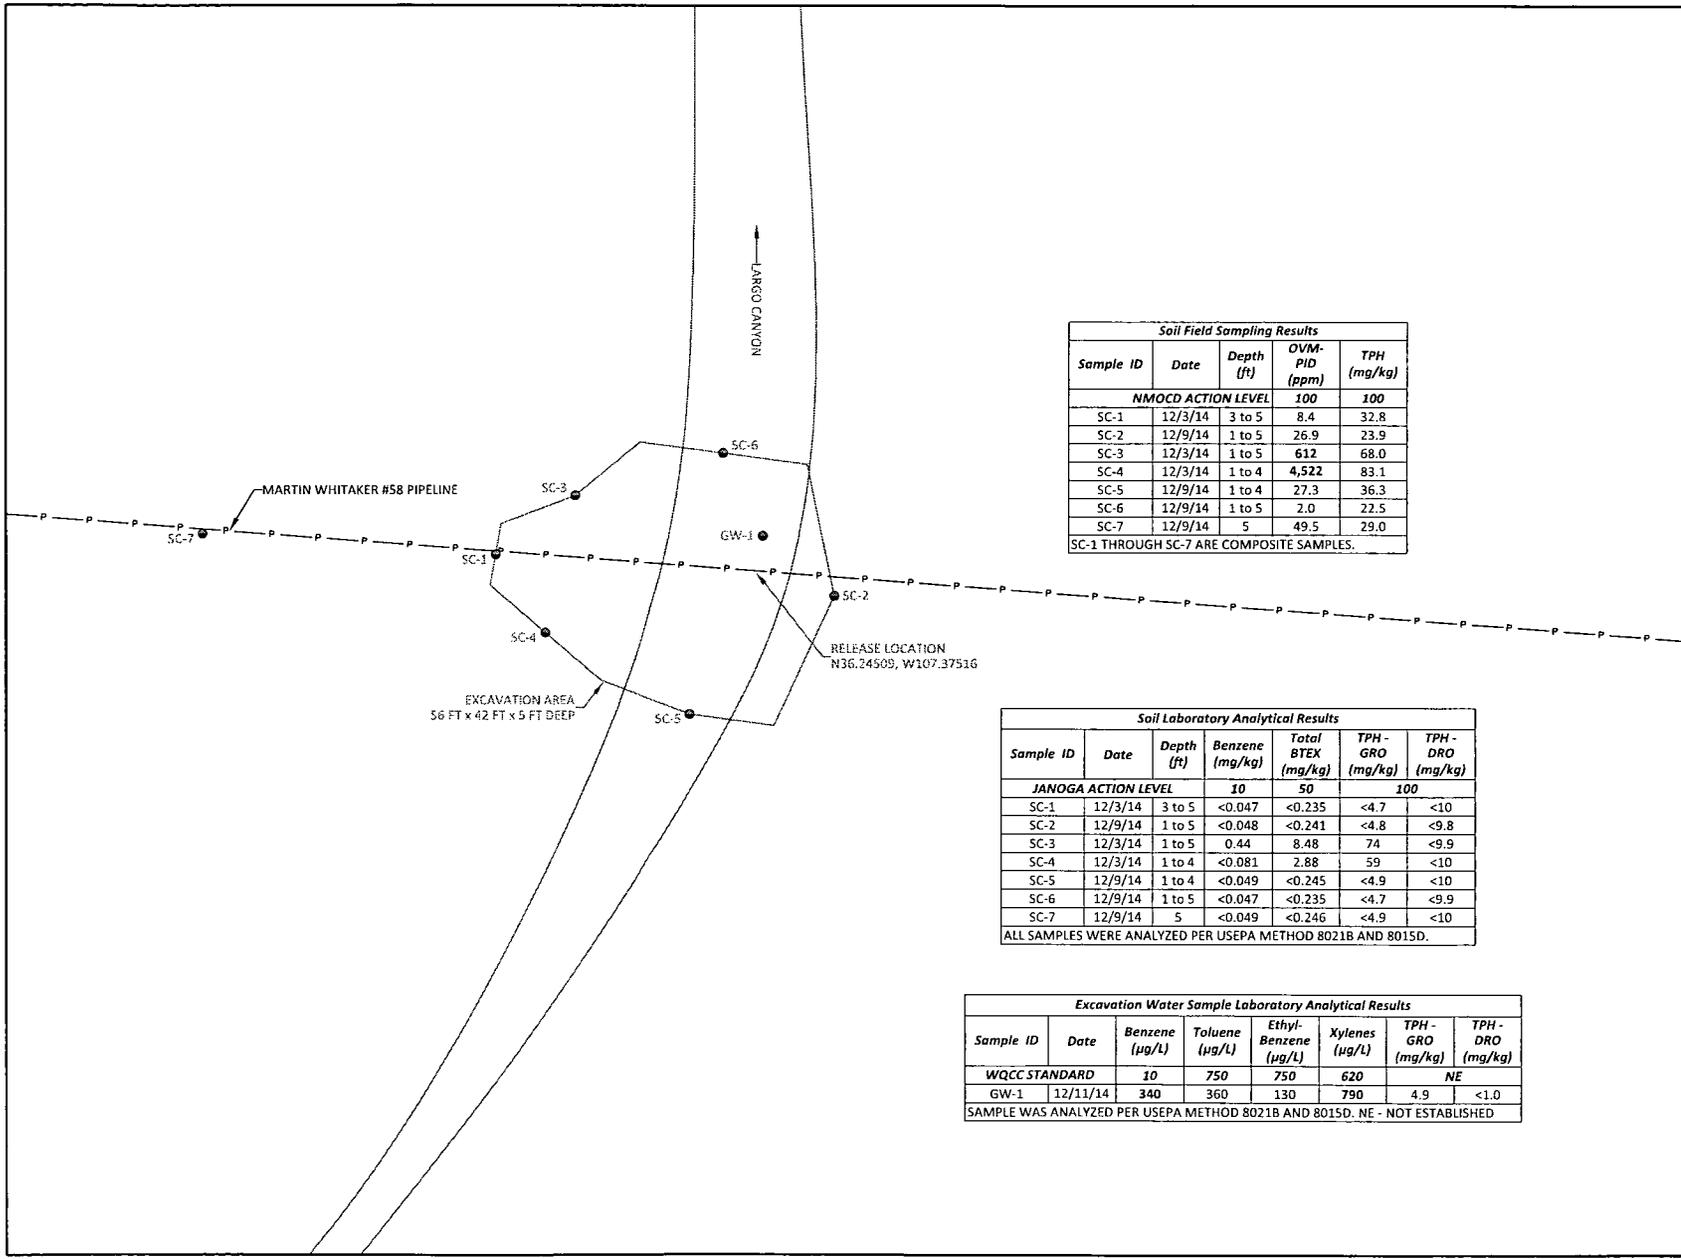
FIGURE 3

Prior to December 3, 2014, Beeline contractors began an excavation along the pipeline and determined that the pipeline release was the result of corrosion. On December 3 and 9, 2014, AES collected a total of six confirmation soil samples for field screening and laboratory analysis from the walls of the final excavation. At the request of the NMOCD, one 5-point composite confirmation soil sample was also collected along the length of pipeline to be replaced. Note that heavy precipitation necessitated the removal of excess rain water via hydro-vacuum trucks from the excavation. Prior to backfilling the excavation, one grab sample was collected from the recharged groundwater on December 11, 2014, under the supervision of NMOCD. The final excavation measured approximately 56 feet by 42 feet by 5 feet deep. The excavation was backfilled with clean, imported material. Petroleum impacted soil was transported to the Envirotech Landfarm for proper disposal. Soil and groundwater sample locations and final excavation extents are included on Figure 3.

Soil field screening results showed that VOC concentrations via OVM ranged from 2.0 ppm in SC-6 to 4,522 ppm in SC-4. TPH concentrations ranged from 22.5 mg/kg in SC-6 to 83.1 mg/kg in SC-2. Field screening results are summarized in Table 1 and presented on Figure 3. The AES Field Sampling Report is attached.

Laboratory analytical results for the soil samples showed benzene concentrations ranging from below the laboratory detection limits in several samples up to 0.44 mg/kg in SC-3. Total BTEX concentrations ranged from below laboratory detection limits in several samples up to 8.48 mg/kg in SC-3. TPH concentrations as GRO/DRO ranged from below the laboratory detection limits in most samples up to 74 mg/kg in SC-3. Laboratory analytical results are included in Table 2 and on Figure 3. The laboratory analytical reports are attached.

Laboratory analytical results for the water sample (GW-1) reported dissolved phase concentrations of 340 µg/L benzene, 360 µg/L toluene, 130 µg/L ethylbenzene, and 790 µg/L xylenes. Dissolved phase TPH concentrations as GRO/DRO were reported at 4.9 mg/L. Laboratory analytical results are included in Table 3 and on Figure 3.

**FINAL EXCAVATION SAMPLE LOCATIONS AND RESULTS
DECEMBER 2014**
 BEELINE GAS SYSTEMS
 MARTIN WHITAKER #58 PIPELINE RELEASE
 NW¼ NW¼, SECTION 9, T23N, R5W
 RIO ARriba COUNTY, NEW MEXICO
 N36.24509, W107.37516

Based on the final field screening and laboratory analytical results of the excavation of petroleum hydrocarbon impacted soils at the Martin Whitaker #58 Pipeline release location, benzene, total BTEX, and TPH concentrations were below applicable JANOGA (NMOCD) action levels. However, laboratory analytical results from the excavation water sample indicate that groundwater may be potentially impacted above the WQCC standards for benzene (10 µg/L) and xylenes (620 µg/L). Installation and sampling of temporary hydropunch points in the vicinity of the release area is recommended in approximately six months to evaluate the natural attenuation of residual dissolved phase contaminants.

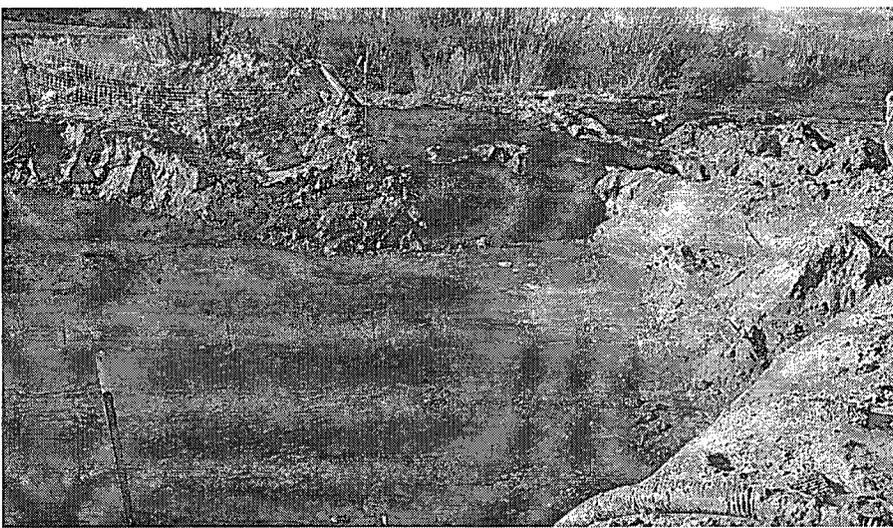
Photo #2

Client: Beeline Gas Systems	
Project Name: Martin Whitaker #58 Rio Arriba County, NM	
Date Photo Taken: December 9, 2014	
Wellhead GPS and Location: 36.24509, -107.37516 NW¼ NW¼, Section 9, T23N, R5W	
Taken by: Emilee Skyles, AES	Subject: Excavation Clearance, December 2014
	Excavation Dimensions: 56 ft x 42 ft x 5 ft deep
	Description: Facing north, final excavation limits of the northern half of the excavation. Water sample GW-1 was collected from the recharged water near the middle of the photo. Depth to water is approximately 5 feet bgs.
