May 21st, 2012

RE: Termination Request
Quantum Resources Management, LLC
Conoco 7 St. #12 AD: UL/K sec. 7 T19S R29E
API No. 30-015-25160

**QUANTUM
CONOCO 7 ST.
#12 AD**
 API: 3001525160
 UL/K SECTION 7
 T-19-S R-29-E
 EDDY COUNTY, NM

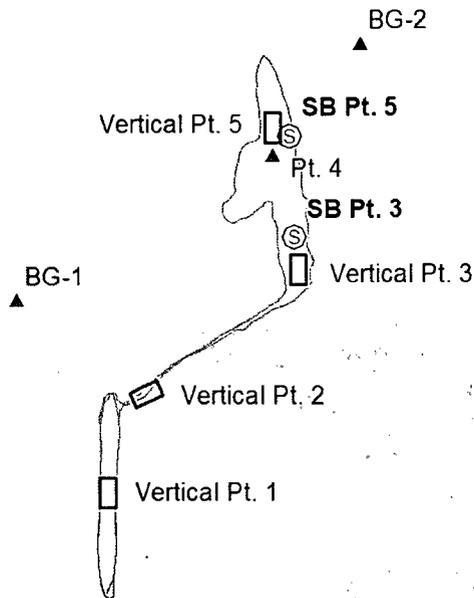
Figure 2

Two soil bores were advanced at the site on February 16th, 2012 near verticals Pt. 3 and Pt. 5. Pt. 3 was advanced to 20 ft bgs and Pt. 5 was advanced to 16 ft bgs (Figure 2). The samples were field tested for both chloride and hydrocarbons and representative samples

were taken to a commercial laboratory for analysis (Appendix B). Pt. 3 at 17 ft bgs returned a chloride reading of 8,100 mg/kg, a GRO reading of non-detect and a DRO reading of 11.4 mg/kg. Pt. 3 at 20 ft bgs returned a chloride reading of 160 mg/kg and GRO and DRO readings of non-detect. Pt. 5 at 14 ft bgs returned a chloride reading of 400 mg/kg and GRO and DRO readings of non-detect. Pt. 5 at 16 ft bgs returned a chloride reading of 112 mg/kg and GRO and DRO readings of non-detect.

- ⊙ SOIL BORES
- STAIN (6,000 sq ft)
- ▲ SAMPLE POINTS

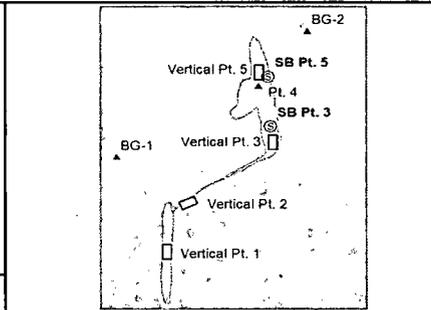
Company: Quantum
Project Name: Conoco 7 St. #12 AD
Well ID: VERTICAL & SB Pt. 3

Comments:
 Lithology taken from the surface through 20 ft and samples analyzed from 13 ft to 20 ft.
DRAFTED BY: L. Weinheimer
 TD = 20 ft GW = 150 ft

Depth (feet)	Chloride field tests	LAB	PID	Description	Lithology	Well Construction
0 ft	10897	CI-11600	88.8	0 - 5 ft Red silt, slightly clayey at top increasing with depth. Unconsolidated and damp. Very scattered caliche fragments (< 2 mm) throughout. No stain or odor.		
1 ft	5920		4.2			
2 ft	2961		2.9			
3 ft	4399		1.8			
4 ft	6876		2			
5 ft	2493		2.1	5 - 8.5 ft Tan clayey silt with larger fragments of caliche (up to 3 cm), decreasing in abundance toward bottom. Damp, no stain, no odor.		
6 ft	1273		1.6			
7 ft	454		1.6			
8 ft	1733		1.7			
9 ft	395		1.4

Depth (feet)	Chloride field tests	LAB	PID	Description	Lithology	Well Construction
10 ft	450		2.3	8.5 - 13 ft Red/tan clayey silt, damp, no stain, no odor. Becoming increasingly clayey and more reddish toward bottom. Caliche fragments (to 1 cm) from 11.5 ft to 13 ft.

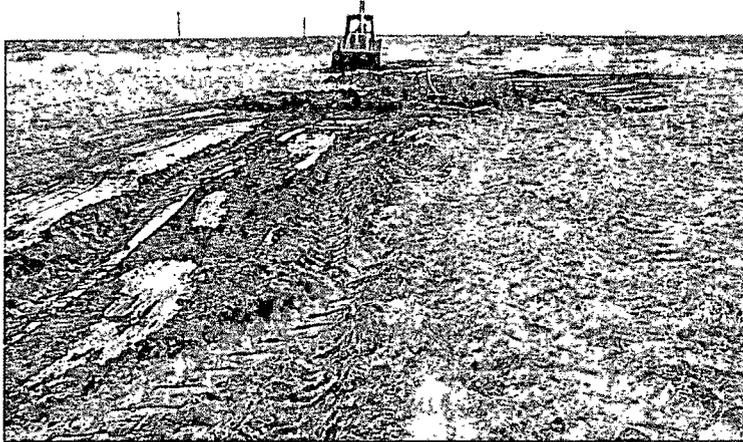
Initial leak area, facing south

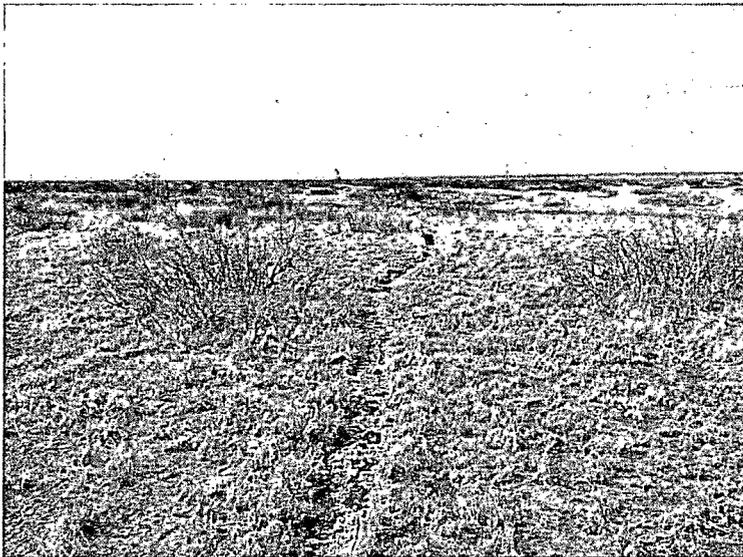
Initial leak area, facing west

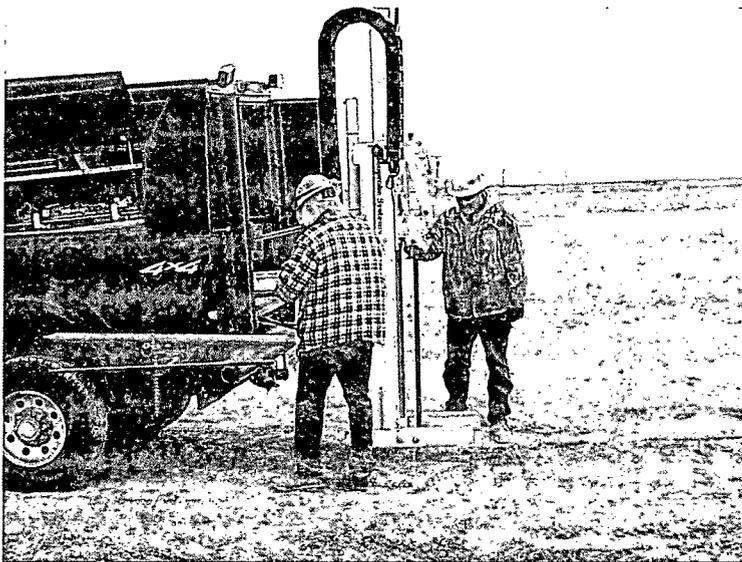
Geo-probe at Pt. 5, facing north

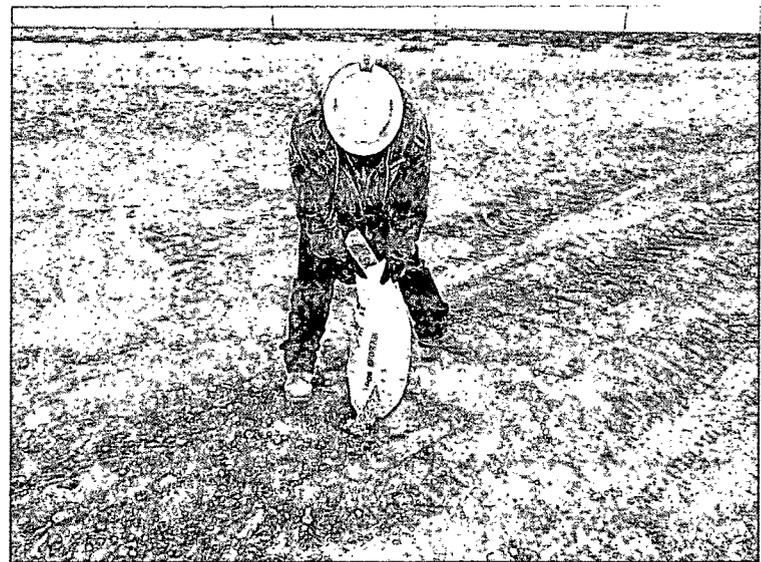
Plugging Pt. 5 bore in total with bentonite

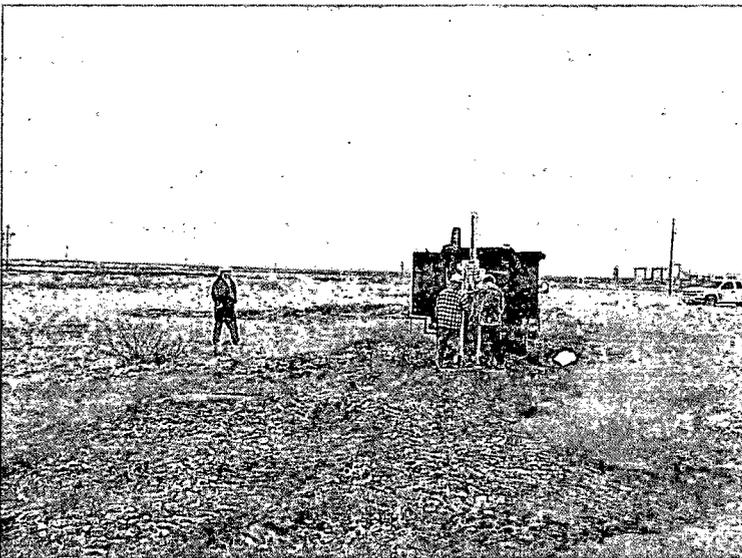
Geo-probe at Pt. 3, facing west

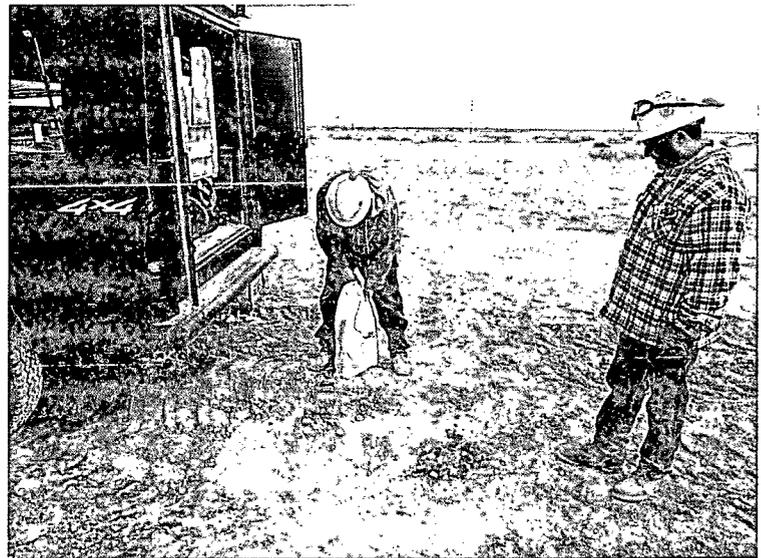
Plugging Pt. 3 bore in total with bentonite

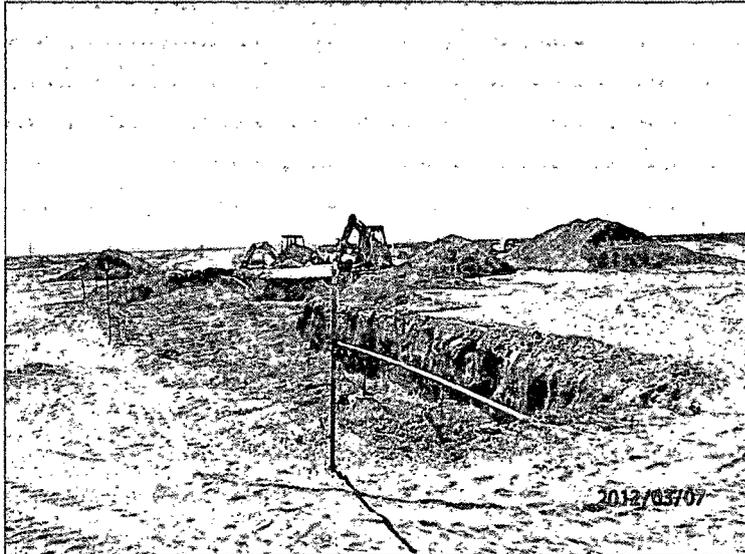
Excavating the site for liner installation, facing southwest
3/7/12

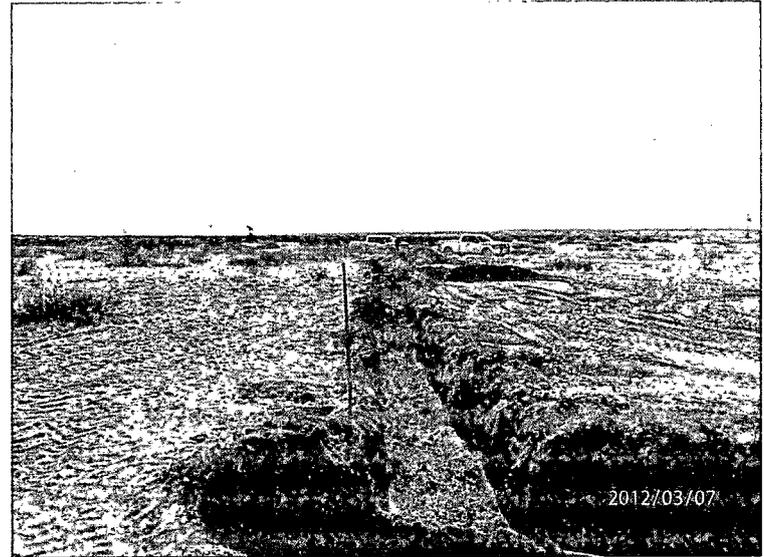
Excavation of remaining release, facing west 3/7/12

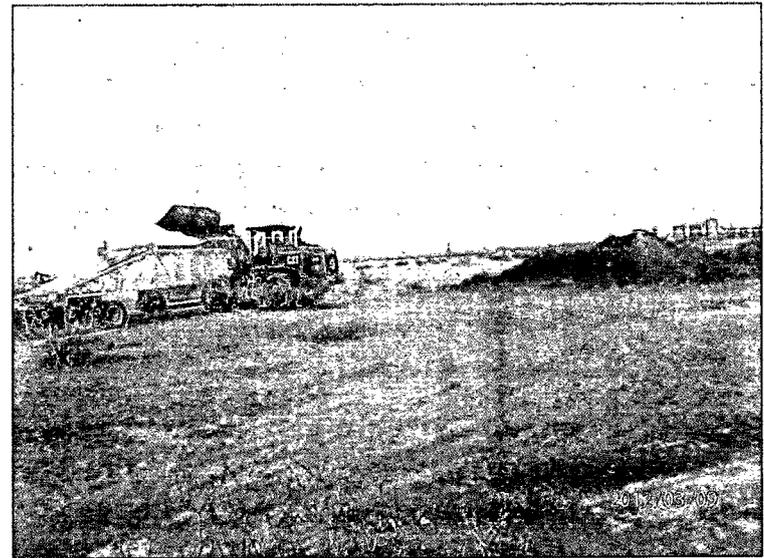
Exporting soil, facing northwest 3/9/12

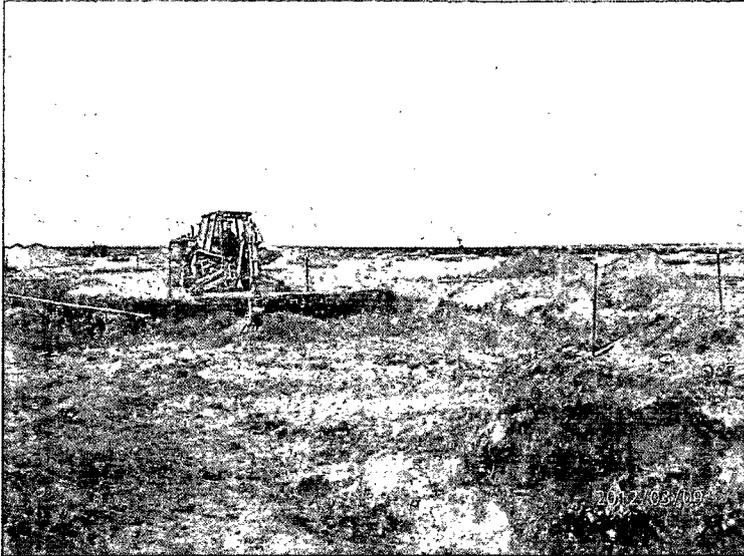
Installing 6 in pad for liner, facing southwest 3/9/12

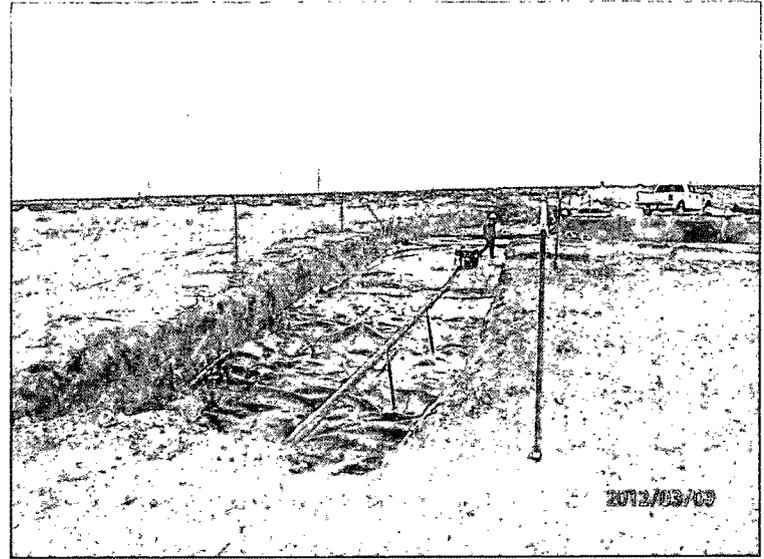
Liner installed, facing southeast 3/9/12

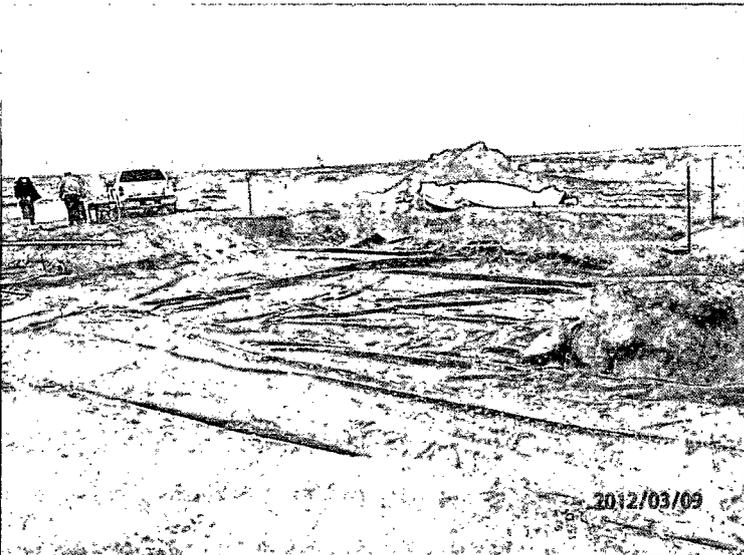
Liner installed, facing southwest 3/9/12

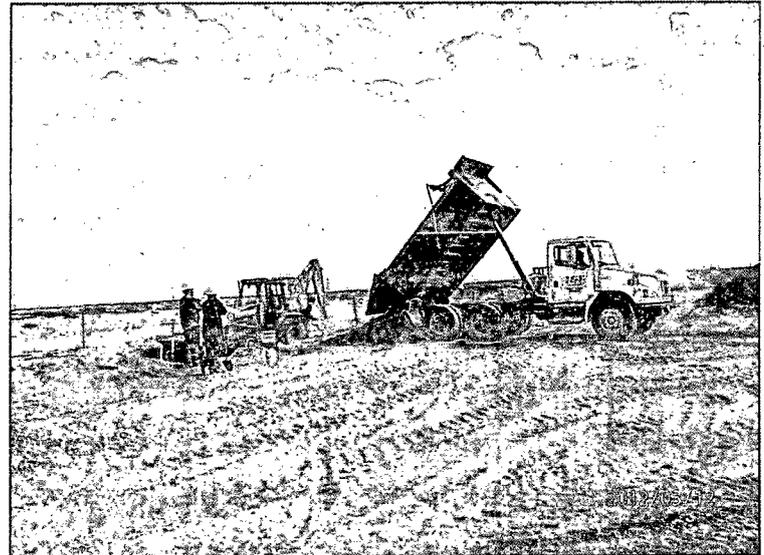
Importing clean top soil, facing southeast 3/12/12

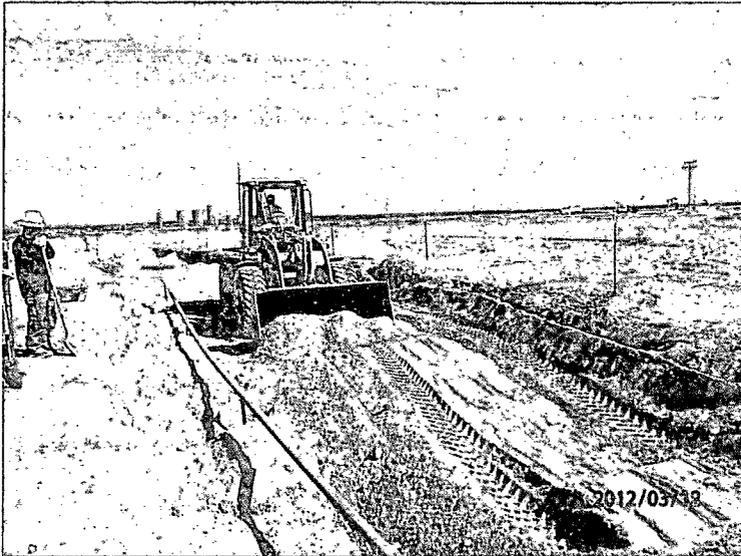
Backfilling the liner excavation, facing northeast

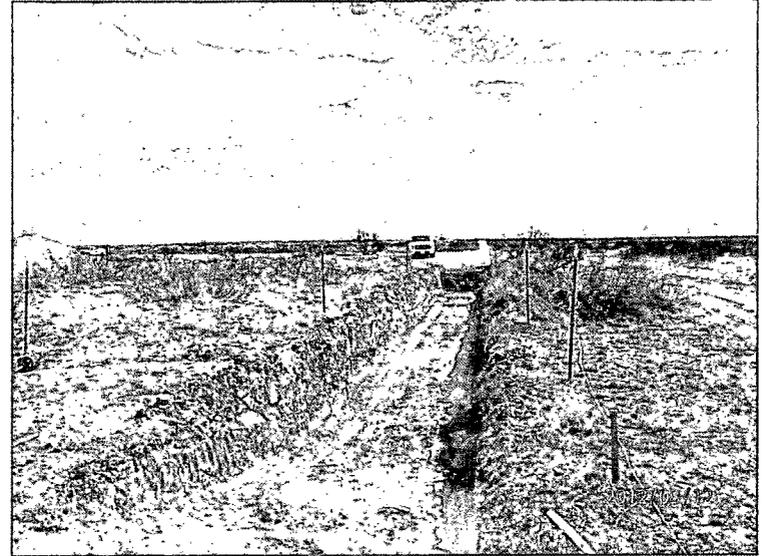
Road excavation completed, facing southeast 3/12/12

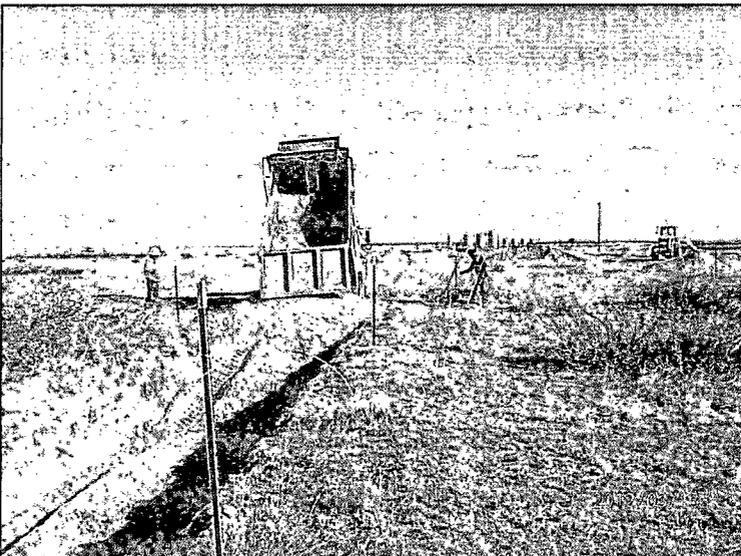
Importing caliche, facing northwest

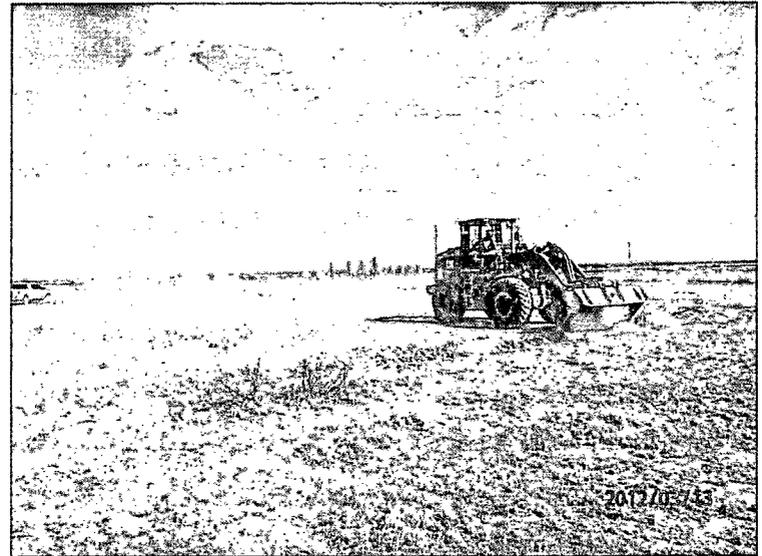
Backfilling excavation of remaining release, facing northeast

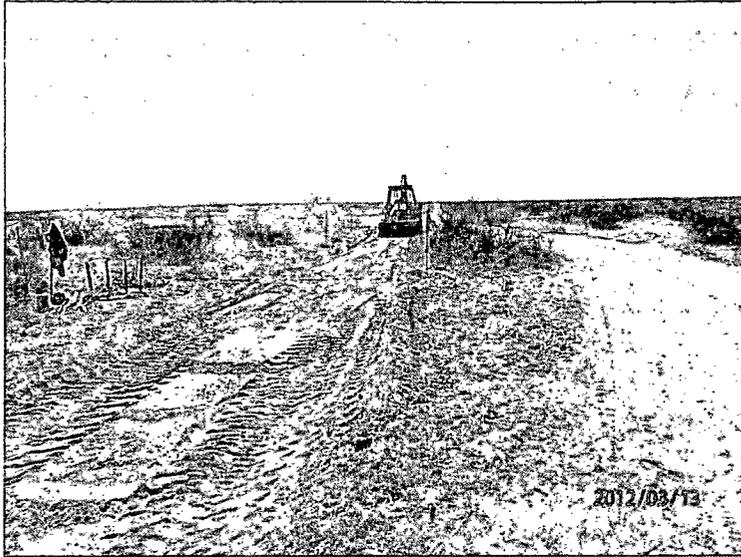
Backfilled road excavation, facing south 3/13/12

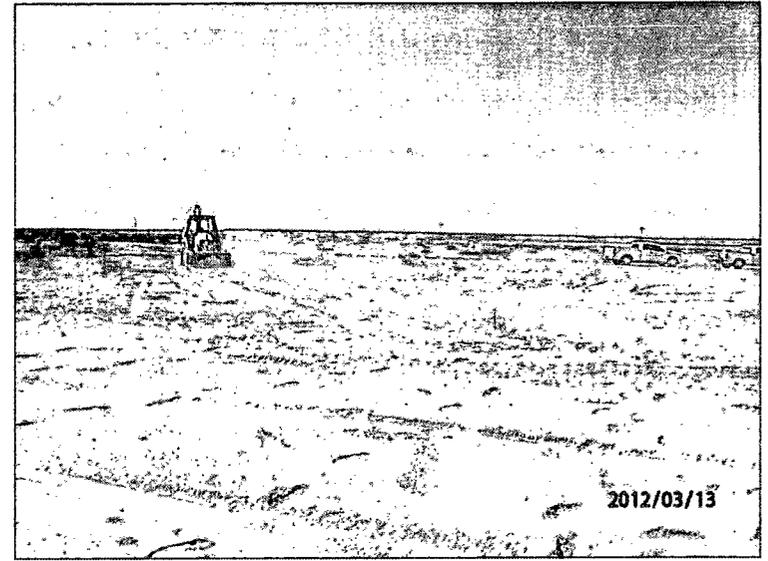
Contouring site to the surrounding area, facing north-west 3/13/12

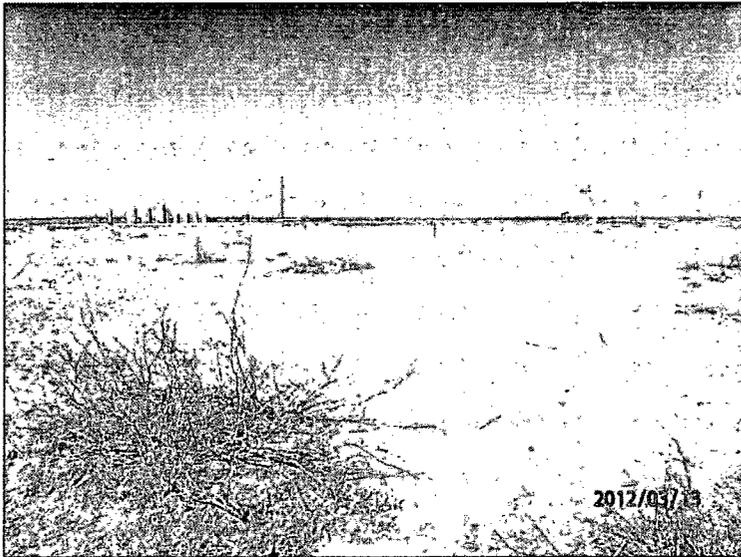
Site completed, facing northeast 3/13/12
