Bluestem Energy Holdings, LLC.

Flint-2

**Township 19 South, Range 25 East, Section 25
Eddy County New Mexico**

Closure Report

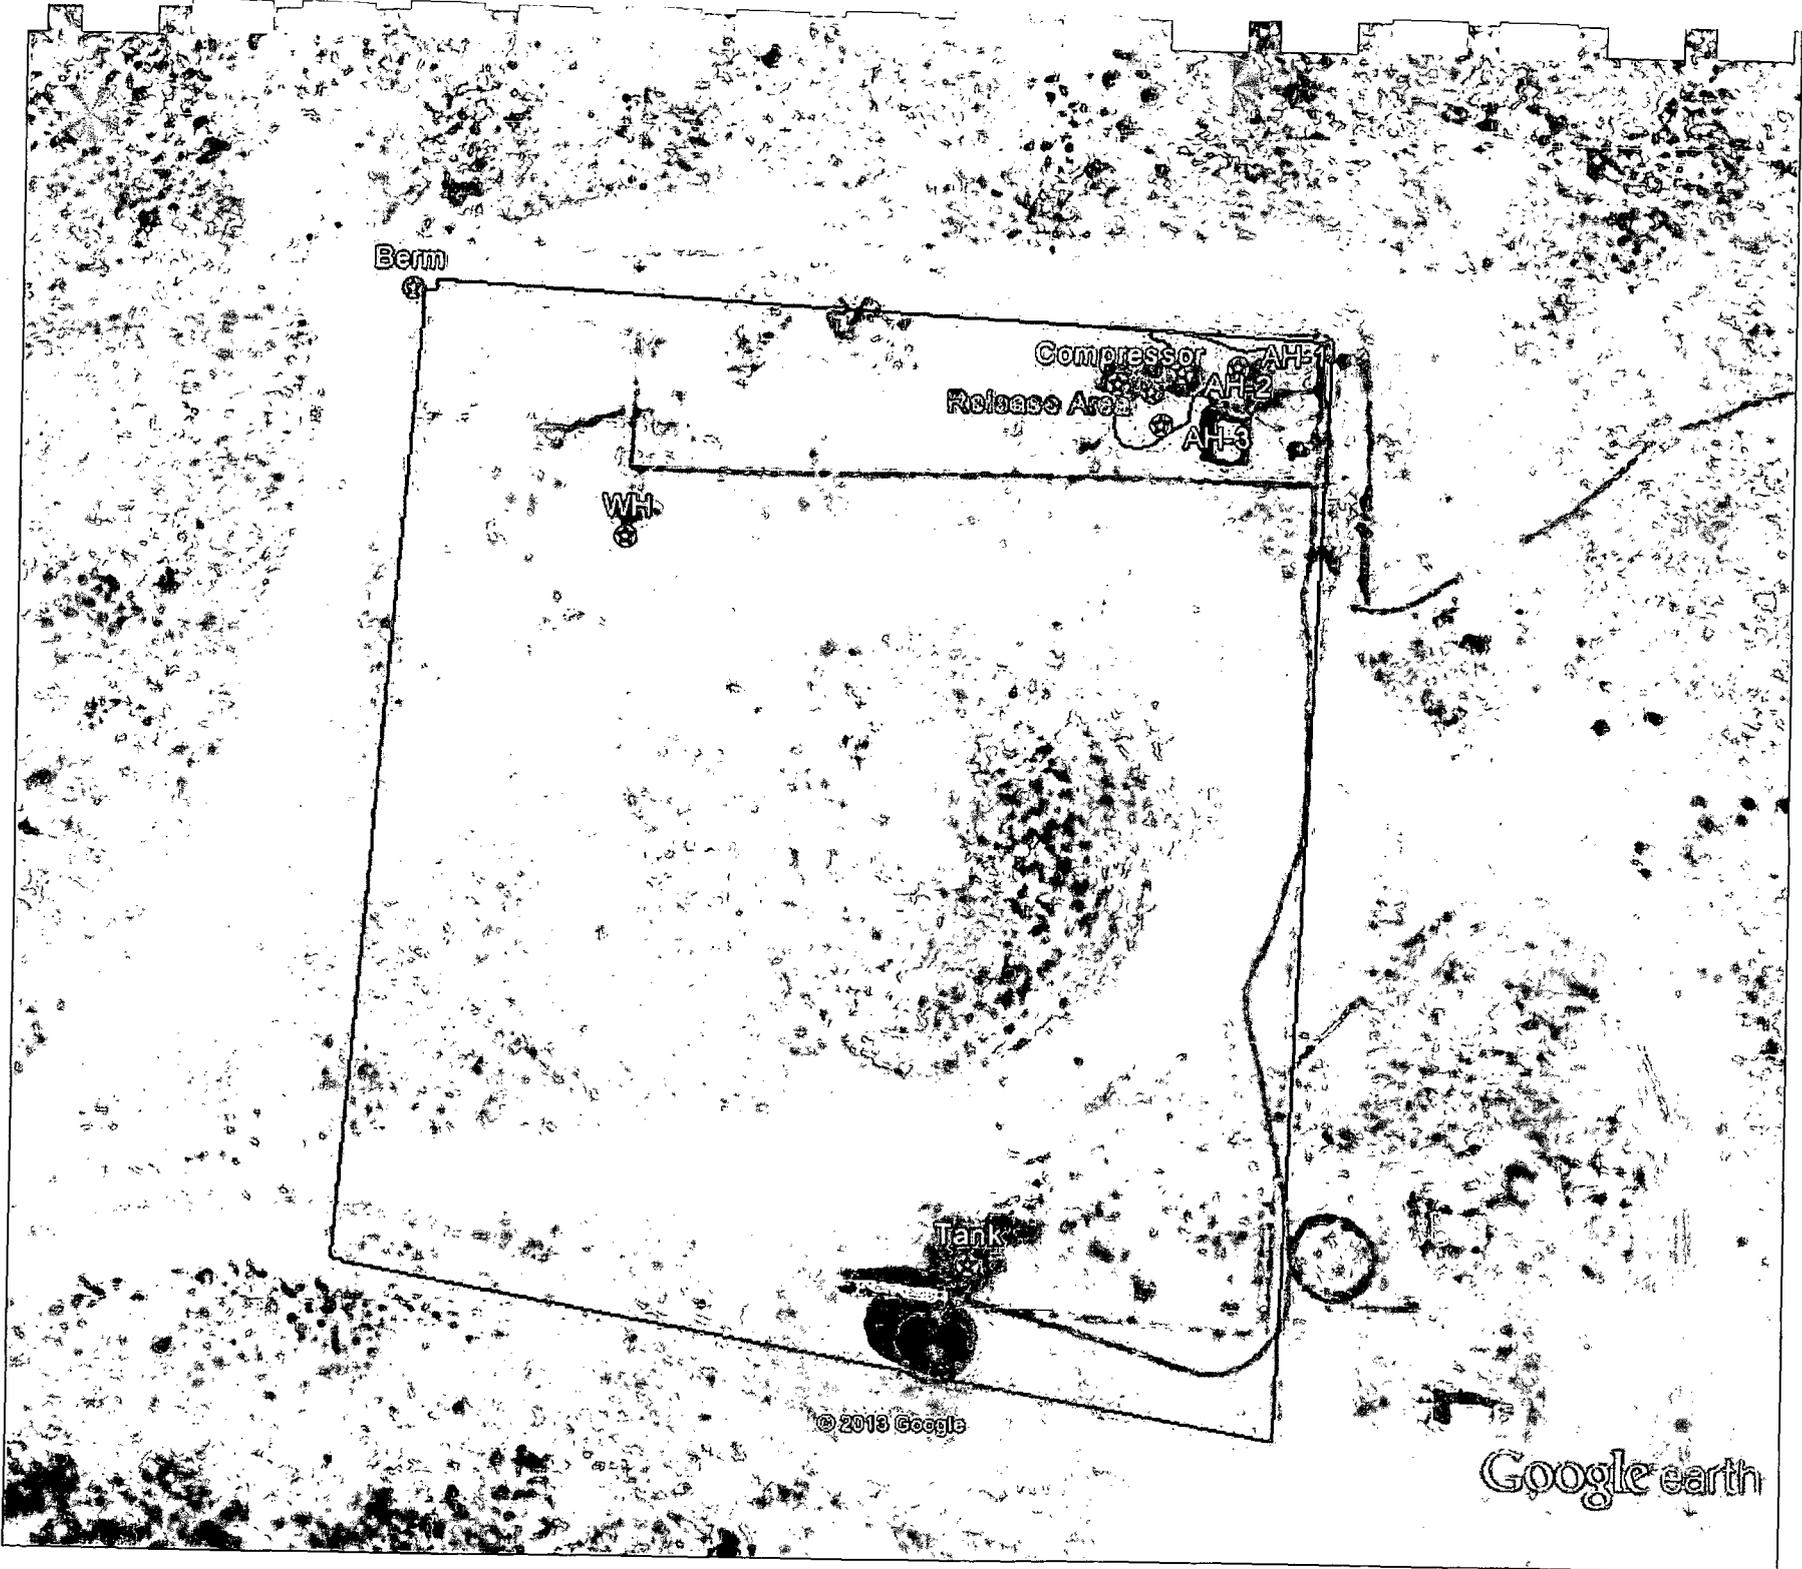
Figure 2
Site Map

On February 27, 2013, Mr. Bob Allen, SESI representative was onsite to assess the impacted area. Mr. Allen observed spray from the compressor traveling northeast of location approximately 360 ft., with no pooling areas. Site photographs were obtained of the impacted area.

Compressor
Release Area

AH-1
AH-2
AH-3

On March 5, 2013, SESI was onsite at the Bluestem Energy Flint #2 to obtain soil samples of the release area near the compressor. Back hoe and Roustabout crew of three were onsite excavating the release area removing all the staining to one and a half foot in depth. Three (3) auger holes were installed at a depth of two (2) ft. and soil samples were retrieved at that depth. The excavated soils were transported to an NMOCD approved facility for disposal.

On March 8, 2013, SESI arrived at the Bluestem Flint #2 and set up equipment and divided the impacted spray area into three sections using white pin flags. The micro blaze application was applied on the impacted area. The results of the final sampling show all TPH levels to be below the target level of 1,000 ppm therefore, the excavation was backfilled with clean soils contoured to match the surrounding area.

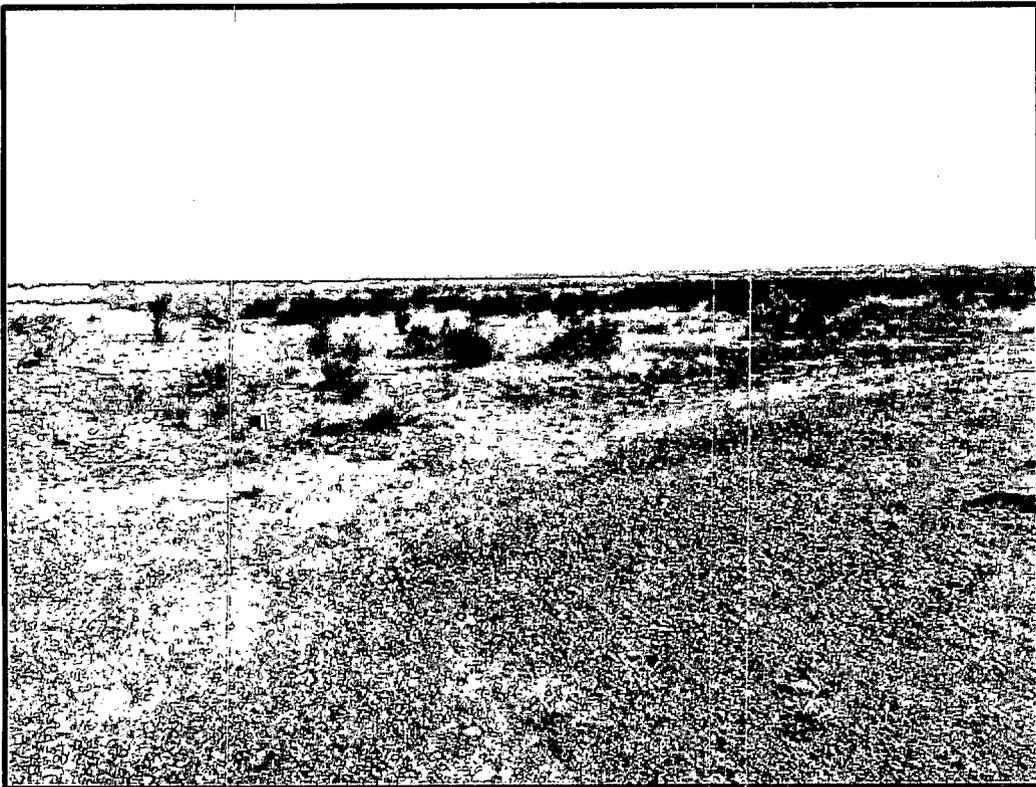
Impacted area looking Northeast

According to Mr. Mike Bratcher, NMOCD Artesia representative, and Mr. Allen's onsite conversation, a Micro blaze application will be applied over the entire impacted vegetation.

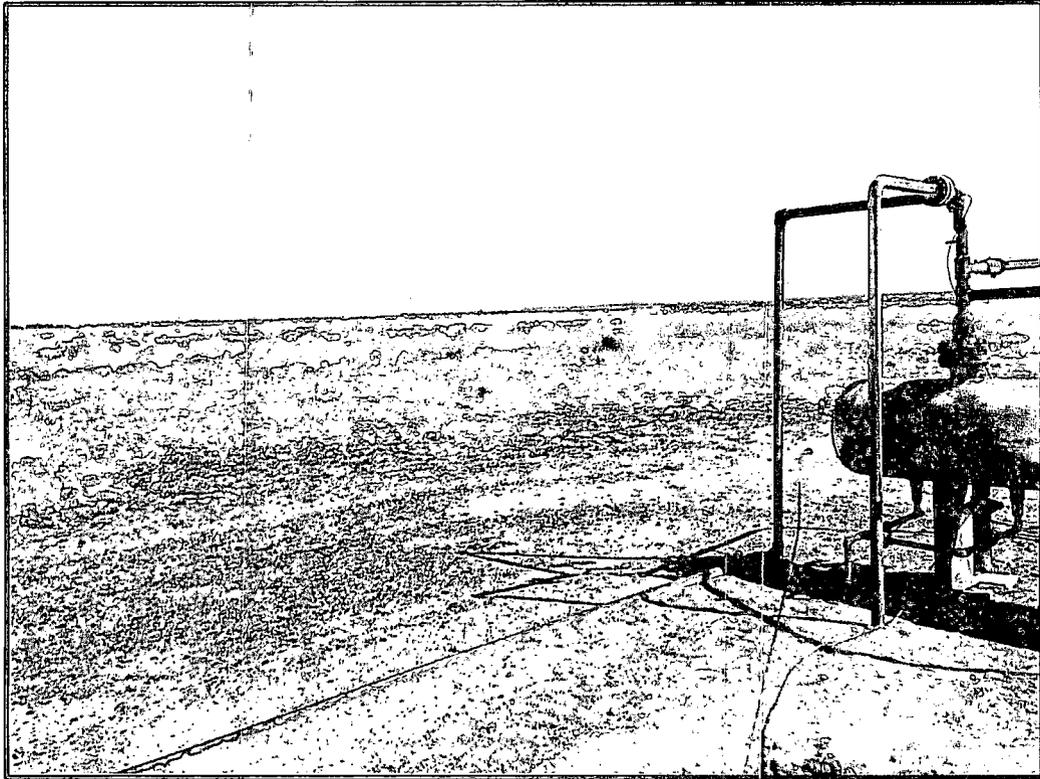
Impacted area looking Northeast

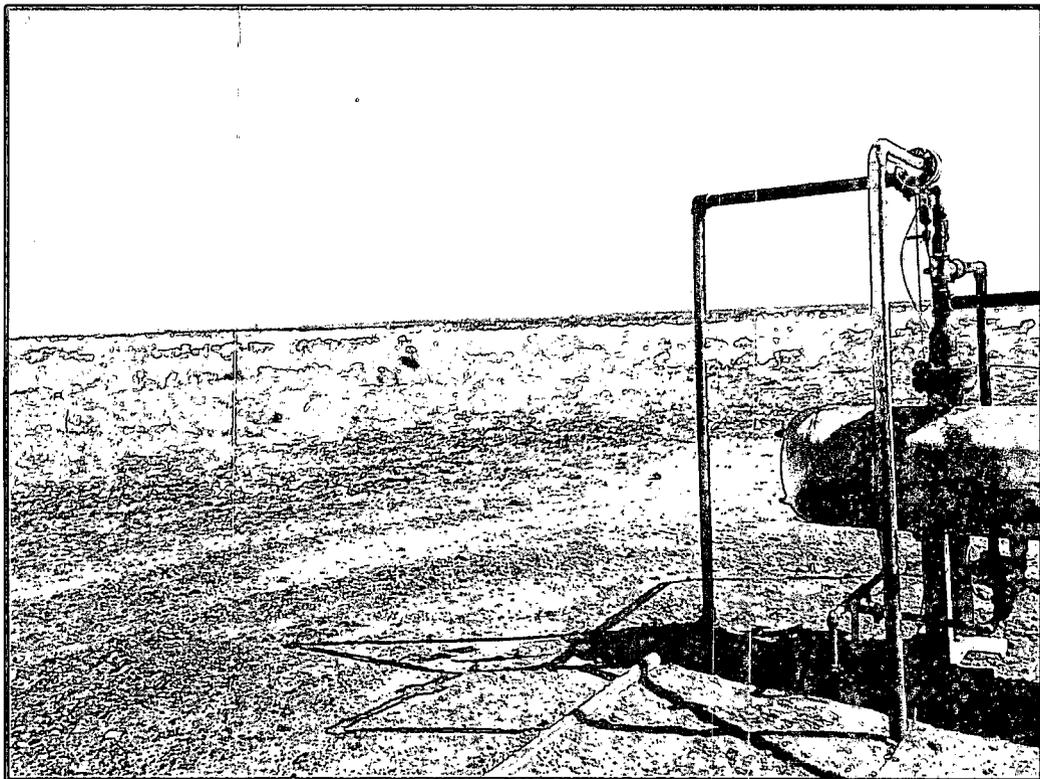
Impacted area looking Northeast

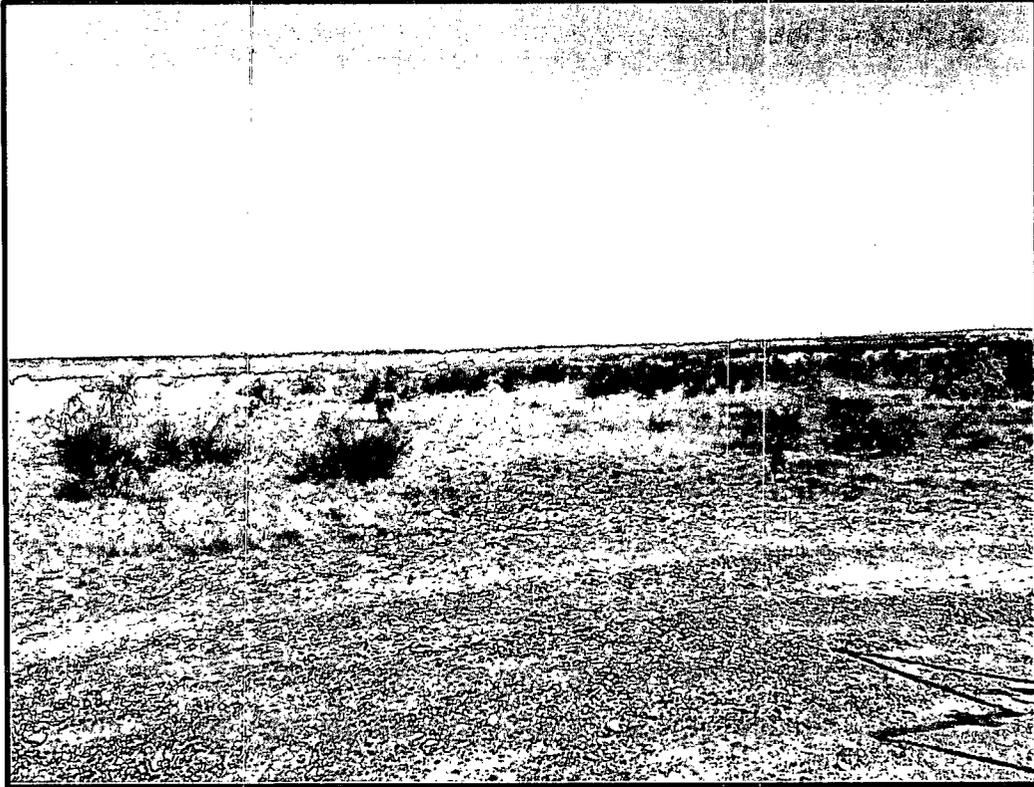
Impacted area looking Northeast

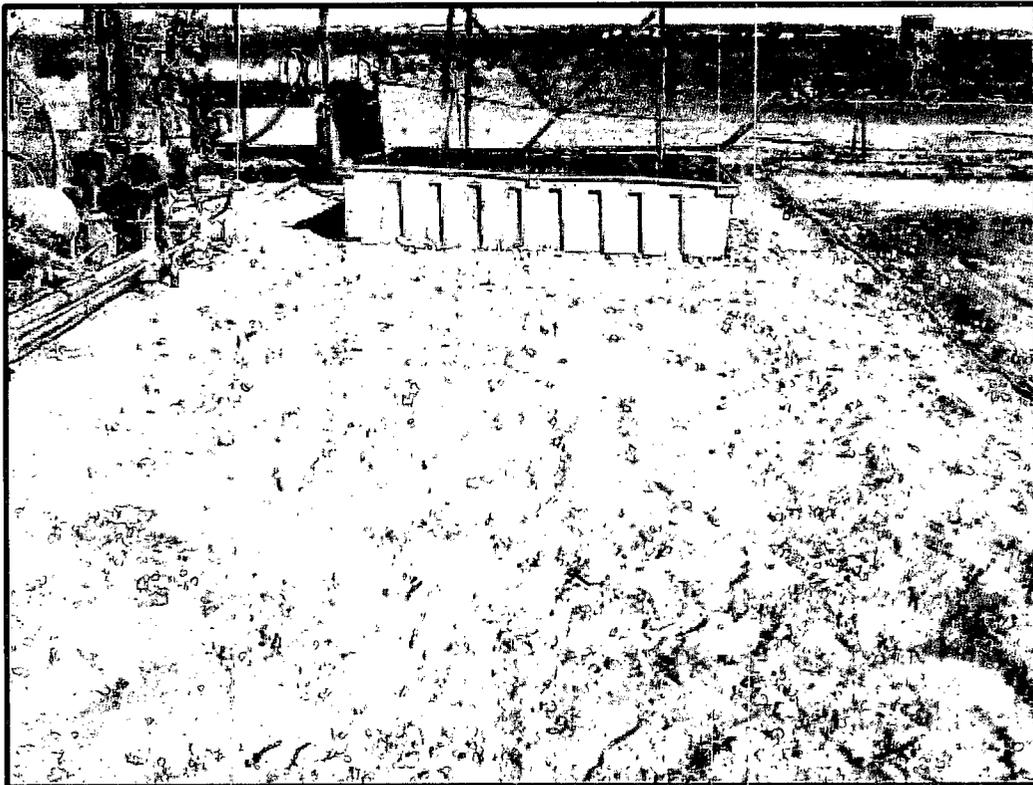
Excavated area backfilled facing East

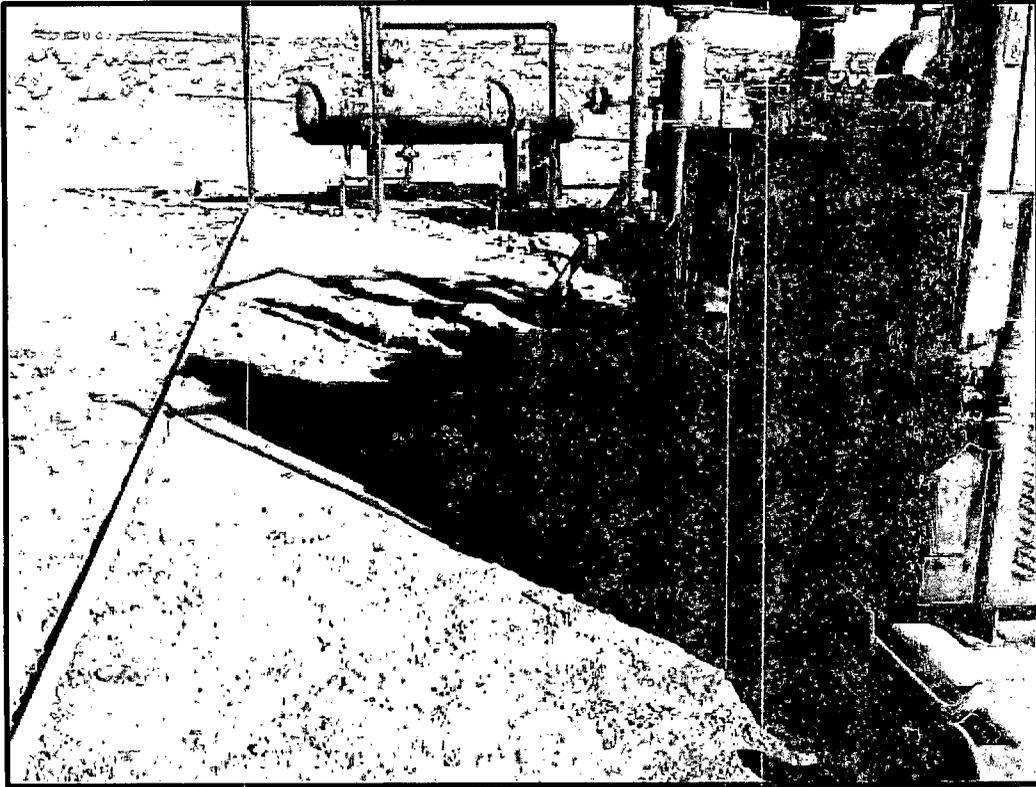
Excavated area backfilled facing East

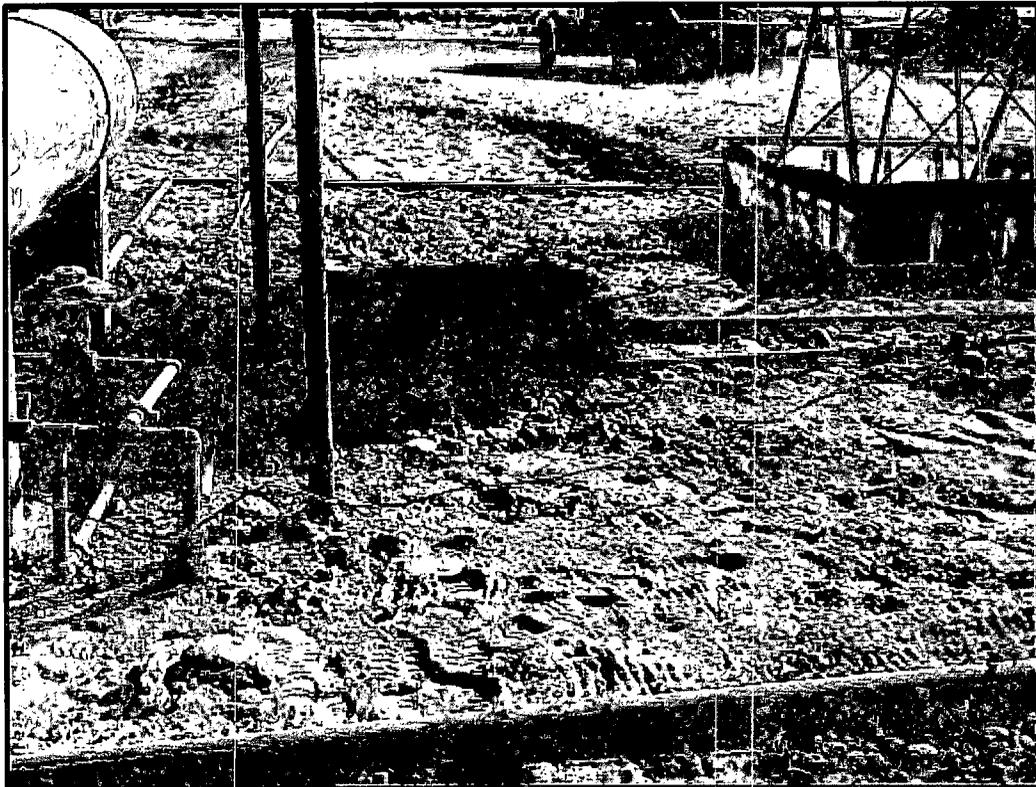
Excavated area backfilled facing South
