**Holly Energy Partners  
T #2 Release  
Section 15, Township 20S, Range 28E  
Eddy County, New Mexico**

**Closure Report**

**March 15, 2010**

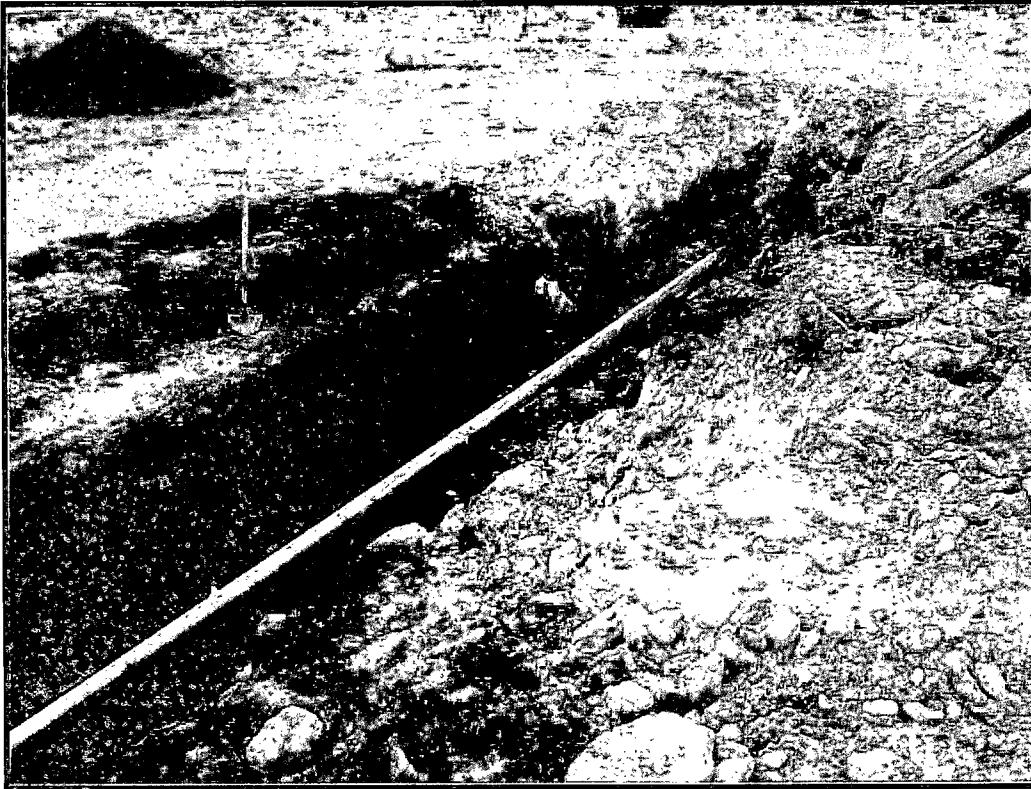
Release area facing east

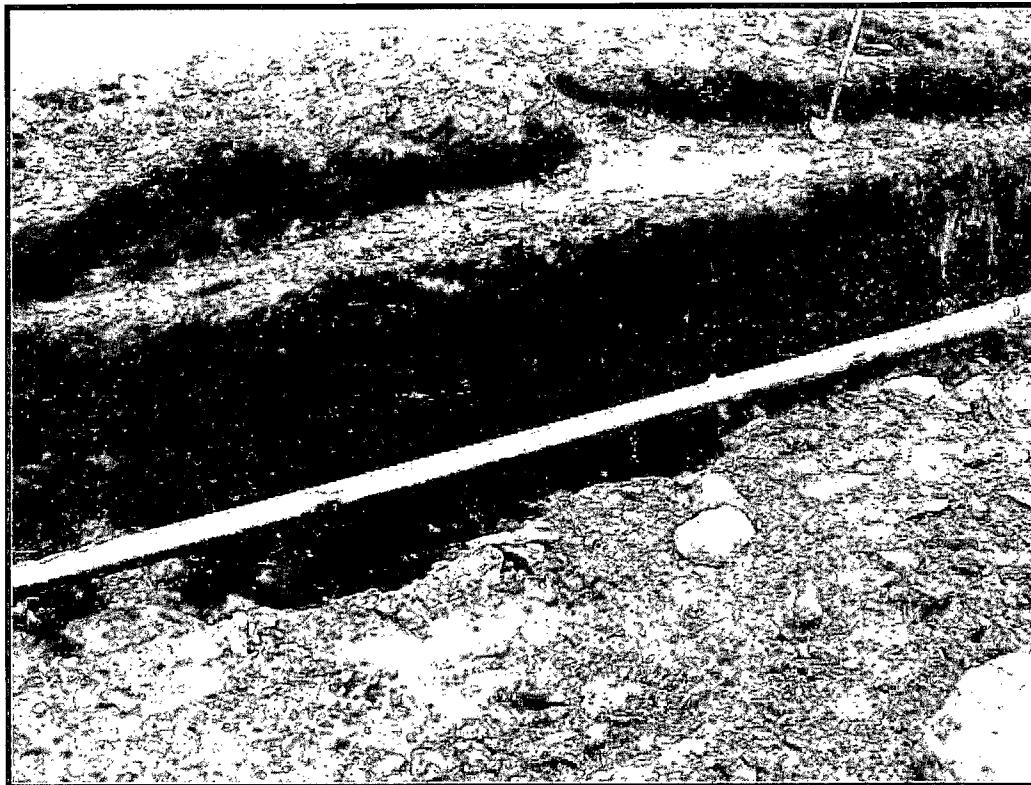
North wall of release area facing north

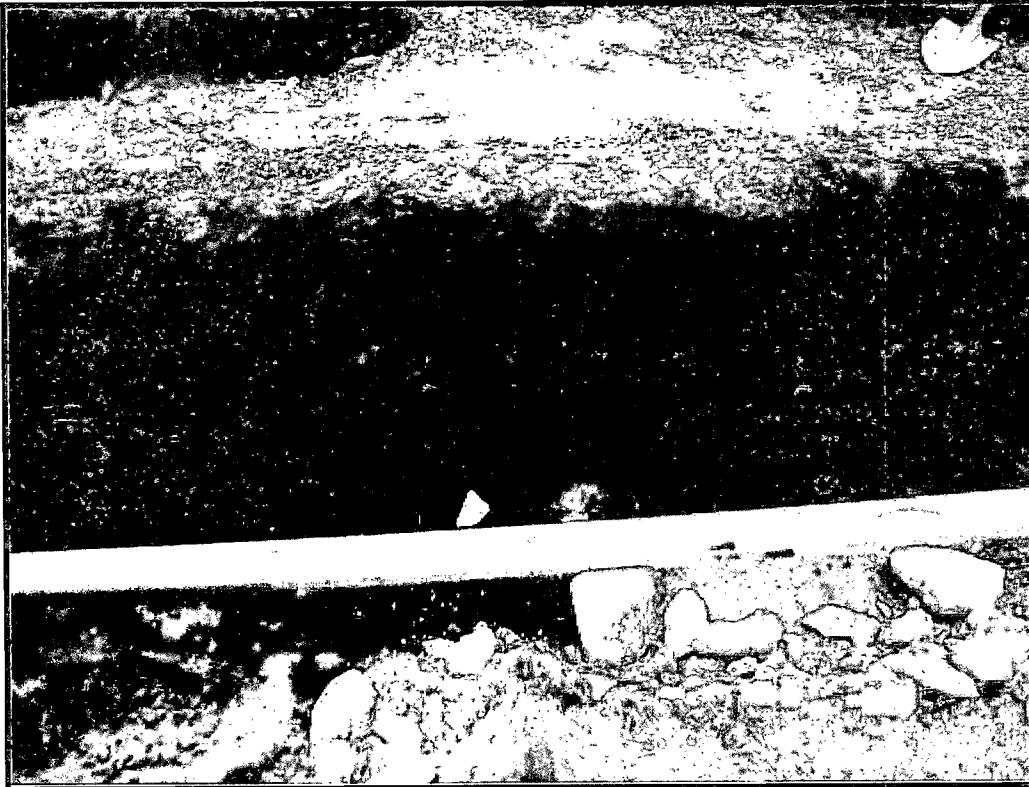
North wall of release area facing north

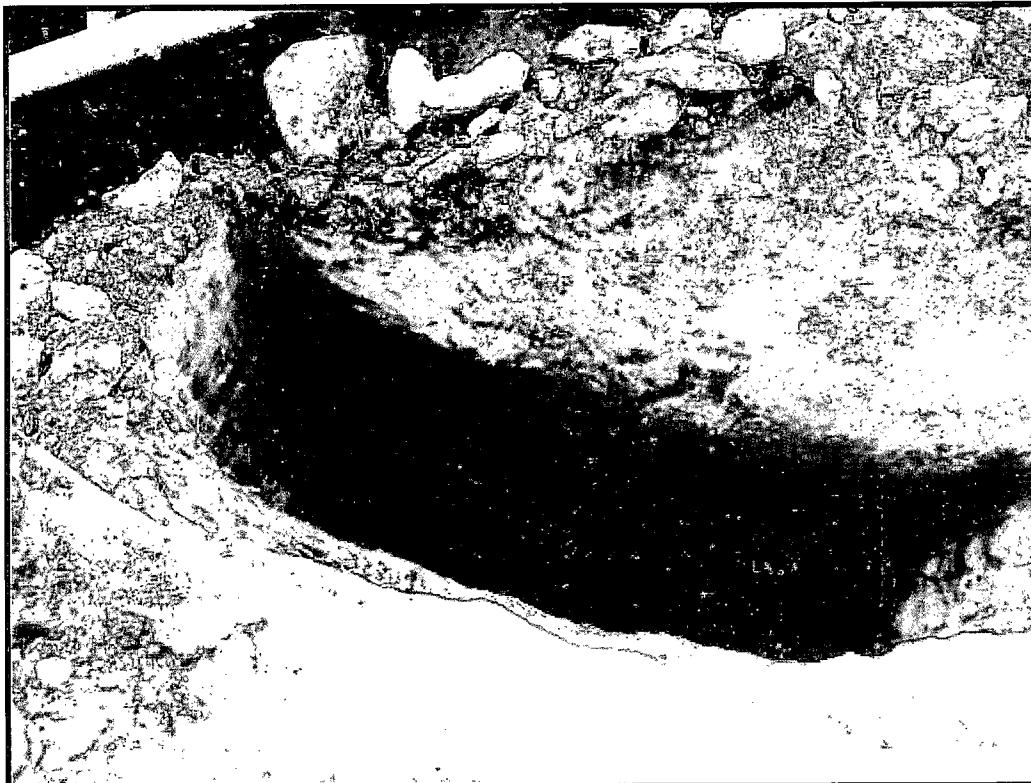
Test Trench at 9'bgs facing east

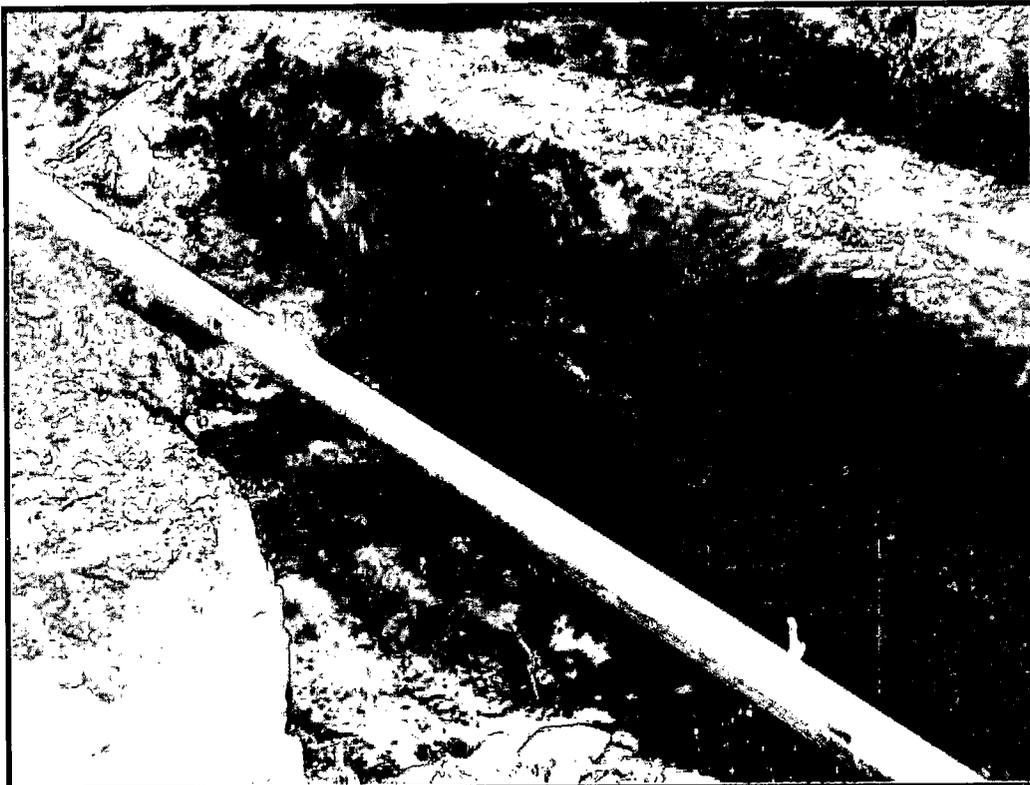
North wall of release area facing northwest

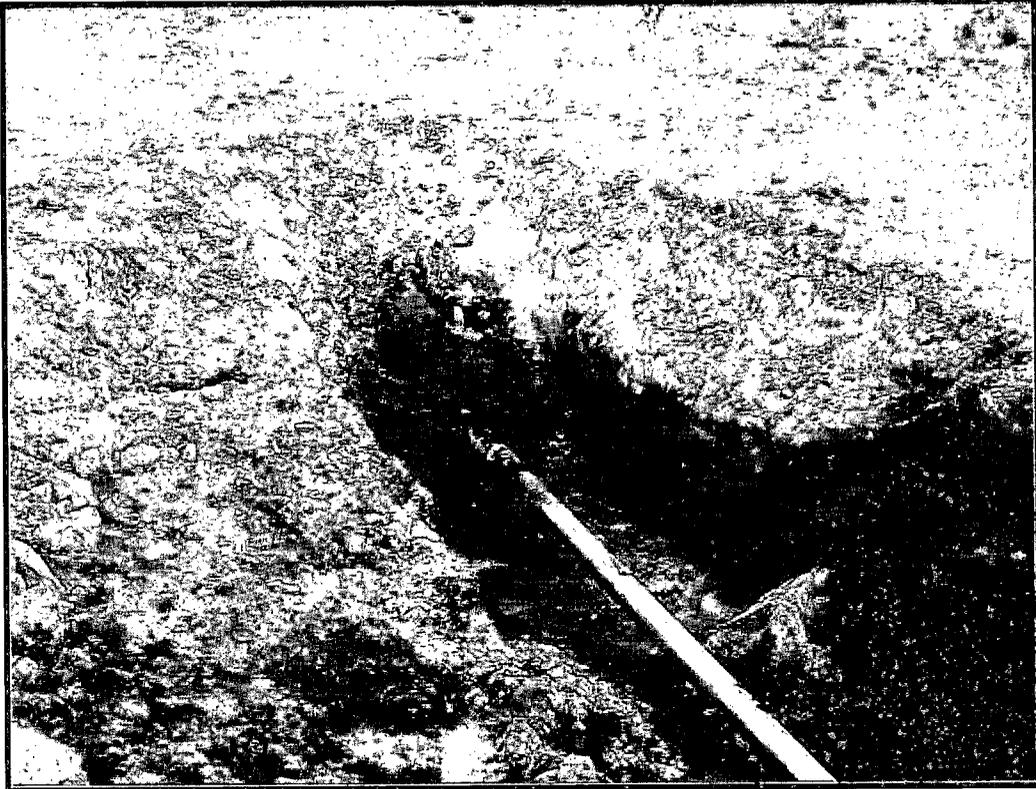
Release area facing west

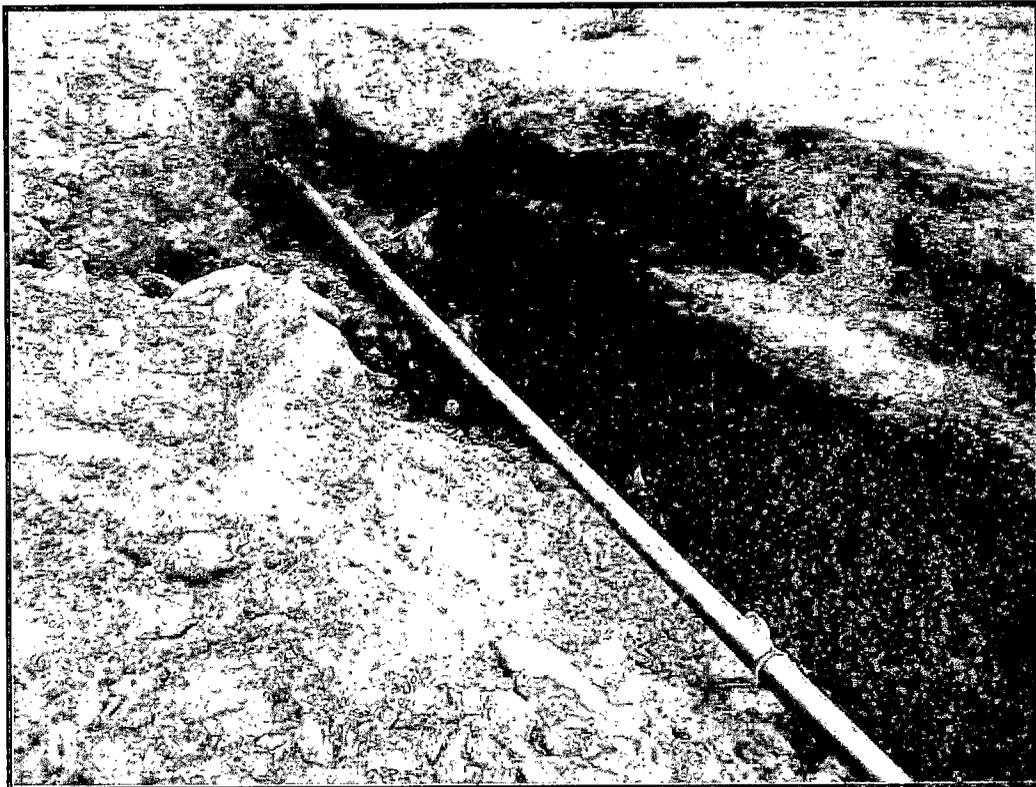
Backfilled test trench facing west

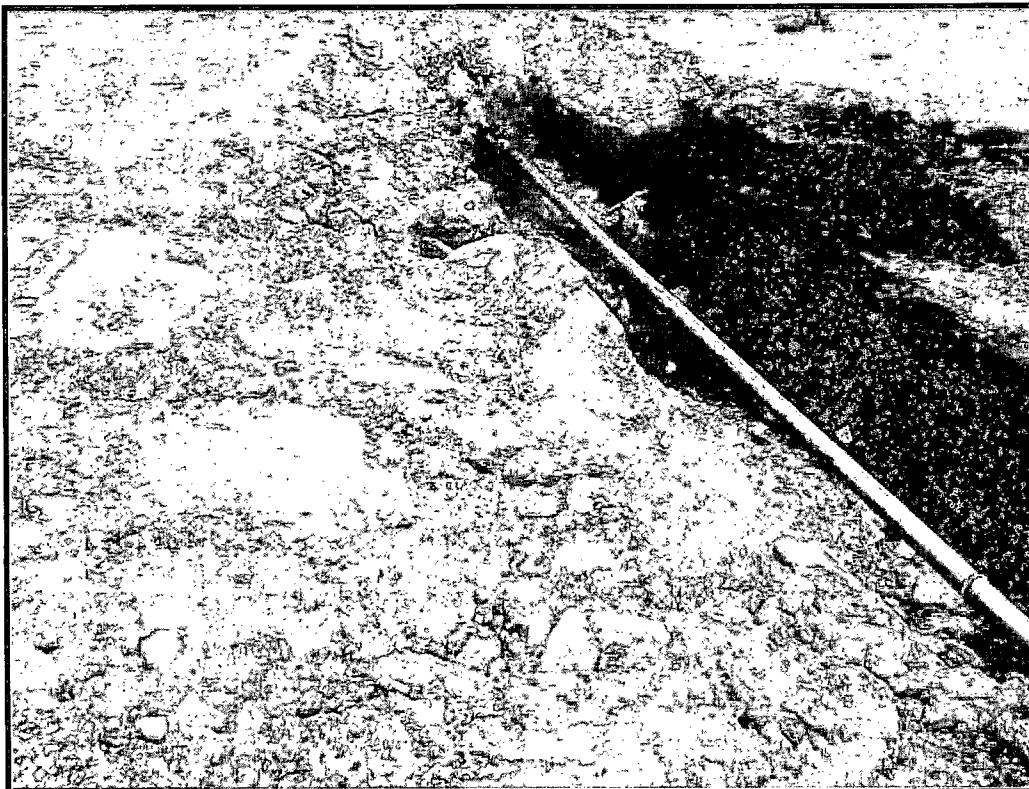
Backfilled test trench facing west

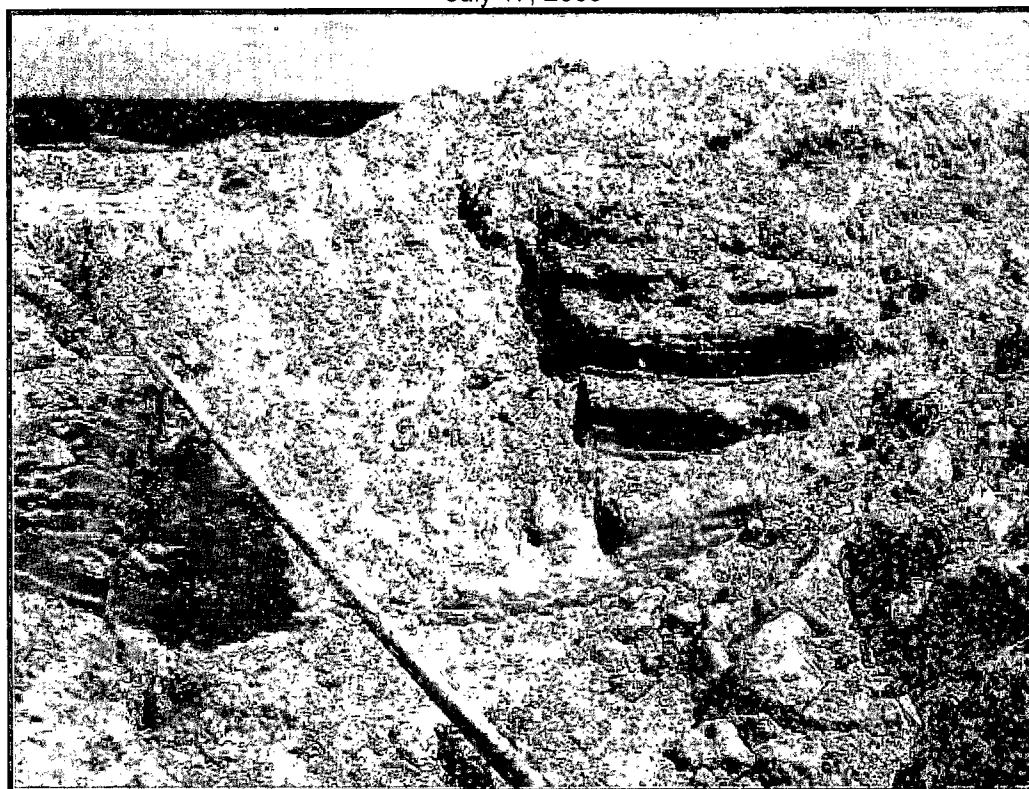
Excavated slope area facing east

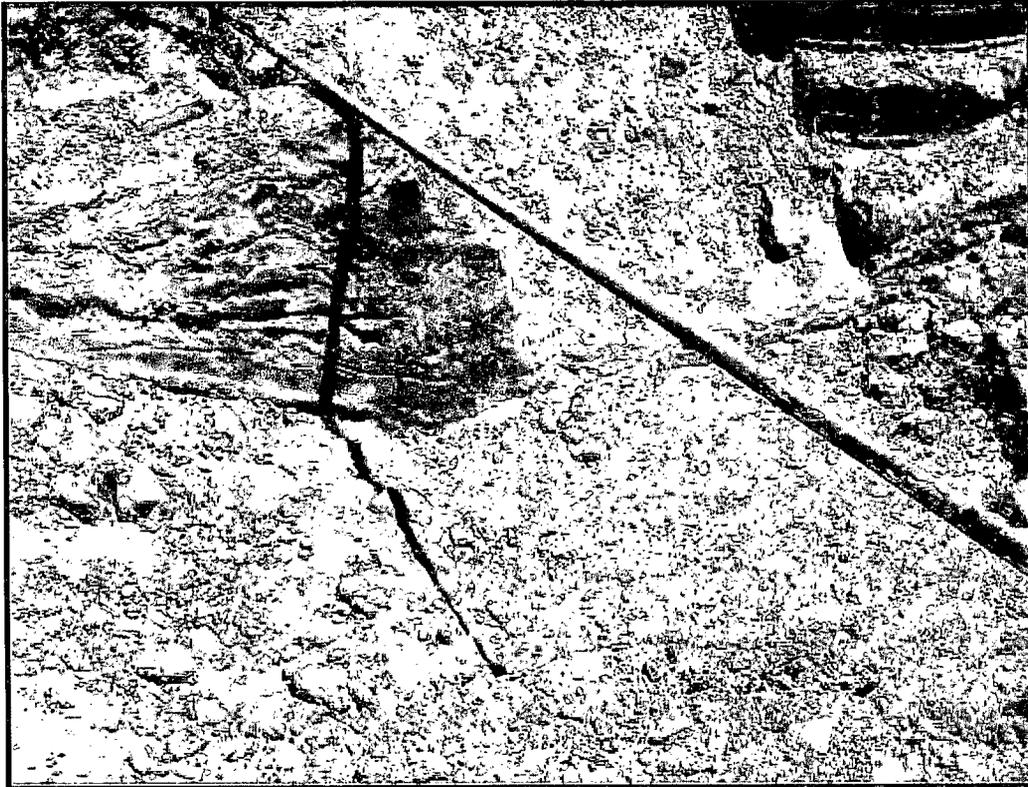
Excavated bottom

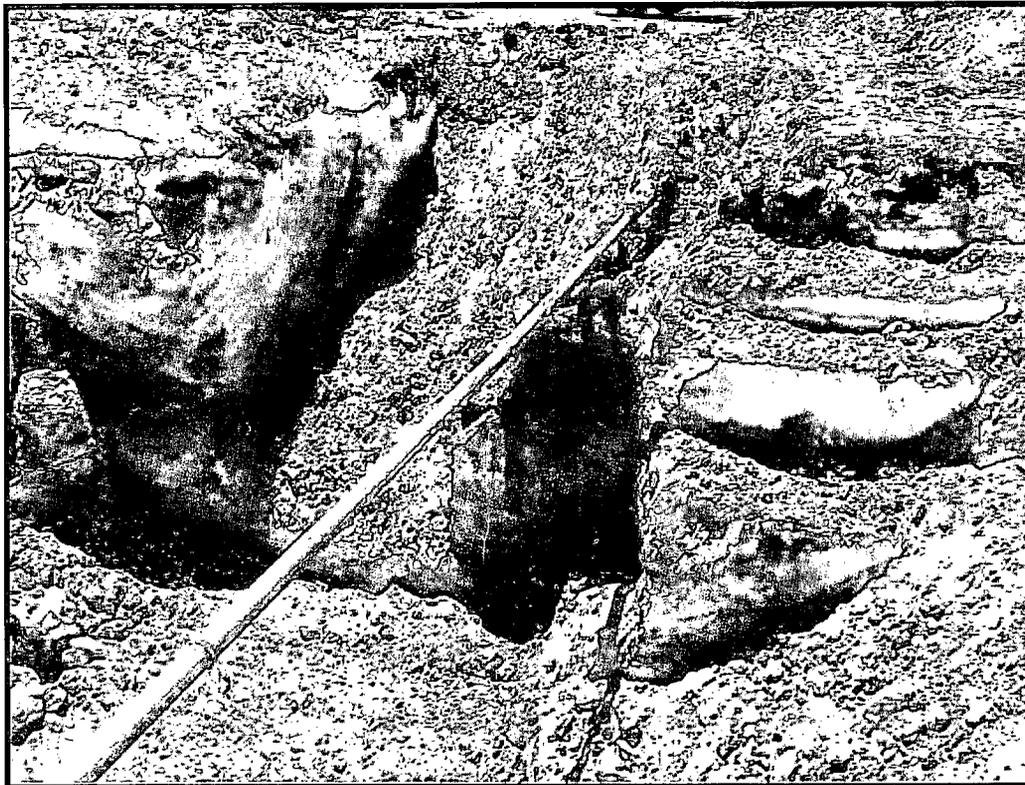
Excavated sloped area facing east

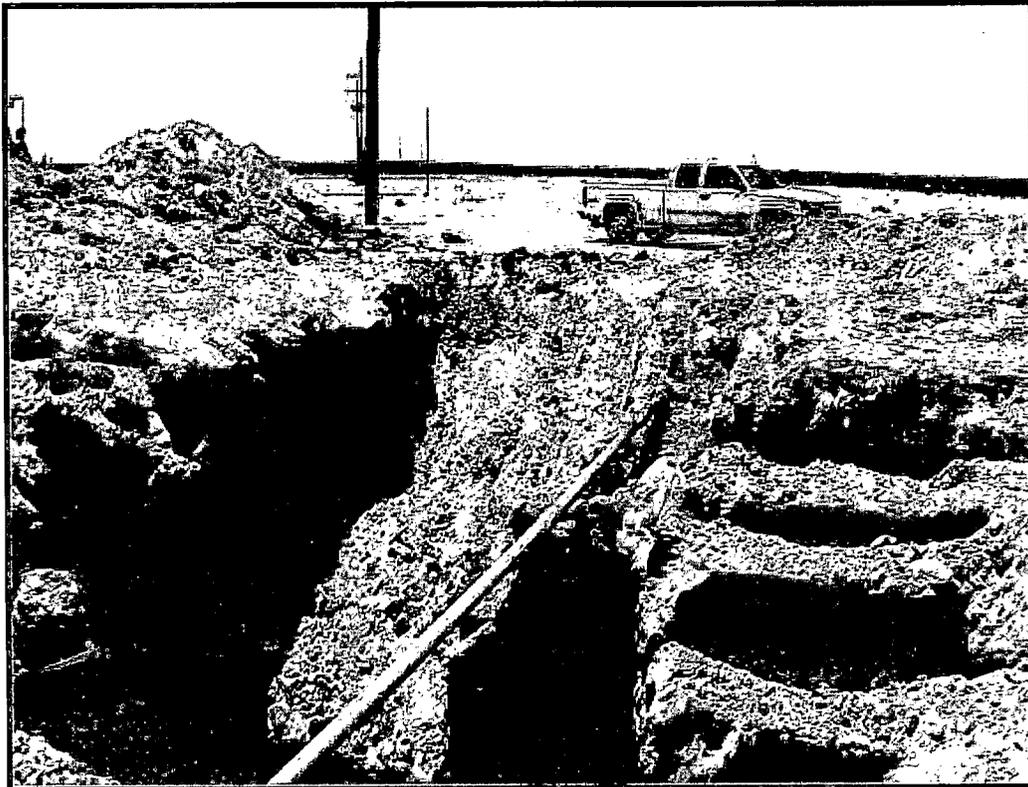
Excavated sloped area facing west

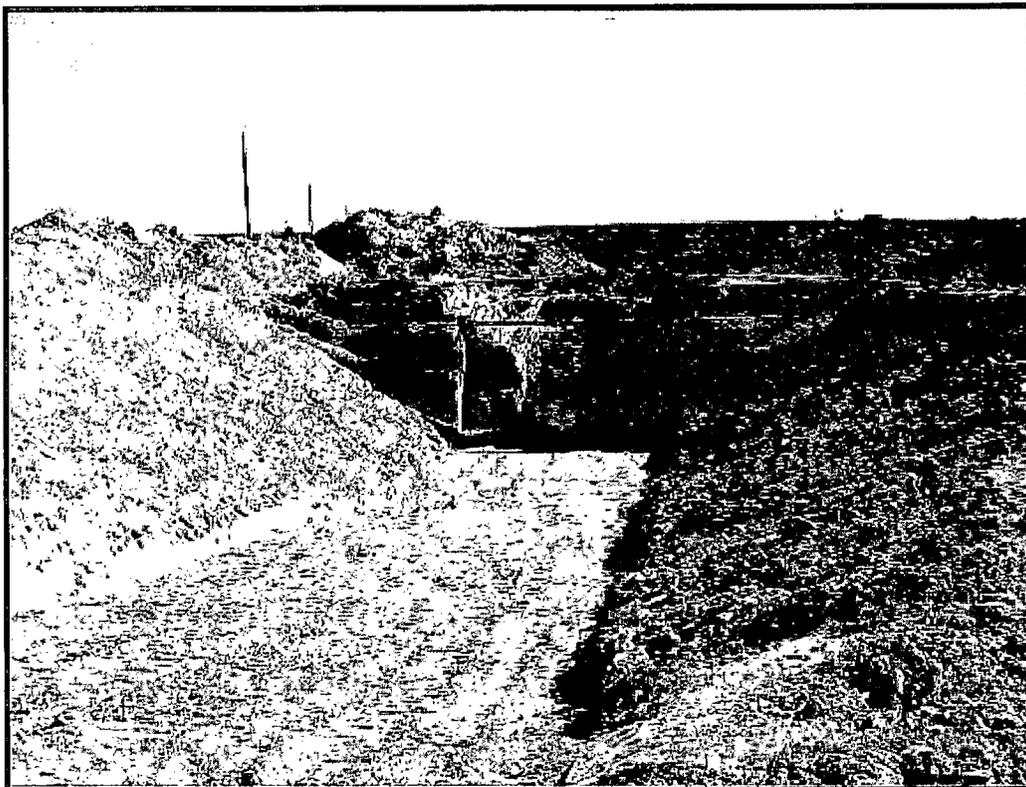
Excavated ramp area facing north

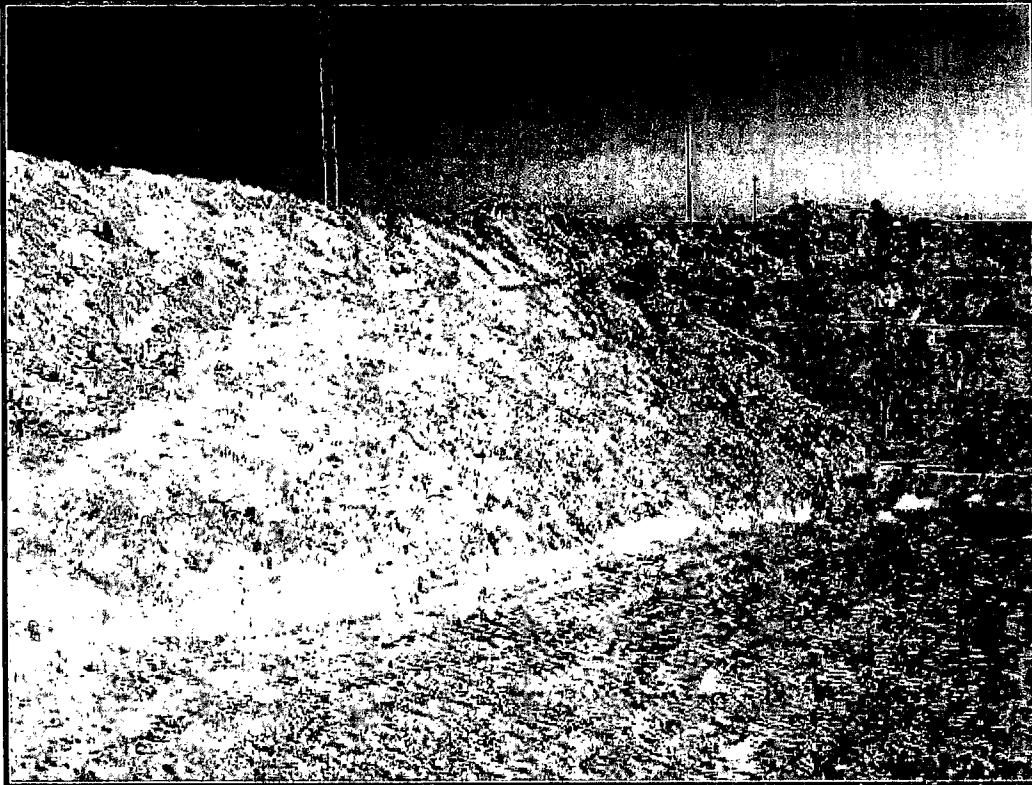
Excavated ramp with slope facing northwest

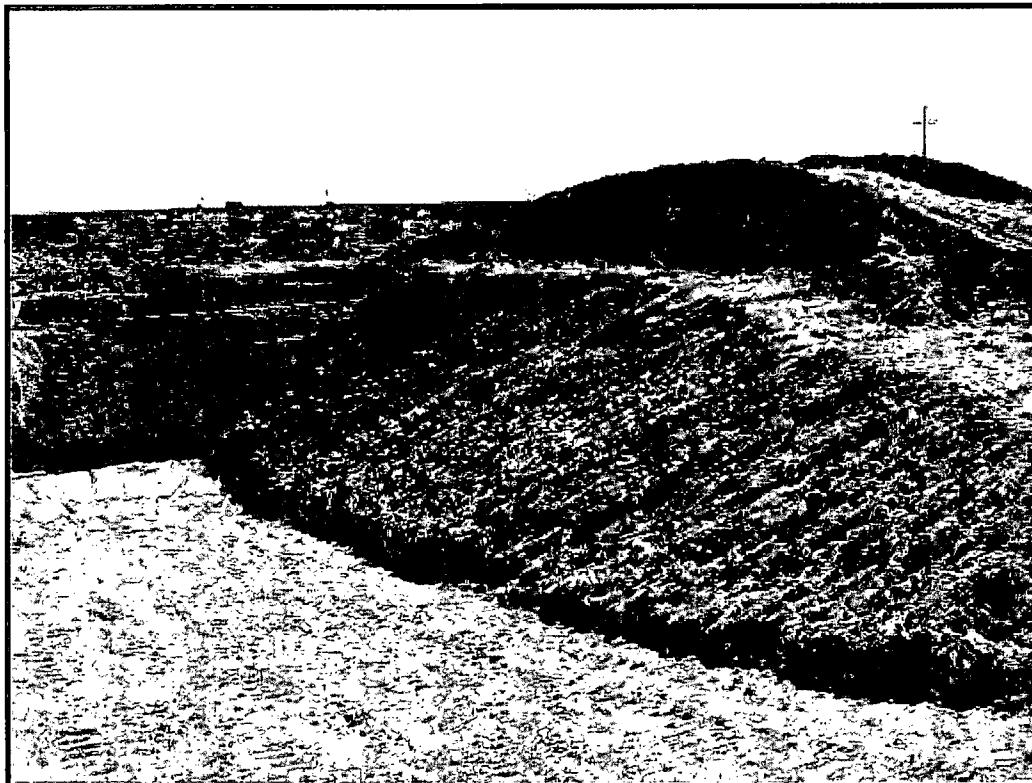
Excavated ramp area with slope facing northeast

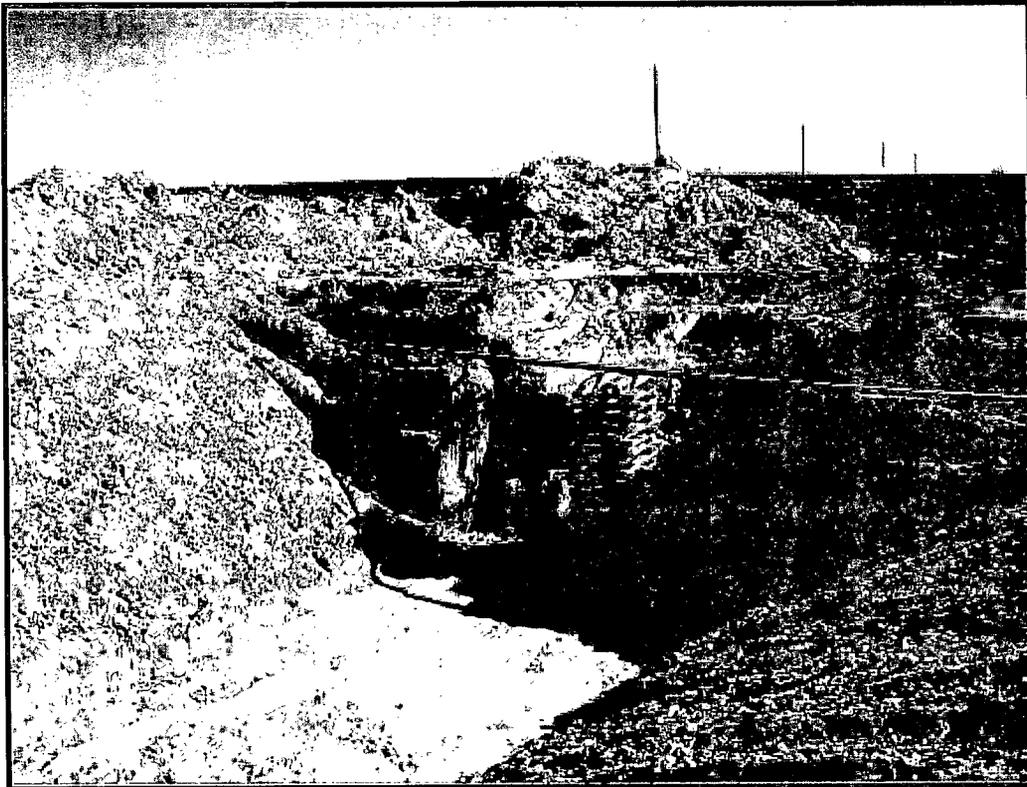
Excavated bottom facing north

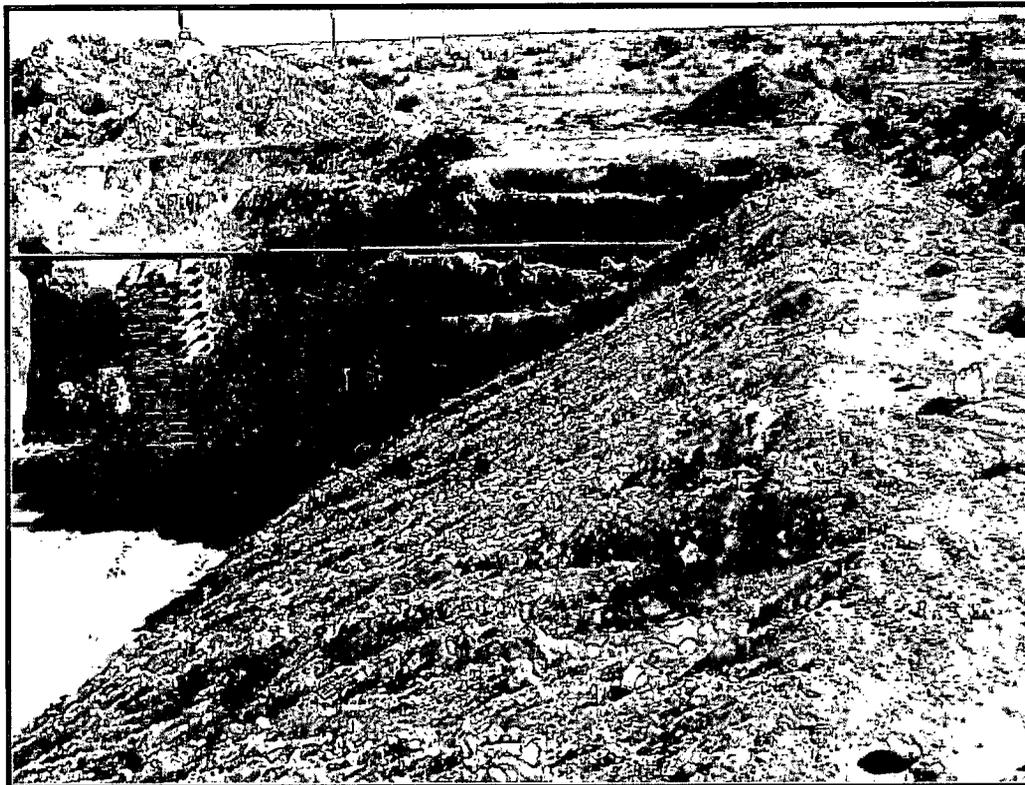
Excavated slope facing north

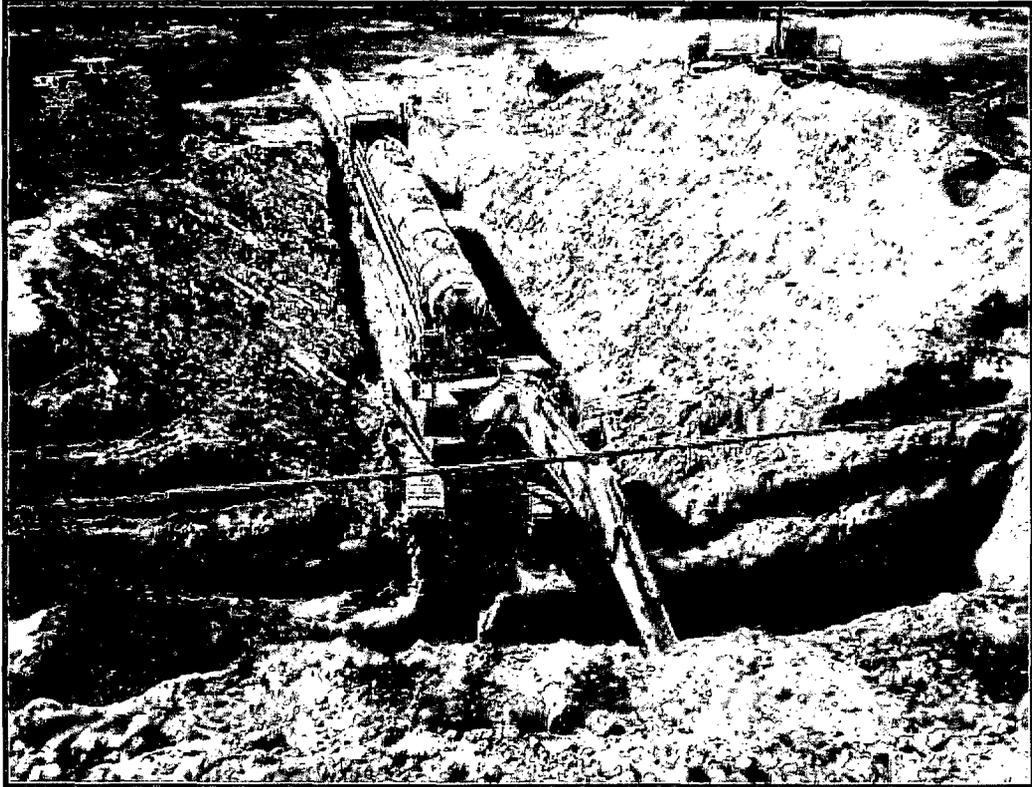
Excavation Facing South

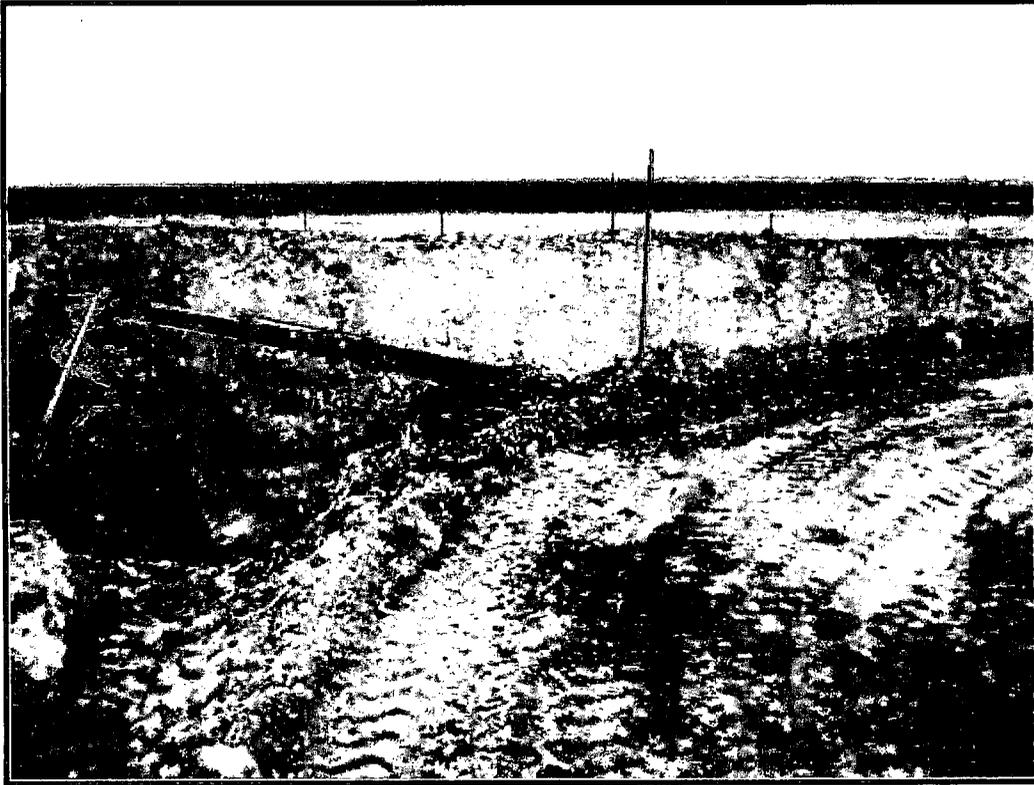
Excavation Facing East

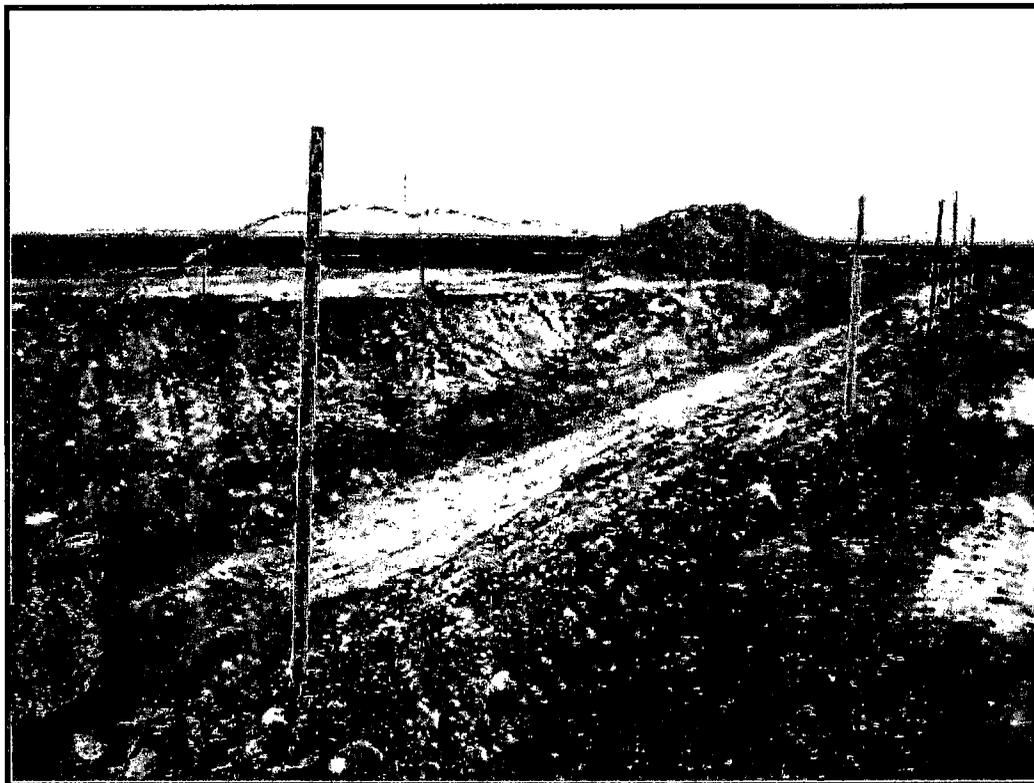
Ramp Facing East

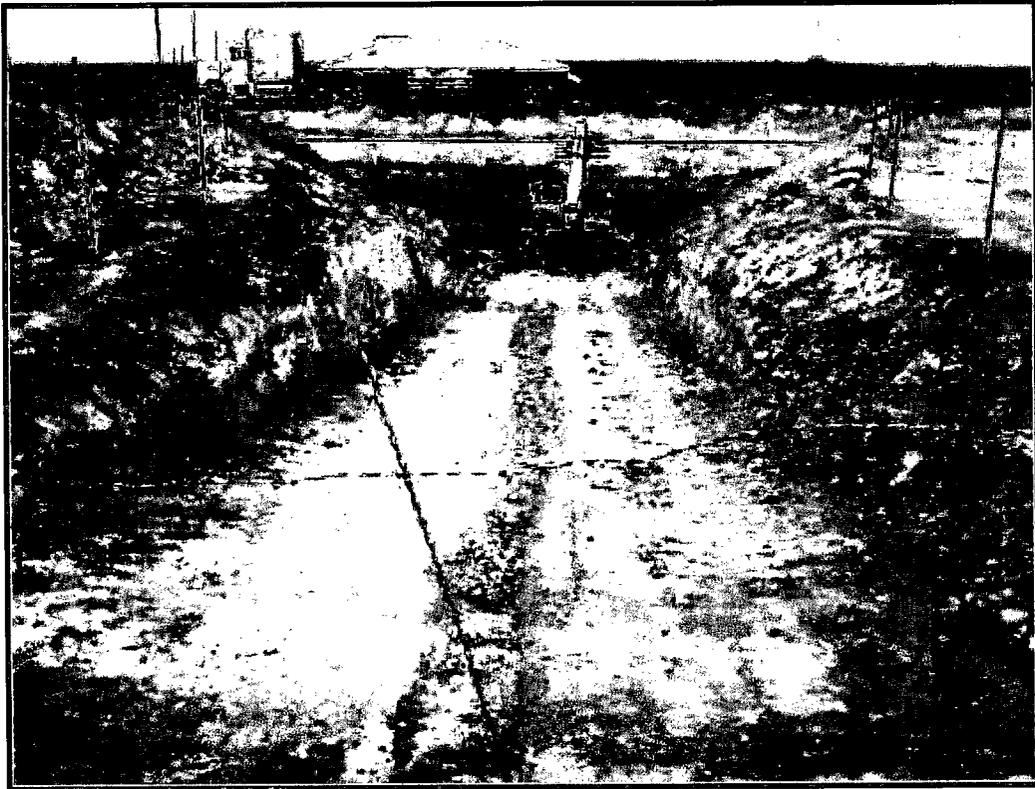
Ramp Facing North

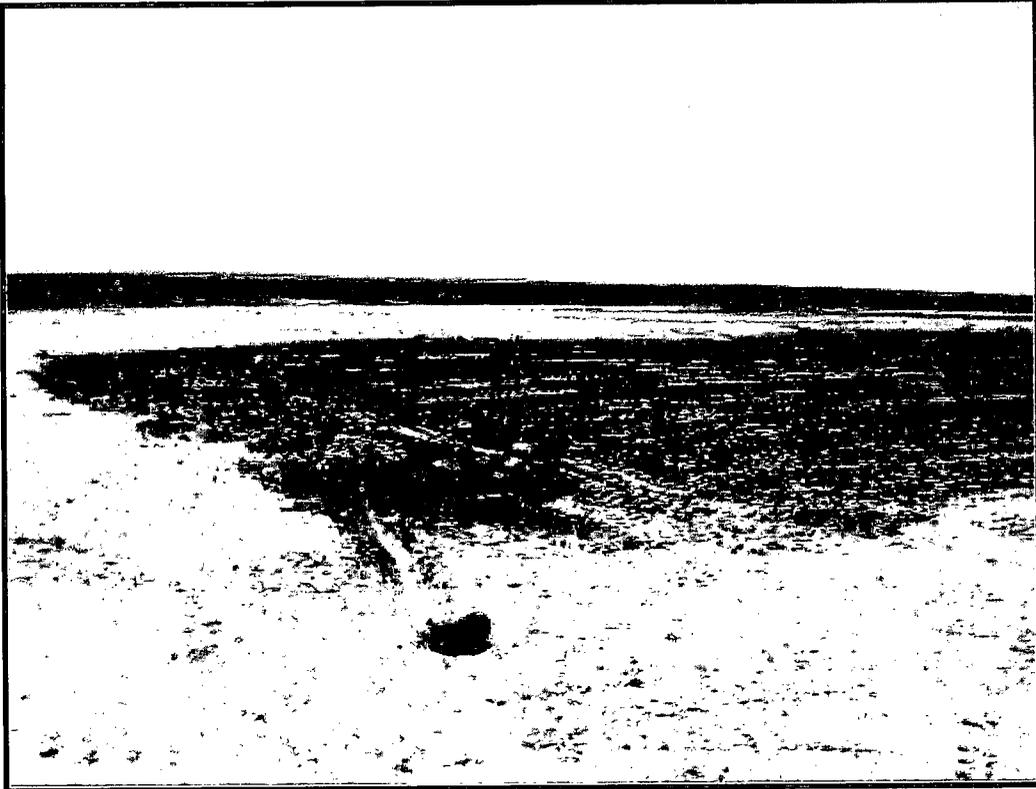
Backfilled Excavation Facing East

The entire area was then backfilled with 3,400 yards of like soils and contoured to natural grade.

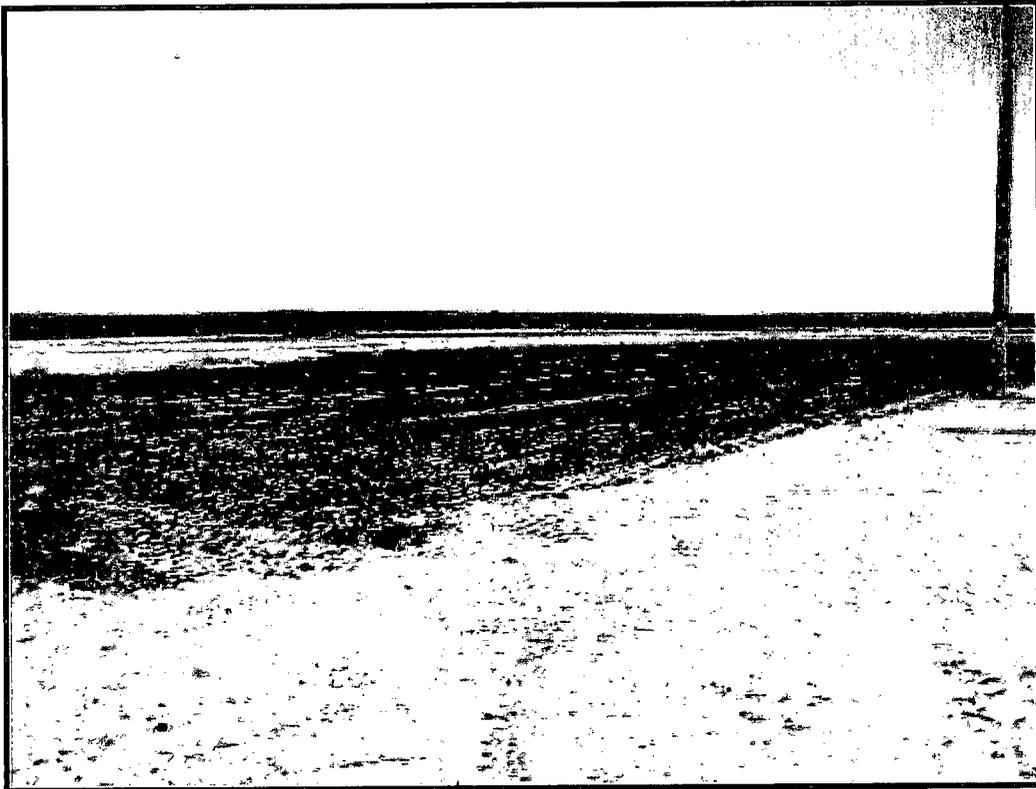
Backfilled Excavation Facing SE

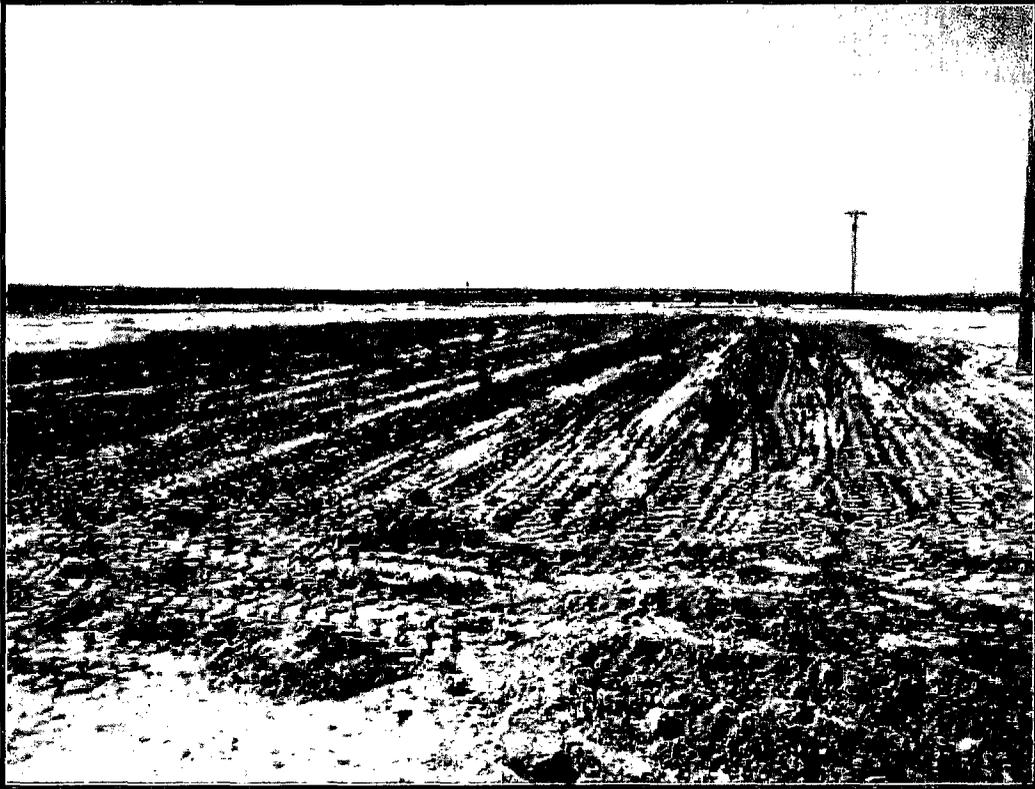
Backfilled Excavation Facing South
