Subject: **Remediation and Closure Report**  
DCP Midstream  
M-27 Line Release  
2RP-1448

DCP Midstream has contracted Talon/LPE (Talon) to perform soil assessment and remediation services at the M-27 Line release. The incident description, soil sampling results, remediation activities and closure request are submitted herein.

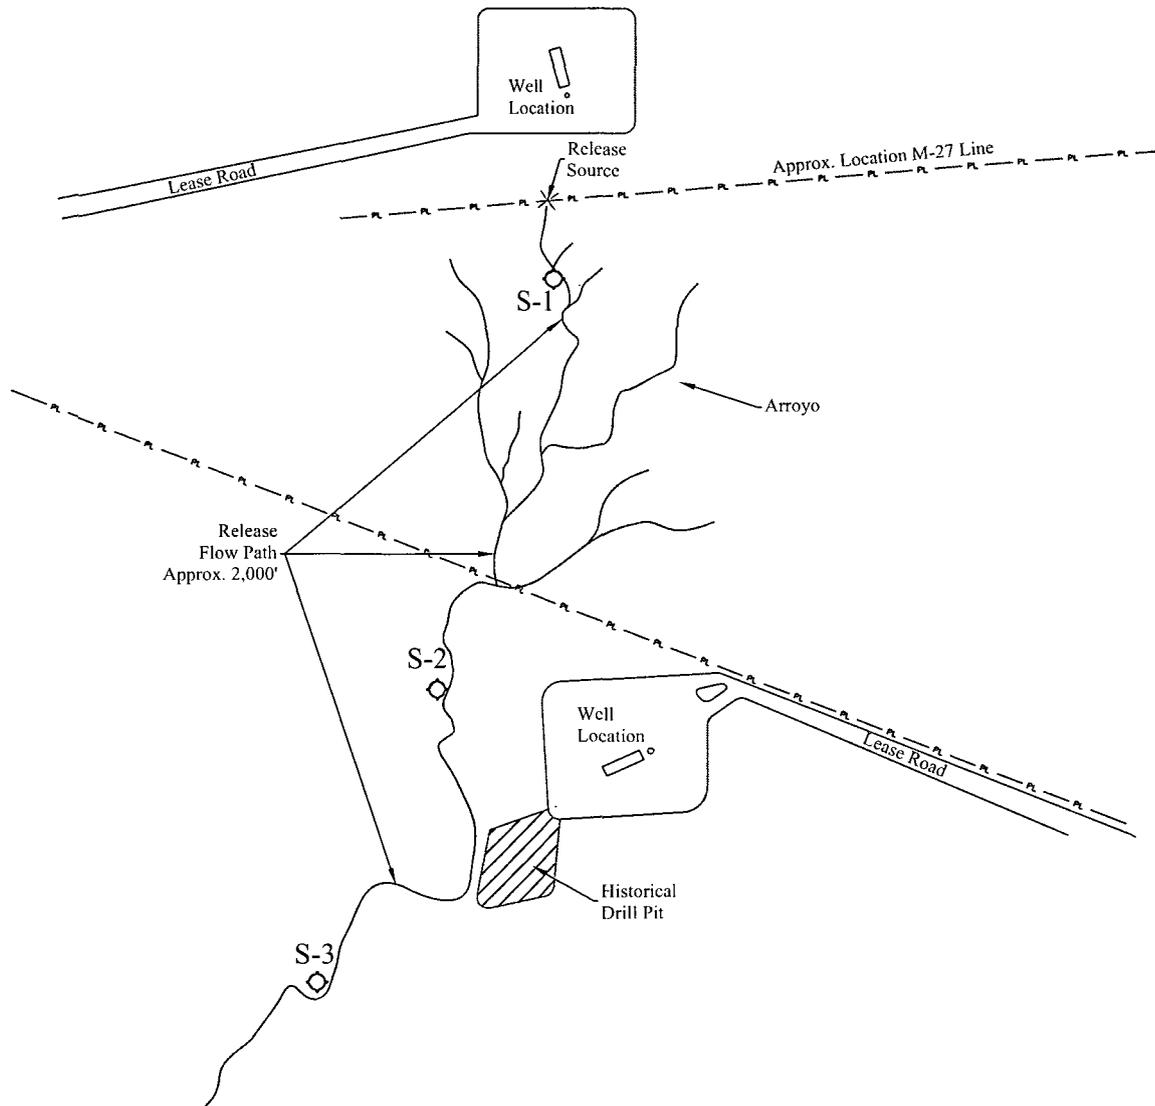
M-27 Flow Line Release  
DCP Midstream, LP  
Eddy County, New Mexico  
Figure 1 - Site Plan

- ◊ - Sample Location
- - - Pipeline
- ~ - Release Flow Path

On December 5, 2012 the M-27 six-inch steel natural gas gathering pipeline was observed to have leaked due to a corroded section of pipe. The pipeline was shut-in and sorbent materials were used to prevent further flow into the arroyo. Approximately 15 barrels of condensate flowed down a gradual slope and into a 10-foot deep dry arroyo, continuing another 2000-foot. A site plan illustrating the impacted area and sample locations is attached.

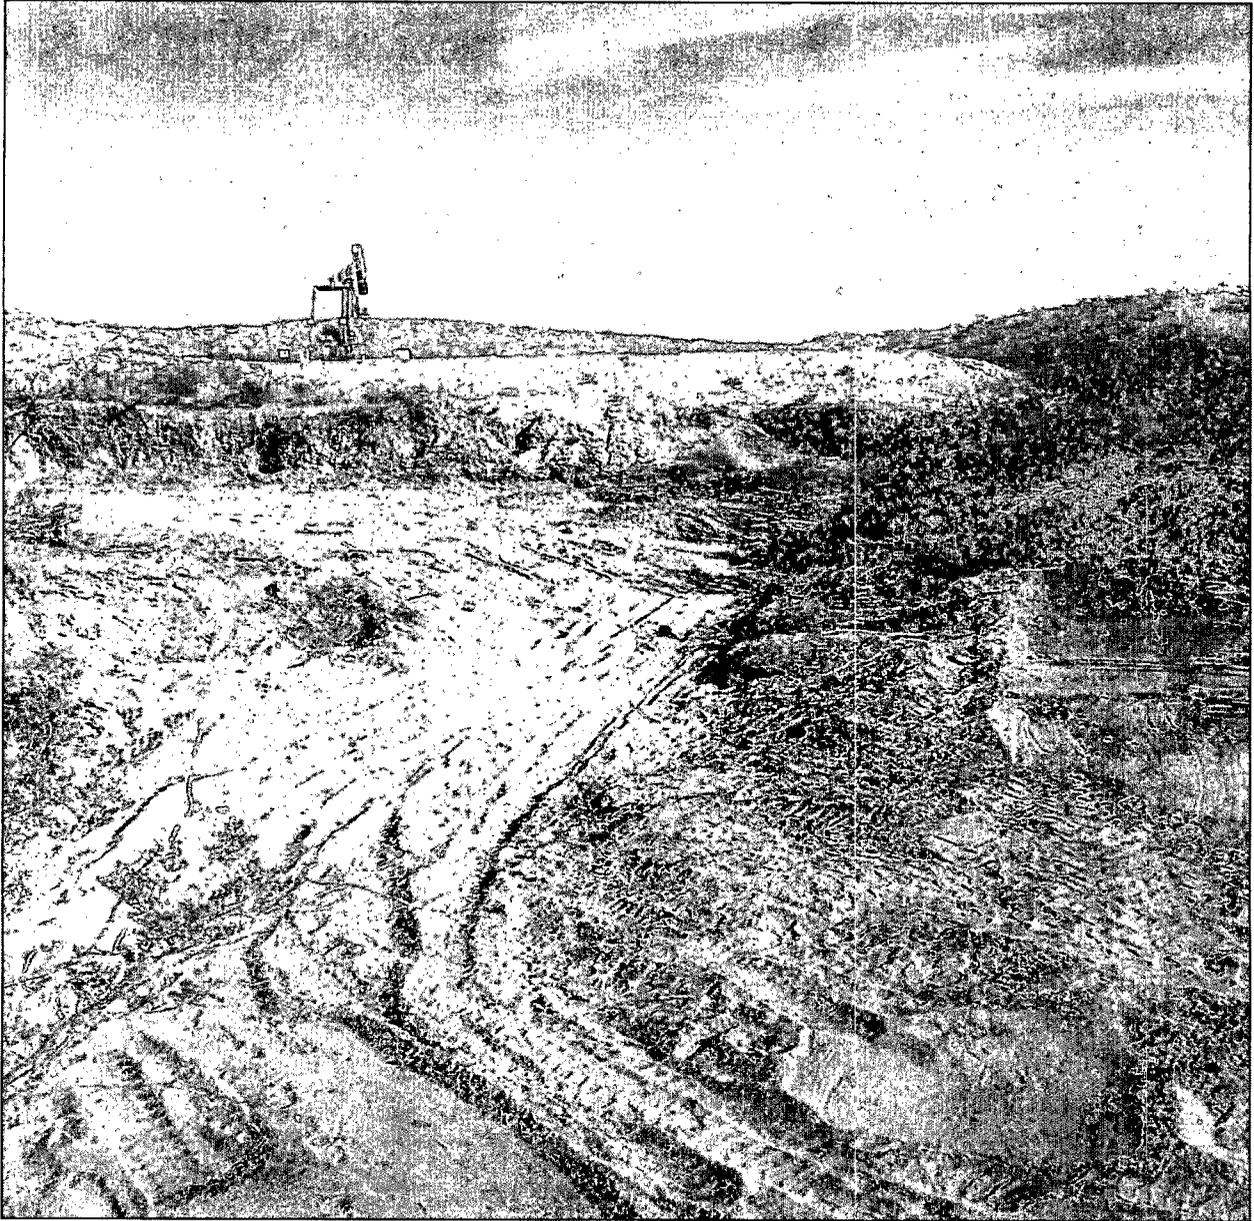
Photo 4

Excavation and backfill downgradient of drilling pit

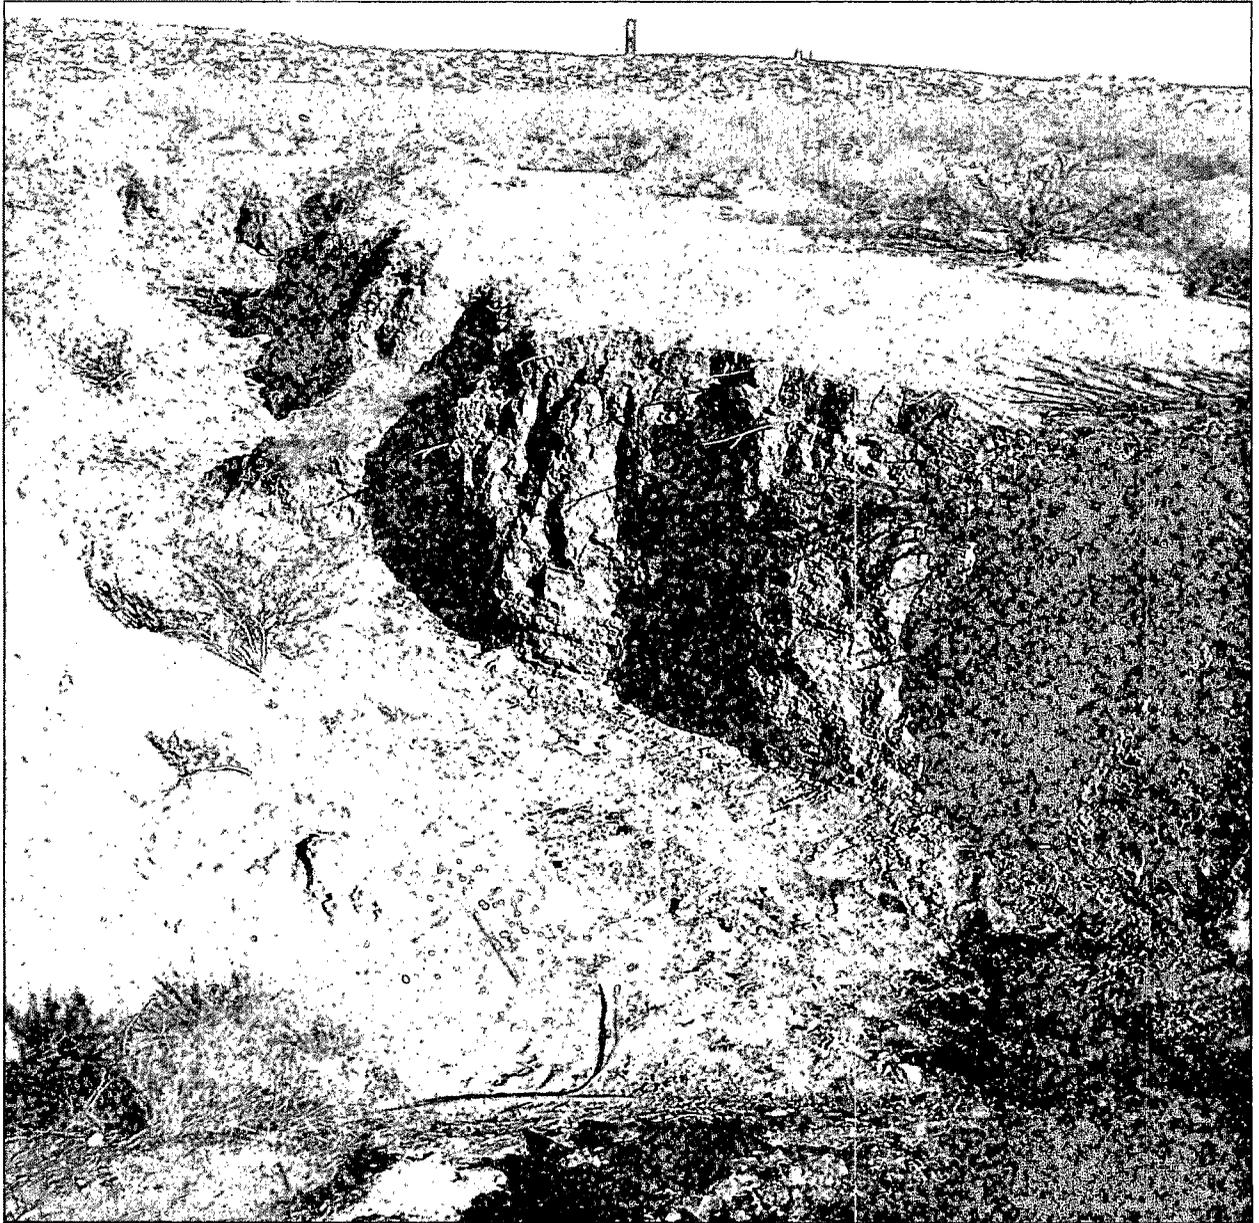
Photo 7

The arroyo – an overview
