**Enterprise
Trunk K #8**

Release Notification and Corrective Action

**EXCAVATION AND CORING INVESTIGATION REPORT
TRUNK K #8 16 INCH NATURAL GAS PIPELINE RELEASE
UNIT N, SECTION 25, TOWNSHIP 27 NORTH, RANGE 8 WEST,
36.539789°, -107.638800°
SAN JUAN COUNTY, NEW MEXICO
July 31, 2015**

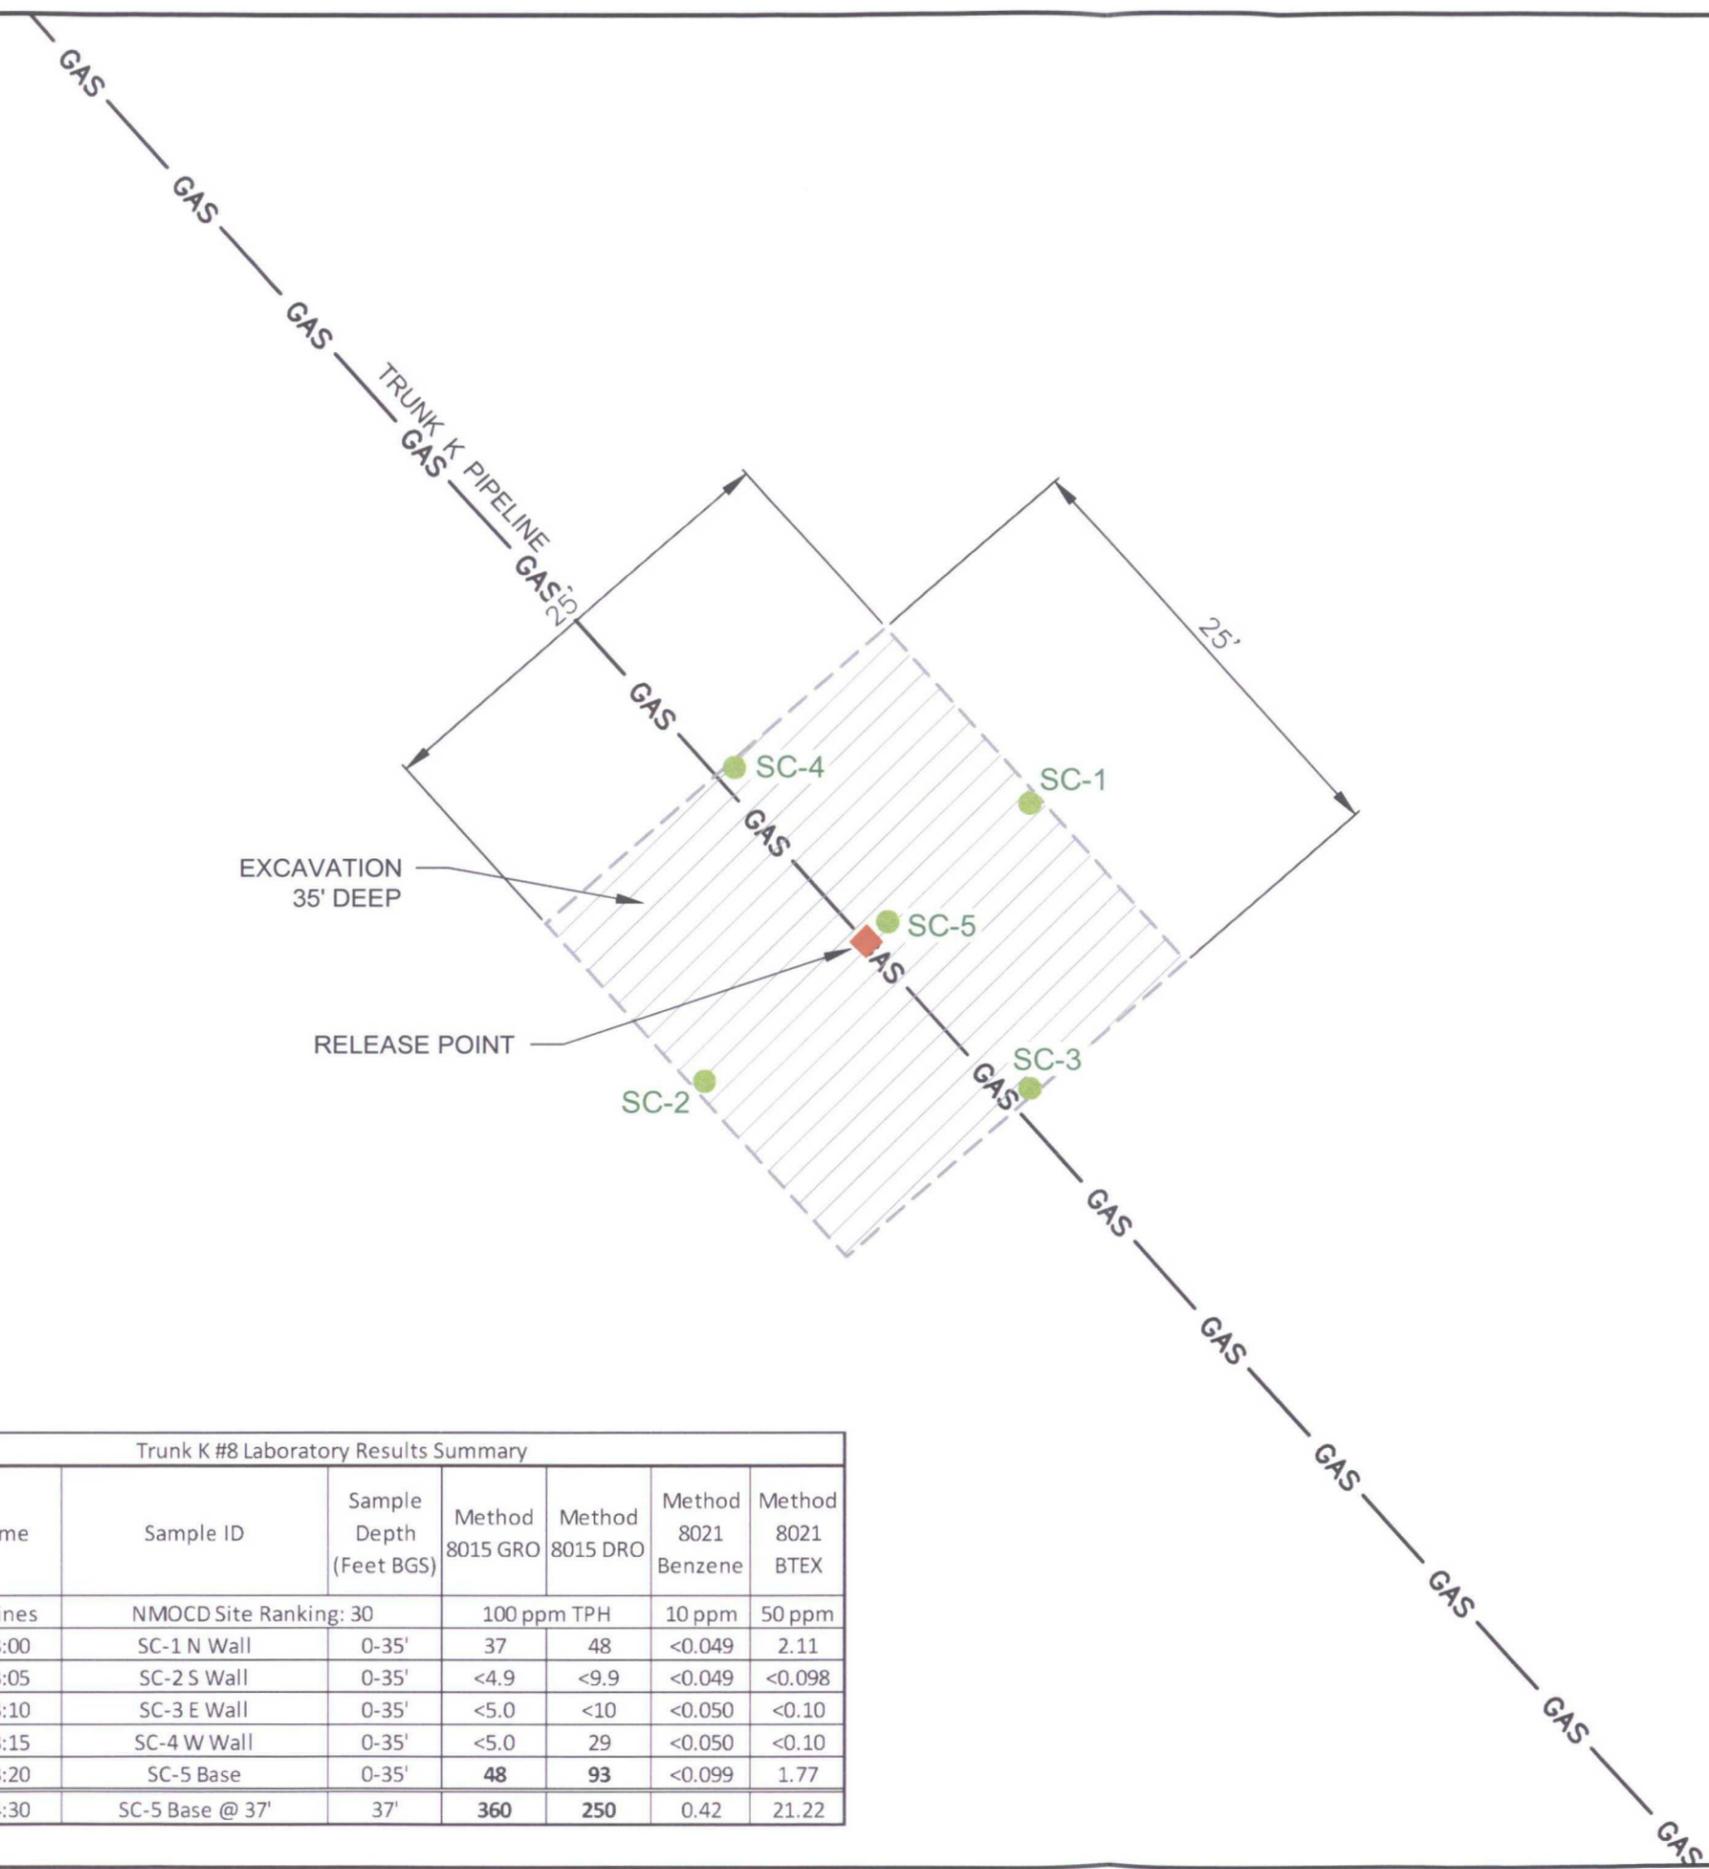
Closure sample collection dates were scheduled for May 1, 2015 with the BLM and the NMOCD. Neither party was present to witness the sample collection. Five, multi-aliquot composite samples were collected from the final excavation sidewalls and base using an excavator on May 1, 2015. Sample SC-5 Base @ 35' feet was above NMOCD Guideline remediation action levels (RALs) with a GRO concentration of 48 mg/Kg and a DRO concentration of 93 mg/Kg, resulting in a combined TPH concentration of 131 mg/Kg. All other samples were below NMOCD Guideline RALs.

On May 12, 2015 the location of sample SC-5 was further excavated to approximately 37 feet bgs. A composite sample was collected from this location, labeled SC-5 Base @ 37' and submitted for laboratory analysis. Laboratory results for this sample were still above NMOCD Guideline RALs with a combined TPH of 610 mg/Kg. The depth of the excavation, compounded by the proximity to culturally sensitive areas and competent bedrock rendered continuing the excavation of this location infeasible. SMA recommended application of an oxidizer, backfilling and drilling to delineate the vertical extent of the contamination. A summary of laboratory results for excavation samples is included as Table 3. A copy of the laboratory report is included in Appendix C.

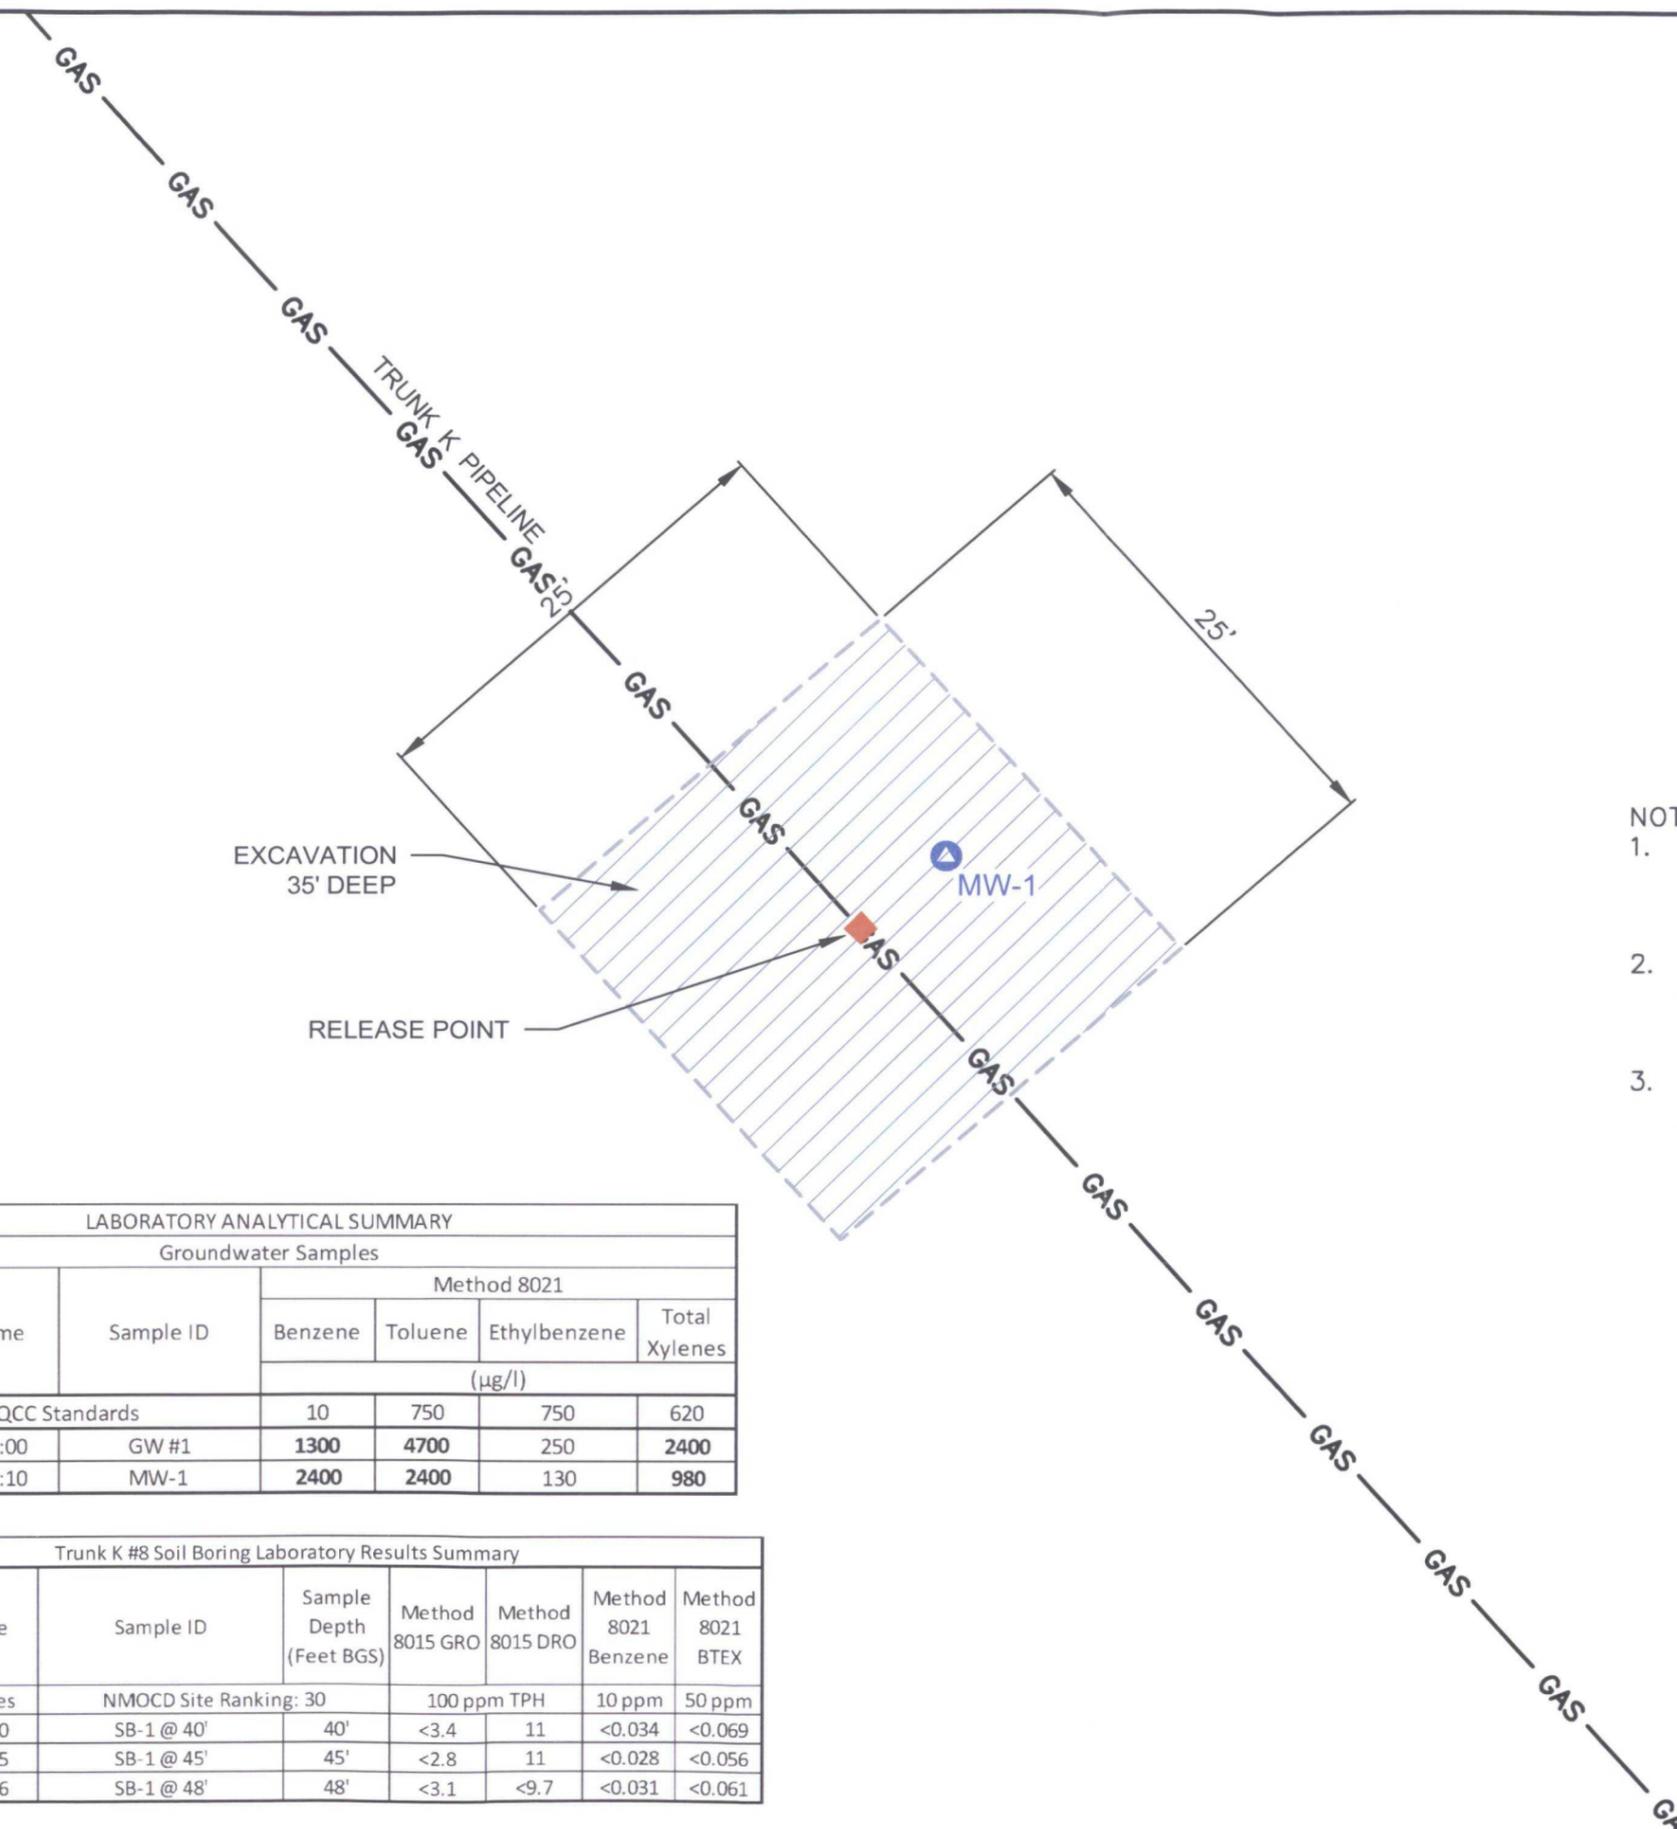
Date: July 2015
 Scale: Horiz: 1" = 10'
 Vert: NA
 Project No: 5123699
 Figure 5

Water was encountered at approximately 40 feet bgs during coring activities. A grab sample was collected from within the HSA with a clean disposable bailer, placed in HgCl₂ preserved 40ml VOA sample jars, and submitted to Hall for rush analysis to determine if the monitoring well was required. The results of this sample indicated contamination above New Mexico Water Quality Control Commission (NMWQCC) groundwater standards and the borehole was completed as a monitoring well on June 24, 2015.

On June 26, 2015 SMA purged and collected a groundwater sample from the developed monitoring well. The sample was then couriered under chain of custody procedures to Hall Environmental Analysis Laboratory in Albuquerque, NM for laboratory analysis via EPA Method 8021 for benzene, toluene, ethylbenzene and xylenes (BTEX). All purged water was collected and containerized for offsite disposal at the Envirotech Landfarm. Disposal documentation is included in Appendix B.

SMA Recommendations: Because groundwater contaminant concentrations are above NMWQCC standards, SMA recommends the installation and sampling of three additional monitoring wells to further delineate the extent of groundwater impact at the Trunk K #8 site.

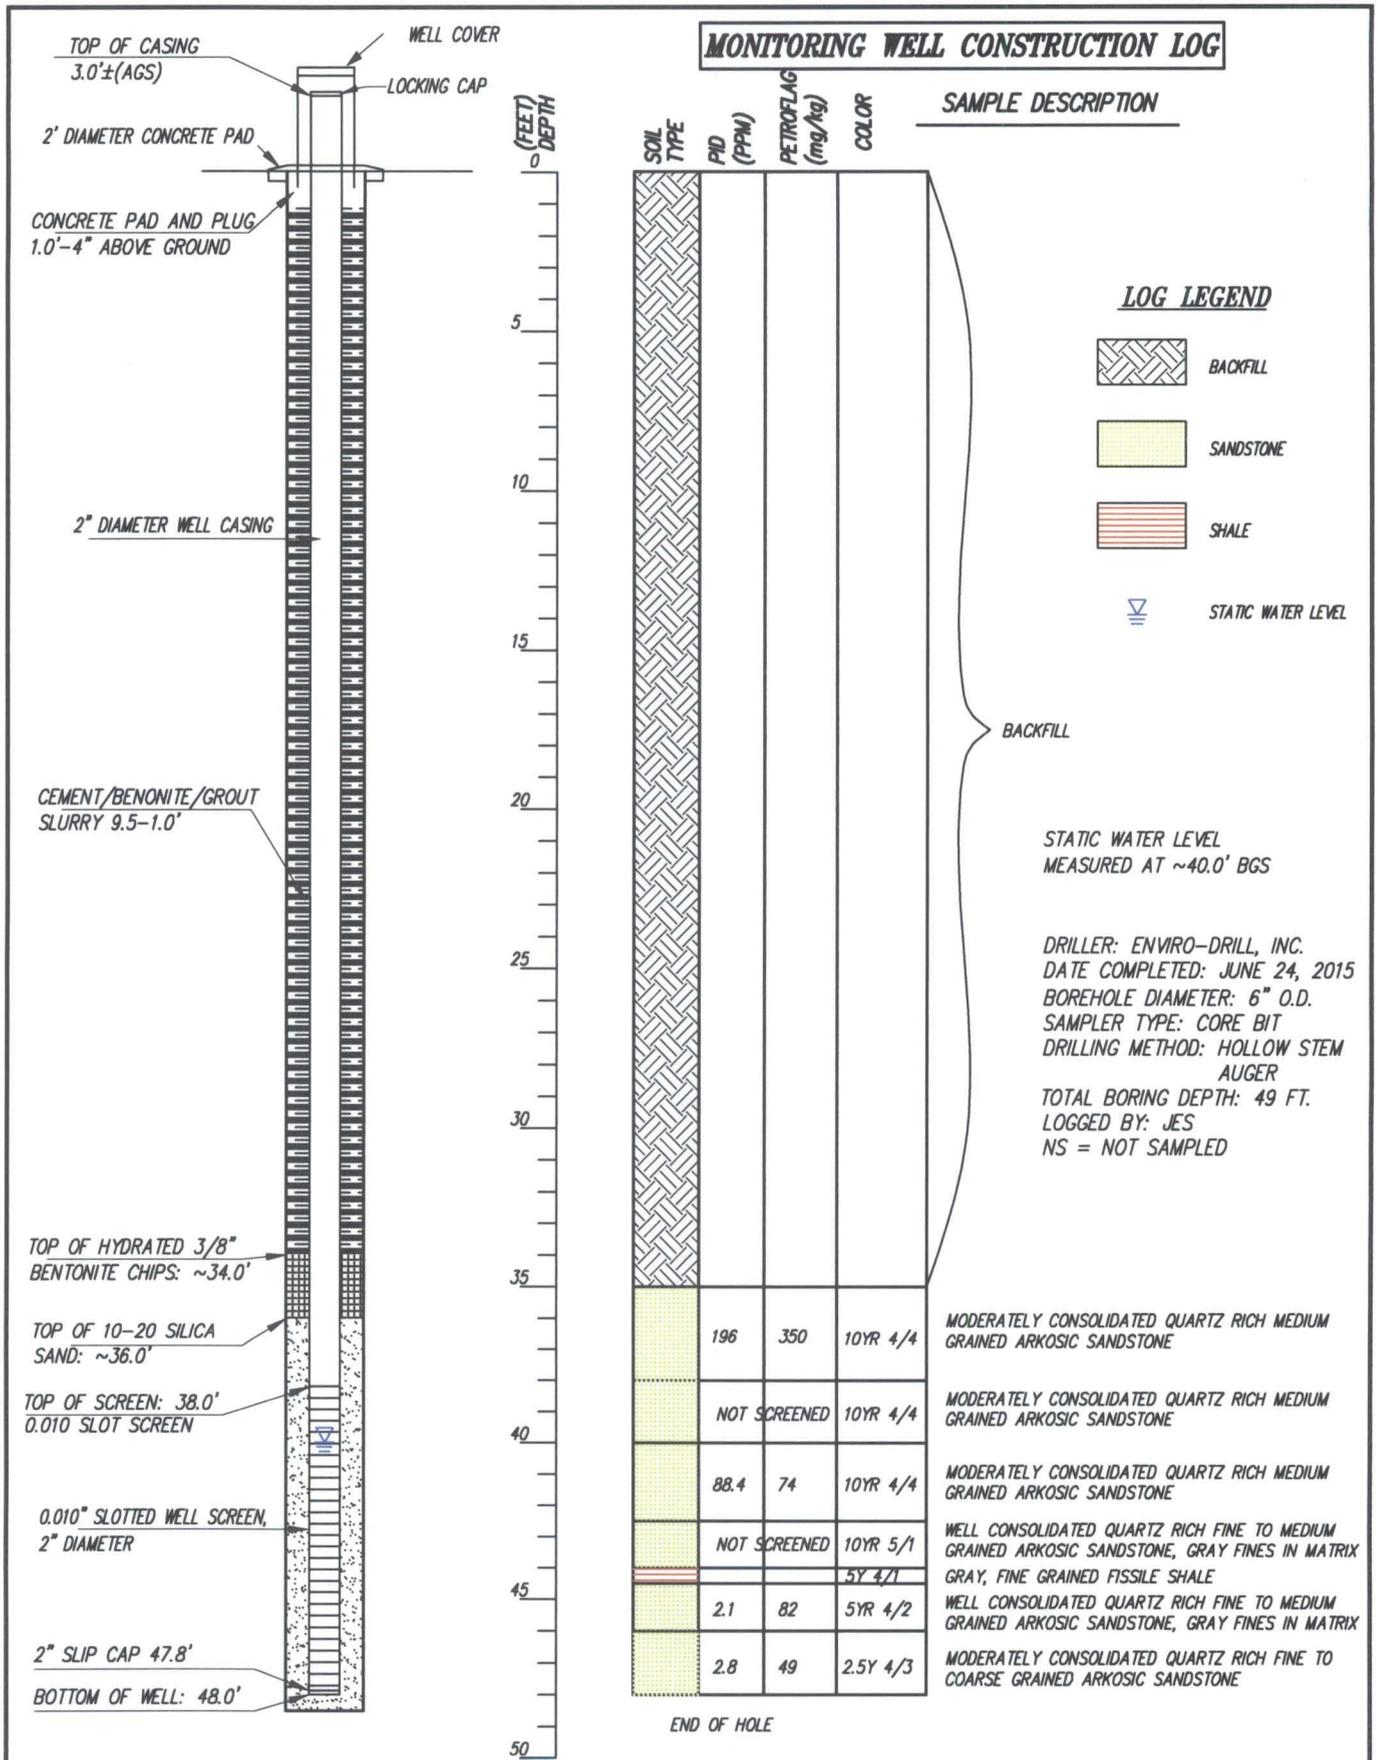
The soil boring was advanced to 48 feet bgs through sandstone with the coring bit during sampling. After groundwater was encountered and hydrocarbon impact detected, the borehole was completed to 48 feet bgs with the HSA tooling. Threaded 2" PVC well casing was used to construct the monitoring well with a 2.5 foot sump, 10 feet of 0.001 inch slotted well screen, and solid riser casing to about 3 feet above ground surface. A well completion diagram is included as Figure 3.

The well was completed with an aboveground steel well shroud cemented into a 2 foot round pad with a minimum thickness of 4-inches. The well was fitted with 3 protective bollards to prevent damage from vehicle collisions, livestock or wildlife.

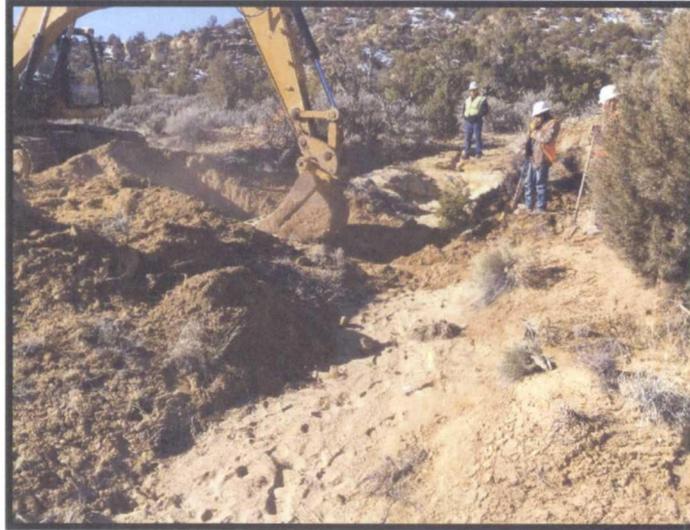
Photo 1: Trunk K #8, excavation located in a small tributary wash to Largo Wash.

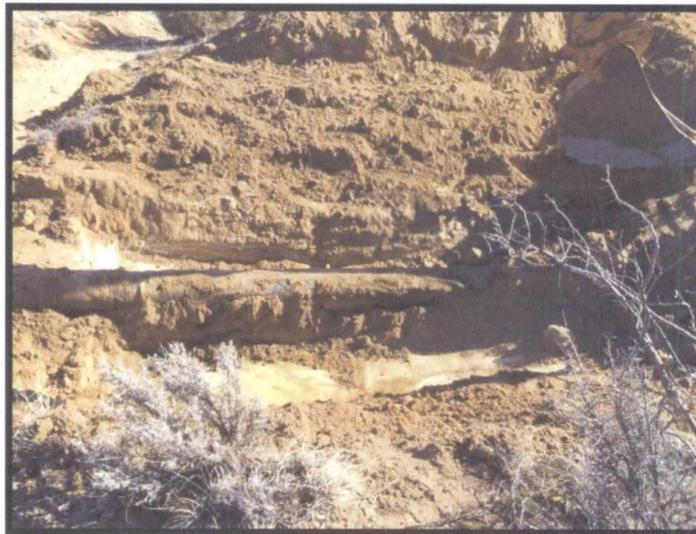
Photo 2: Trunk K #8 excavation encountered competent sandstone at a shallow depth, the sandstone unit extended to below the total depth of the excavation.

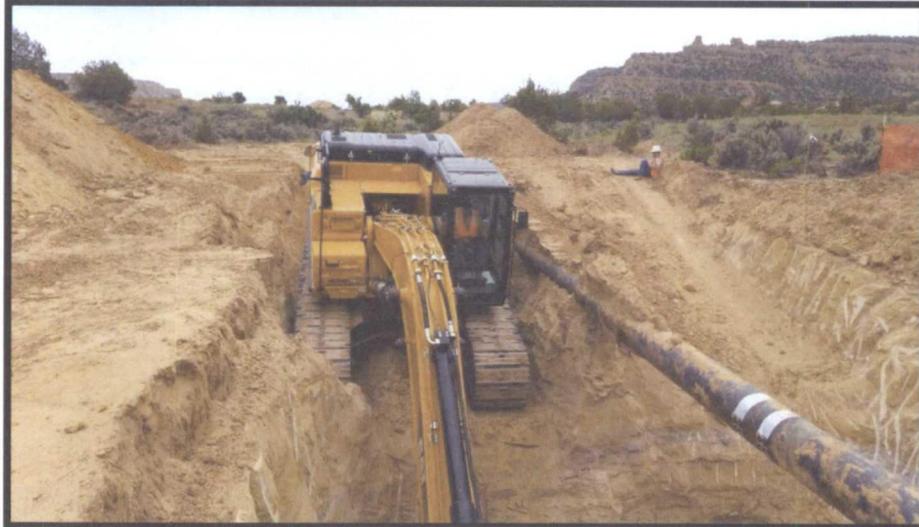
Photo 3: Trunk K #8 Final depth measured 37' BGS. Photo shows deepest bench on NE side of excavation.

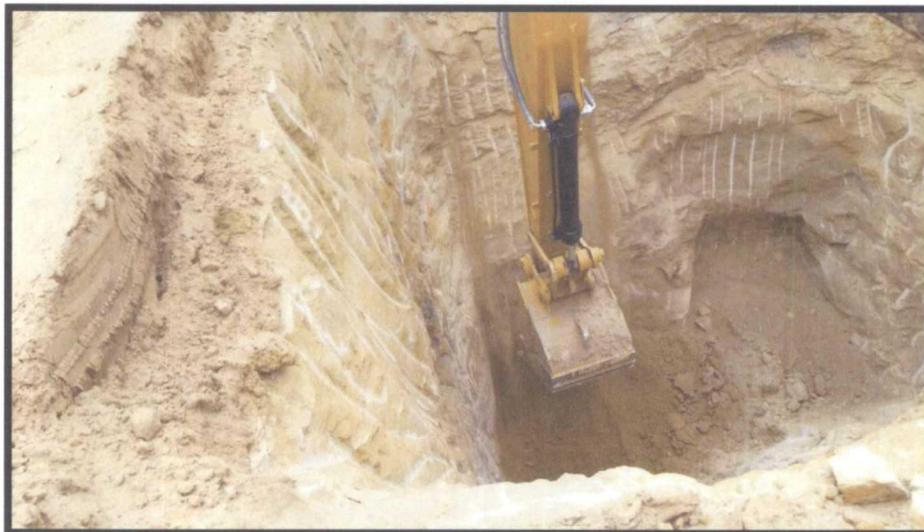
Photo 4: Trunk K #8 at total depth (37' BGS), samples collected as composites from multiple bucket scrapes against sandstone bedrock. Very competent sandstone visible to depth.

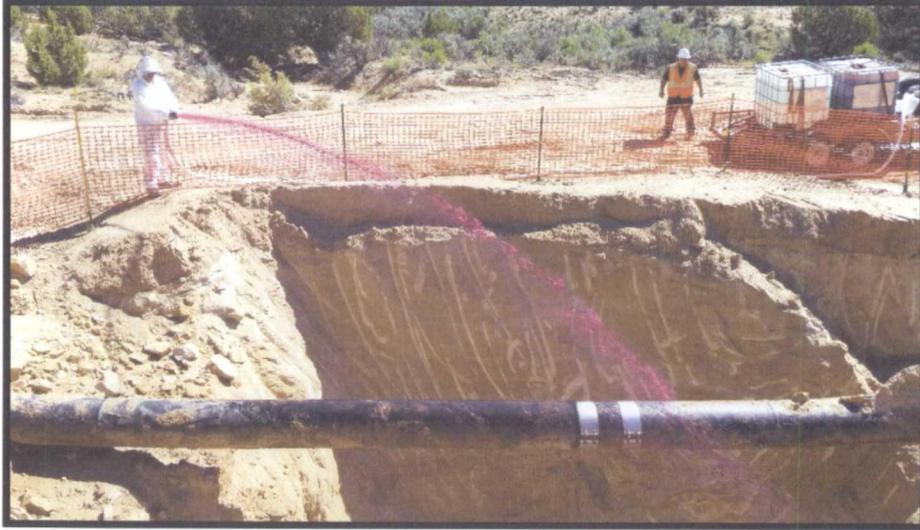
Photo 5: Potassium Permanganate application at the Trunk K #8 excavation.

On June 8, 2015, after receiving approval by the BLM, SMA oversaw the application of the chemical oxidizer potassium permanganate (KMnO₄) to the excavation. 300 gallons of a 5% concentration solution of KMnO₄ was applied to the base of the excavation. The oxidizer was applied by Envirotech Inc. The excavation was then backfilled with clean imported soil by Halo Services Inc. contractors.

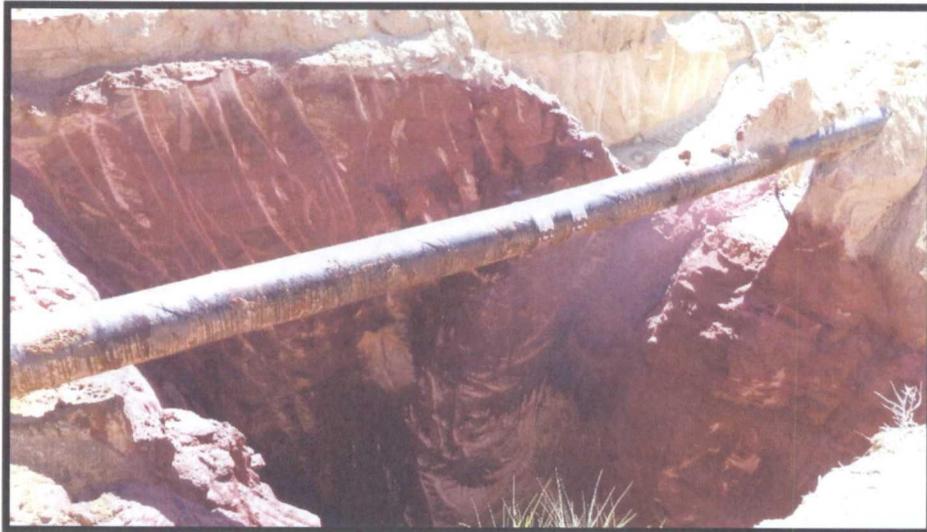
Photo 6: Trunk K #8 excavation after potassium permanganate application.

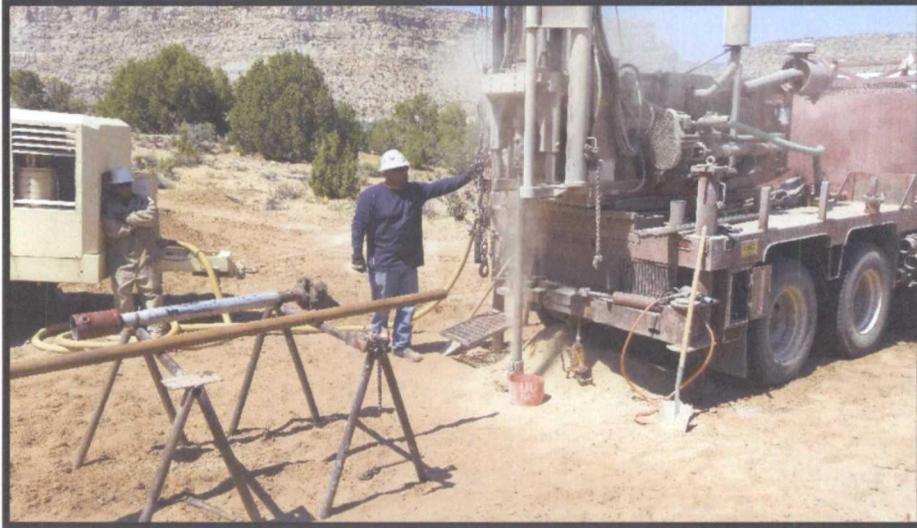
Photo 7: Soil coring drilling method collecting soil samples at the Trunk K #8 release location after potassium permanganate application and backfill.

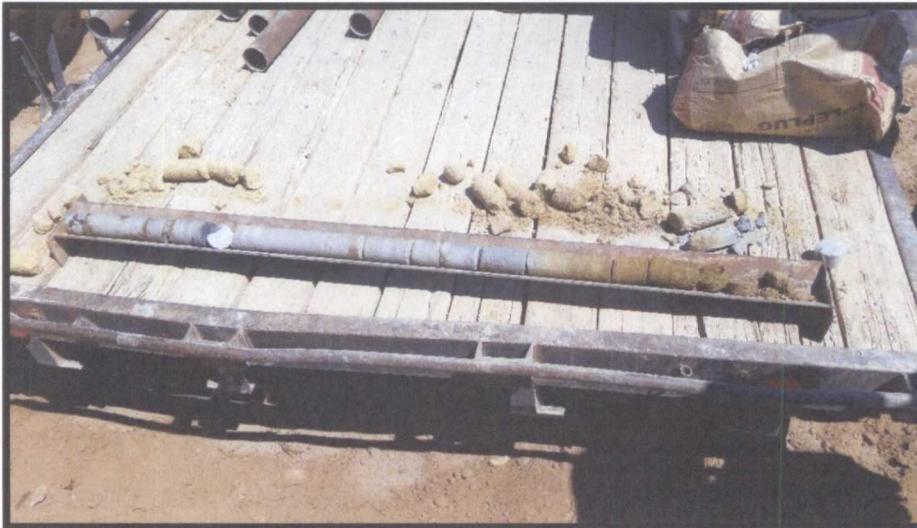
Photo 8: Soil core sample collected from the Trunk K #8 borehole., 43 – 48 feet bgs.

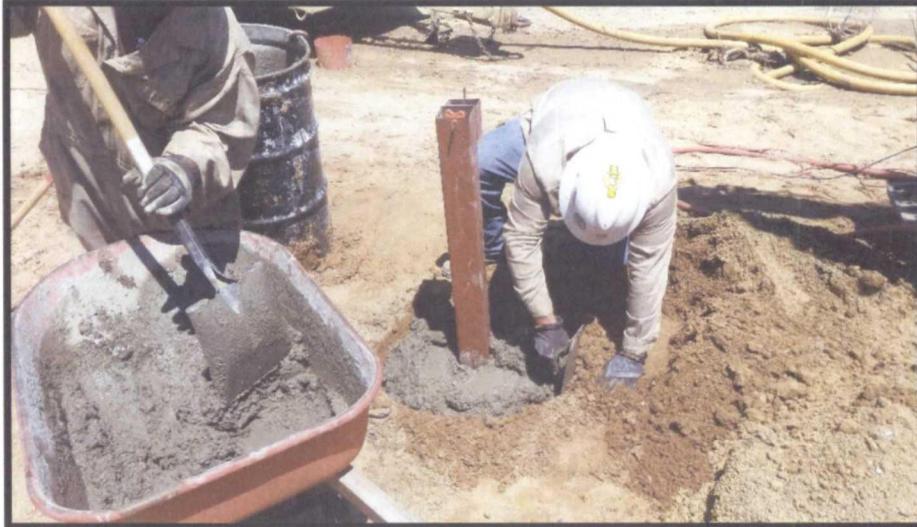
Photo 9: Installation of above ground protective well cover for MW-1.

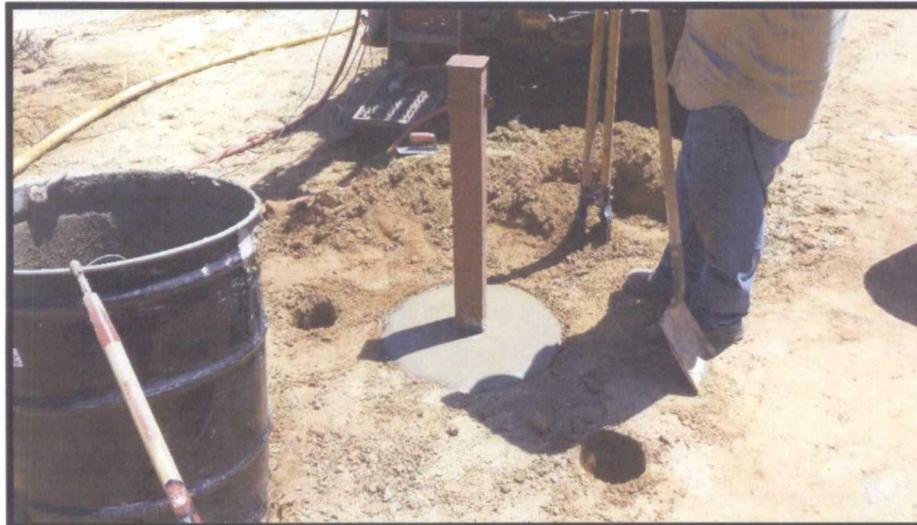
Photo 10: Installation of protective bollards around MW-1.

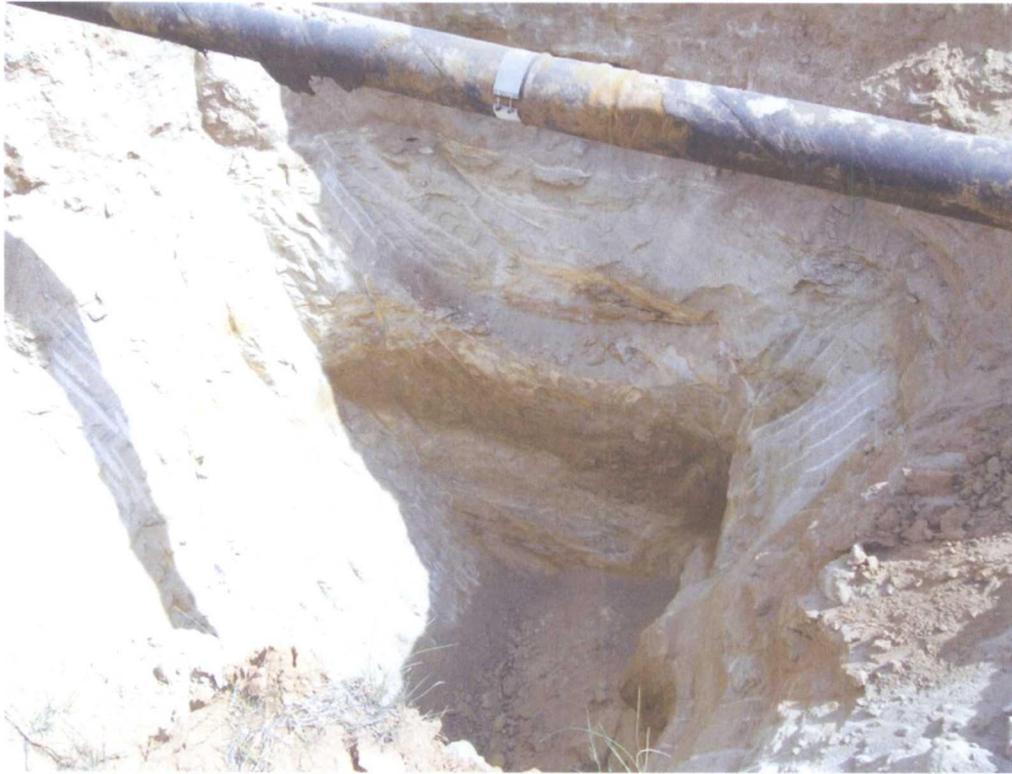
Trench 1 excavation in progress.

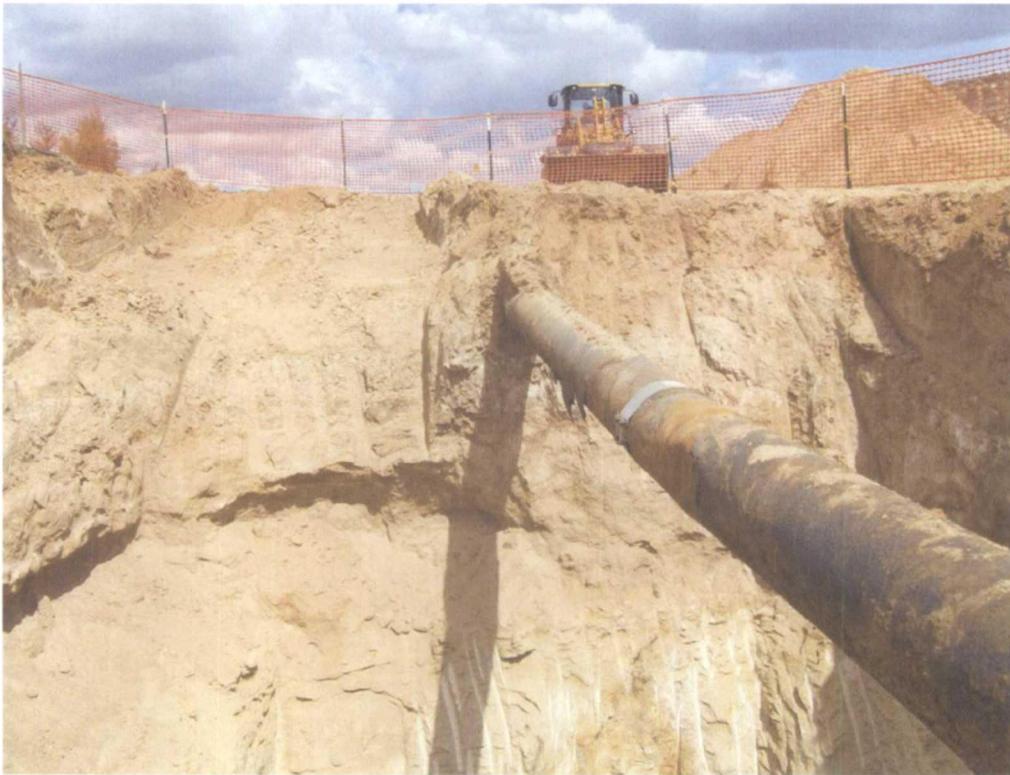
Trench 2 with repaired pipe.
