REMEDIAL INVESTIGATION/ CLOSURE REPORT

B-LINE RELEASE SITE

DEFS REF: 130013

LEA COUNTY, NEW MEXICO

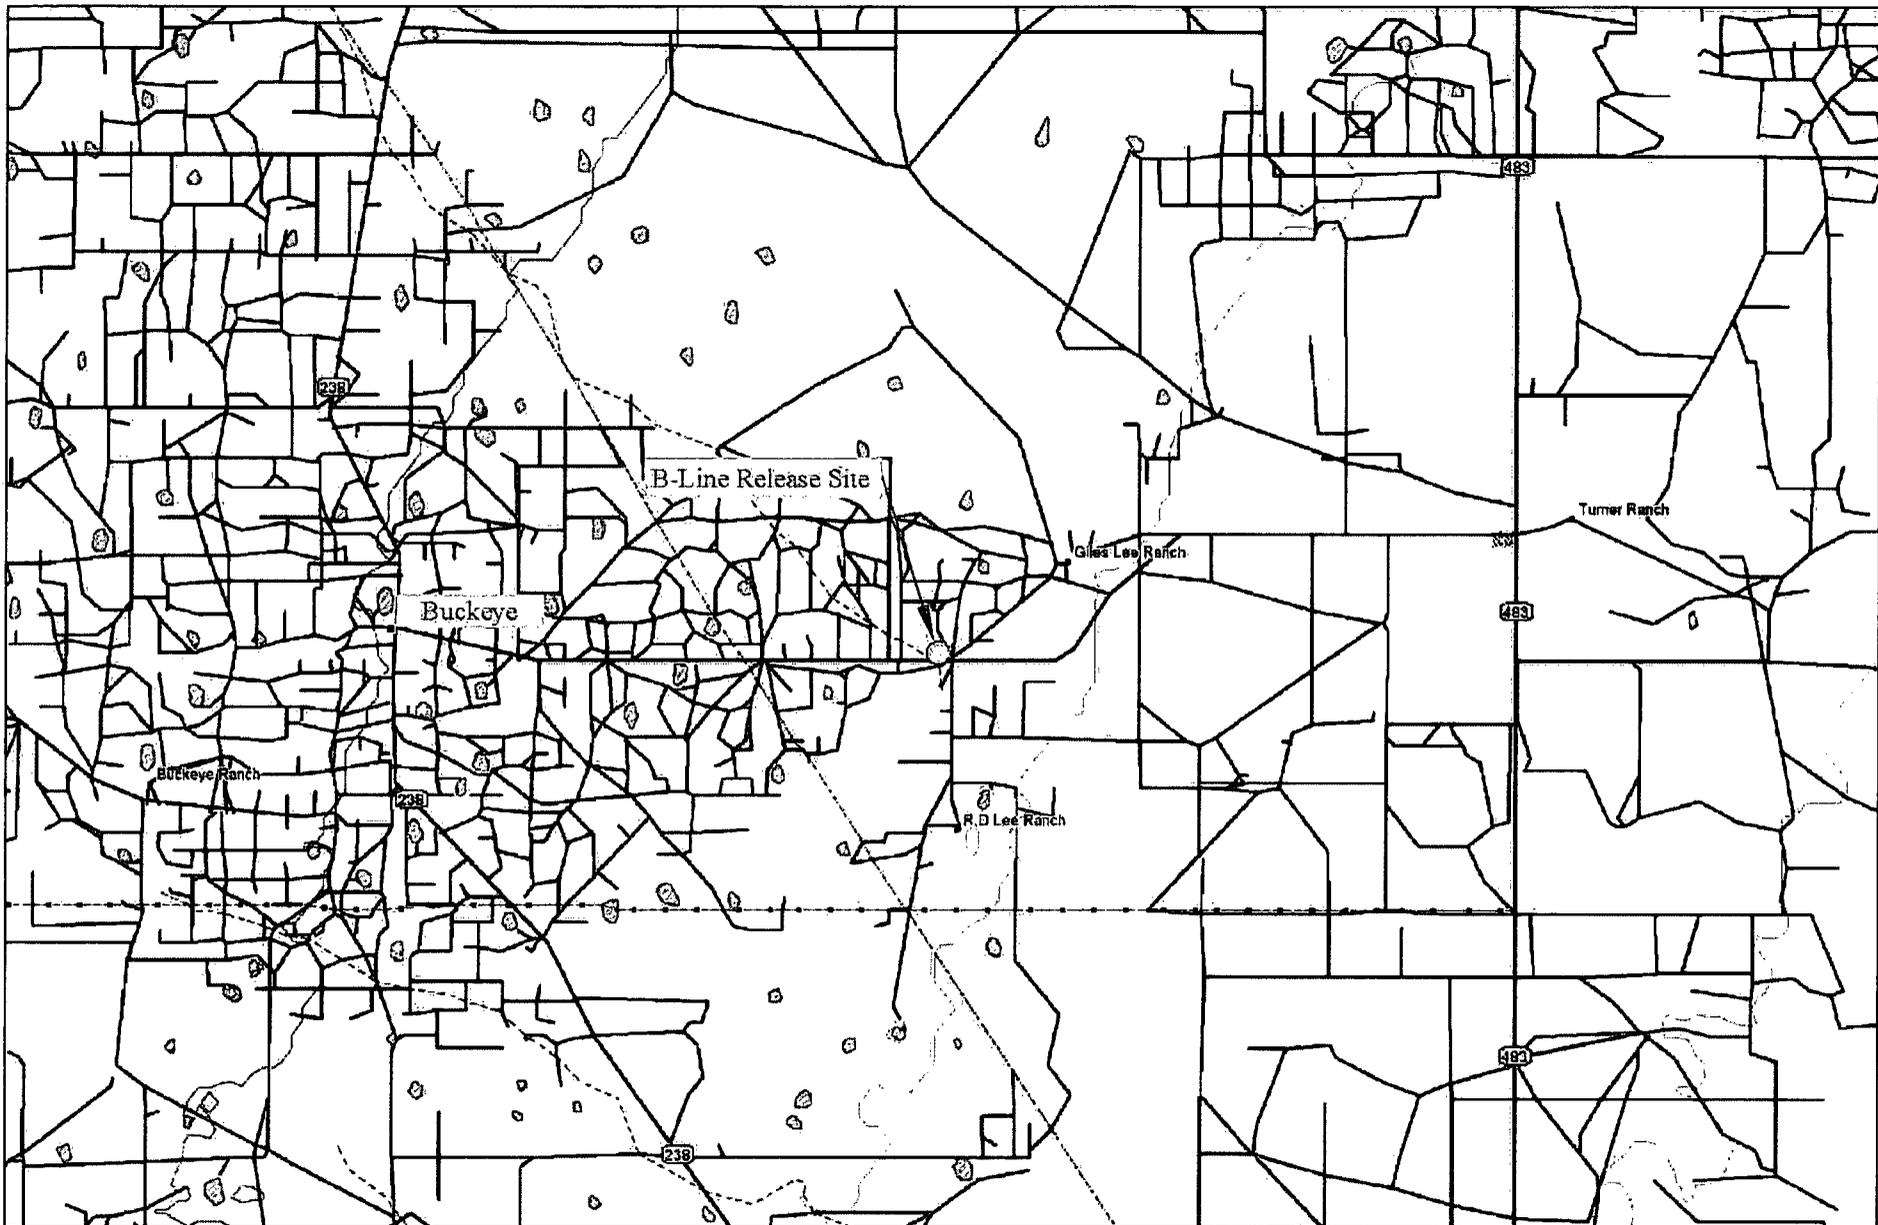
Figure 1
Area Map
 Duke Energy Field Services
 B-Line

Lea County, New Mexico
 SE 1/4 of the SW 1/4, Sec. 26, T17S, R35E
 N 32° 47' 57.0" W 103° 25' 49.0"
 Elevation: 3,909 feet amsl

This report addresses the site investigation and remediation of the Duke Energy Field Services (DEFS) B-Line 8-inch natural gas pipeline remediation site. This release site is located in Unit Letter N (SE¼ of the SW¼), Section 26, T17S, R35E, at a latitude of N32° 47' 57.026" and a longitude of W103° 25' 49.000". The site is approximately 4.4-miles east of Buckeye, New Mexico. The property is owned by the State of New Mexico and utilized for livestock grazing (reference *Figures 1 and 2*).

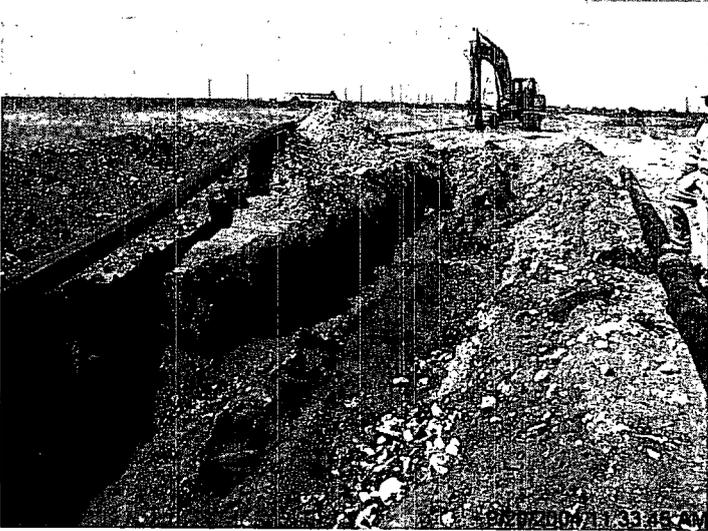
Photo #1: Release area, looking westerly. Note that the steel line is being replaced with a polyethylene line.

Source of contamination: 8" steel line began leaking, probably due to internal corrosion. Line clamp installed and line replaced.

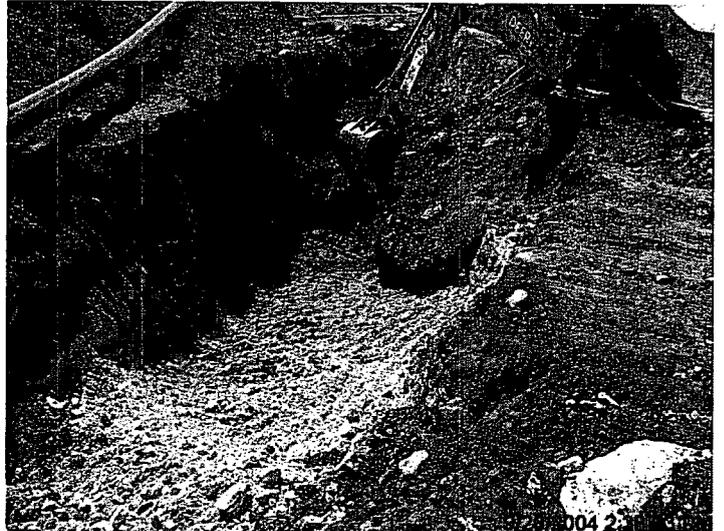
Photo #2: Initial excavation activities, looking westerly.

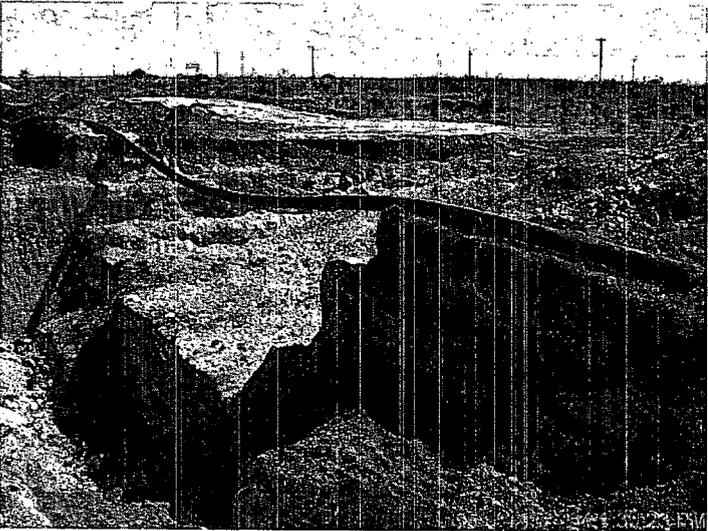
Photo #3: Excavation, looking northeasterly.

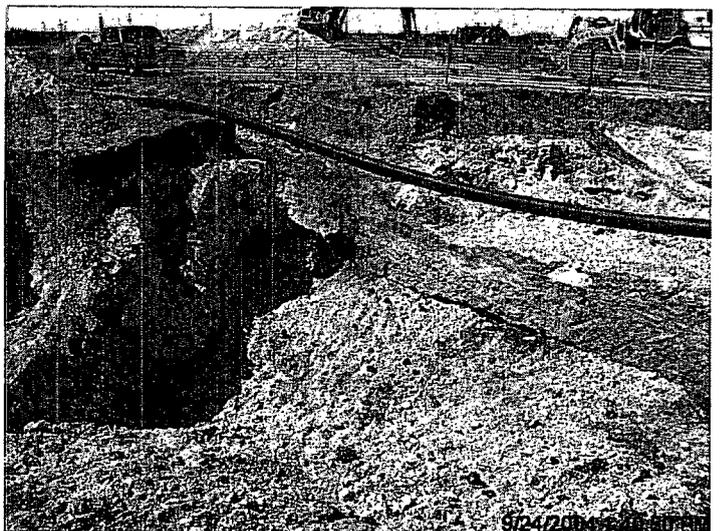
Photo #4: Excavation, looking northwesterly.

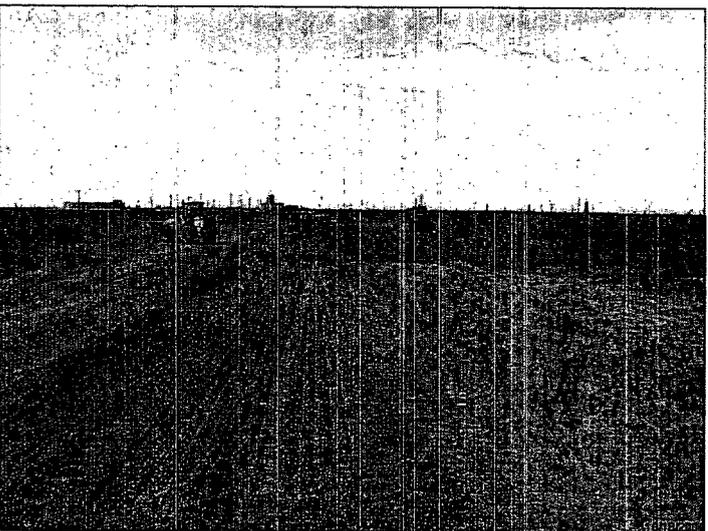
Photo #5: Grading and contouring, looking westerly.

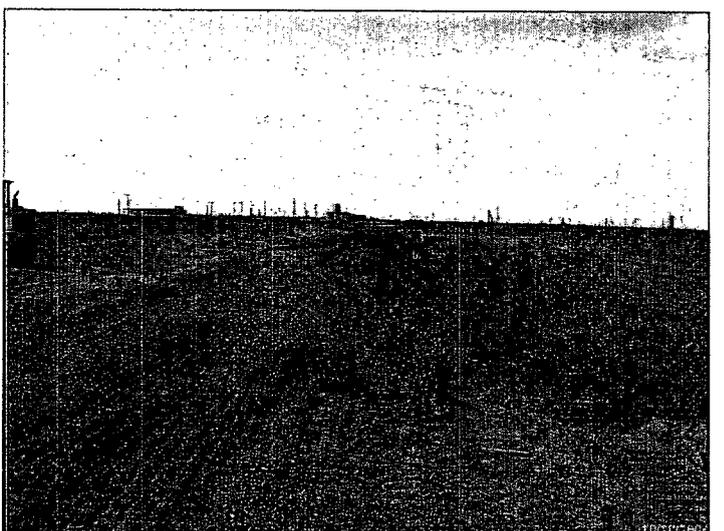
Photo #6: Site graded and contoured, looking westerly.
