CLOSURE REPORT

SS LINE 20"

DEFS REF: 130012

UL-F (SW¼ OF THE NW¼) OF SECTION 32 T21S R37E

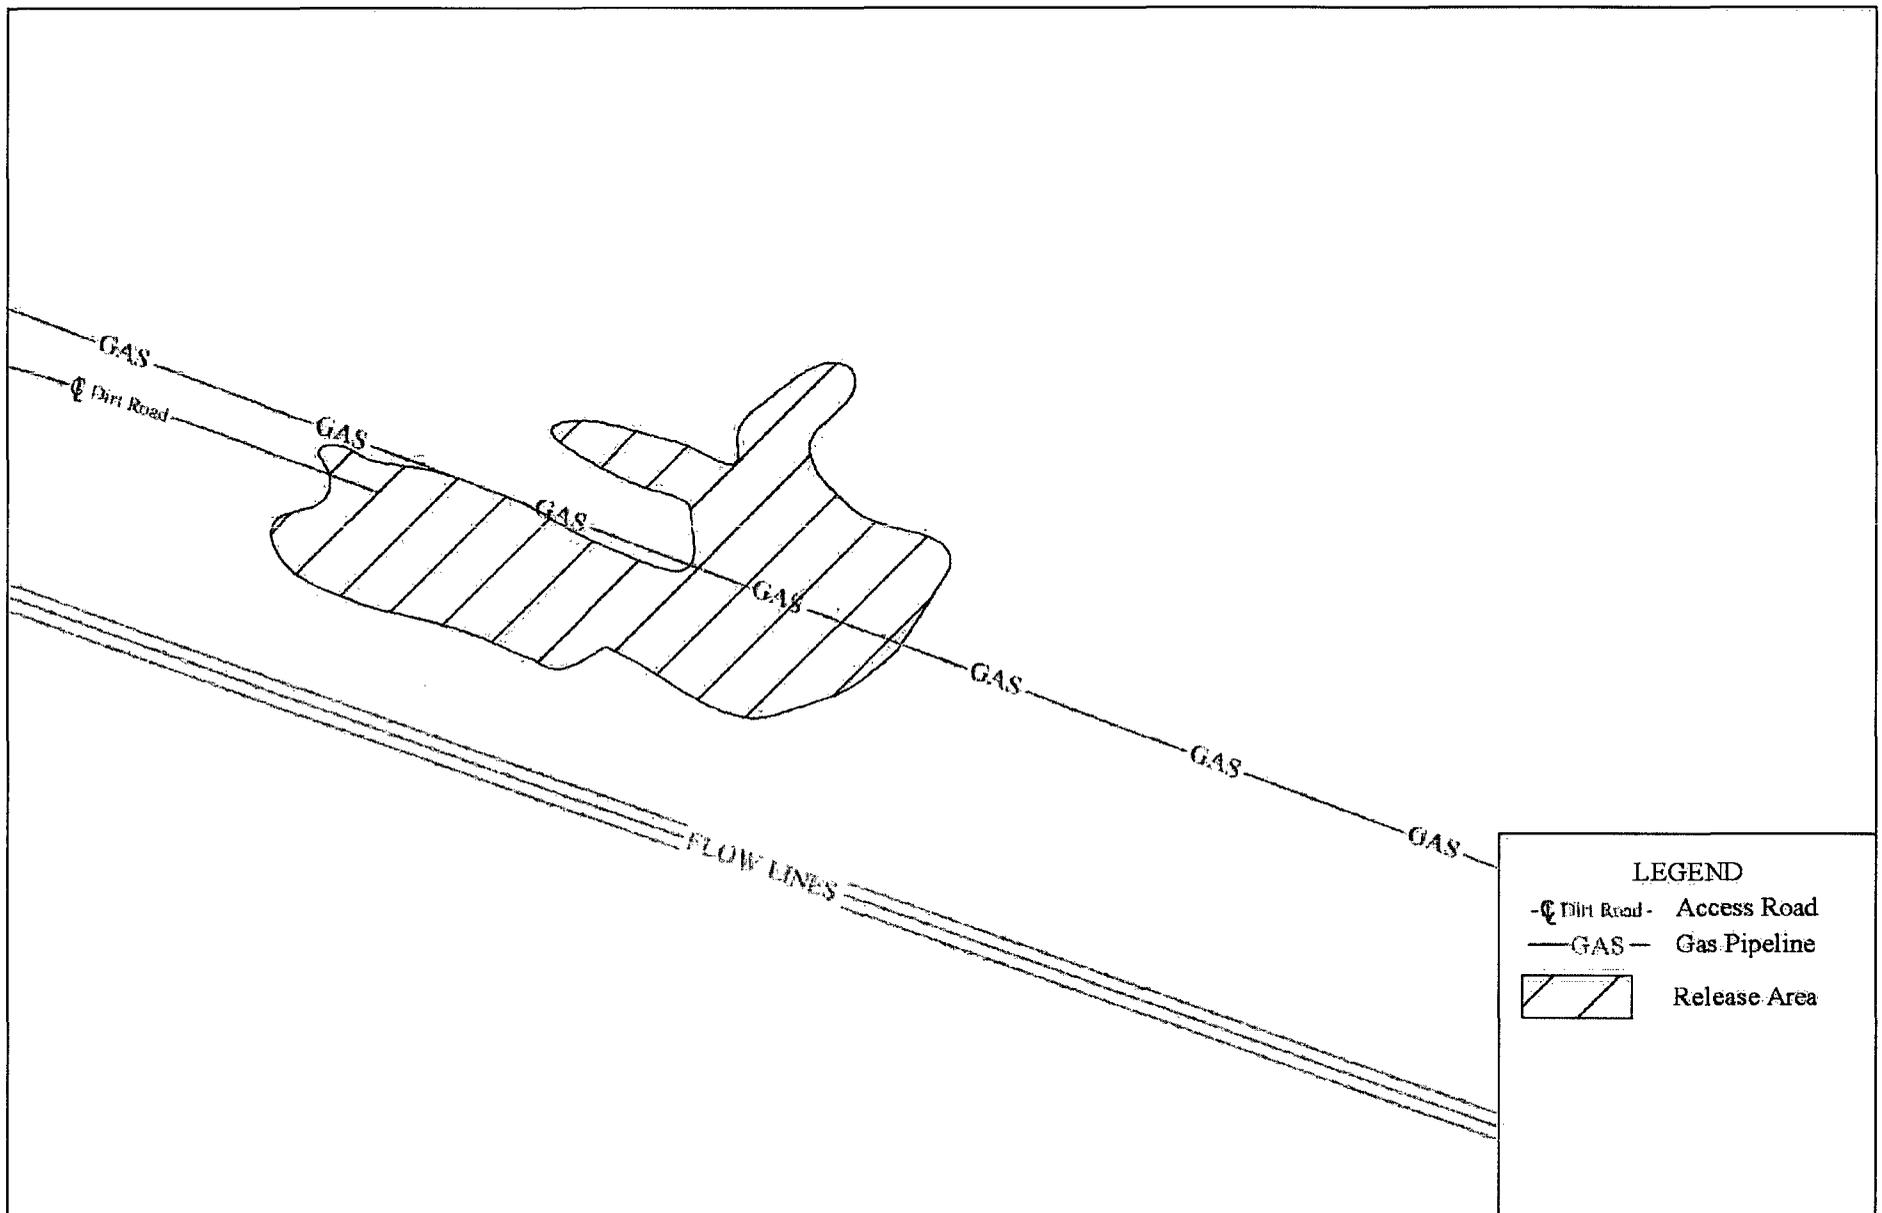
Figure 3
Site Map
 Duke Energy Field Services
 SS Line - 20"

Release Area

On September 1, 2004, composite soil samples were collected from the excavation floor (BHC-B). A portion of the sample was analyzed in the field for organic vapor concentrations. Field analyses indicated organic vapor concentrations of 749 ppm. The remaining portion of the sample was submitted to an independent laboratory for quantification of TPH, BTEX constituents and chlorides. Laboratory analytical results indicated benzene concentrations were not detectable at or above laboratory method detection limits (MDL). Total BTEX concentrations were reported at 14.4 mg/Kg, below the NMOCD remedial thresholds of 50 mg/Kg. Analytical results indicated TPH concentrations were 5,882 mg/Kg, in excess of the NMOCD remedial thresholds of 1,000 mg/Kg. Chloride concentrations were reported at 4,319 mg/Kg, in excess of the New Mexico Water Quality Control Commission (NMWQCC) chloride groundwater standard of 250 mg/L (reference *Table 1* and *Figure 3*).
