Re: Removal of Hydrocarbon-Impacted Soils from the C-23-2 (Site #3) site
Township 20 South, Range 36 East, Section 25, Unit B

Re: Remediation Closure Approval for Removal of Hydrocarbon-Impacted Soils
C-23-2, (sites: 1, 2, 3)
Site Location: UL-B, Sec 25-T20S-R36E
All Dated: August 7, 2003

SITE MAP

C-23-2 (Site #3)

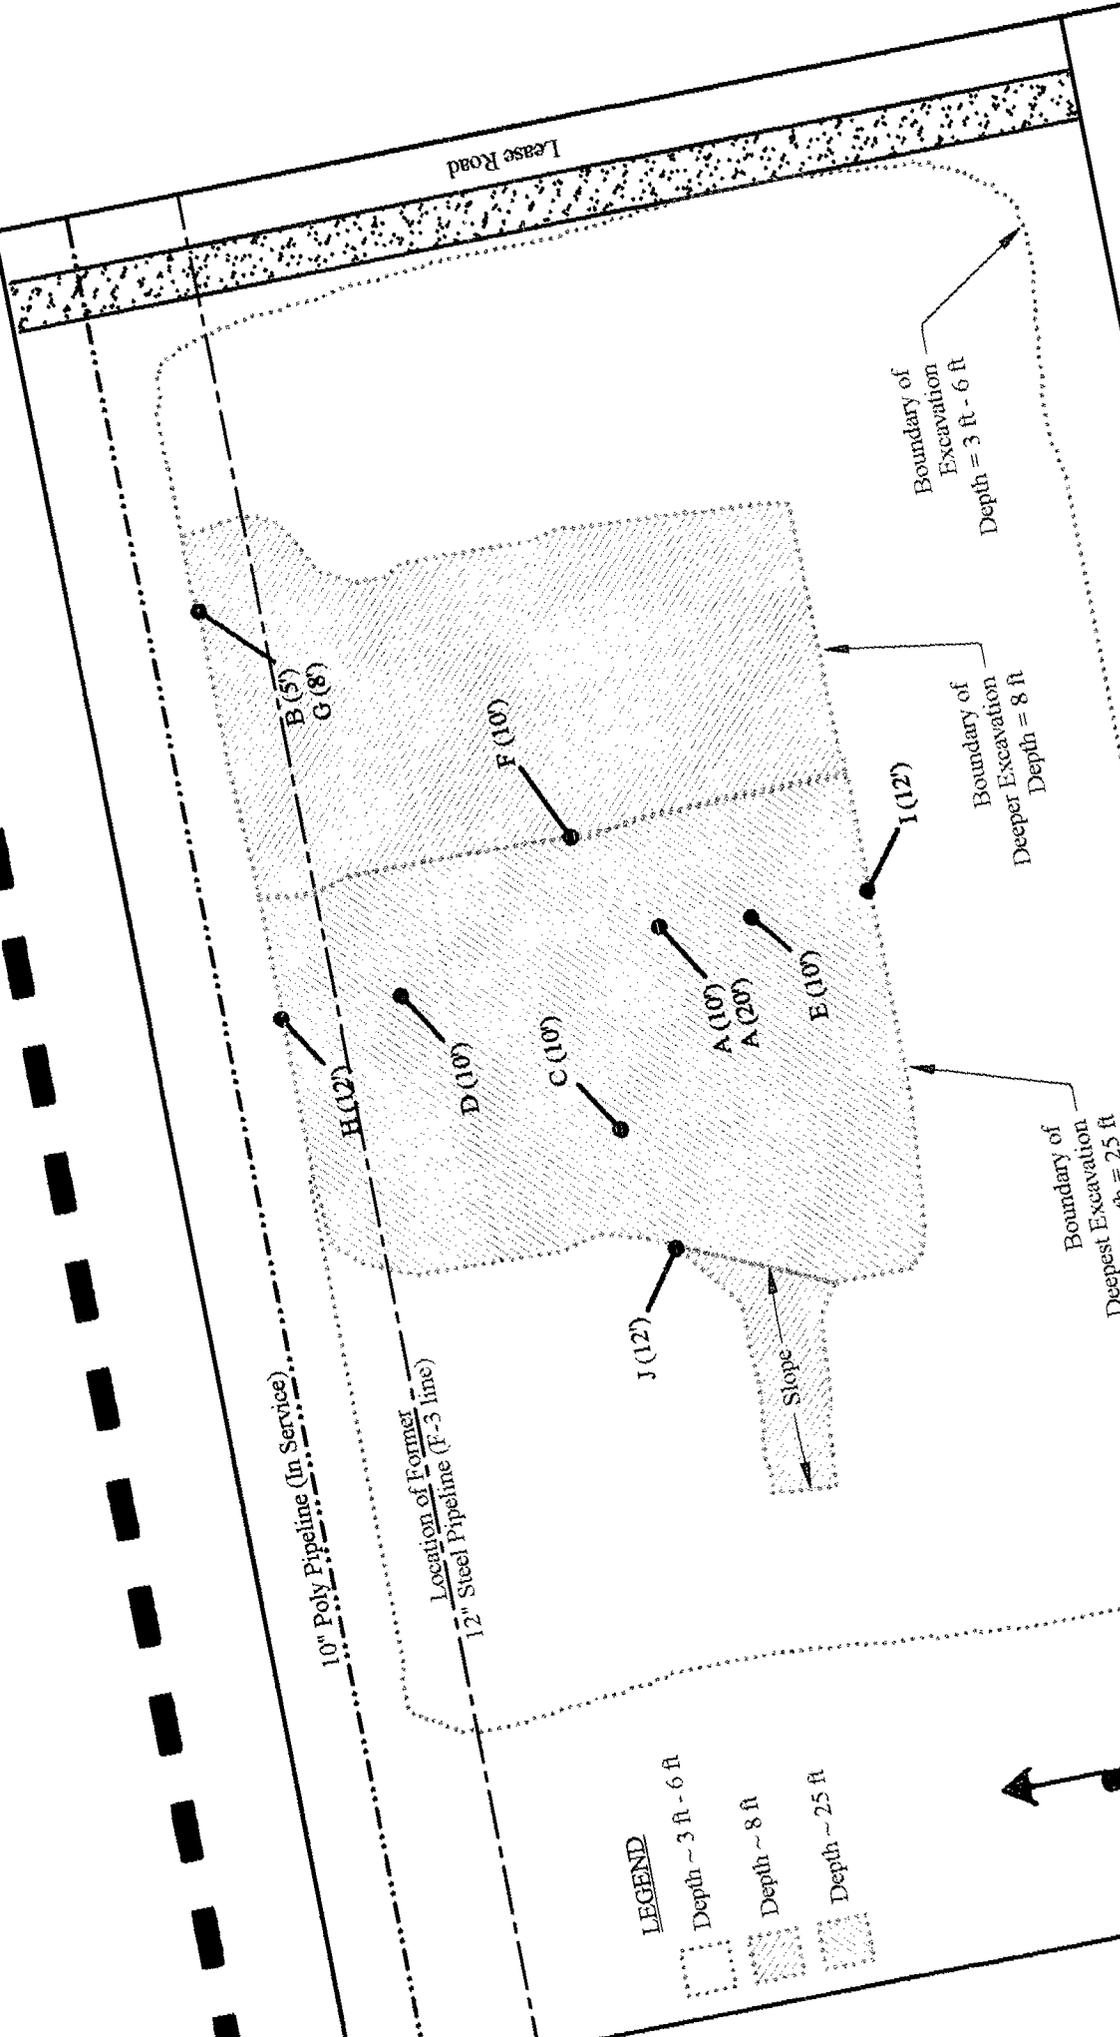
Comments: The areas beyond samples A (10'), B (5'), C (10'), D (10'), and E (10') were excavated further until concentrations were below OCD guidelines (<100 mg/kg) as confirmed by subsequent samples A (20'), G (8'), J (12'), H (12'), and I (12'), respectively.

- Depth ~ 3 ft - 6 ft
- ▨ Depth ~ 8 ft
- ▩ Depth ~ 25 ft

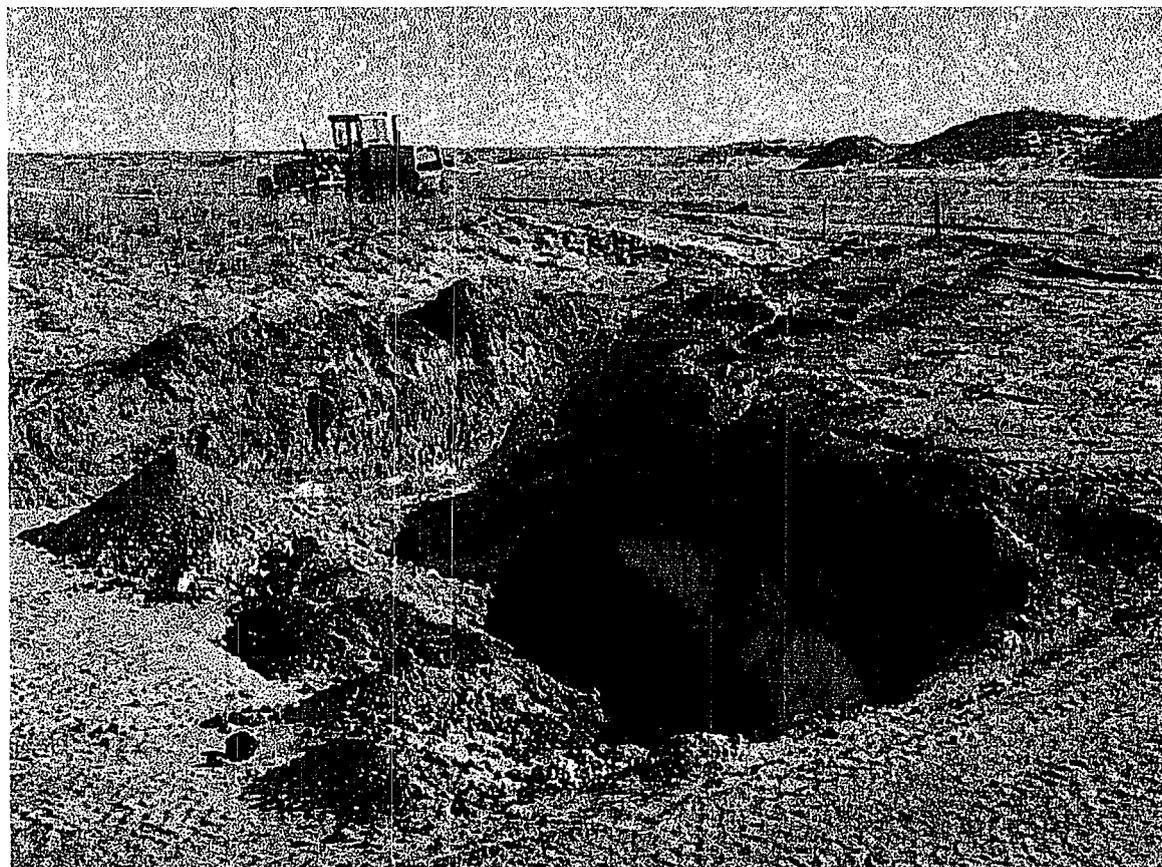
2 View facing northeast showing floor of excavation at 10 ft below surface. Sample A (10') was taken from floor (bottom of photo) and indicated a GRO = 565 mg/kg and DRO = 3,610 mg/kg.

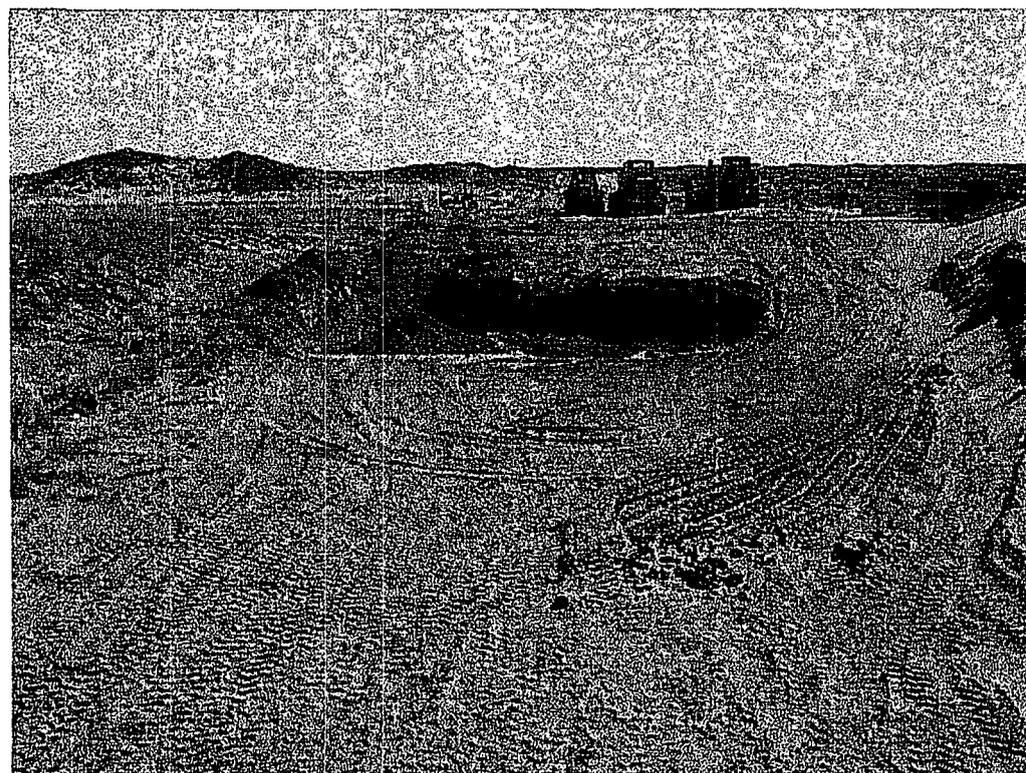
4 View facing east parallel to pipeline ROW showing status of excavation on 03-06-03. Left side of main excavation is adjacent to the C-23-2 pipeline, which is currently in service. The former F-3 line located 10 feet south of the C-23-2 pipeline has been removed.

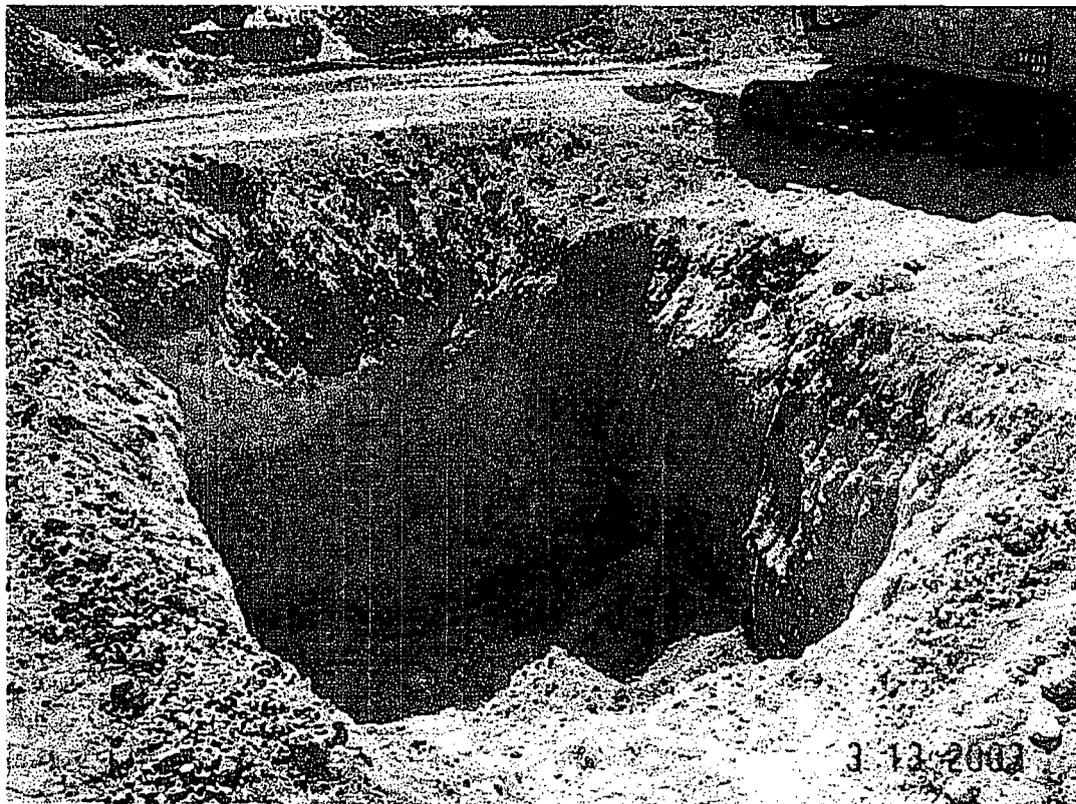
6 View facing southwest showing floor (20 ft below surface) and the south and west walls at completion of excavation activities.
