**GLORIETTA EAST WELL # 01-02 12-23-04**

## ENVIRONMENTAL SITE INVESTIGATION

## Glorietta East Well # 01-02

### 12-23-04

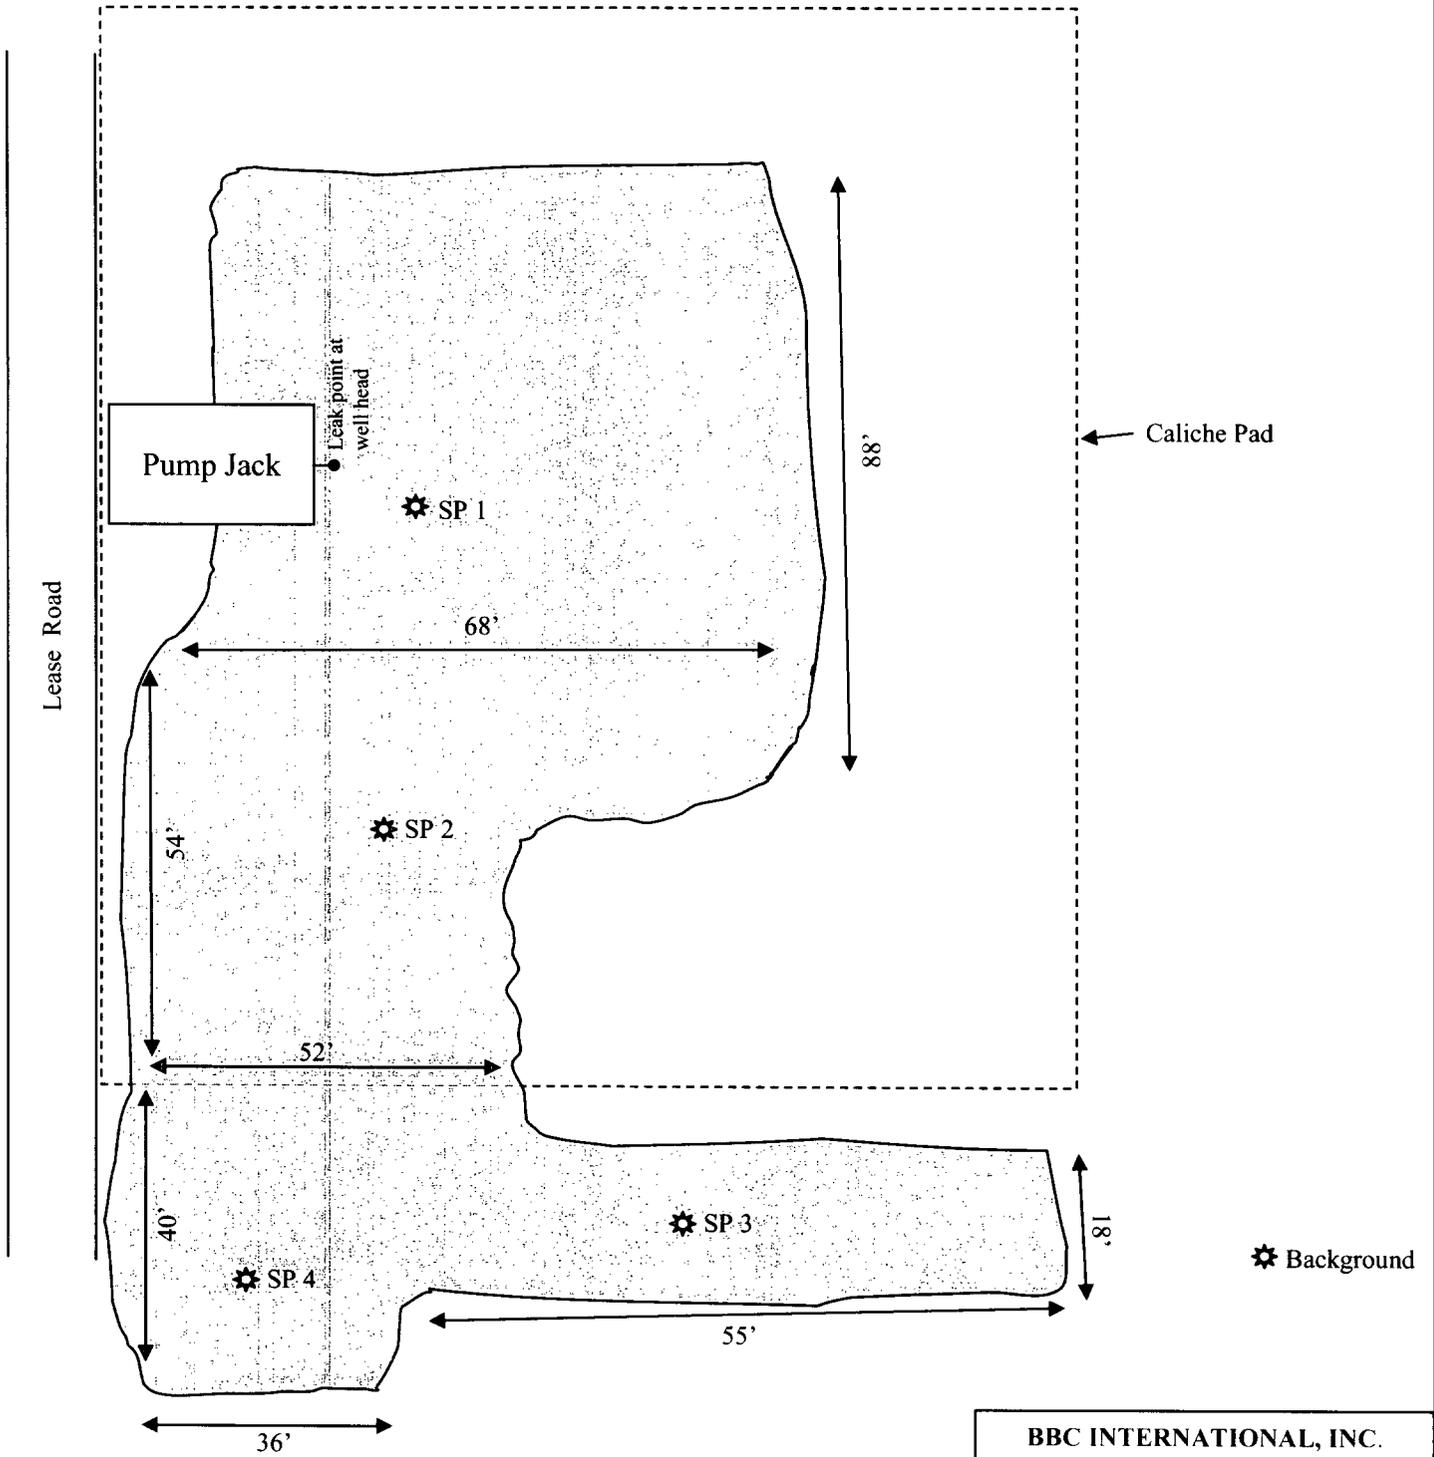
# CONOCOPHILLIPS GLORIETTA EAST 01-02

The leak area runs north to south from the wellhead across the well location into the pasture on the south end. The impacted area measures approximately ~~182 feet in length and 68 feet wide.~~ A sketch of the leak area including the sample points can be reviewed in Appendix II of this report. Photographs of the site can be reviewed in Appendix III of this report. The surface soil is mostly caliche with some brown topsoil. There is no water source within 1,000 feet of the site. There is no surface water within 1,000 feet of the site. Based on data from the New Mexico Office of the State Engineer, there are three recorded water wells located in Section 28, Township 17 South, and Range 35 East and the average depth to water is ~~70 feet.~~ The bedrock in the Buckeye area is very shallow and at this site is approximately one foot below the surface of the topsoil.

non detect, Ethyl Benzene – non detect, Total Xylenes – non detect. Laboratory analytical results for this sampling event can be reviewed in Appendix I of this report and the sample point locations can be seen in the site diagram located in Appendix II of this report. On March 22, 2005 BBC personnel conducted a second sampling event at the site. Previous sample points were relocated using GPS coordinates, and one additional sample point was added. Five samples were taken using a backhoe. Three samples were taken from previous sample points SP1, SP2, and SP3. Two samples were taken from the new sample point SP4. Due to the extremely hard rock layer the deepest sample point was SP2 – 2'. The samples were taken to Cardinal Laboratories and SP4 – 1' was analyzed for BTEX, TPH (GRO and DRO), and Chlorides all other samples were analyzed for Chlorides only. Laboratory analysis for SP1@2' is: Chlorides – 720 ppm. Laboratory analysis for SP2@2.5' is: Chlorides – 1200 ppm. Laboratory analysis for SP3@1.5" is: Chlorides – 1760 ppm. Laboratory analysis for SP4@1' is: GRO – non detect, DRO – non detect, Chlorides – 14400 ppm, Benzene – non detect, Toluene – 0.008 ppm, Ethyl Benzene – non detect, Total Xylenes – non detect. Laboratory analysis for SP4@1.5' is: Chlorides – 3439 ppm. Laboratory analytical results for this sampling event can be reviewed in Appendix I of this report and the sample point locations can be seen in the site diagram located in Appendix II of this report.
