Name of Company	Southern Union Gas Services	Contact	Rose Slade
Address	801 S. Loop 464 Monahans, Texas 79756	Telephone No.	432-940-5147
Facility Name	Tunstil #1286	Facility Type	Natural Gas Pipeline
Surface Owner	Bureau of Land Management	Mineral Owner	API No 30-025-28822

**2RP-3307**

On February 22, 2011, Southern Union discovered a release had occurred on the Tunstil #1286 pipeline. Failure of a section of the 6-inch (6") low-pressure steel pipeline resulted in the release of an unknown volume of natural gas, crude oil, and produced water mixture. During initial response activities, the pipeline was fitted with a temporary pipeline clamp to mitigate the release. Following initial response activities, the affected pipeline segment was replaced.

Figure 2  
 Site & Sample Location Map  
 Southern Union Gas Services  
 Tunstall #1286 (Main Excavation)  
 NMOCD Ref #2RP  
 Eddy County, New Mexico

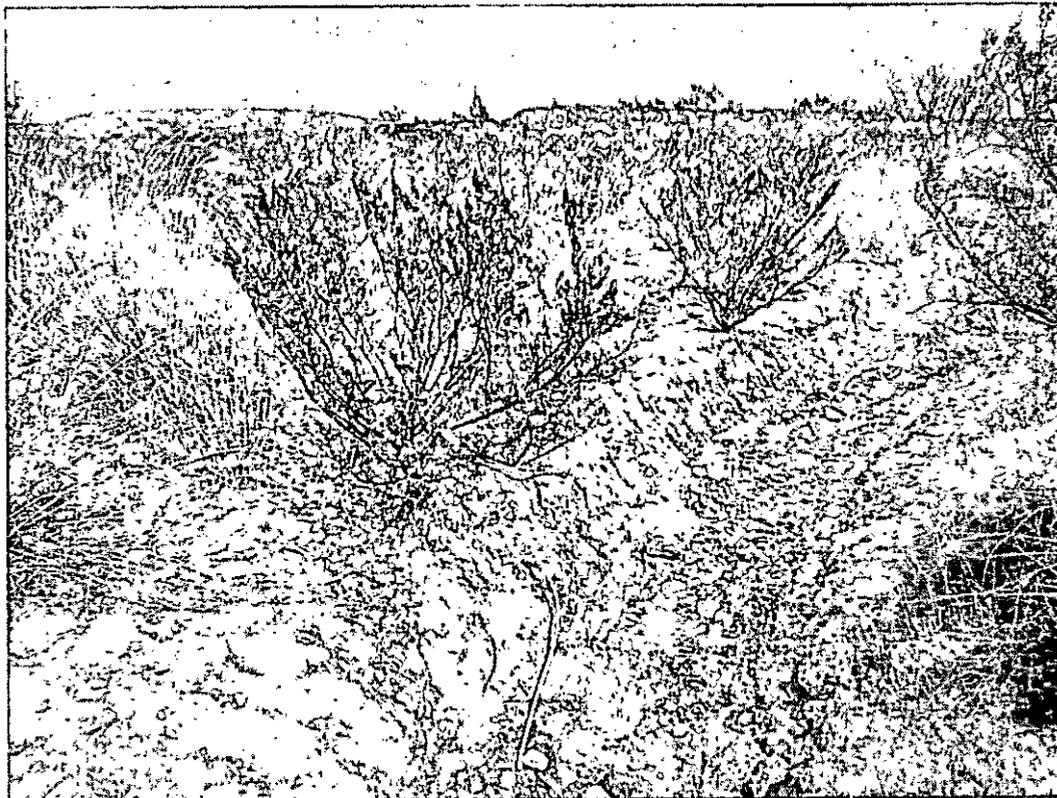
Figure 4. Photograph of the impacted portion of the ephemeral wash located Southwest of the Tunstil #1286 Release Site (Looking South)

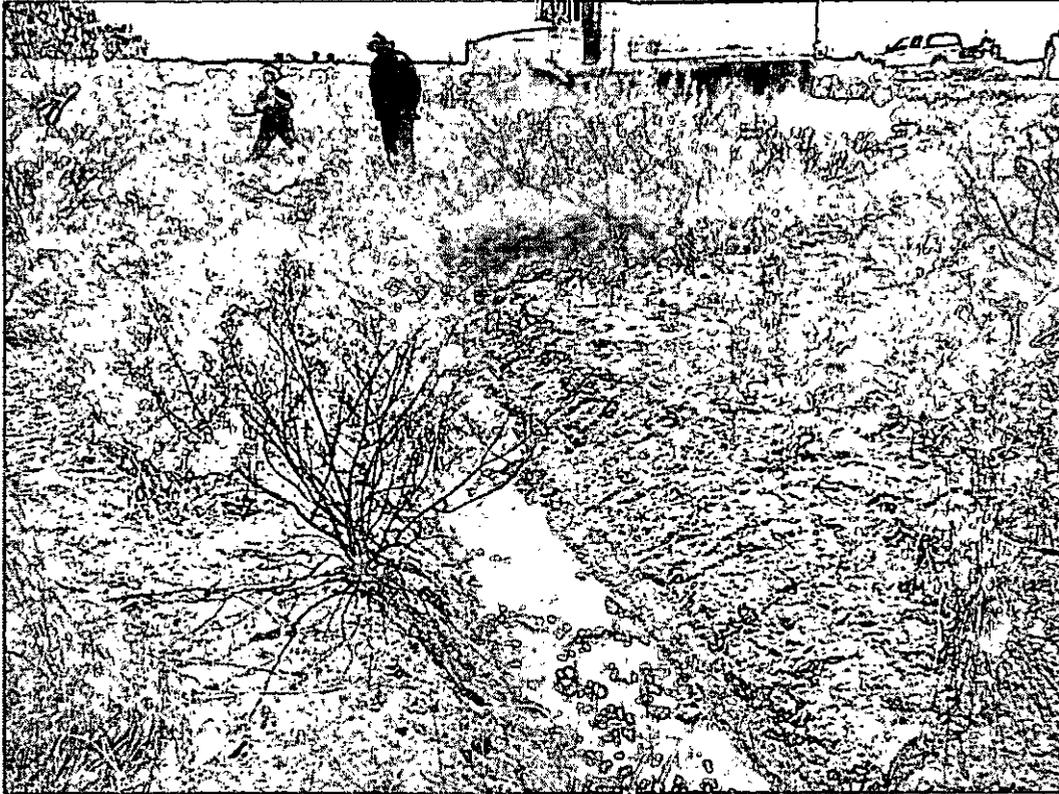
Figure 5. Photograph of the freshwater "Washing" technique utilized to remediate the impacted portion of the ephemeral wash at the Tunstil #1286 Release Site (Looking Northeast)

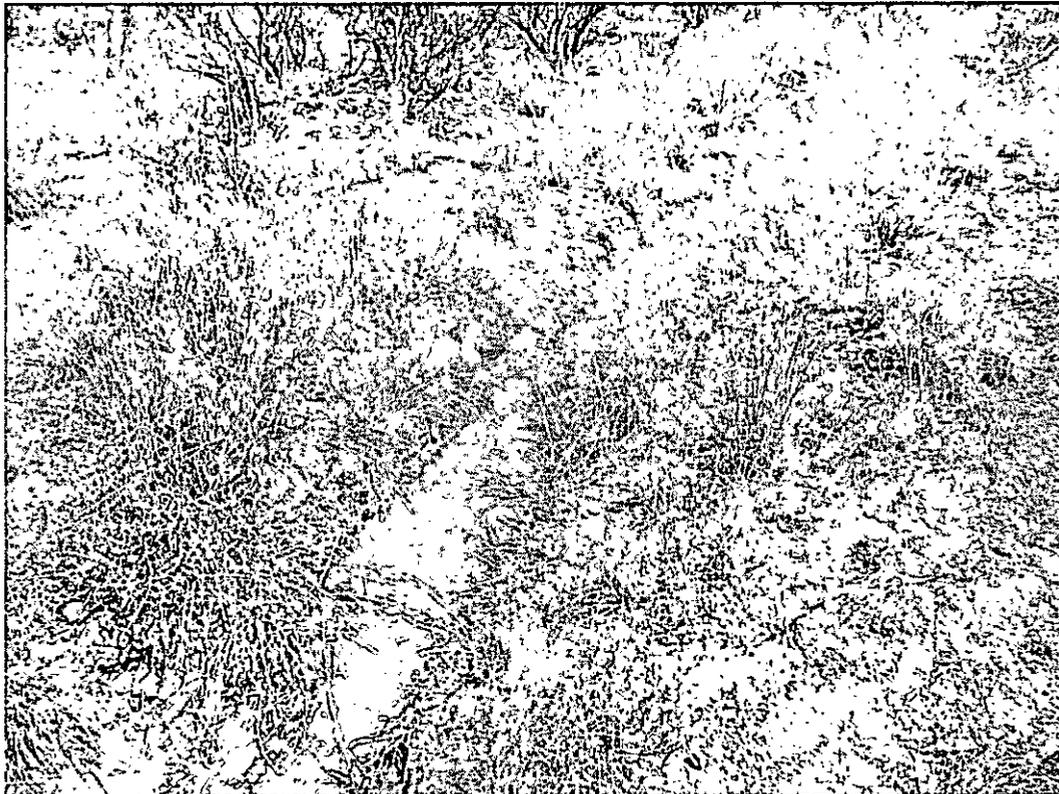
Figure 6. Photograph of the freshwater "Washing" technique utilized to remediate the impacted portion of the ephemeral wash at the Tunstil #1286 Release Site (Looking North)

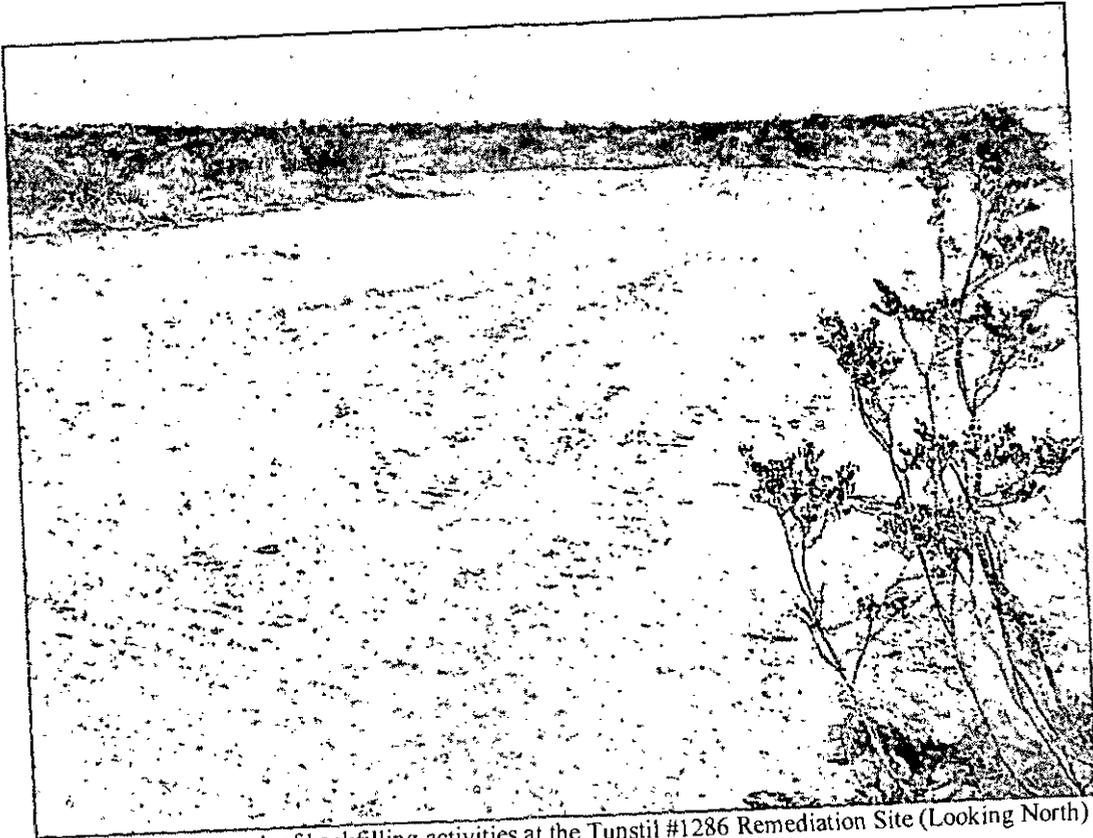
Figure 15. Photograph of backfilling activities at the Tunstil #1286 Remediation Site (Looking North)

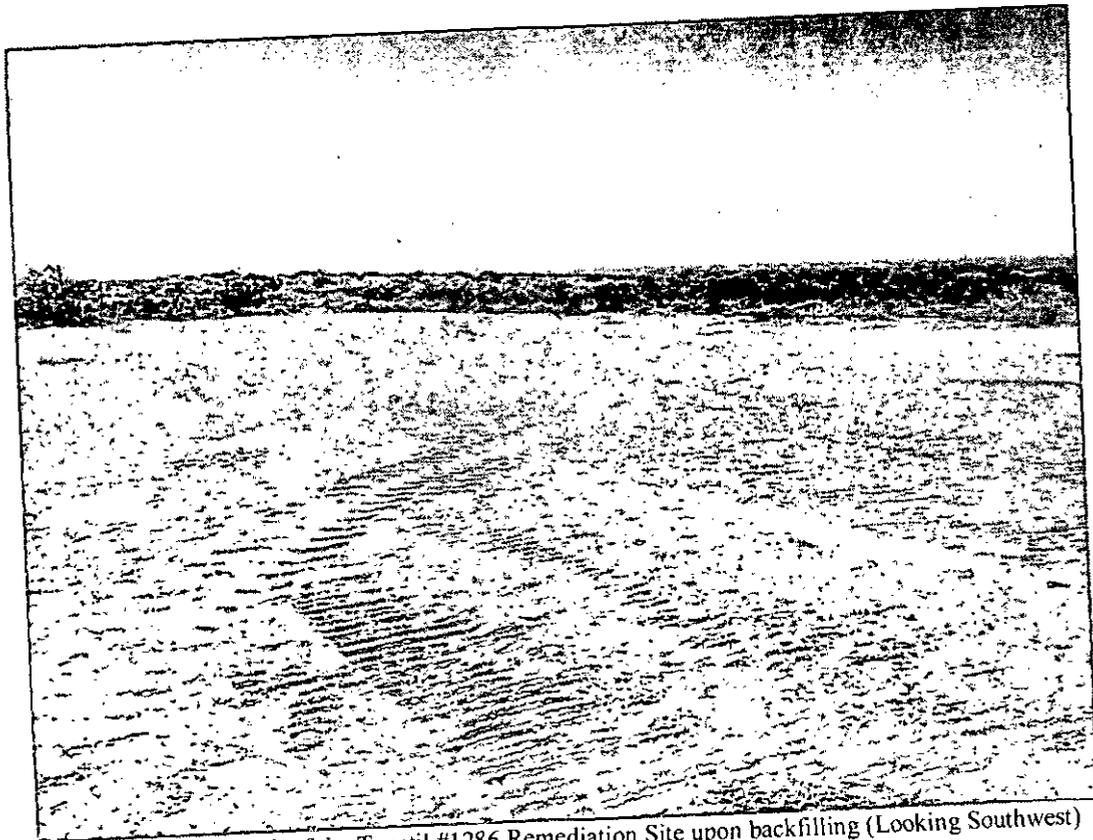
Figure 16. Photograph of the Tunstil #1286 Remediation Site upon backfilling (Looking Southwest)
