**Corrective Action
Report**

Manzanares Compressor Station Sump Overflow
Unit G, S17 T29N R9W
San Juan County, New Mexico

January 4, 2012
SWG Project No. 0411019

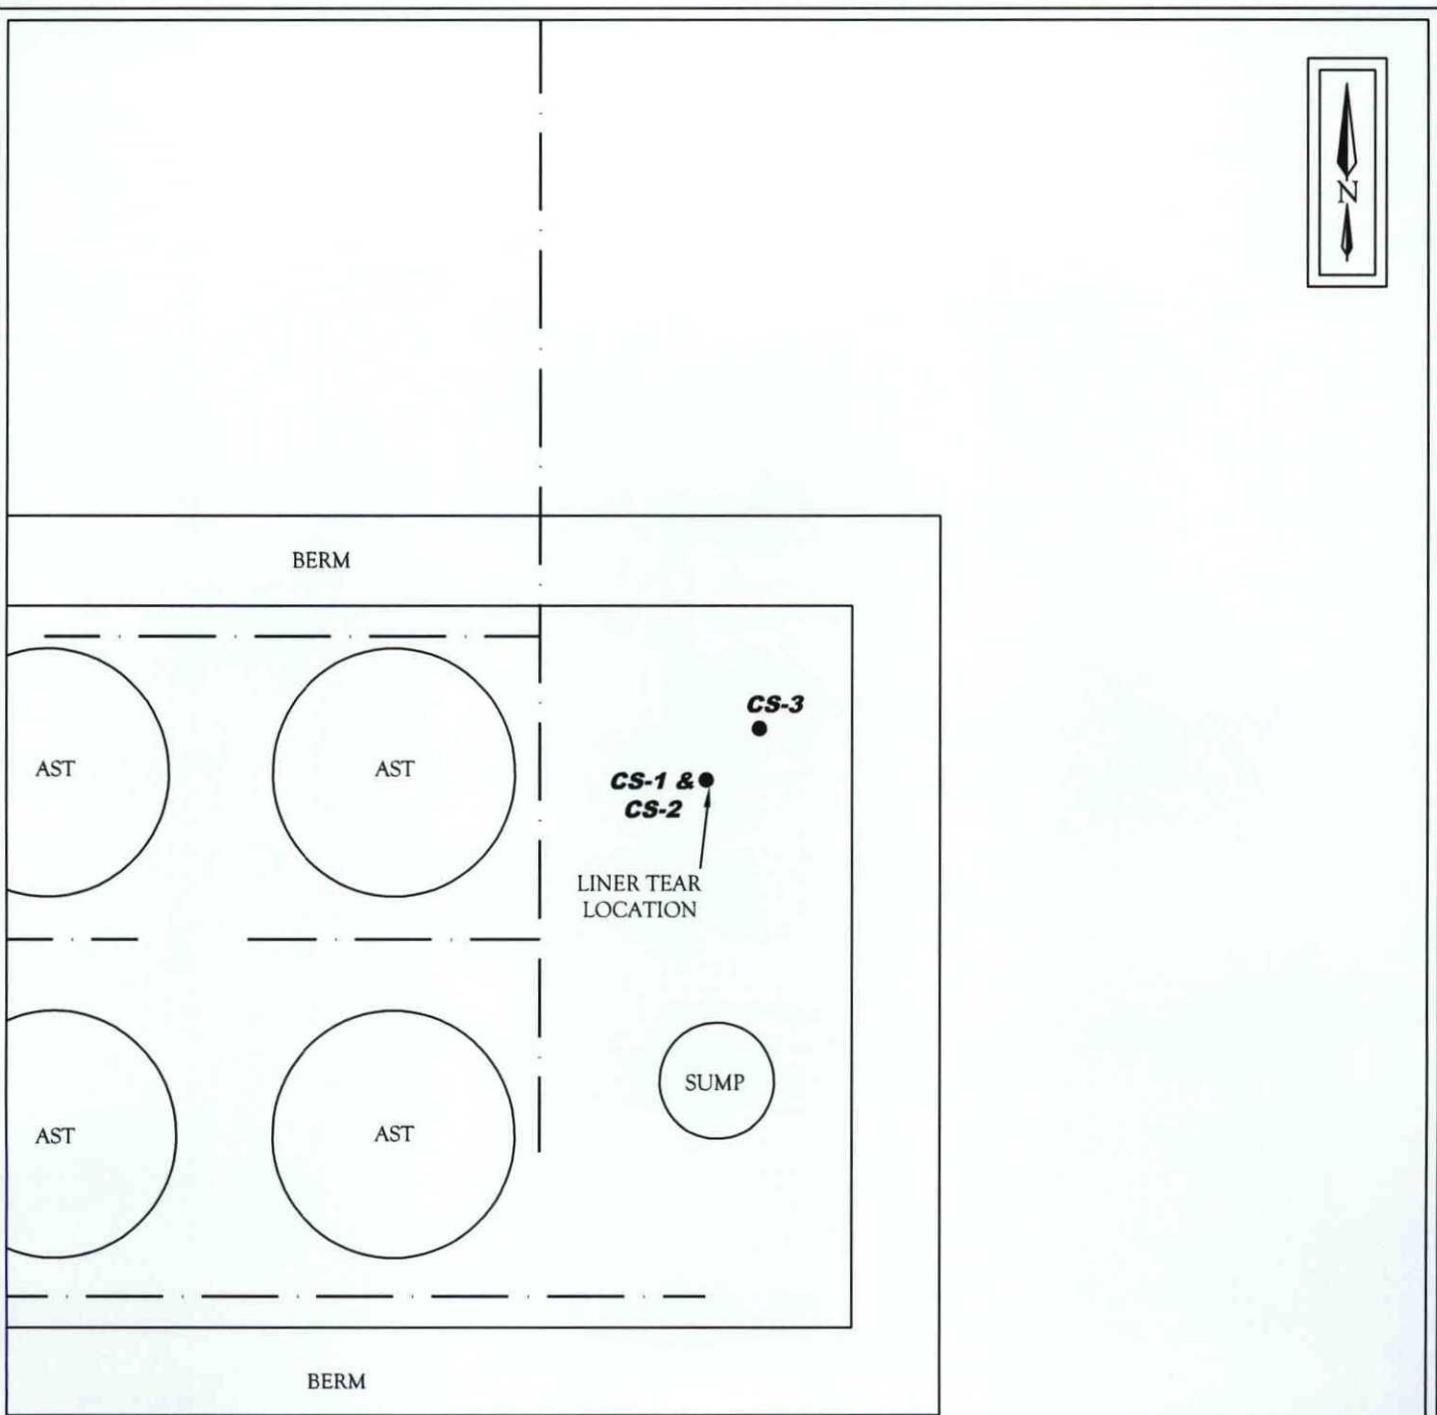
Figure 3
Site Map

Figure 3 is a Site map that indicates the approximate location of the delineation samples in relation to pertinent Site features (Appendix A). Photographic documentation of the field activities is included in Appendix B.

Figure 3 (Appendix A) depicts the approximate dimensions of the containment area, and the analytical sample locations.

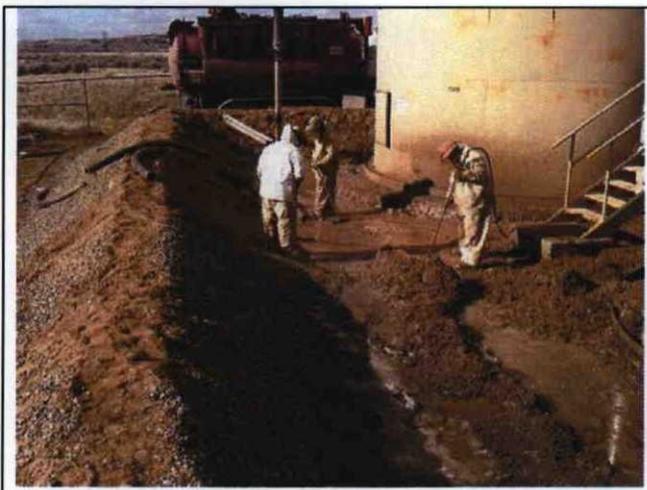
1.) View of clay and road base removal activities.

Clay and road base material present on the containment floor were removed by Riley Industrial Services, Inc. (Riley). Riley utilized hydro-excavators to remove the material from the floor of the containment, at which time a 14 inch tear in the liner was identified near the northeast corner of the containment structure.

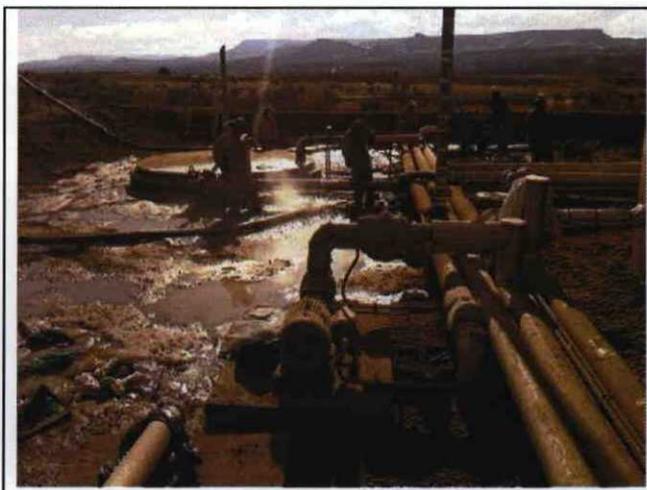
2.) View of clay and road base removal activities.

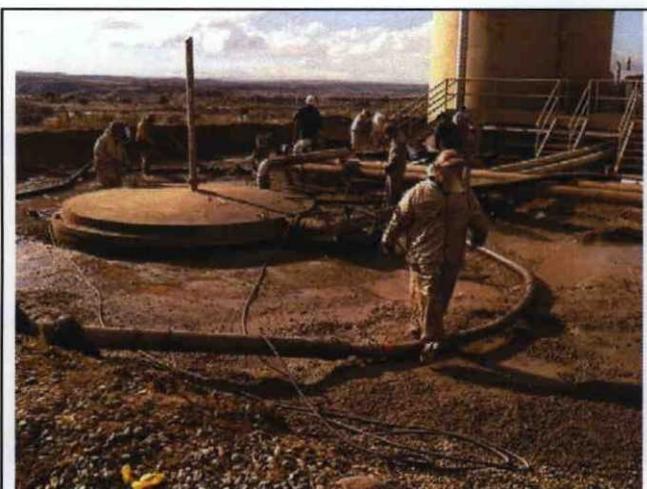
3.) View of clay and road base removal activities. Sump is visible in left of frame.

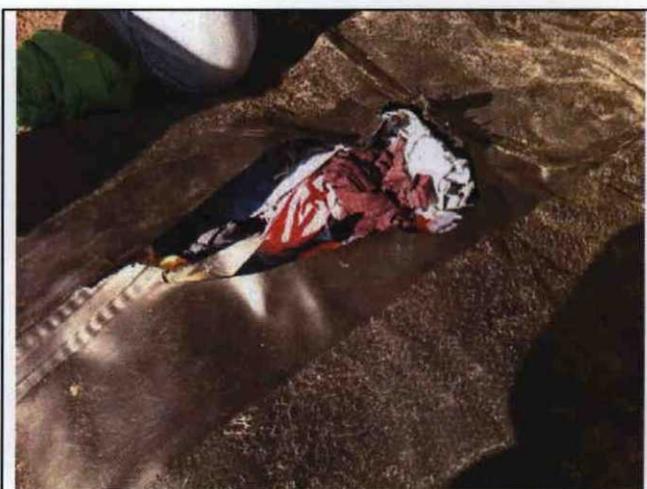
During hydro-excavation activities, a 14 inch tear in the liner was identified near the northeast corner of the containment structure. To address this potential release to the environment, delineation activities were initiated on December 20, 2011.

- Based on the size, shape, and location of the liner tear, it is very possible that it resulted during clay and road base removal activities. Alternatively, if the liner tear was present prior to the sump overflow, the underlying clayey lithology, combined with the weight of overburden from the clay and road base material that were above the liner, appear to have significantly limited any vertical or lateral migration of condensate into the underlying soils.

4.) Discovery of tear north of sump. Rags used to hold up liner during remaining cleaning activities.

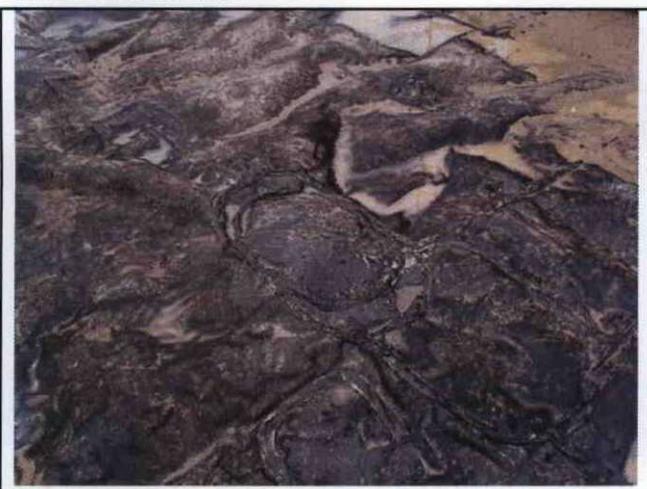
5.) View of tear after repair.

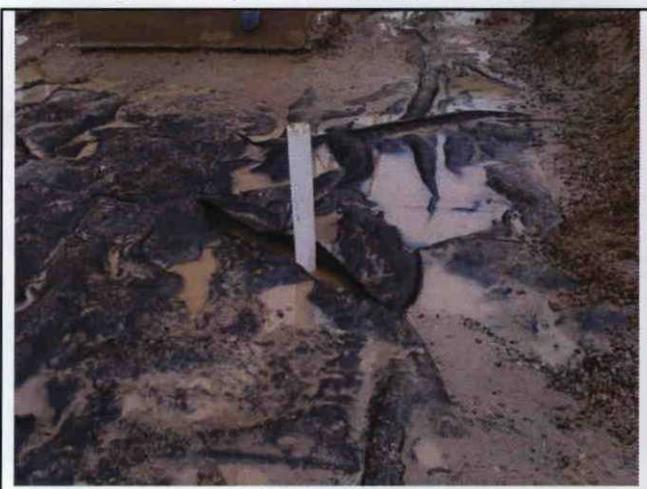
In coordination with the OCD, SWG utilized a hand auger to collect delineation samples from selected locations beneath the containment liner. To determine sample collection depths, SWG screened separate head-space samples of the sub-liner soils with a photoionization detector (PID) fitted with a 10.6 eV lamp. With OCD concurrence, SWG advanced 2 shallow soil borings beneath the liner. Two samples, CS-1 and CS-2, were collected from directly beneath the liner tear at depths of 1 foot bgs and 1.5 feet bgs, respectively. A third soil sample, CS-3, was collected beneath the liner at a nearby pooling area that appears to be one of the lowest, if not the lowest area within the containment, at a depth of 2 feet bgs.

6.) View of sample location CS-3 in pooling area. PVC used to keep water out of boring. Water on liner drained to ground from above, after liner was cut for sample access.
