## **Site Remediation Summary**

**Pure Gold A Federal #8**

**Eddy County, NM**

**API 30-015-35296**

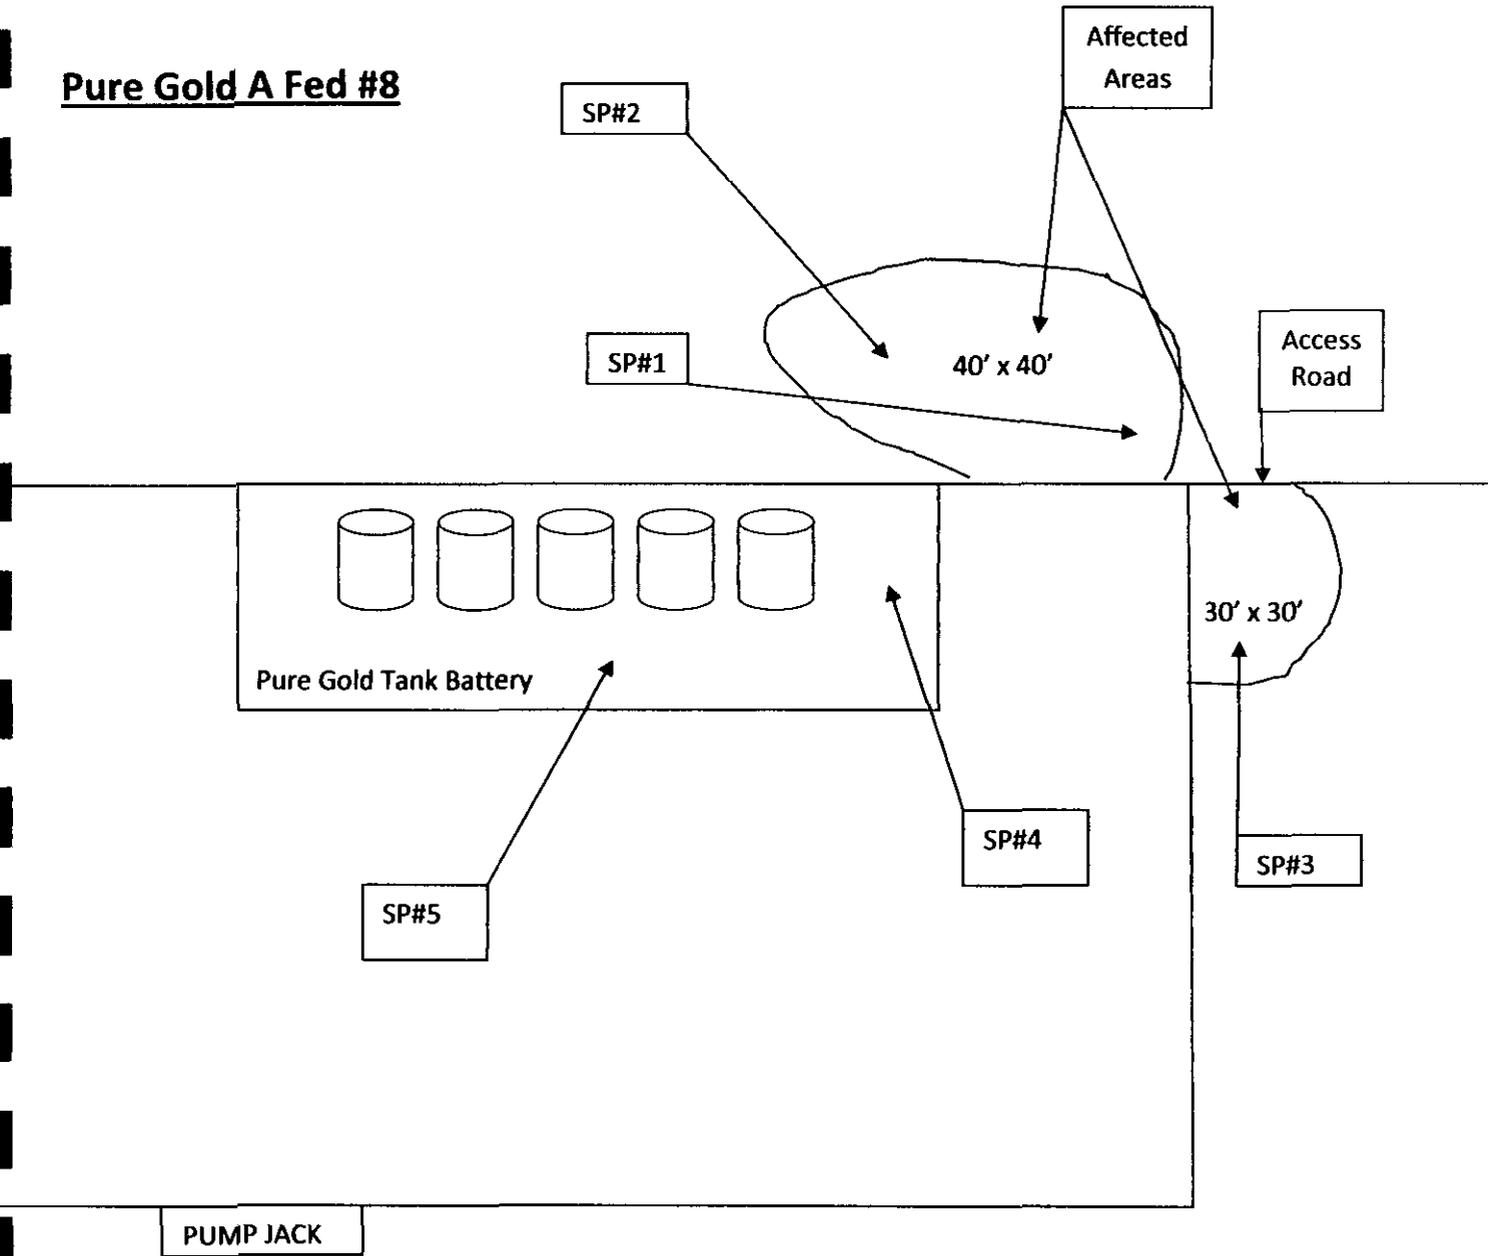
**Pure Gold A Fed #8**

The affected area south of the tank battery had two spots that were remediated, SP 1&2. SP1 had very low concentrations of contaminants with only slight discoloration and was remediated by blending this soil in with deeper soil. SP2 had surface contamination only and was remediated by removing approximately one foot of contaminated soil and backfilling with clean material. The affected area was then contoured to match the surrounding landscape and re-seeded using a BLM #2 seed mixture.

The affected area west of the tank battery, SP3, was remediated by removing five feet of contaminated material from an area approximately 30' x 30'. Once soil analysis confirmed the outward perimeter of contamination had been remediated, the excavated area was lined with a 20mil synthetic liner, and backfilled with clean material. The affected area was then contoured to match the surrounding terrain and re-seeded using the same seed mixture as the area south of the tank battery.

The inside of the tank battery, SP 4&5, had one foot of contaminated soil removed by hand. The tank battery was then lined with a 20mil synthetic liner. The liner was placed underneath all exposed lines and underneath the edges of the tanks. The area was then backfilled with clean material and topped with pea gravel.

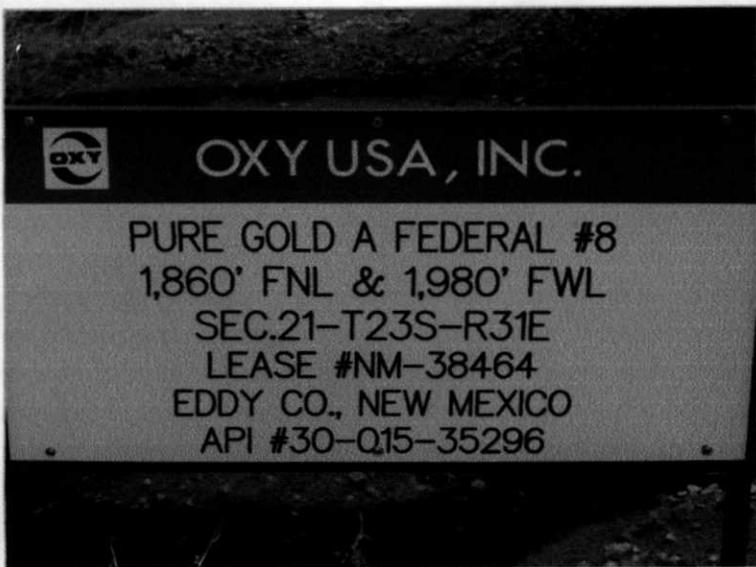
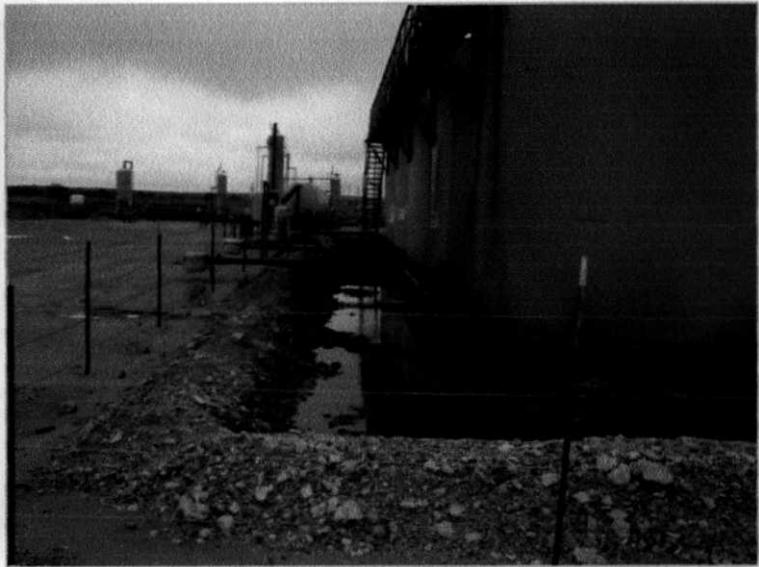
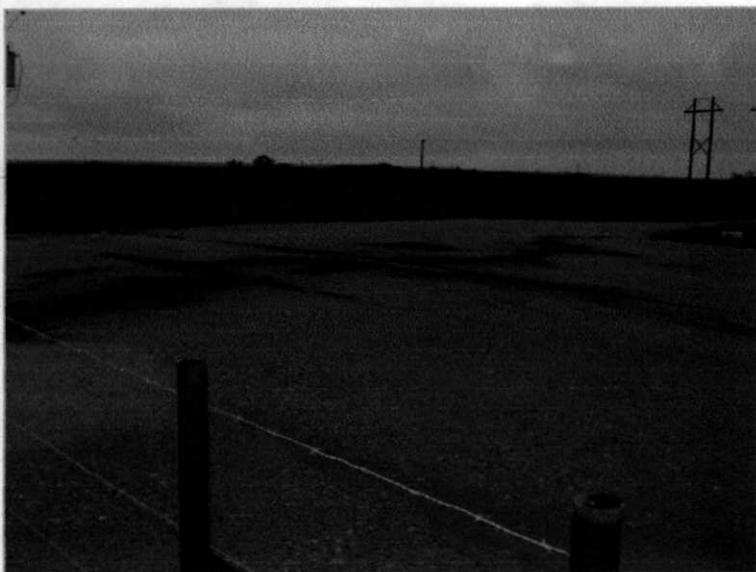
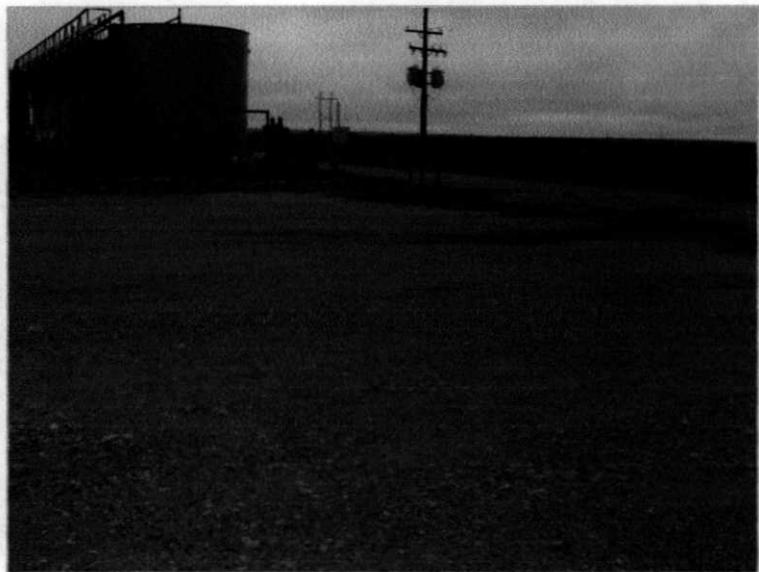
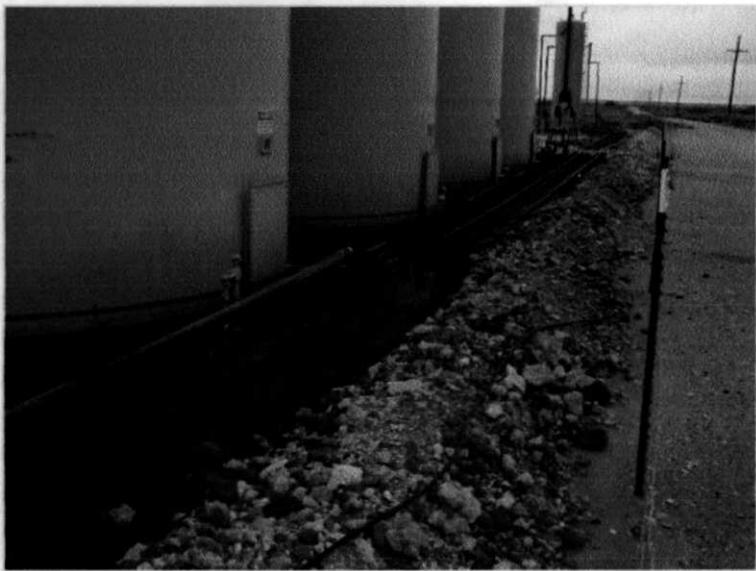
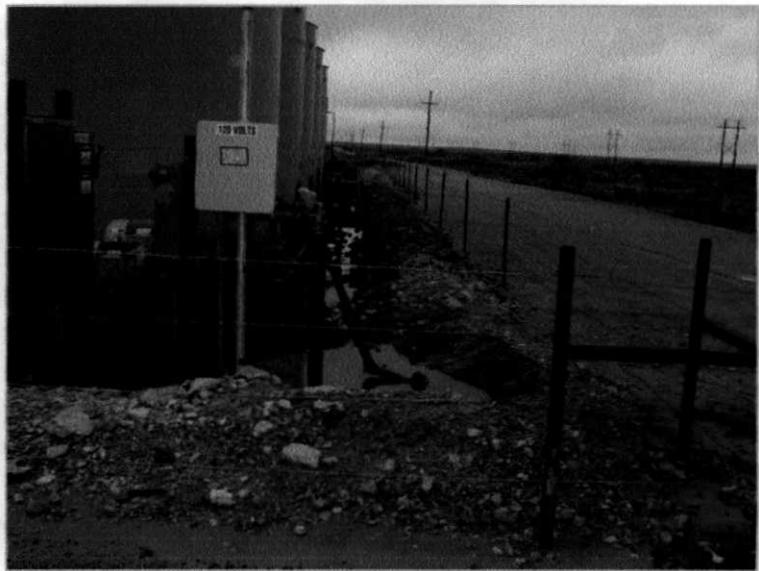
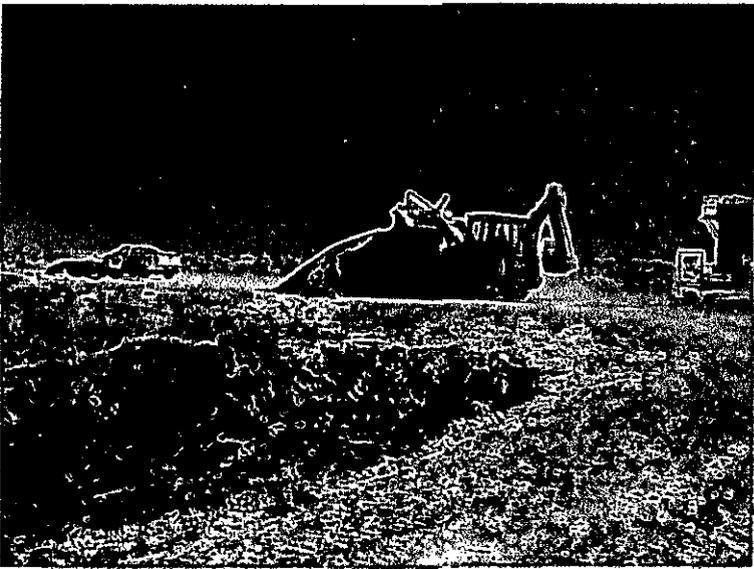
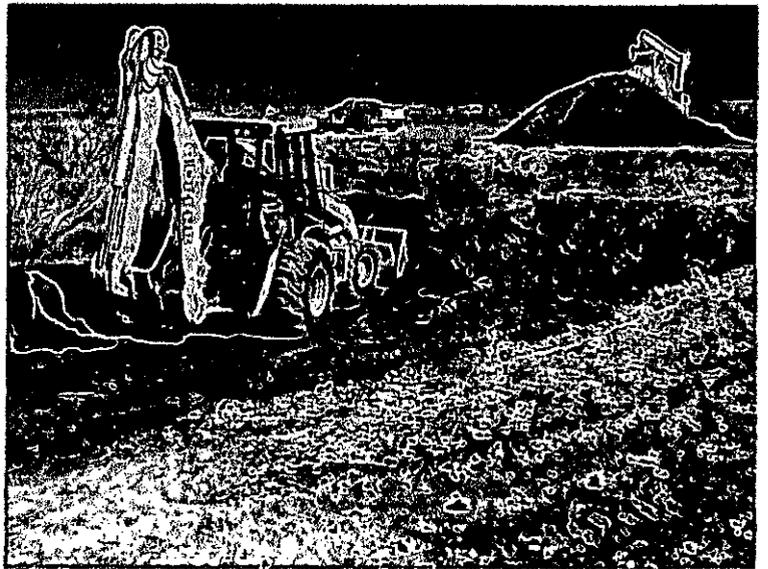
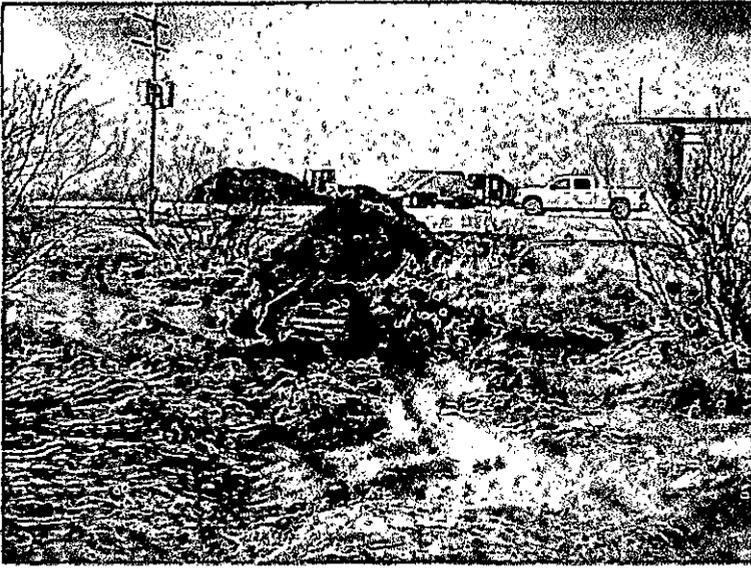
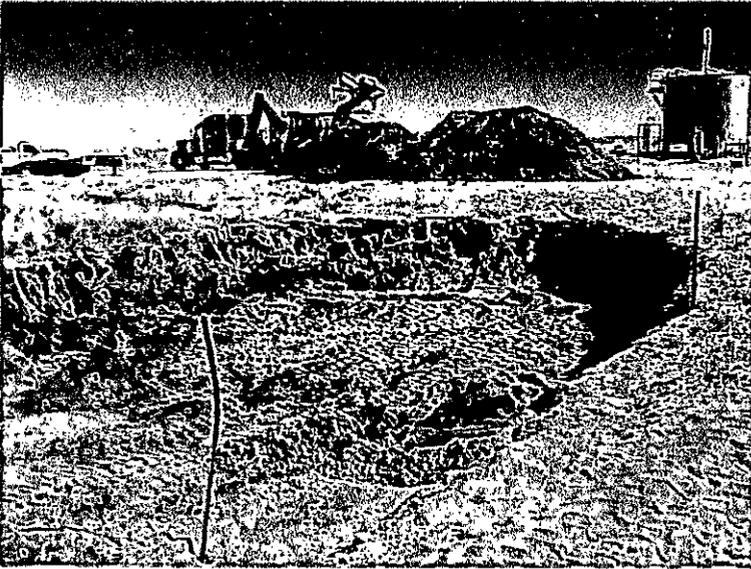
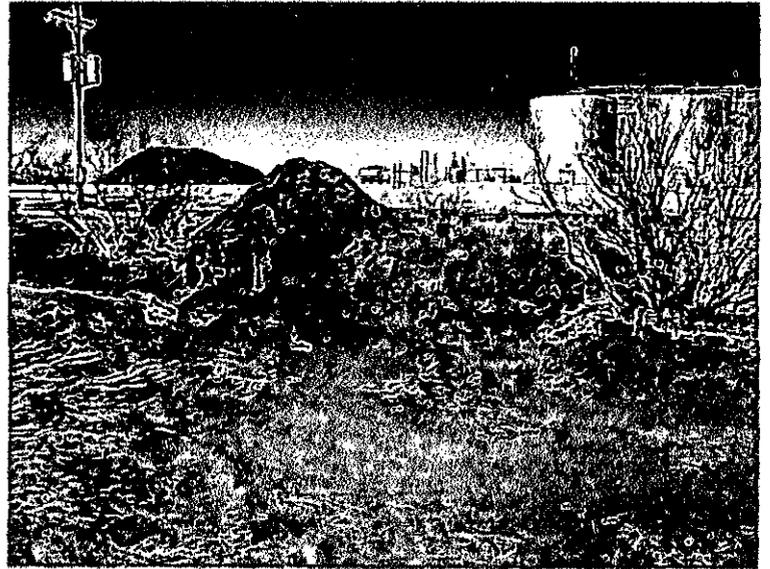
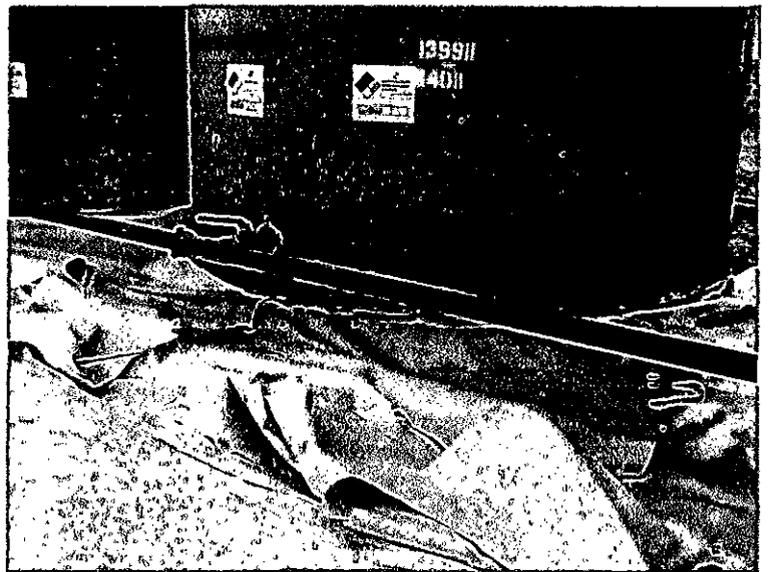
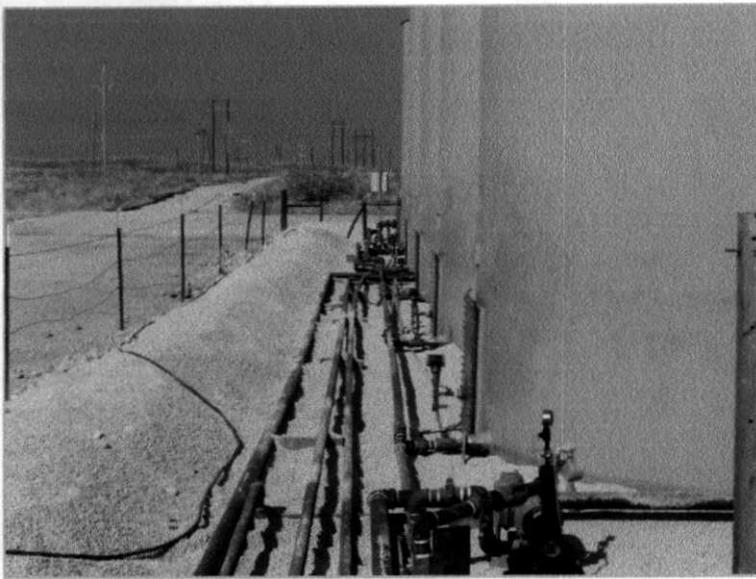
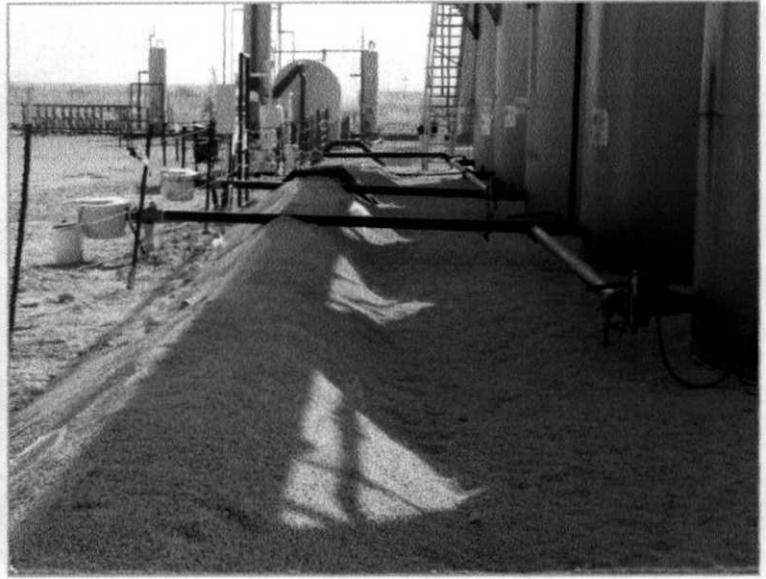
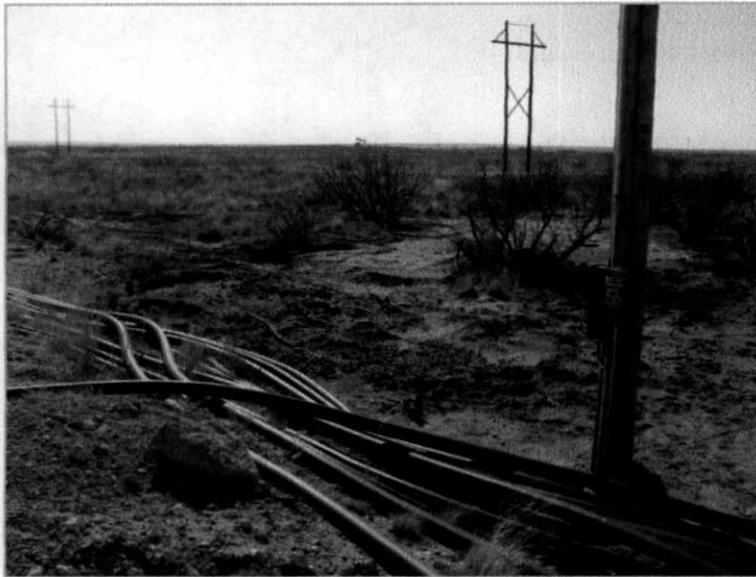
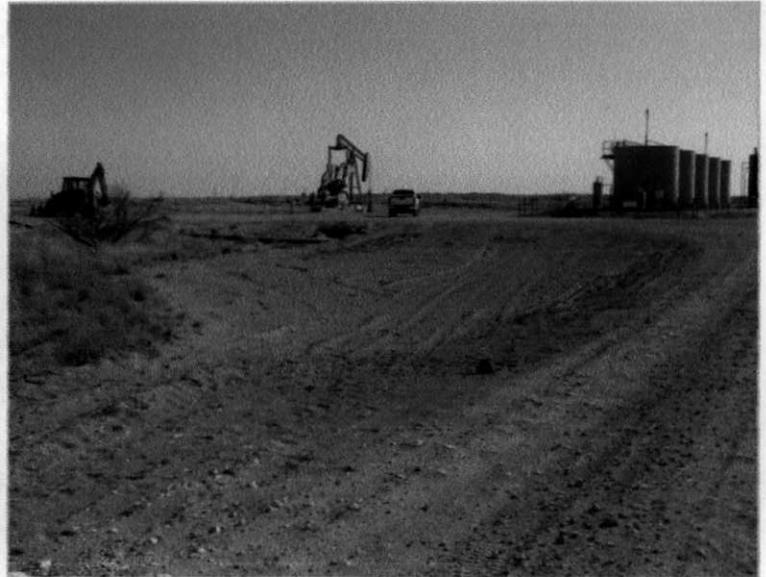
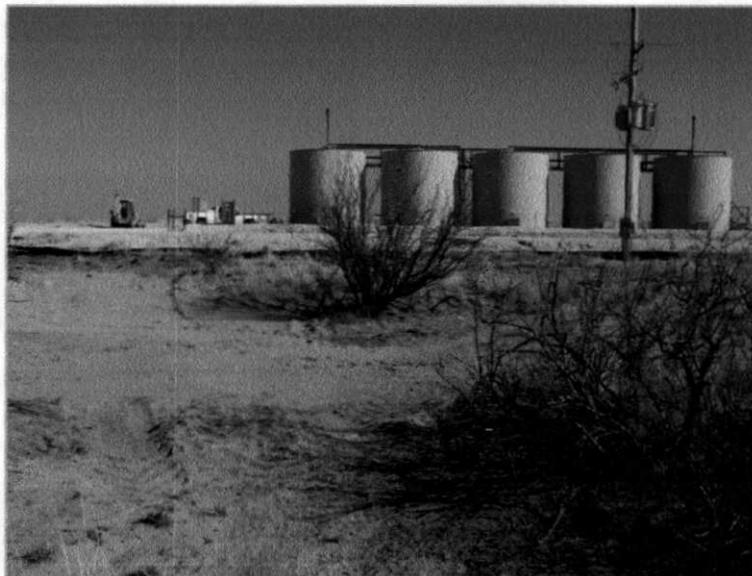
# Attachment 4

Due to having three distinct areas affected by the release, this project was divided into three separate work areas, the area south of the tank battery (SP's 1&2), the area west of the tank battery (SP 3), and the inside of the tank battery (SP 4&5). Each affected area was addressed and remediated separately. All contaminated soil was disposed of at a NM OCD approved facility.
