Report Type: Work Plan

Site:	Sand Tank 32 State Commingle #2 - 6" Water Line				
Company:	COG Operating LLC				
Section, Township and Range	Unit J	Sec. 32	T-17-S	R-30-E	
Lease Number:	API- 30-015-29513				
County:	Eddy County				
GPS:	32.78840° N			103.99165° W	
Surface Owner:	State				
Mineral Owner:					
Directions:	Intersection of 529 and CR-216 travel south on CR-216 2.2 mi to Hagerman Cutoff, continue south 0.3, turn left 1.1 mi on lease road, turn left 0.7 mi to location.

Re: Assessment and Work Plan for the COG Operating LLC., Sand Tank 32 State Commingle #2 – 6" Water Line Located in Unit J, Section 32, Township 17 South, Range 30 East, Eddy County, New Mexico.

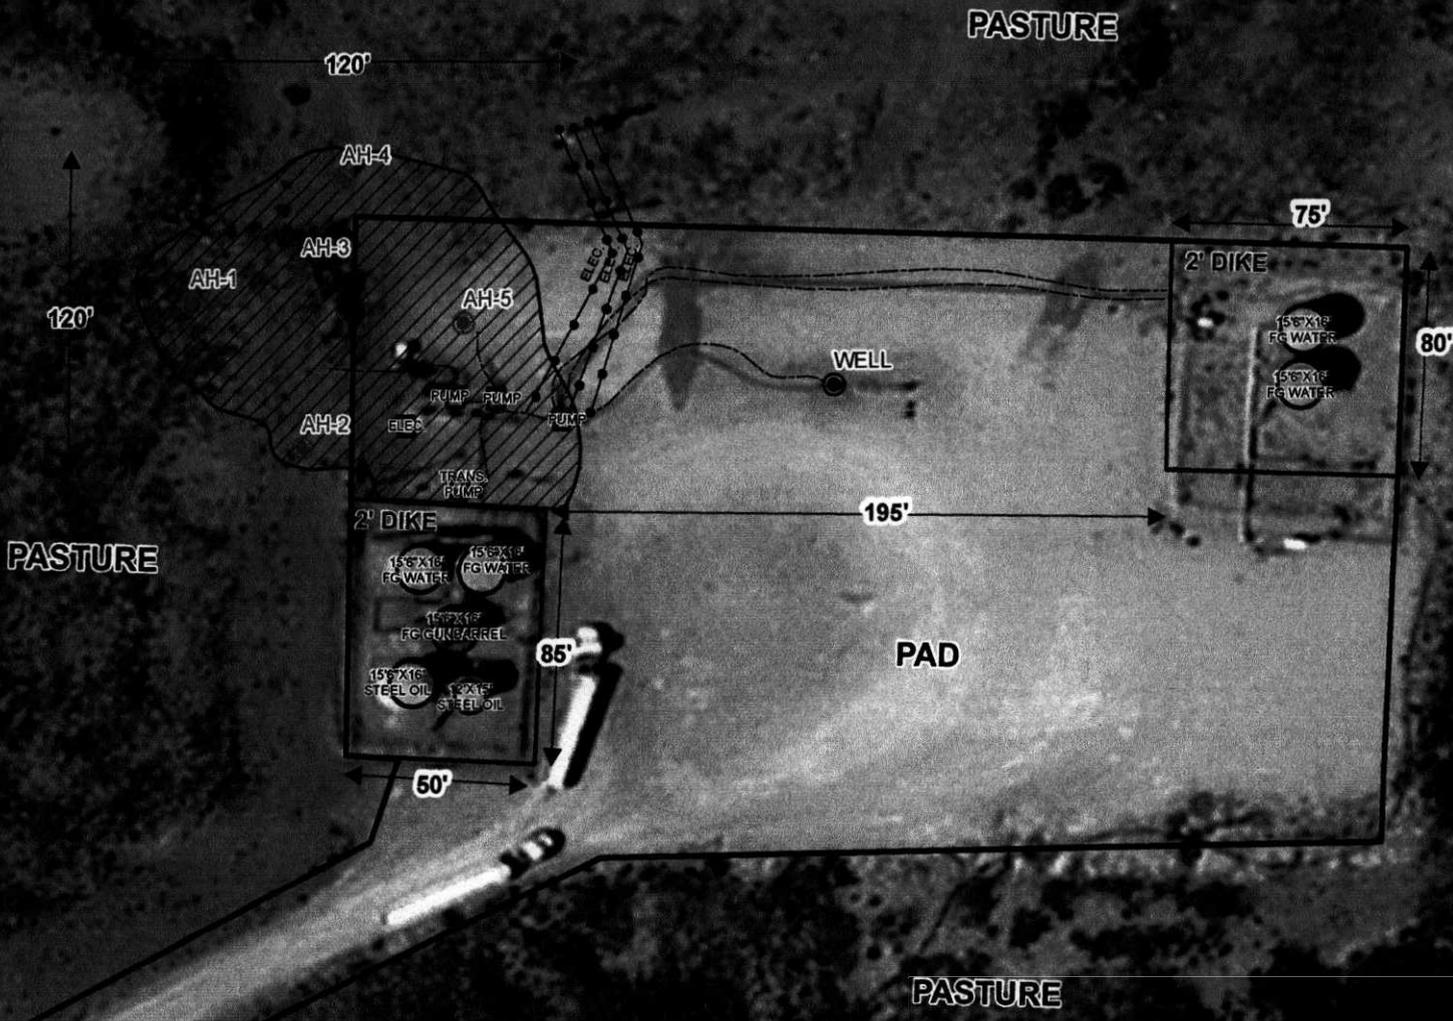
Figure 3	
Sand Tank 32 State Corn #2-6" Transition Water Line	
Spill Assessment Map	
Eddy County, New Mexico	
Project : 114-6401445	
Date : 7/26/2012	
File : H:\GIS\6401445

The spill initiated from the 6" waterline located north-northwest of the tank battery outside the facility firewalls. The impacted area measured approximately 120' x 120'. The spill footprint is shown on Figure 3. The initial Form C-141 is enclosed in Appendix A.

On July 2, 2012, Tetra Tech personnel inspected and sampled the spill area. A total of five (5) auger holes (AH-1 through AH-5) were installed using a stainless steel hand auger to assess the impacted soils to a maximum depth of 10-10.5' below surface. Selected samples were analyzed for TPH analysis by EPA method 8015 modified, BTEX by EPA Method 8021B and chloride by EPA method 300.0. The sampling results are summarized in Table 1. The auger hole locations are shown on Figure 3. Copies of laboratory analysis and chain-of-custody documentation are included in Appendix C.
