| | DATE | DEPARTMENT | PREPARED BY |
|--|---|--|---|
| C-141 ZRP-401 Site #1 Site Summary + Closure Data E-mail Correspondence Site Sketch " " | 4/7/15 | | T. Gay |

Release Notification and Corrective Action

Bass 3 Federal #4 Flowline Spill #1

Ranking Analysis, Remediation Plan and Closure Request

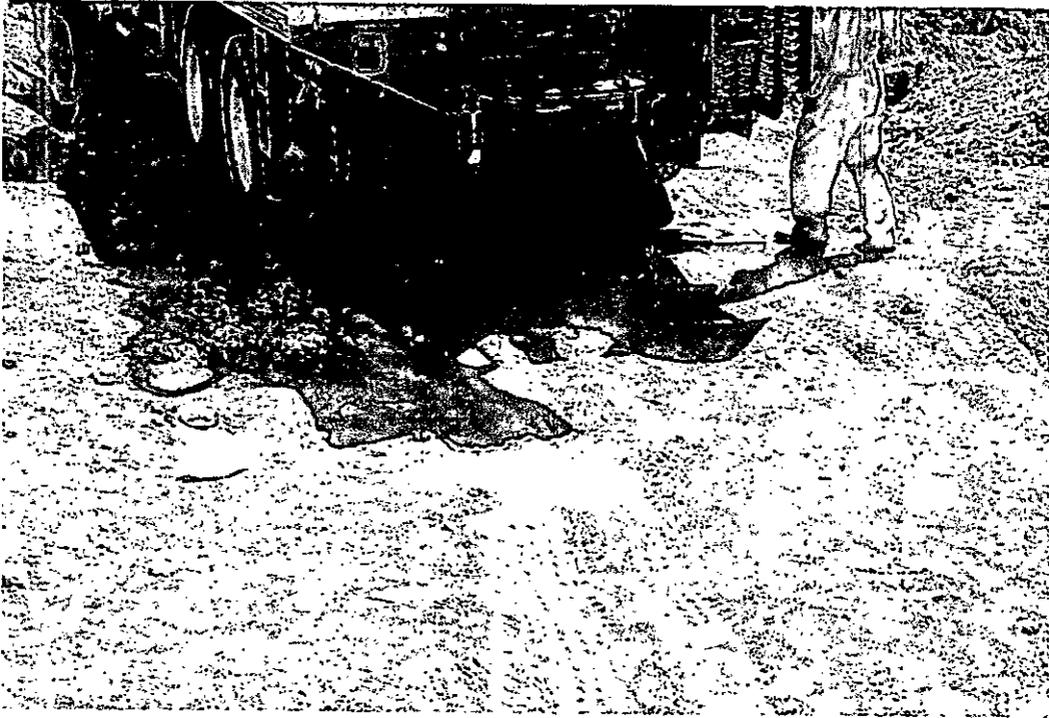
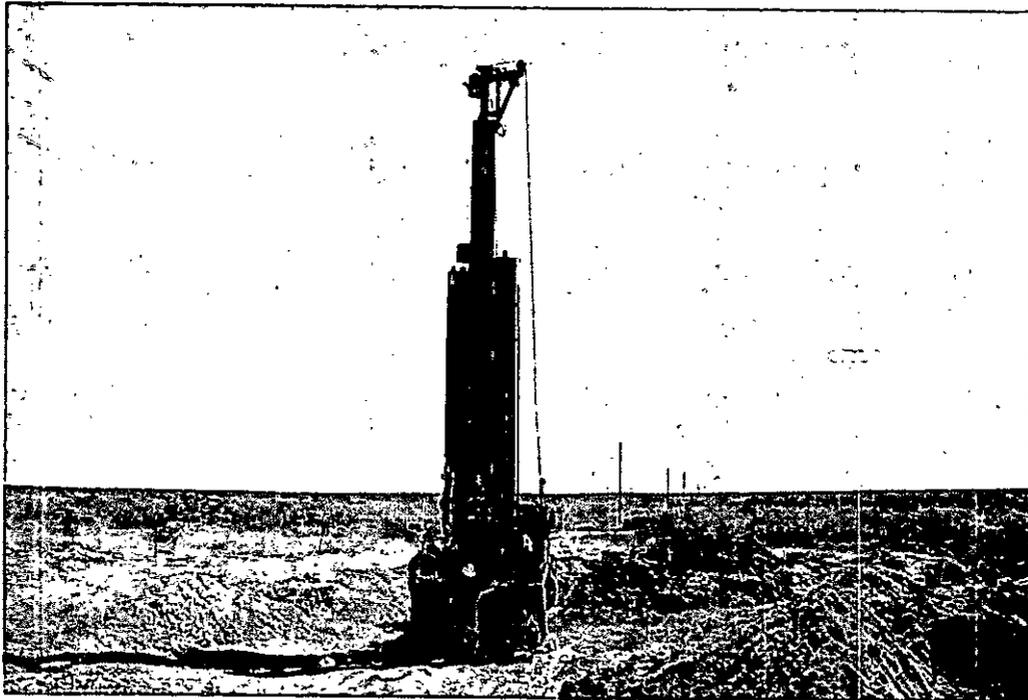
Photos 4/27/10 Struab drilling horizontal extent Site #1

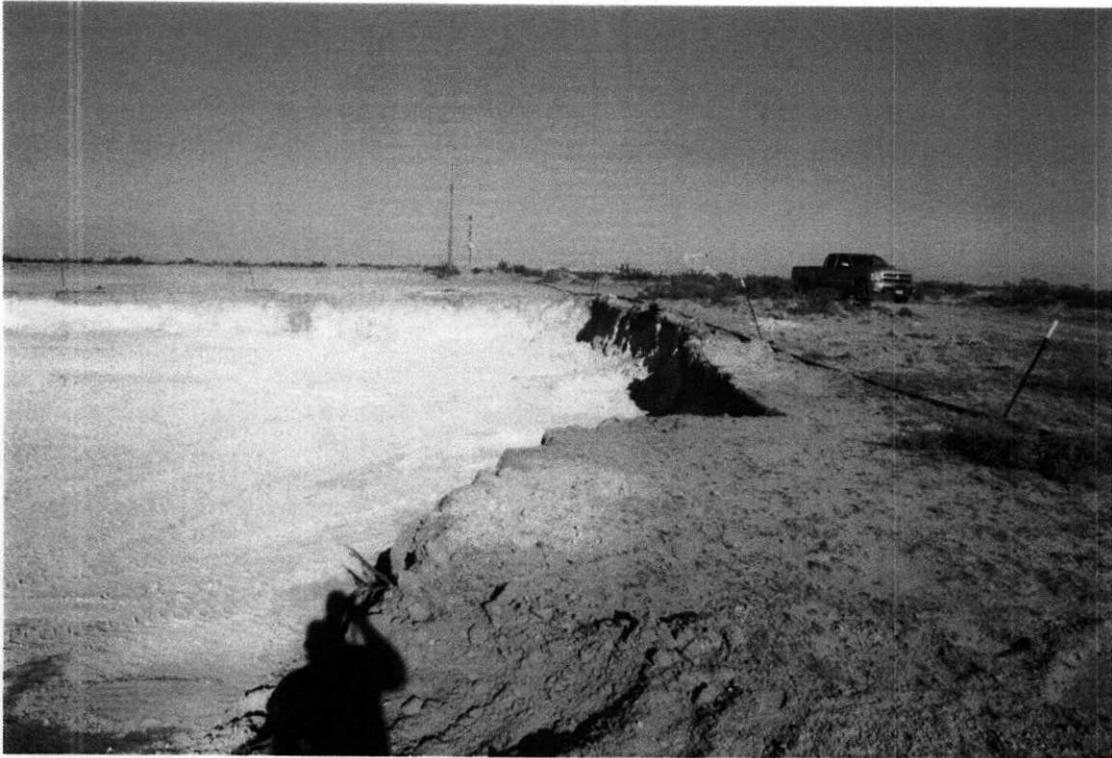
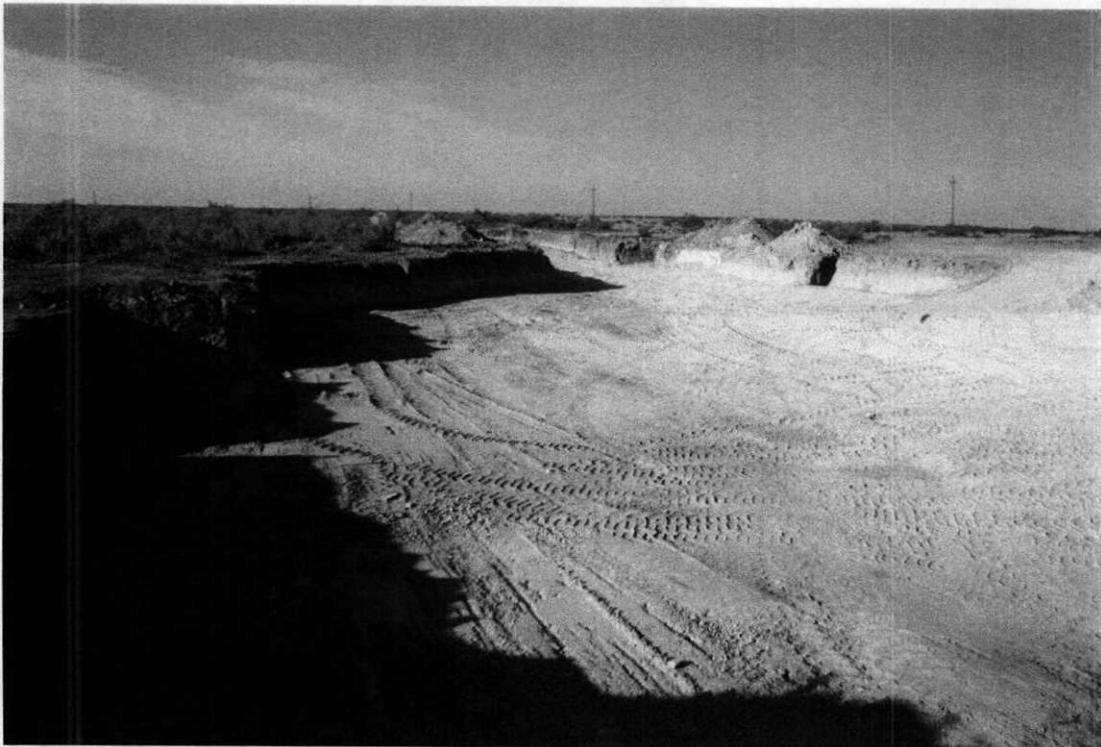
Photos 6/17/10 After floor prep

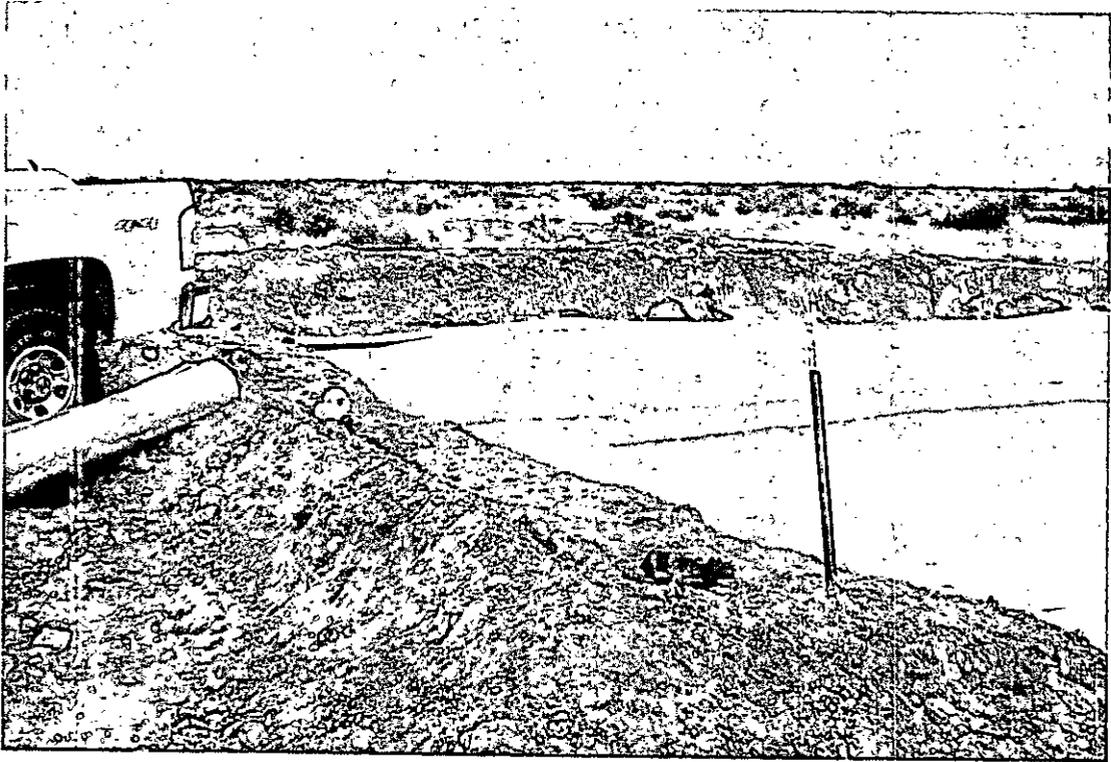
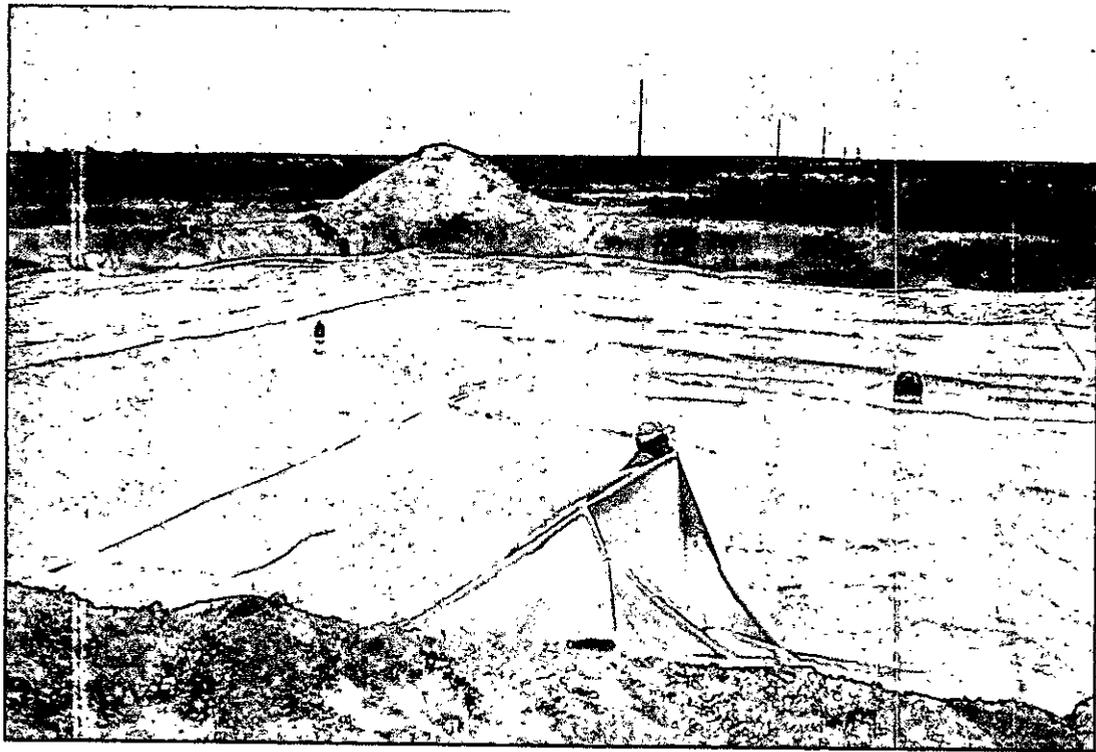
Liner installation Area #1 on 7/21/10

Place a minimum of 1 ft. of clean pad material in the entire bottom of the excavation, cover the entire bottom of the excavation with a liner, spec. 20 Mil FT2. Lay in 1 ft. of rock free pad material on top of the liner, then complete the backfill with clean soil. The backfill material will be water packed while being placed into the excavation. Final restoration will be in compliance with the BLM assuring contouring and seed mix is adequate for the area.

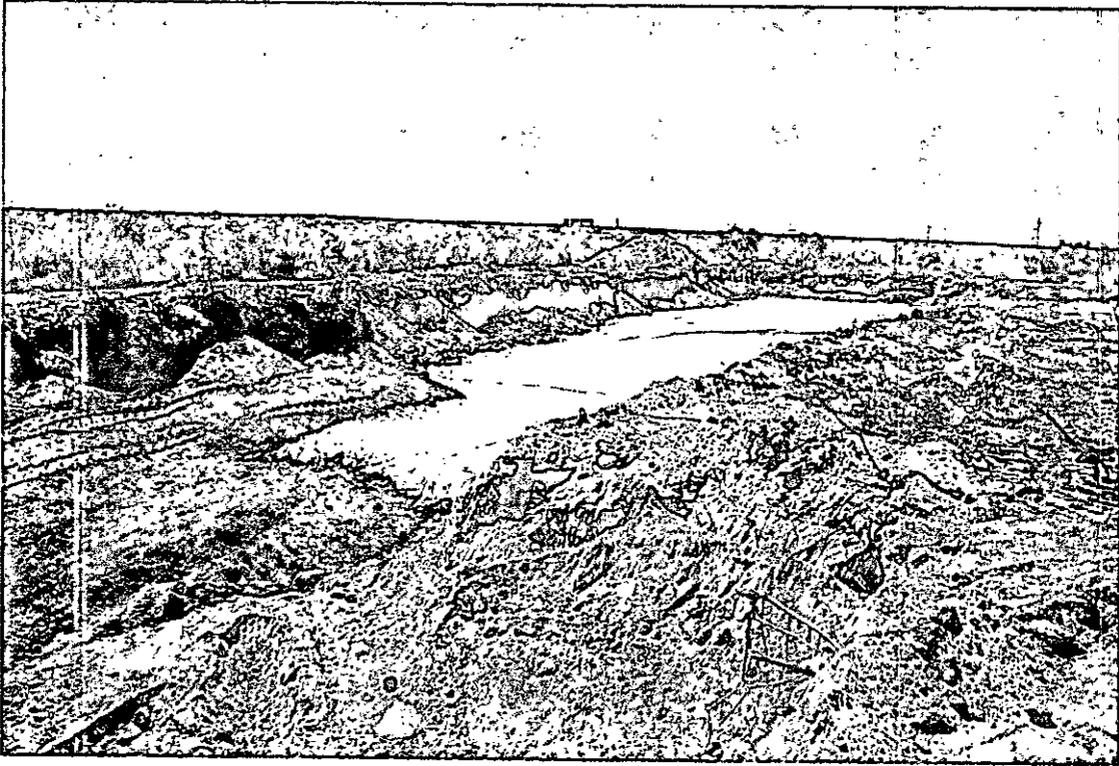
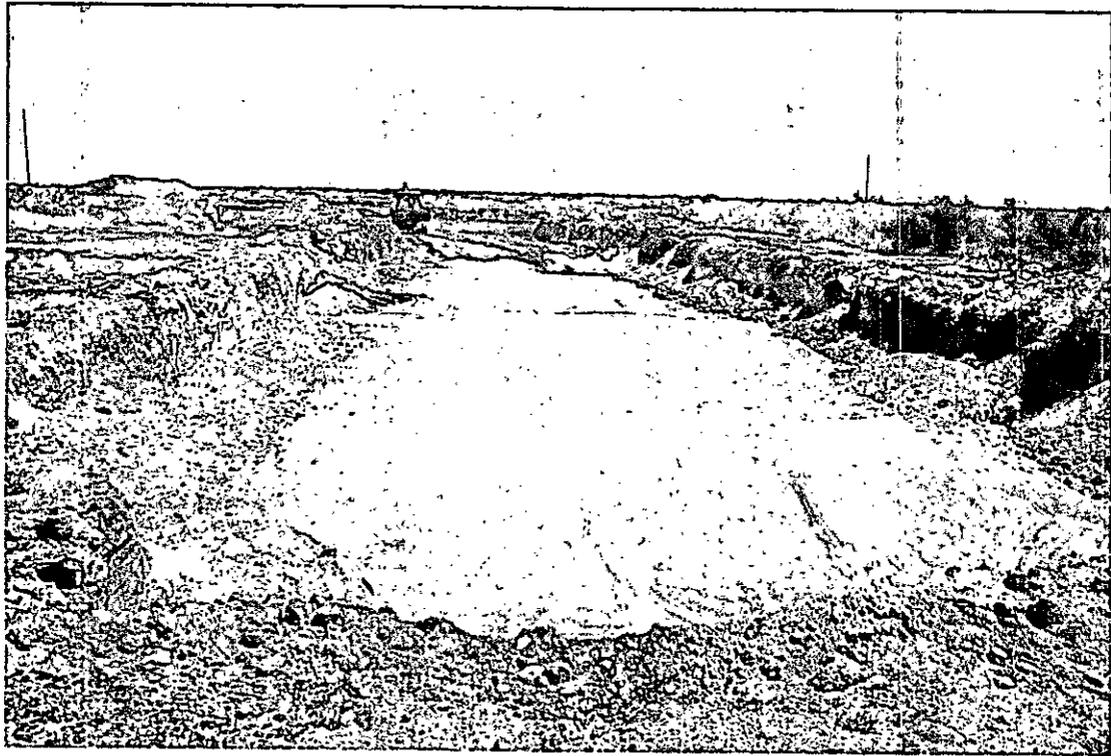
Laying in clean sand 7/22/10

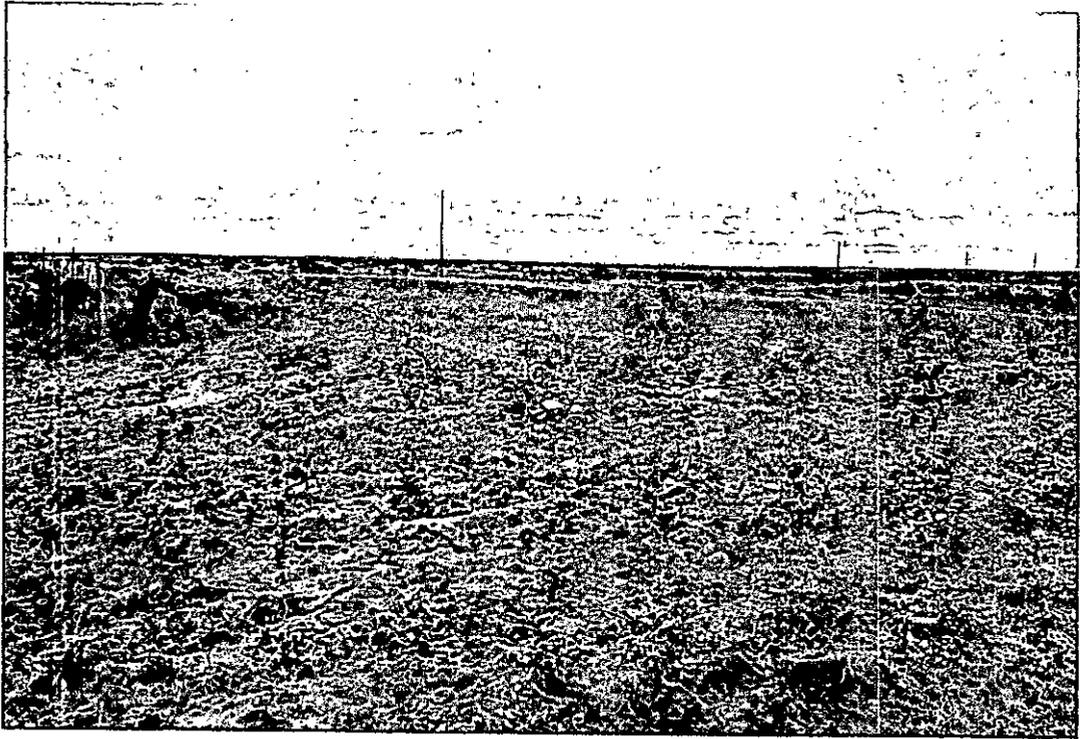
After backfill and re-seeding 9/20/10

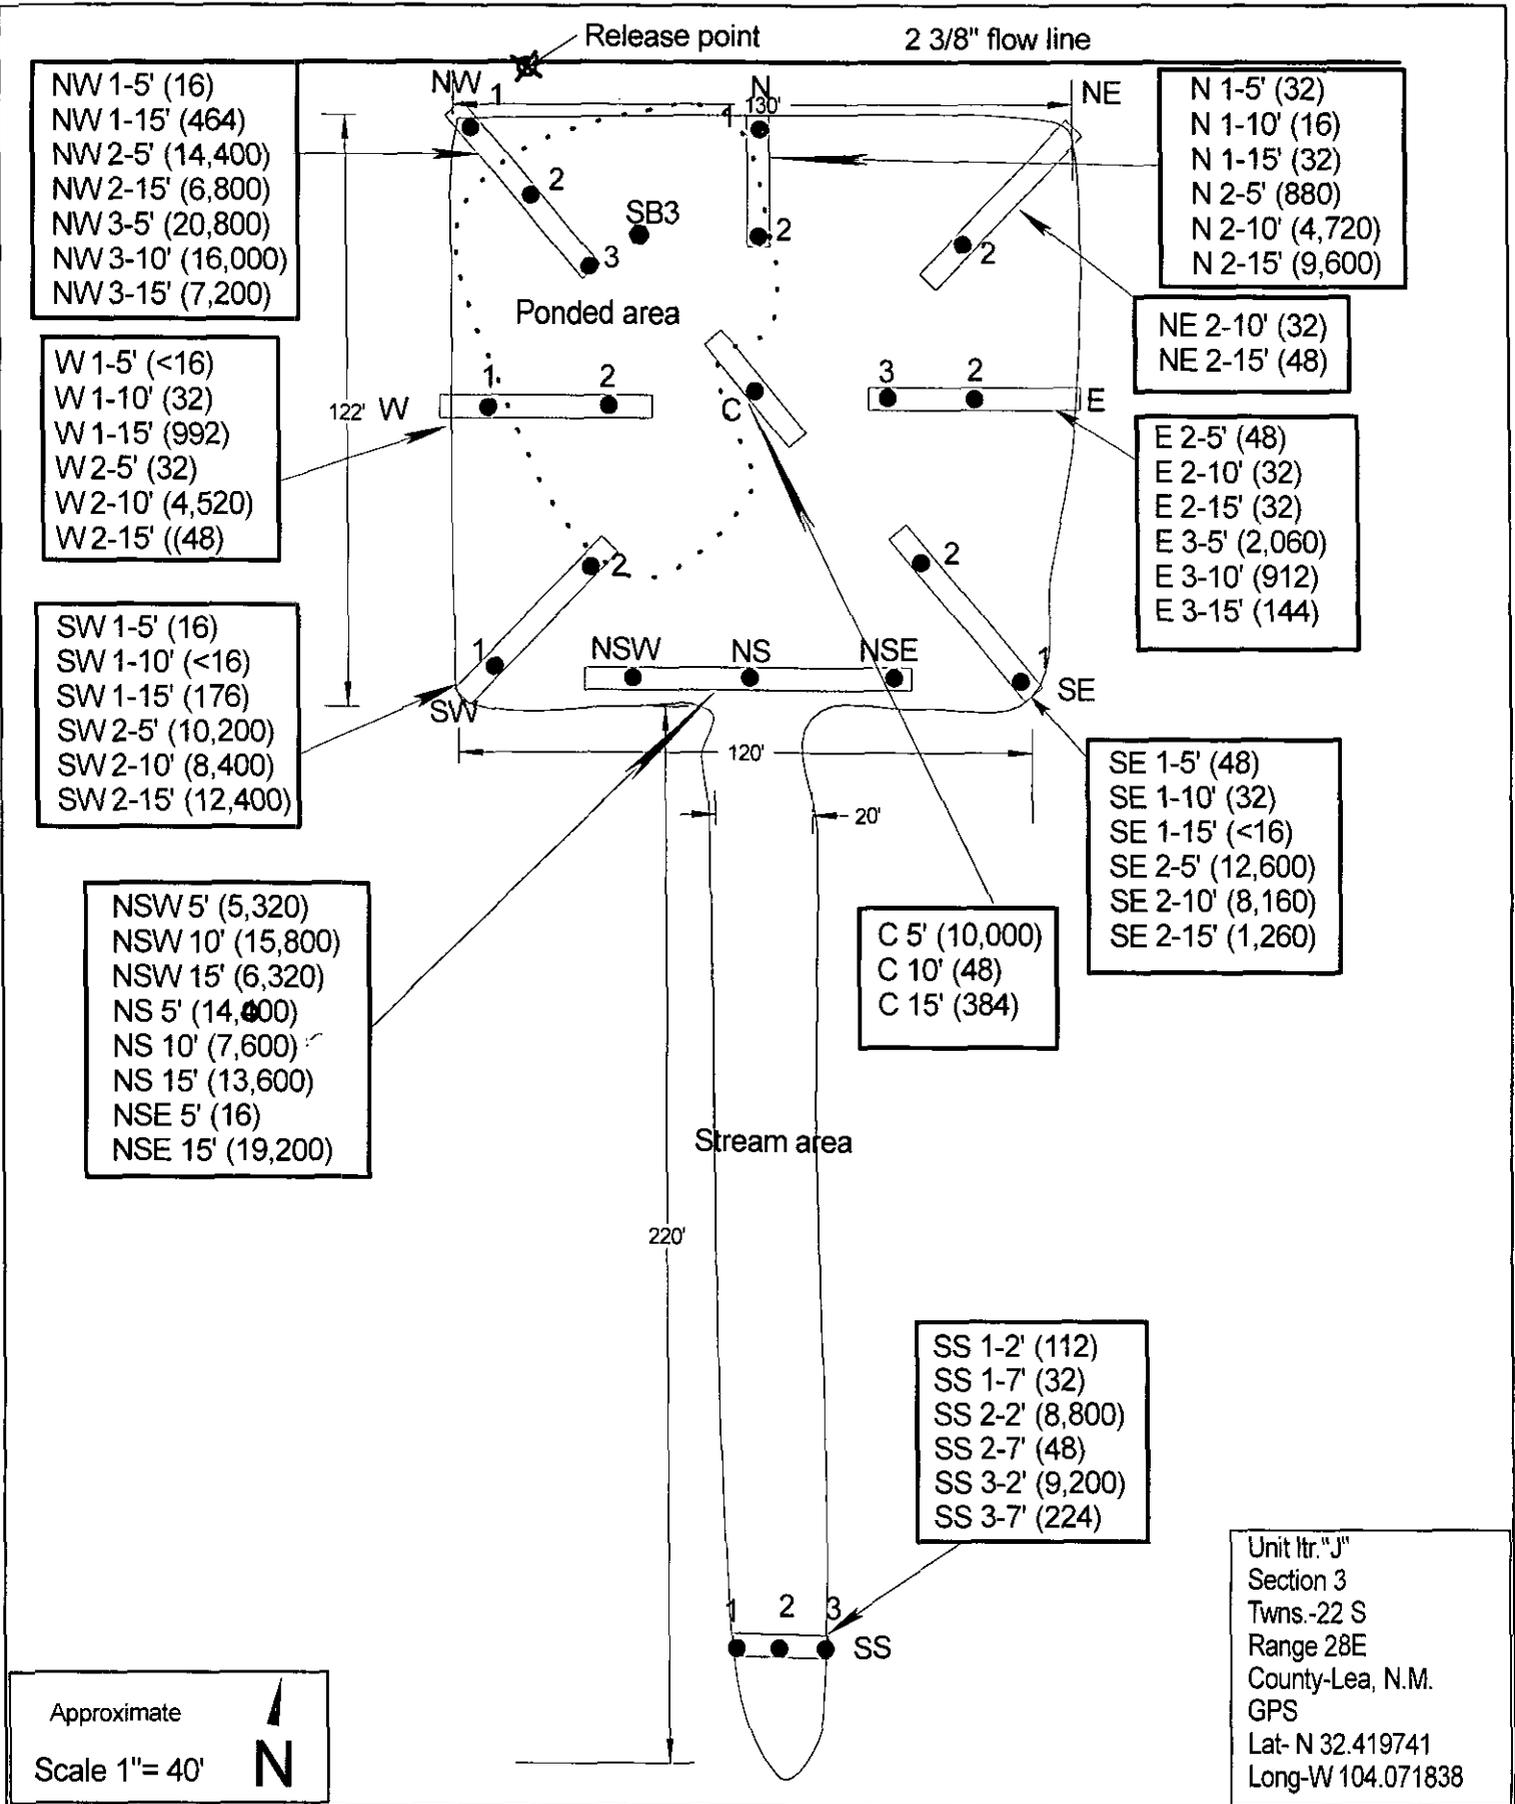
Figure 1-Chlorides

SITE PLAN: Bass 3 Federal #4

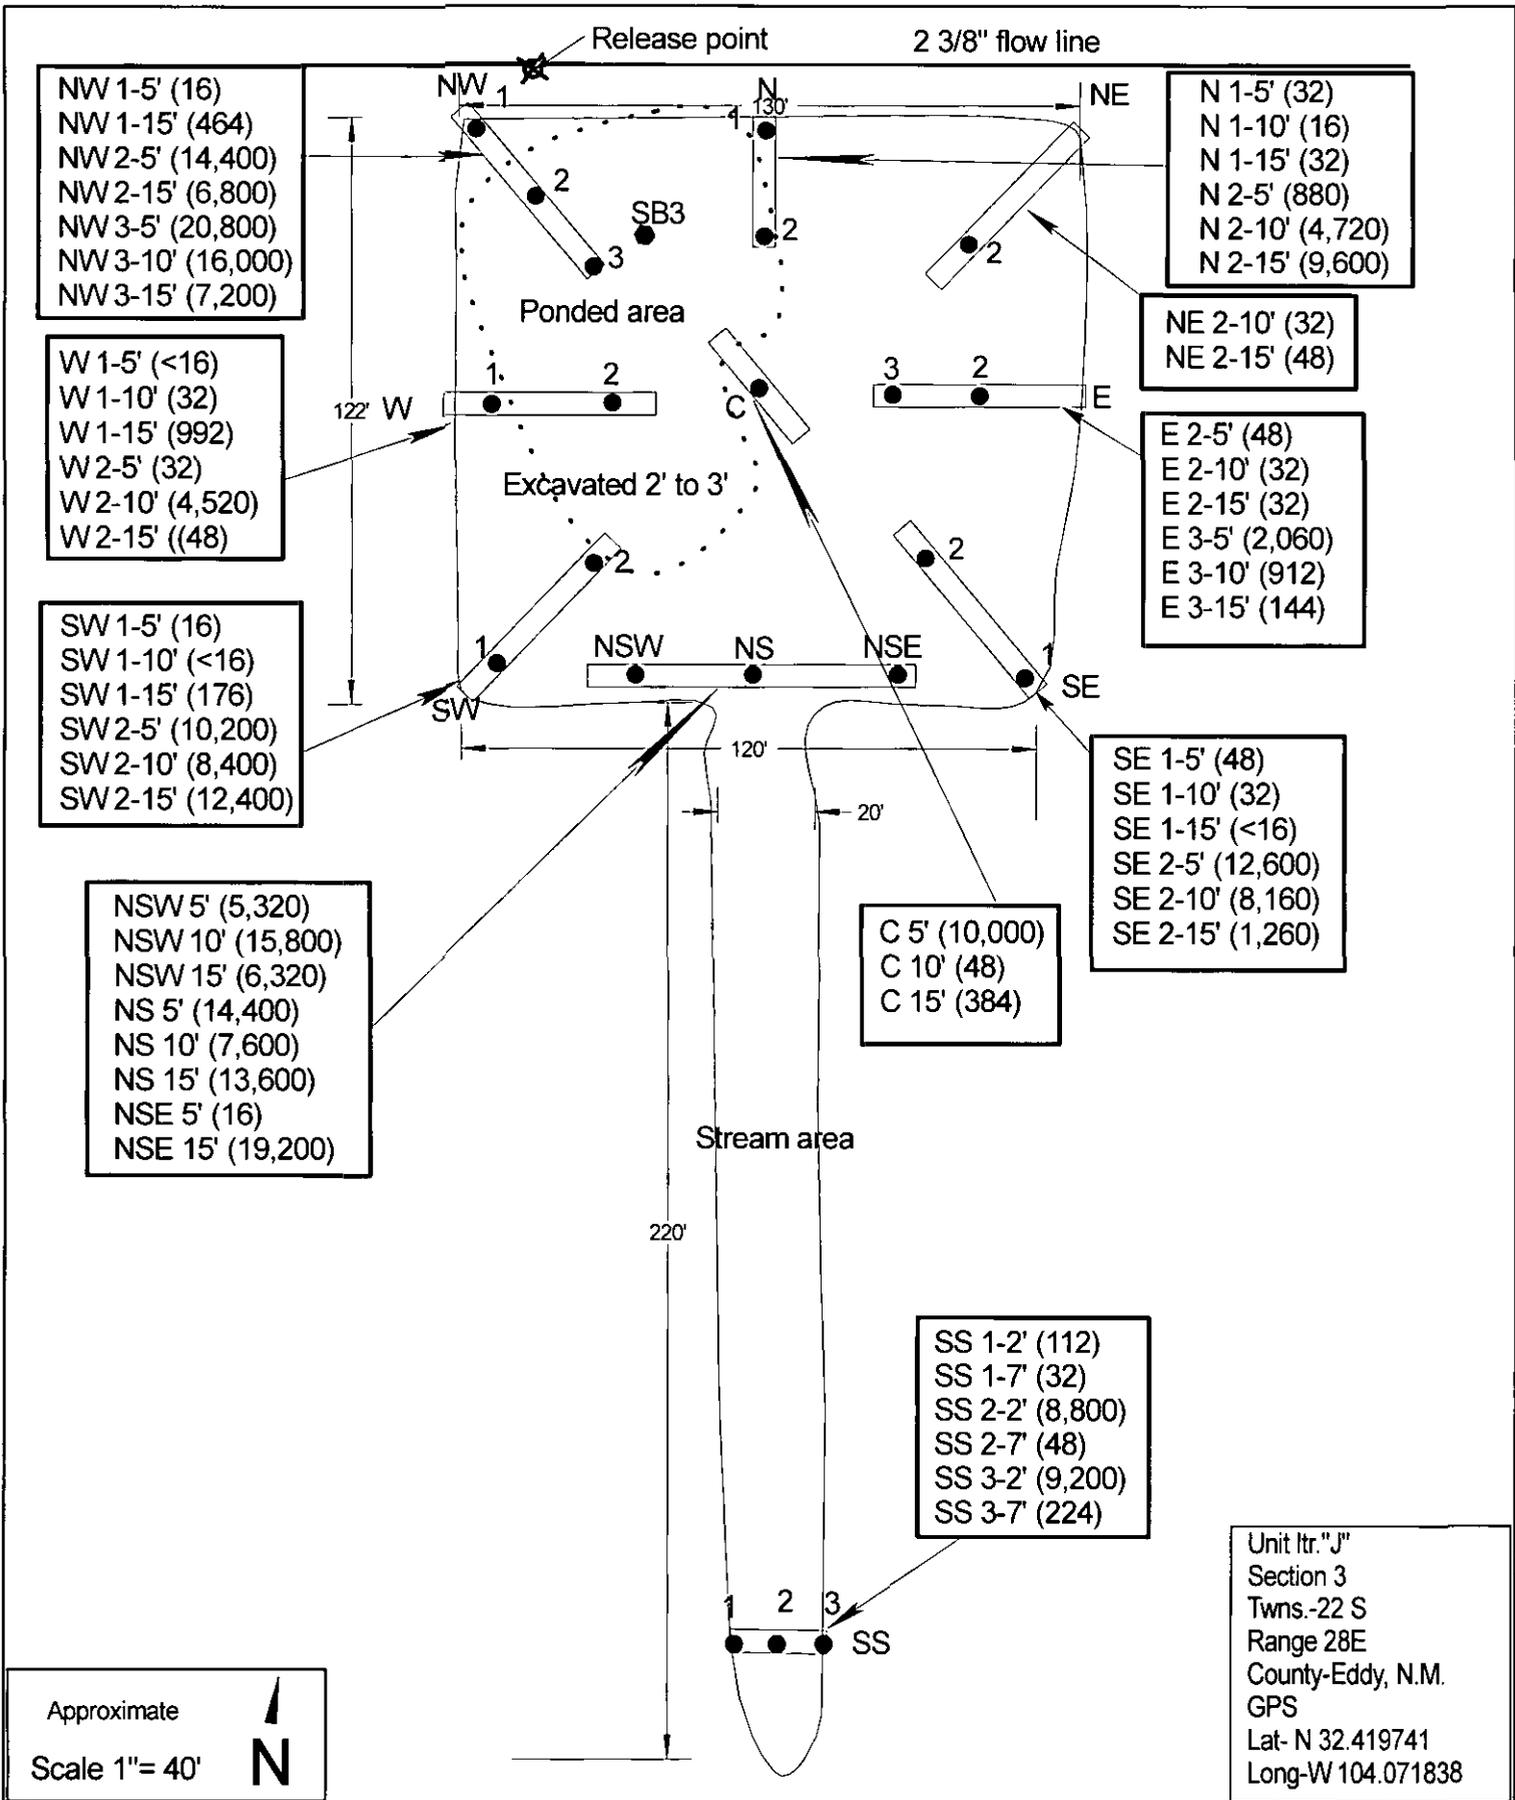
Figure 1-Chlorides

SITE PLAN: Bass 3 Federal #4

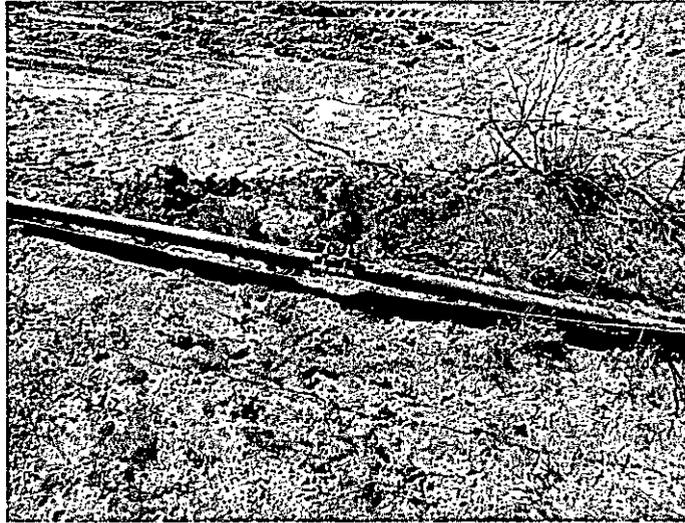
NW looking SE

Bass 3 Federal #4 Flow Line Spill #1
After initial response 3/10/10

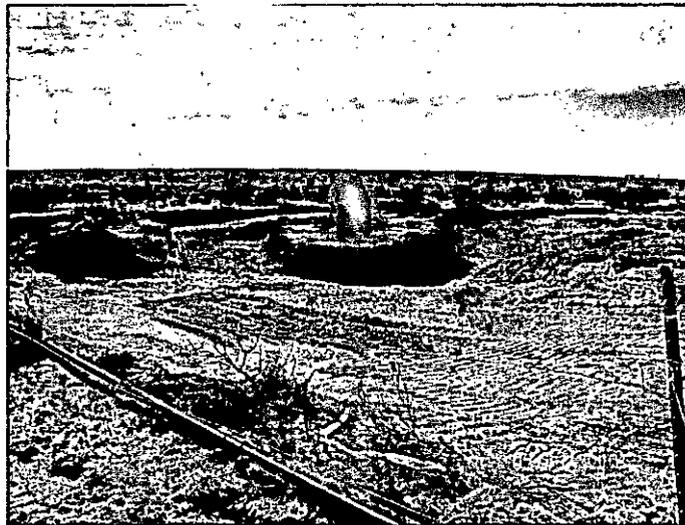
NW Looking SE

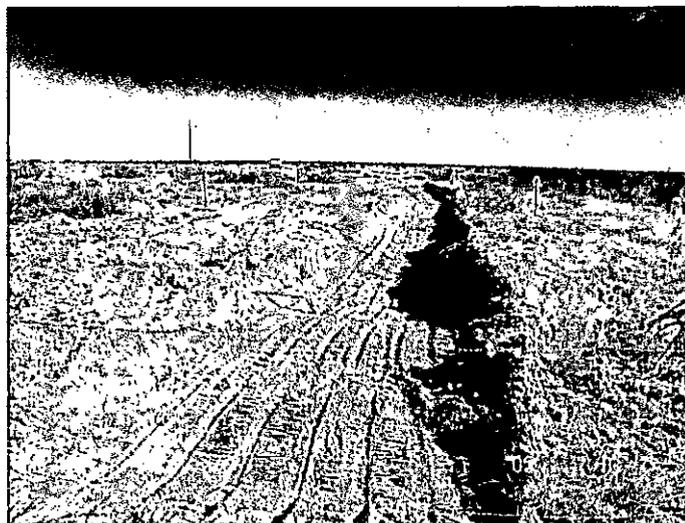
S Looking N

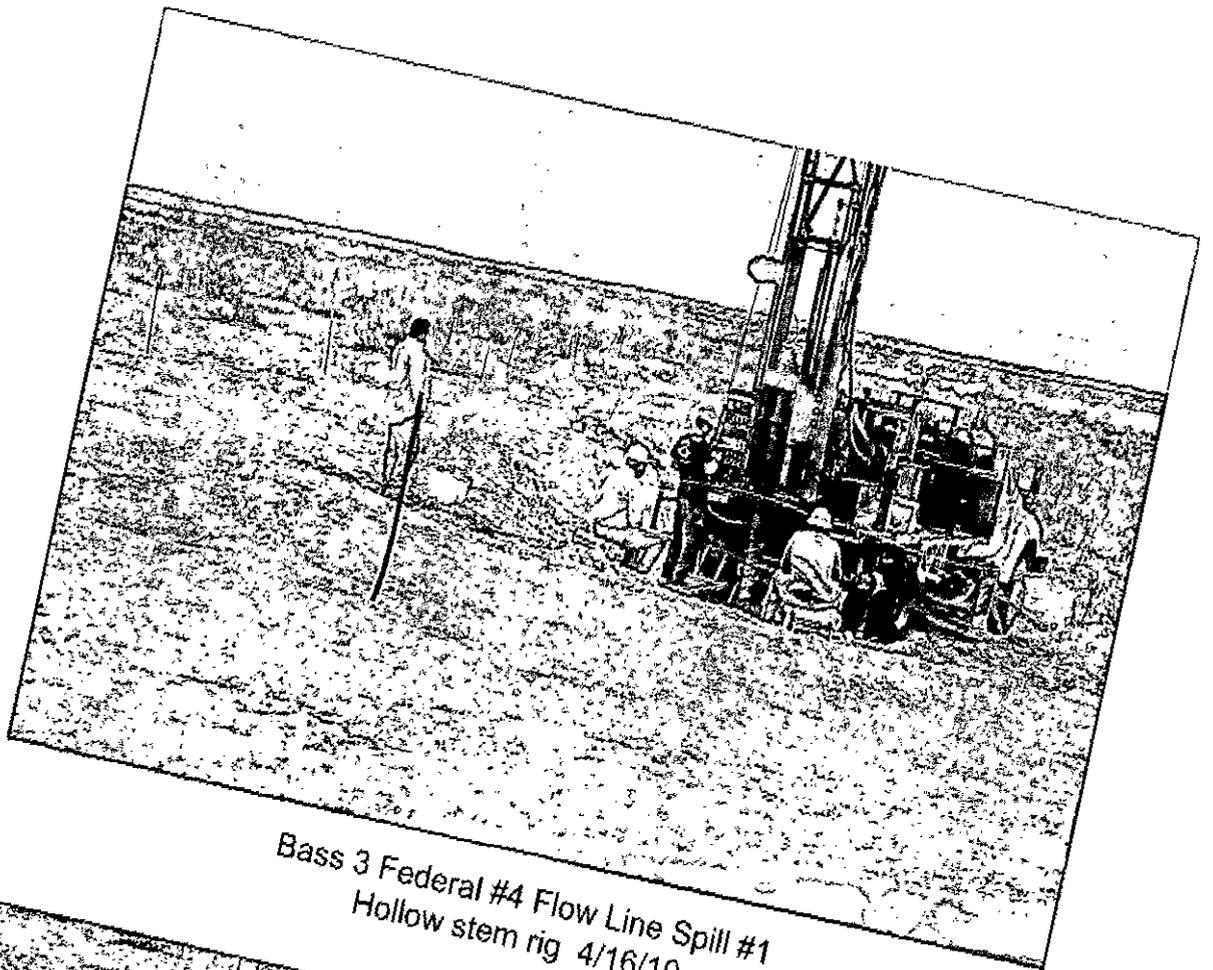
Bass 3 Federal #4 Flow Line Spill #1
Hollow stem rig 4/16/10

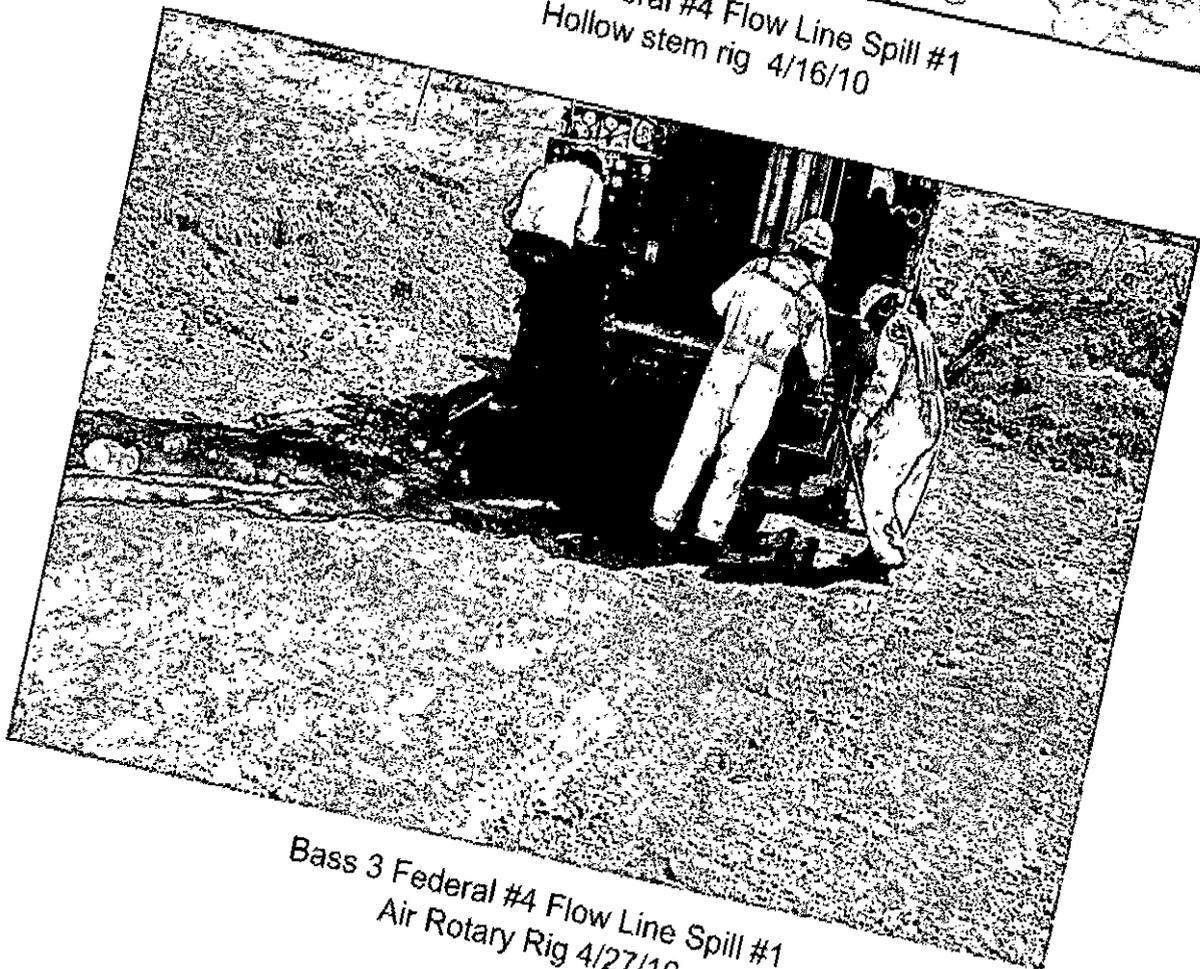
Bass 3 Federal #4 Flow Line Spill #1
Air Rotary Rig 4/27/10

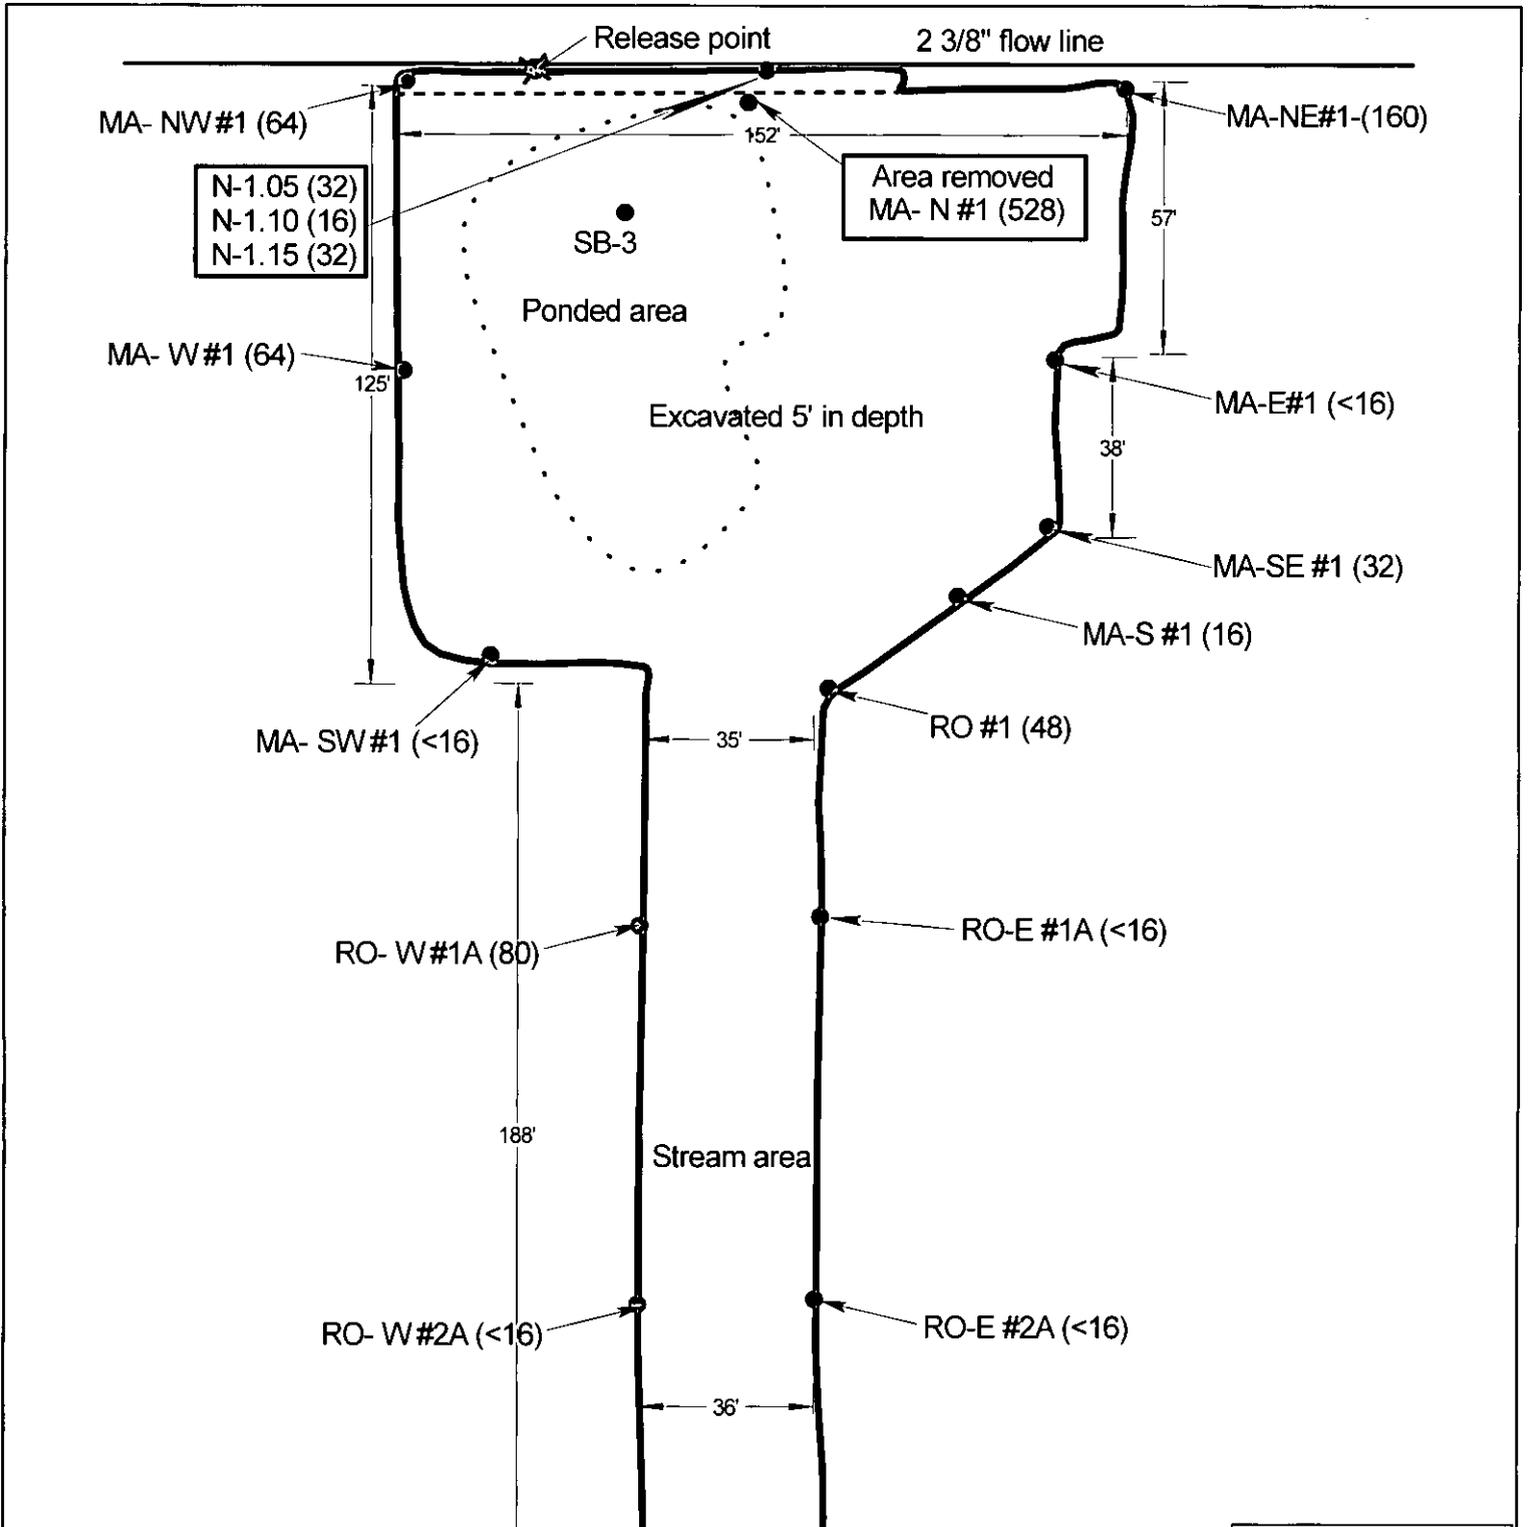
Figure 2-Chlorides

Unit ltr. "J"
 Section 3
 Twns.-22 S
 Range 28E
 County-Eddy, N.M.
 GPS
 Lat- N 32.419741
 Long-W 104.071838

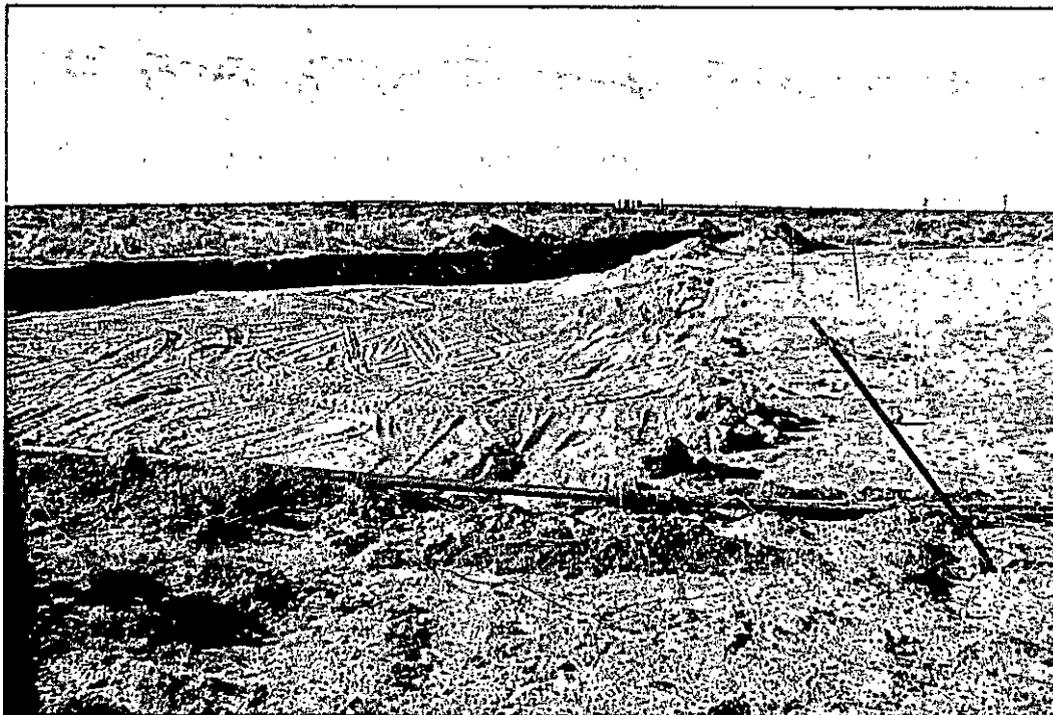
Bass 3 Federal #4 Flow Line Spill #1
Looking North to South 6/17/10

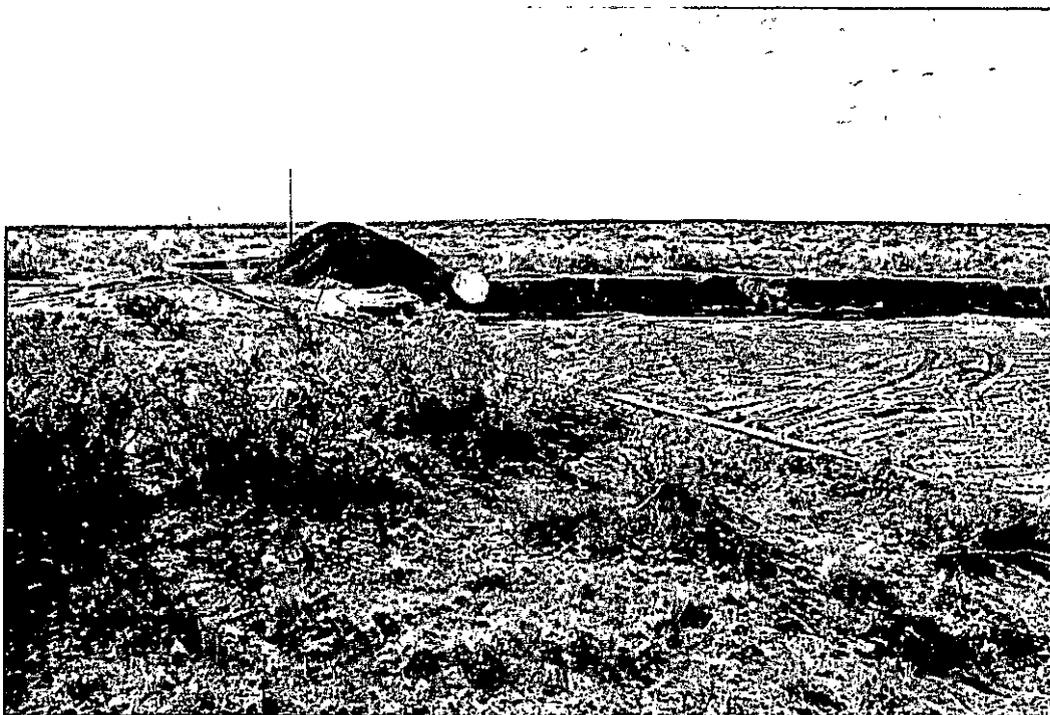
Bass 3 Federal #4 Flow Line Spill #1
Looking West to East 6/17/10

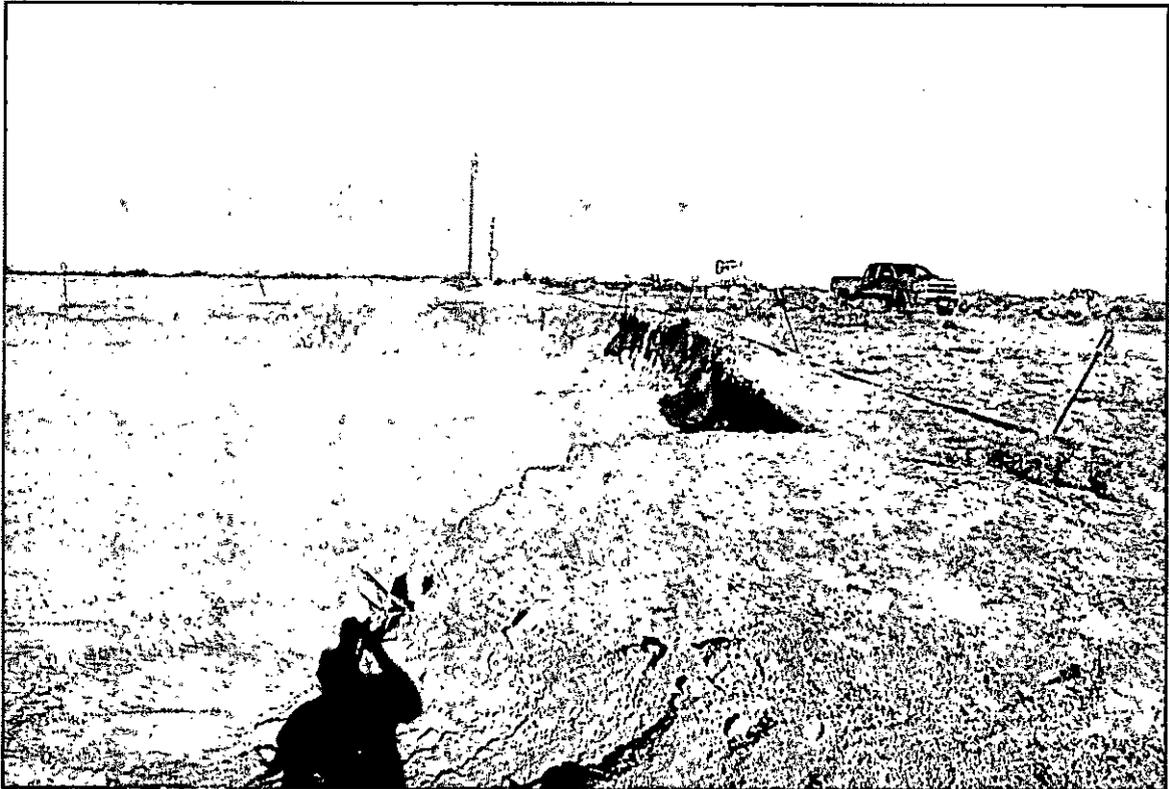
Bass 3 Federal #4 Flow Line Spill #1
Looking East to West 6/17/10
