| | DATE | DEPARTMENT | PREPARED BY |
|--|---|--|---|
| C-141 ZRP-401 Site #1 Site Summary + Closure Data E-mail Correspondence Site Sketch " " | 4/7/15 | | T. Gay |

Release Notification and Corrective Action

Bass 3 Federal #4 Flowline Spill #1

Ranking Analysis, Remediation Plan and Closure Request

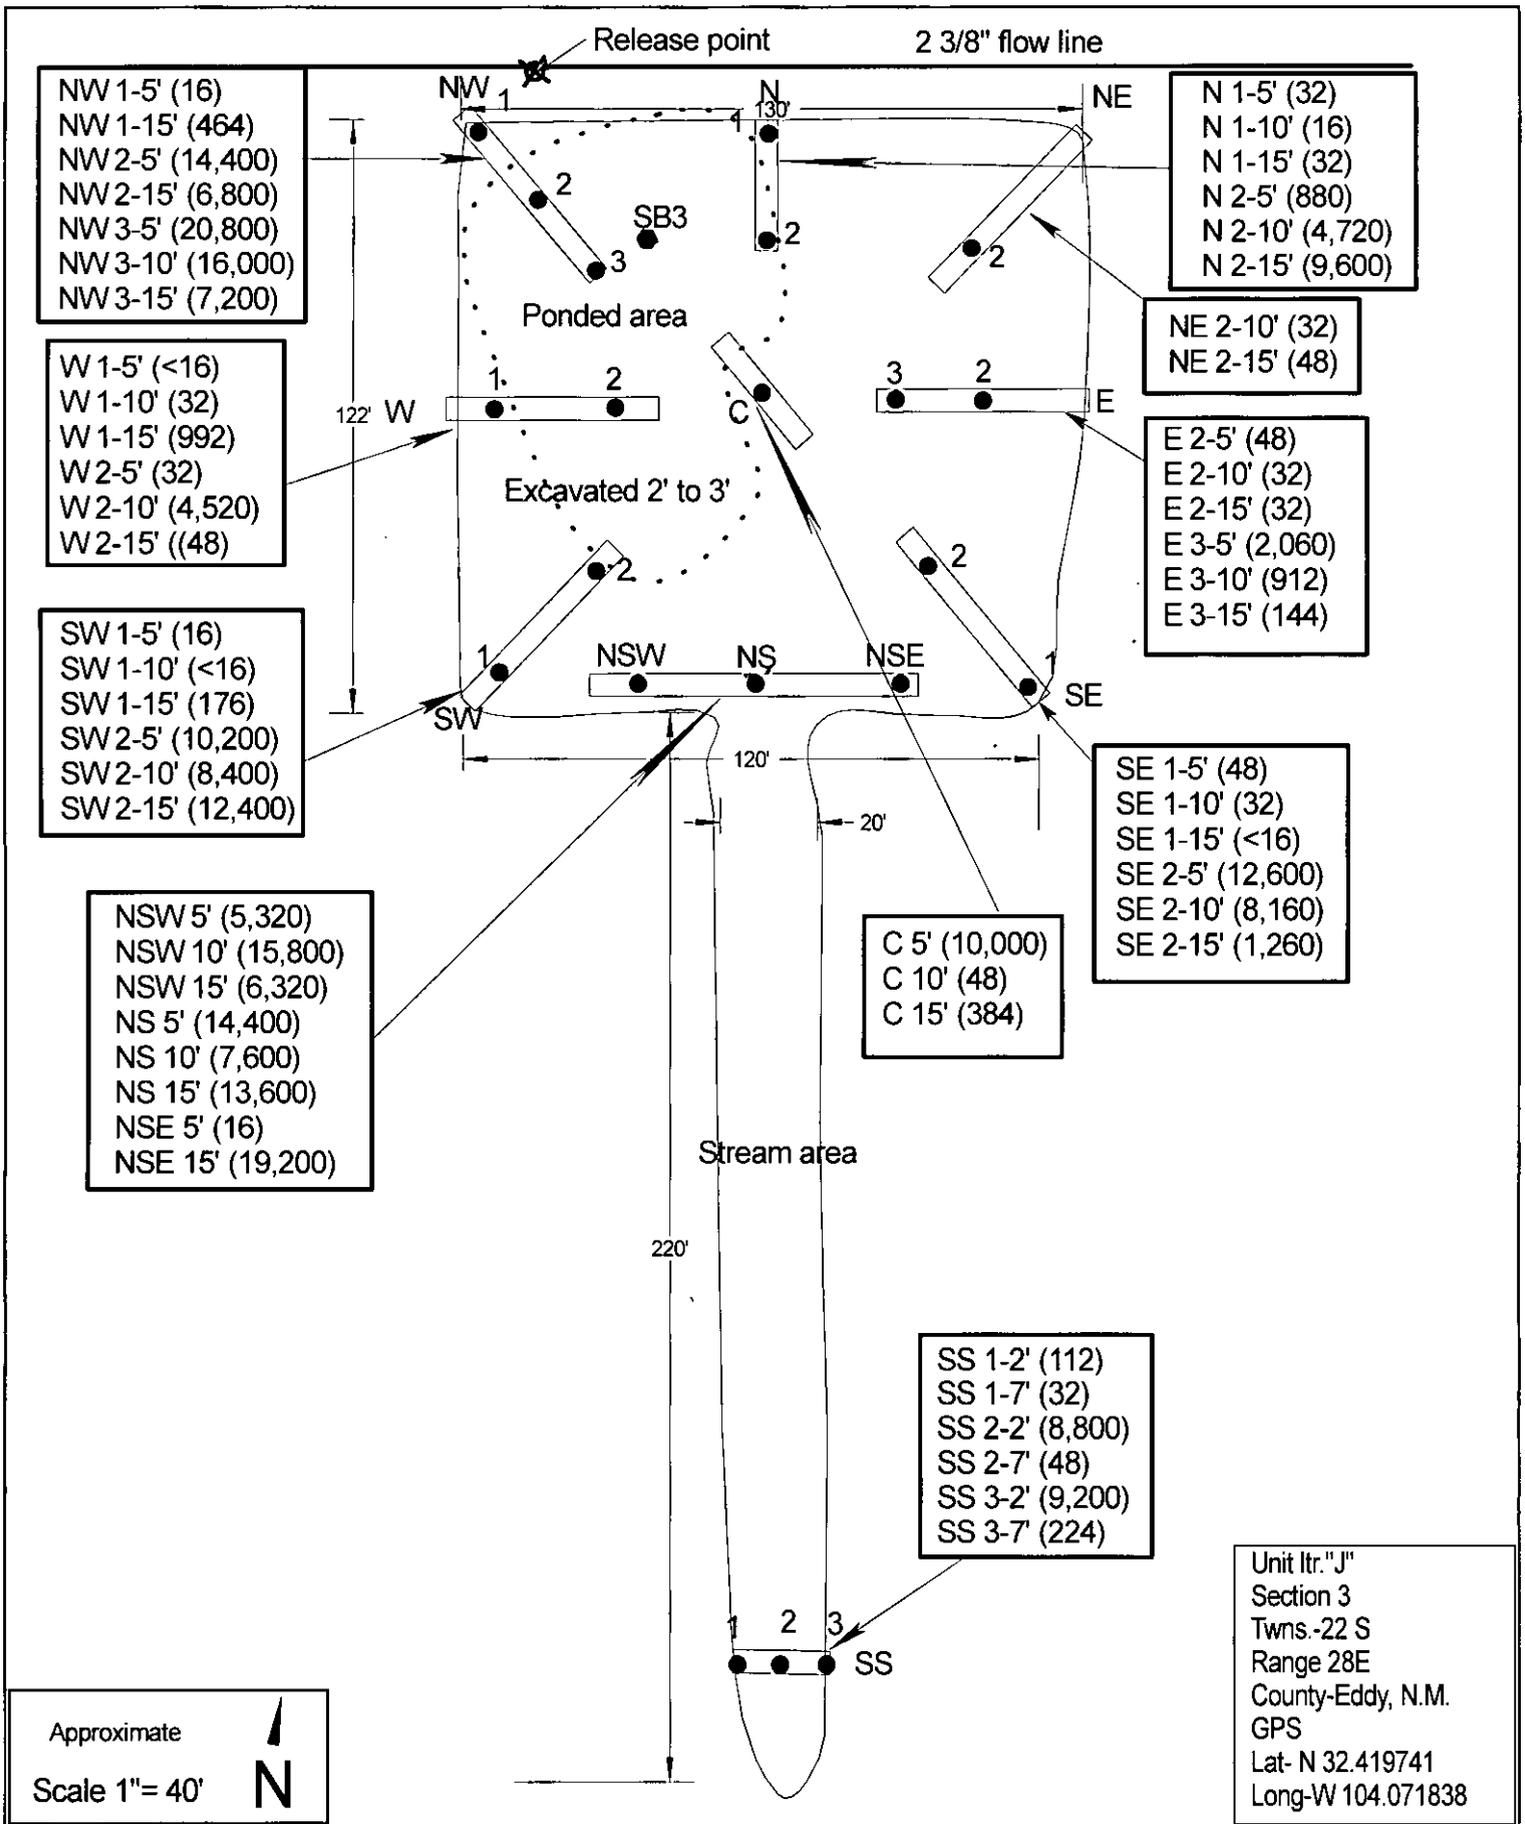
Figure 1-Chlorides

SITE PLAN: Bass 3 Federal #4
